**THE WEATHERING OF SANDSTONE ON
HISTORIC BUILDINGS: CULZEAN
CASTLE, A CASE STUDY**

A thesis submitted for the degree of Doctor of Philosophy

© **Carolyn Susan Hayles**

Department of Geology & Applied Geology
University of Glasgow

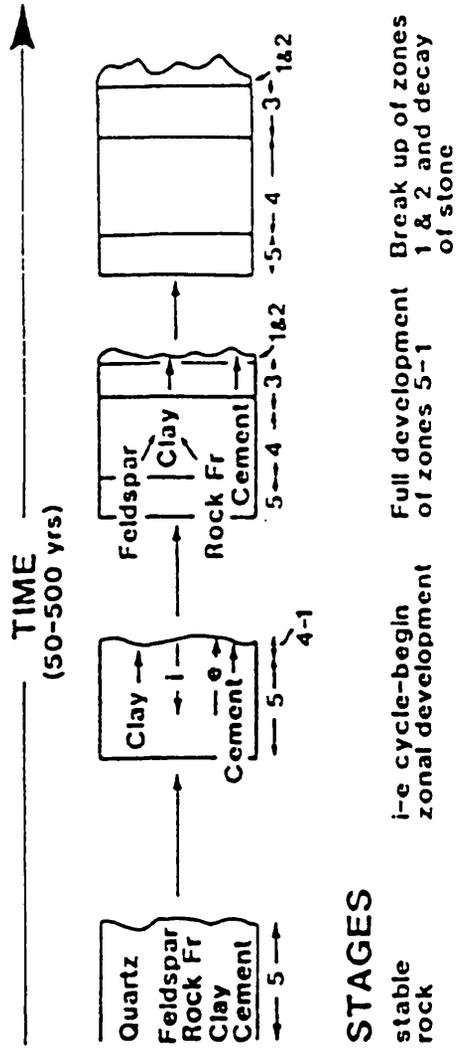
Figure 1.3 A hypothetical cycle in the degrading of sandstone (after B J Bluck, 1992)

2. re-precipitation of dissolved mineral cements;
3. gradation to zone *two* (with colour change);
4. depletion of mineral cement; and
5. original rock.

The model shows the importance of water ingress-egress in the production of a profile of stone weathering, as confirmed below by Mausfield & Grassegger (1994). Of importance in this cycle was the enrichment of clays in zones *two*, *three* and *four*, and a corresponding reduction in feldspars when compared with the feldspar-clay ratios of the fresh rock in zone *five*. Bluck suggests that sandstones may acquire more clay by the breakdown of feldspars during weathering processes, which allows for the transportation and reprecipitation of these elements as clay minerals towards the surface of the stone. It is proposed that in the outer zones *one* and *two*, increased moisture retention time will allow clays to expand and aid other factors such as frost action to break up the stone.

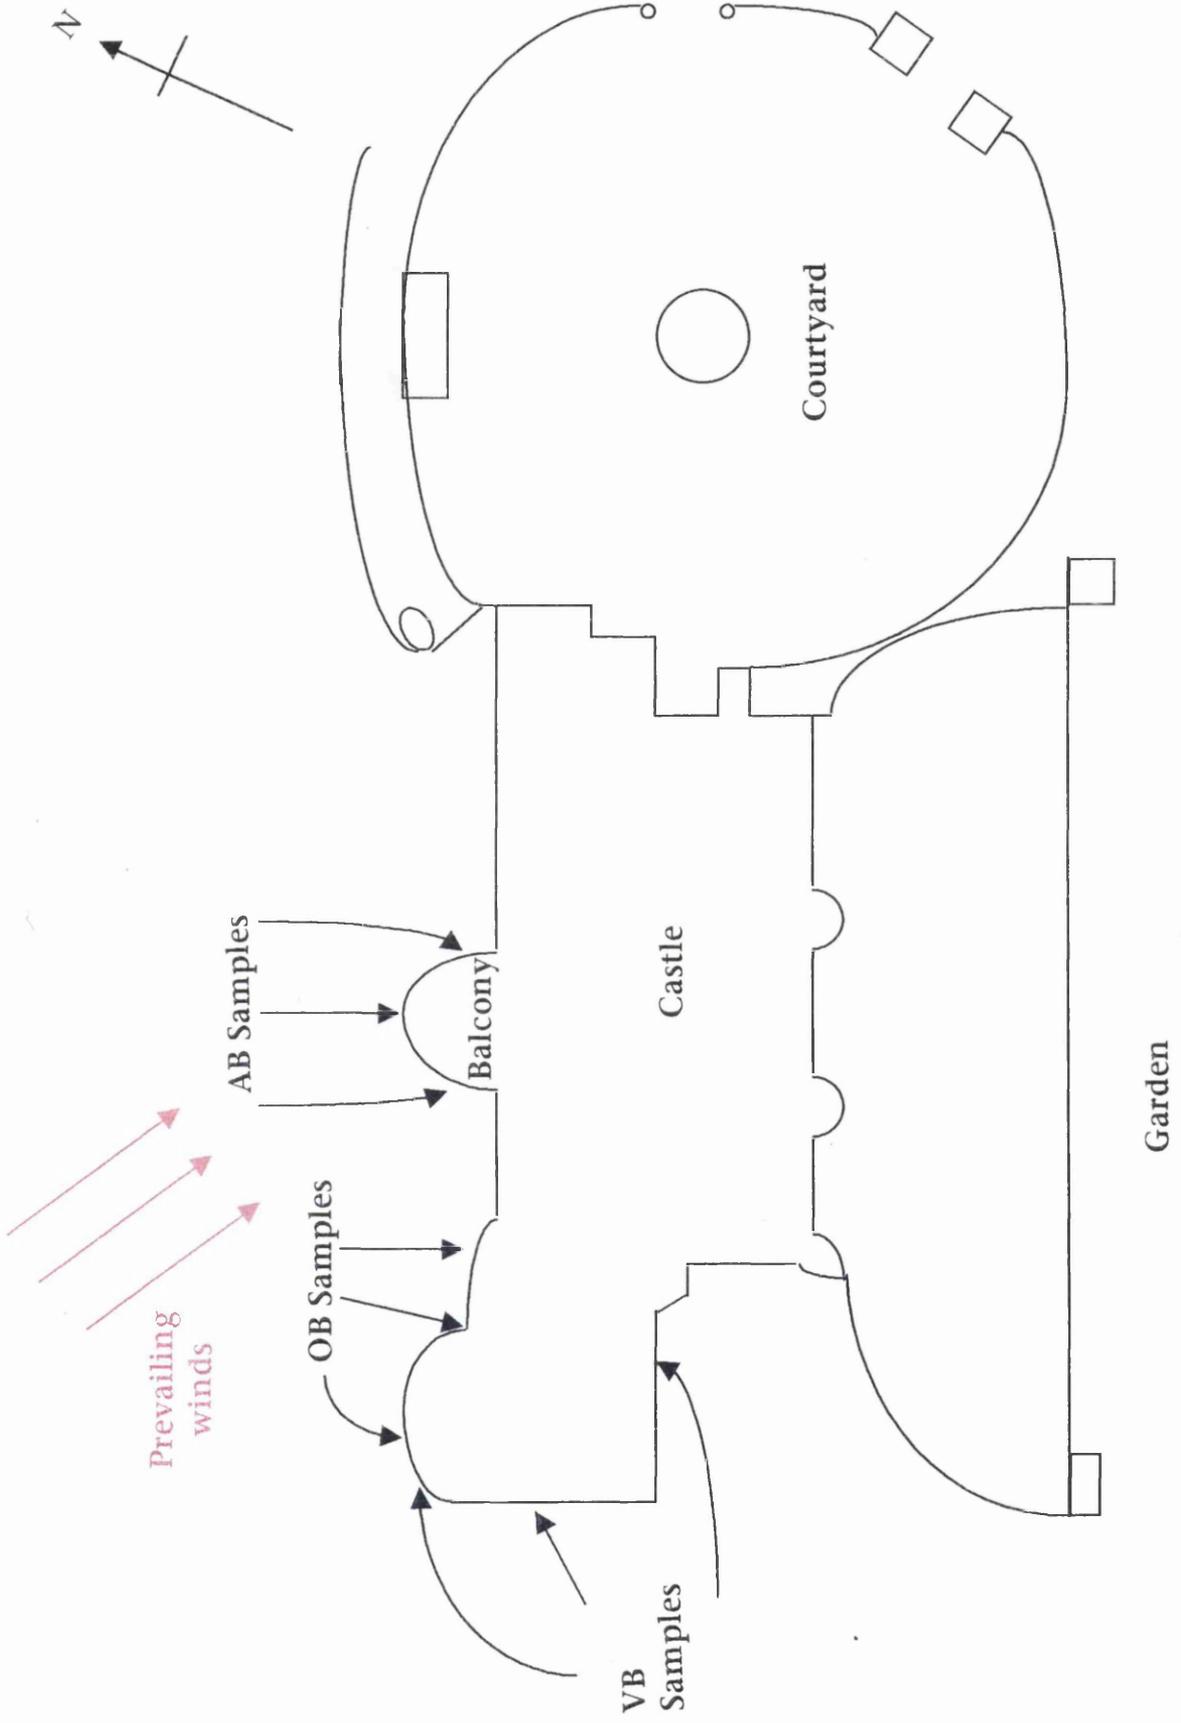
Figure 2.2 Sketch plan of Culzean Castle and coring sites

2). The stone above the balcony was the most decayed stone of the entire building, and thus in greatest need of restoration. The stones here are directly subjected to the prevailing South Westerly winds at a height of 10 m above sea level. The location of the cores drilled from the balcony can be seen in Figure 2.3.

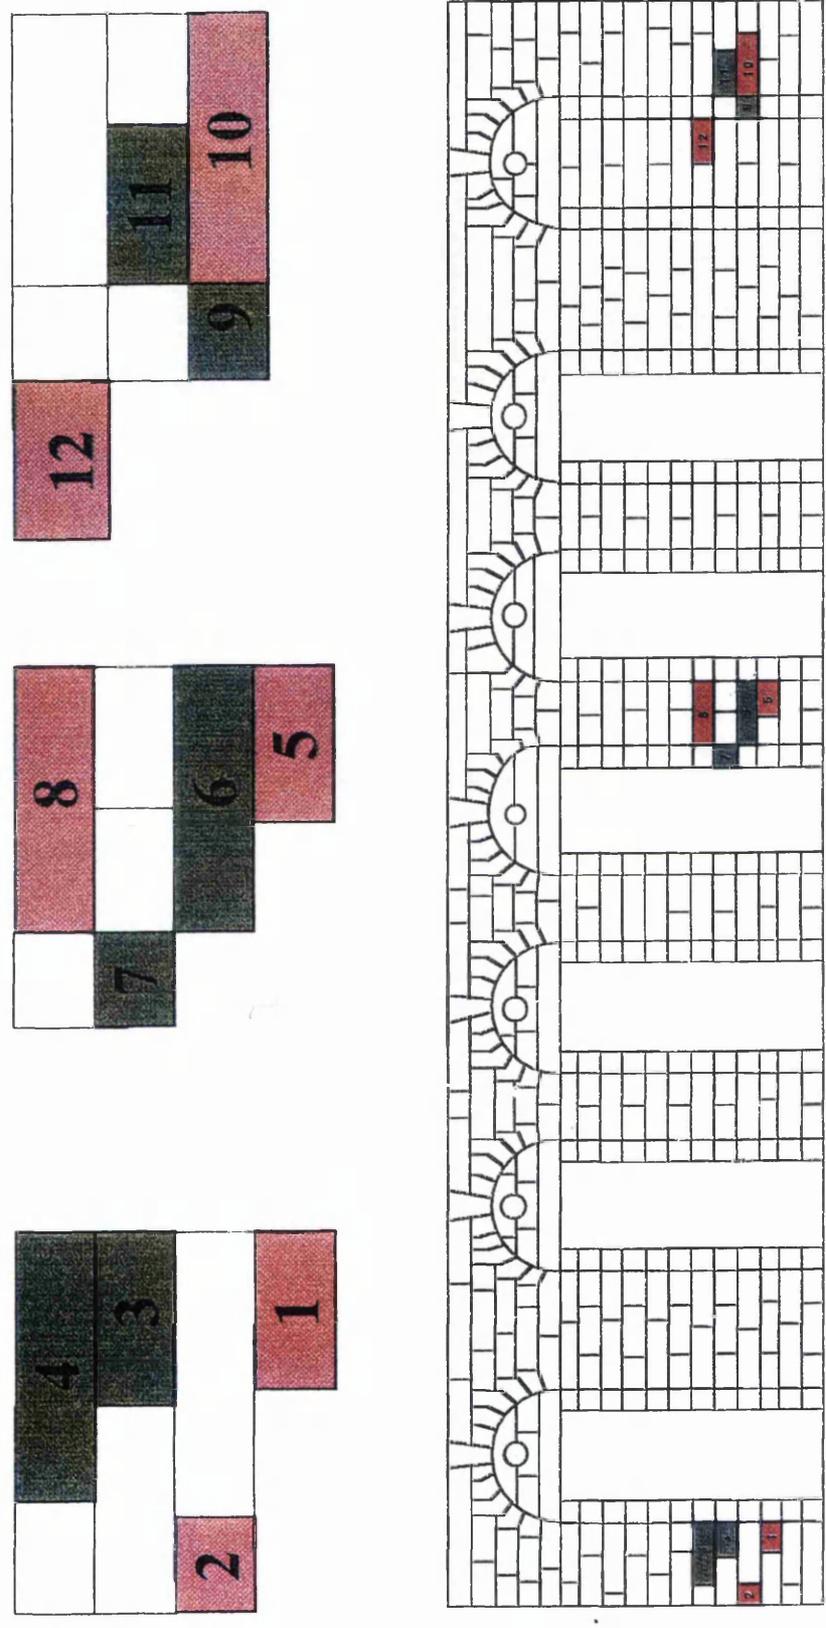
Elevation of the Drum Tower Balcony to show position of stone blocks classified according to weathering criteria and from which cores were taken for analysis

thickness, were falling away from the wall. There were numerous similar surfaces that lay parallel with the stone surface. There was an indicative increase in porosity due to loss of the stone's cementing material.

Some stone blocks were rendered with a cement mortar. Often the cement was seen spalling off with the patina attached. The condition of the material from which the balcony was made varied from completely exfoliated blocks to blocks still intact.

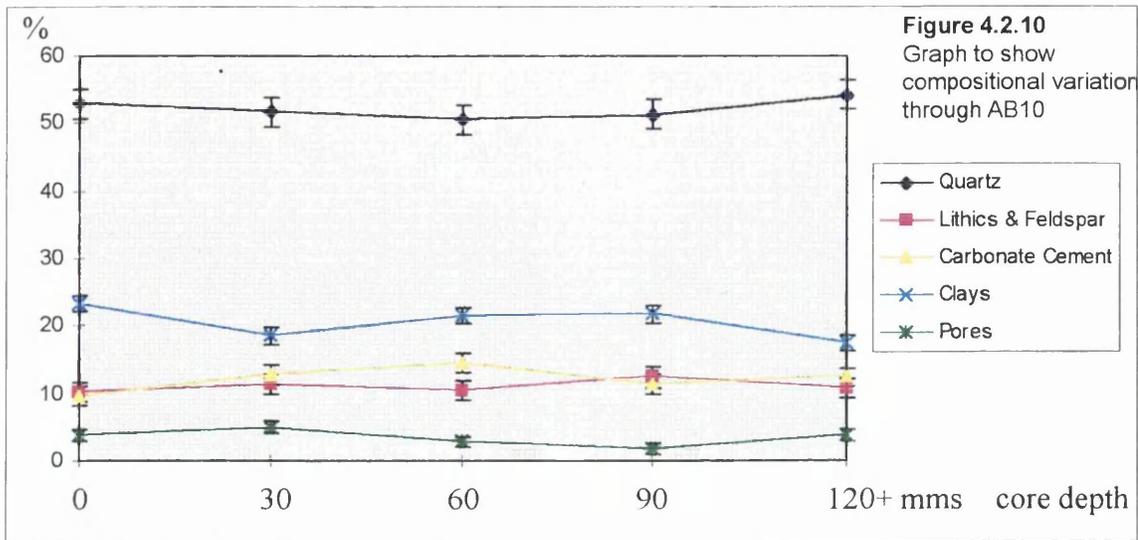
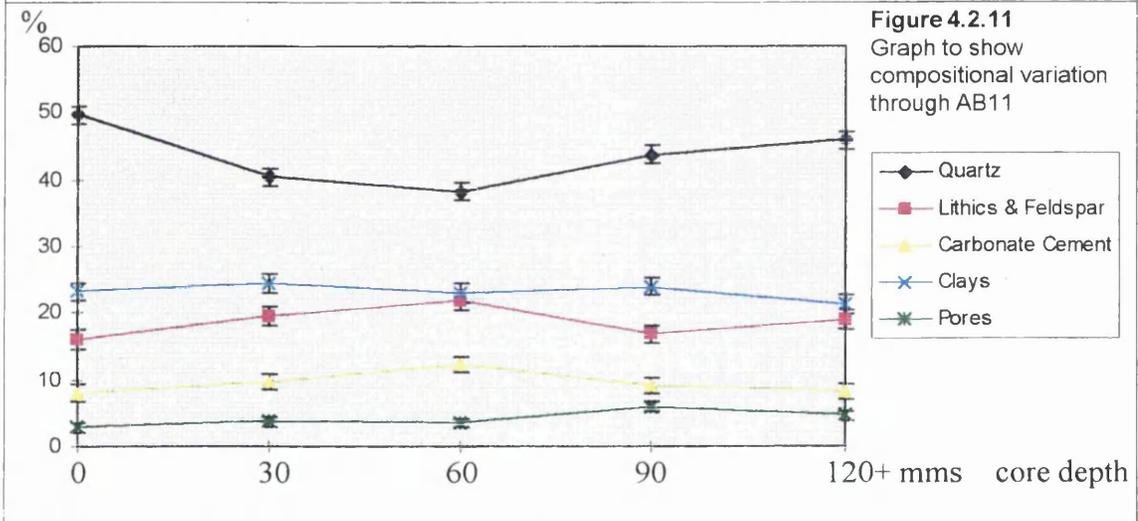
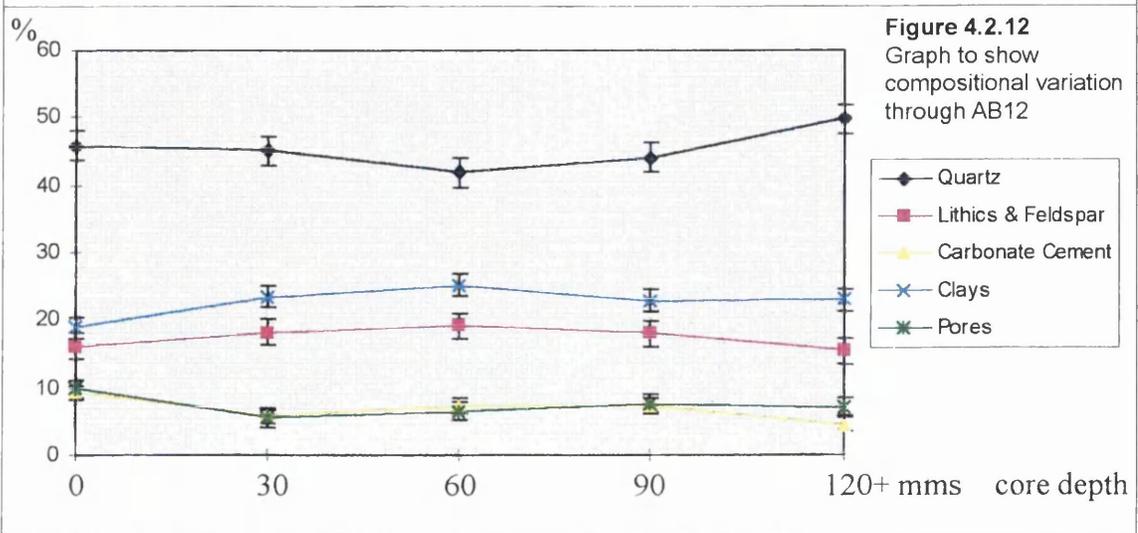
Figure 4.2 Mineralogic compositional profiles by SEM Atomic Number Contrast

AB5, AB7, AB8 and to lesser extent AB1 and AB12 show an increase in pore space at the surface of the stone. All of these samples exhibited granular disaggregation when visual assessment of the surface of the stone was undertaken.

AB4, AB6 and AB9 exhibit a reduction in pore space at the surface of the stone. AB6 retains a spalling patina and a reduction in pore space within this crust would be expected. However both AB4 and AB9 have surface scaling and this reduction in pore space may be indicative of the beginnings of a patina where ions in solution (externally or internally derived) are being reprecipitated in the pore space.

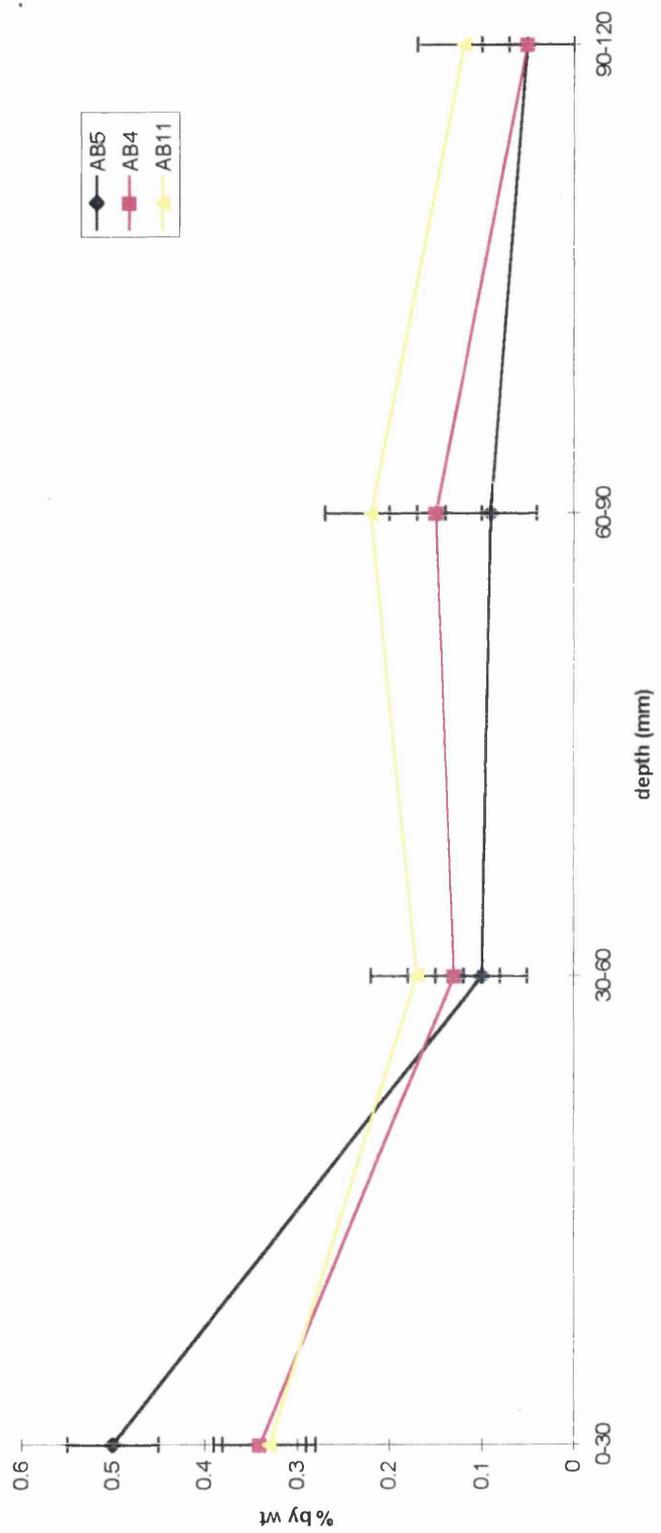
Figure 4.6 Graph to show variation in soluble salt and carbonate content by % weight of sample

4.8.3 Soluble salt crystallisation, hydration and hygroscopy

Therefore a number of different possible soluble salt phases have been determined including halite, gypsum/anhydrite and thenardite/mirabolite. It is known that halite is hygroscopic, it has the ability to readily absorb water vapour from the atmosphere. Halite will therefore undergo continuous changes in volume dependent on its access to moisture. Sodium sulphate (thenardite/mirabolite) will undergo hydration readily. It will hydrate and dehydrate relatively easily in response to changes in temperature and humidity. As water is absorbed the volume of the salt will increase up to 300% (Goudie & Viles, 1997) and this can develop pressure against the pore walls in which the salts are located. Gypsum will produce a greater crystallisation pressure than mirabolite and the solubility of gypsum will increase in the presence of other soluble salts, lowering its deliquescence humidity (Zhender, 1996). The mixture of salts present is also important because salts will precipitate out at different times (Fitzner & Sneath, 1982). The order of crystallisation will depend on their hygroscopicities.

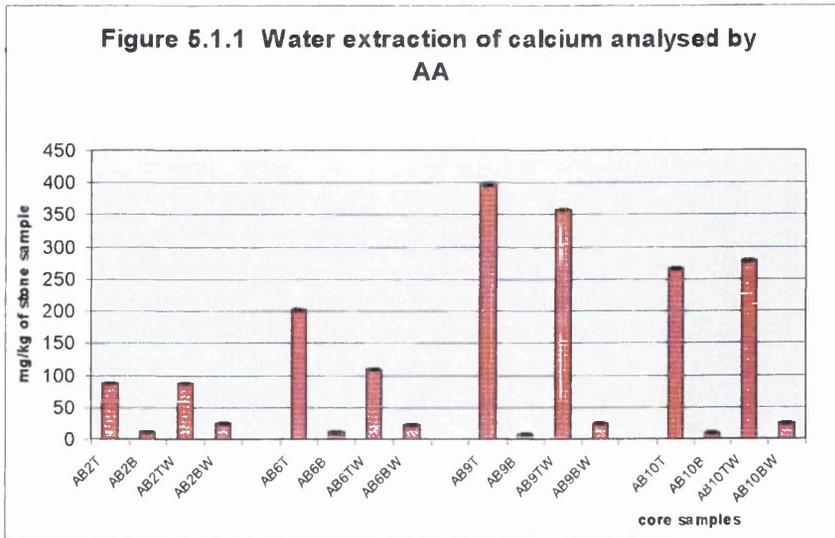
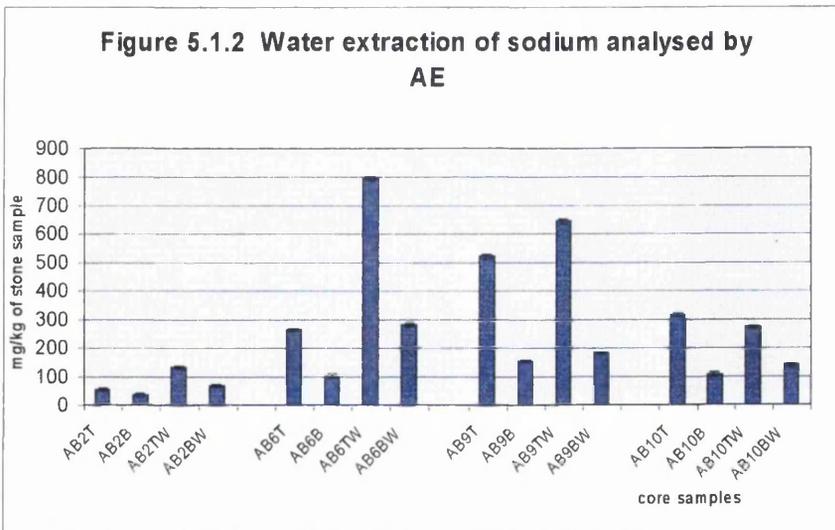
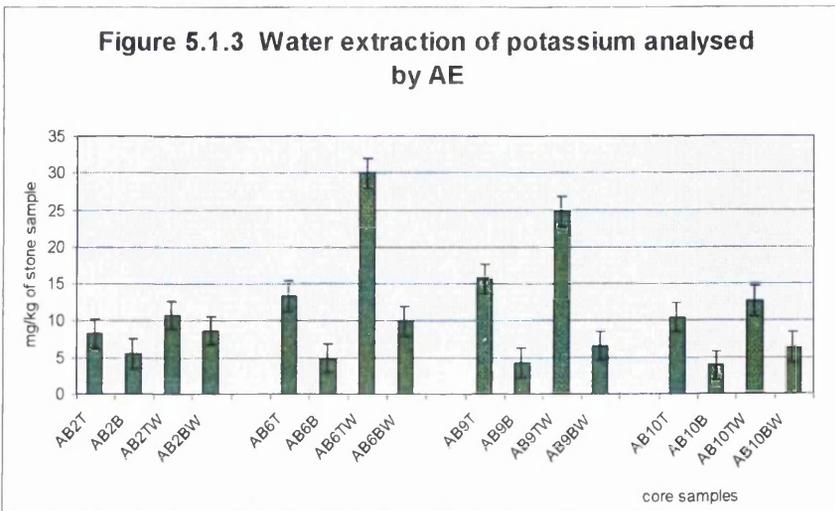
Figure 5.1 AA and AE: Results from water extraction experiments
 Results from AB2, AB6, AB9 and AB10 given as concentrations of mg/kg of stone sample

AB2T Sample AB2 at the surface (0-40mm) using HPLC
 AB2B Sample AB2 at 110-150mm depth using HPLC

AB2T Sample AB2 at the surface (0-40mm) using rainwater
 AB2B Sample AB2 at 110-150mm depth using rainwater

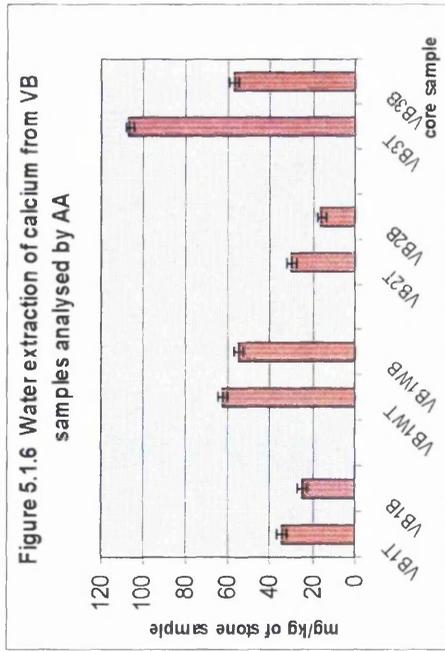
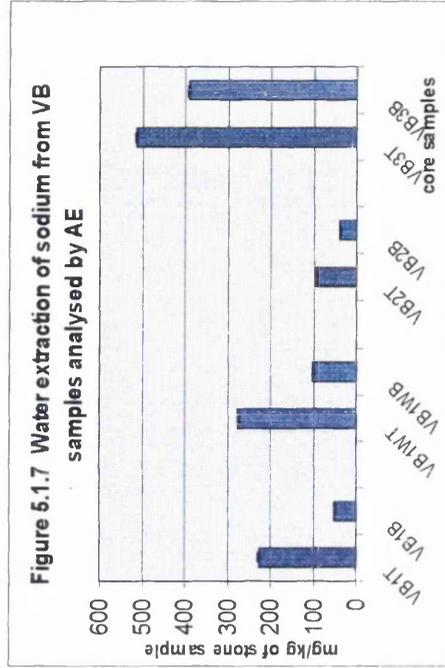
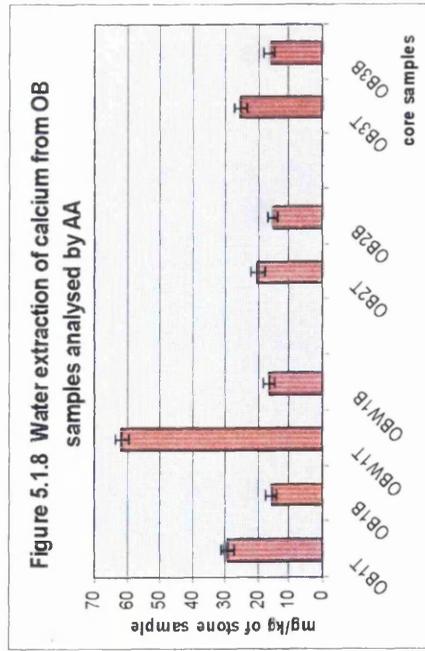
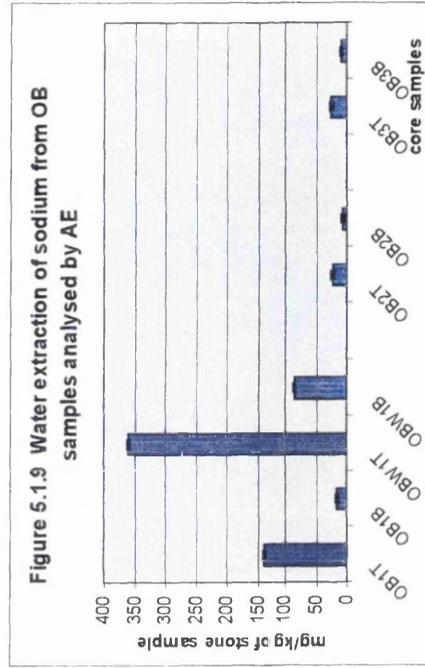
Results from VB and OB given as concentrations of mg/kg of stone sample

small proportion of the Na^+ extracted from the stone could be from soluble precipitates produced during the weathering of feldspar and lithic fragments, and even some of the clays such as smectite.

The differences in the quantity of soluble material analysed using HPLC and Culzean rainwater are marked in AB6, the most deteriorated of all the samples analysed. In sample AB7 similar amounts of Na^+ are extracted from both the surface and interior of AB7, the sample with cement rendering attached. This sample shows reduced insolubility across all the ions analysed compared with the other AB samples.

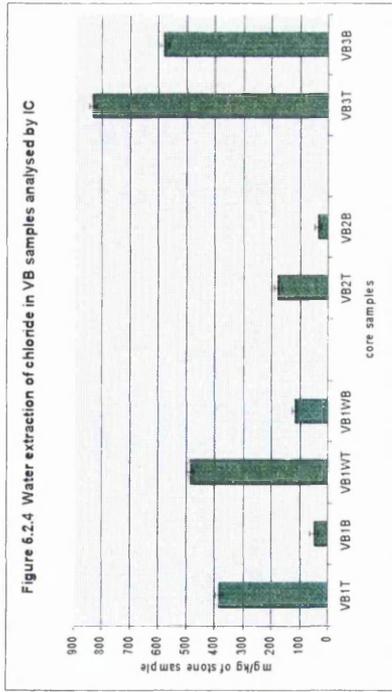
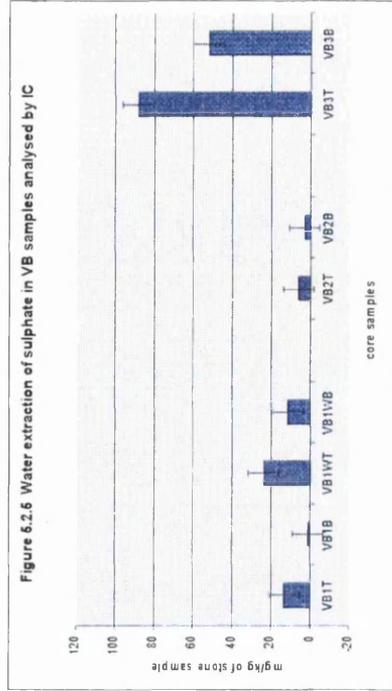
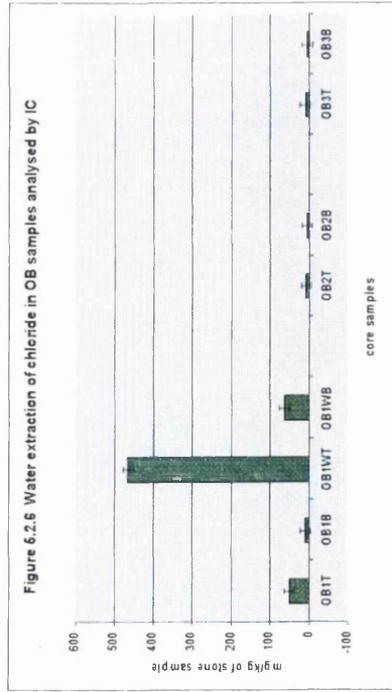
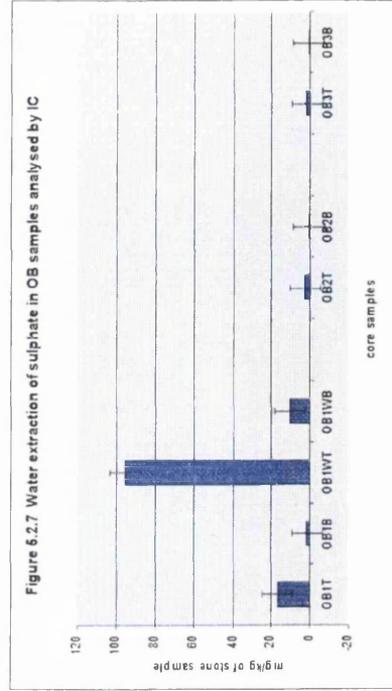
Figure 5.2 IC: Results from water extraction experiments
 Results from VB and OB given as concentrations of mg/kg of stone sample

marine aerosols (3 ppm were found in the Culzean rainwater derived from off-shore wind-driven rain). Sulphurous gases are temporary constituents of the air in so far as they are readily soluble in water and are washed out by rain. Since the Clean Air Act of 1956, there has been a vast decrease in sulphur emissions into the atmosphere. However, it is not known how much SO_4^{2-} is embedded in the stone, particularly as there was a gas house at Culzean which burnt coal to provide power for the castle from the late 1700s onwards. SO_4^{2-} is concentrated at or directly beneath the stone surface (Figure 5.2.2).

XRD results also indicate the formation of thenardite/mirabilite, Na_2SO_4 / $\text{Na}_2\text{SO}_4 \cdot 10\text{H}_2\text{O}$ an highly expansive and thus potentially damaging evaporite, related to halite.

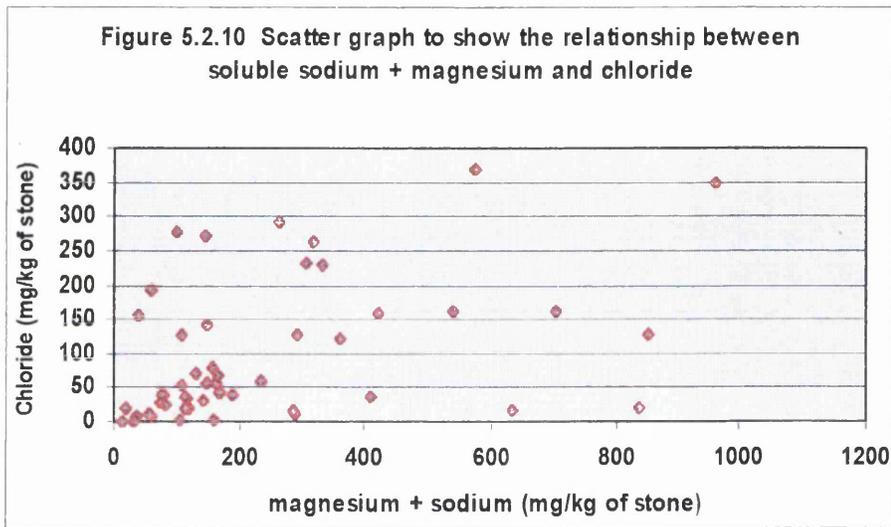
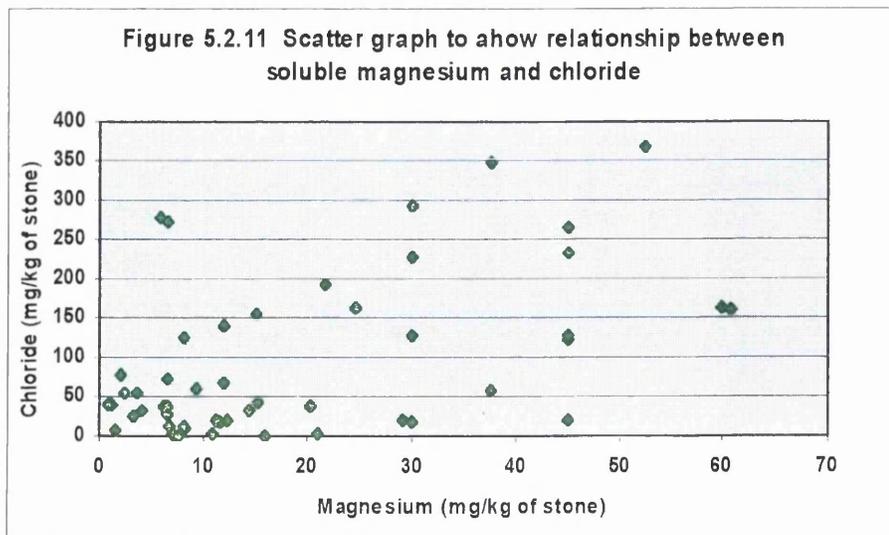
IC, AA & AE: Results from water extraction experiments
Scatter graphs to show the relationship between
anions and cations in solution

may not be derived solely from an external source, but from e.g. clays, where NH_4^+ ions may be dissolved out.

It is believed that both SO_2 and NO_x can have synergistic effects on stone. A number of early investigations (Livingstone, 1985), dismissed the role of NO_x in stone decay because only small quantities of for example, NO_3^- , are found in stone surfaces and runoff water, as at Culzean. However, laboratory studies (Rosenberg & Grotta, 1980; Johansson *et al.*, 1986; 1988) suggest that NO_2^- can enhance SO_2 pick-up without producing nitrates (BERG, 1989). NO_3^- is more prevalent in the samples from Culzean than NO_2^- .

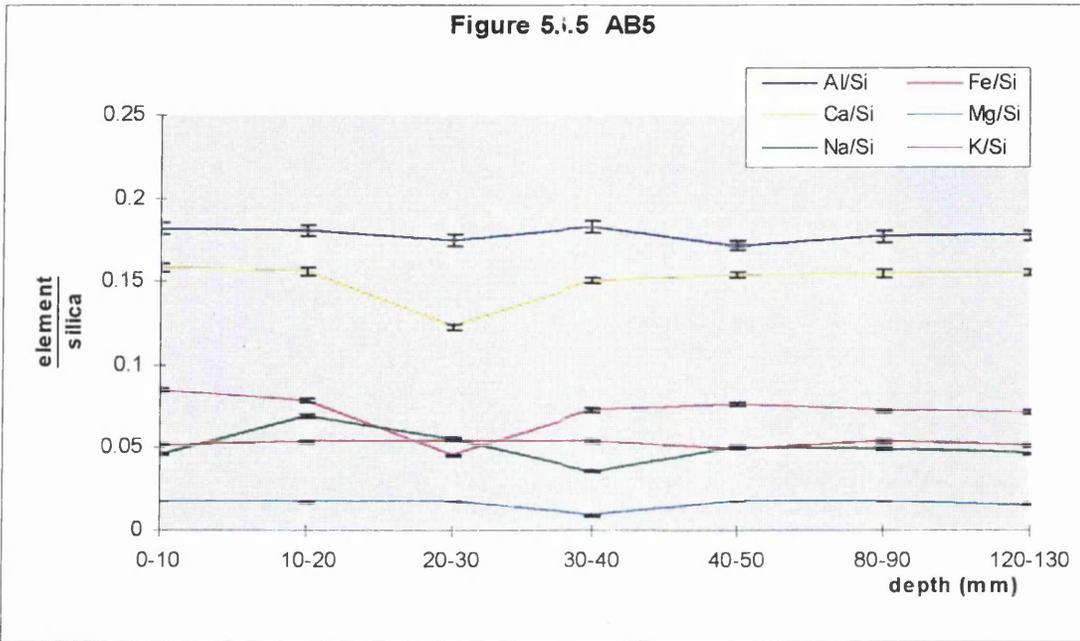
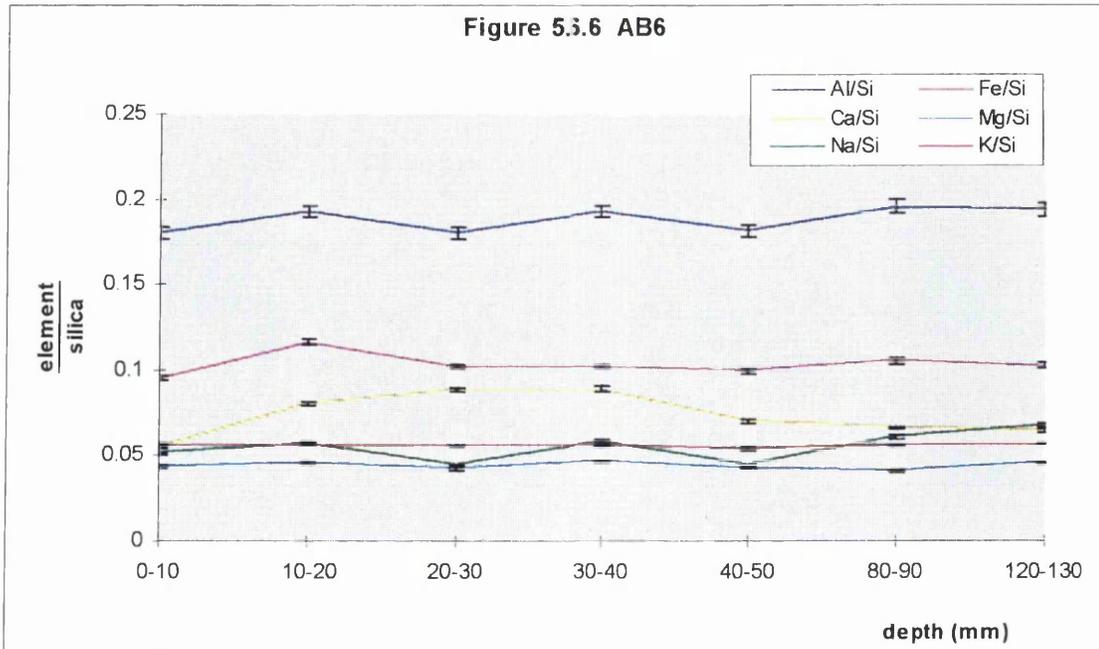
XRF: Results for AB samples
Based on wt% elemental values

amount was extracted in the leaching experiments described in *Section 1*). SO_4^{2-} levels are fairly low except at 10-20 mm depth where increased to 952 ppm. AB6 is also highly enriched in an SO_4^{2-} phase at AB6/2 (Figure 5.3.6).

There are also variations in the Al^{3+} profile which may reflect the state of deterioration, as Al^{3+} is usually the least mobile of elements in a weathering profile (Brownlow, 1996). In addition there may be a concentration of Fe (total) behind the patina where the carbonate cement is reprecipitating after dissolution. This is reflected by the carbonate analysis discussed in Section 4.7.1.

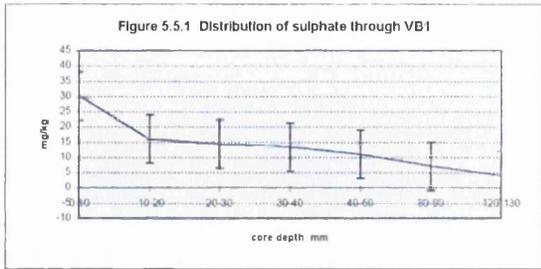
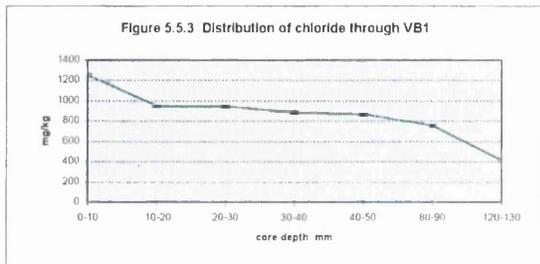
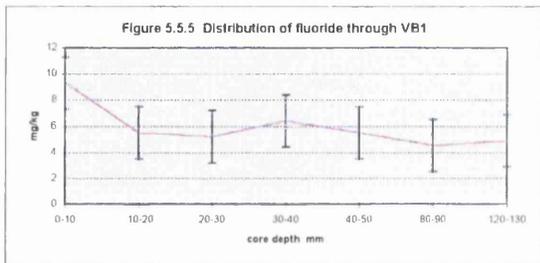
Figure 5.5 Ion Chromatography: Results from VB core samples
 Results given as concentration of mg/kg of stone

It is clear from the concentrations found in OB3 that this sample is taken from higher up and directly facing the sea, as the Cl^- and SO_4^{2-} figures were considerably higher compared with the other OB and OQ samples analysed. The F^- concentrations have also been reproduced, showing that trace amounts were present throughout the depth of the stone analysed. There is no indication of increased values att. The Cl^- concentrations in OB contrast with those shown in the AB samples; the highest figure being 710 ppm in comparison with 2500 ppm for AB and indeed 1251 ppm for the surface of VB1. The VB samples showed higher Cl^- concentrations than those exhibited by OB and OQ. SO_4^{2-} and F^- concentrations were significantly lower (particularly SO_4^{2-}) compared with the AB results. The low values of the OB samples reflect the low 'effective' porosity of the stone as well as its protected location in the foundations of the building. This highlights the importance of aspect (AB being most exposed, OB3 facing the sea, etc) and the strength of the rock matrix of the different stones in determining their response to salinity.

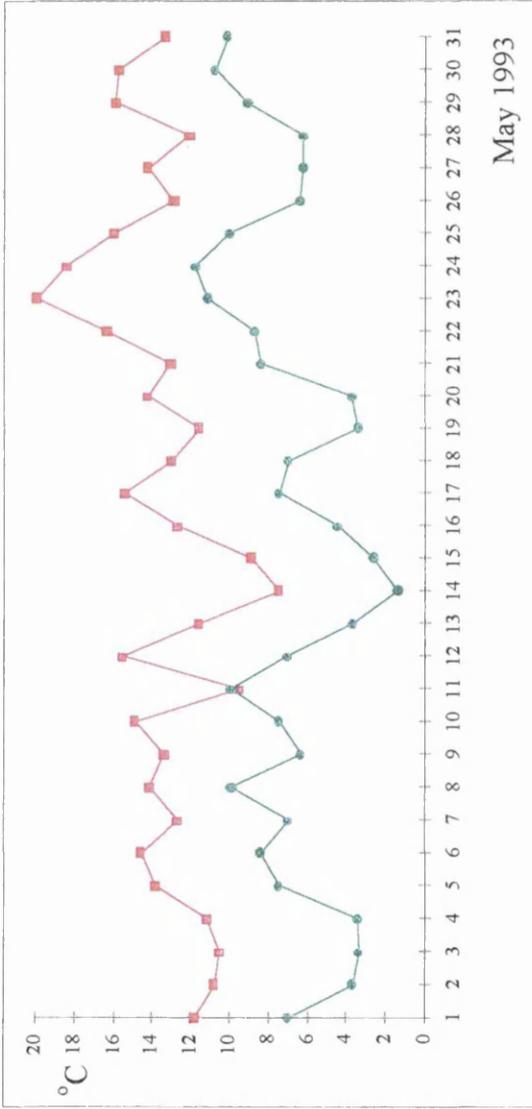
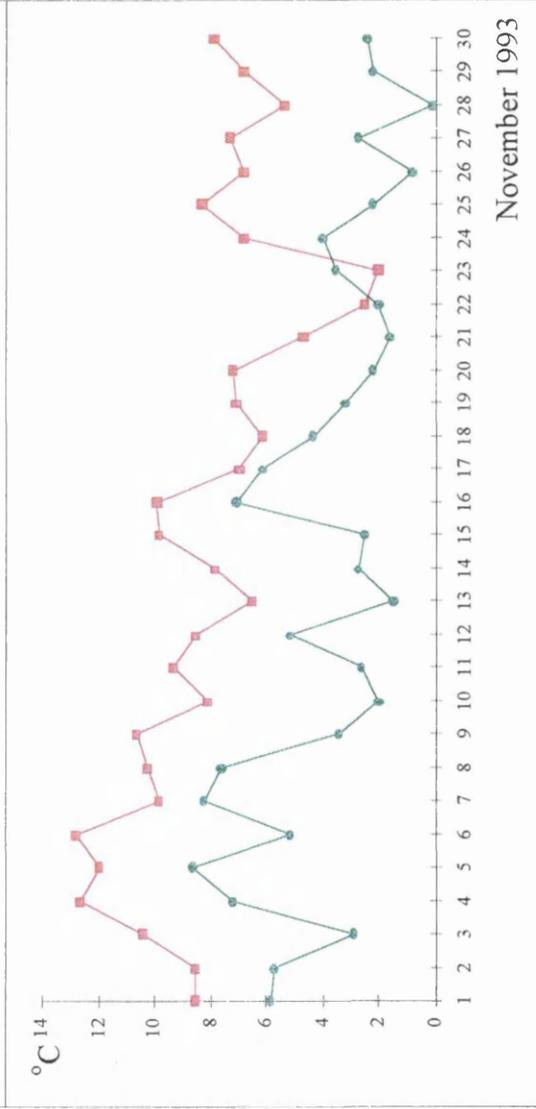
Figure 6.1 Maximum and minimum air temperature variations at Culzean during May and November 1993

of 1993. These exemplify the diversity of wind direction and particularly speed, recorded. Table 21 also shows the rainfall in mm for this recording period. Rainfall was recorded for a period of 9 consecutive days. During this time the stone will have been continually propagated by water from splash, run-off and capillary action, and will not have had an opportunity to 'dry out'. The stone will also undergo rapid changes in surface temperature as wind eddies set up local microclimates altering the surface temperature of the stone.

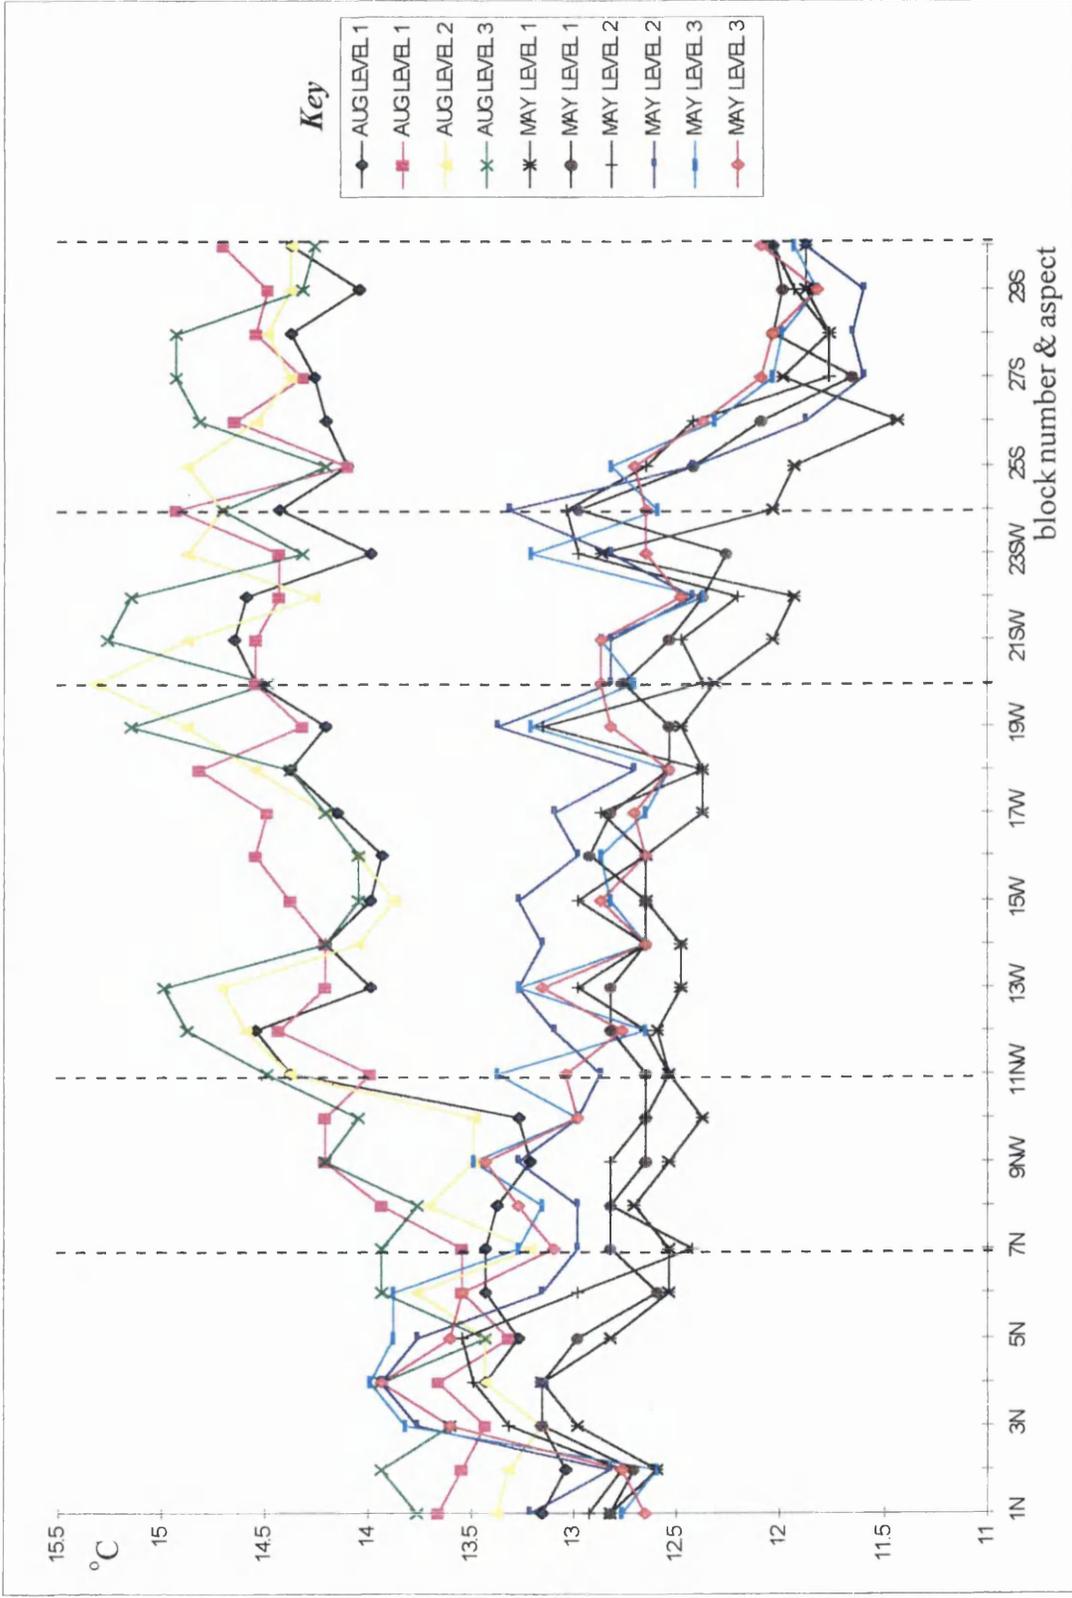
Figure 6.3 Graph to compare Midday surface temperature variations of stone blocks around the balcony from North-to-West-to-South

stone. Heat retention in the stone as a whole can only be attained from the temperature within the stone. Moisture retention in the stone can only be attained from relative humidity within the stone. Thus two different physical phenomena due to temperature fluctuations can be recognised:

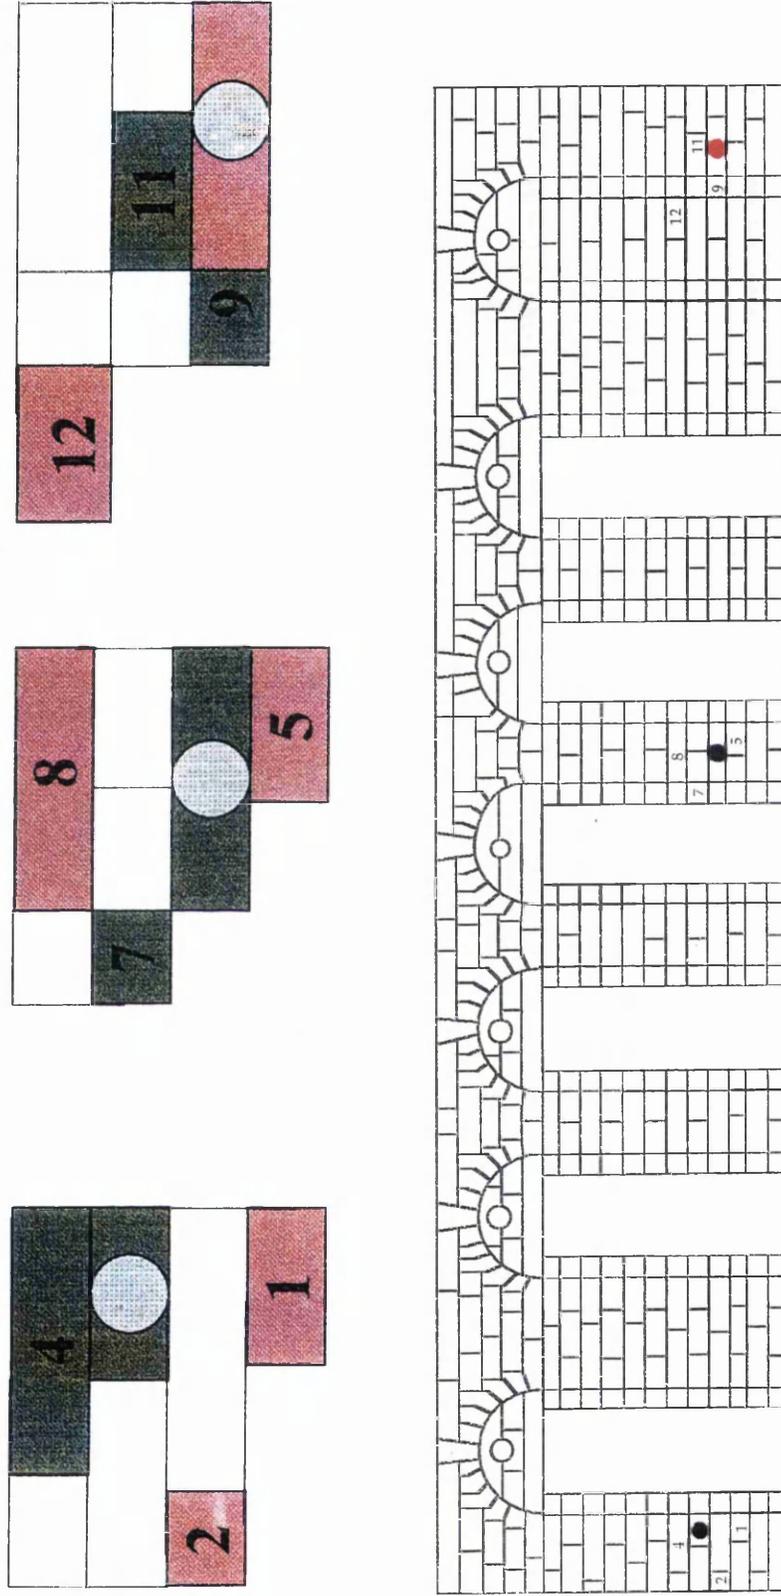
A Plan of the Drum Tower Balcony to show location of plugged bore holes where temperature and humidity measurements were undertaken

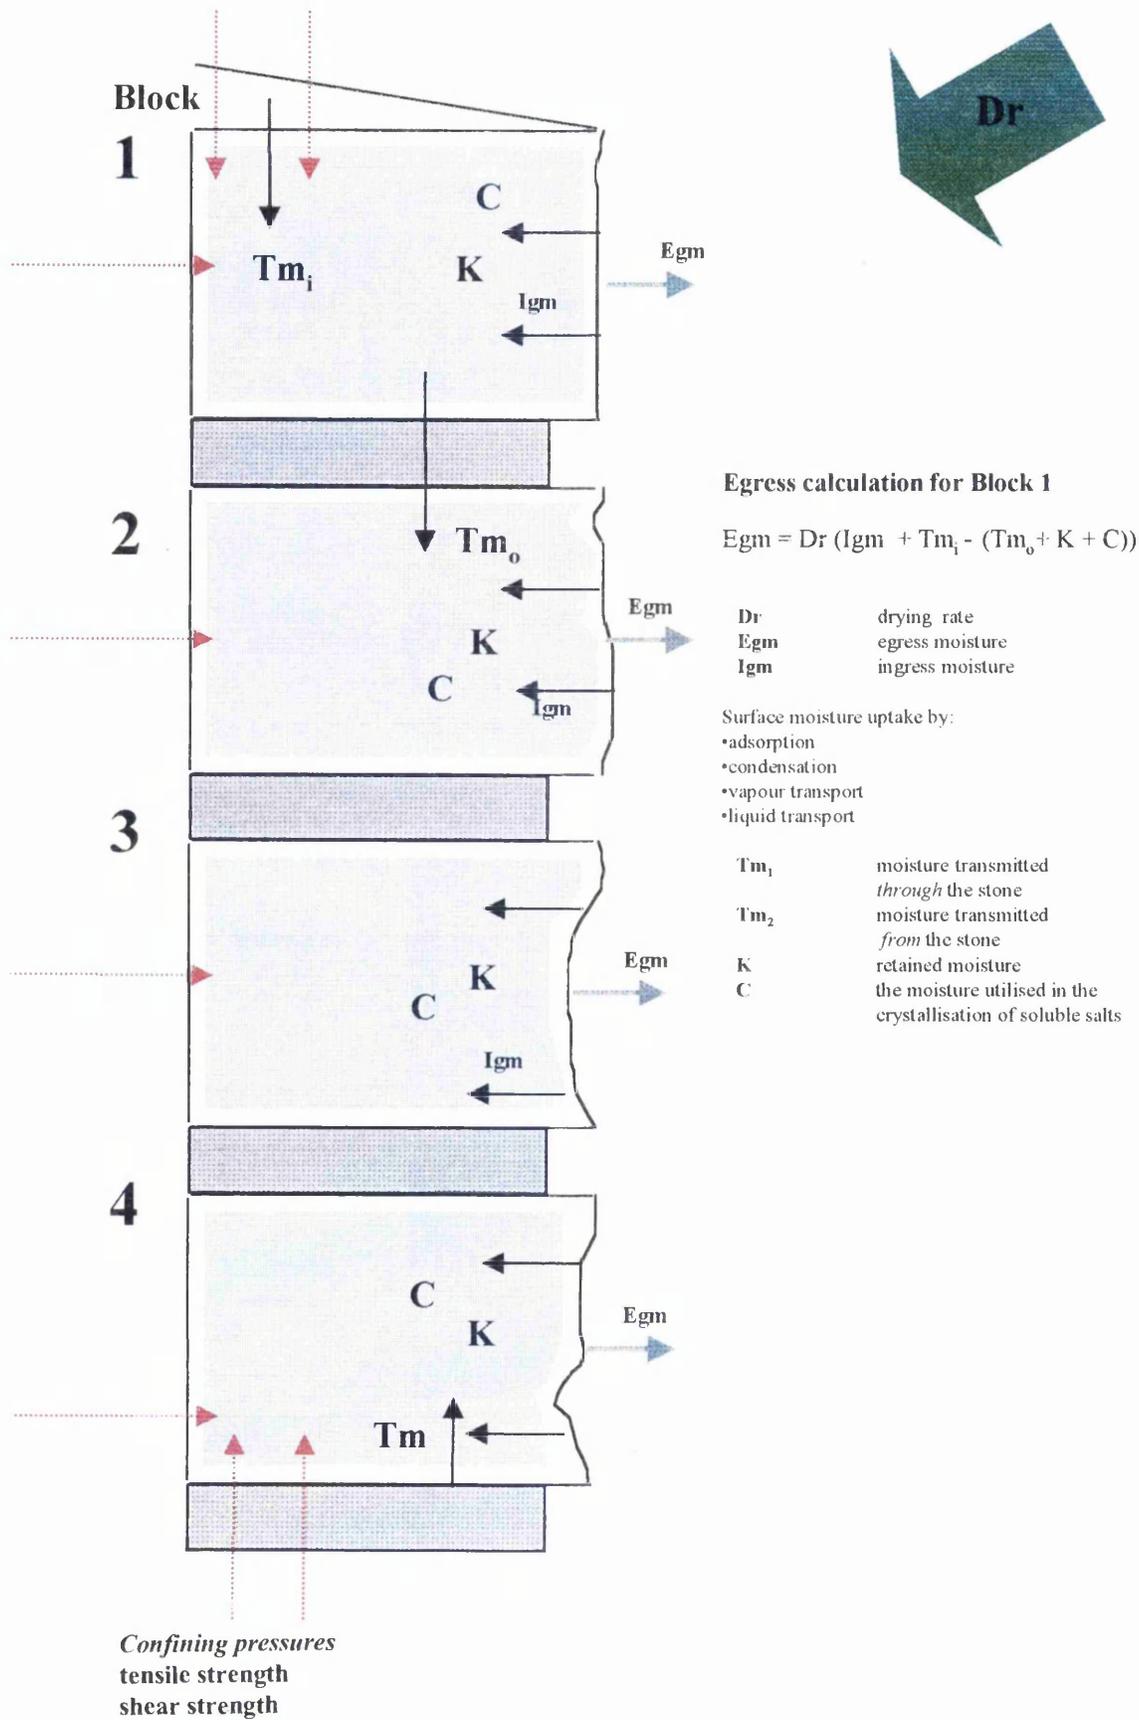
Figure 7.2 Diagram to show moisture ingress and egress and the mechanisms that drive them

Moisture retained in the stone in solution
