**THE WEATHERING OF SANDSTONE ON
HISTORIC BUILDINGS: CULZEAN
CASTLE, A CASE STUDY**

A thesis submitted for the degree of Doctor of Philosophy

© **Carolyn Susan Hayles**

Department of Geology & Applied Geology
University of Glasgow

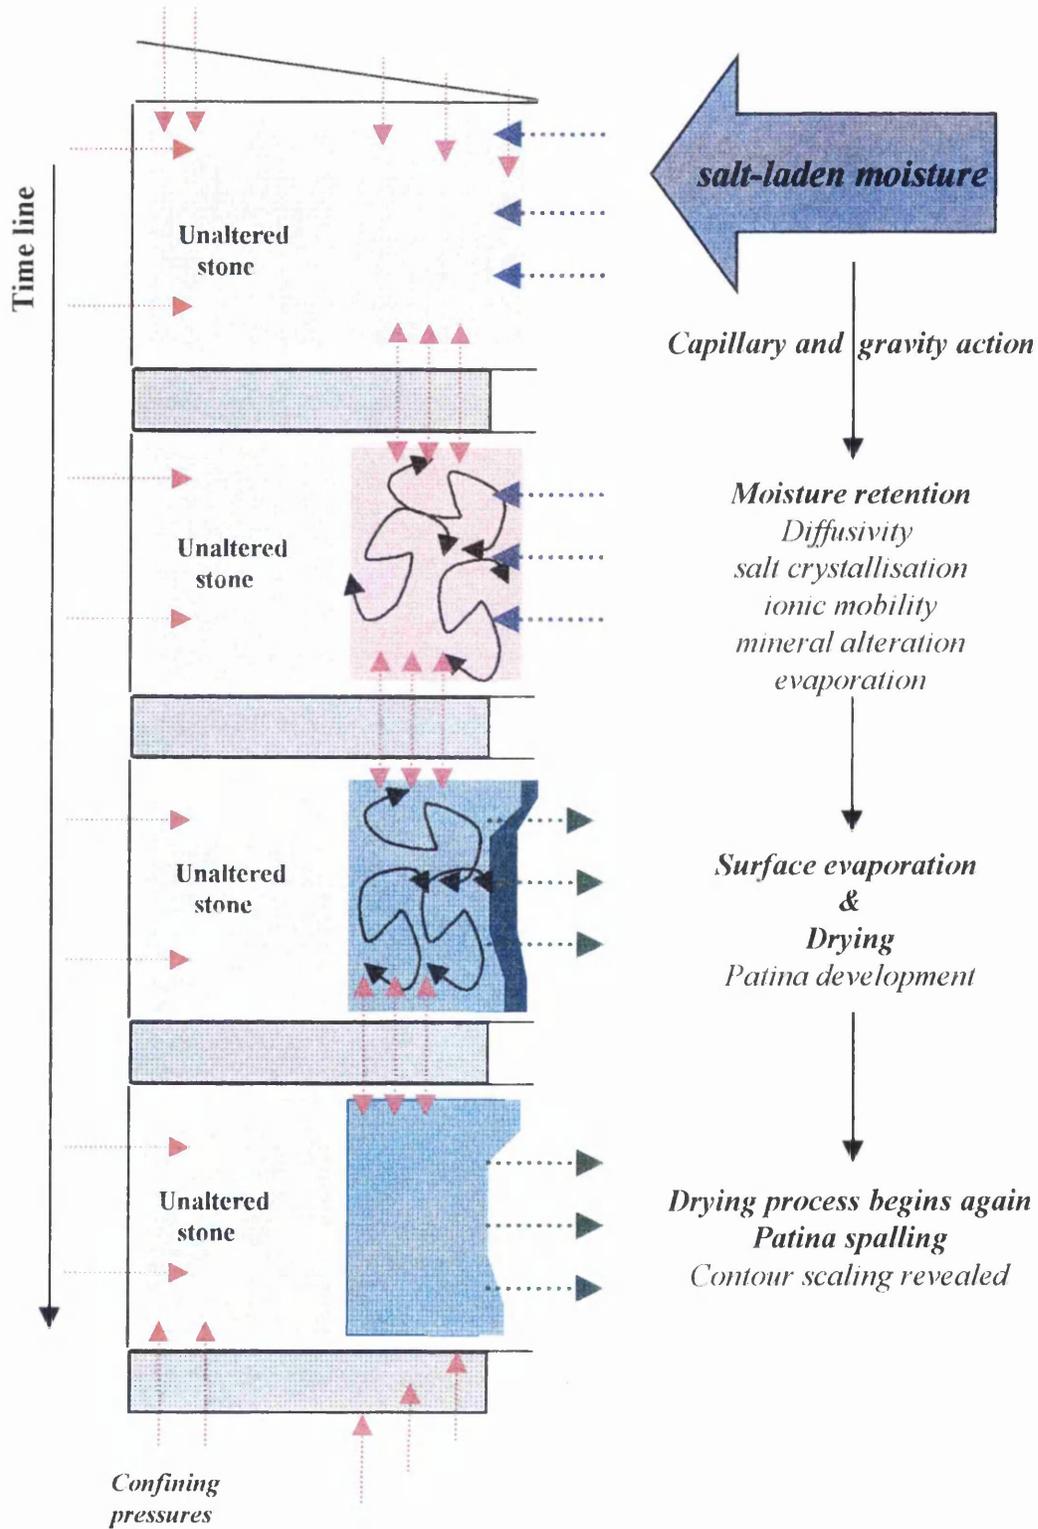
Figure 7.3 AB stone:
Development of current deterioration

They appear and disappear periodically. As they are transported by water, they move in and out of the stone, and along the surface of the stone.

out. Thus *Egm* will be reduced. As such these stones retain solutions that harvest soluble salt crystallisation (on solution saturation), clay production and expansion; and the dissolution and precipitation of new and altered mineral species (Figure 7.3).

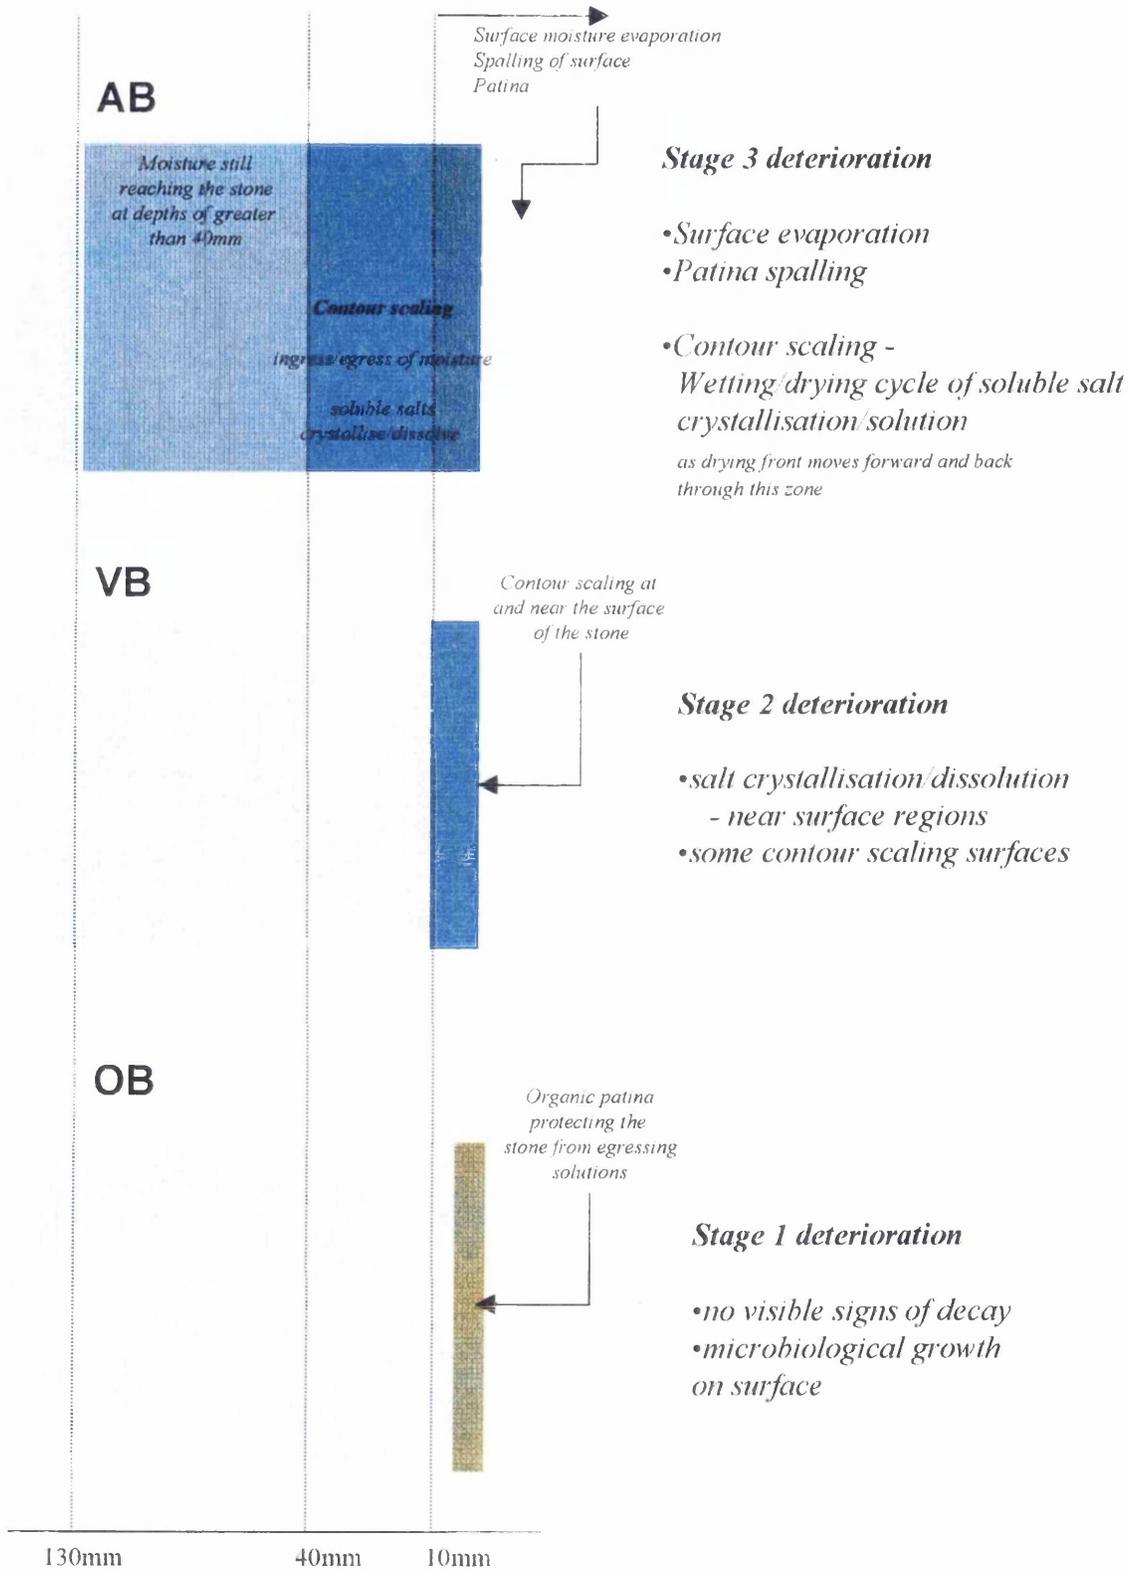
Figure 7.5 Comparison of visible stages of deterioration for the three Culzean stones

AB

Moisture still reaching the stone at depths of greater than 40mm

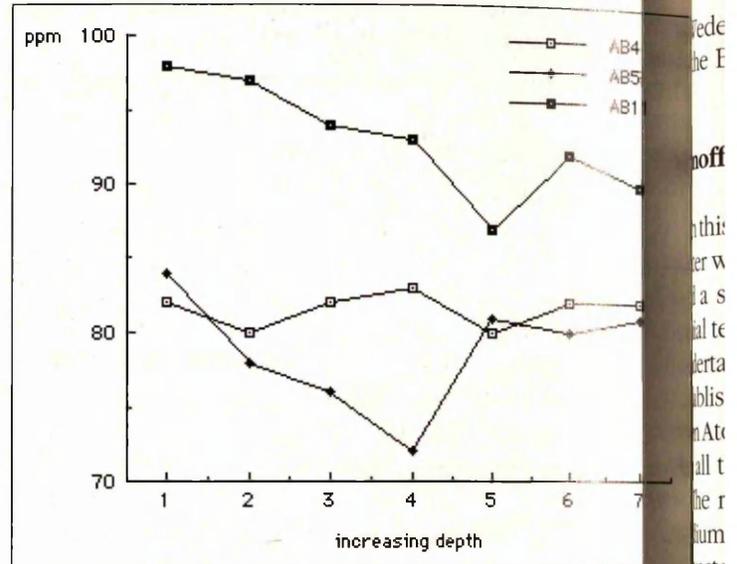
Fig. 12 - To show Sr concentration through 3 cores.

Whilst numerous trace elements, specifically the rare earth elements are mobilised during weathering, they tend to be re precipitated at that site of weathering (Nesbitt, 1979). Despite this, a number of trends can be seen in the trace element distribution patterns through the cores analysed, which can be attributed indirectly to decay mechanisms. Sr is a mobile element, and high Sr levels are recorded particularly in the first few outer centimetres of those stones which retain their exterior

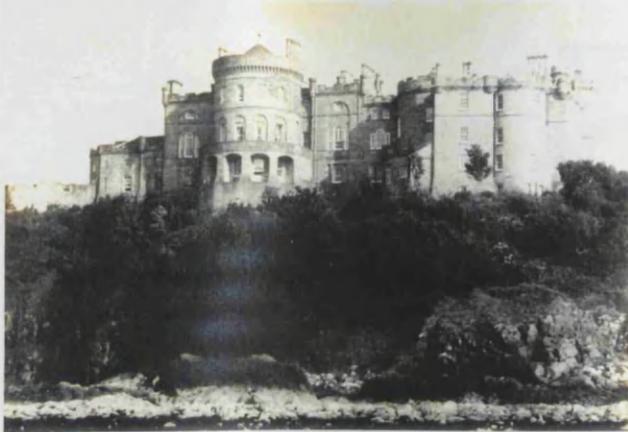
Plate 3 Surface spalling

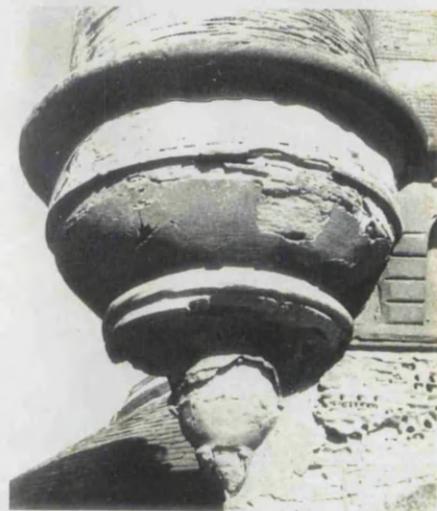
Plate 4 Contour scaling on the balcony

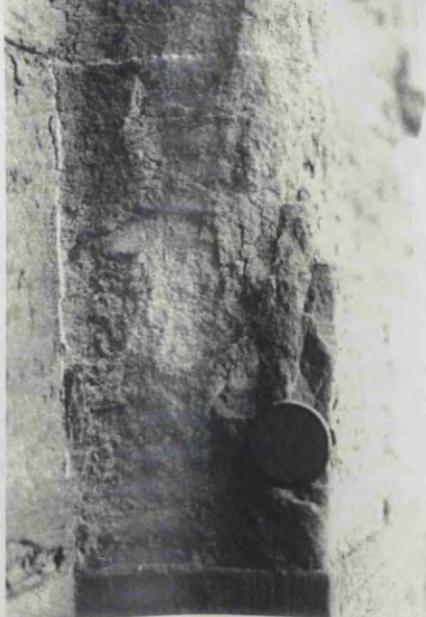
Plate 5 Surface spalling and contour scaling on balcony

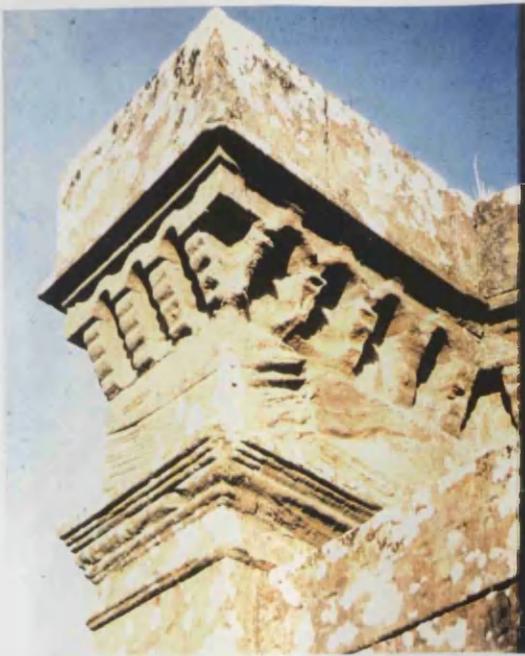
Plate 6 Cavernous weathering

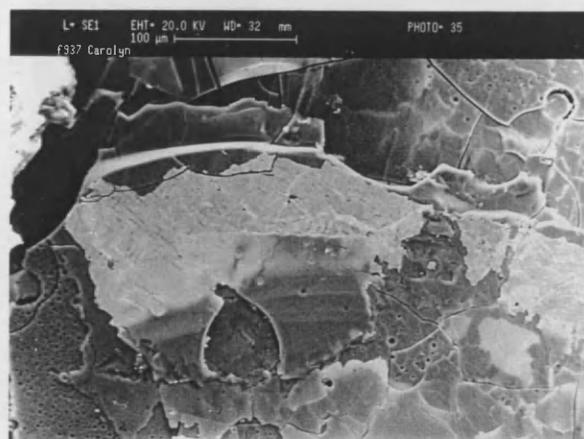
**Plate 50 Partial calcite replacement
In feldspar**

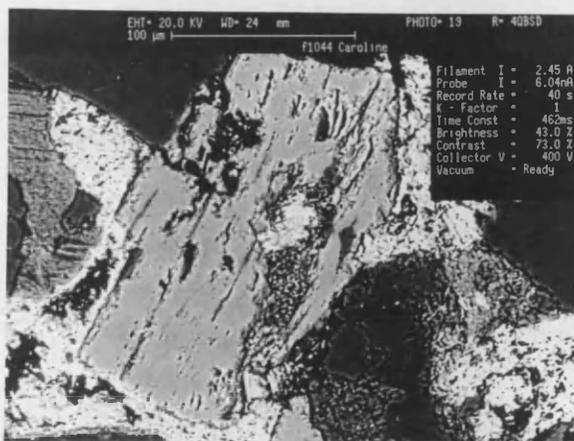
Plate 60 Partial replacement and dissolution

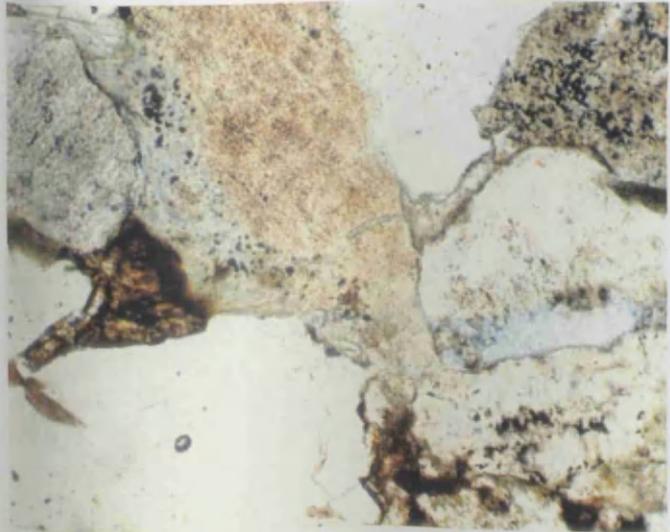
Plate 73 Growth in cracks between
mineral grains in XPL
