# **Durability Studies Relevant to Marine Equipment**

**By**  
**Dimitris Mantzavinos**

A thesis submitted to  
The Department of Mechanical Engineering  
University of Glasgow

in fulfilment of the requirement for  
The Degree of Doctor of Philosophy

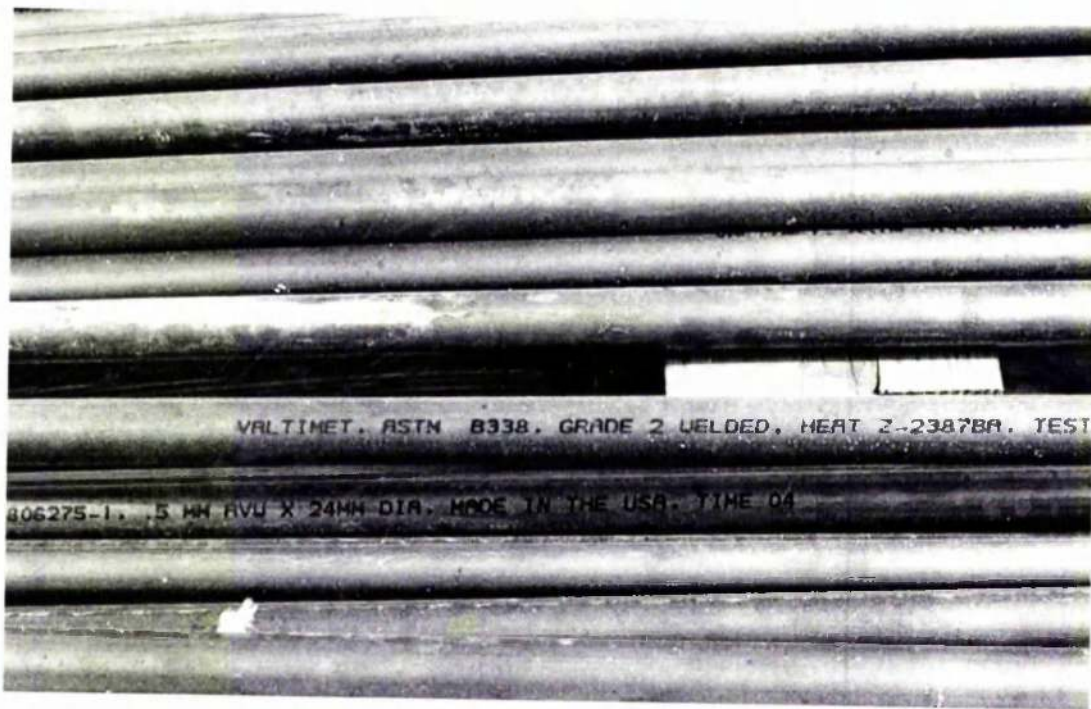
**Figure 2.4.1.2.** Titanium grade 2 tubes ready to be installed in the Las Palmas-Telde MED Desalination Plant.

application in the manufacturing of evaporator, condenser and brine heater tubes [114,115]. The first Multi-stage Flash Distillation (MSF) plant with titanium tubing was put in operation as early as 1965. Since then, many others have also been built for example in Japan, Peru and Indonesia. In 1984, the total weight of titanium used world wide was over 6,000 tons for desalination plants [99], while 14,000 kilometres of tubing is now in use in the Middle East [114]. The largest plant is in Saudi Arabia at Al-Jobail and contains over 2,500 tons of titanium [99]. At the same time, millions of kilometres of titanium tube, both seamless and welded, are being used for power plant condensers and associated auxiliary exchangers [114]. Figure 2.4.1.1, figure 2.4.1.2 and figure 2.4.1.3 demonstrate the use of titanium as heat exchanger in the desalination industry.

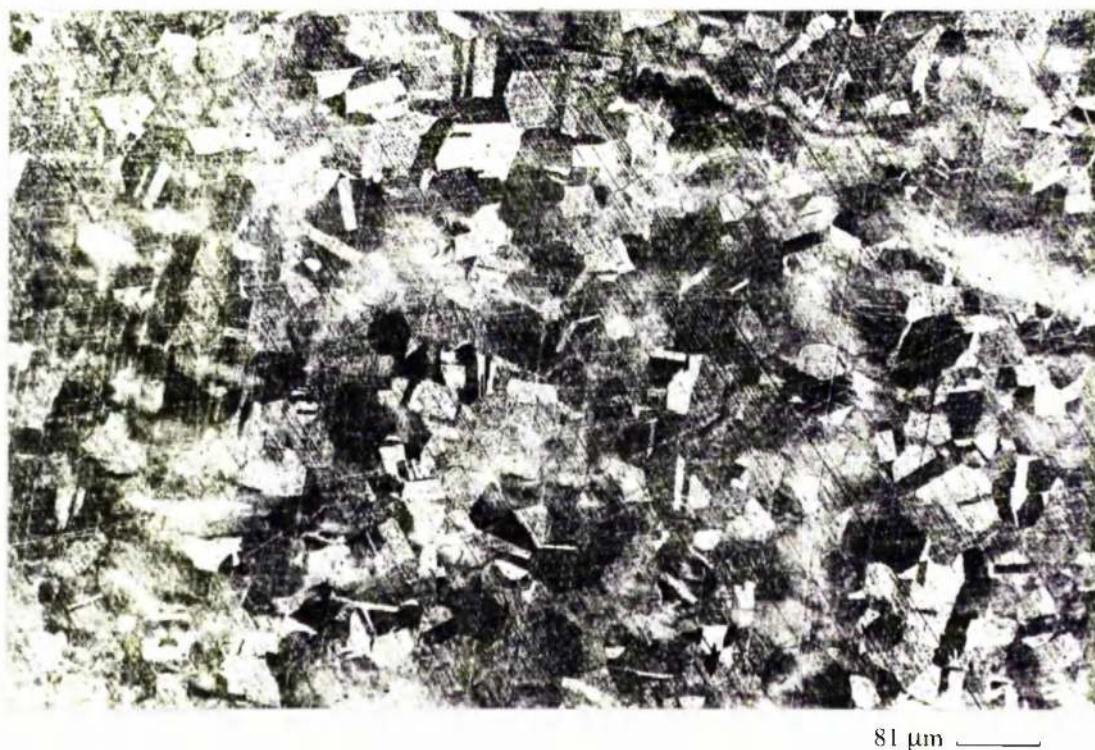
**Figure 4.1.6.** “Etched” appearance on Cu-10%Ni after anodic polarisation upon initial exposure to seawater at 20°C.

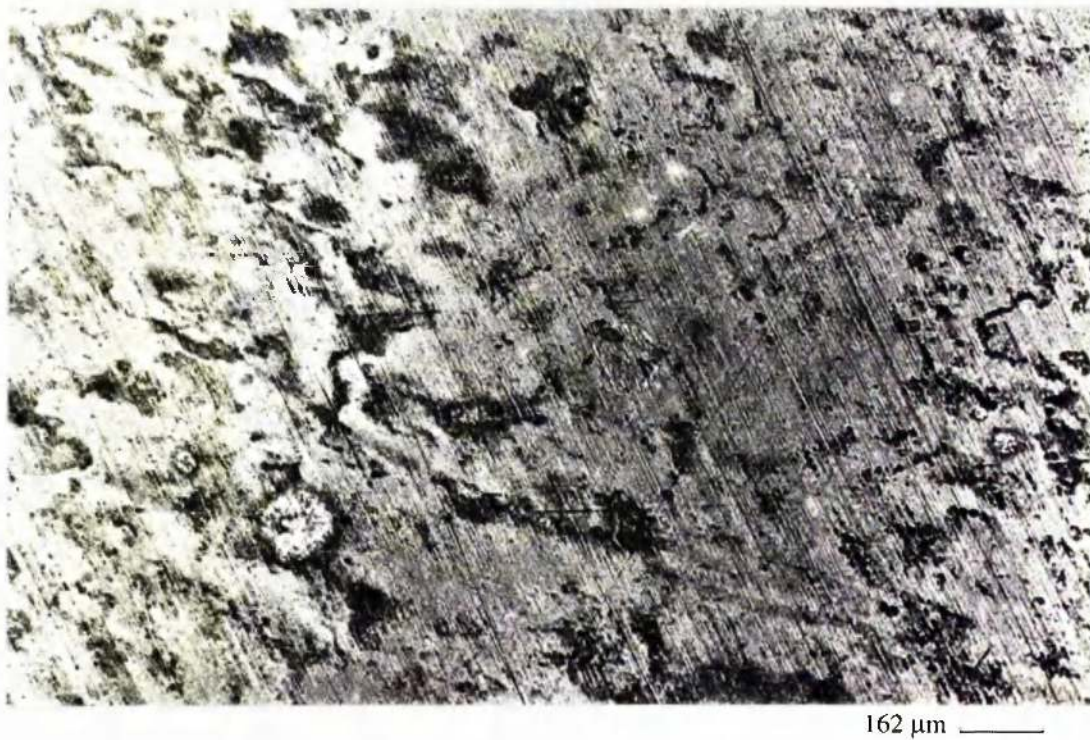
**Figure 4.1.7a.** Uniform layer of general corrosion on Cu-10%Ni after 2 day exposure in seawater at 20°C.

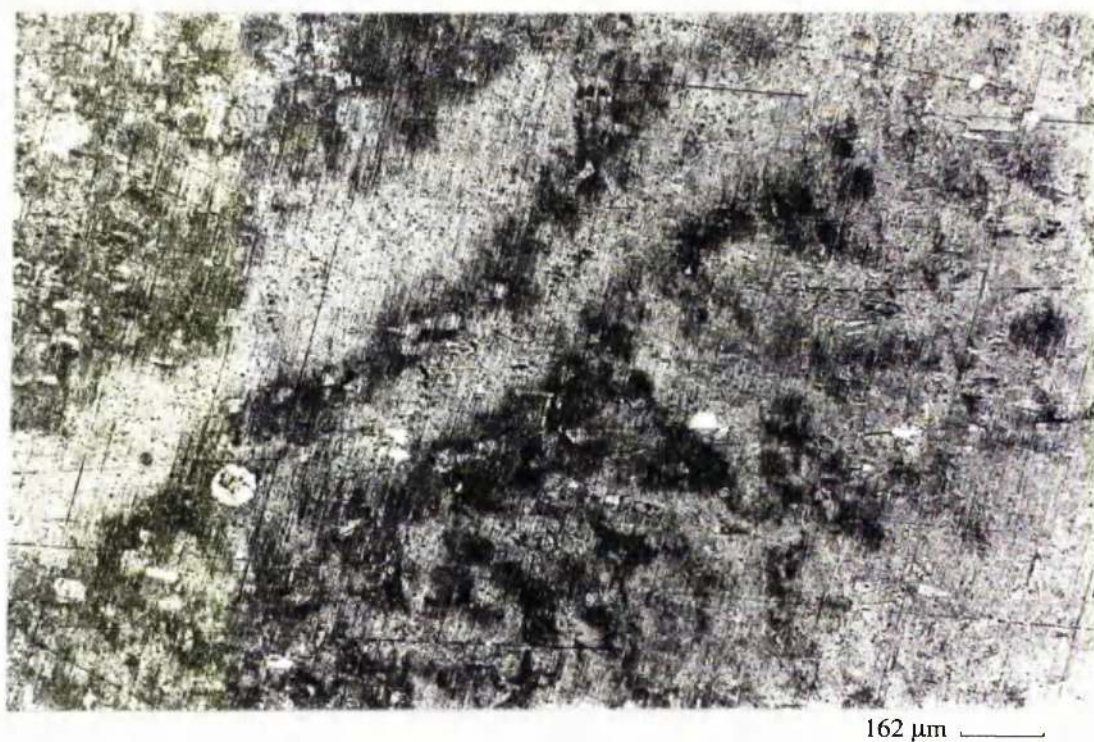
**Figure 4.1.8a.** Uniform layer of general corrosion on Cu-10%Ni when anodically polarised after 2 day exposure in seawater at 20°C.

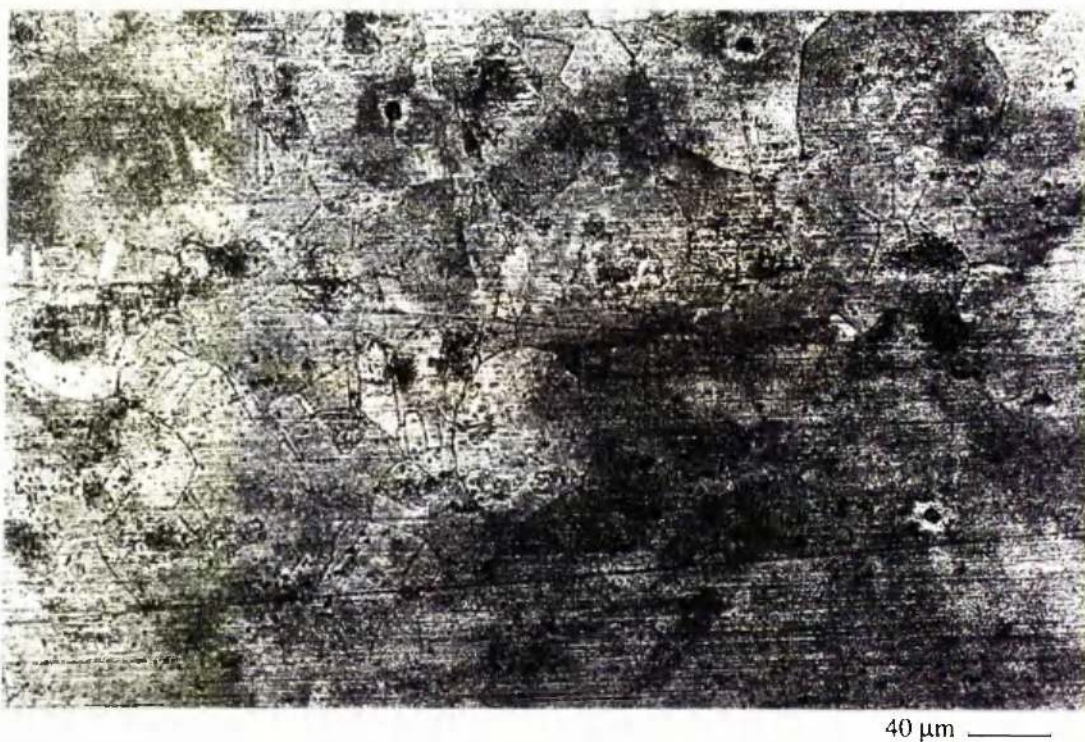
**Figure 4.1.9b.** General corrosion and “etched” surface on Cu-10%Ni after 7 day exposure in seawater at 20°C.

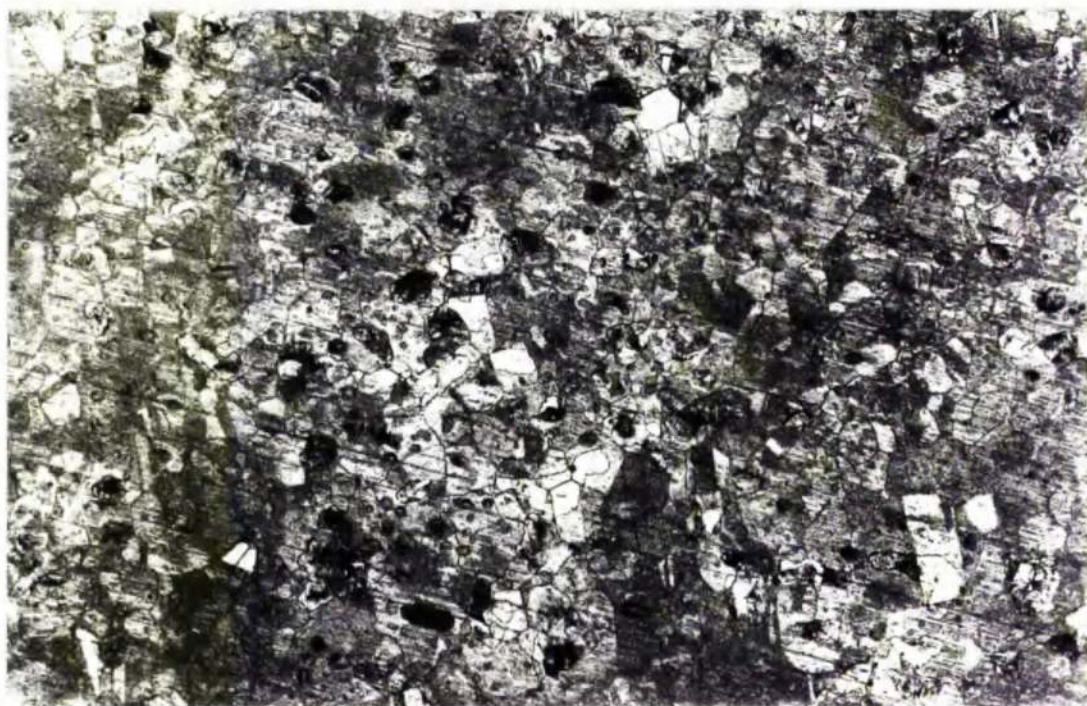
81 μm

**Figure 4.1.10b.** Signs of pitting and intergranular corrosion on Cu-10%Ni when anodically polarised after 7 day exposure in seawater.

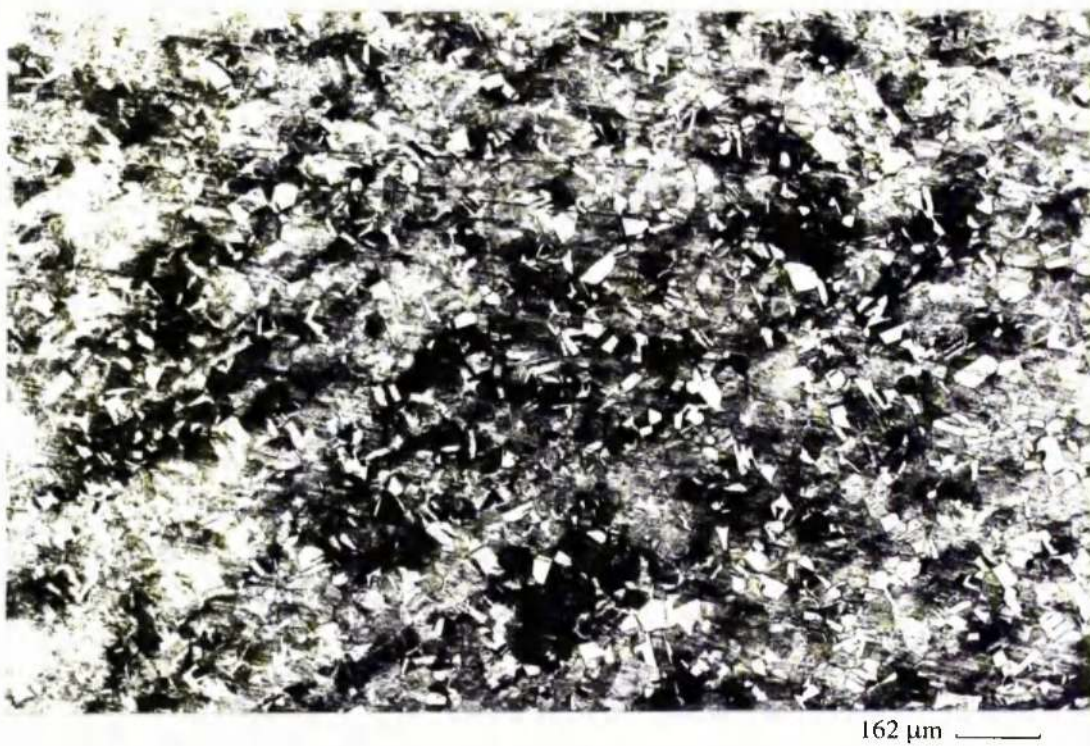
**Figure 4.1.11a.** Etched appearance on Cu-10%Ni after anodic polarisation upon initial exposure to distilled water at 20°C.

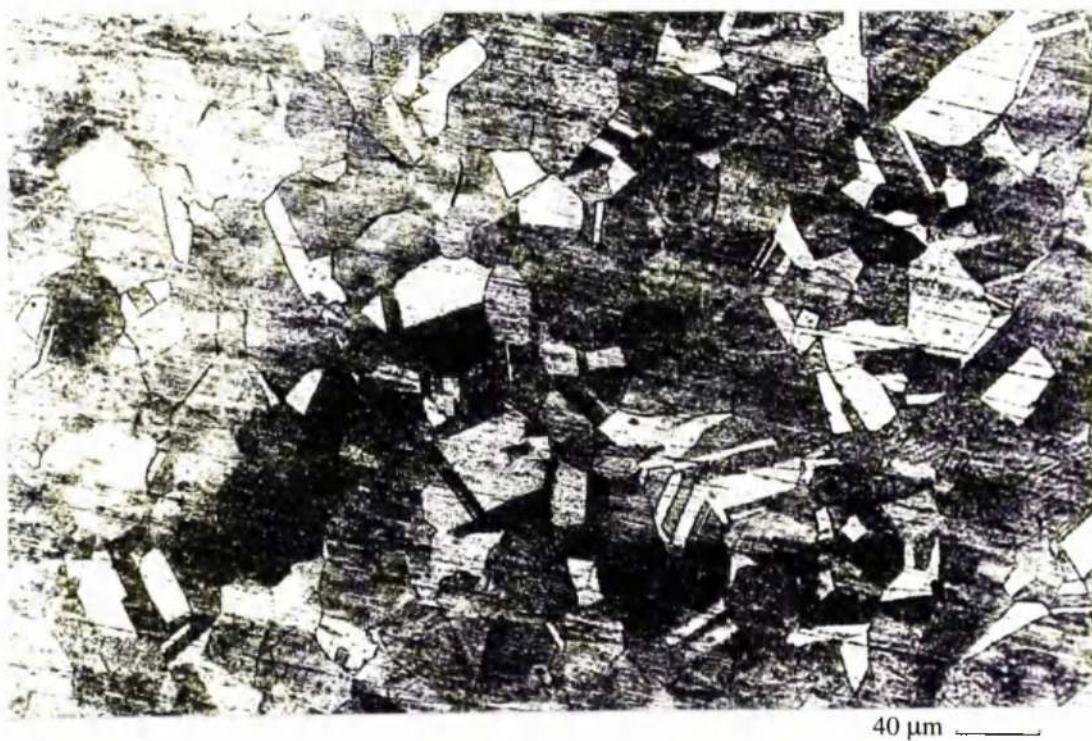
**Figure 4.1.11b.** Close-up view of the above features.

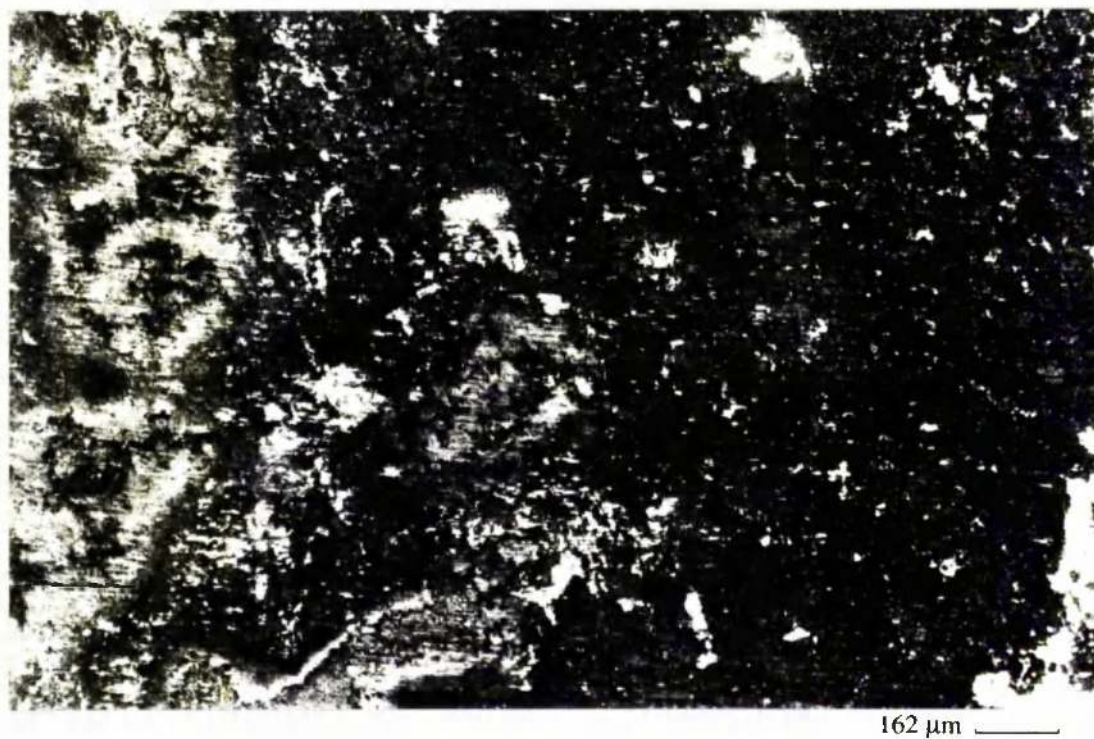
**Figure 4.1.12a.** General corrosion and clean patches on Cu-10%Ni after 2 day exposure in distilled water at 20°C.

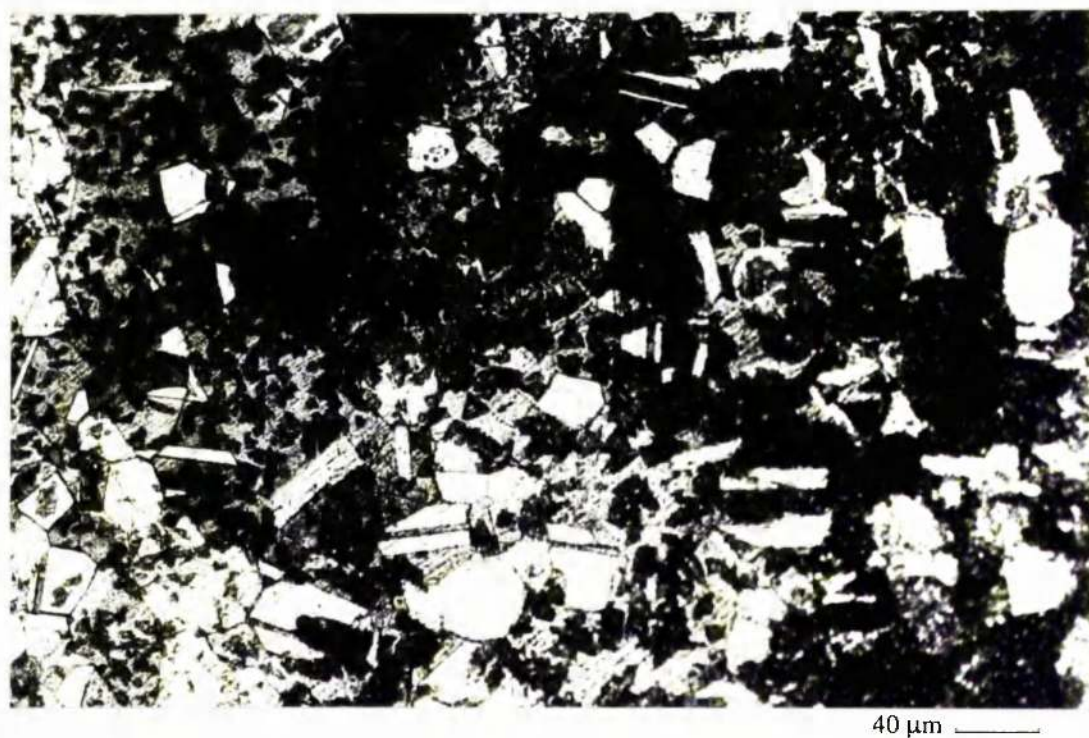
**Figure 4.1.13a.** Etched appearance and general attack with shallow pitting on Cu-10%Ni when anodically polarised after 2 day exposure in distilled water at 20°C.

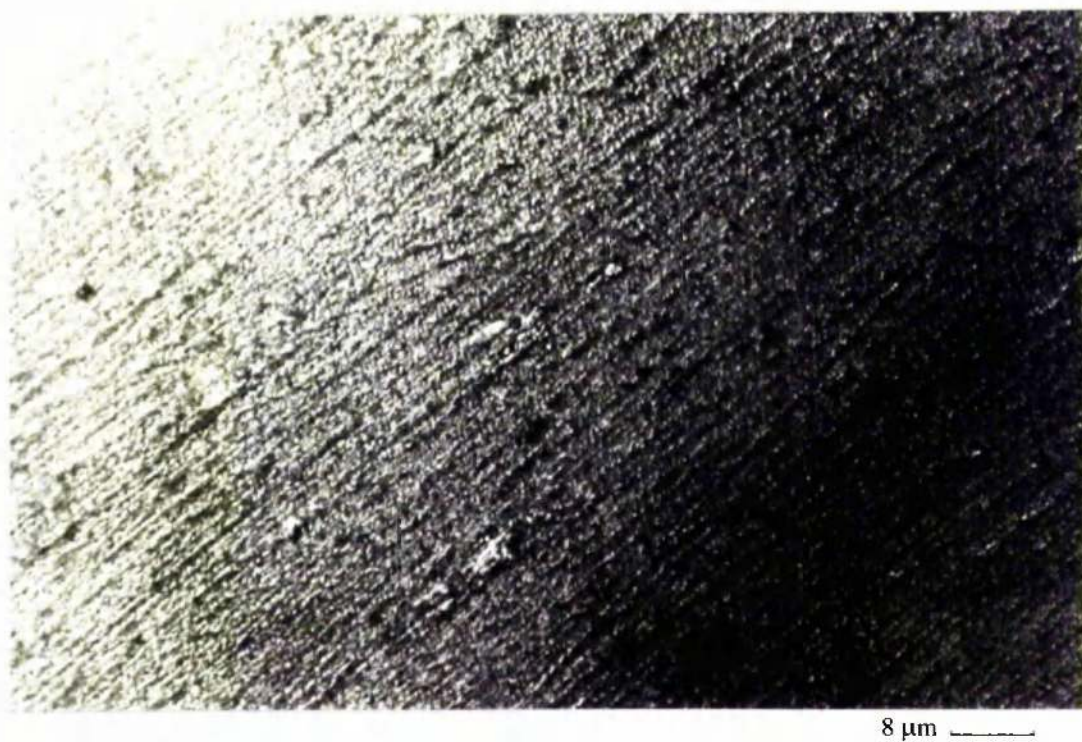
**Figure 4.1.13b.** At high magnification the dark regions on the above picture appear to be uniform.

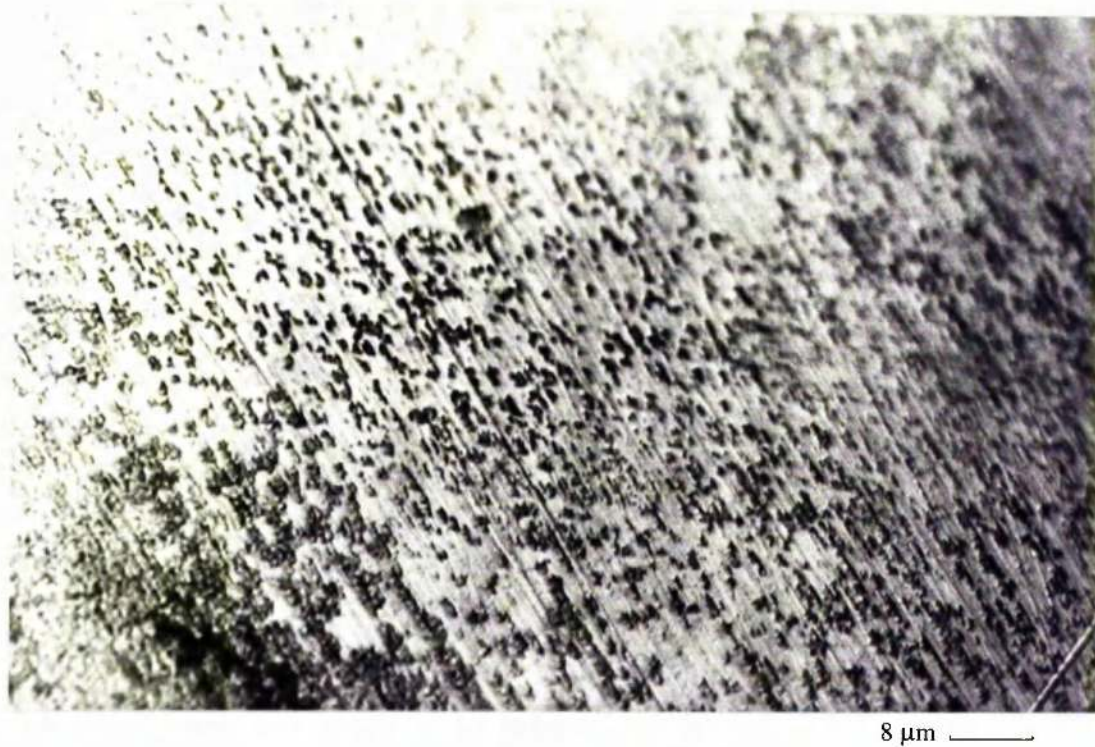
**Figure 4.1.14b.** High magnification reveals numerous particles on the bright surface.

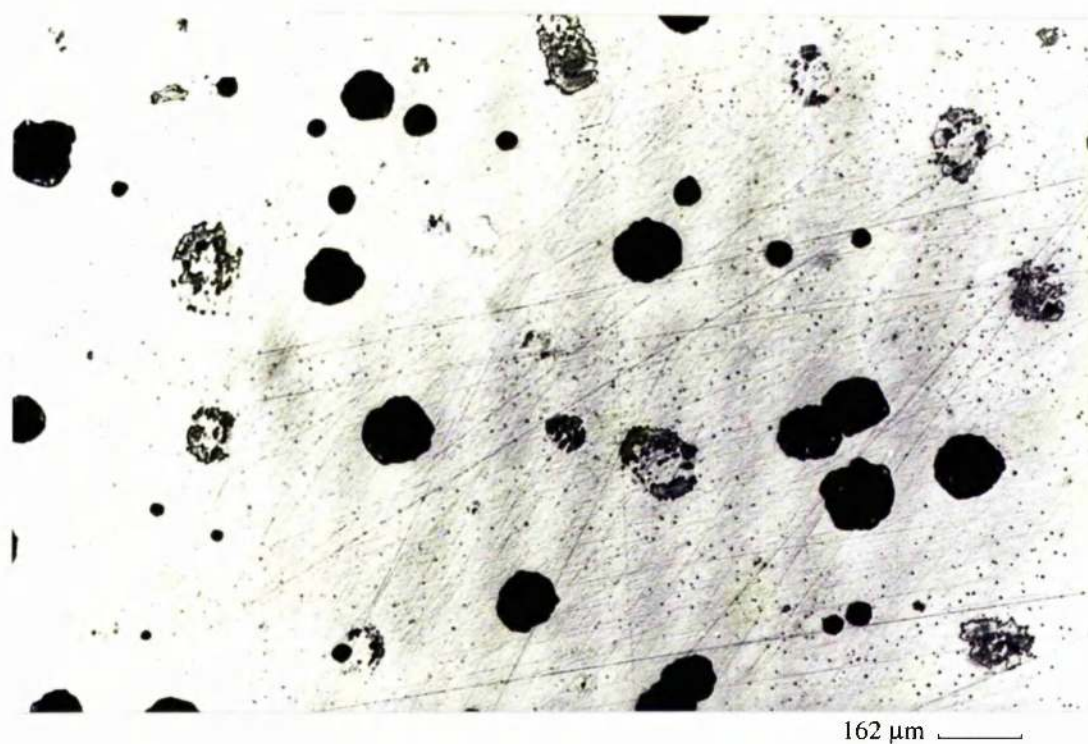
**Figure 4.1.15a.** Pitting attack and circular regions consisting of individual particles on Cu-10%Ni when anodically polarised after 7 day exposure in distilled water at 20°C.

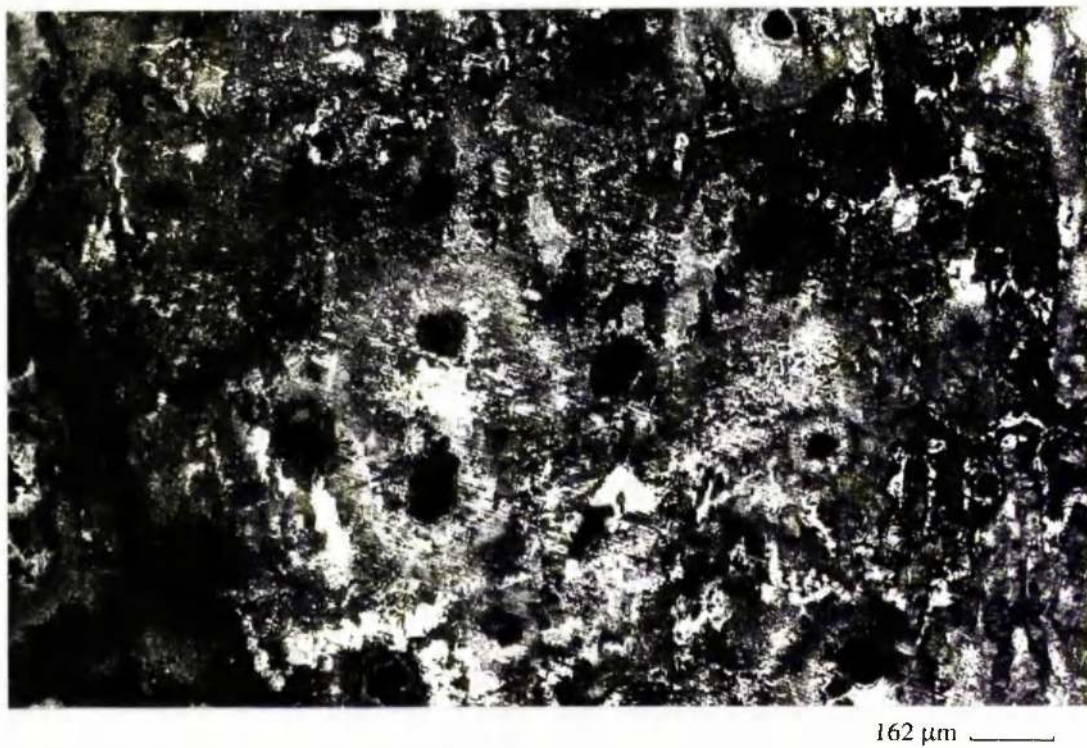
**Figure 4.1.16a.** General corrosion and pitting attack on Cu-10%Ni after 60 day exposure in distilled water at 20°C.

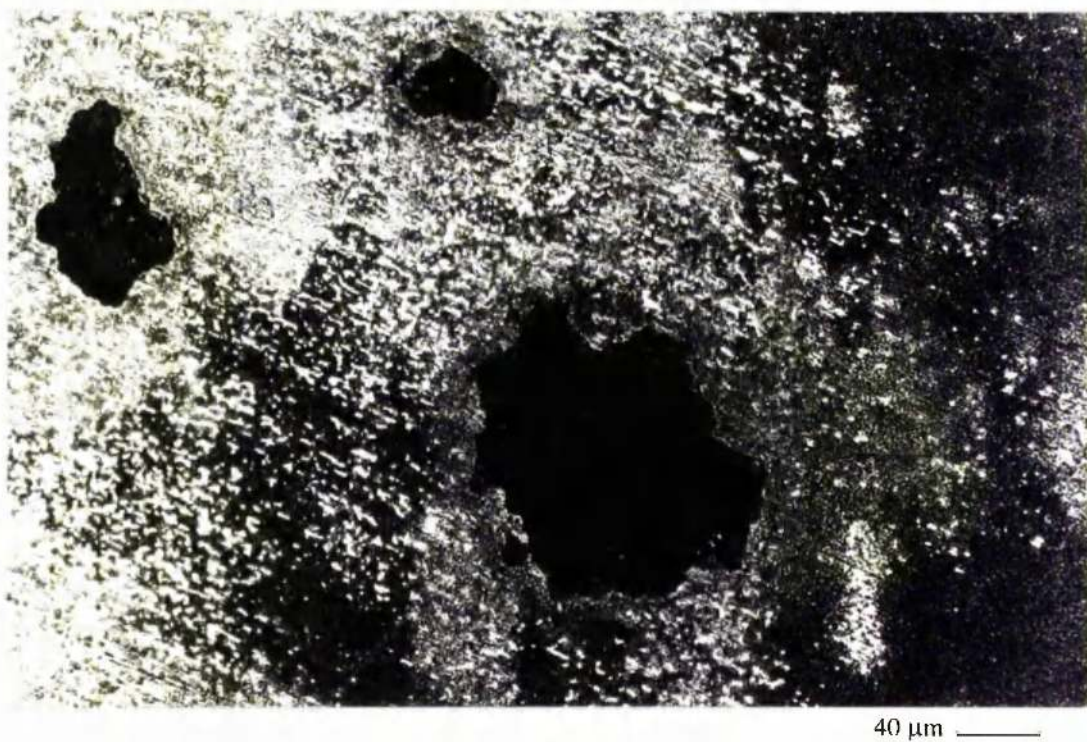
**Figure 4.1.16b.** At high magnification pits are shown to be shallow.

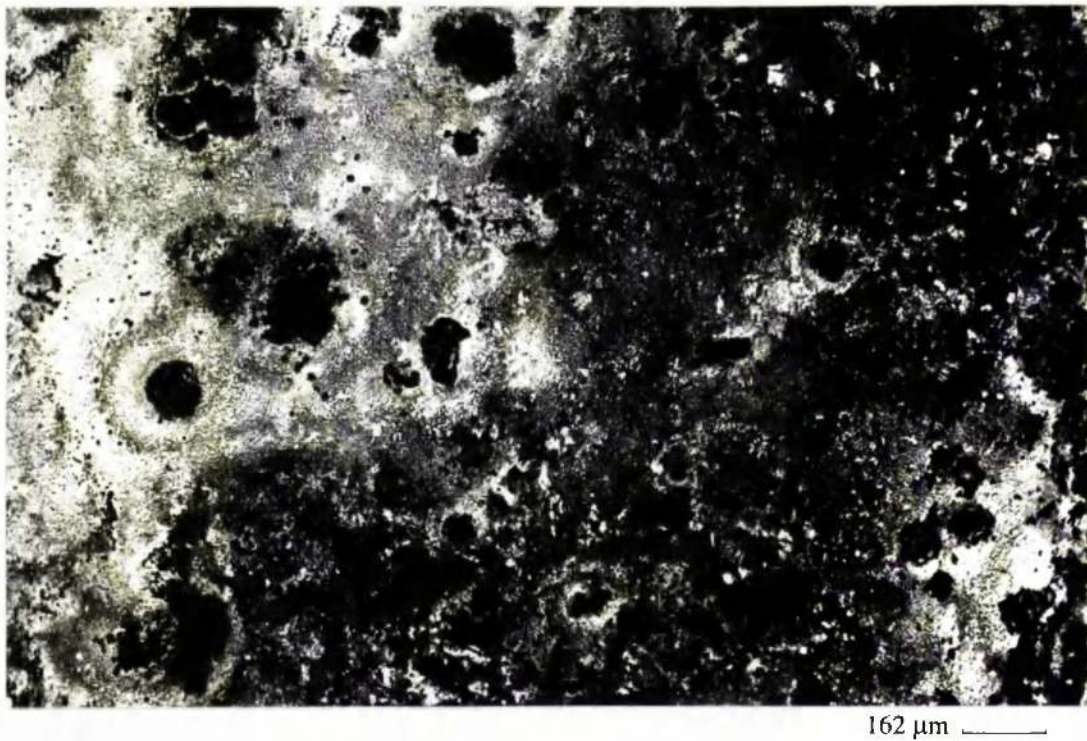
**Figure 4.1.17a.** Pitting and general attack on Cu-10%Ni when anodically polarised after 60 day exposure in distilled water at 20°C.

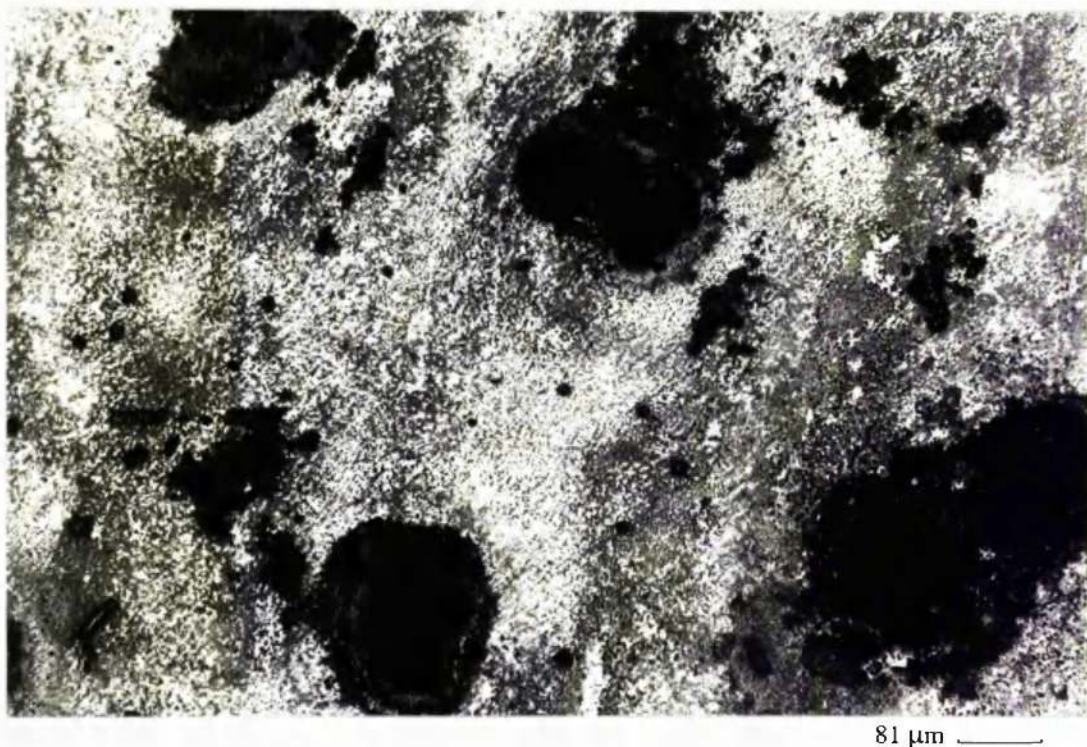
**Figure 4.1.17b.** Small shallow pits were also present on Cu-10%Ni when anodically polarised after 60 day exposure in distilled water at 20°C.

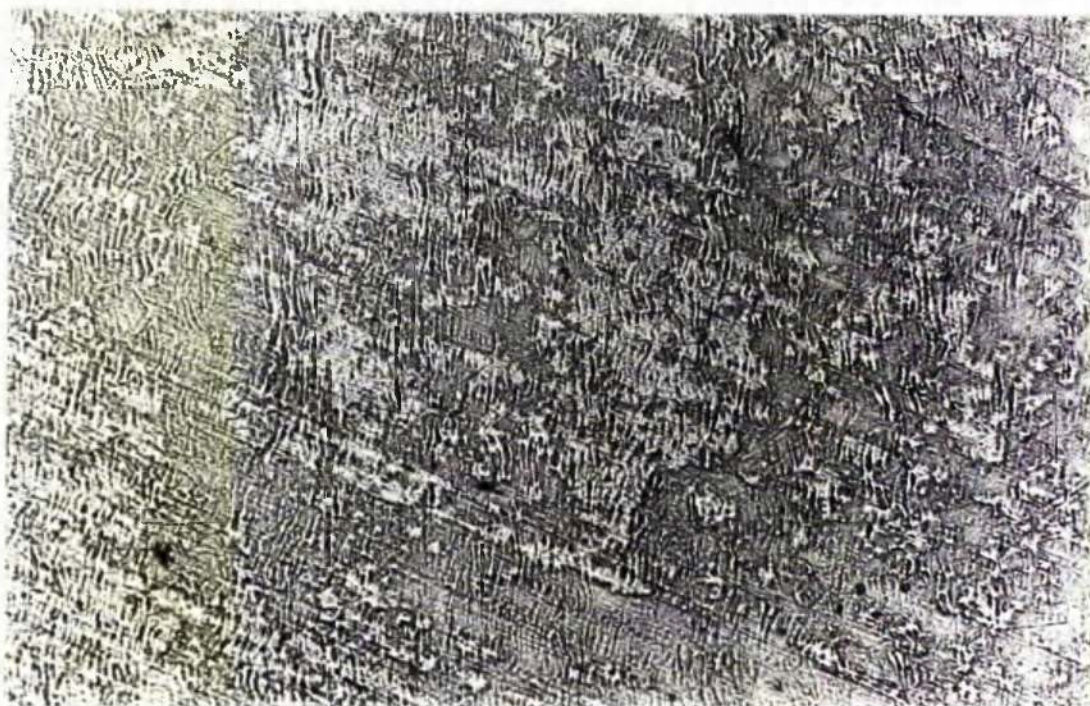
16  $\mu\text{m}$  \_\_\_\_\_

**Figure 4.2.7b.** At high magnification general corrosion is noted to be uniform on Cu-30%Ni after 2 day exposure in seawater at 20°C.

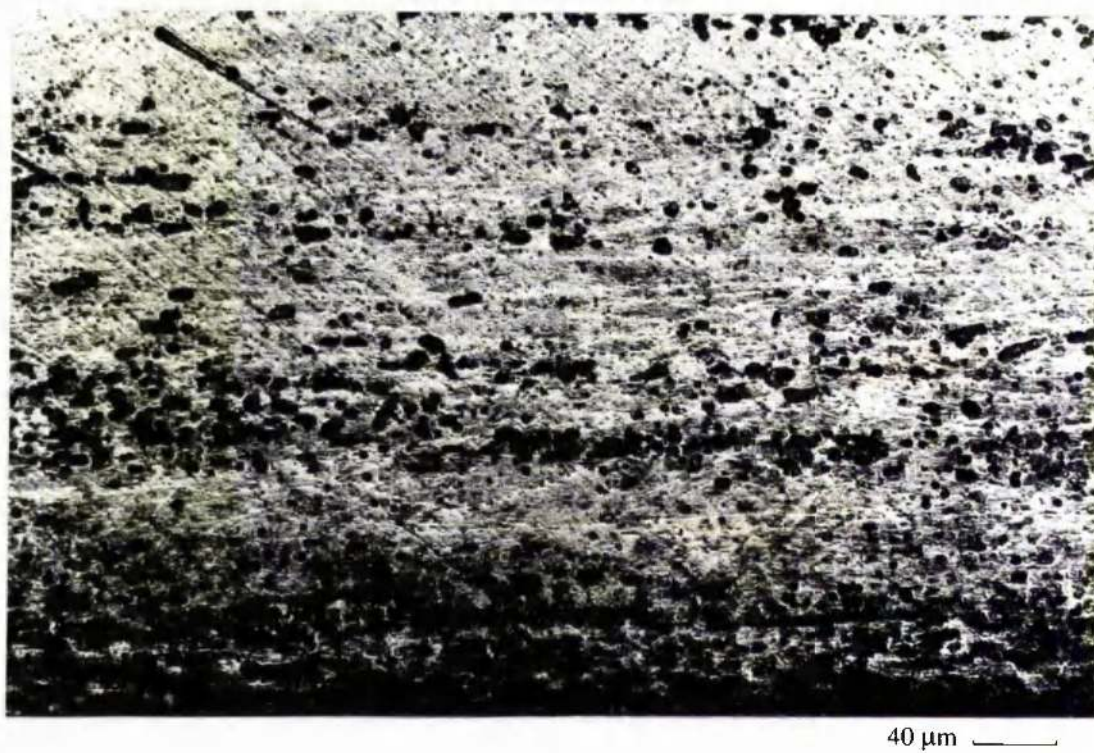
**Figure 4.2.9b.** Pitting attack on Cu-30%Ni after 7 day exposure in seawater at 20°C.

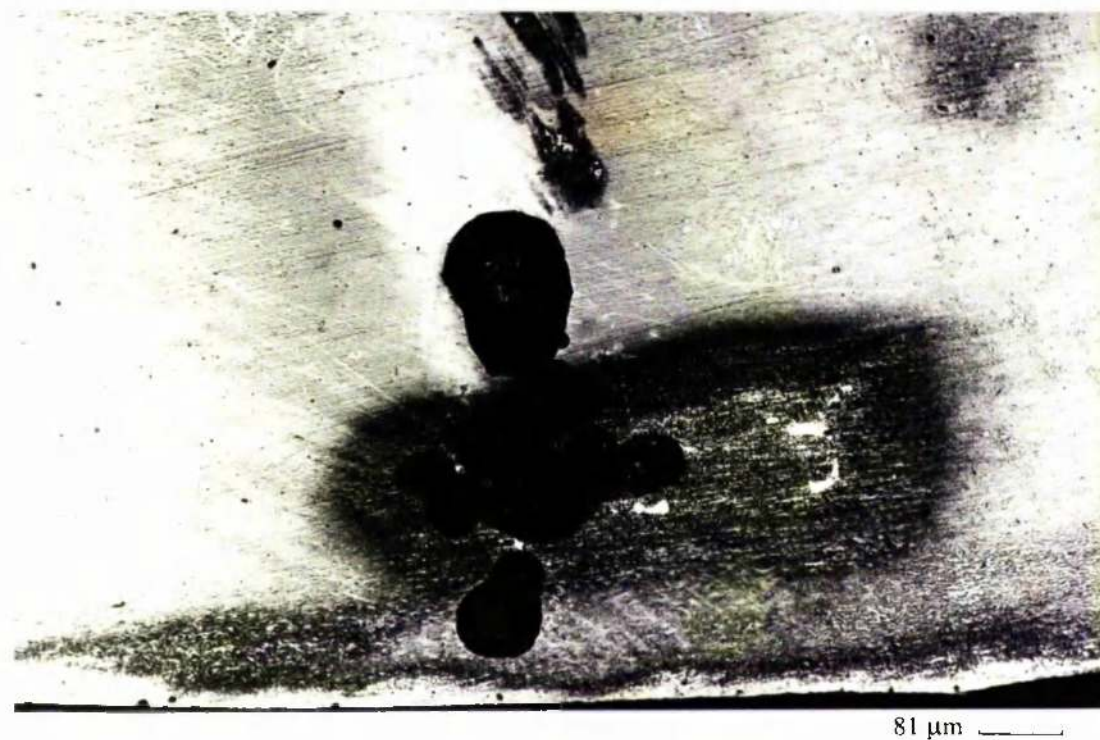
**Figure 4.2.13b.** Large pits were also present on Cu-30%Ni when anodically polarised after 2 day exposure in distilled water at 20°C.

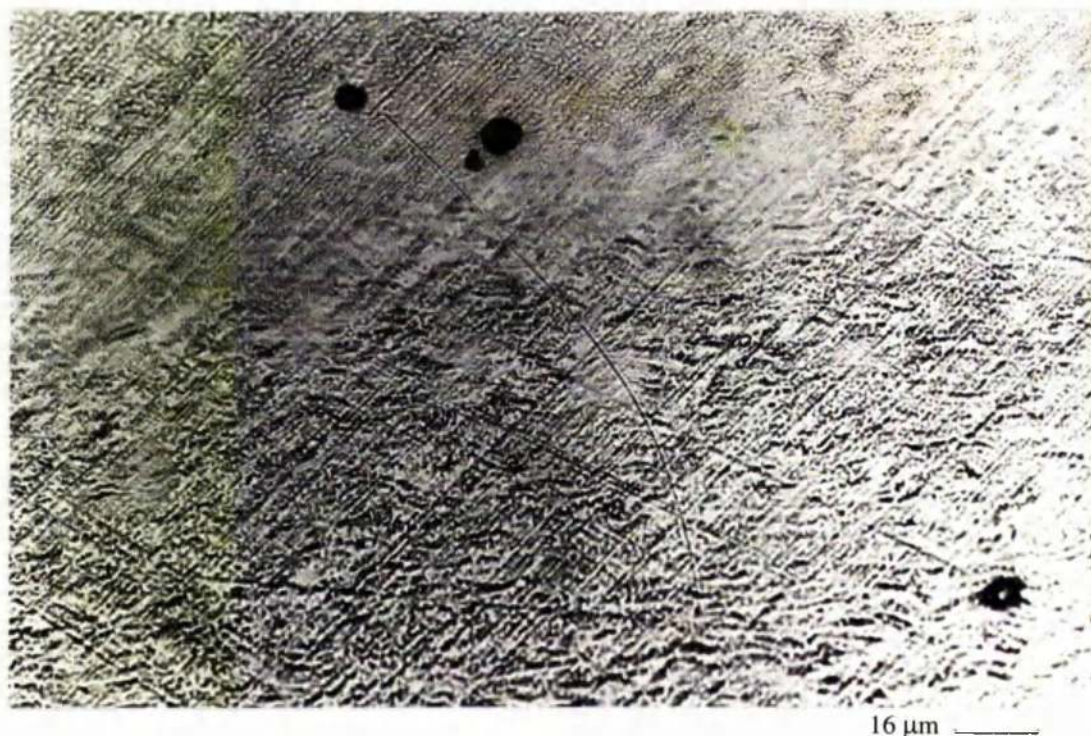
**Figure 4.2.14a.** General corrosion and few small pits on Cu-30%Ni after 7 day exposure in distilled water at 20°C.

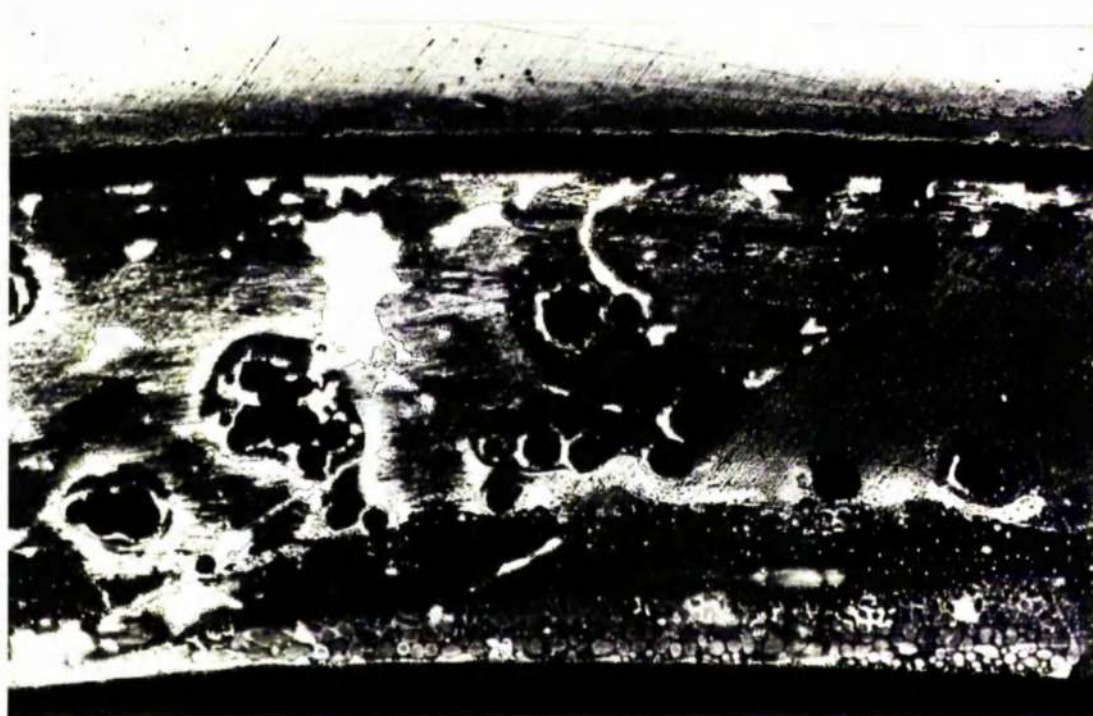
162 μm

**Figure 4.2.15a.** Severe pitting attack and dark general corrosion on Cu-30%Ni when anodically polarised after 7 day exposure in distilled water at 20°C.

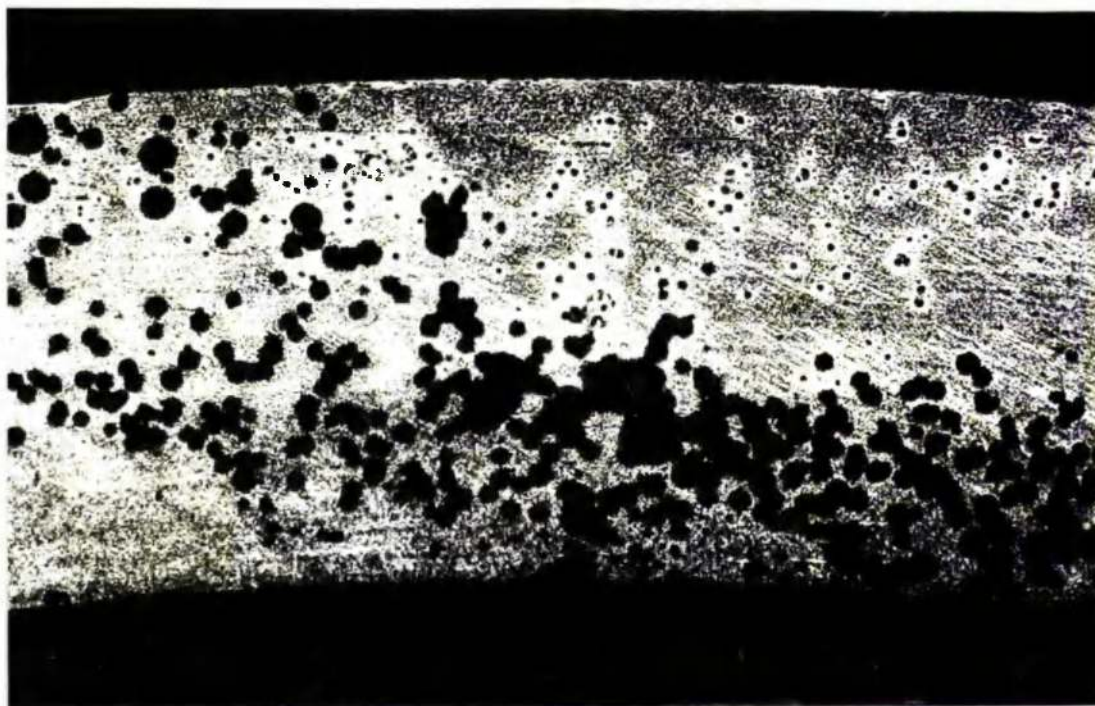
162  $\mu\text{m}$  \_\_\_\_\_

**Figure 4.2.17b.** Quite severe and extensive pitting attack on another part of the specimen shown in the previous figure.

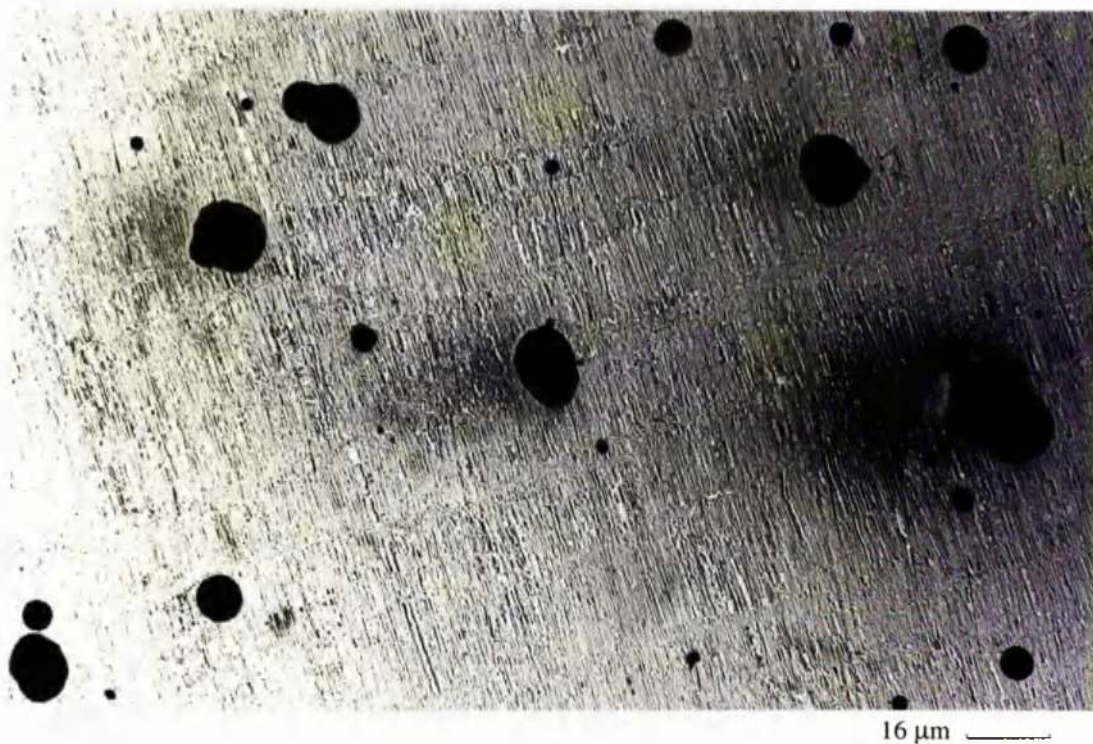
**Figure 4.2.20a.** Pitting attack on the outer surface of Cu-30%Ni when anodically polarised after 60 day exposure in distilled water at 20°C.

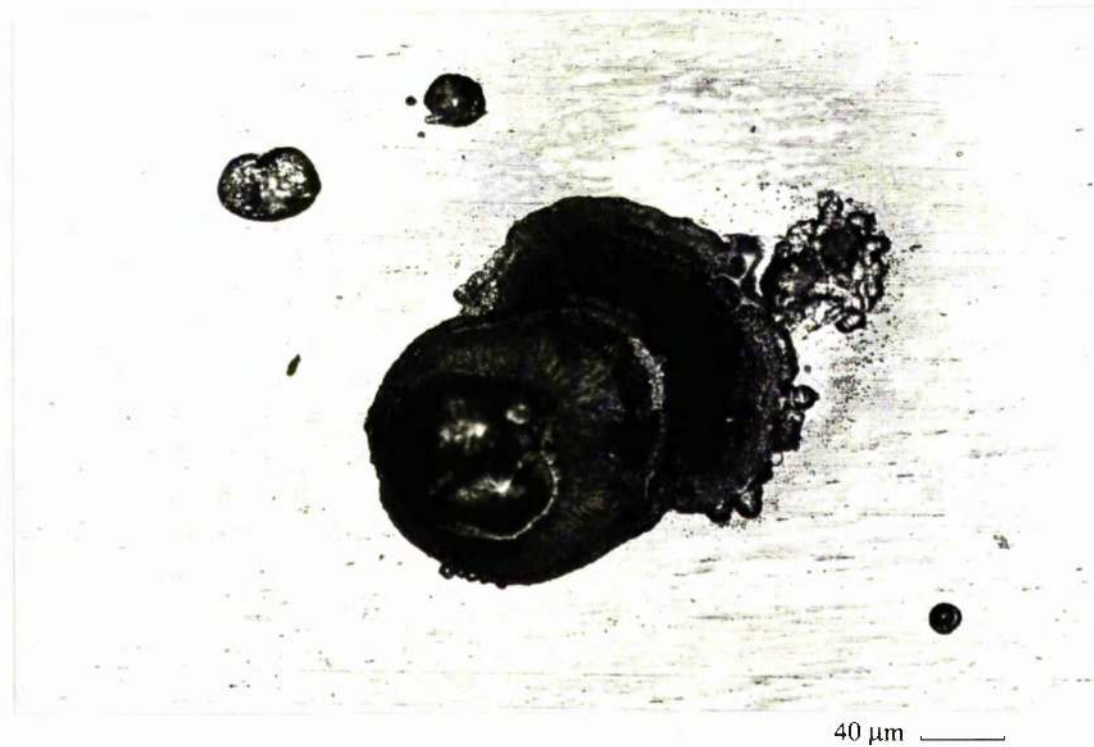
**Figure 4.2.20b.** Pits were noted to be rather deep on the outer surface of Cu-30%Ni when anodically polarised after 60 day exposure in distilled water at 20°C.

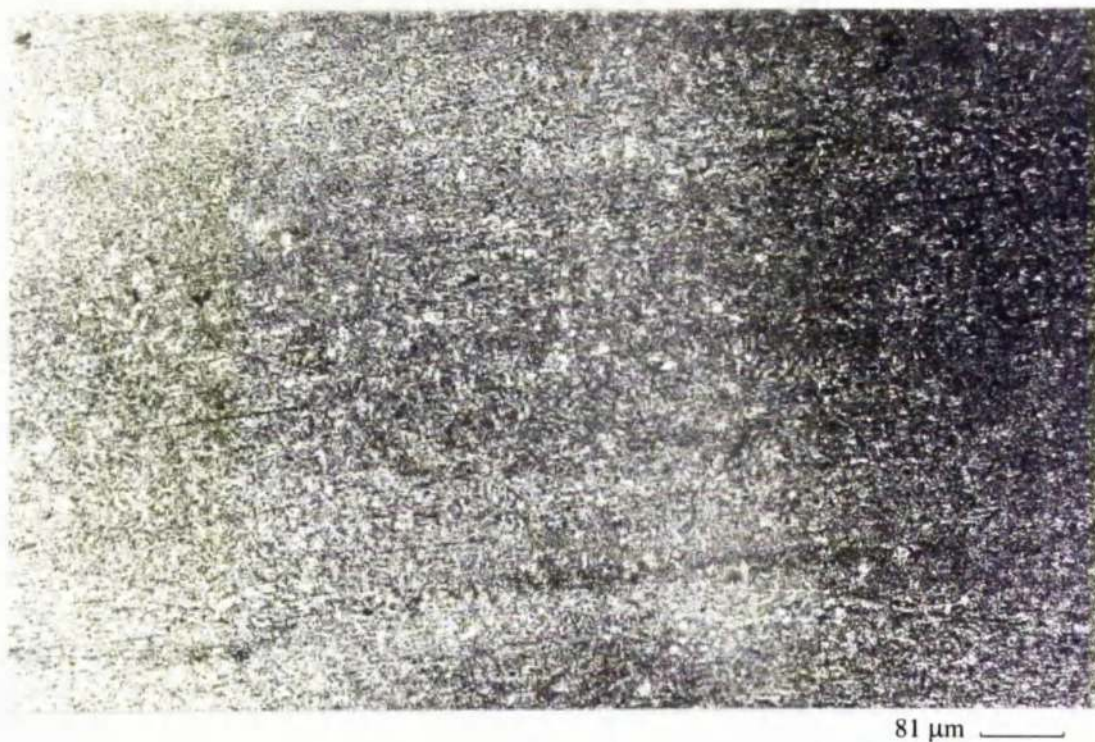
**Figure 4.2.23a.** Uniform layer of general corrosion on Cu-30%Ni when anodically polarised upon initial exposure to distilled water at 50°C with CO<sub>2</sub> injection.

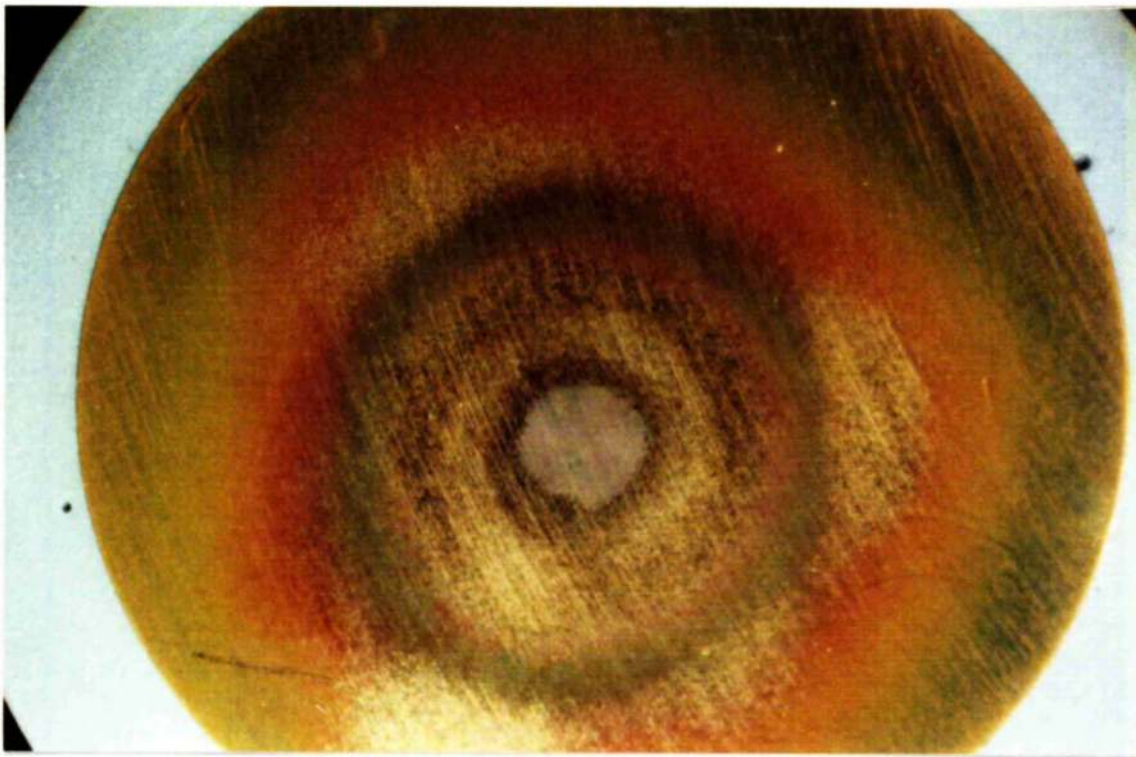
**Figure 6.2.4.** Ti:G2 when anodically polarised after 12 hours of liquid erosion-corrosion at ambient temperature and 71.1 m/s impinging jet velocity (diameter of specimen 32 mm).
