# **Durability Studies Relevant to Marine Equipment**

**By**  
**Dimitris Mantzavinos**

A thesis submitted to  
The Department of Mechanical Engineering  
University of Glasgow

in fulfilment of the requirement for  
The Degree of Doctor of Philosophy

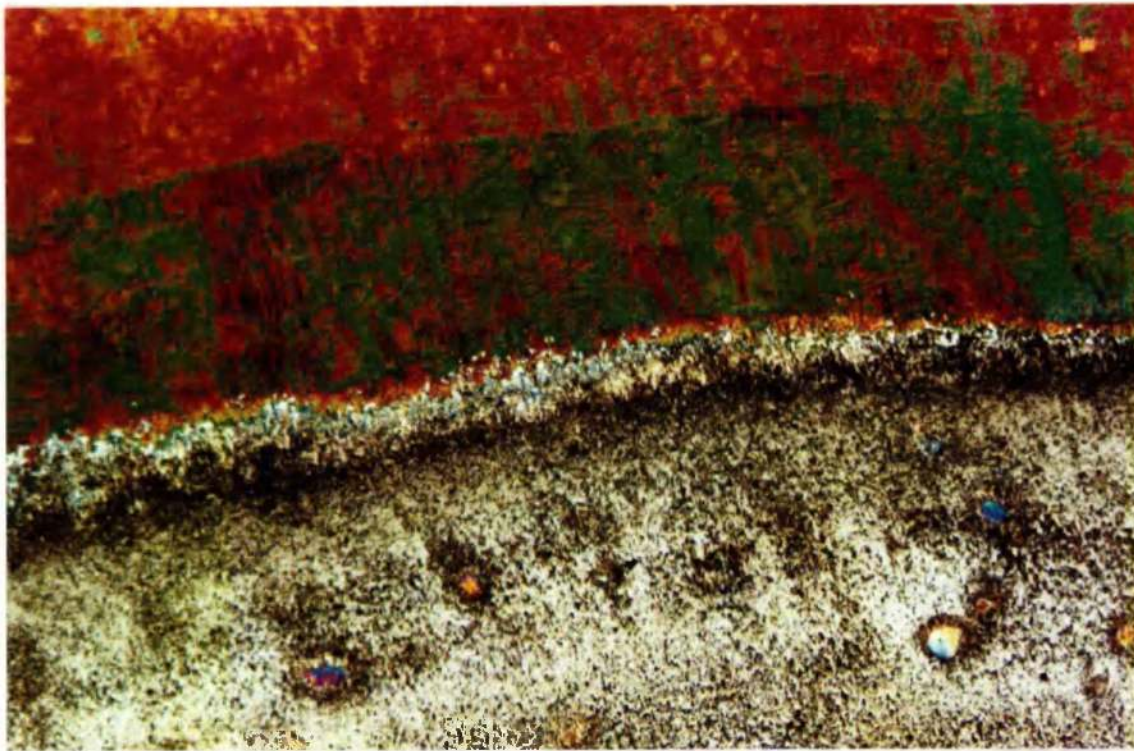
162 μm

**Figure 6.2.7.** At higher magnification, film at white circular region round the centre of the Ti-6Al-4V specimen shown in figure 6.2.6 appears to be not as intense as on the rest of the matrix area.

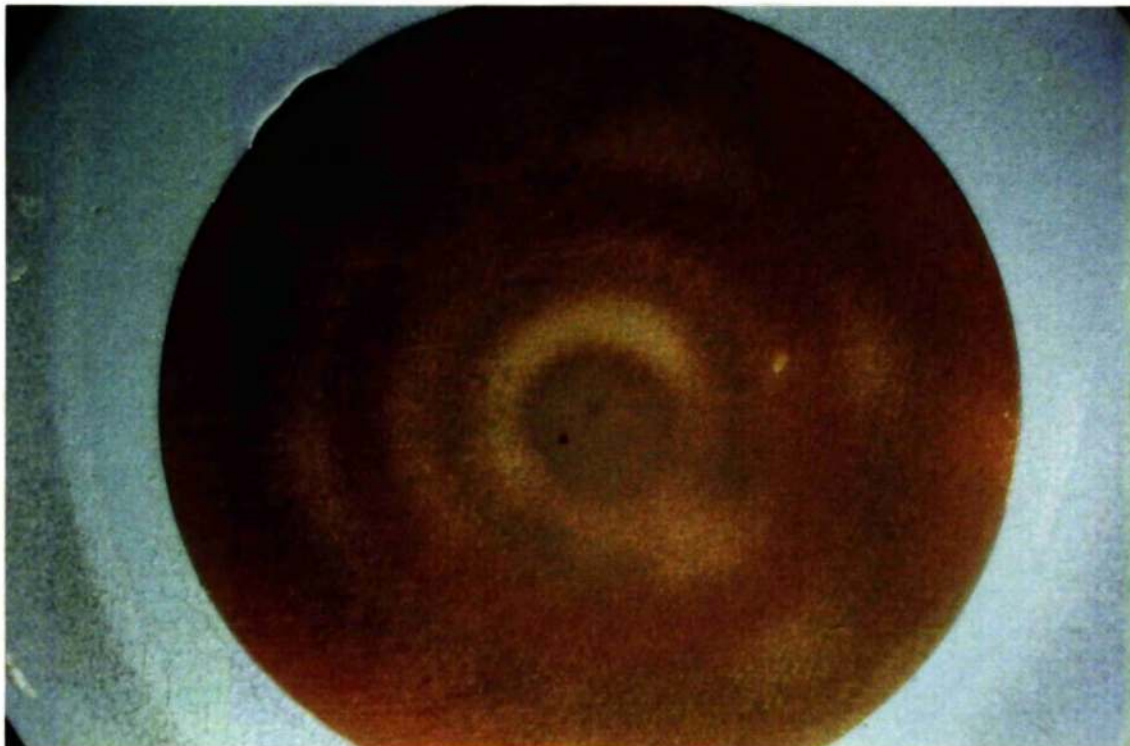
**Figure 6.2.8.** Ti-5111 when anodically polarised after 12 hours of liquid erosion-corrosion at ambient temperature and 71.1 m/s impinging jet velocity (diameter of specimen 26 mm).

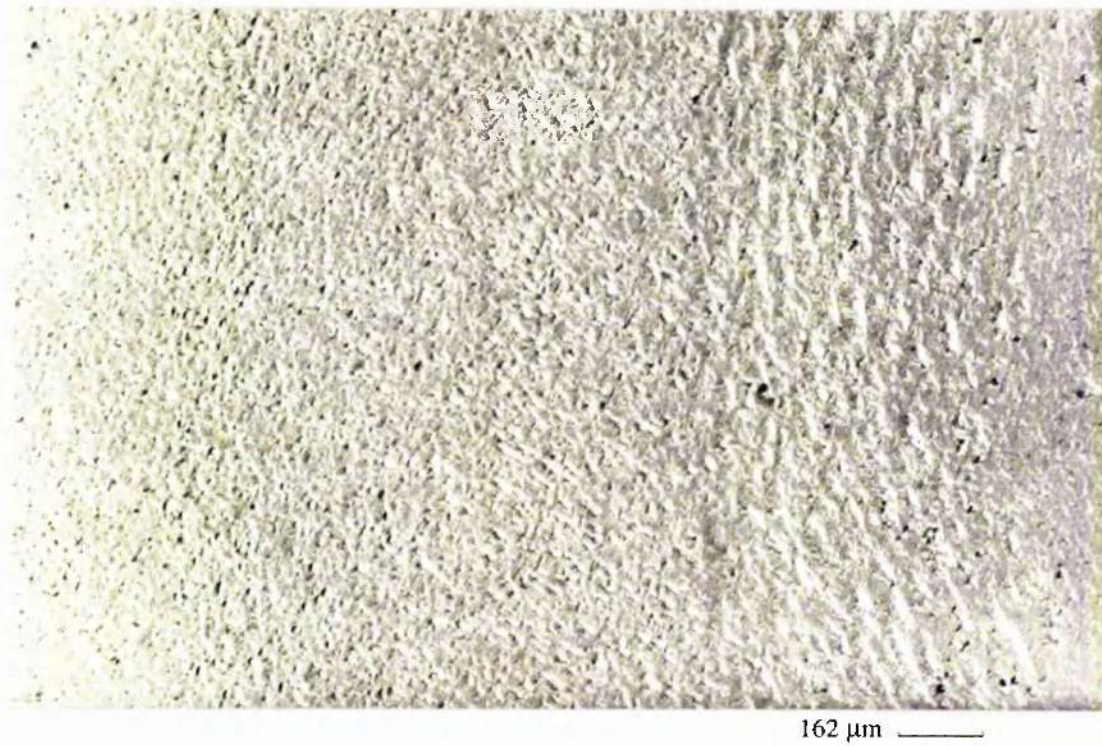
**Figure 6.2.11.** At higher magnification, ring round the centre of the 316L specimen shown in figure 6.2.10 consists of disuniformed surface.

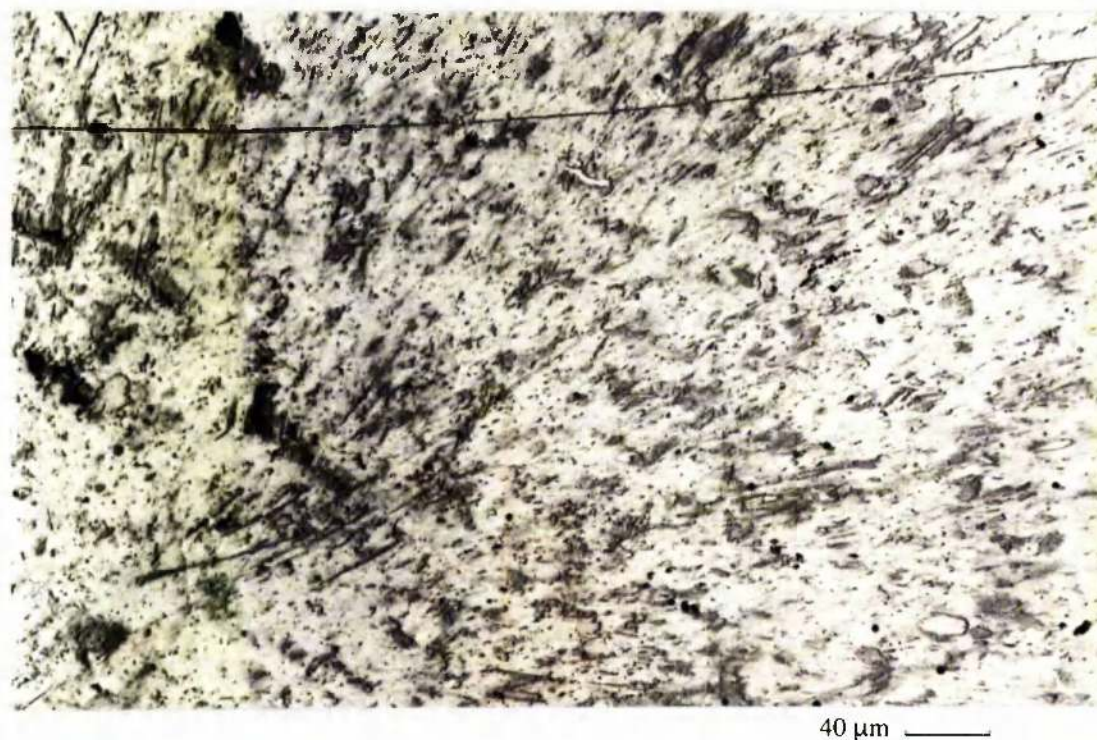
**Figure 6.2.14.** At higher magnification, the area round the centre of the 316L specimen in figure 6.2.13 appeared to quite disuniform.

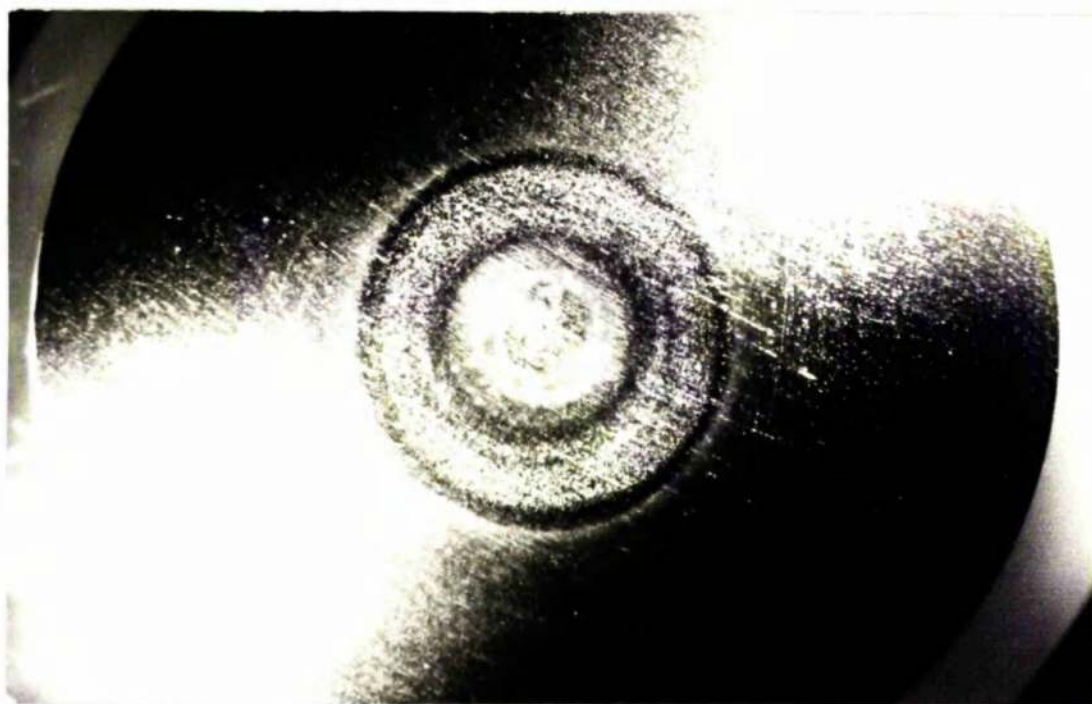
**Figure 6.2.16.** Ti:G2 after 12 hours of liquid erosion-corrosion at 50°C and 71.1 m/s impinging jet velocity **without electrochemical intervention** (diameter of specimen 32 mm).

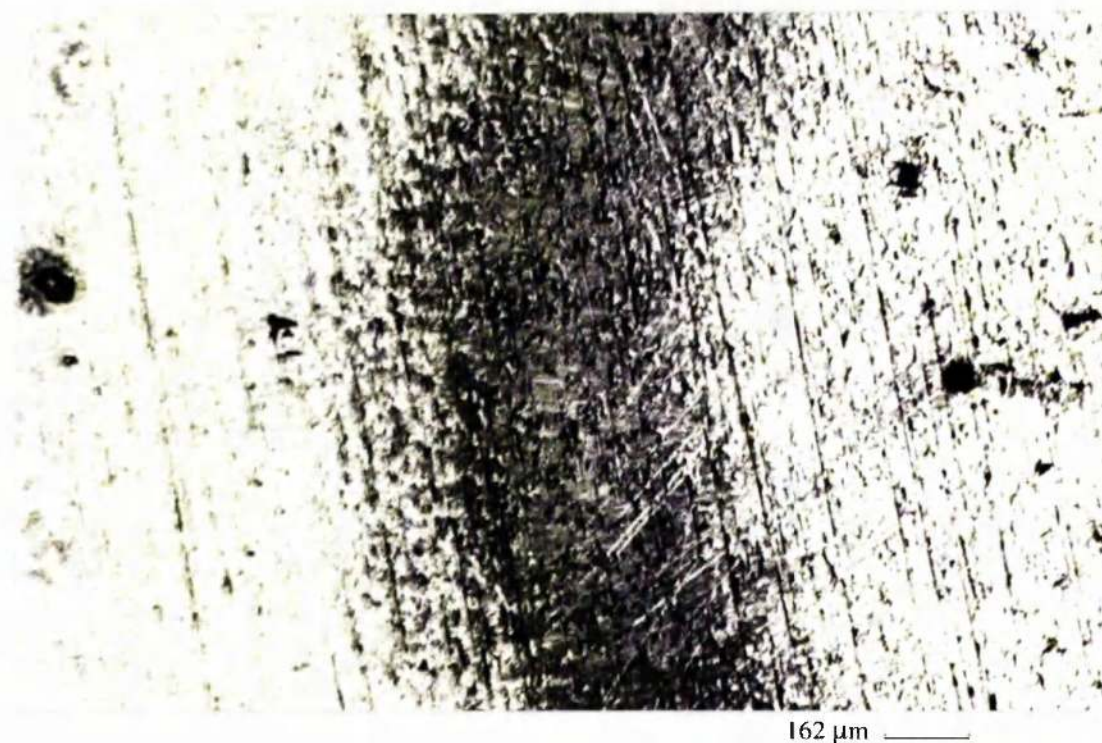
**Figure 6.2.17.** Centre of impingement (right side), first dark ring and next brighter region with pits on the Ti:G2 specimen shown in figure 6.2.16.

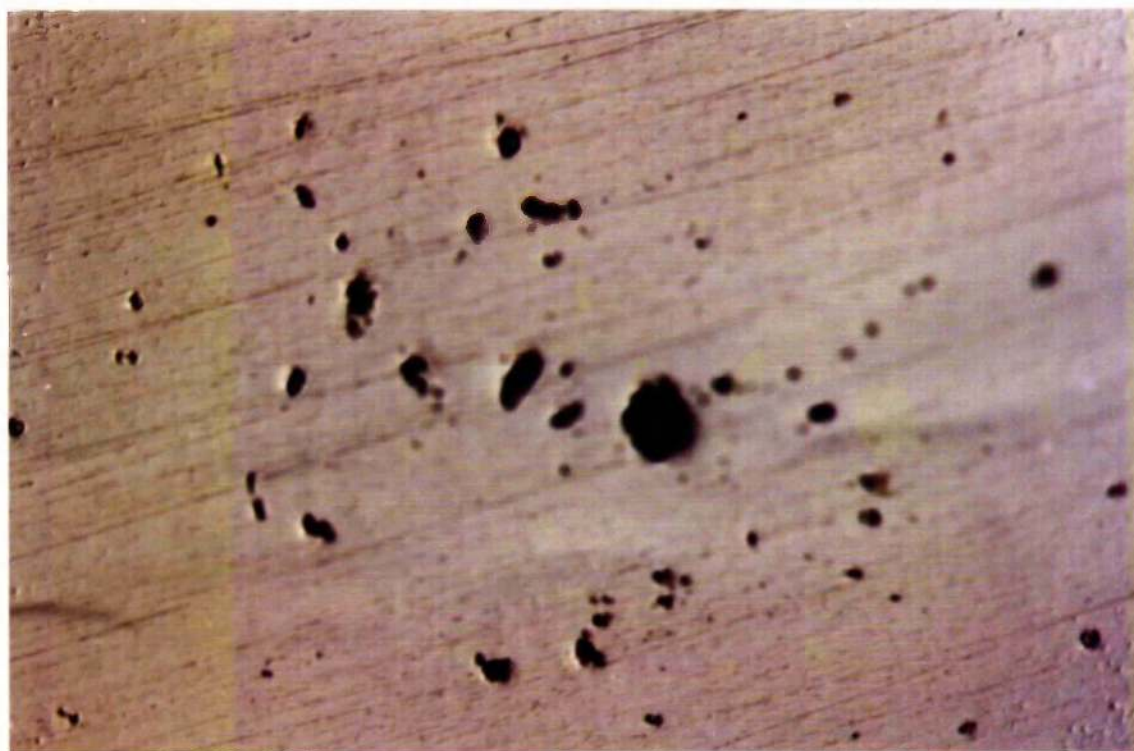
**Figure 6.2.31.** Severe pitting in the centre of the 316L specimen shown in figure 6.2.30.

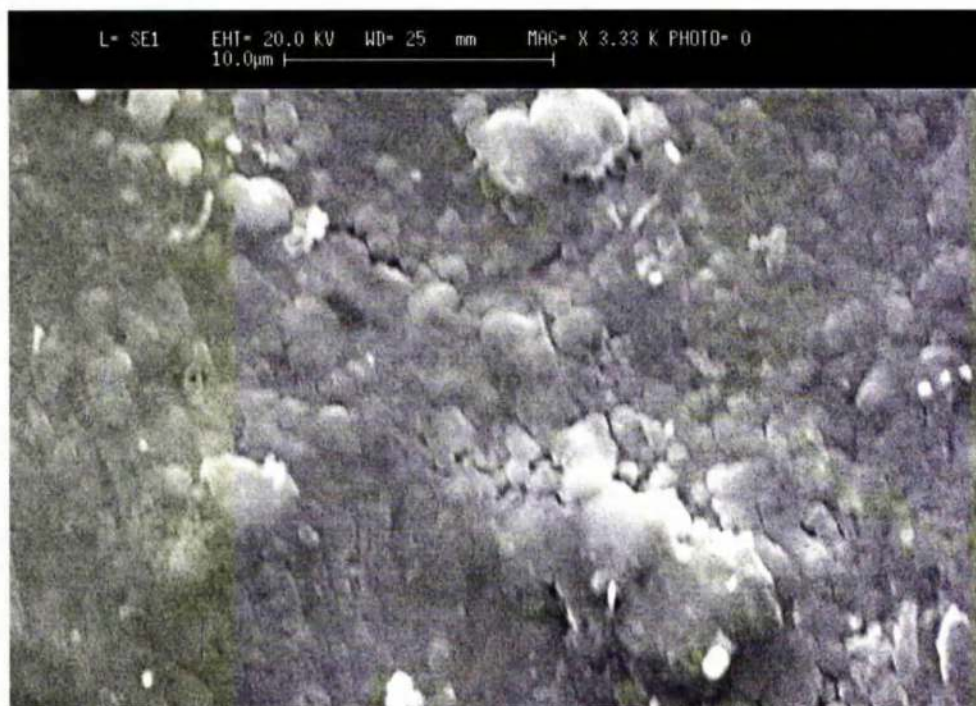
**Figure 6.2.32.** Non-uniform surface on the region directly under the jet of a Ti:5111 specimen when anodically polarised after 12 hours of liquid erosion-corrosion at 50°C and 71.1 m/s (S.E.M. image).

Referring back to the Ti:5111 specimen shown in figure 6.2.27, S.E.M. images (figures 6.2.32 – 6.2.37) have shown that zones of different colour represent zones of different roughness (and presumably different thickness). A scale of degree of roughness from 1 (very smooth) to 4 (roughest) has been given to each separate zone (table 7.2.2) to allow the graphical representation (figure 7.2.1) of the roughness variation on the surface of that particular specimen. Table 7.2.2 also gives the extent of those zones as measured on the magnified scale of figure 7.2.27.

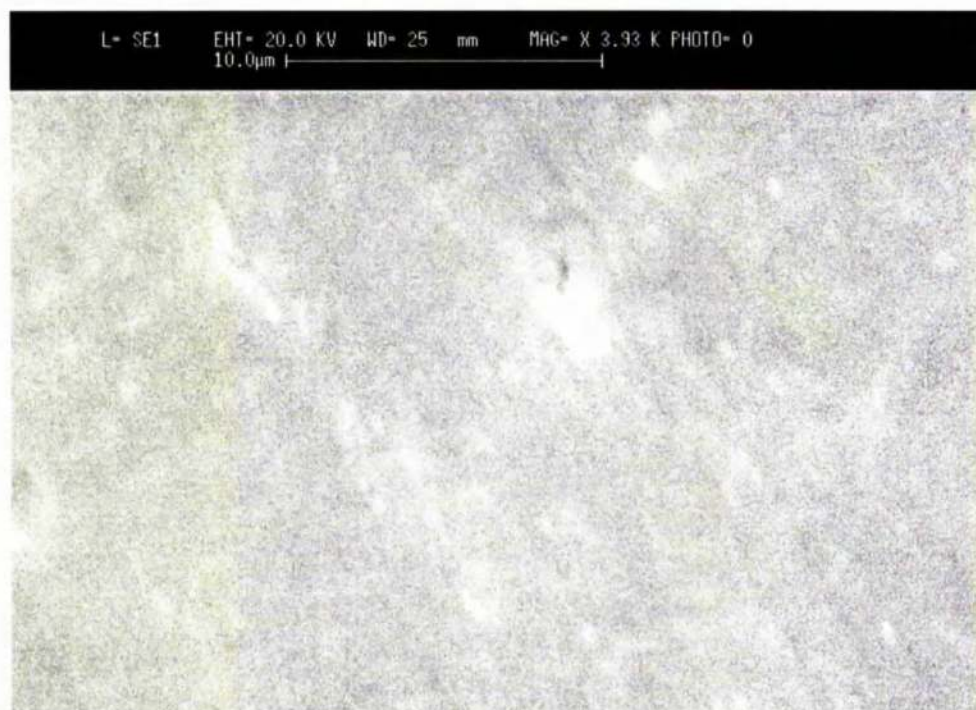
**Figure 6.2.33.** Uniform surface just outside the impinging target (i.e. on first dark ring in dark-blue colour also shown in figure 6.2.27) of a Ti:5111 specimen when anodically polarised after 12 hours of liquid erosion-corrosion at 50°C and 71.1 m/s (S.E.M. image).

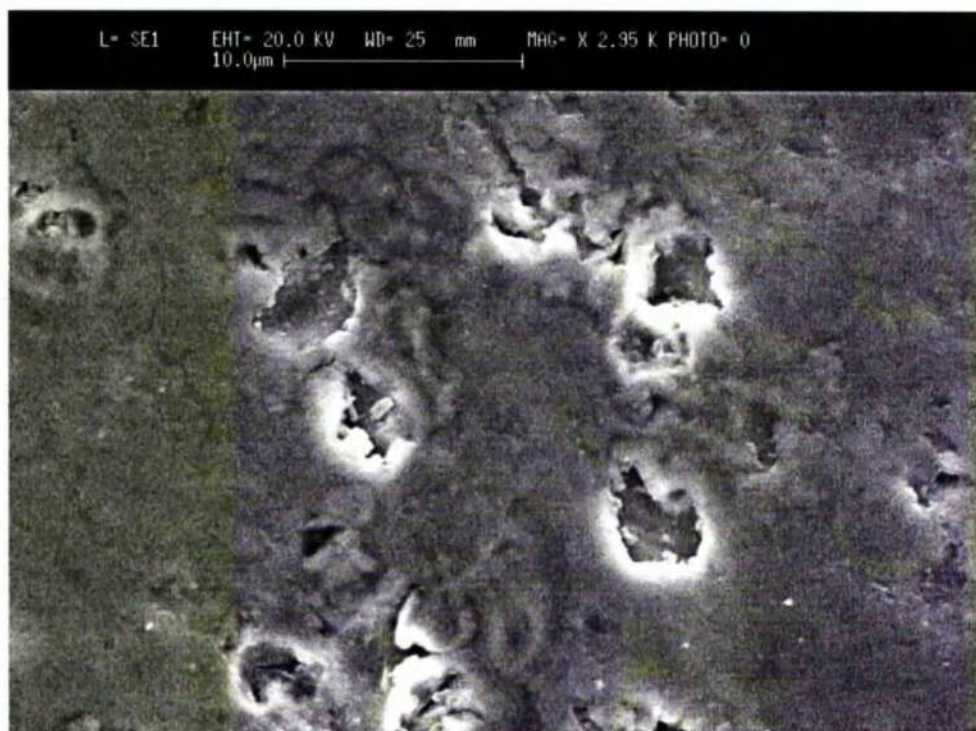
**Figure 6.2.35.** Non-uniform surface on the outer edge of the light-coloured ring (also shown in figure 6.2.27) of a Ti:5111 specimen when anodically polarised after 12 hours of liquid erosion-corrosion at 50°C and 71.1 m/s (S.E.M. image).

outer edge (figure 6.2.35) of the light coloured ring and beyond that the rest of the surface was quite smooth and featureless.

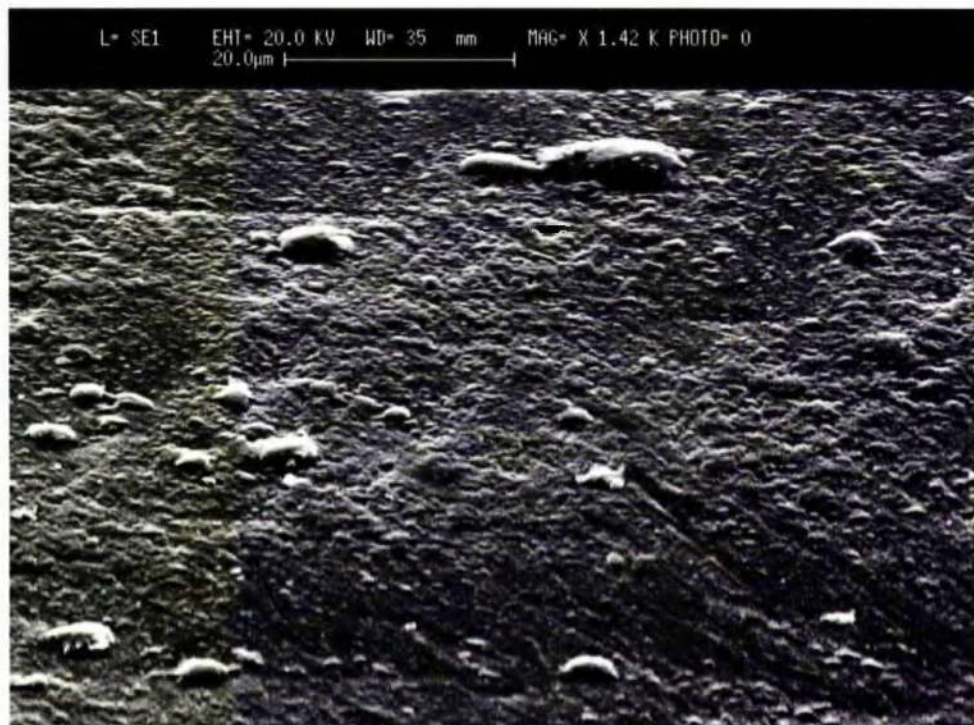
**Figure 6.2.37.** Film on the region directly under the jet (shown in a tilted position) of a Ti:5111 specimen when anodically polarised after 12 hours of liquid erosion-corrosion at 50°C and 71.1 m/s (S.E.M. image).

Rings of different roughness on the Ti:G2 specimen were not as well defined as on the Ti:5111 specimen since the film on Ti:G2 covered rather evenly the entire surface. Quite interestingly, directly under the impinging jet, Ti:G2 (figure 7.2.36) developed much thicker film than Ti:5111 (figure 7.2.37).

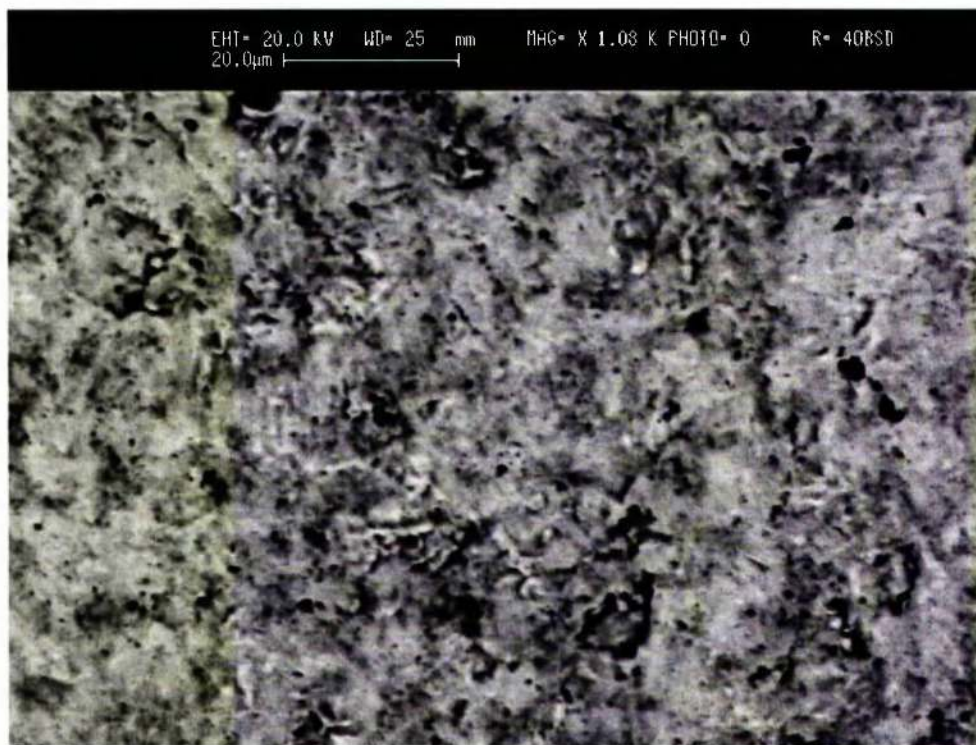
**Figure 6.3.40.** Centre of impingement on Ti:G2 after 16 hours of solid/liquid erosion-corrosion (S.E.M. image).

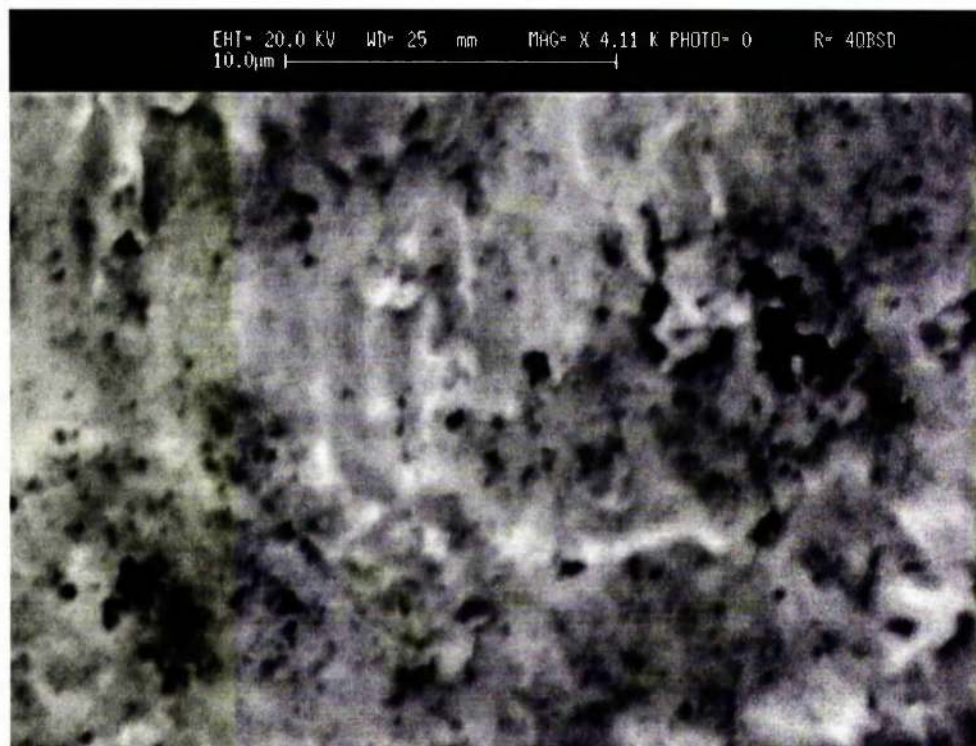
**Figure 6.3.41.** Centre of impingement on Ti:G2 at higher magnification after 16 hours of solid/liquid erosion-corrosion (S.E.M. image).

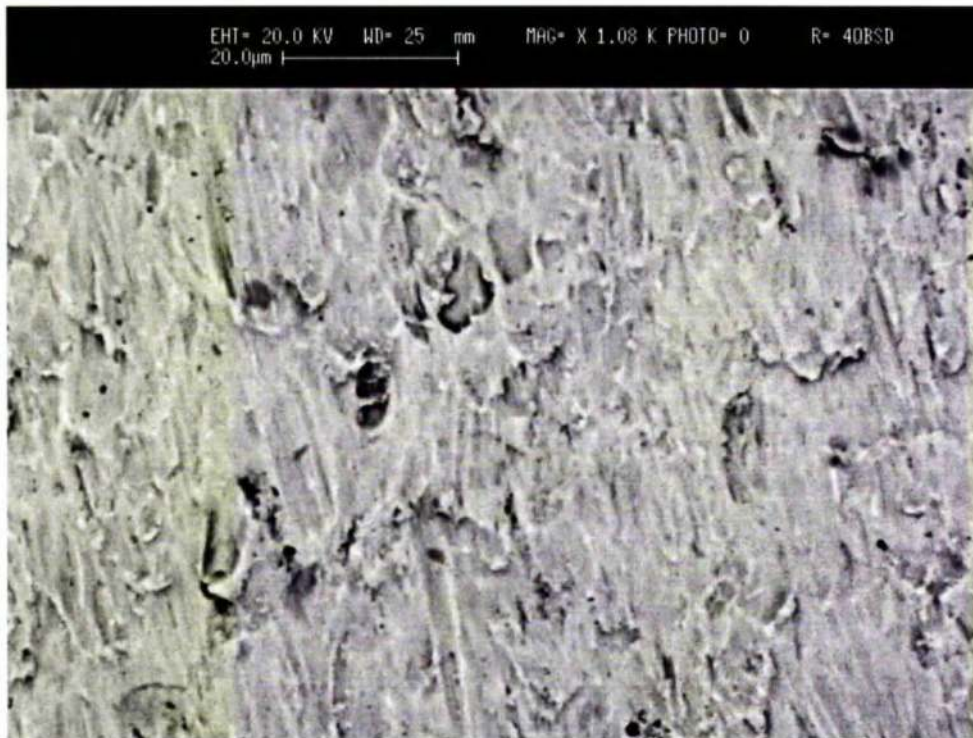
**Figure 6.3.42.** Skid marks outside the directly impinged zone of the same Ti:G2 specimen shown in figures 6.3.40 and 6.3.41(S.E.M. image).

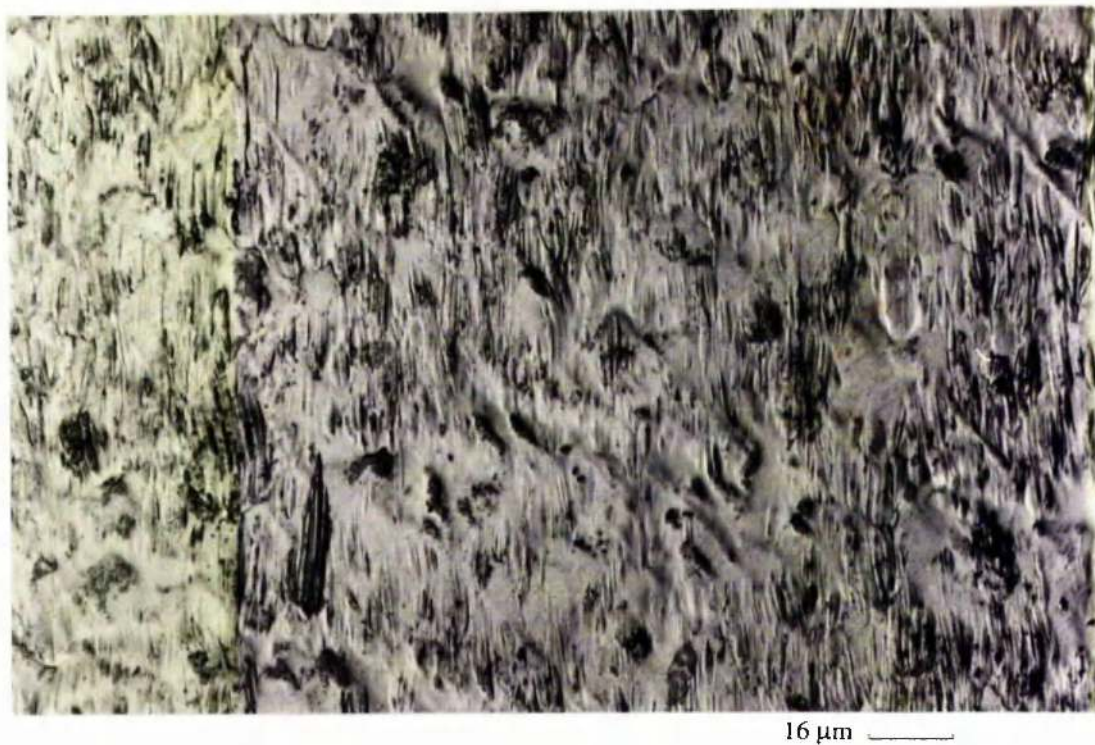
**Figure 6.3.43a.** Quite intense skid marks in dark ring just outside the wear scar (shown in figure 6.3.38) on Ti:G2 tested in solid/liquid erosion-corrosion for 16 hours.

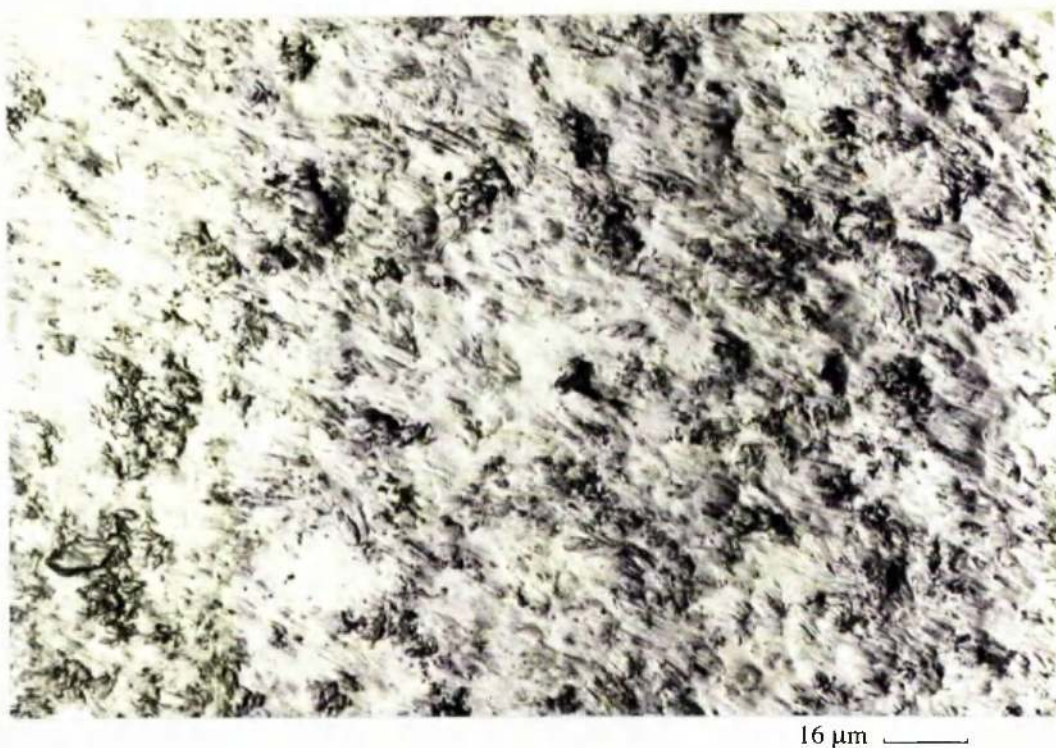
**Figure 6.3.43b.** Less intense skid marks in region further out the outer dark ring on Ti:G2 tested in solid/liquid erosion-corrosion for 16 hours.

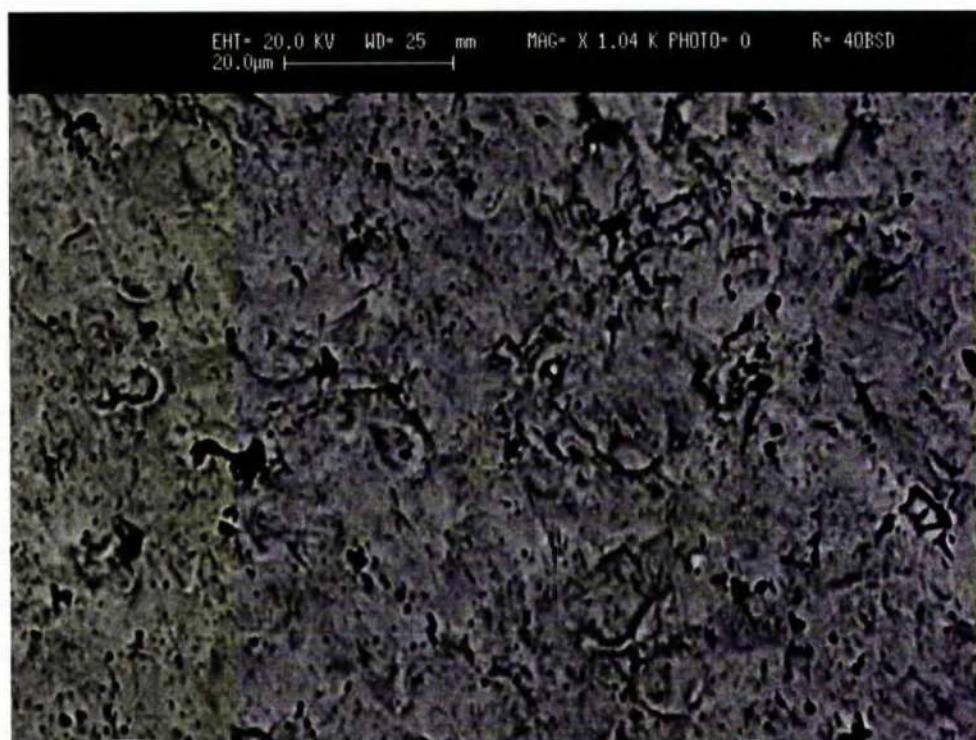
**Figure 6.3.45.** Centre of impingement on 316L after 16 hours of solid/liquid erosion-corrosion (S.E.M. image).

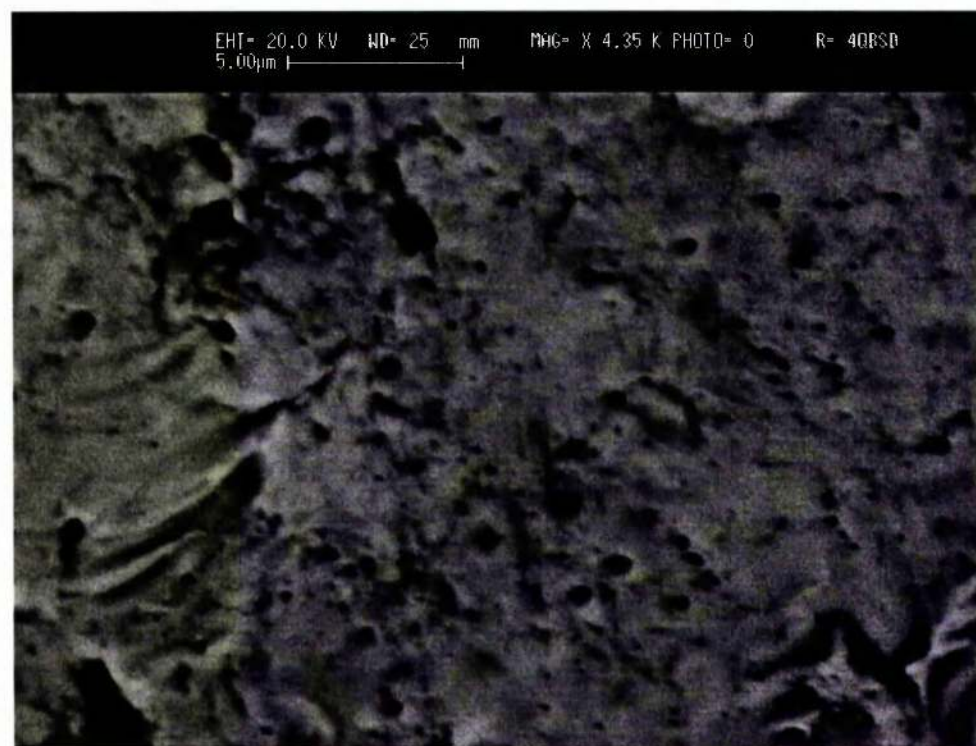
**Figure 6.3.46.** Centre of impingement on 316L at high magnification with possible evidence of plastic deformation after 16 hours of solid/liquid erosion-corrosion (S.E.M. image).

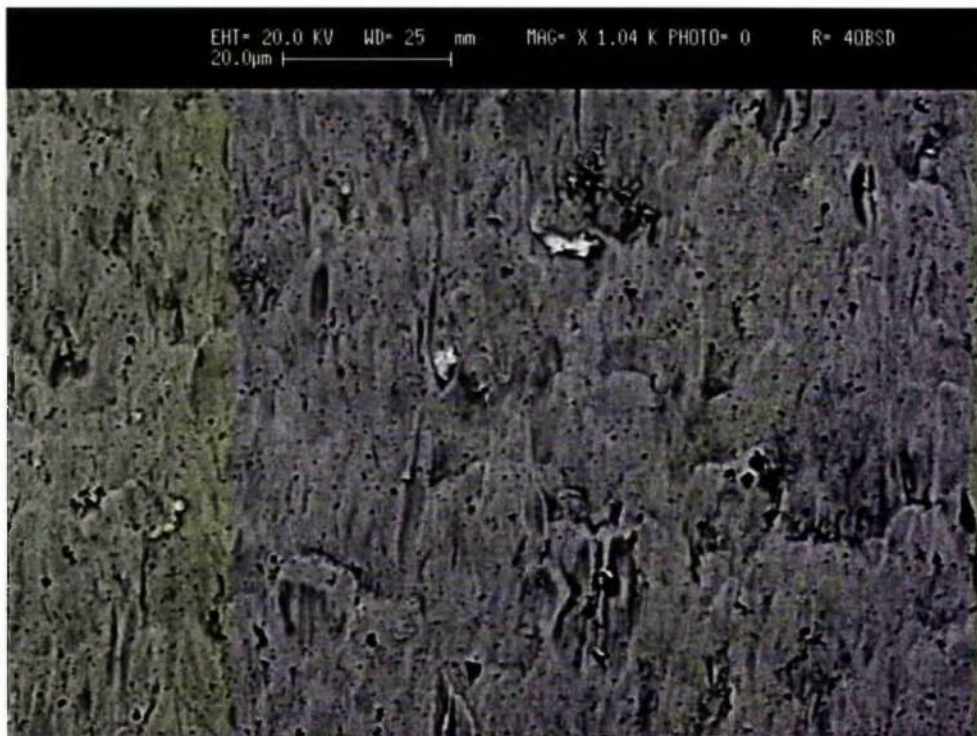
**Figure 6.3.47.** Skid marks along with numerous possible cracks outside the directly impinged zone of the same 316L specimen shown in figures 6.3.45 and 6.3.46 (S.E.M. image).

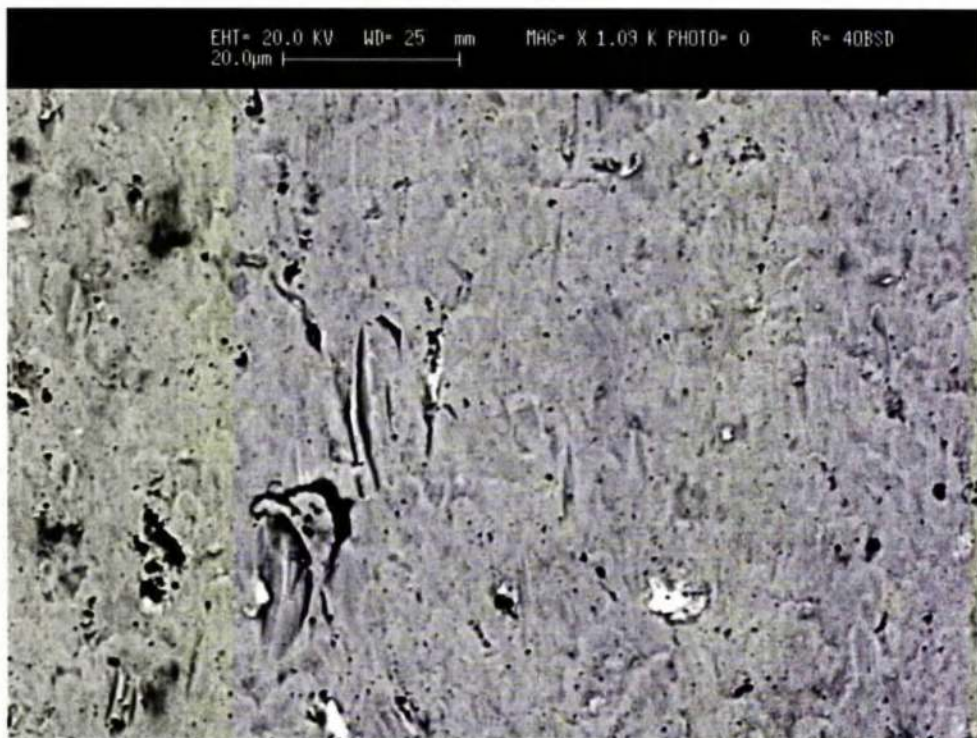
**Figure 6.3.48.** Evidence of damage right at the very outside of the surface of the same 316L specimen shown in figures 6.3.45, 6.3.46 and 6.3.47 (S.E.M. image).

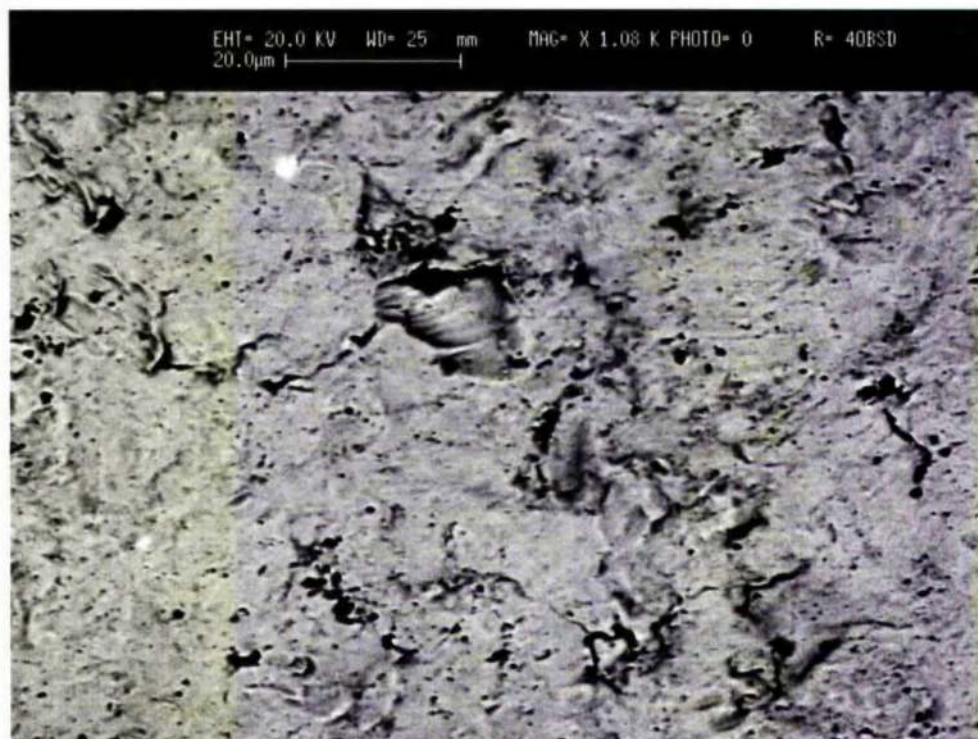
**Figure 6.3.50.** Centre of impingement on Z100 with possible evidence of plastic deformation after 16 hours of solid/liquid erosion-corrosion (S.E.M. image).

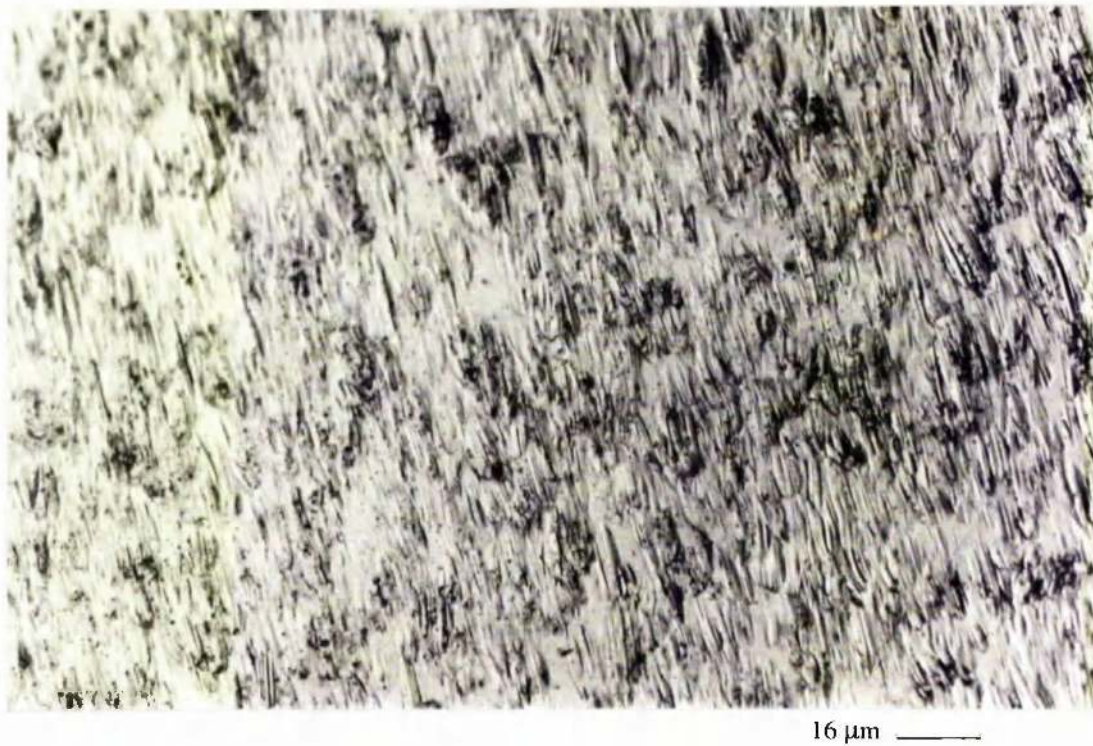
**Figure 6.3.55.** Quite intense skid marks in dark ring just outside the wear scar on Ti-6Al-4V tested in solid/liquid erosion-corrosion for 16 hours.

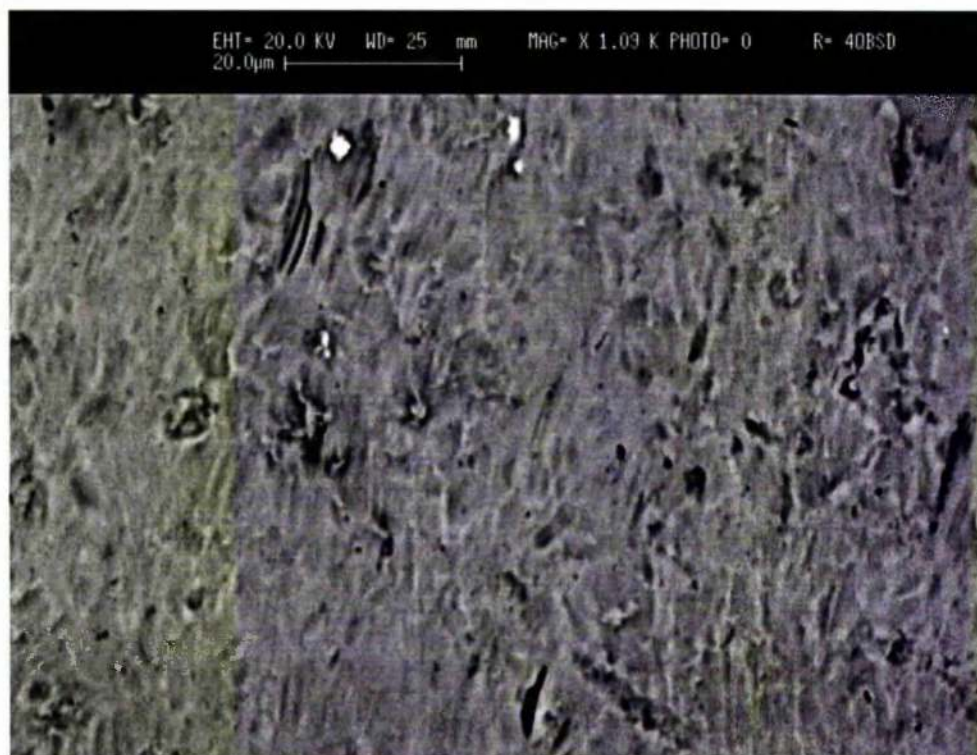
**Figure 6.3.56.** Skid marks along with numerous possible cracks outside the wear scar of the same Ti-6Al-4V specimen shown in figures 6.3.53 and 6.3.54 (S.E.M. image).

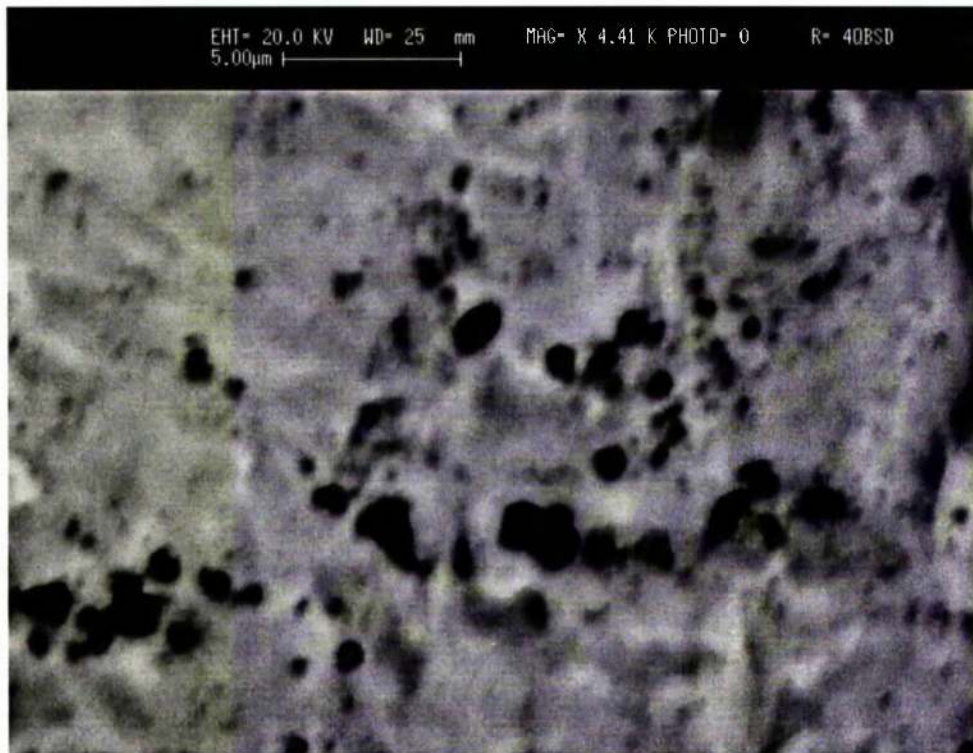
**Figure 6.3.57.** Centre of impingement on Ti-6Al-4V after 16 hours of cathodic protection in solid/liquid erosion-corrosion (S.E.M. image).

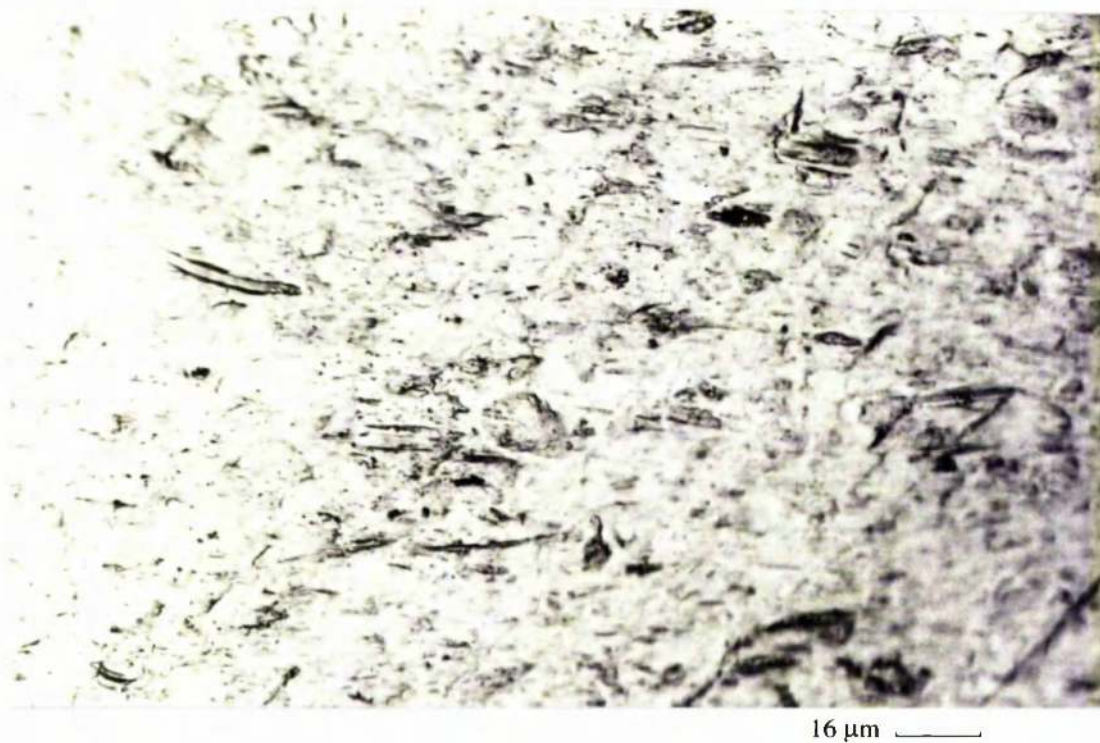
**Figure 6.3.59.** Skid marks just outside the wear scar of a Ti:G2 specimen tested in solid/liquid erosion-corrosion under cathodic protection for 16 hours.

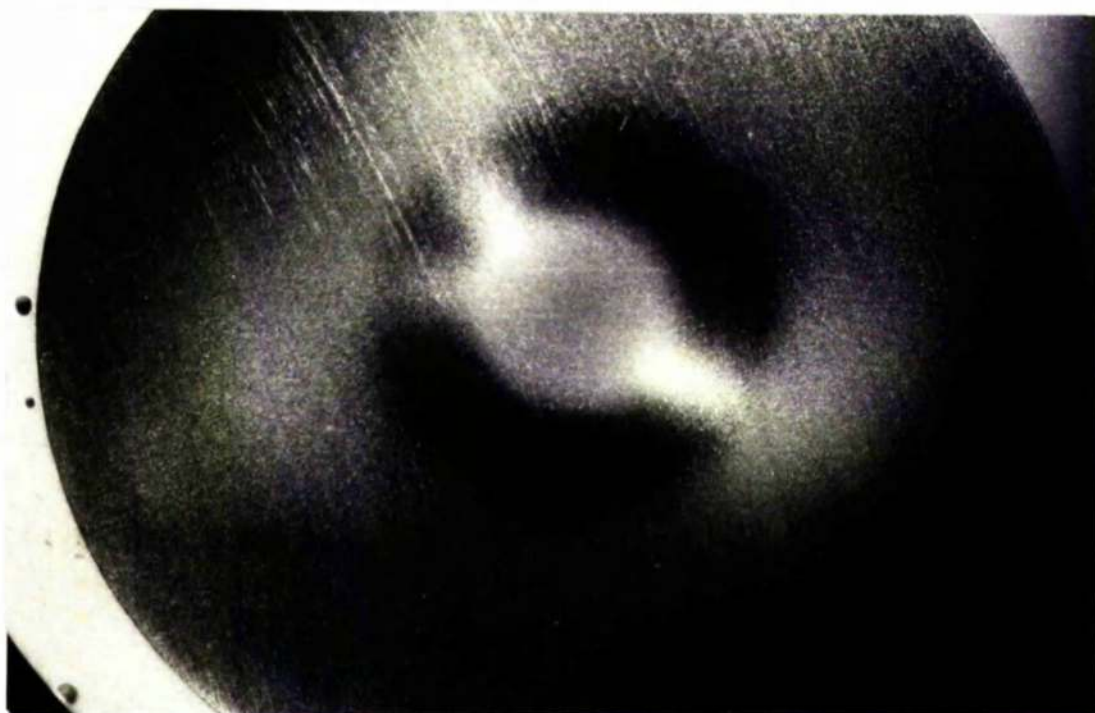
**Figure 6.3.60.** Ti:G2 specimen as a whole when anodically polarised after 4 hours of solid/liquid erosion-corrosion (diameter of specimen 32 mm).

Figure 6.3.60 shows the same outer dark ring around the wear scar of a Ti:G2 specimen that was anodically polarised after 4 hours of solid/liquid erosion-corrosion as the one developed during free solid/liquid erosion-corrosion (see figure 6.3.38). Figure 6.3.61 shows severe pitting in the centre (region directly under the jet) of a 316L specimen that was anodically polarised after 16 hours of solid/liquid erosion-corrosion. Pitting outside the centre was not as intense but certainly quite obvious (figure 6.3.62). No such pitting was observed on Ti:G2 (figure 6.3.63) or Z100 (figure 6.3.64) when anodically polarised after 16 hours of solid /liquid erosion-corrosion. This suggests that, under such conditions of exposure, the erosion corrosion behaviour of superduplex stainless steel is closer to titanium than to austenitic stainless steel. However, as shown in figure 6.3.65, in contrast to Ti:G2, Z100 after 16 hours developed small but numerous comets outside the directly impinging zone.

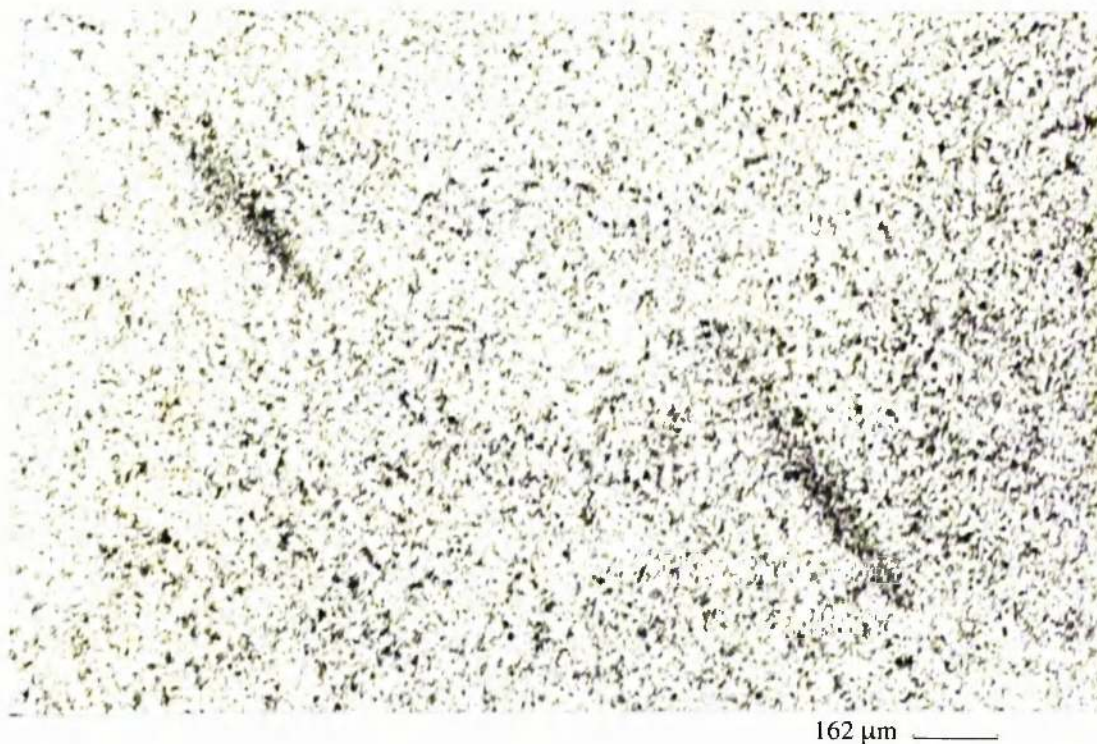
**Figure 6.3.65.** Small comets outside the directly impinged zone on the same Z100 specimen shown in figure 6.3.64.
