# **Durability Studies Relevant to Marine Equipment**

**By**  
**Dimitris Mantzavinos**

A thesis submitted to  
The Department of Mechanical Engineering  
University of Glasgow

in fulfilment of the requirement for  
The Degree of Doctor of Philosophy

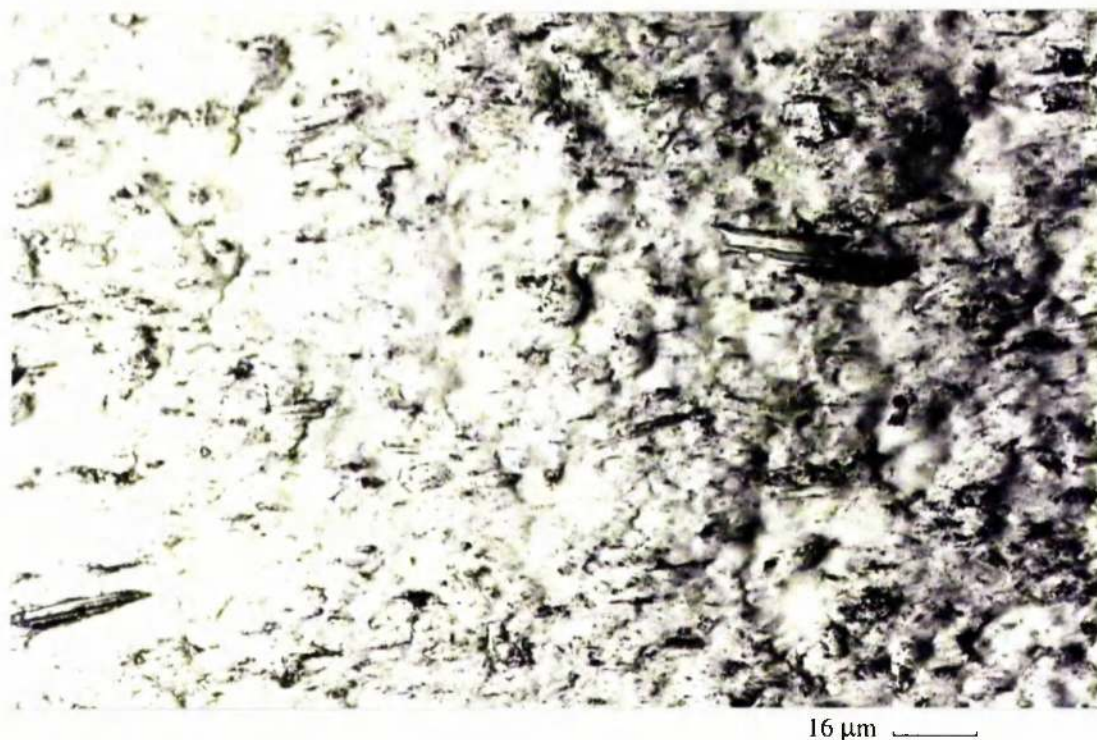
**Figure 6.3.66.** Skid marks on the surface outside the wear scar of a Ti:G2 specimen tested in solid/liquid erosion-corrosion with particle concentration 907 – 955 ppm.
