**An Investigation of the Corrosion Behaviour of a Range of
Engineering Materials in Marine Environments**

**Submitted in Fulfilment of the Requirements for the Degree of Doctor of
Philosophy (Ph.D.)**

by Anne Neville

**Department of Mechanical Engineering,
University of Glasgow,
September 1995**

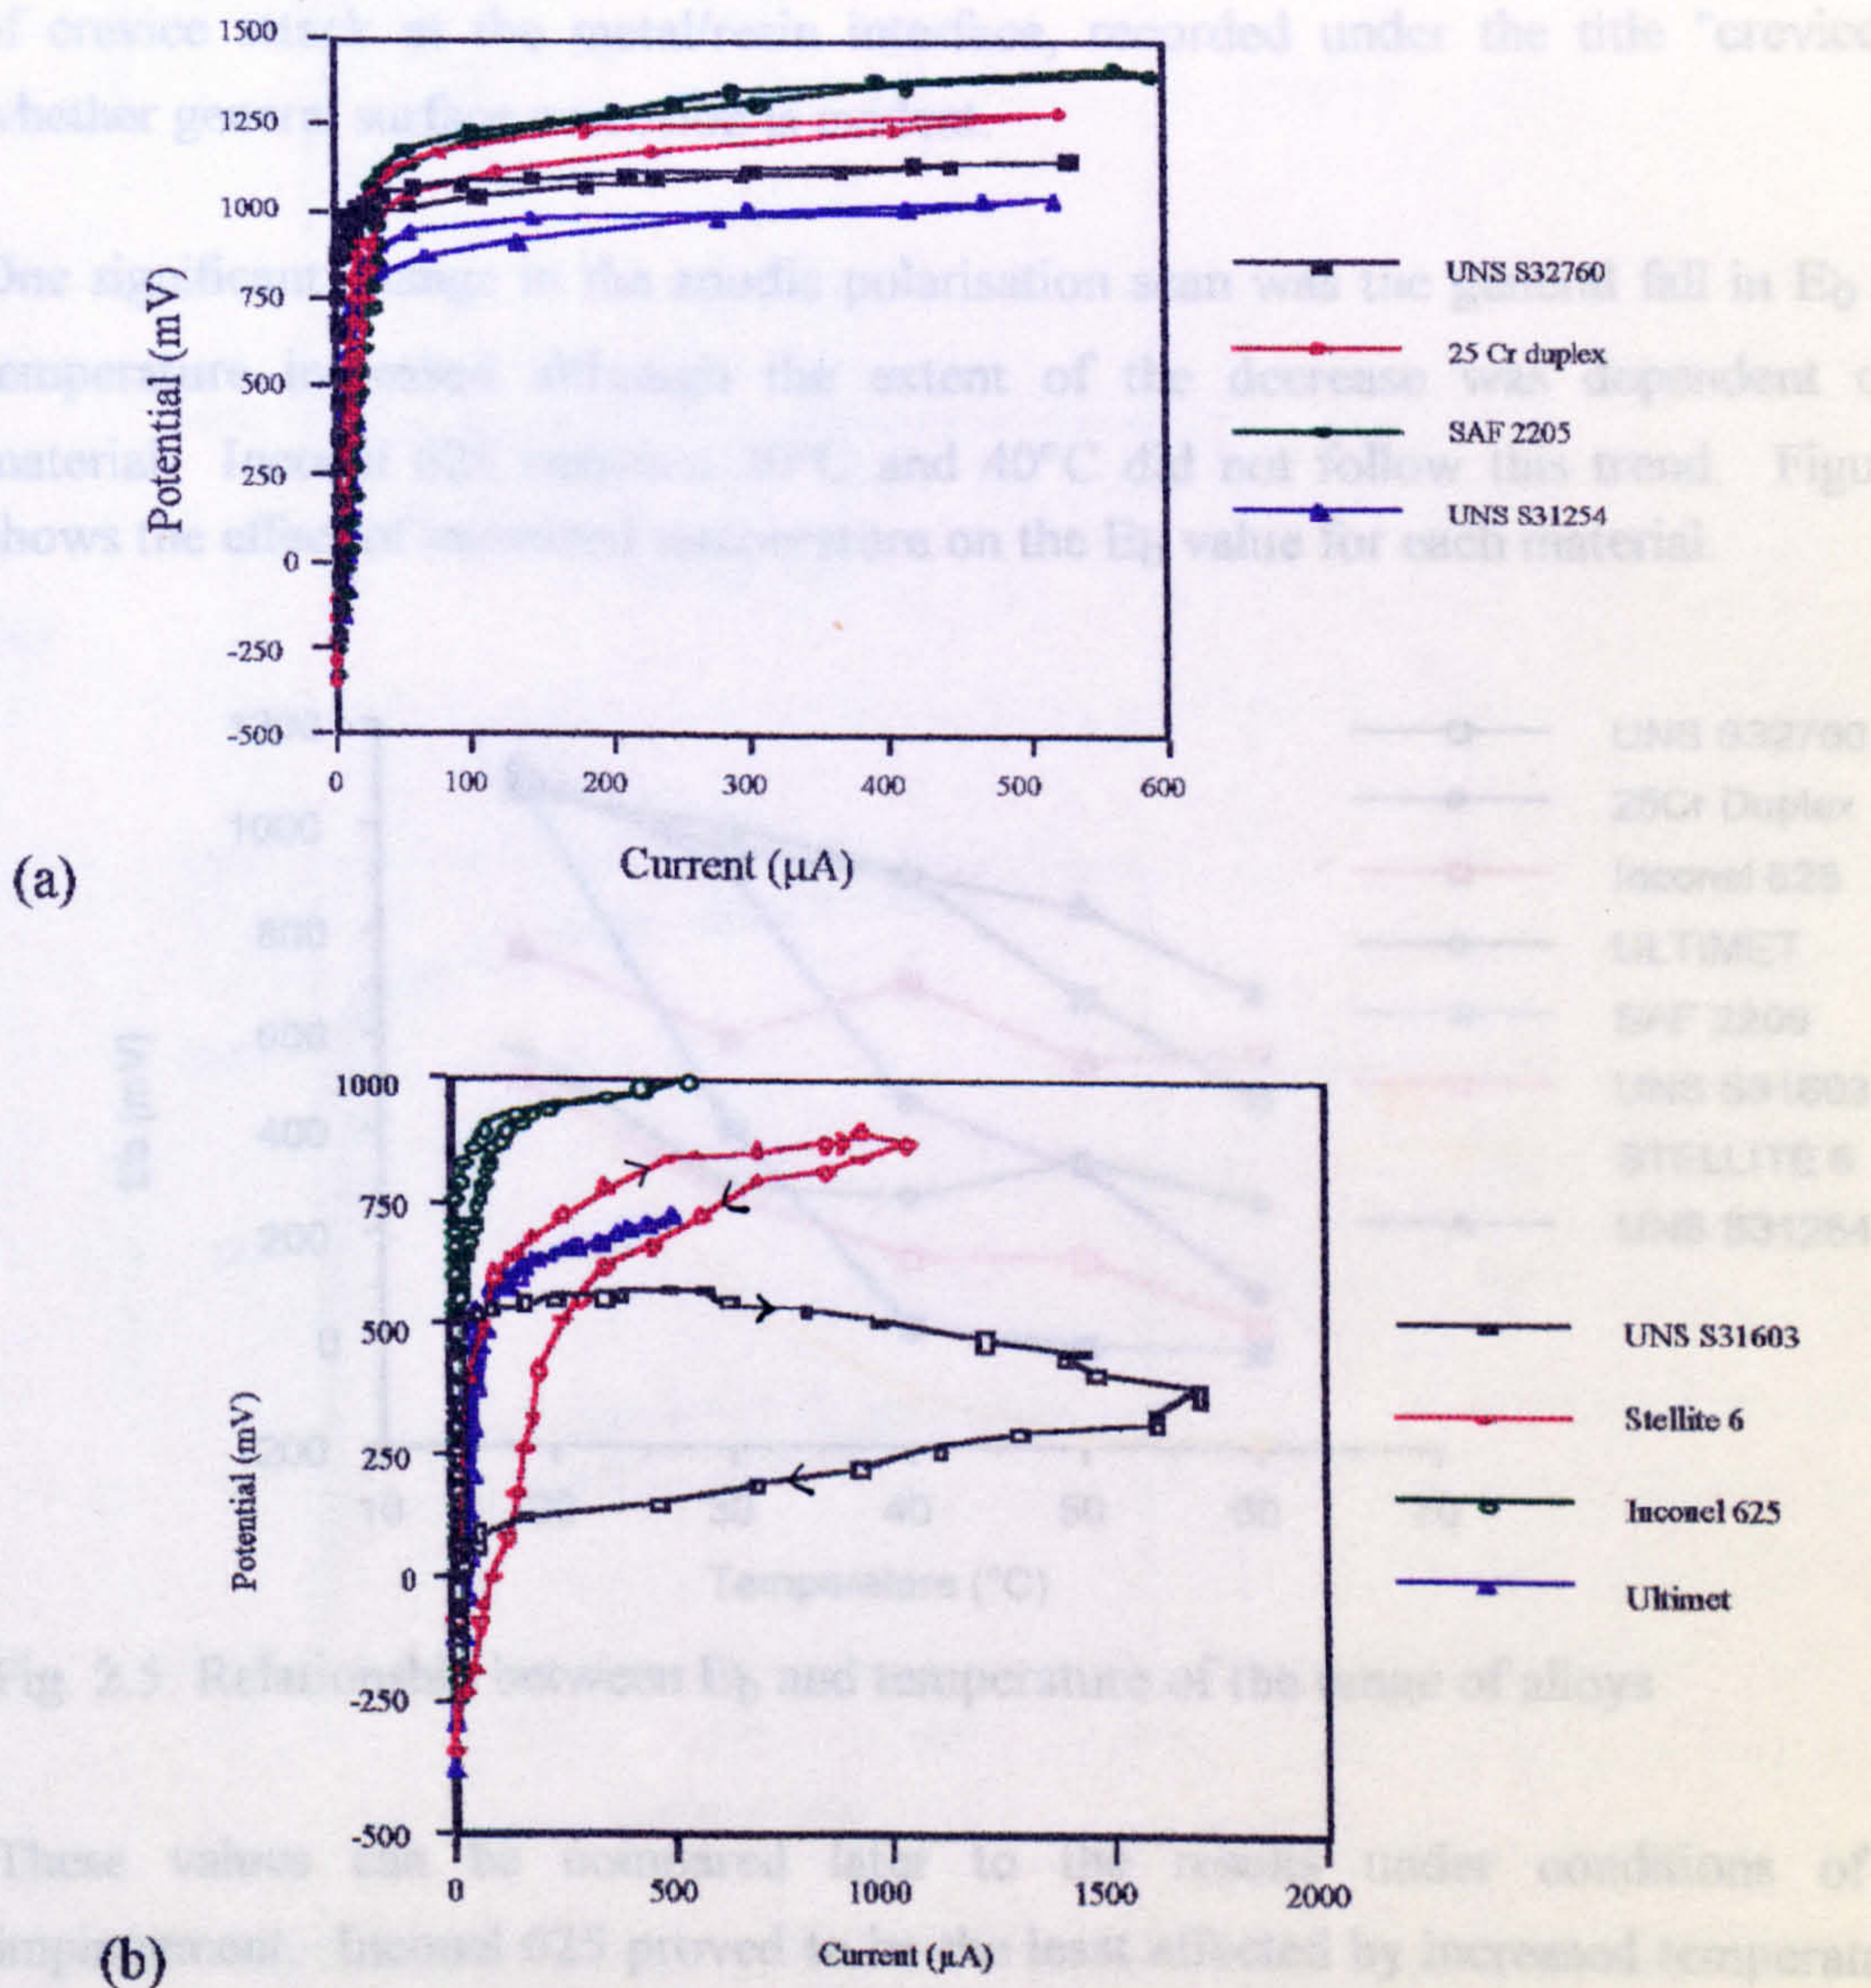
Fig. 2.4. Anodic polarisation at 18°C in static seawater (a) Superduplex, superaustenitic and duplex stainless steels and (b) cobalt-base alloys, Inconel 625 and austenitic UNS S31603 stainless steel

Static tests in ambient temperature sea water clearly demonstrated (Fig 2.4) the superiority of the duplexes, super-duplex and the superaustenitic stainless steel over UNS S31603 and also over the nickel-base and cobalt-base alloys in resisting passive-film breakdown (i.e. higher E_b values) and this enhanced corrosion resistance of the higher-alloyed stainless steels is in accordance with much other previous research conducted at ambient temperature.

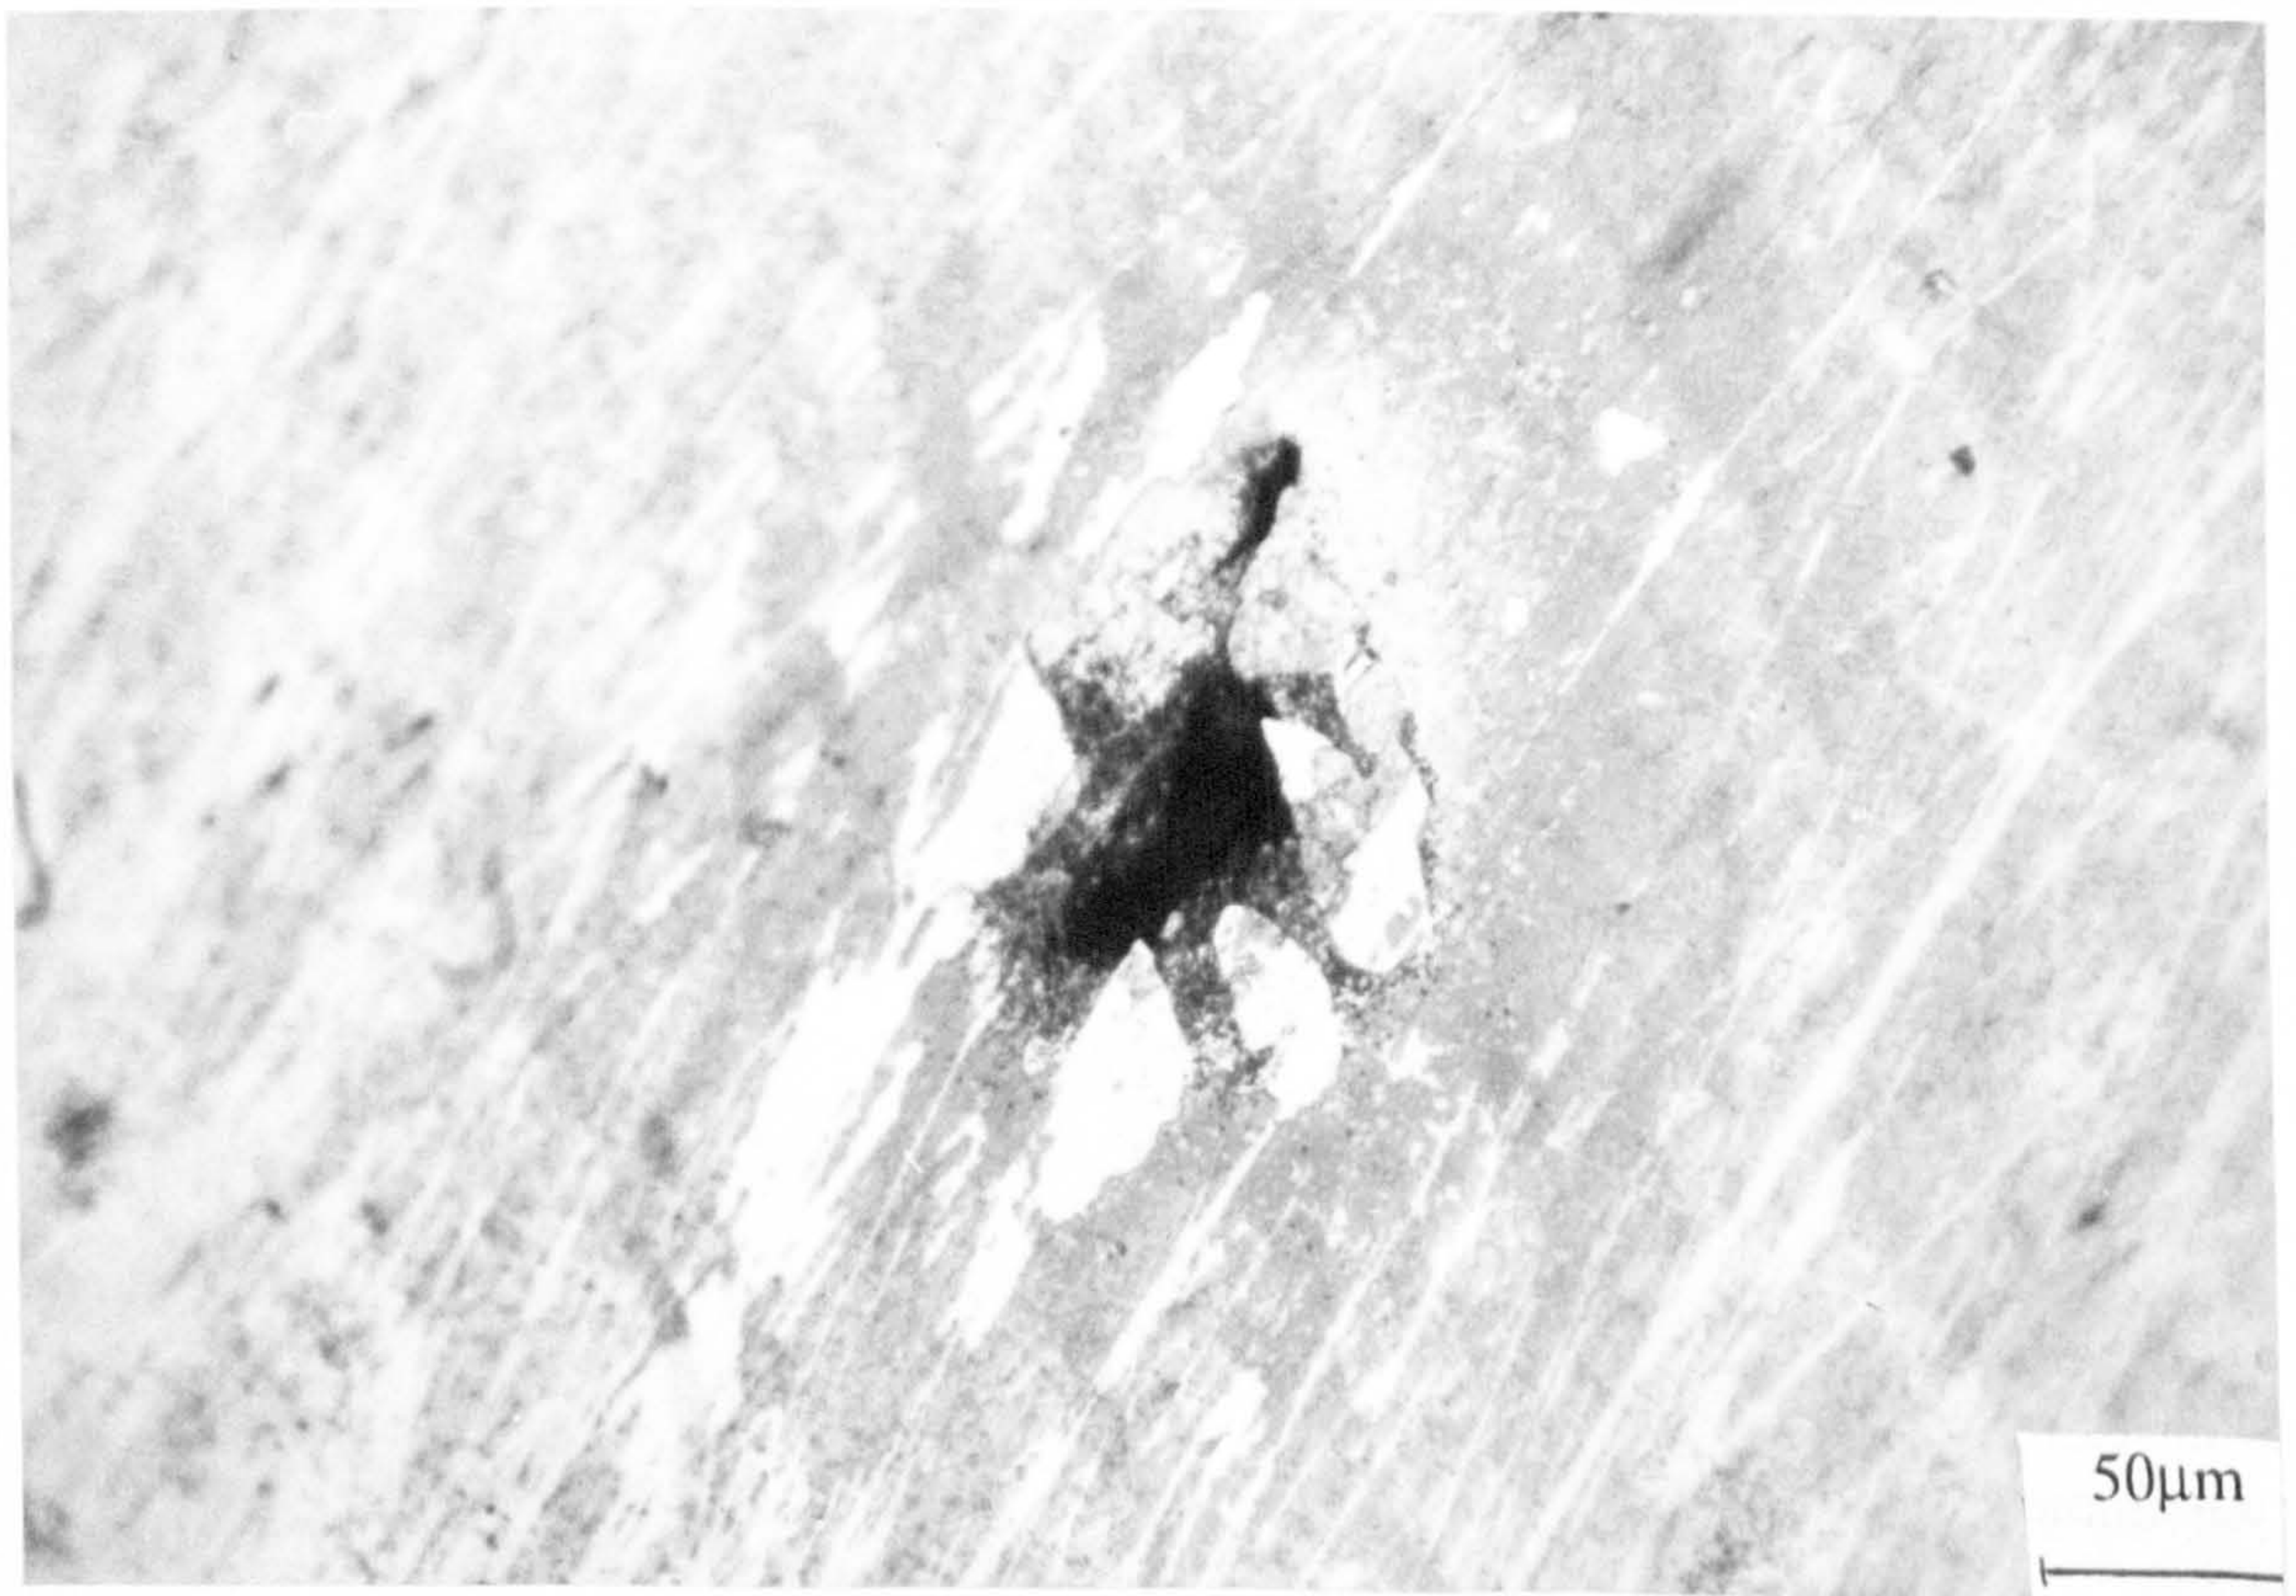
As shown in Figs. 2.8c and d, continued increase in temperature to 50°C meant that the superduplex alloy could no longer begin to repassivate and high currents were attained after the scan reversal. A fall in I_{\max} was recorded on increasing the temperature from 50°C to 60°C as shown in Figs 2.8d and e. Figure 2.11a shows a light micrograph of a fully developed pit on this material after anodic polarisation at 50°C. The grain structure can clearly be seen in the vicinity of the pit. The attack seems to be propagating via the grain boundaries, leaving individual grains protruding into the pit as can be seen more clearly in the SEM micrograph (Fig 2.11b) of a different region on the same superduplex specimen. Microanalysis via EDAX facilities on the SEM, yielded a higher Fe and Ni concentration on the grain (area 1 on Fig 2.11b) and higher Cr and Mo concentrations on the area adjacent to the grain (area 2 on Fig. 2.11b), confirming area 1 as austenite and area 2 as ferrite. Table 2.7 gives the exact compositions which indicate that the partitioning ratio for Mo and Ni is greater than for Cr and Fe. This large extent of propagation is in contrast to pits formed at 30°C where only initial film breakdown in the immediate area can be seen (Fig. 2.11c) due to rapid repassivation. With the exception of Inconel 625, the attack at 50°C and 60°C comprised of mixed mechanisms of general and localised attack.

Fig. 2.8. Anodic polarisation in static seawater at (a) 18°C (b) 30°C (c) 40°C (d) 50°C and (e) 60°C

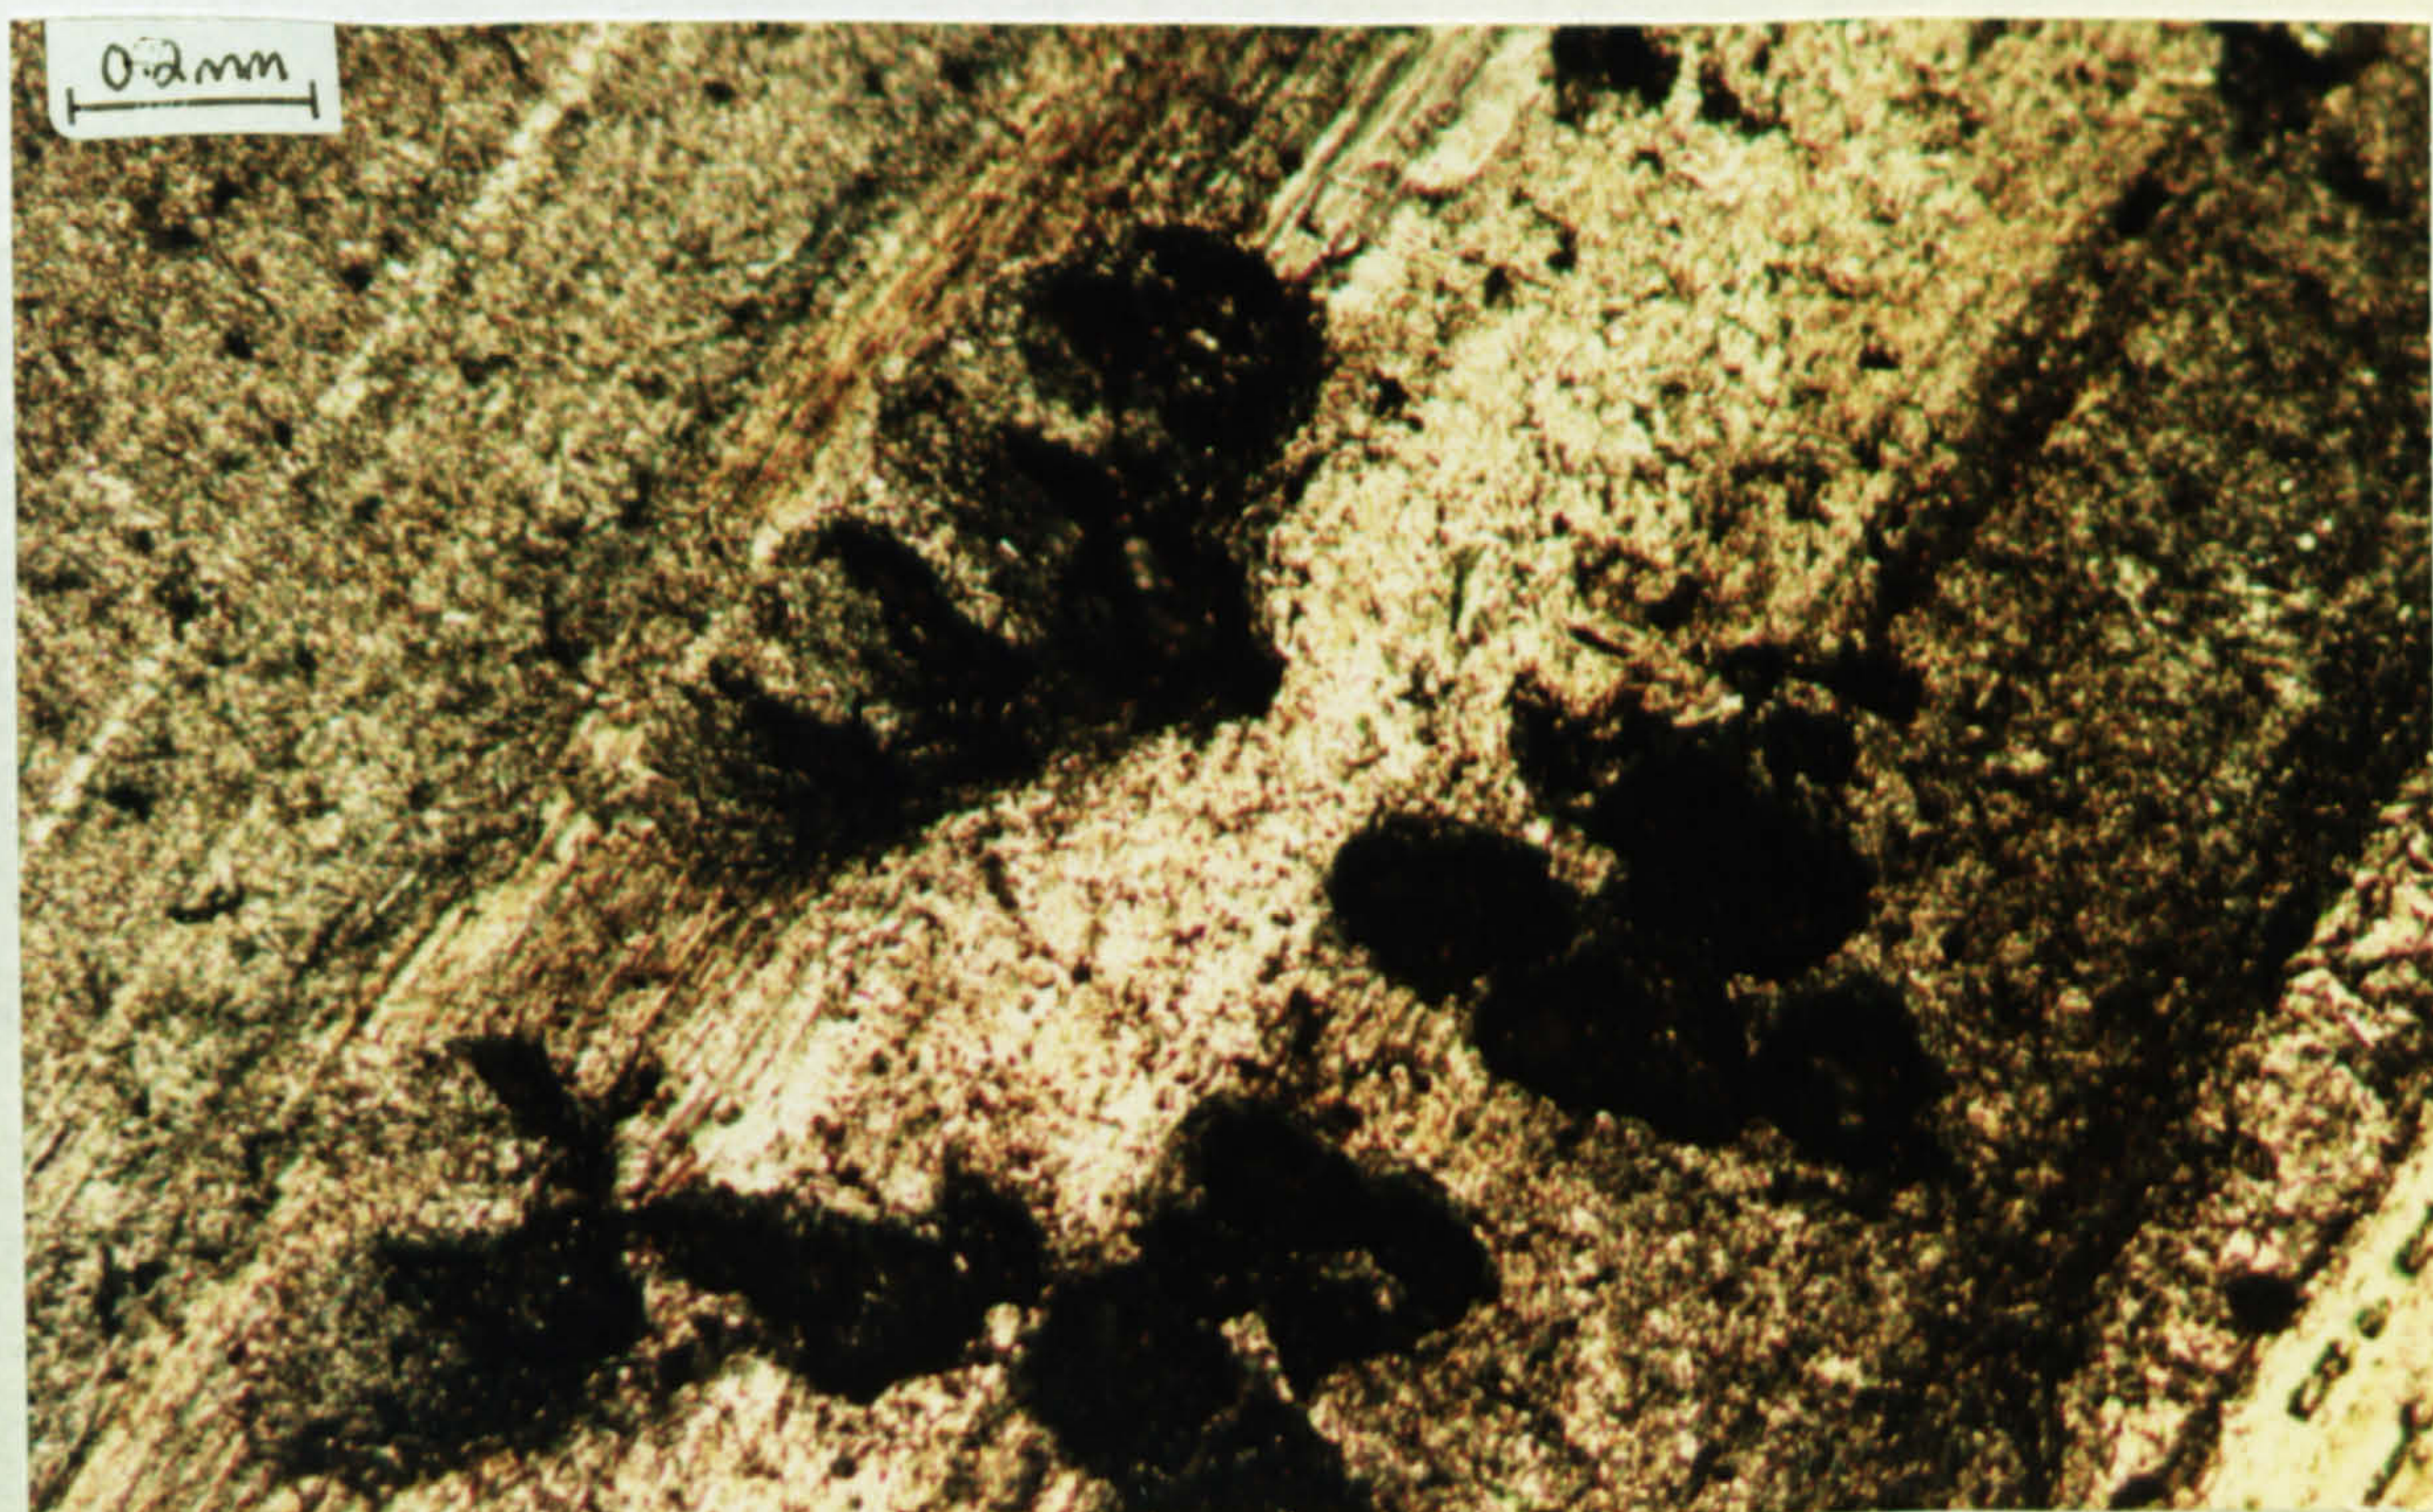
Fig. 3.1(a) Pitting on the outer surface of a Stellite 6 wear ring after exposure to seawater at 90°C and approximately four times the concentration of normal seawater and (b) closer view of pitting on the outer surface of the Stellite 6 wear ring

Closer examination of the wear ring surface using light and ultimately scanning-electron microscopy showed there to be overall surface attack which could be seen in an etching of the surface to reveal the dendritic cast structure of the Stellite 6 alloy. Figure 3.3 shows clearly the appearance of the Stellite 6 microstructure in which pitting attack could be found.

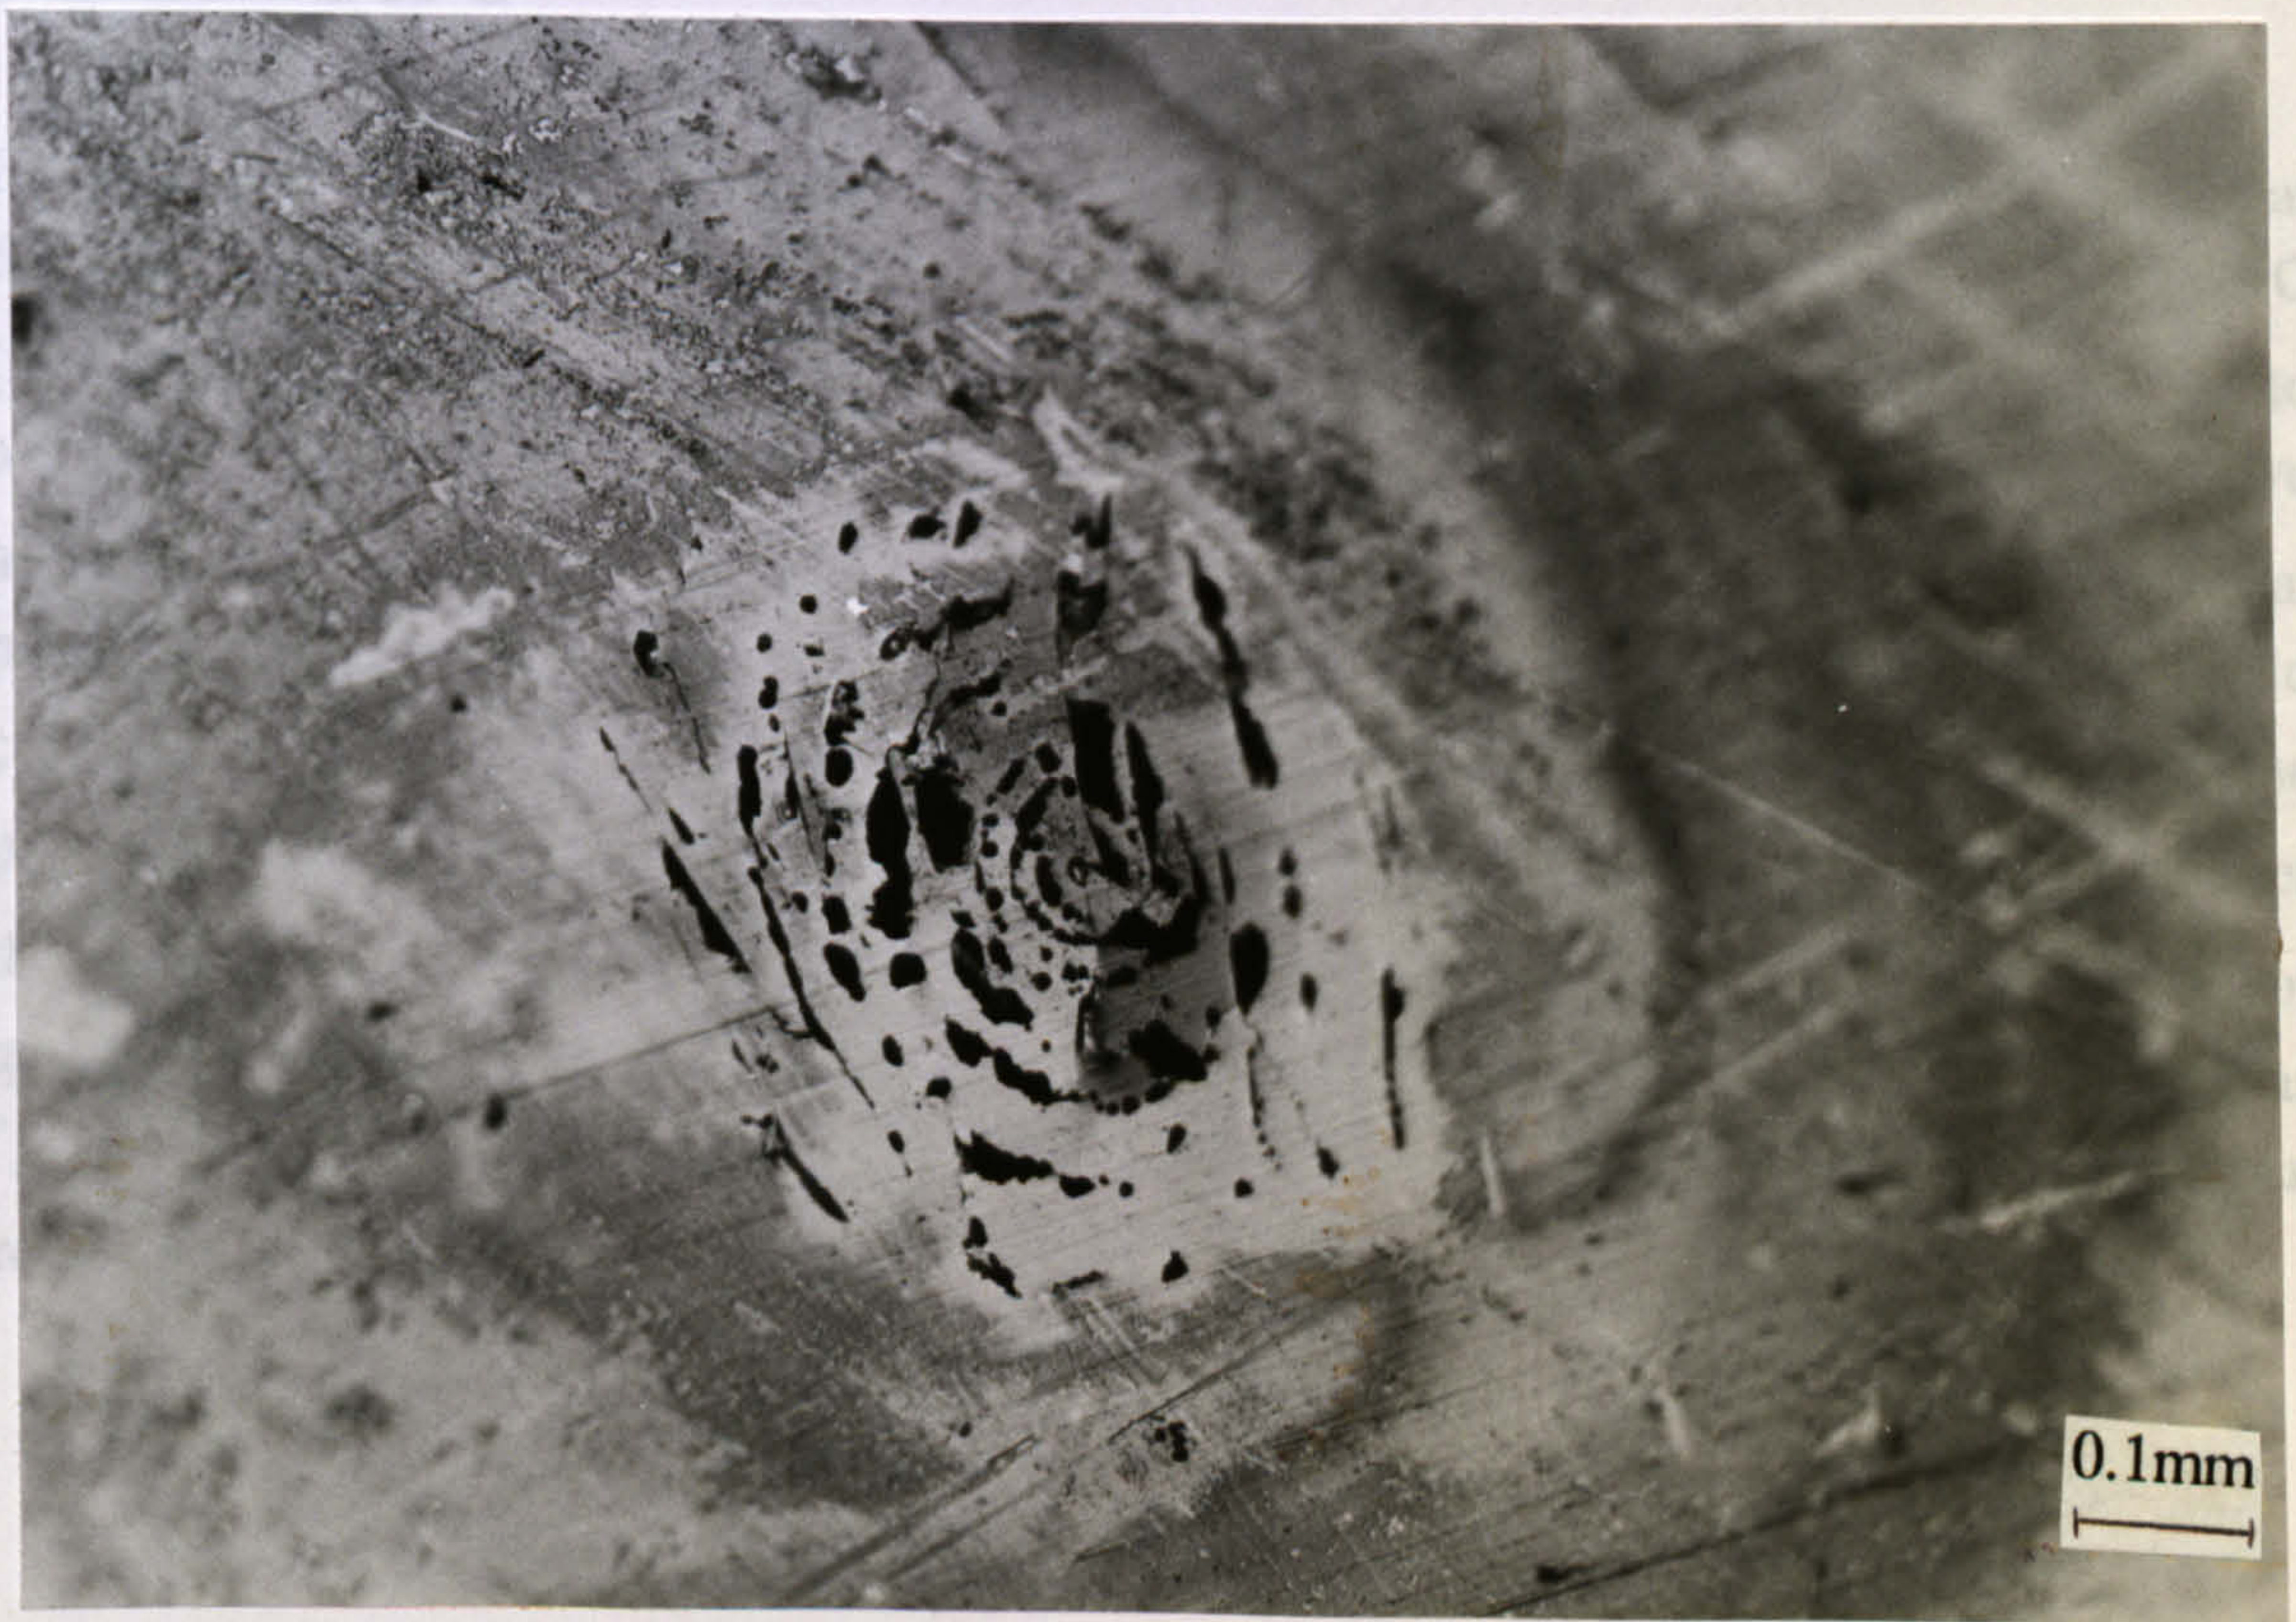
Fig. 3.14. Pitting attack on UNS S32760 after anodic polarisation at 90°C

The electrochemical results were substantiated by the post-test examination which revealed extensive localised attack at 90°C on both materials and maximum pit depths of more than five times those measured at 50°C (136µm and 174µm for the superduplex and the 25Cr duplex respectively compared to 23µm and 26µm at 50°C). As observed at 50°C, and indeed on the actual failed sleeving, a coloured film was evident over the surface within which the surface was obviously etched (Fig. 3.12). The pitted sites, once corrosion products were removed, could be identified by a skeletal structure with a deep pitted region beneath. Figure 3.13 shows on the 25Cr duplex the thin layer of perforated material over the pit and the same effect is seen on the superduplex alloy in Fig. 3.14. Attempts were made to correlate the attack to one of the phases (and perhaps relate the attack to the attack seen on the auxiliary sleeving) but EPMA showed there to be attack on both phases, the lighter shadow representing the austenitic phase and the darker shadow the ferritic phase in figure 3.15. Pitting on the austenite islands (lighter shadow) and also on the adjacent ferrite matrix can be seen.

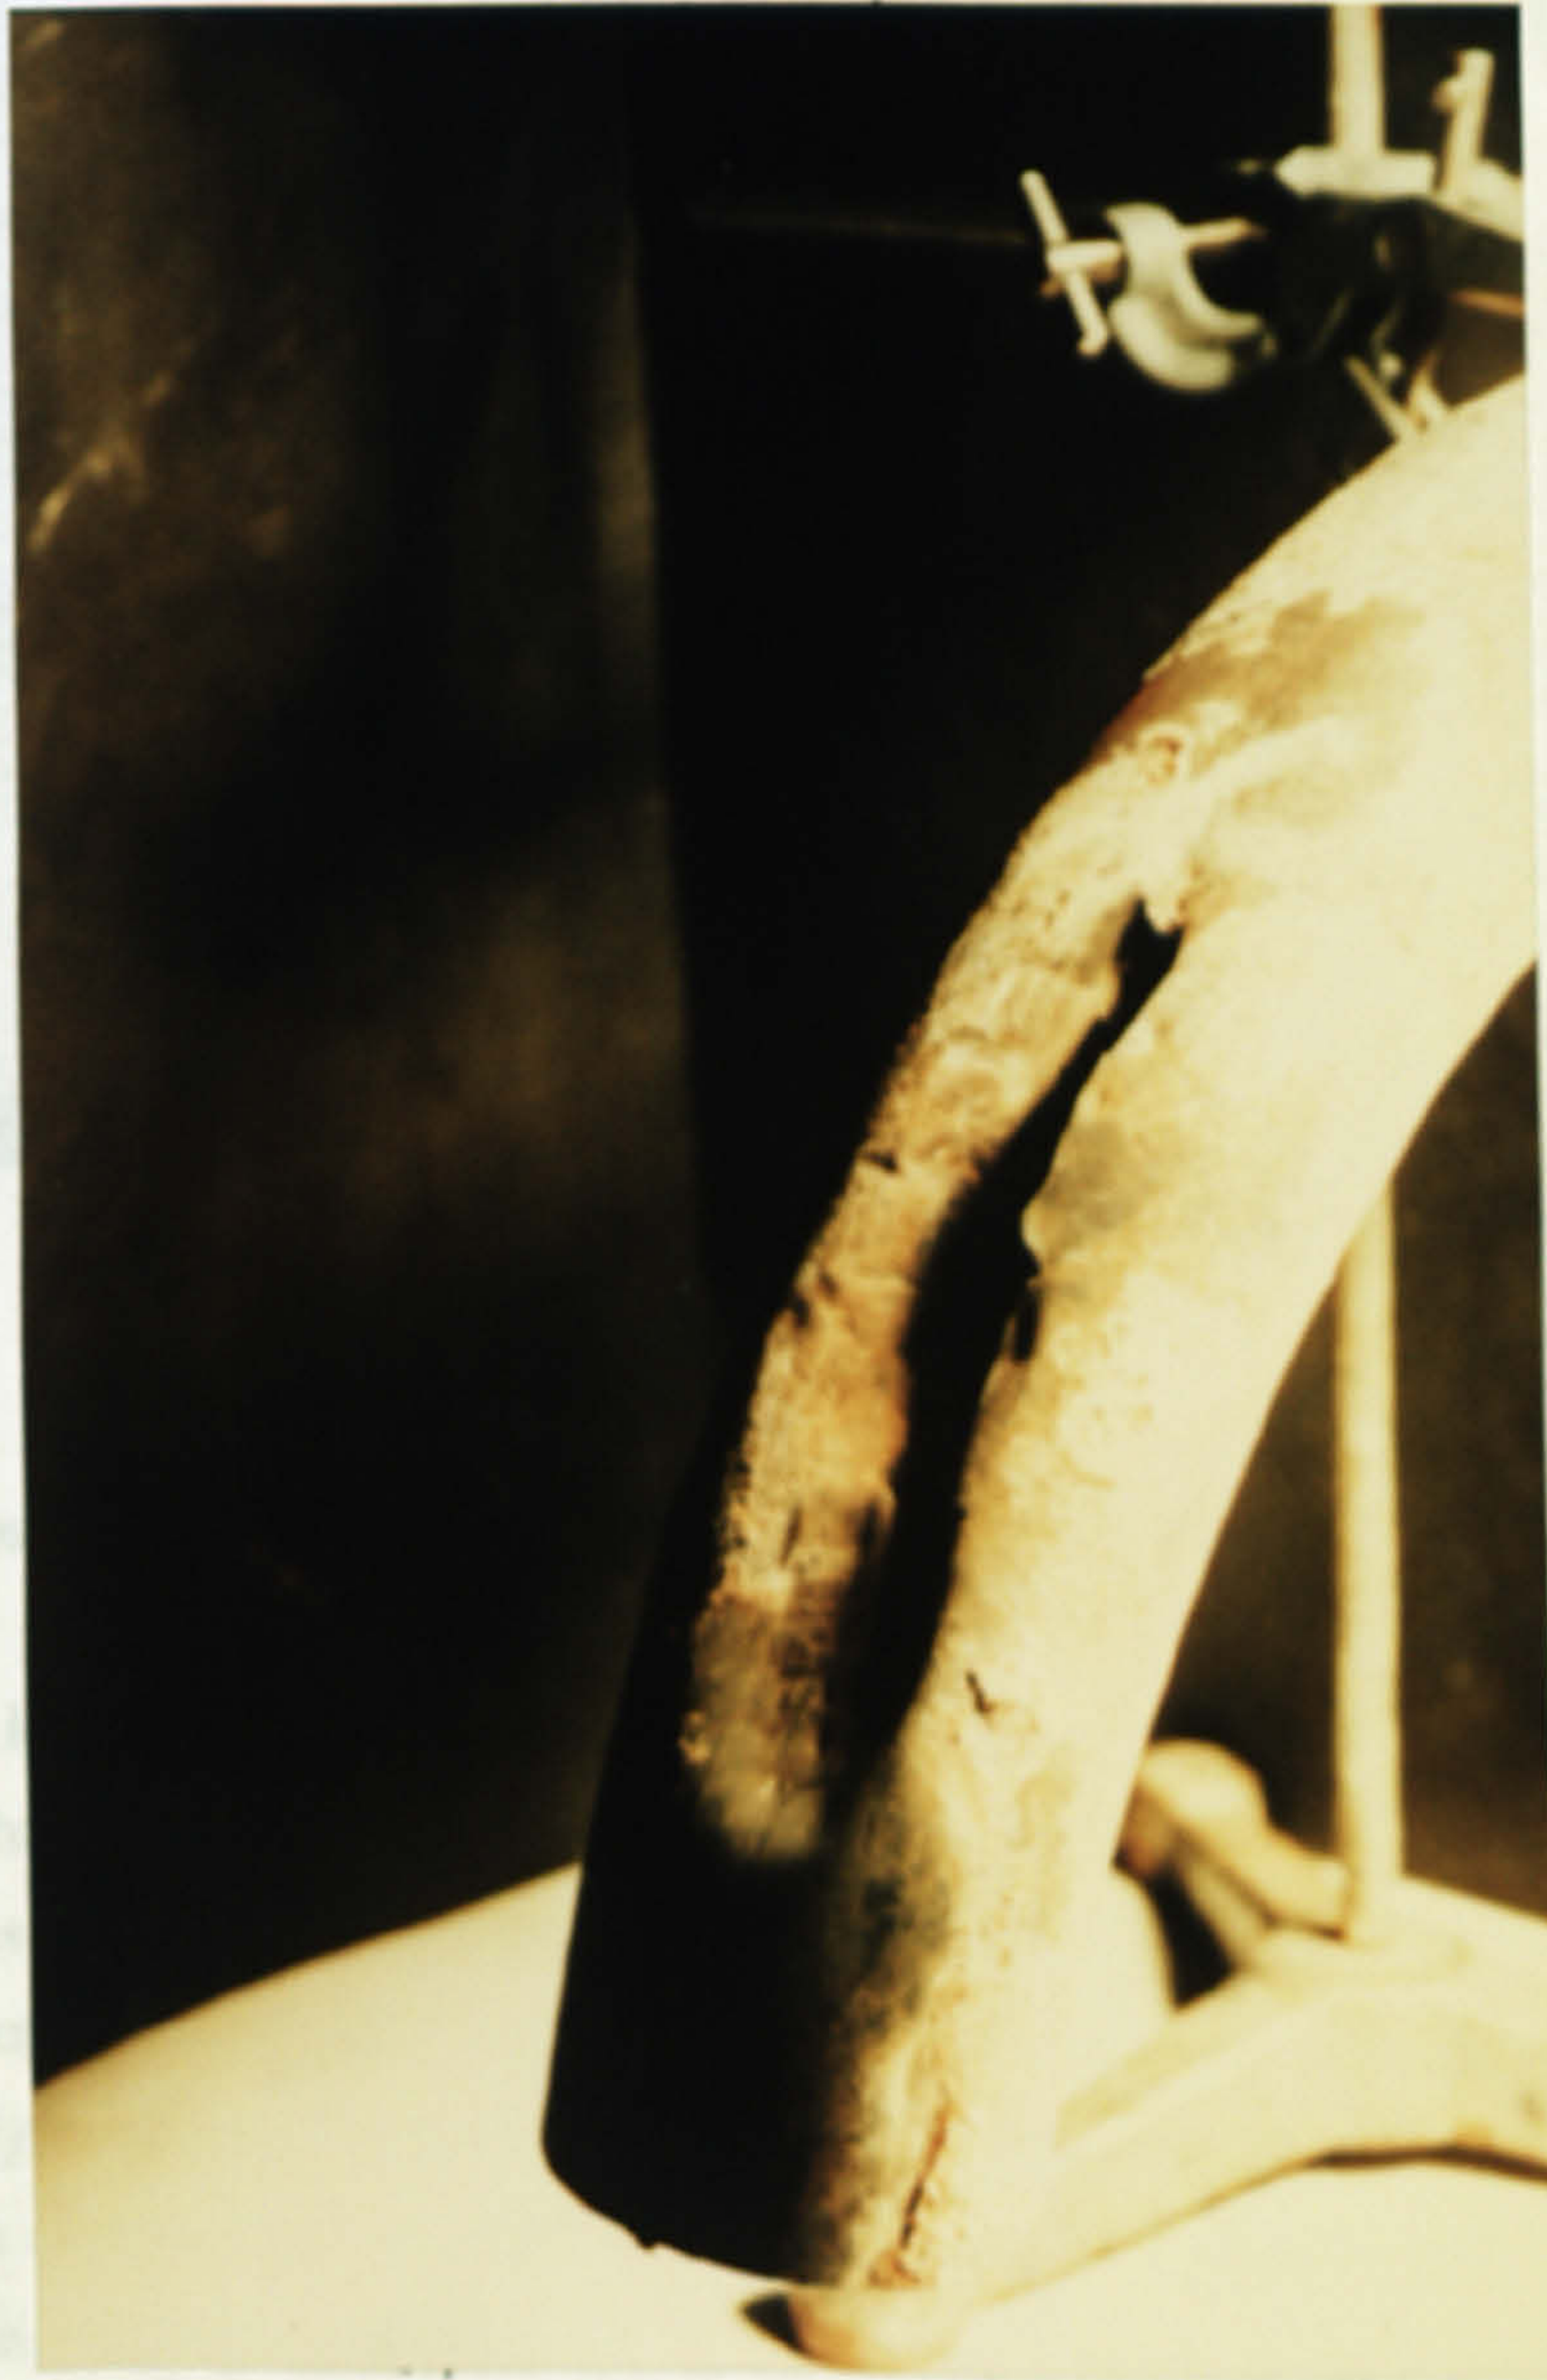
Fig. 4.1. Perforation of a pipe bend due to liquid impingement

The need to minimise costs in handling fluids demands higher flow rates with the inherent risk of flow-dependent corrosion of engineering equipment [1]. Impingement attack occurs on pumps [2] as impeller speeds are increased, on pipes where high intensity turbulence exists in unstreamlined geometry changes or where the flow direction is suddenly changed and on valve seats where high velocities are induced during throttling [3]. The impingement on the pipe bend shown in Fig. 4.1 was severe enough to cause perforation over a period of twelve years.
