**An Investigation of the Corrosion Behaviour of a Range of
Engineering Materials in Marine Environments**

**Submitted in Fulfilment of the Requirements for the Degree of Doctor of
Philosophy (Ph.D.)**

by Anne Neville

**Department of Mechanical Engineering,
University of Glasgow,
September 1995**

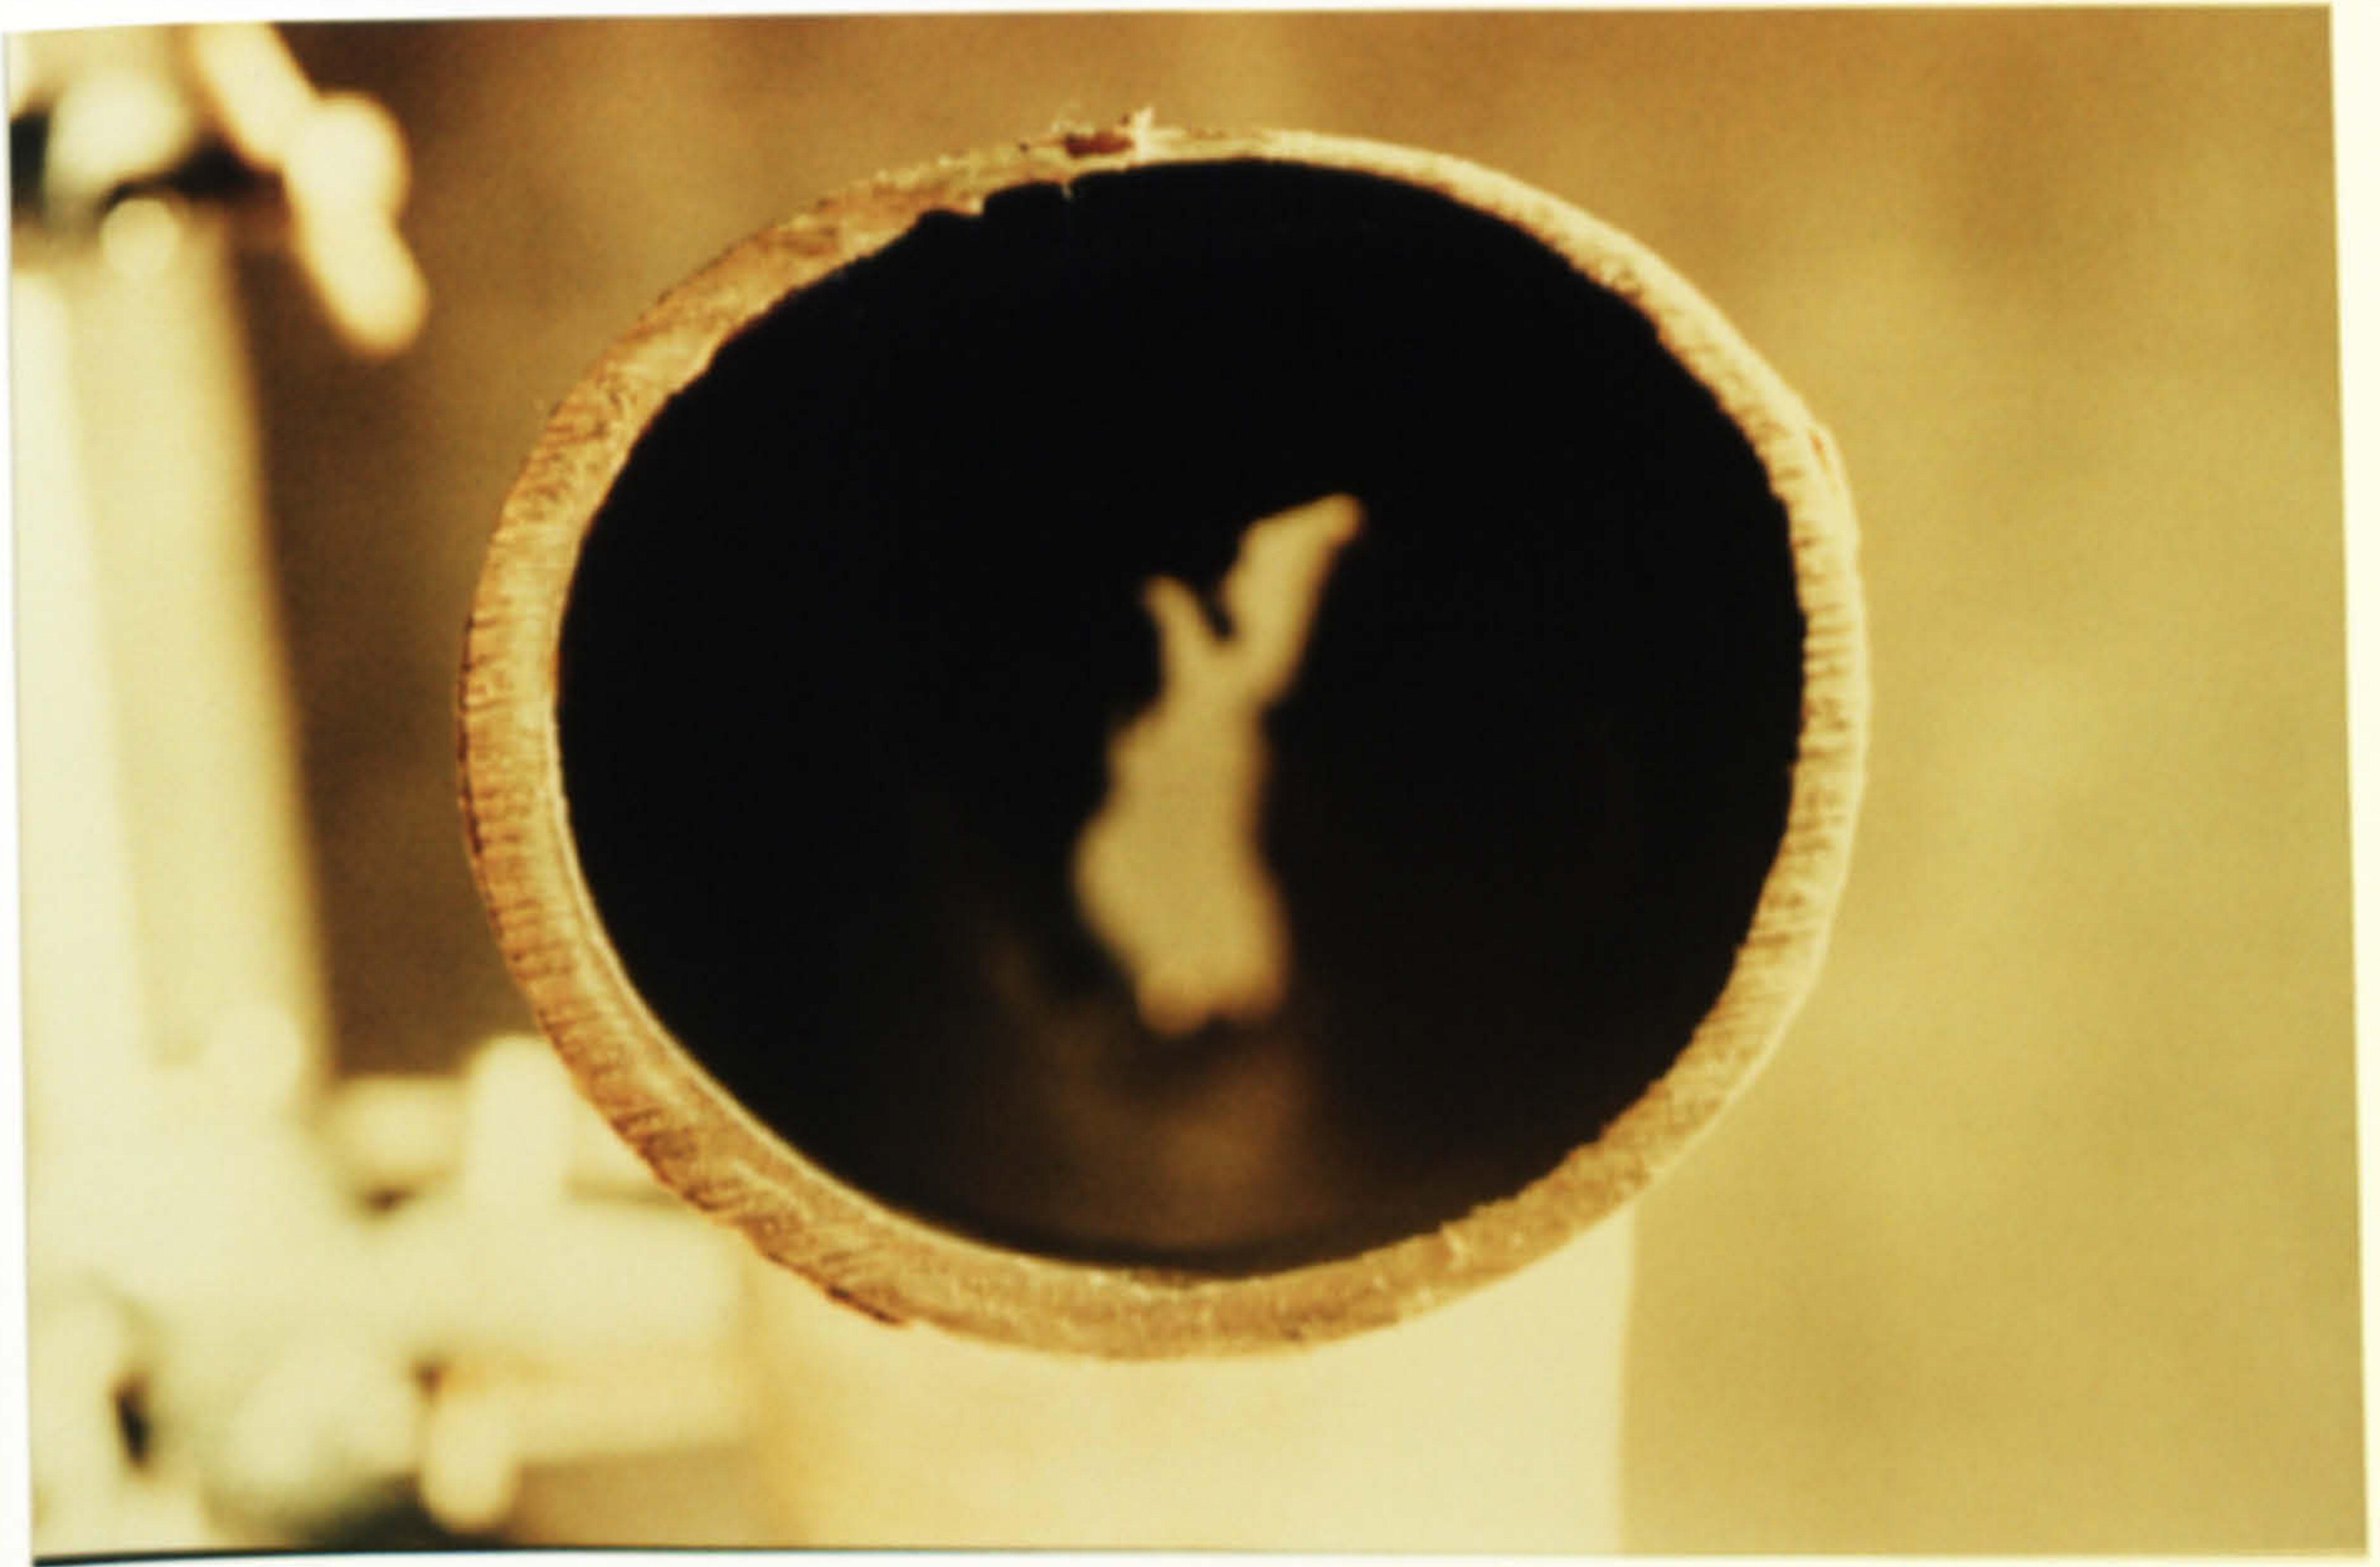
Fig. 4.2. Loss of thickness at outer pipe curvature

The pipe handled condensate from a heat exchanger system at a pressure of 275kPa and temperature of approximately 80°C. The loss of thickness on the outer material at the pipe bend can be clearly seen in Fig. 4.2.

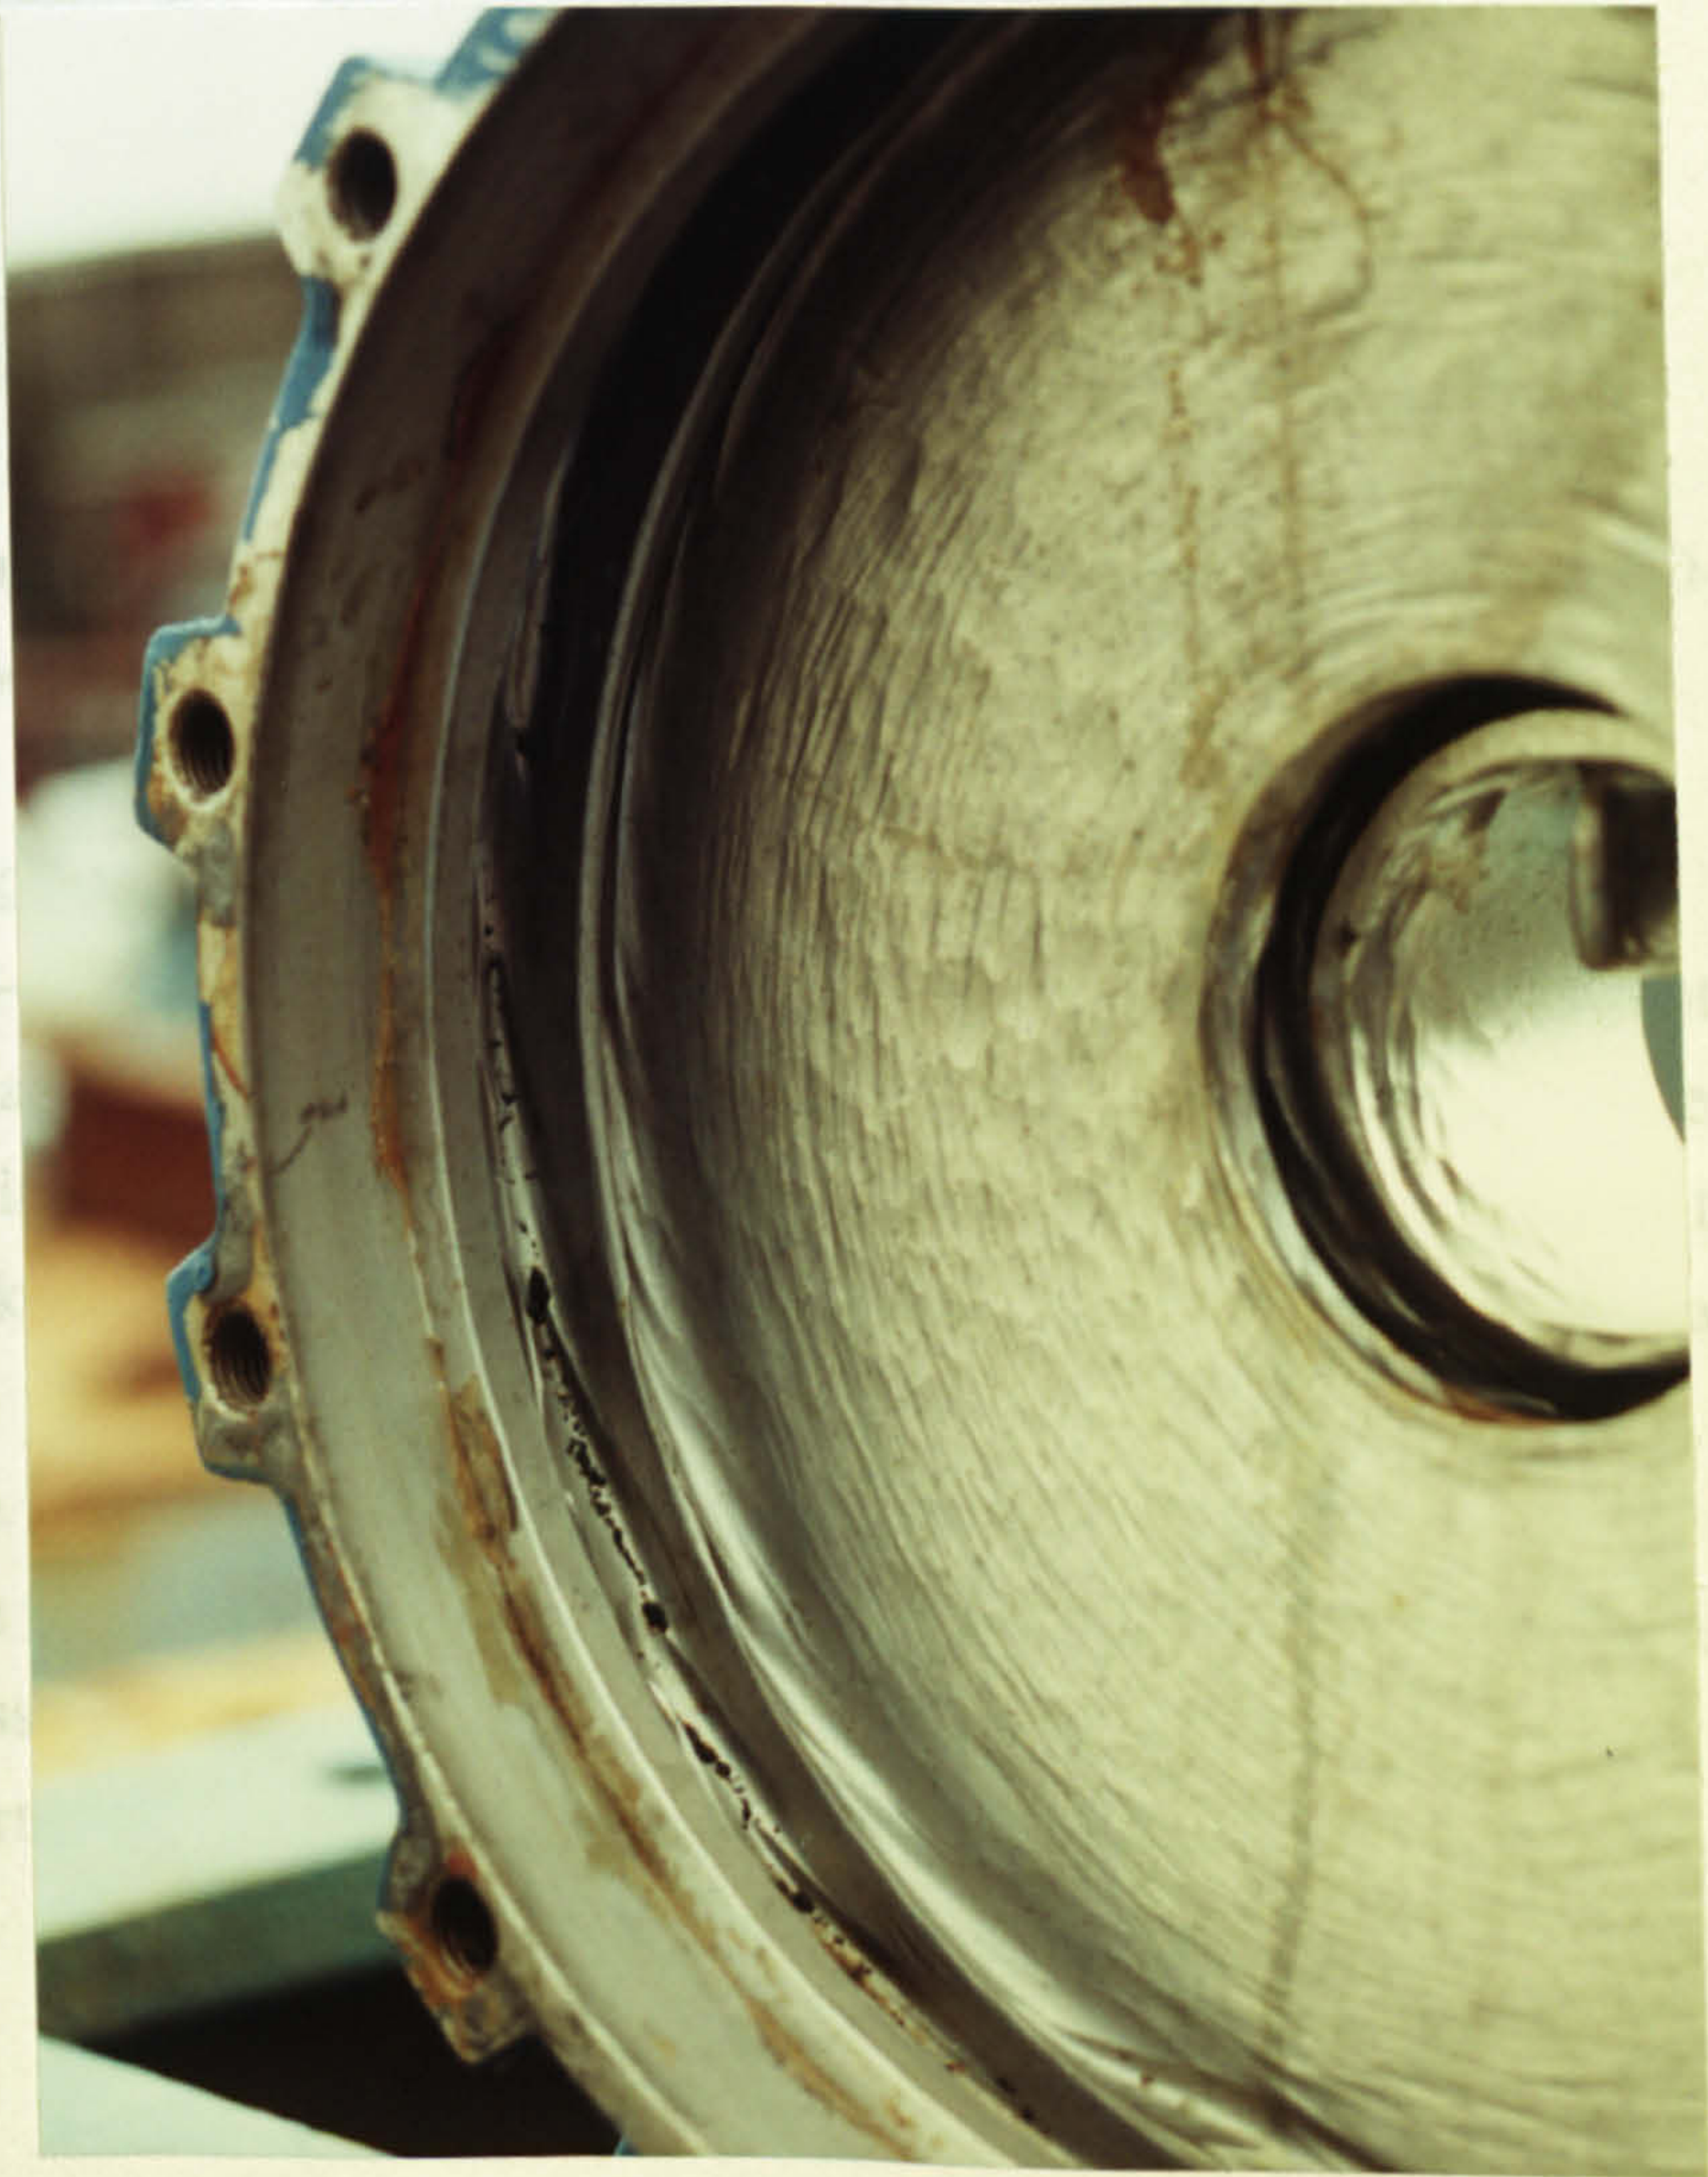
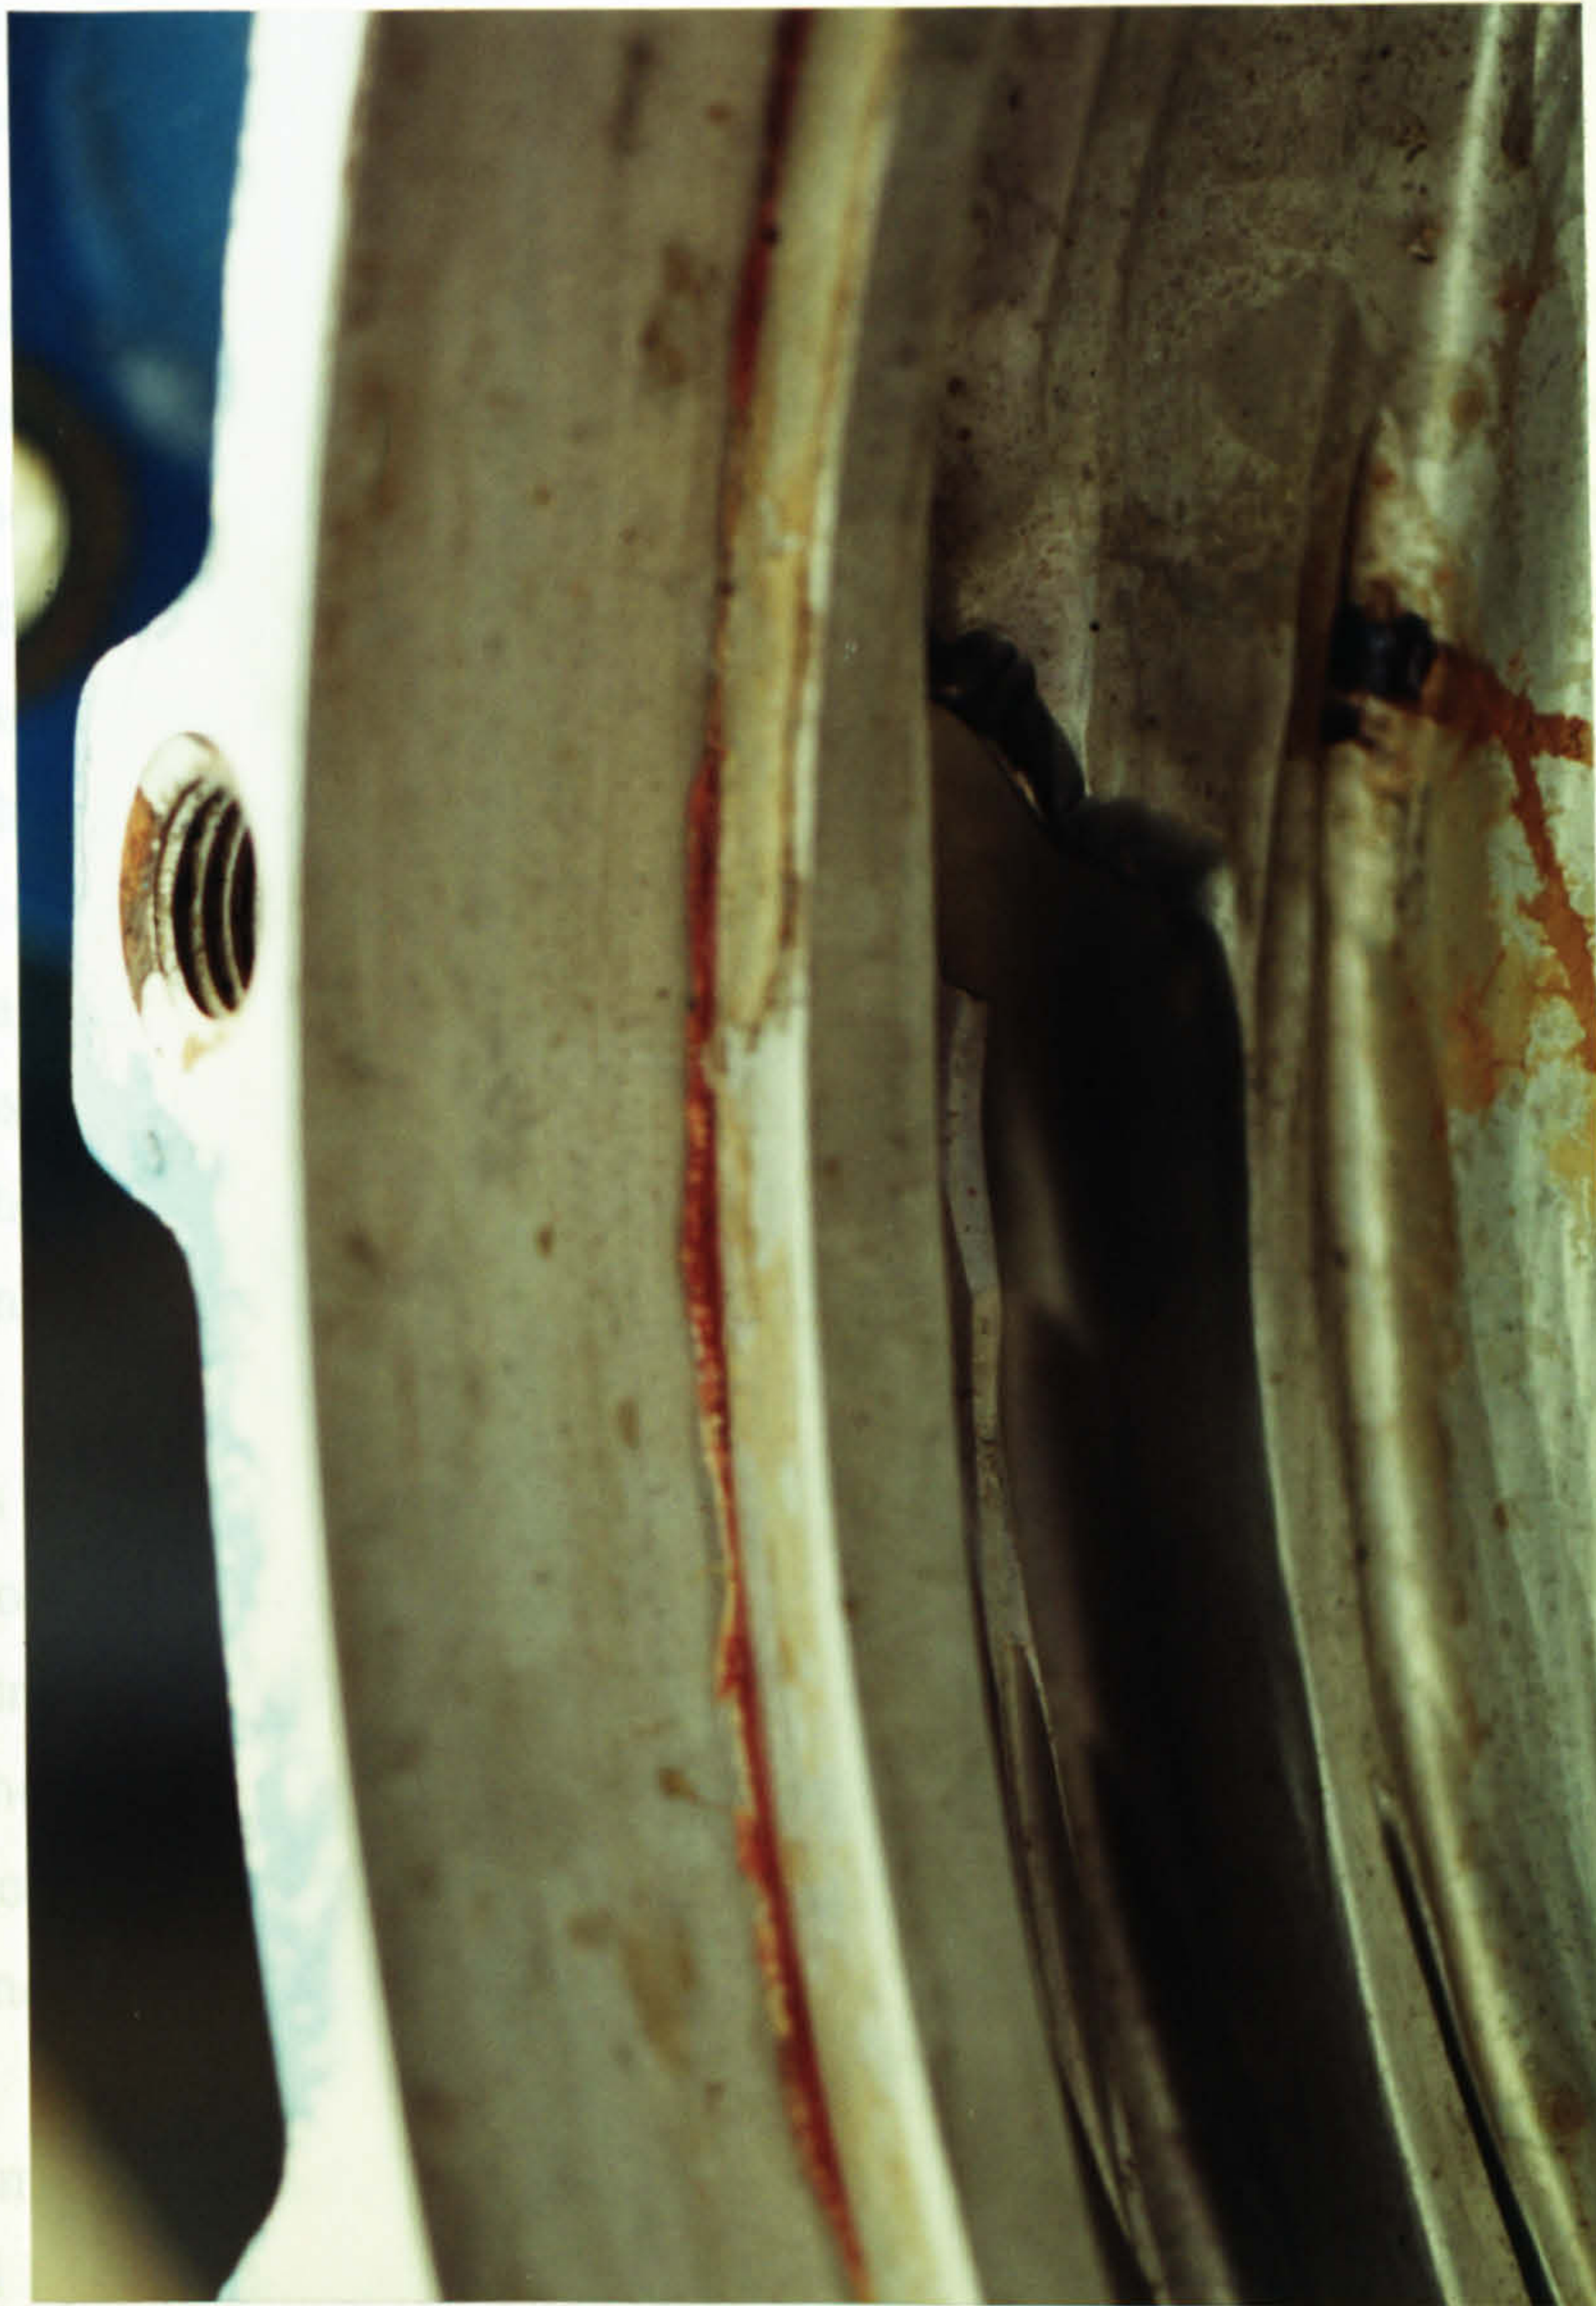
(b)
Fig. 5.6a and b. Erosion on the UNS S31603 pump casing after 240-300 hours in periodic service

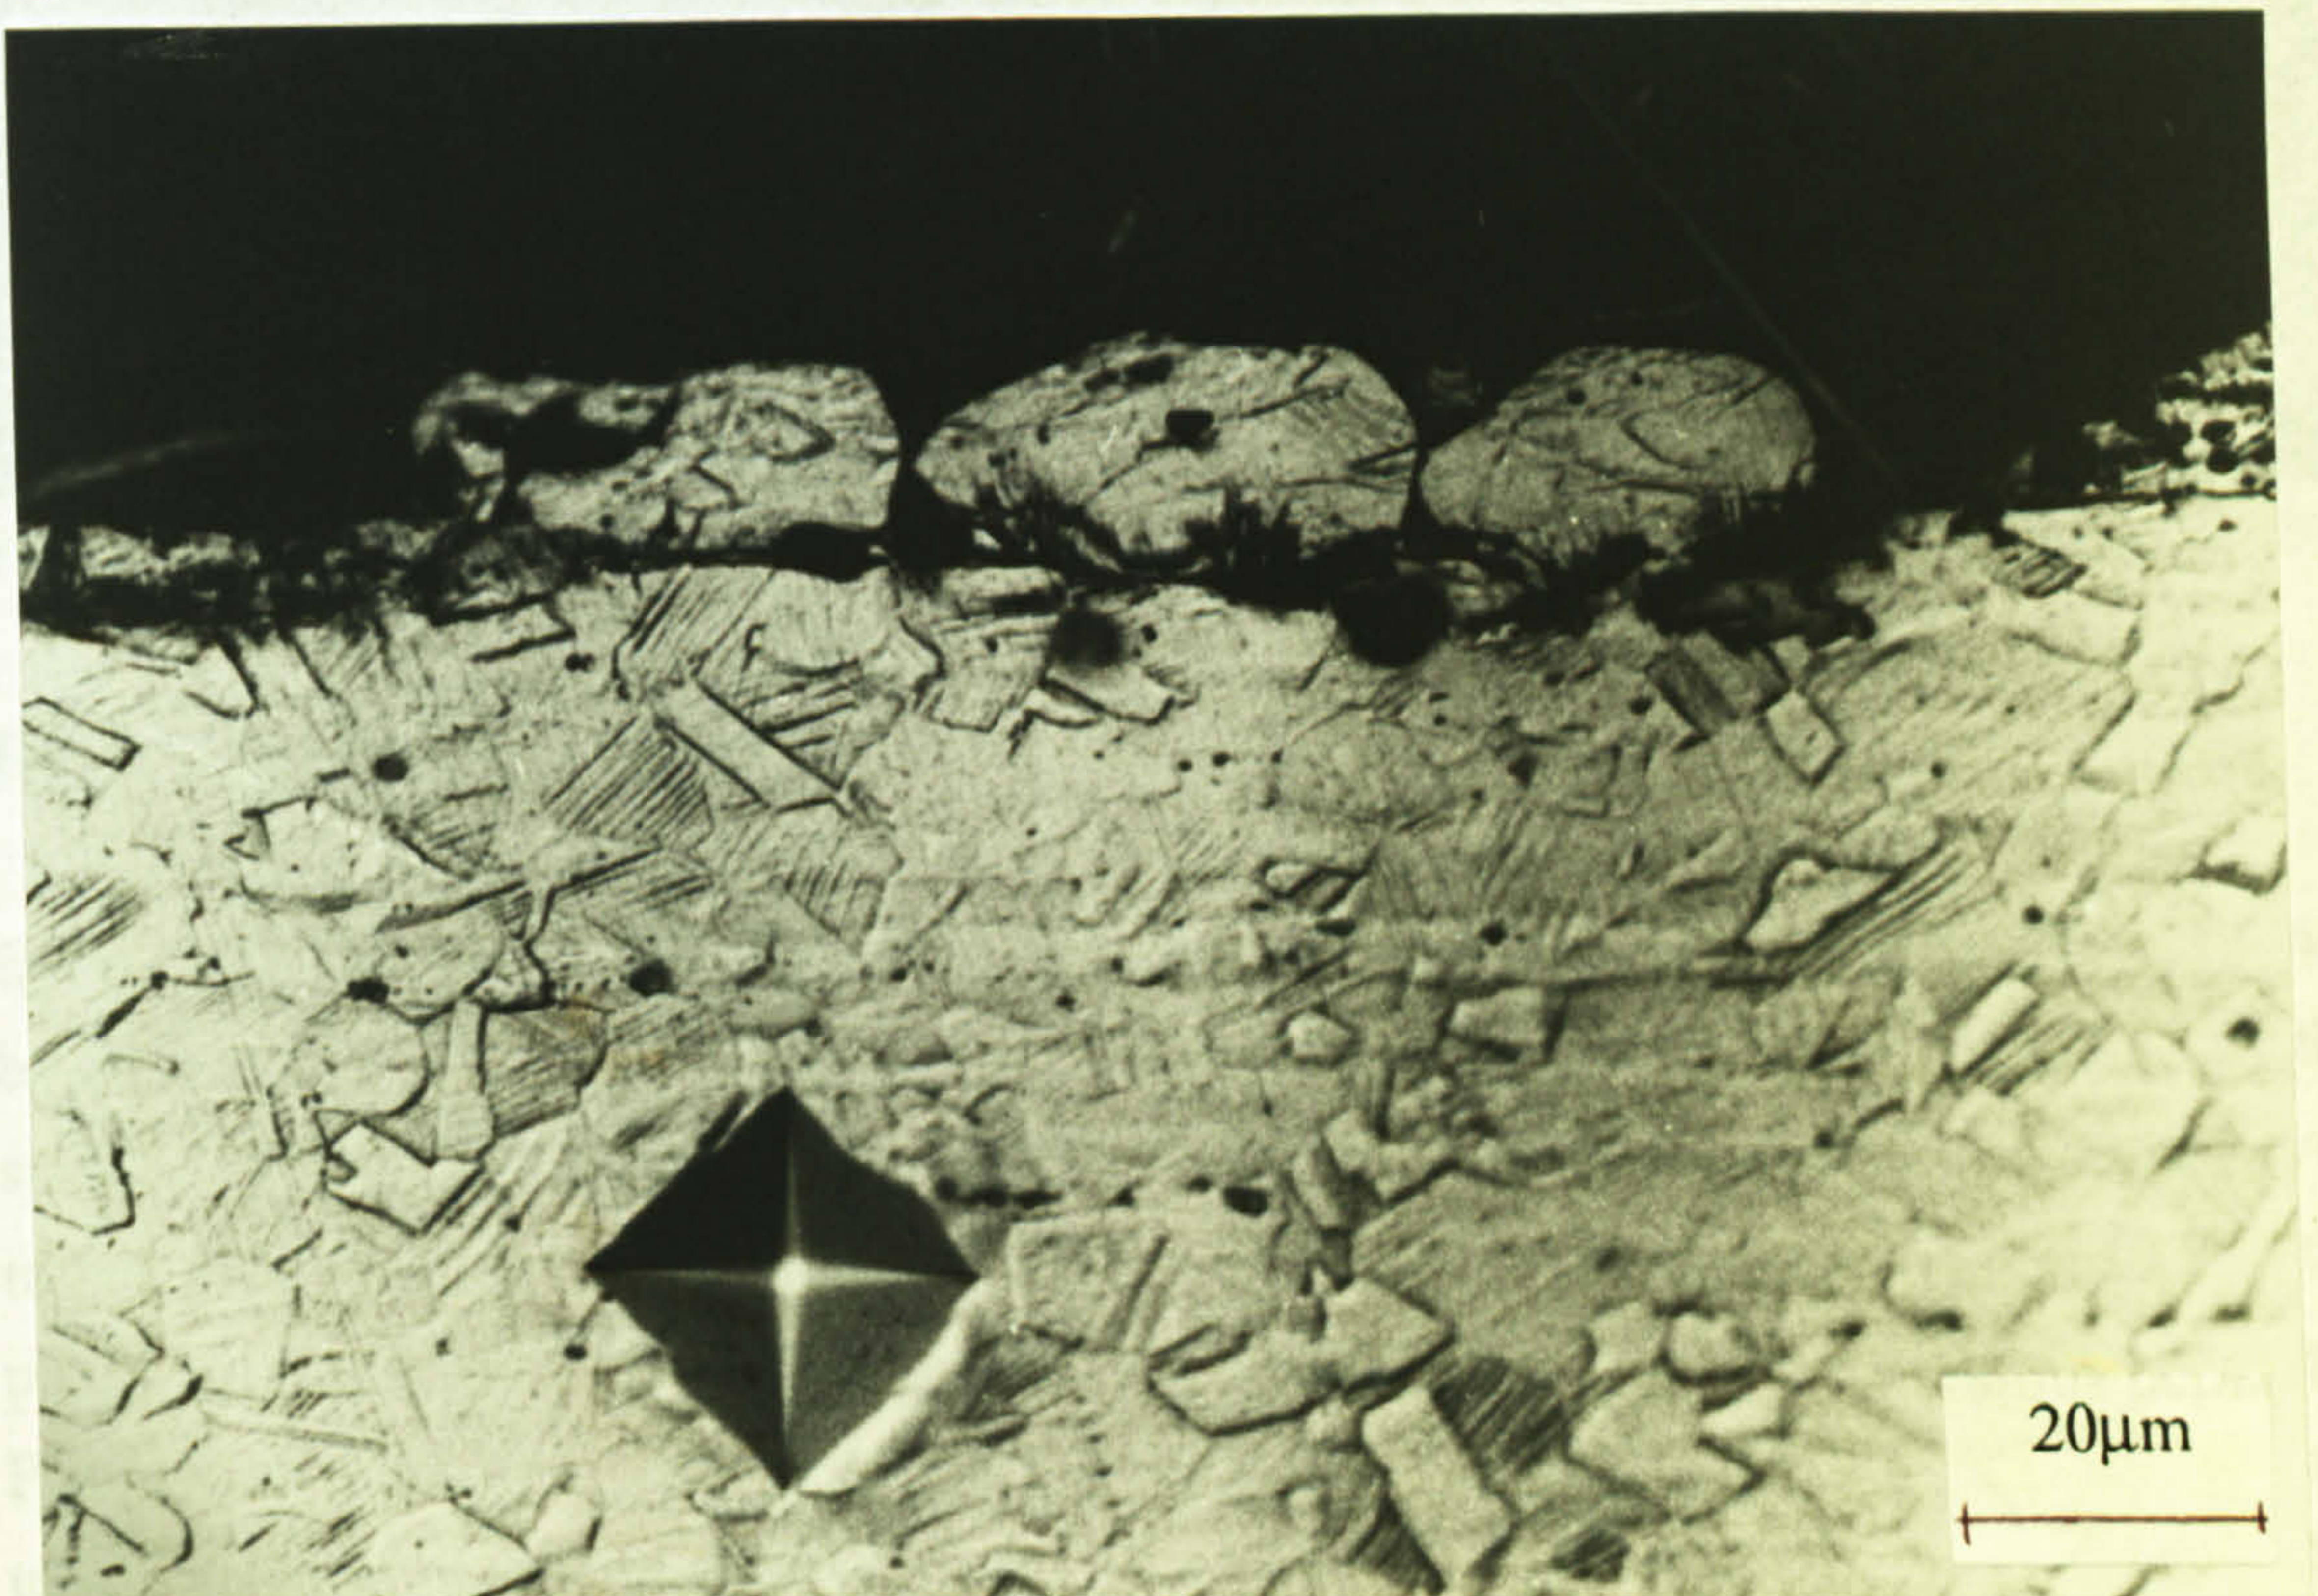
Fig. 5.50. Fragments of material detaching from the surface of an eroded sample of UNS S31603

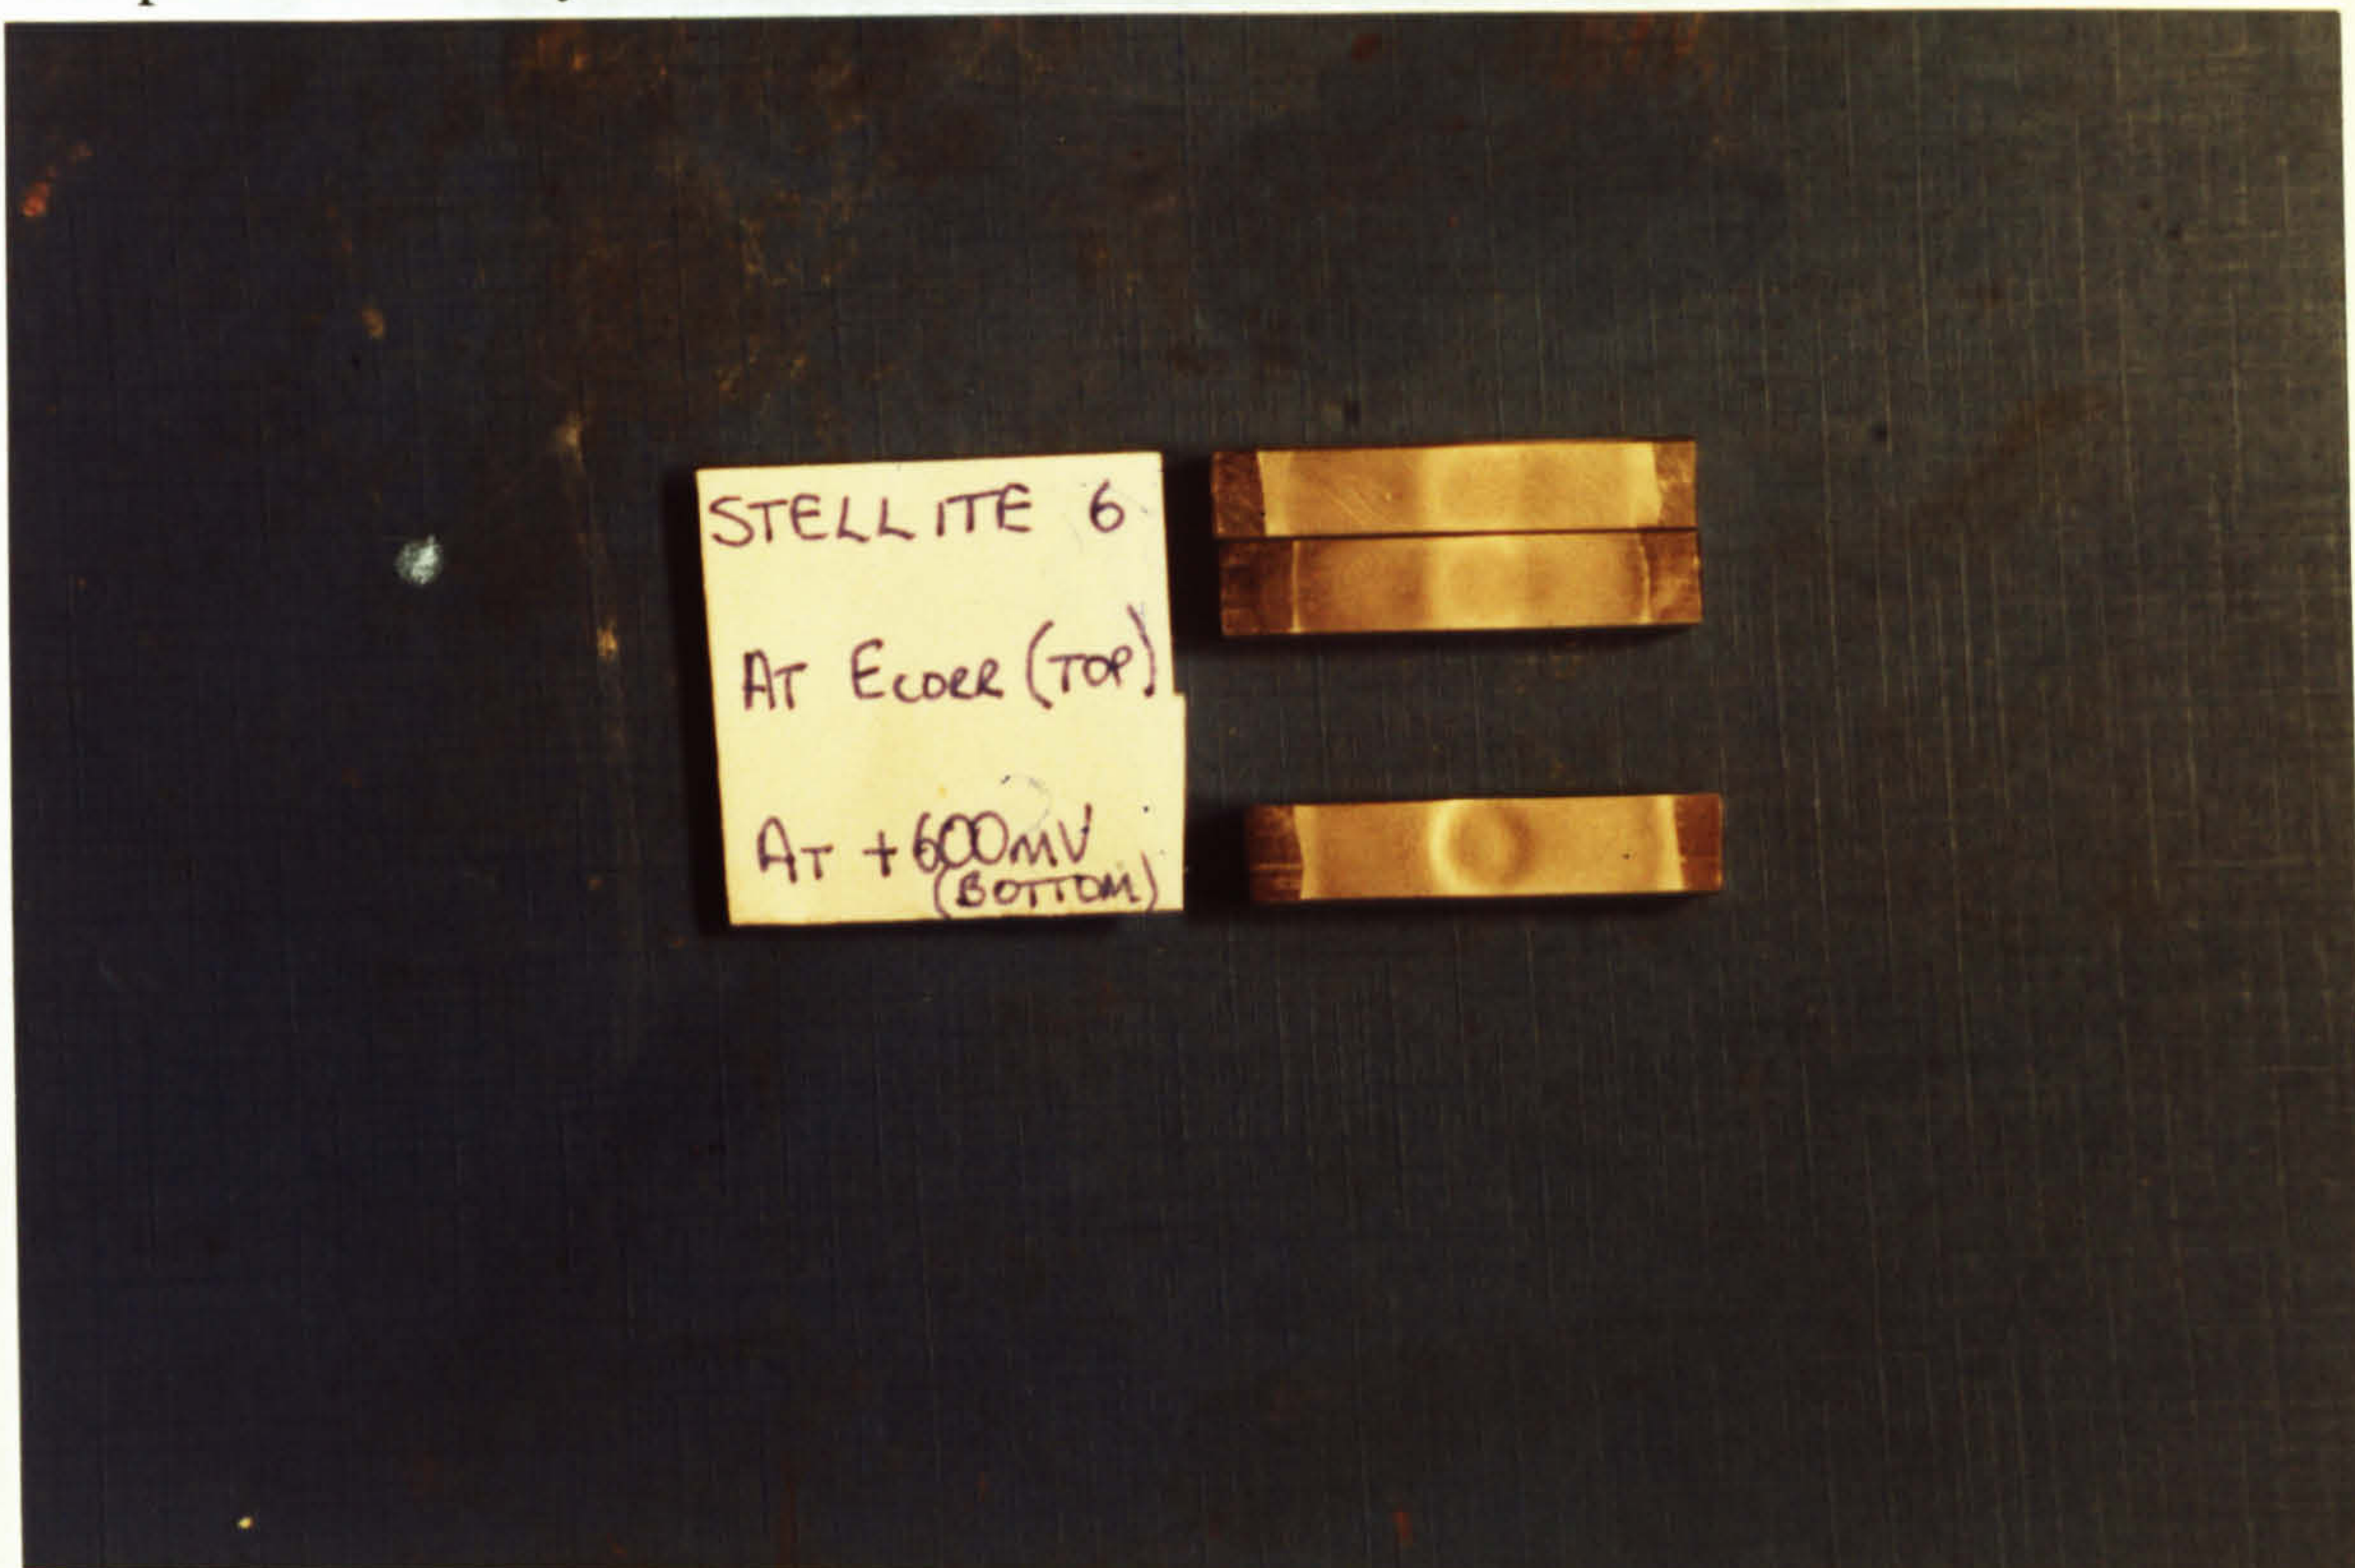
Fig. 5.51. Deeper wear scar on specimen under potentiostatic control at 600mV (SCE)
