**Emergency management:
Seismology to minimise aircraft crash location search time**

Nadine Alavès

Submitted in fulfilment of the requirements for the degree of
Master of Science by Research

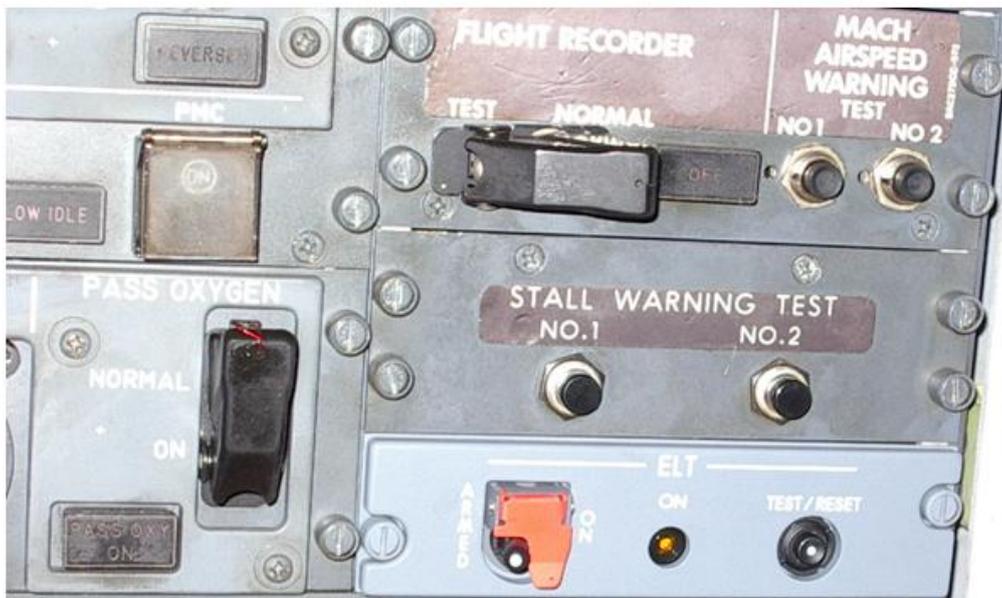
The ELT is mainly composed of the following parts: a remote control unit, a main unit and an outside antenna. The remote control unit is located in the aft overhead panel of the cockpit.

Figure 25: ELT remote control unit in a Boeing B737 cockpit panel

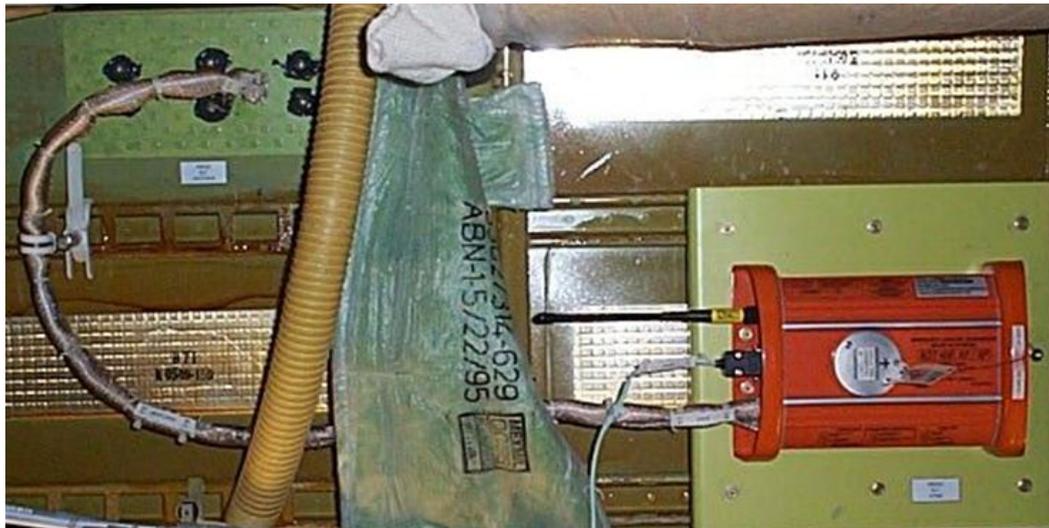
The main unit is found inside the rear top fuselage. It is connected to the outside antenna by a large cable. It is also connected to the main unit into the cockpit by a wire.

The antenna is located outside on the top rear fuselage of the aircraft.

Figure 26: an ELT main unit (orange) linked by a large cable (bottom left of main unit) to an antenna backside unit inside the fuselage (green rectangle, top left of the picture)

Firstly, of the three main components two are fragile: the main unit and the antenna. The main unit is made to resist to any kind of shocks. It also needs to be water and fire resistant. If one of these components is damaged the ELT cannot transmit a signal. Moreover, even if all the components aren't damaged, the antenna may relay an intermittent signal.

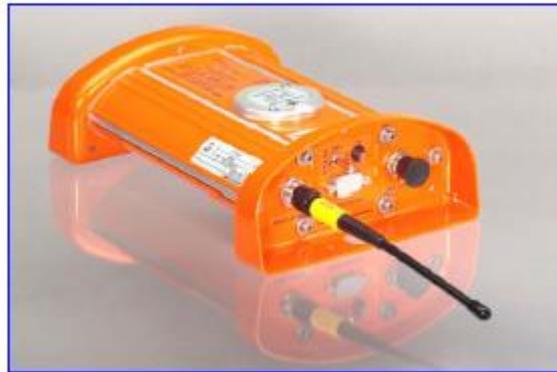
Figure 28: Automatic fixed ELT

ICAO (2001) describes an automatic fixed emergency locator transmitter as “an automatically activated ELT which is permanently attached to an aircraft”.

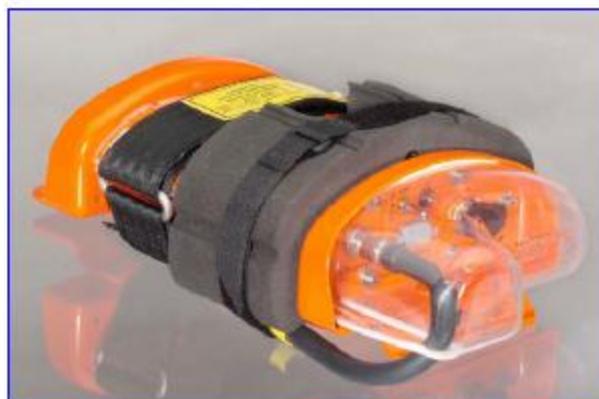
Figure 29: Automatic portable ELT

ICAO (2001) describes an automatic portable emergency locator transmitter as “an automatically activated ELT which is rigidly attached to an aircraft but readily removable from the aircraft”.

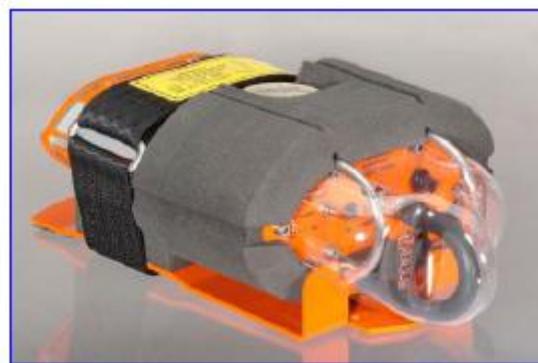
Figure 30: Survival ELT

ICAO (2001) describes a survivable emergency locator transmitter as “an ELT which is removable from an aircraft, stowed so as to facilitate its ready use in an emergency, and manually activated by survivors”.

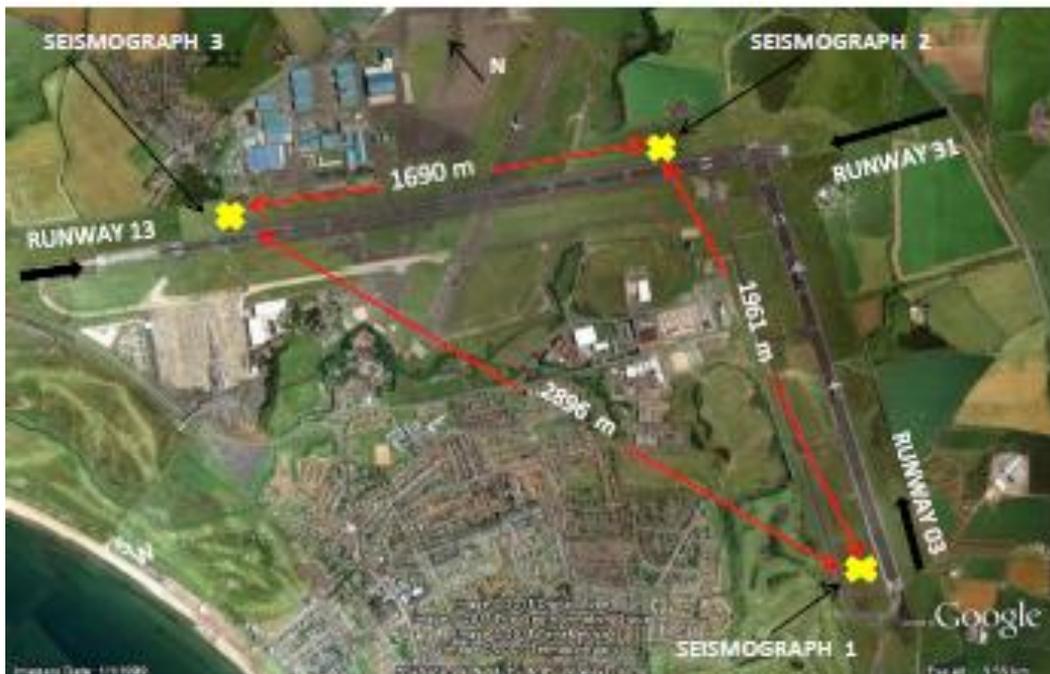
Consequently to this an experiment was conducted at Prestwick international airport located west of Scotland during a day. Two main runways that intersect a right angle at their ends are operated at that airport.

Figure 32: Map of Prestwick airport showing the location of the seismographs
