Analysis of a Wheelhouse and Other Structures  
in Grimsay, Western Isles.

Alasdair John M<sup>c</sup>Kenzie

This thesis is submitted in fulfilment of the requirements  
for the degree of M.Phil.in the Department of Archaeology,  
Faculty of Arts, University of Glasgow, October 2005.

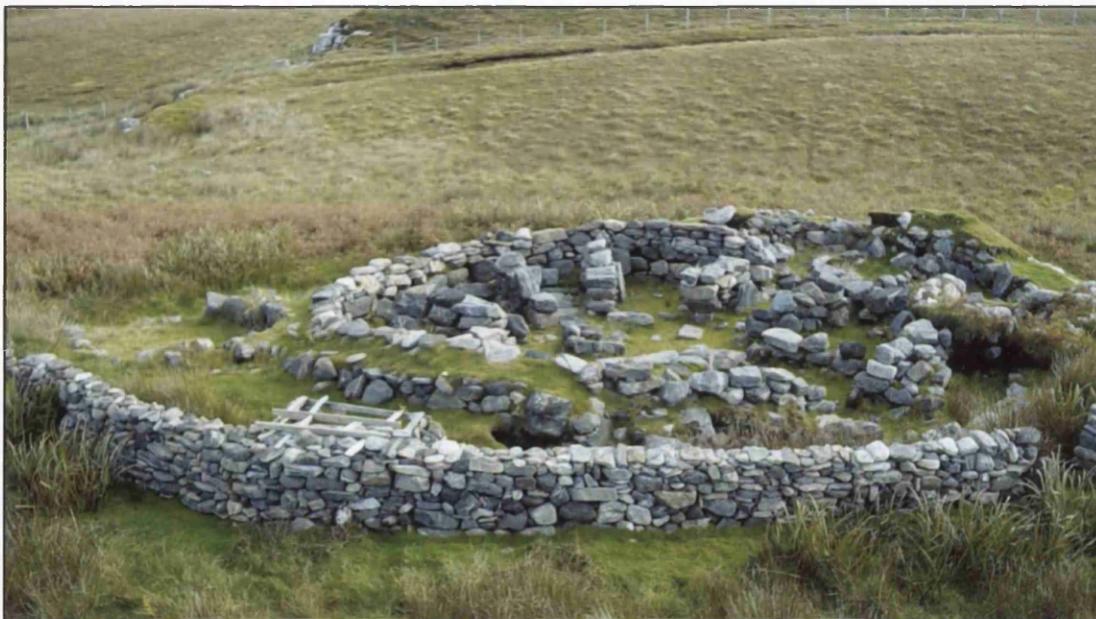
The excavation of the Bagh nam Feadag wheelhouse and other structures (Plate 1) on the island of Grimsay was conducted from 1993 to 1997 by a retired engineer, Roy Ashworth. The information presented in this thesis is based upon the data generated by that excavation and supplemented with a survey of the standing remains by this author.

Plate 1: The structures revealed by excavation, with excavators wall and hut in foreground.

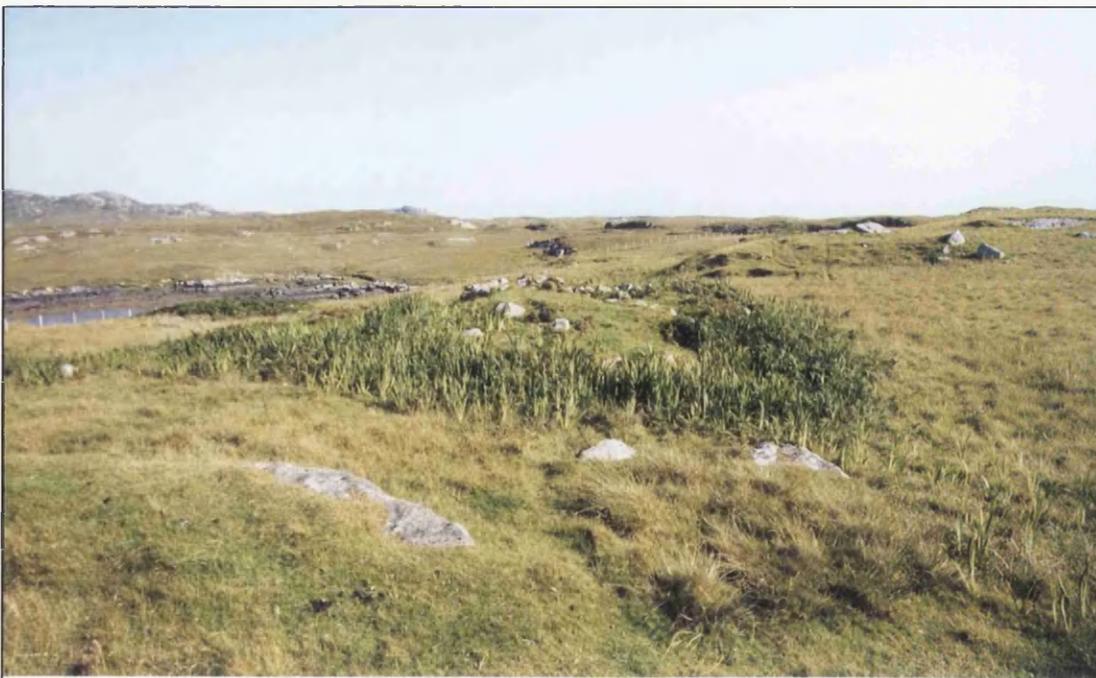
Little information is available regarding the condition of the site before it was excavated. Another possible wheelhouse site to the north (Plate 2) lies beneath a grass and fern covered mound with some indications of walling. The walling visible at the top of the mound (NS1, figure 10) is clearly relatively recent compared to whatever lies below it. Given that Roy Ashworth was intrigued by hillocks that stood out in the landscape, it would seem logical that the site excavated would have been in a similar condition.

Plate 2: View of possible wheelhouse at North Site One looking east over to yet another fern covered structure (NS2).

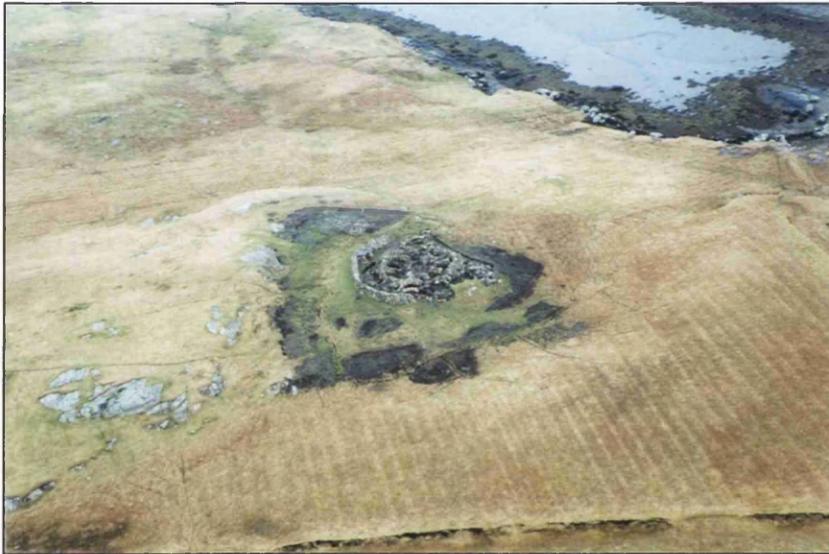
The excavator, Roy Ashworth, worked on his own at the site, removing a large amount of stone from the central area of the wheelhouse which may have included fallen rubble from corbelled cells. The location of the excavator's spoil heaps can be seen in the aerial photographs taken towards the end of the works (Plate 3a & 3b).

Plate 3a: Aerial photographs of Bagh nam Feadag structure taken towards the end of the excavation (©Hothersall).

All illustrations would be accompanied by a large archive of photographs and notes which when viewed together will provide a comprehensive record of the condition of the site in 2004. Some of the photographs in the archive were provided by Sue Hothersall from the Association of Certified Field Archaeologists and date from around 1998, shortly after the excavation ceased. Only two photographs exist showing the site during excavation, in the form of oblique aerial photographic prints (Plate 3).

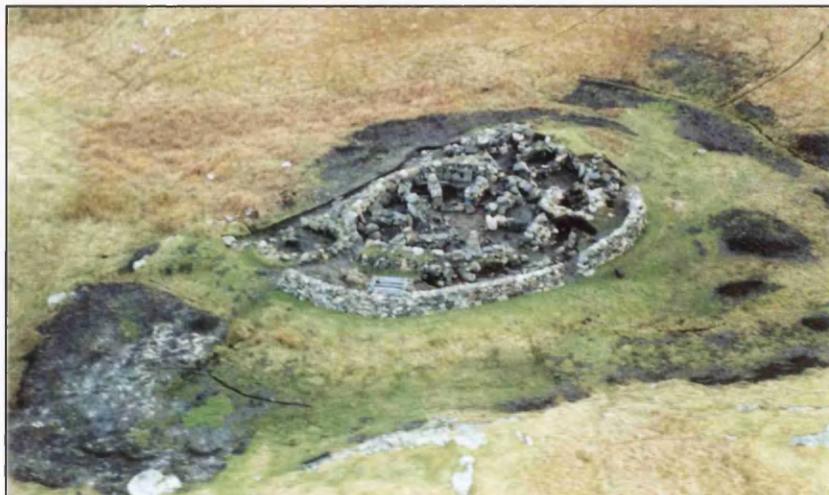
Plate 3b: Aerial photographs of Bagh nam Feadag structure taken towards the end of the excavation (©Hothersall).

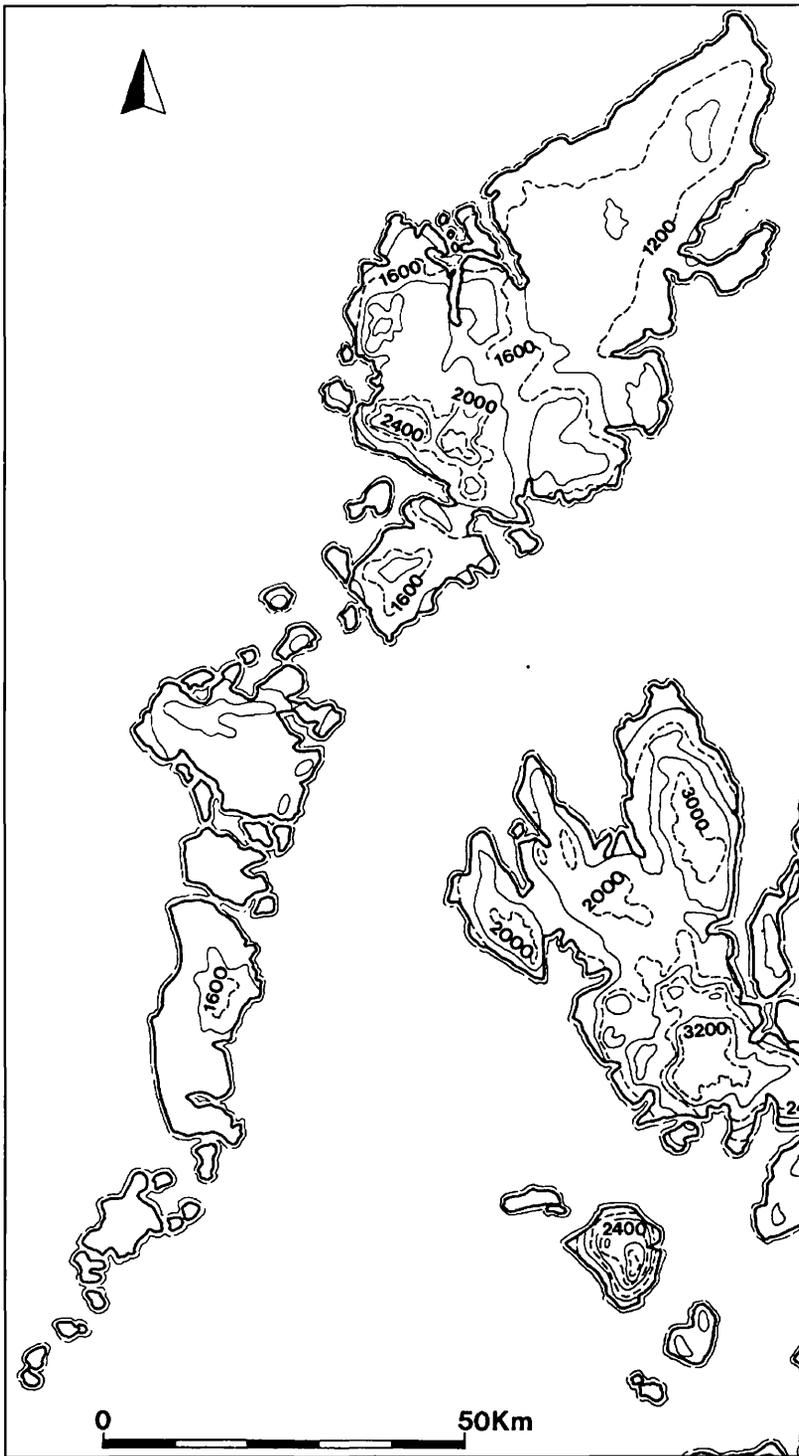
receive a typical annual rainfall of 1200mm, whereas in Lewis and Harris the hills of that area cause averages of 1600mm to 2400mm (Figure 5).

Figure 5: Rainfall in Skye and the Western Isles, measured in mm  
(from Armit 1996, 20).

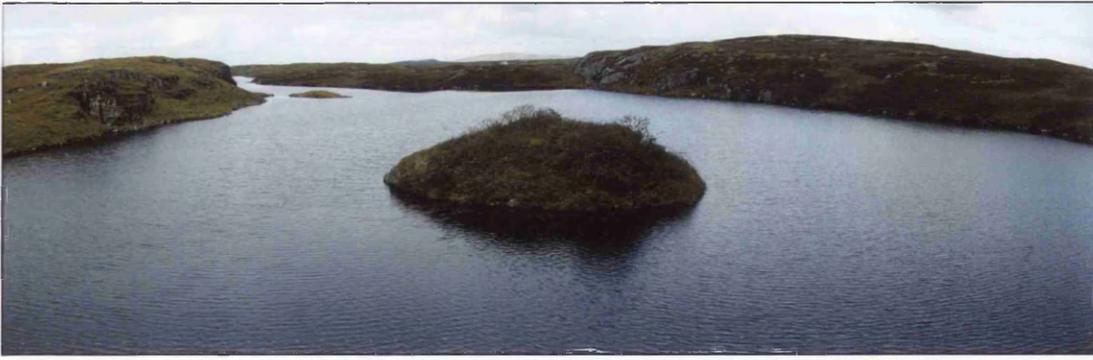
The excavated site is not the only known structure on this part of the moorland. Dun Ban (NF85NE 7), a promontory fort located approximately 1km south east of structure II, with evidence for an Atlantic Roundhouse and later cellular buildings, is the only other recorded site in the immediate vicinity, situated to the south in the eastern end of Loch Hornary (Plate 6, located in figure 16). A further two possible sites exist a short distance to the north at the Bagh nam Feadag wheelhouse site (see NS1 & NS2 in chapter 2.3).

Plate 6: Photograph of Dun Ban in 2004 looking north westwards, with the entrance at the front right.

The closest structure to Bagh nam Feadag which may be contemporary with the Bagh nam Feadag settlement during its various phases can be found on an islet in Loch Hornary, 100 metres to the south east (see Plate 6 above). Dun Ban is situated on the summit of a steep-sided, natural outcrop in the south eastern portion of the loch, surrounded by hills and hidden from the current road around Grimsay (figure 13). Although a causeway existed linking the dun to the shore, it is impassable today and could indicate an increase in water levels of approximately one metre since its primary use. The entrance for the structure faces the causeway (south), contrasting with various other Atlantic roundhouses (e.g. Dun Bharabhat and Loch na Berie) which occupy islands, and locate the entrance on the opposite wall from where the causeway meets the islet, necessitating a walkway around one side (Armit 1992, 34). Such a feature is often viewed as defensive, it is curious that this step was not taken at Dun Ban, although maybe unsurprising considering the location of the site in the landscape, as it has limited defensive qualities. The remains of the structure indicate that it was built with massive walls, however simply interpreting this as being a defensive measure as opposed to inferring a social or political message may be short-sighted (Plate 10).

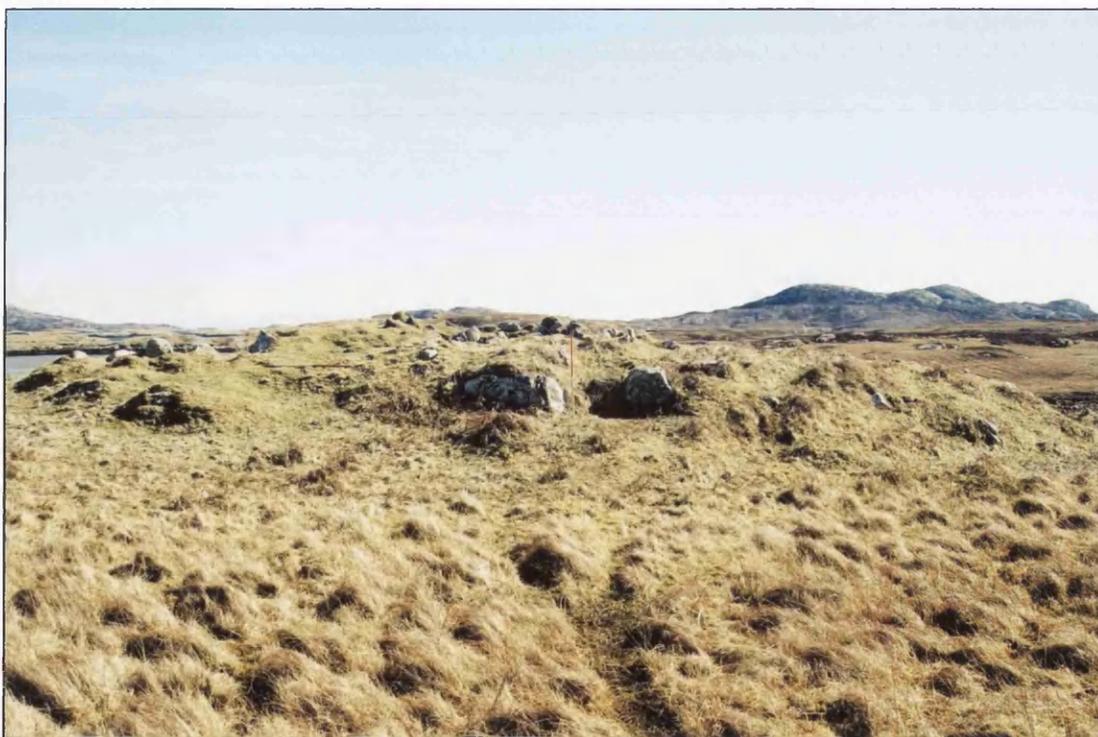
Plate 7: North Site One looking eastwards.

A short distance to the north west of the structures excavated by Ashworth a substantial mound can be seen (Plate 7), some 20m in diameter with later buildings or temporary shelters inserted on top and into the side (NS1). The structures contained within this mound appear to have made use of an outcrop of rock on its north eastern corner. A sherd of pottery collected from a rabbit burrow towards the bottom of the

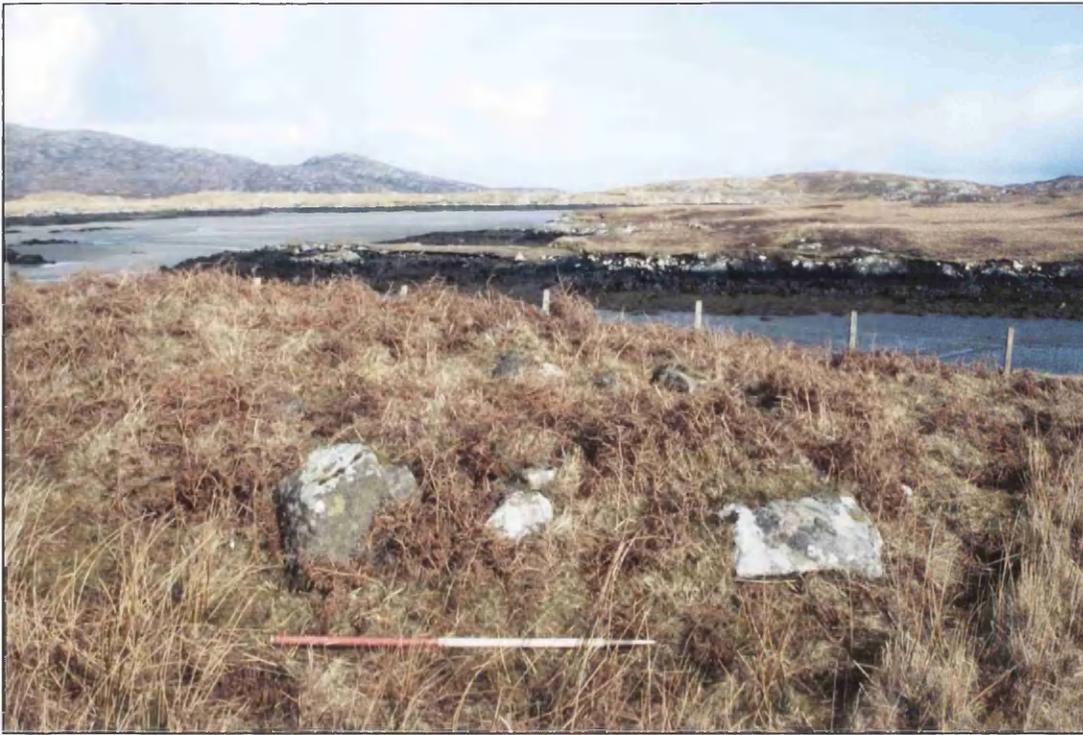
Another less substantial mound is located near the fence line beside the sea inlet (NS2). This sub circular mound, measuring 10m in diameter is possibly too small to contain a wheelhouse or similar building, however, recycling of stone for other buildings in the vicinity should be considered. The edge of the mound is defined by stones with some indications of walling in the centre (Plate 9; Figure 12). This structure may be a temporary shelter with its proximity to the sea inlet perhaps being indicative of its function.

Plate 9: North Site Two looking east towards the sea inlet.

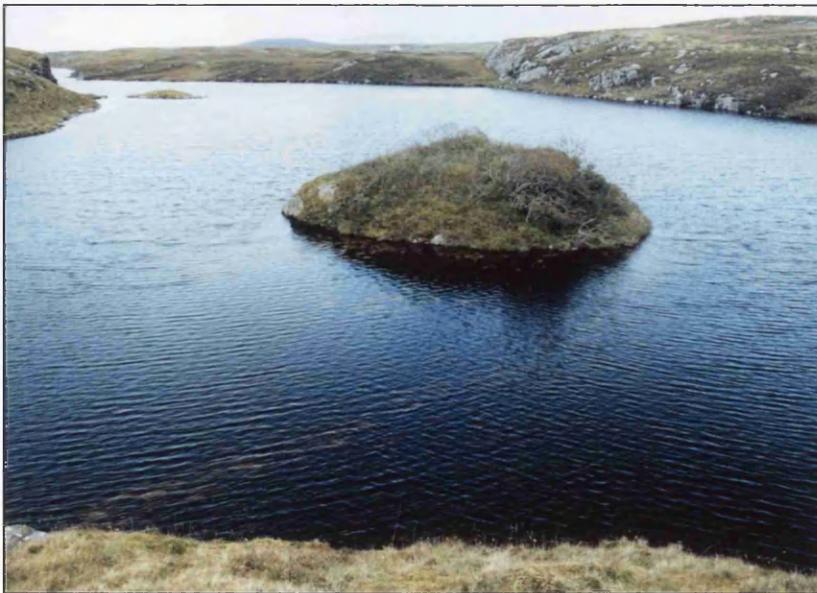
Plate 10: View of Dun Ban showing submerged causeway.

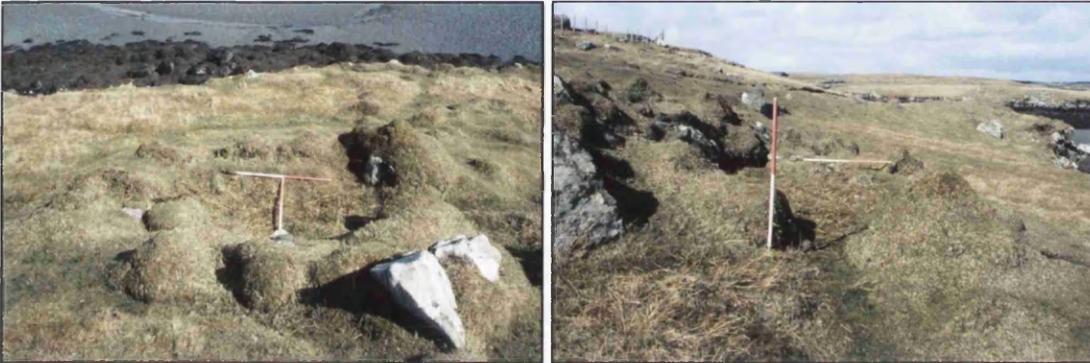
Located on a small narrow piece of land between the sea inlet and modern fence line a small rectangular structure with a south facing entrance and low turf and stone walls. The feature measures 2.5 by 2.5 metres internally making this a very small temporary shelter. As can be seen in plate 11, it is situated only a short distance from the high water line.

Plate 11: Views of feature five looking east with inlet in background (left) and north showing entrance (right).

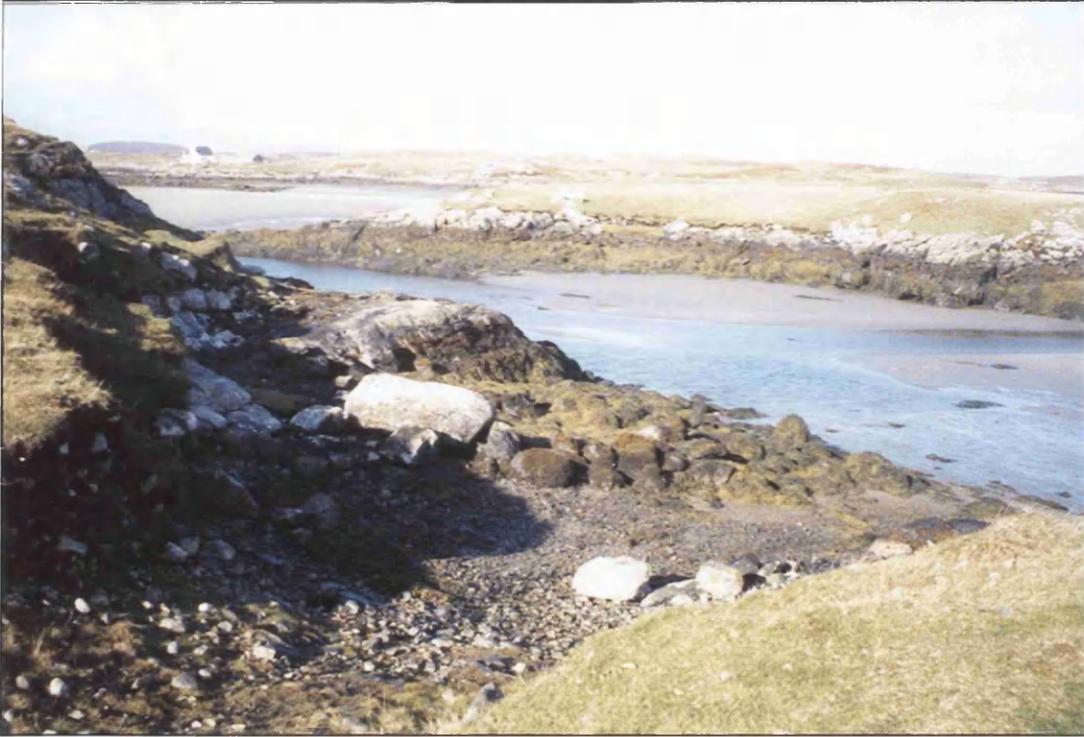
Plate 12: The track leading from the field down to the sea inlet (©Hothersall).

Feature six consists of a small pier like structure found at the end of a small track (Plate 12) enabling access to the sea inlet from the pastureland above. This track is well worn and has been used recently. The function of this may be associated with the collection of shellfish, found in abundance here, or the removal of seaweed. A post card dating to around 1950 depicts this area being used for the collection of seaweed (Plate 13).

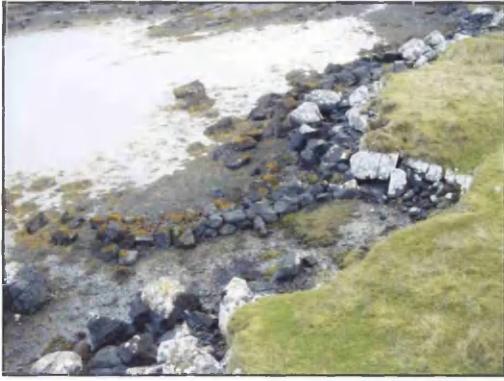
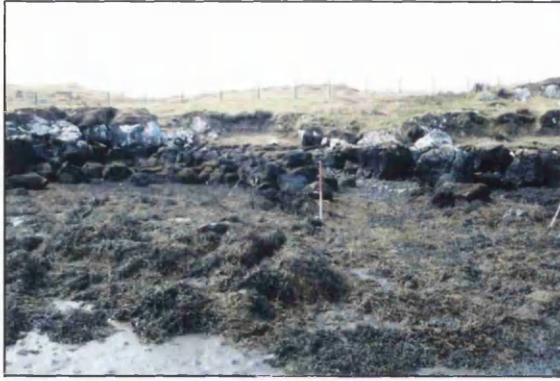
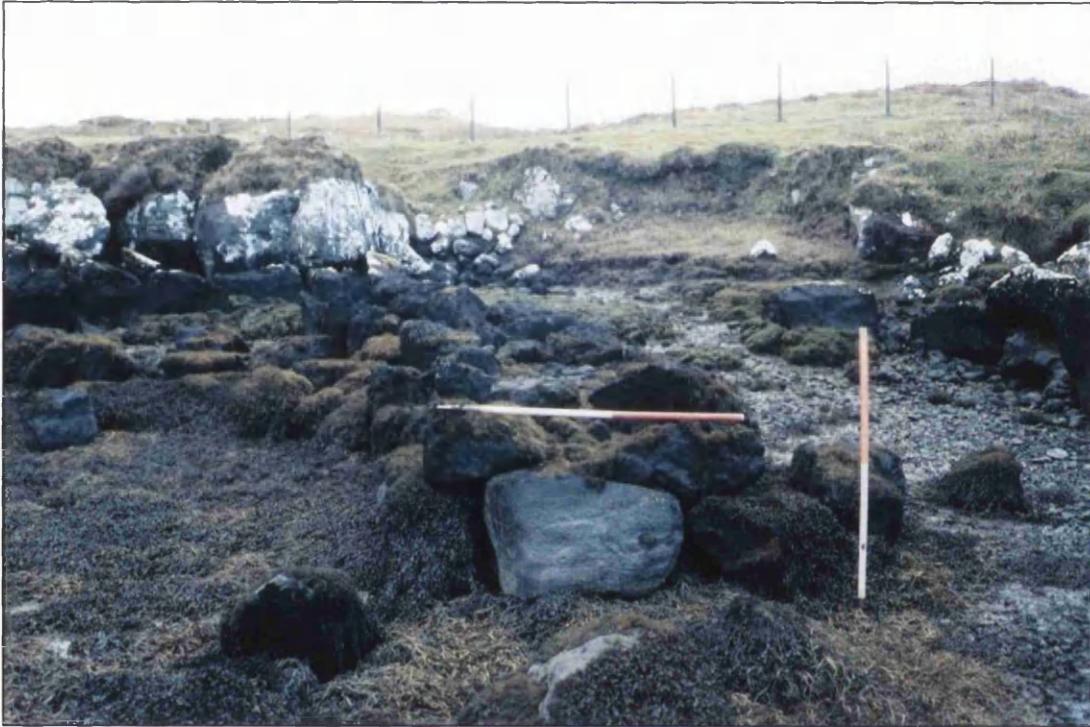
Situated at the south-eastern corner of the small inlet close to the site is a stone built wall or jetty projecting from bedrock at the high-water line out towards the middle of the channel (Plate 15). This structure was not recognised during the 1998 survey although this area of the field was examined. It may have been that the tide was in or that it was not detected against the naturally deposited rock.

Currently there is a drop of two metres from the turf covered surface of the shore down on to the top of the structure. The dry-stone construction covered by the sea for part of the day, has been set into the sandy sea bed, with possible traces extending further out into the bay.

Plate 15a: Views of feature 18.

The function of feature 18 is not known and is referred to here as some type of jetty or pier. Written accounts often describe the sea off Grimsay, like the majority of the Uists, as being rich in fish and shellfish. Before the construction of a pier at Kallin on the south eastern corner of Grimsay ‘fishermen... had no proper landing area so they had to load and unload their catch along rocky shores, which proved very inefficient’ (Lawson 2000, 48). The only designated area mentioned for such a practice is at Baymore situated a short distance above the 1960s pier built at Kallin. Given the size and nature of feature 18 this author has interpreted it as a means of mooring boats and unloading creels/catch.

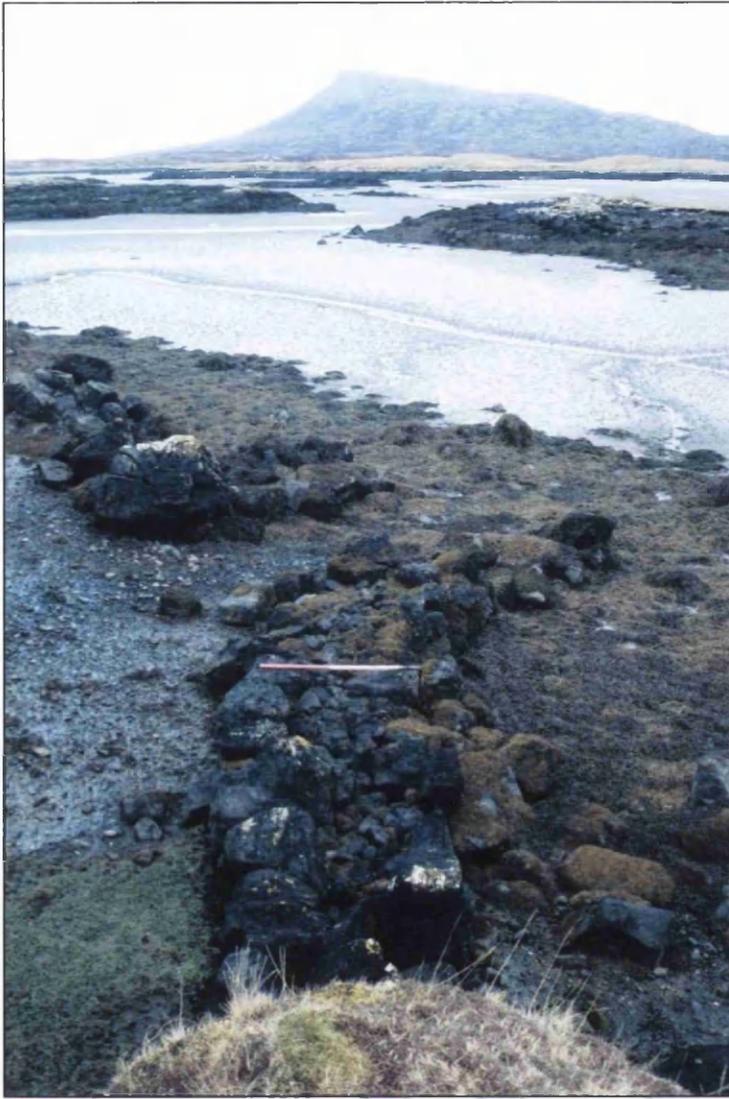
Plate 15b: Views of feature 18.

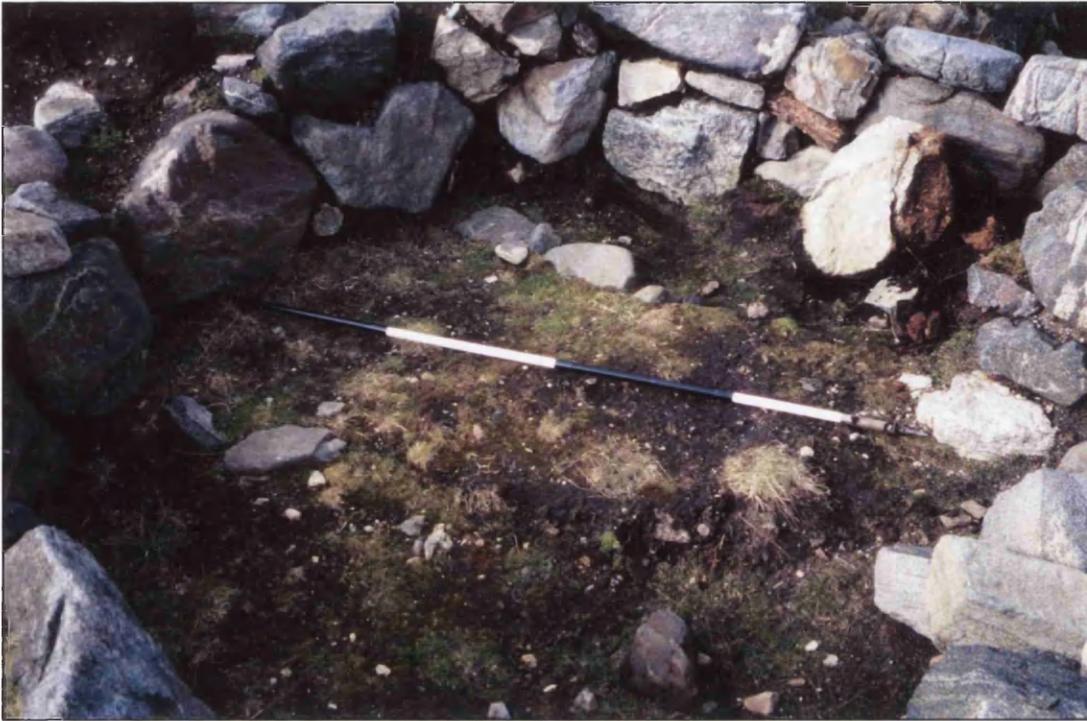
Plate 17: Photograph from 1998 showing a raised mound where structure I runs underneath structure IVa (©Hothersall).

mound could be seen continuing into structure IVa but is now no longer visible (Plate 17).

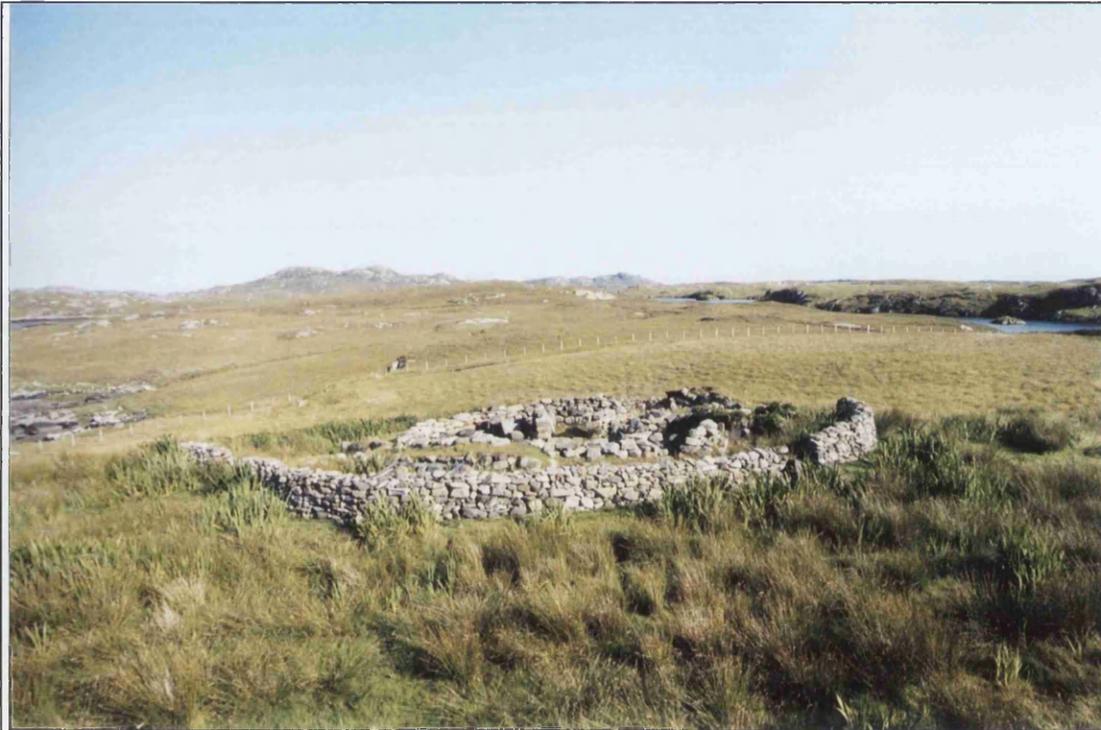
Plate 18: View looking east with the excavators wall in the foreground.

The 1999 survey also suggested that only the inner wall of structure I had been revealed, however, the two large stones directly opposite the entrance of structure II could make up an outer face making the wall similar in thickness to structure II. Again, this would require testing by excavation as the excavation that took place did not progress any further westwards, perhaps due to the constraints of the dry stone wall that had been erected in this area (Plate 18).

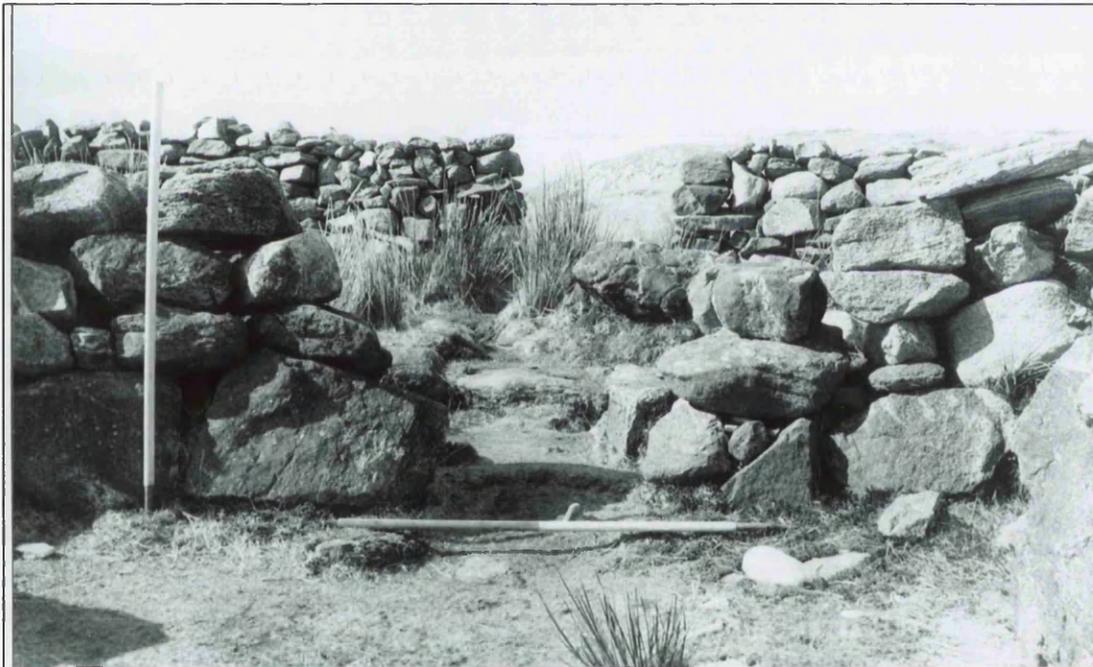
Plate 20: Interior of wheelhouse entrance with substantial stones at the bottom and possible re-building on upper levels.

The structure II outer walls flanking the wheelhouse entrance are conspicuous in comparison with the rest of the outer walling, giving the impression that they may have been re-built. Although the survey revealed that a varying amount of the upper courses throughout the site had been consolidated by the excavator, the entrance area looks to have had the greatest modification. Very little packing material can be seen between the stones and the general impression is that the upper stone work is not in situ (Plate 20 & Figure 19).

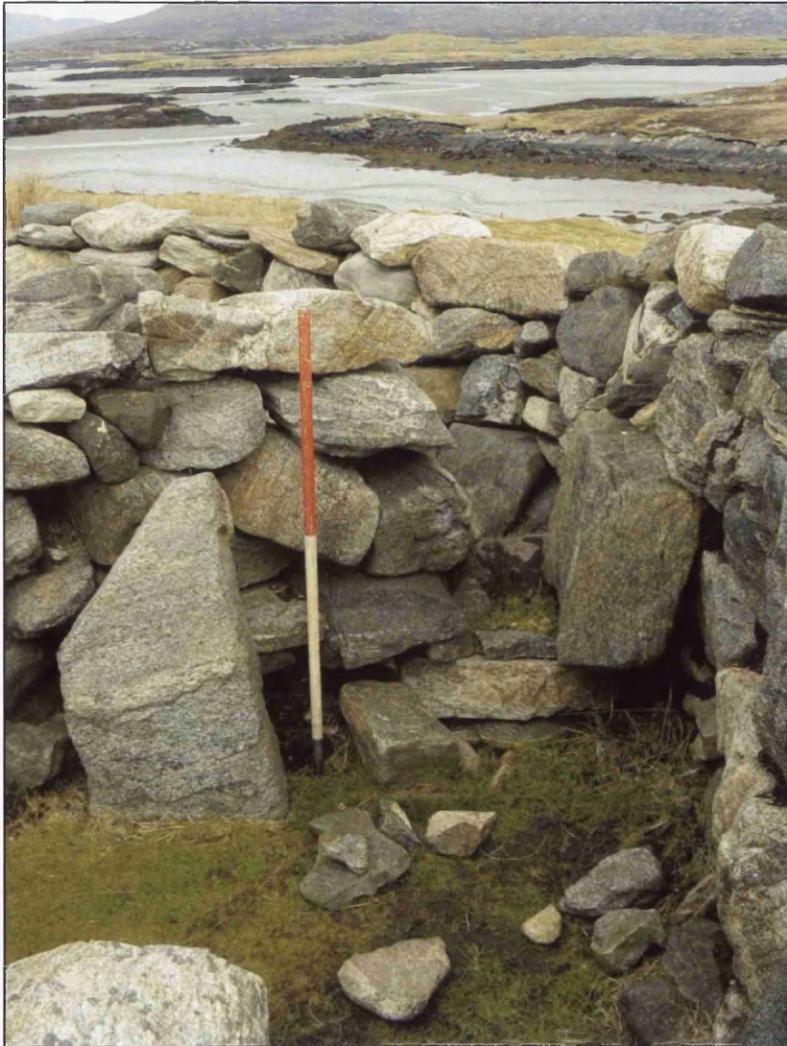
Plate 23: View from bay six of the aisle behind pier D with bonded and protruding stonework.

Access into this bay via the aisle is restricted, with evidence of the piers being partly bonded into the outer wall. Also, behind pier D, a large stone forming part of the outer wall protrudes 0.4m (Plate 23 & Figure 16). When the line of structure I is projected it is possible that features in this area have been modified and incorporated into the wheelhouse II build, however, there is no clear evidence of a blocked entrance. The possibility that the presence of the duct and arrangement of piers in this area were part of an earlier structure would be significant if further examination were to prove that structure I contained piers flanking its entrance.

As can be seen in the photograph and drawings (Plate 23 & Figure 21), this large wall stone rests upon a flat stone which underlies pier D and extends significantly into the aisle. A similar feature can be seen between pier E and the outer wall. The blocking of aisles in this way is unprecedented, although there are examples elsewhere for various ways of blocking aisles. Other location variations include the deliberate bonding of piers to the outer wall, later insertion of stones to fill the gap or in the case of Alt Chriasal (Plate 24), evidence remained showing a build up of midden material, effectively blocking the passage (Branigan & Foster 2002, 82).

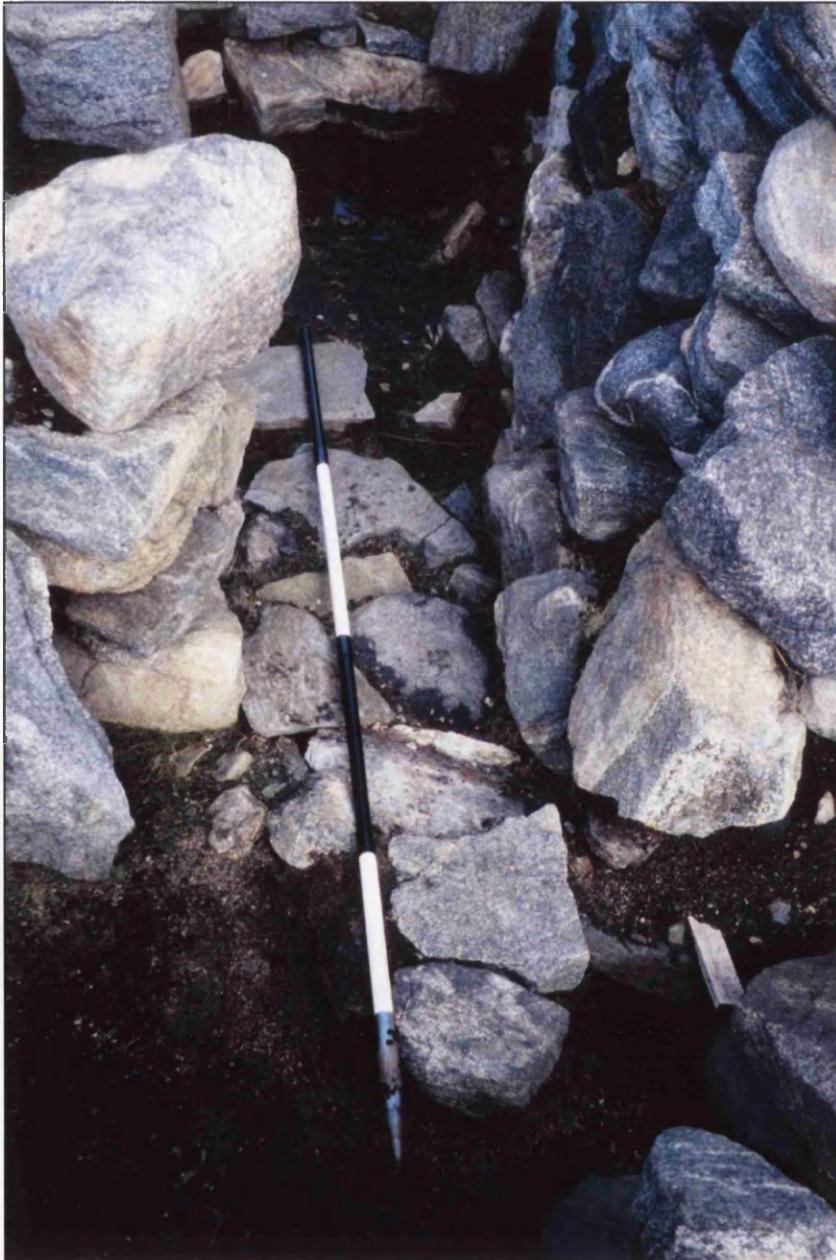
Plate 26: Strip of paving found behind pier C (©Hothersall).

given the slope of the ground towards the east, it is possible that the bays in the eastern curve of the wheelhouse were excavated to their primary floors. The strip of paving is 1.9m in length (Plate 26).

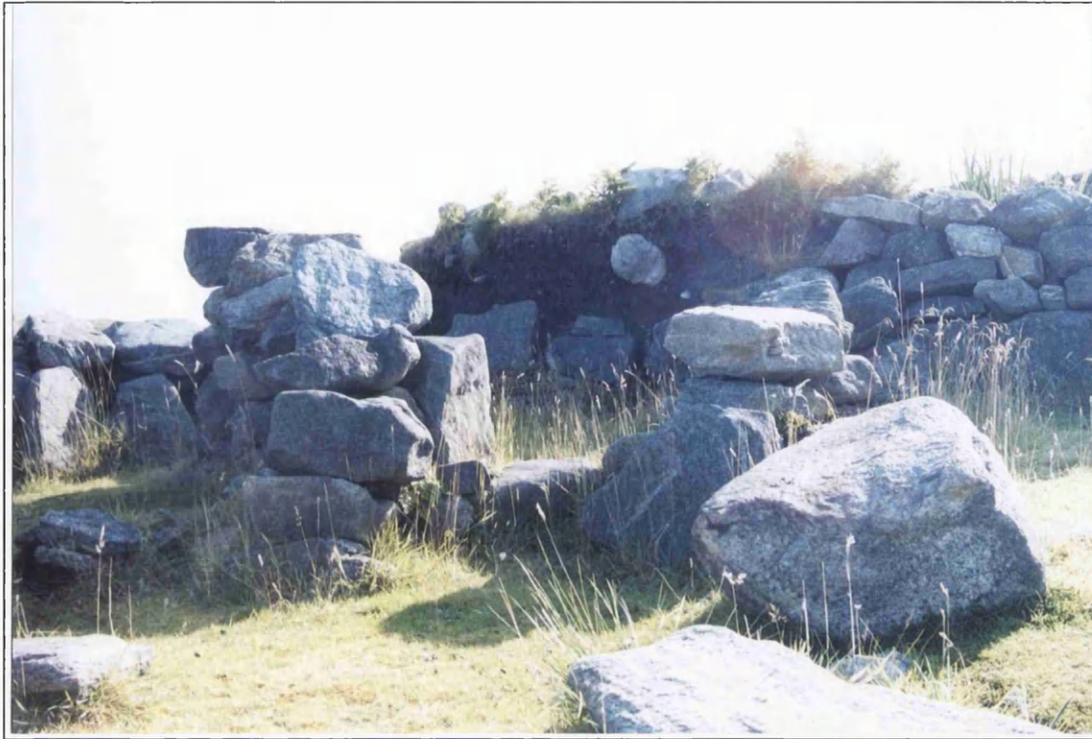
Plate 28: Bay eight with wheelhouse wall behind removed and shieling inserted on top.

The current floor level of bay eight is 0.3m above that of the central space, with kerbing at the threshold. The excavator here has only penetrated to the top level of the kerb on the interior and thus the primary floor remains some depth below. The floor is clear other than a large stone resting against pier B and another beside pier A. Again, the wheelhouse wall behind this bay has been removed, on this occasion by the shieling that had been inserted onto the mound (Plate 28).

Pier A only remains as one course of stones with fairly small stones embedded in dark soil. The stones above this lower course are not in situ and have been placed on top. The 1998 survey commented that there is possible remains of a kerb between pier A and H. This is unlikely as wheelhouses tend to not have any kerb at the

entrance and the original floor level is lower. This author considers rubble from the collapse may have been mistaken for a kerb.

Due to the amount of stone that has been removed relating to the shieling (structure VI) in this area it is difficult to say whether any adaptations were made at an earlier point in time in conjunction with the construction of structures IVa and IVb.

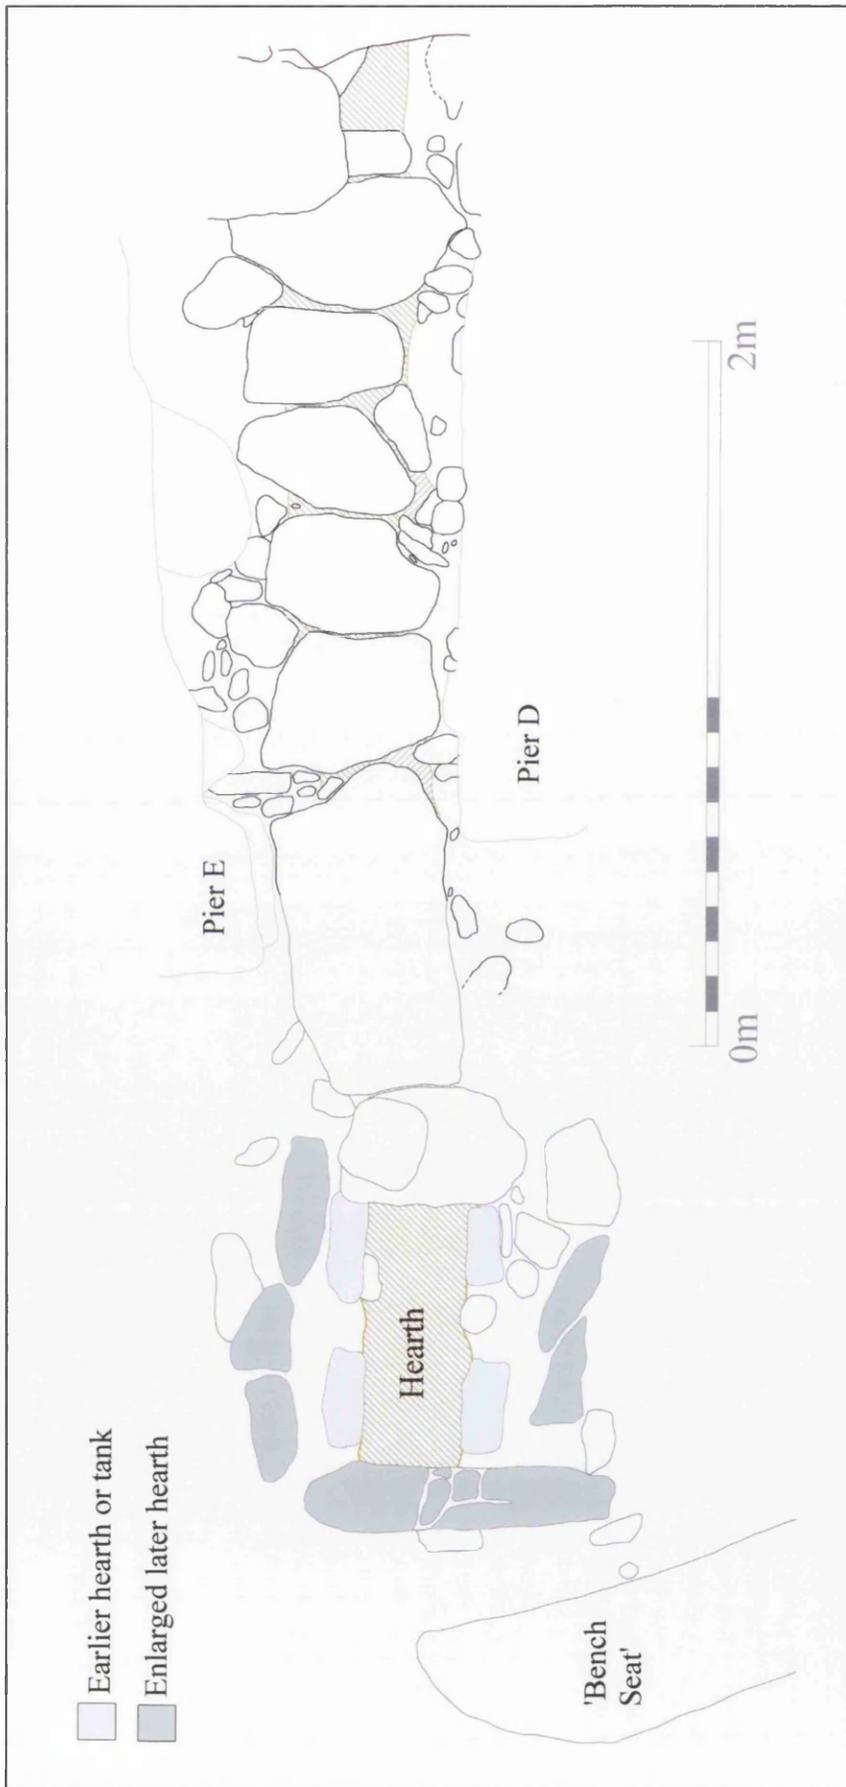
Figure 24: Plan of the hearth and duct in the centre of the wheelhouse (II).

The most striking feature within the central space of the wheelhouse (II) is the rectangular hearth with a stone lined duct running from it out under the outer wall (see Figure 19 & Plate 29a). The hearth, which shows signs of heat cracking to the some of the stones, produced an abundance of orange peat ash during excavation (MacVicar pers. comm.). It is clear that the hearth has been modified on at least one occasion, transforming it from a small rectangle measuring c. 72cm by 33cm to a larger rectangle of c. 72 by 68cm (Figure 24). The widening of the hearth at this later date

Stratigraphically, during the earlier phase (see Figure 24) the duct would have functioned with this smaller rectangular box. However, after the expansion of the hearth and resulting build up of material the duct would have been blocked unless it was routinely cleared out, and although this evidence does not exist, those who witnessed the site being excavated testified that the hearth was full of ash to the limits of the later configuration therefore at some point at least in the site's use the hearth was allowed to expand.

may have also raised it above the functional level of the duct, if encouraging air circulation was its purpose.

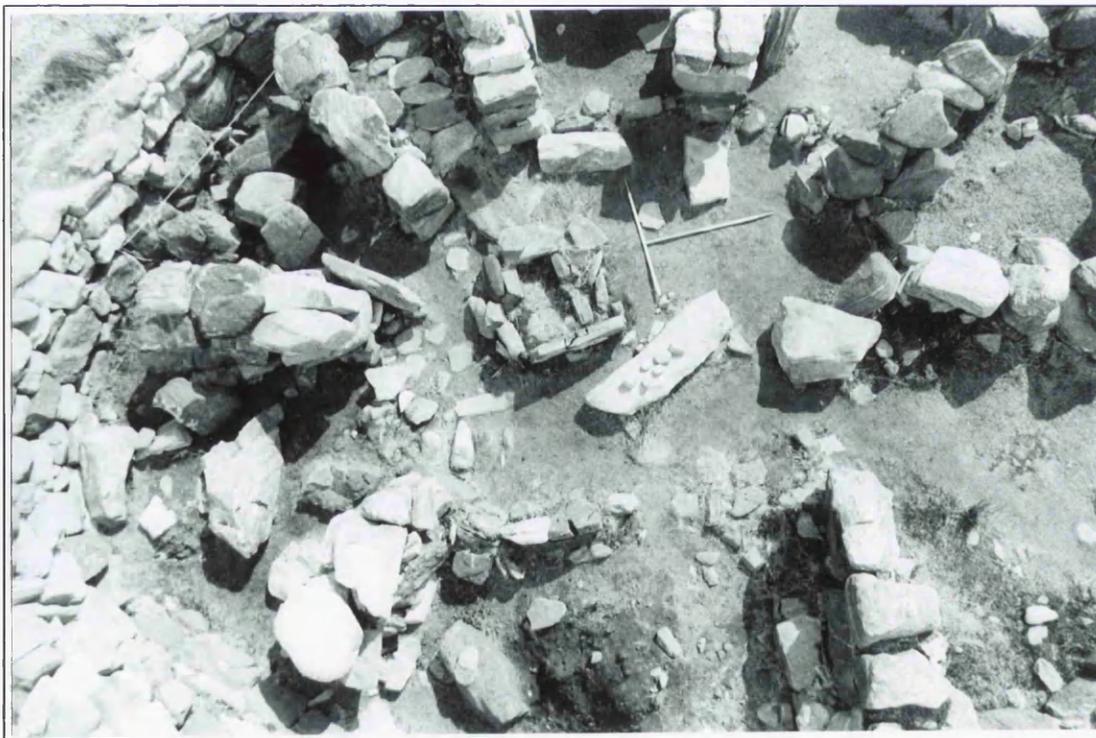
Plate 31: Plan view of the wheelhouse interior, with bay two at bottom centre and pier H at the bottom right.

As can be seen in plates 31 and 32, pier H is not only built in a different style to the others, but projects from the outer wheelhouse wall at an angle that would upset the internal ring of stone which helped form a corbelled roof over the bays.

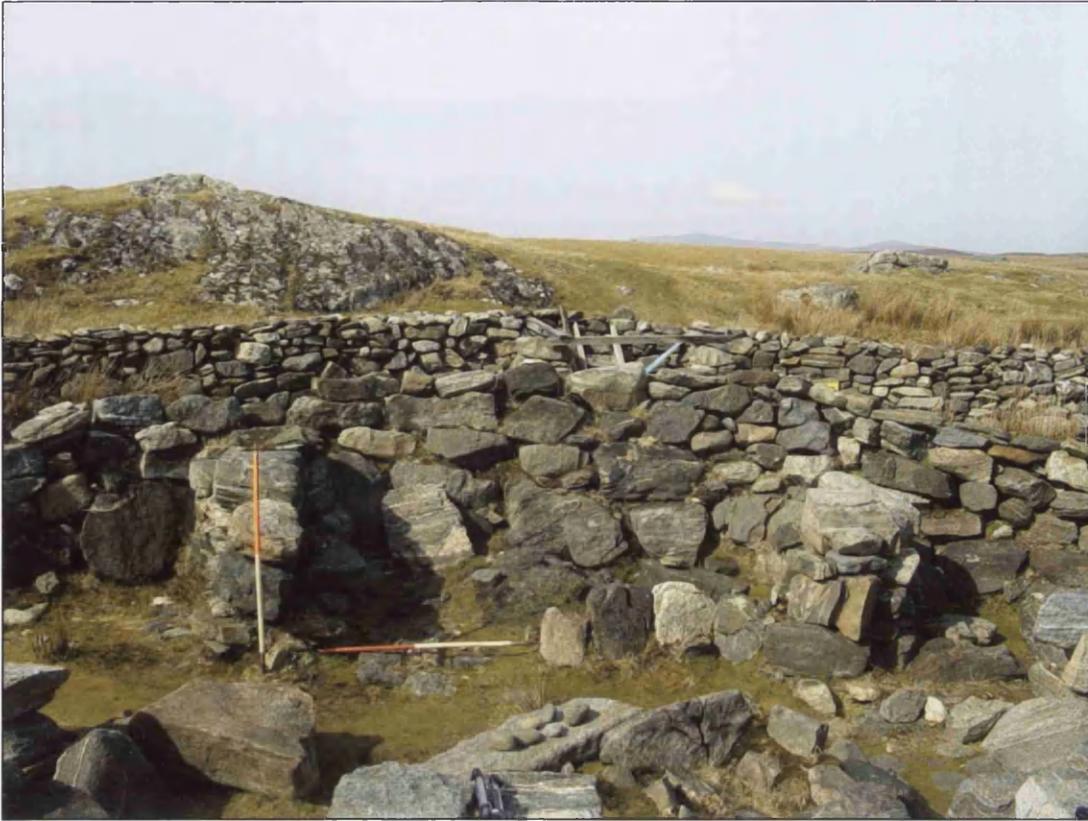
Plate 33: View from central wheelhouse space of bay two with piers H (left) and G (right) some 3.6metres apart.

Another anomaly with bay two which is flanked by piers H and G is the large gap between these terminals (2.4 metres). This is too great a distance to span with a lintel and there are no other examples of wheelhouses with bays of this size (Plate 33). Therefore, it is argued here that pier H is a later insertion into structure II.

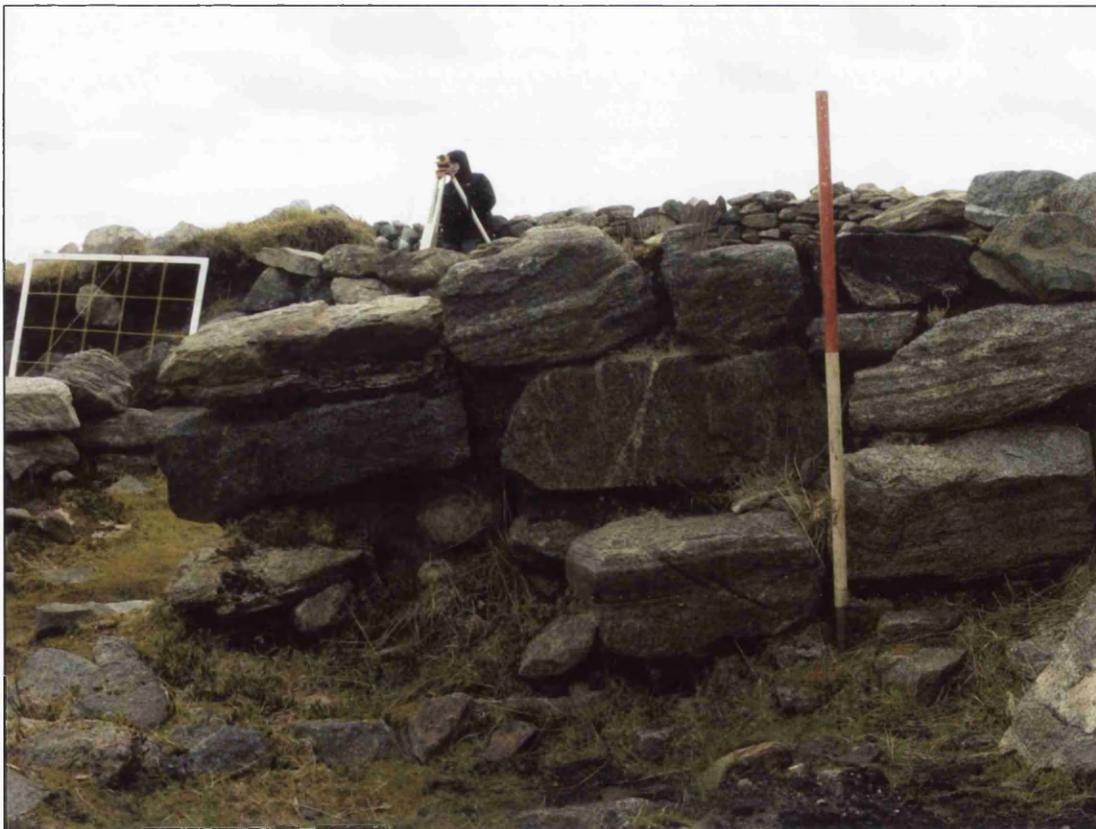
Plate 34: Pier H viewed from within bay two showing protruding 'bench' stones.

Pier H incorporates a stone bench, or platform at a low level on its northern face (Plate 34 & Figure 26).
