Analysis of a Wheelhouse and Other Structures  
in Grimsay, Western Isles.

Alasdair John M<sup>c</sup>Kenzie

This thesis is submitted in fulfilment of the requirements  
for the degree of M.Phil.in the Department of Archaeology,  
Faculty of Arts, University of Glasgow, October 2005.

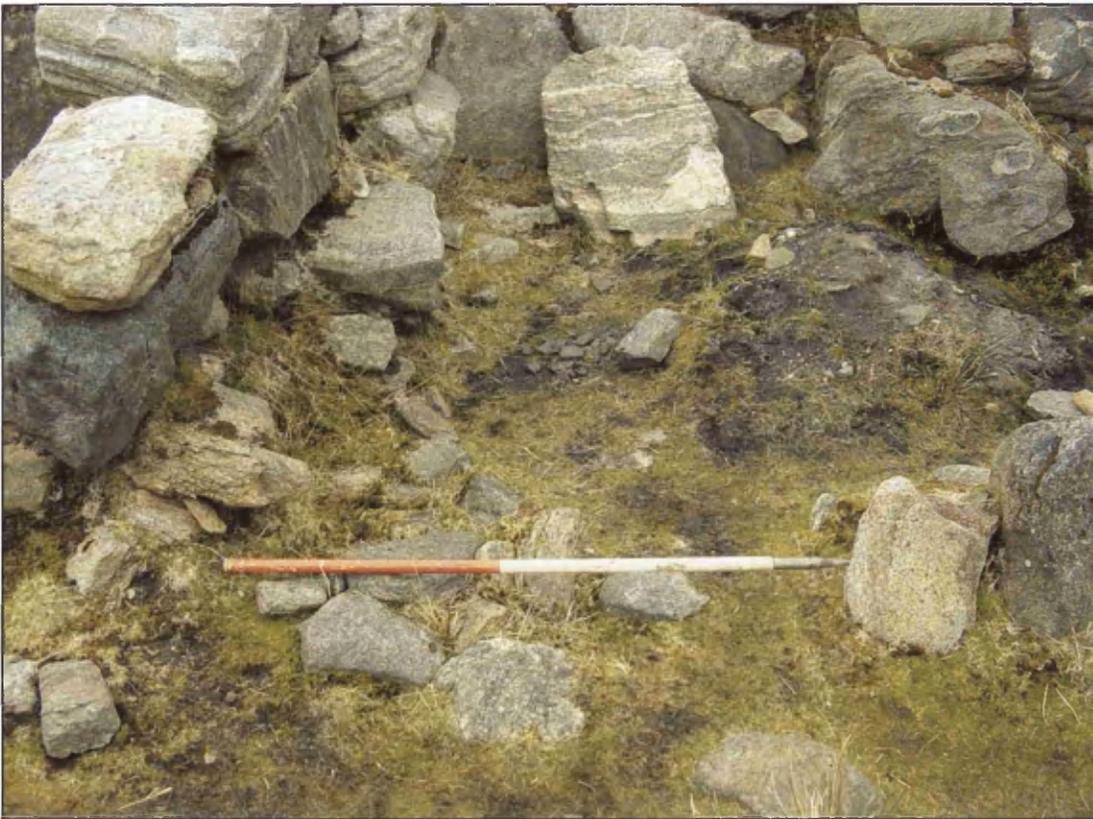
Plate 35: Small stones set into the floor of bay two, curving from the 'benching' around to the orthostatic kerb, leaving a small void.

The 1998 survey interpreted the fallen stones around the base of pier H as part of the orthostatic division that had collapsed (Wood 1998, 9), however, it is suggested here that this break relates to the entrance of structure III. Further excavation would establish whether this is the case or not.

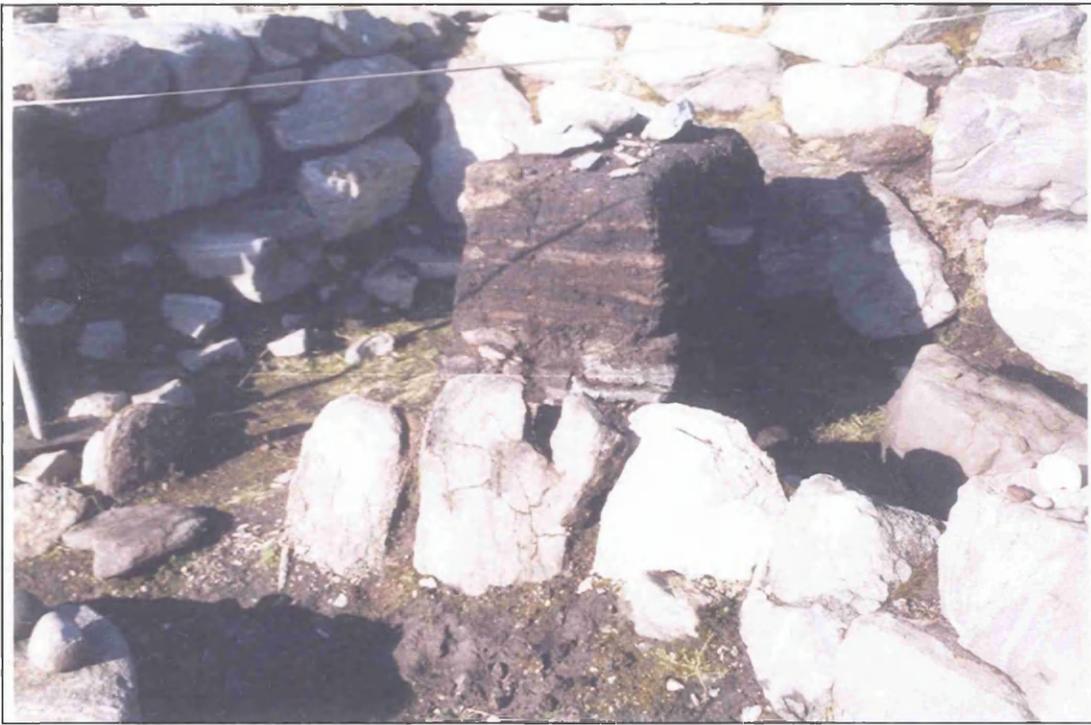
Plate 36: View of structure III in 1998 with baulk (centre) intact (© Hothersall).

In the centre of bay two, a baulk was left intact by the excavator, which has since slumped to less than half its original height which was approximately 70cm. (Plate 36 & Figure 28).

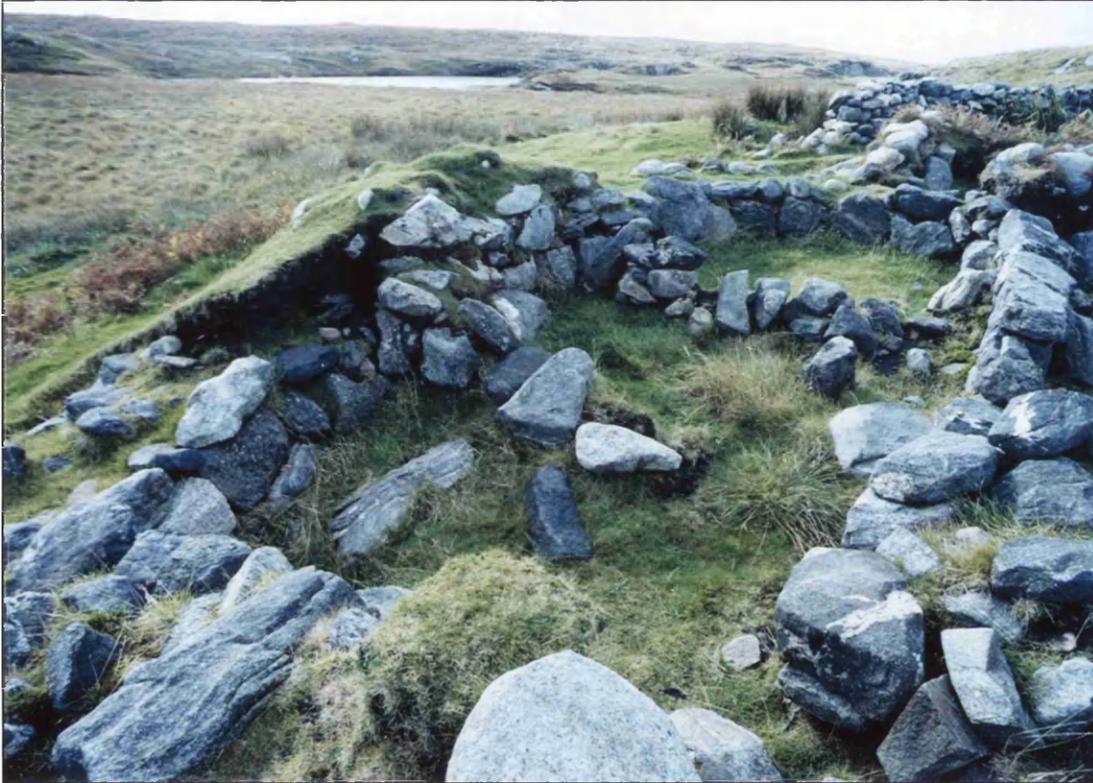
Plate 37: Detail of the junction between structure IVa and IVb.

corner of structure IVb. It is suggested here that this trace of walling forms the outer wall of structure IVa. As can be seen in figure 28, by projecting the lines of the sub-rectangular walling where the western division can be seen, the feature meets this trace of walling. Plate 37 illustrates the point at which the walling has been altered.

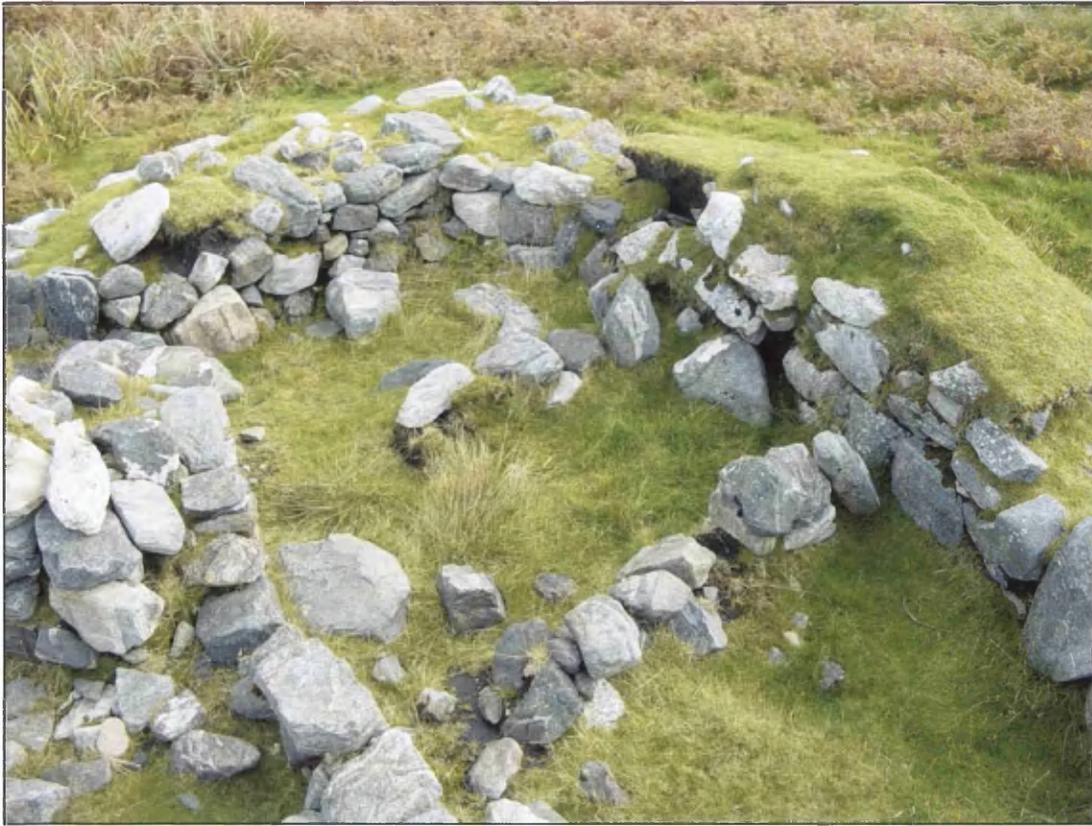
Plate 38: View of structures IVa and IVb looking westwards.

From examination of the style of construction it is clear that structure IVa is made up of larger stones, with IVb made up of smaller stones and a poorer finish (Plate 38).

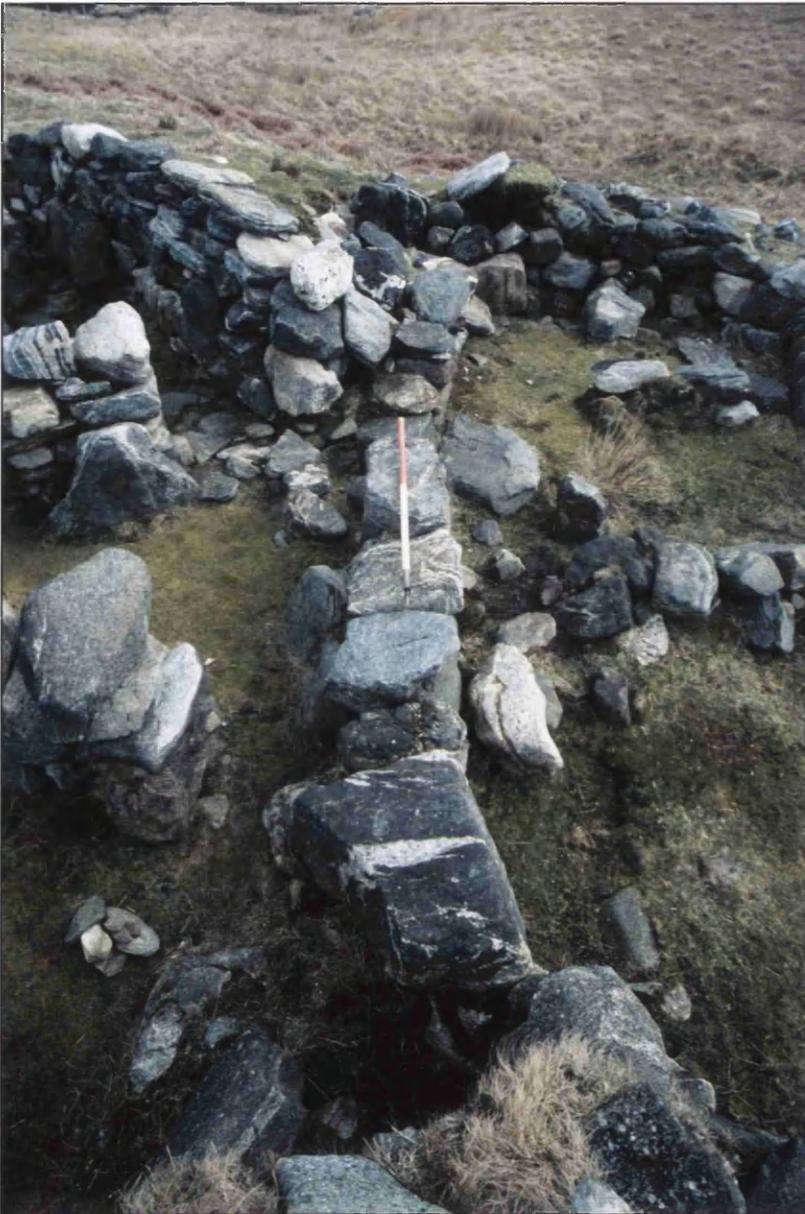
Plate 39: The northern wall of structures IVa and IVb as it cuts through the arc of the wheelhouse (structure II) wall.

This thickness of the walling for structure IVa is consistent all round with the exception of the northern section which abutted the wheelhouse (II) and the eastern portion which has been removed. The walls appear to be double faced, with a turf core on all sides apart from the northern side. The northern wall is significantly thinner and of a different style. It would seem plausible that this northern wall was revetted against the mound containing the wheelhouse which by his stage, presumably, was already established (Plate 39).

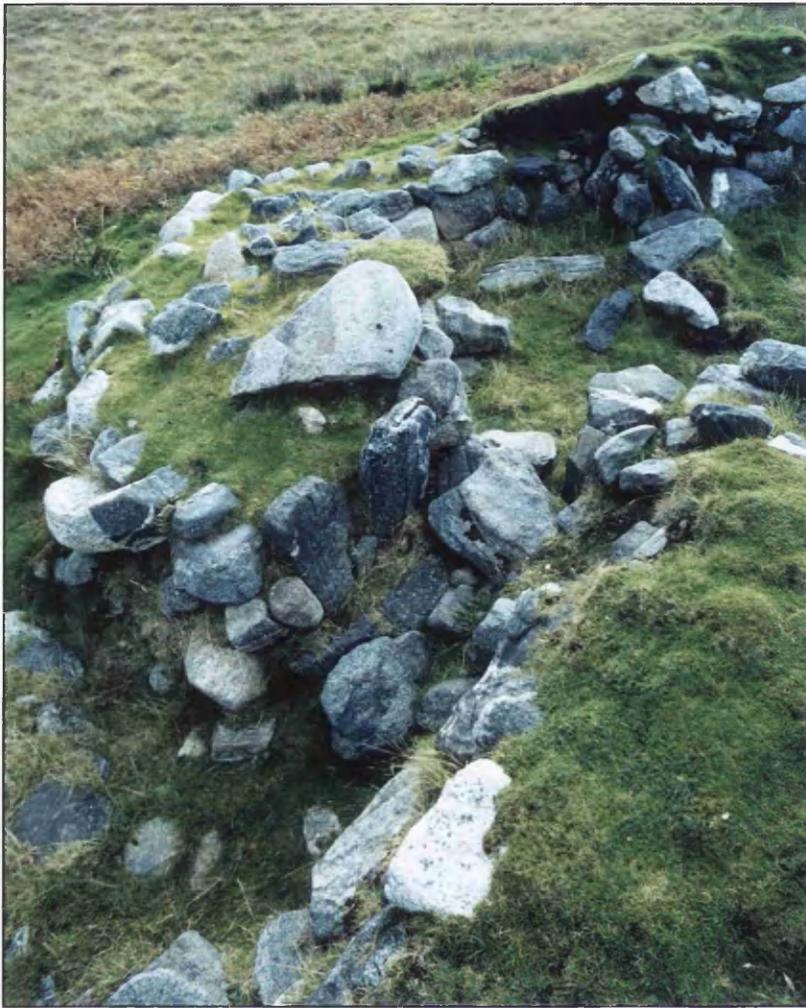
Plate 40: The entrance to structure IVb.

The entrance to structure IVb can be found on the north eastern corner, built against the outer wheelhouse wall which contributes, along with the outer wall of structure IVb, to form a short passage (Plate 40). A platform has been created immediately in front of this entrance with small flat stones and continues over the exit of the duct which extends from inside the wheelhouse. It is unclear to what extent the duct was covered with these stones when first built or whether they were adapted to accommodate the entrance to structure IVb.

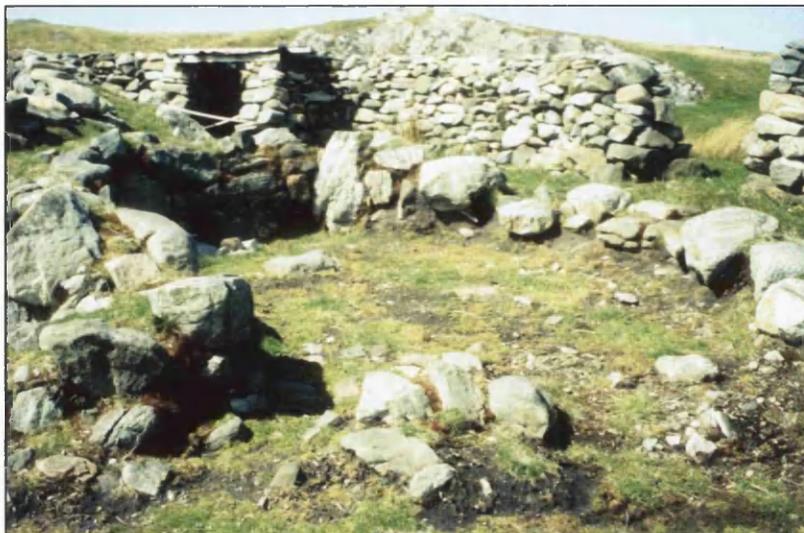
Plate 41: Two photographs depicting structure V(a) in 1998 (top ©Hothersall) and in 2004 (bottom).

Structure V(a) (Plate 41) has been revetted into the side of the wheelhouse (II) and has no surviving wall on the east side. The original floor of this structure V(a) was probably not reached during the excavation. The walling that is visible is quite substantial with possible double facing and an earthen core. The walls stand to a maximum height of 0.7m sloping down to 0.25m on the eastern edges. A slight trace of stones can be seen along the eastern flank.

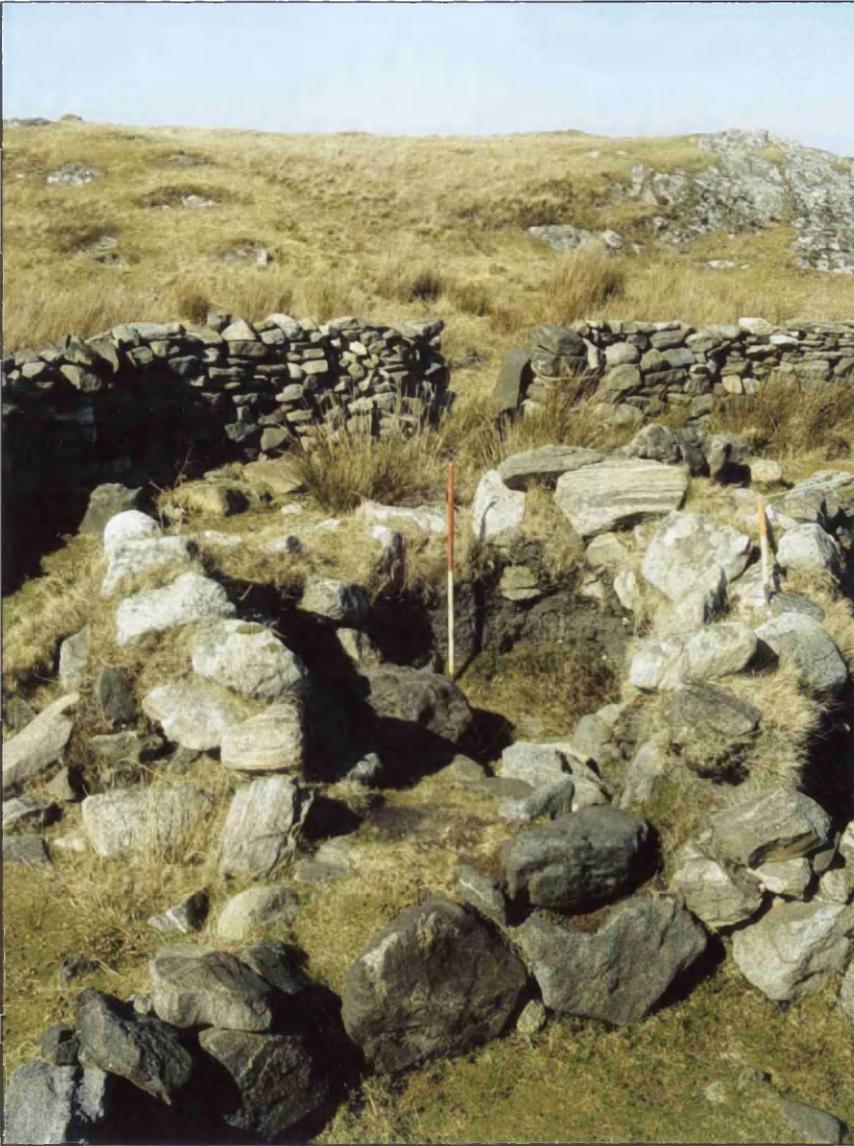
Plate 43: The shieling (structure VI) that had been inserted on top of the mound.

Although the shieling has been fully excavated, its outline still survives, and it would appear that the excavator was primarily intent on revealing the structures and not removing them completely to find what lay at the bottom of the mound. Plate 43 shows the round shieling which has a diameter of 1.95m. The stones were bedded on a dark brown loam which does not contain the same midden addition common elsewhere and utilised in the earlier structures. Floor surfaces associated with this shieling have been removed in the pursuit of structure I, the line of which can be seen running under and into structure IVa.

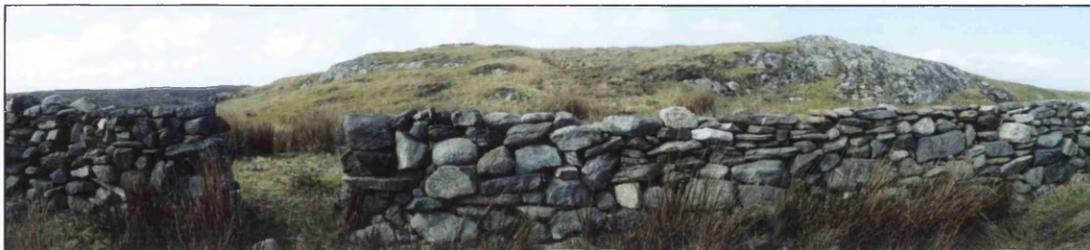
Plate 44: The surrounding dry stone wall built by the excavator.

As can be seen on the two aerial photographs (Plate 3 above) taken shortly after the end of the excavation and (Plate 44) an arc of dry stone walling has been built on the western side of the site in the space between the structures and the quarry face.

This dry stone wall also incorporates a temporary structure which can be described as the ‘dig hut’, utilised by the excavator for protection from the wind and rain. This wall was built using the tumbled stones removed from the mound during the excavation and demonstrates the vast quantity of stones that had been quarried nearby or brought to the site. Although the quarry adjacent to the site has been cited as the main source of stone (Wood 1998, 7) it is also possible that a significant portion could have been sourced from the bay to the north east where loose stones are still evident (Plate 45).

At Bagh nam Feadag, unlike the Cletraval wheelhouse in North Uist, the stones that were removed during the excavation are at least still visible on the site, albeit in the form of a recent wall and shelter (Plate 44 above). Although no detailed quantification of the building material at the site was carried out, it appears likely that most of the stones remain and have simply been moved around the site by the various phases of occupation. Given the remoteness of Bagh nam Feadag in relation to the modern road and settlement on Grimsay, it seems logical that the mound was not realised as a source for pre-quarried building material in recent years.

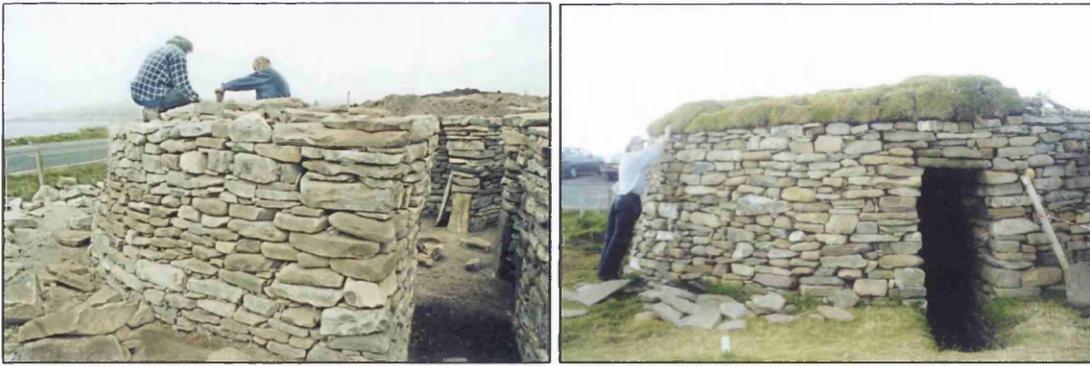
Plate 46: Experimental construction of a freestanding wheelhouse at Scatness, Orkney.

The volume of stone required to execute the construction of a wheelhouse can only be theorised as the only experimental work in rebuilding a wheelhouse was conducted in Shetland using the vastly different flagstones prevalent both there and in the Orkney Isles (Plate 46).

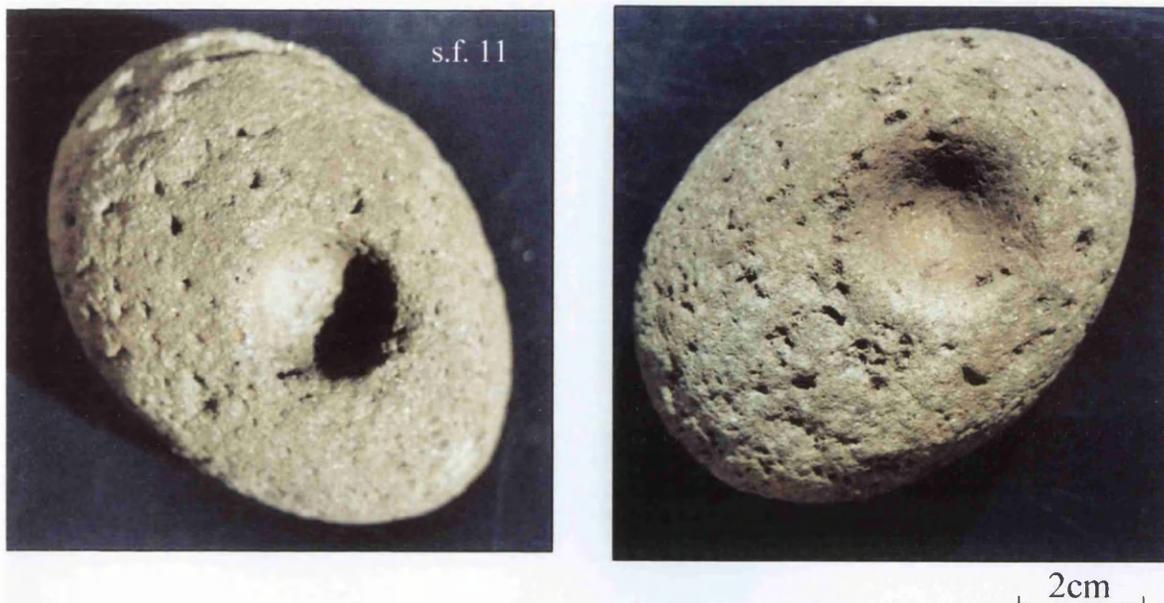
Plate 48: Stone with pecked/drilled impressions.

This artefact is formed from an oval pebble and has an indentation on opposing sides. These indentations are steep sided with one travelling further into the stone than the other, perhaps pecked initially then drilled. Alternatively, the function of the tool has caused the interior of the impressions to become polished. The purpose of this artefact is not known and so the following interpretations are offered; unfinished hammer stone, unfinished stone weight, strike-a-light, mortar or palm protector.

Oval, 88mm by 62-65mm, maximum thickness 51mm. Diameter of pecked impressions 25mm and 29mm.

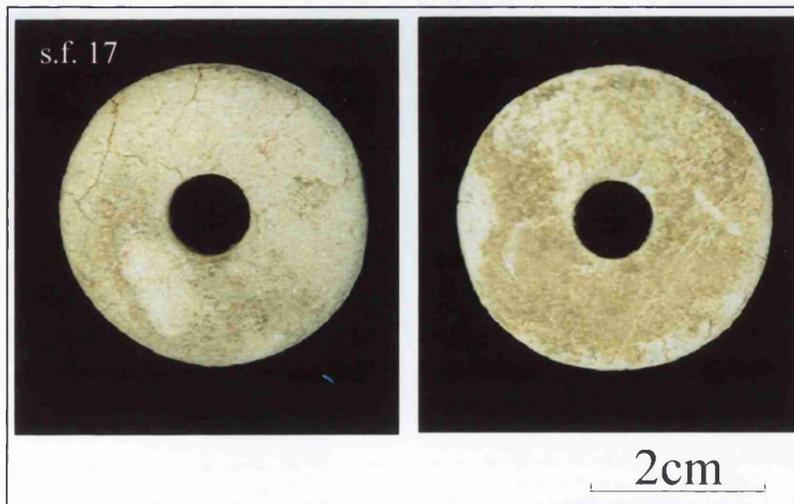
Plate 51: Stone spindle whorl.

Outer diameter of 35mm and 9mm thick. Hole diameter 5mm.

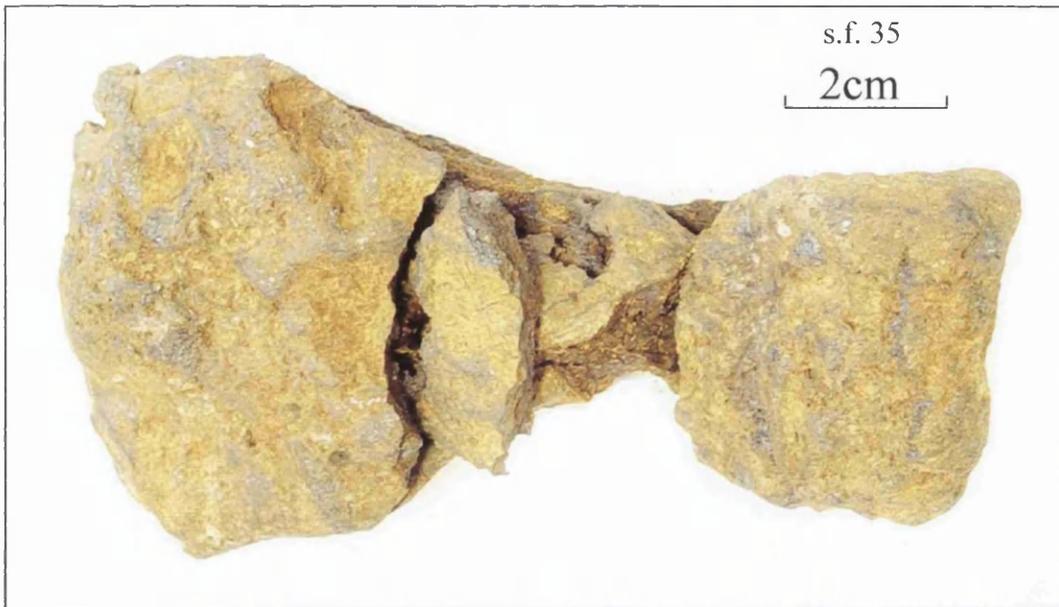
Plate 57: Iron axe head.

The axe head is accompanied with no contextual information at all. The axe head was in fairly good preservation upon discovery, but has since deteriorated somewhat. The metal has fractured in the centre where it is at its thinnest and weakest. The flat back would suggest it was intended for woodworking and not as a weapon. It is likely that the axe was formed from a single bar of iron which has been folded over and shaped. Dimensions given here are only approximate as handling the item would have damaged it further.

Length (from blade to haft) 115mm. Haft hole, oval 37mm by 26mm. Height of blade, 56mm.

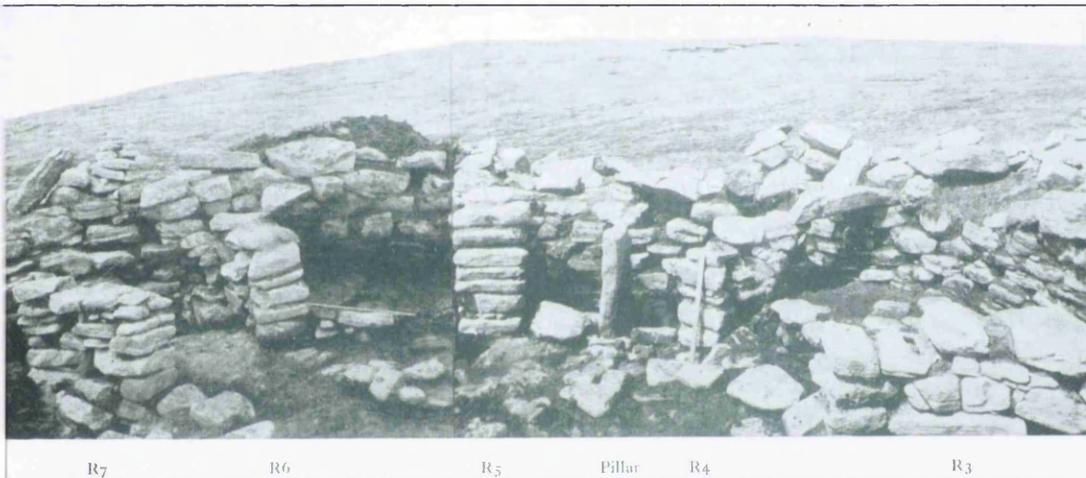
Plate 76: Wheelhouse bays at Cletraval showing pillar added during phase two between piers R5 and R4 (from Scott 1948, 50).

- Phase 3: Roof collapsed and architrave fell from bays VIII and IX into central space
  - Mass of rubble removed
  - New wall of poor construction close to the west at entrance creating a hut, or smaller house (Scott 1948, 48-53; fig 3)
  - Entrance passage used but partly collapsed
- Phase 4: Entrance passage filled to a depth of 2 feet 3 inches and a small hut built over it and within the thickness of the outer wheelhouse wall.

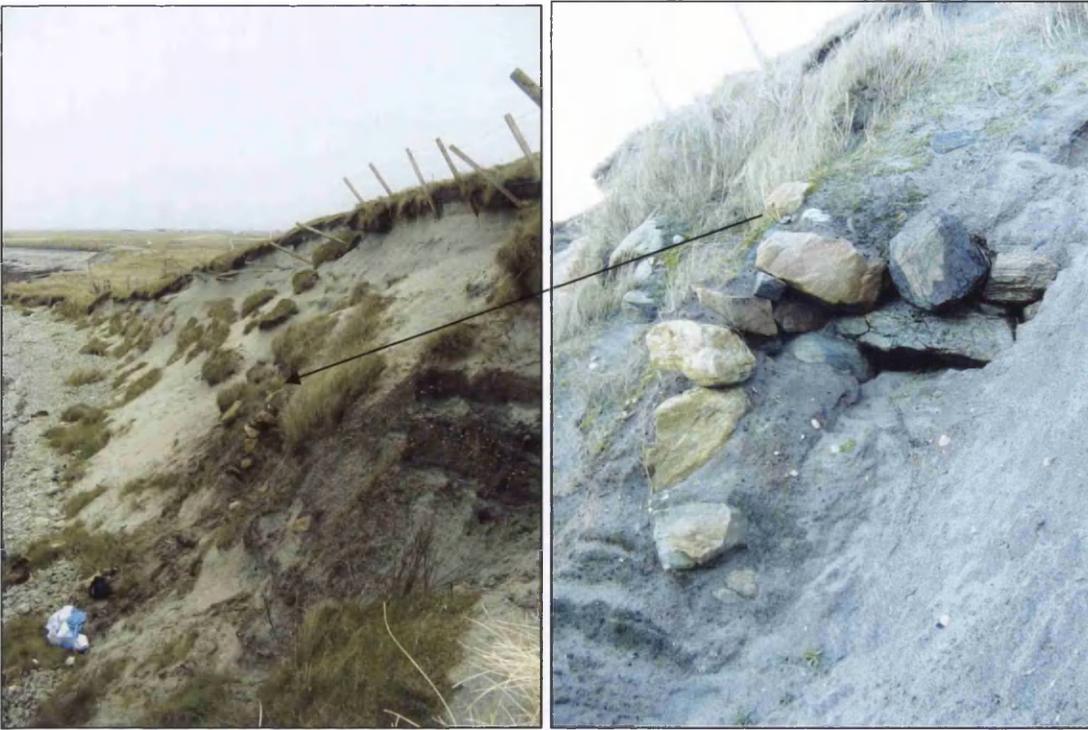
Plate 74: An Ceothan wheelhouse, near Balivanich, Benbecula, in 2004  
before the storm.

The concentration of wheelhouses in such a small area at Vallay is mirrored in Balivanich (NF785557), Benbecula, where two wheelhouses (Scott 1956), were found during the construction of the airport runway and a third exposed in 2002 and largely removed by a violent storm in January 2005 (Plate 74). Plate 74 depicts the middens and area of erosion (left) and where the lintel bonds with the outer wall (right), the latter having been largely removed. The exposed middens contain pottery typical of wheelhouse assemblages including sherds with hatched triangle and wavy cordon motifs. The other two wheelhouses are situated 1.5km to the north east.

Clearly a number of wheelhouses have already been lost in this manner and as can be seen above, continue to do so.
