CORROSION OF COPPER IN A PUBLIC WATER SUPPLY

Thesis submitted for the degree of Master of science
to the Faculty of Engineering

Department of Mechanical Engineering
University of Glasgow

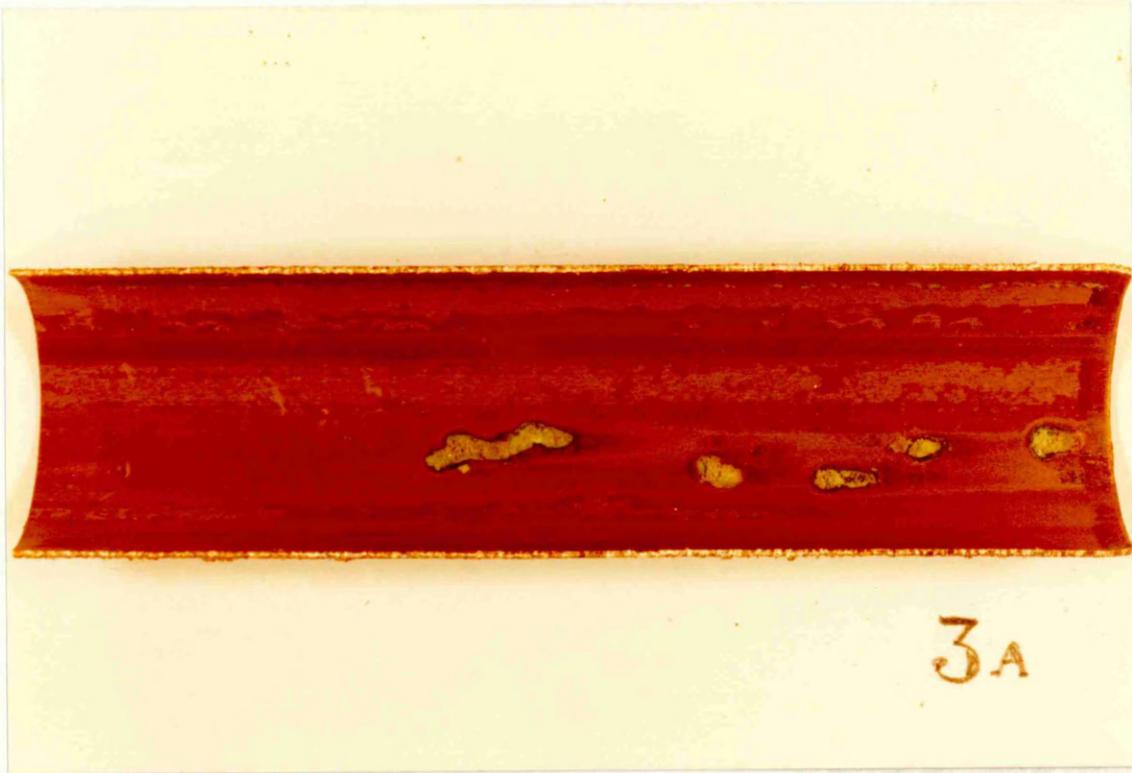
Photograph 1 shows the onset of corrosion in form of isolated pits on the interior surface(pipe)

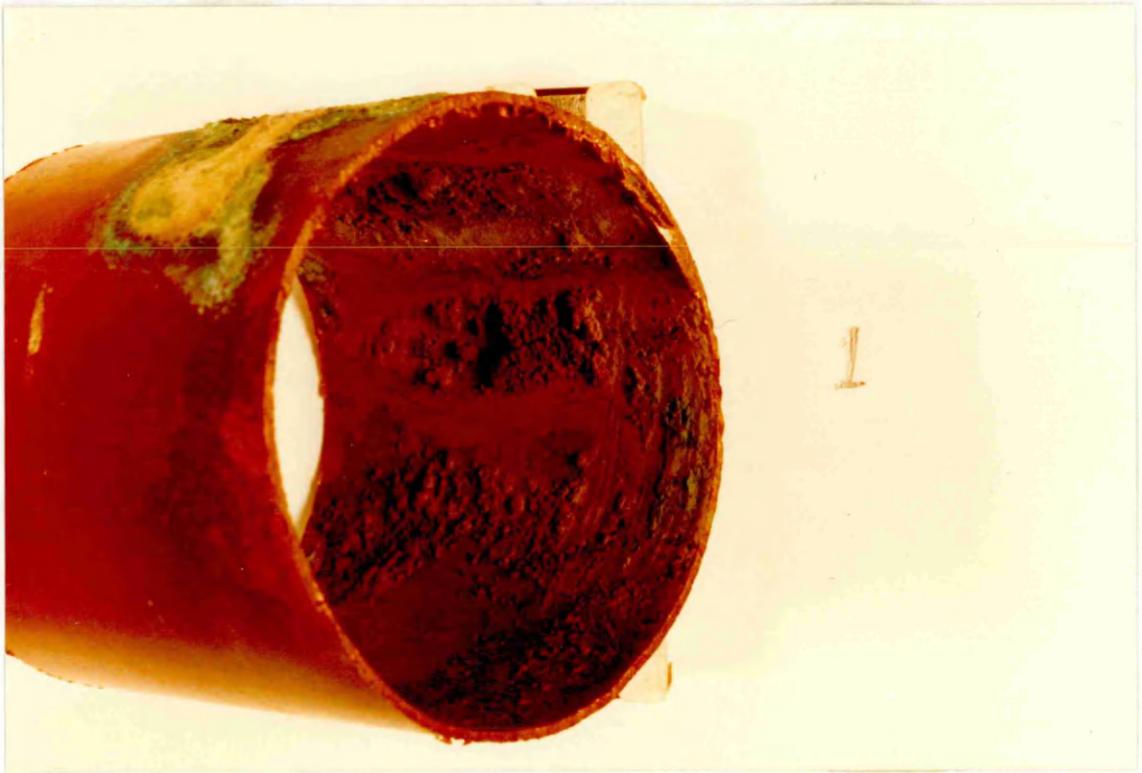
Photograph 2 shows more extensive corrosion product in a pipe bore.

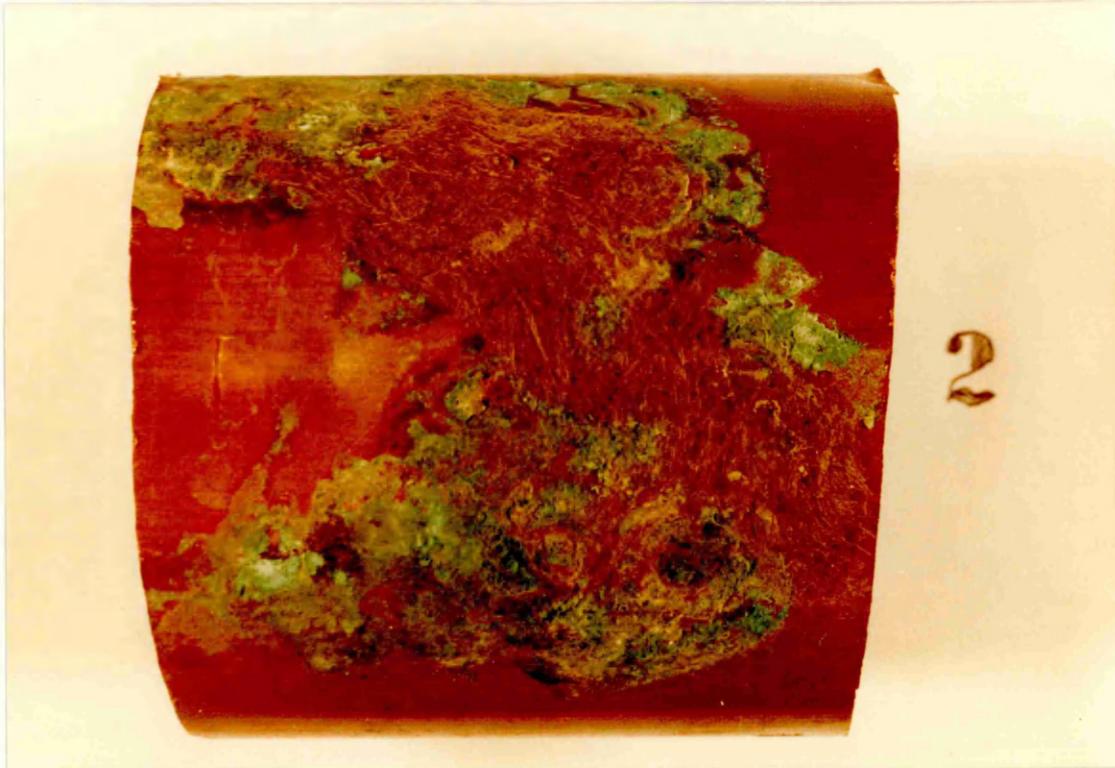
Photograph 3 shows the spread of corrosion product to outside of a pipe after perforation.

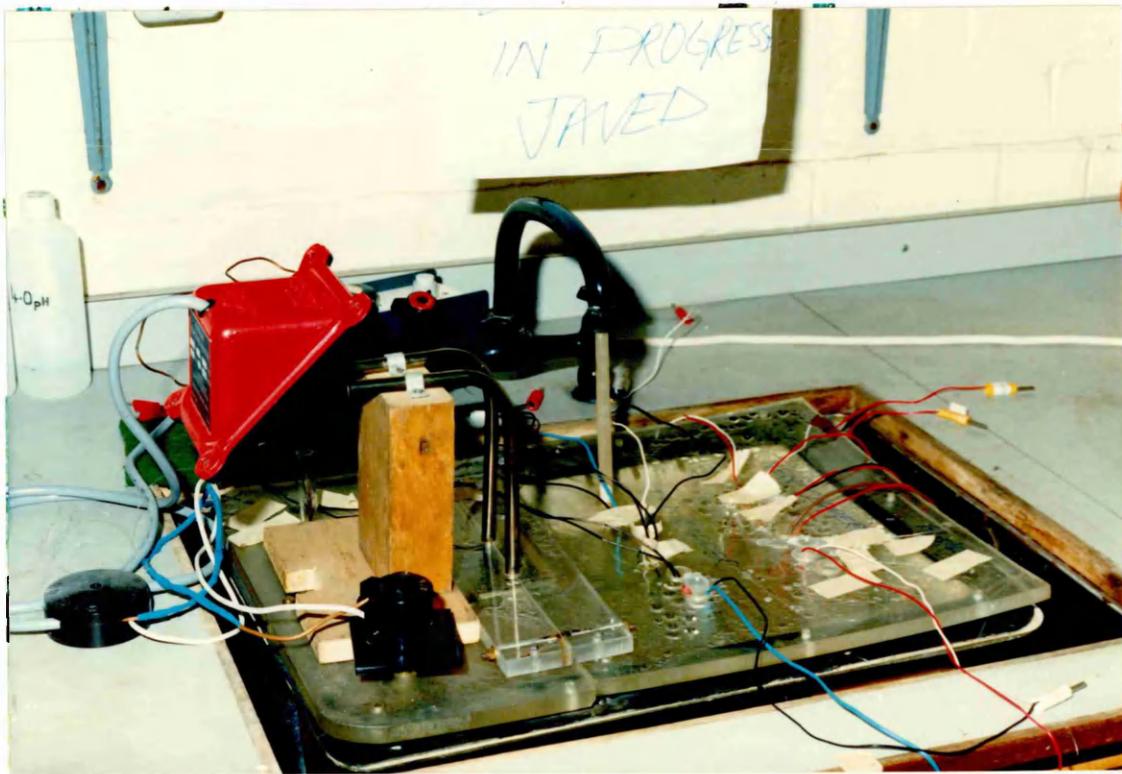
Photograph 2 shows the hot water tank arrangement for copper specimens in hot water (60)

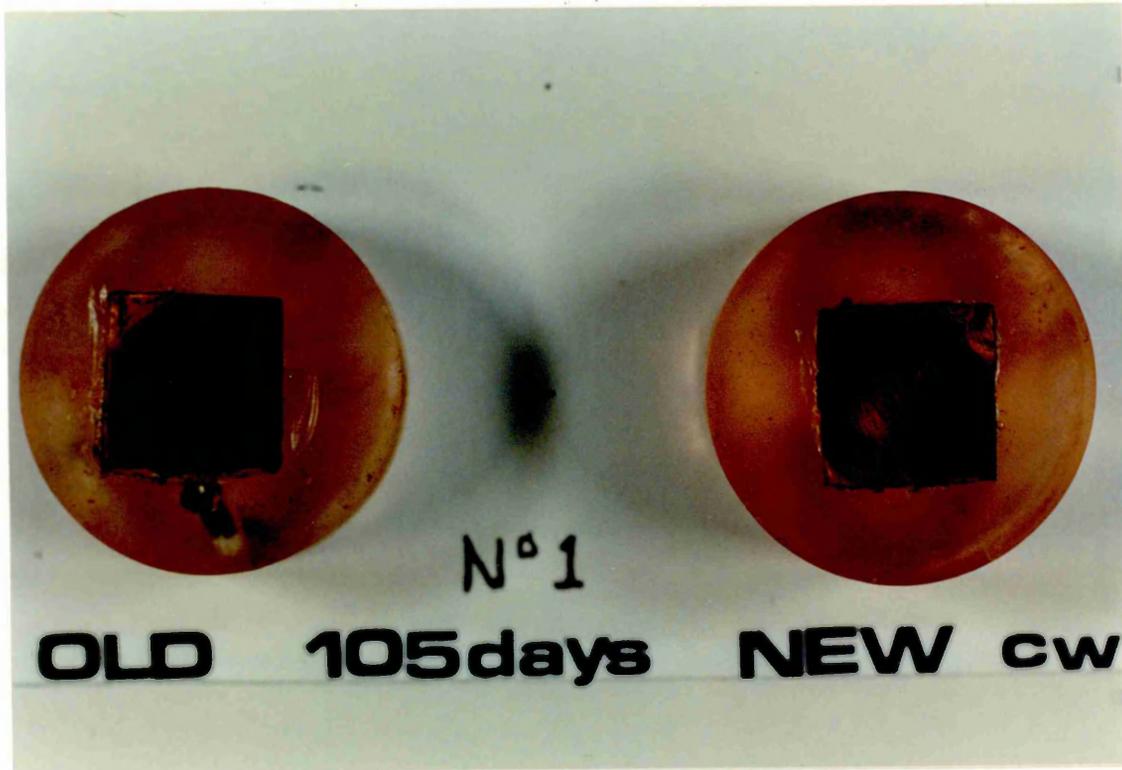
Photograph 1 shows the surface of copper specimens after 105 days of immersion in cold water.

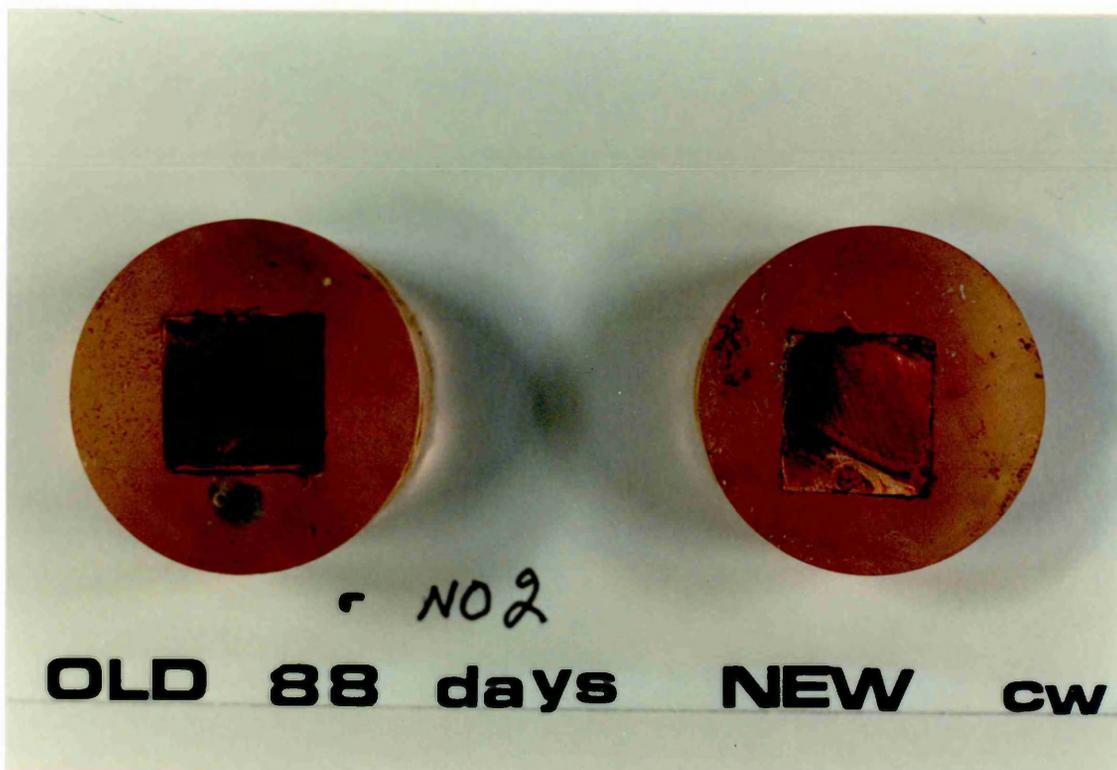
Photograph 2 shows the surface of copper specimens after 88 days of immersion in dark condition.

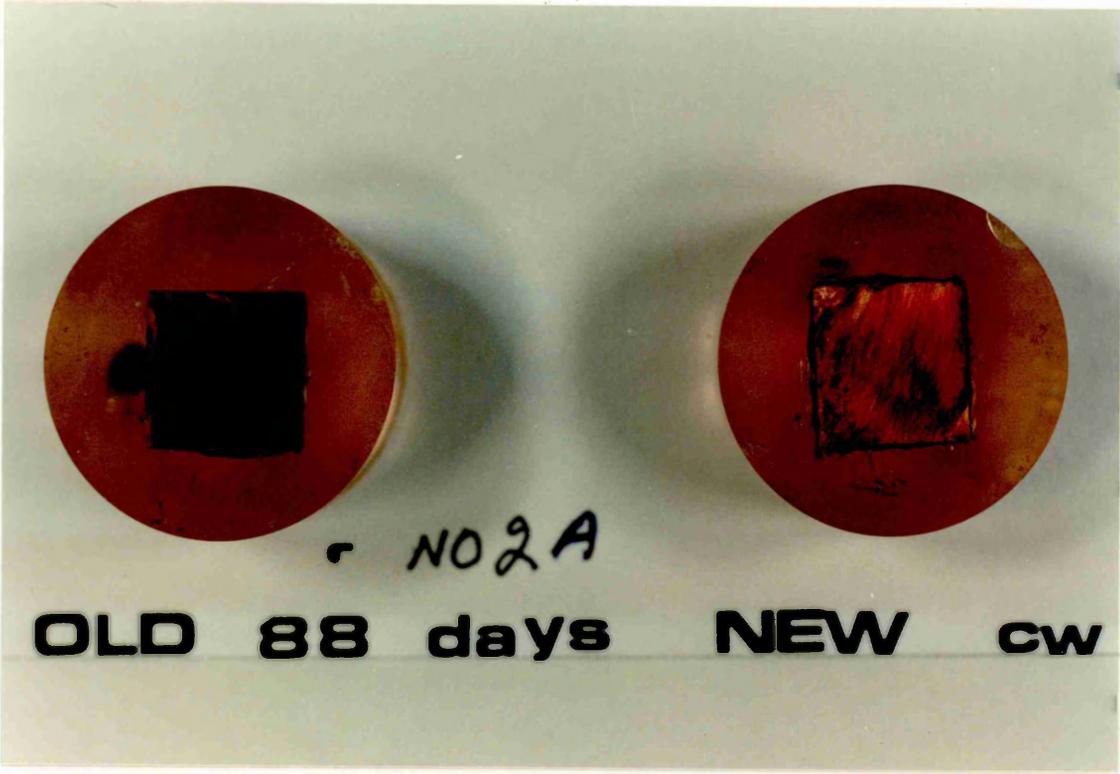
Photograph 2A shows the surface of copper specimens after 88 days in both dark and light cond.

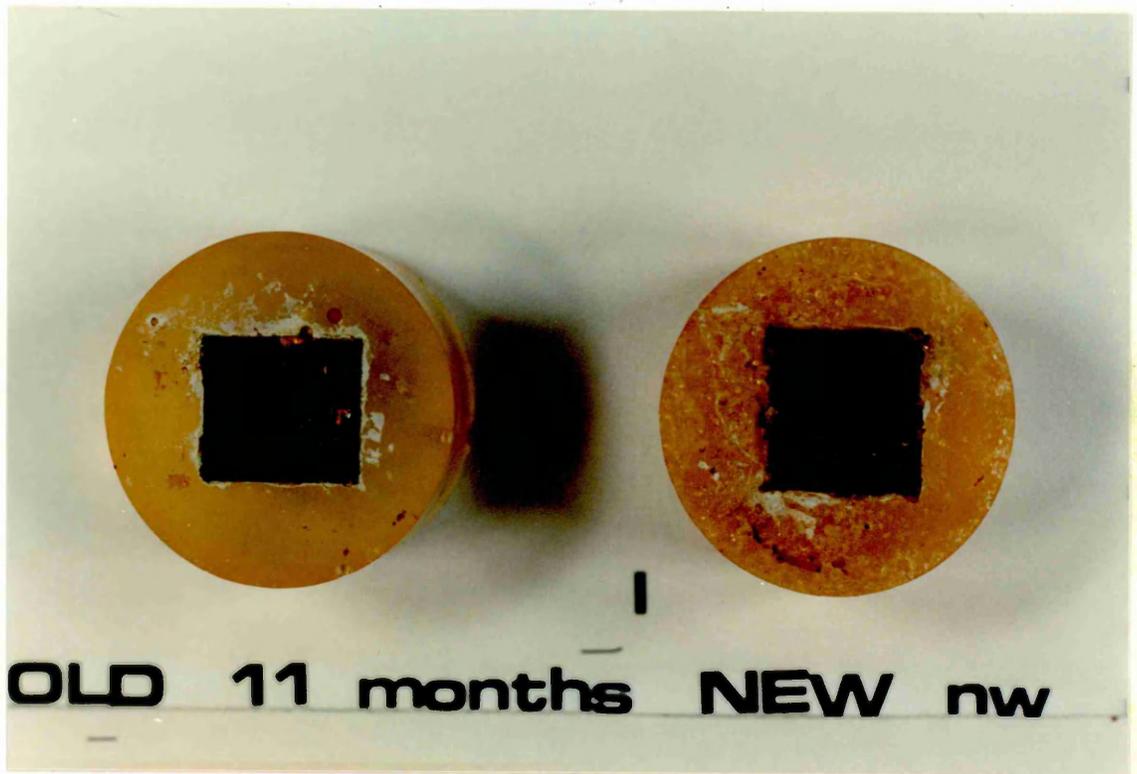
Photograph I shows the surface of copper specimens after 11 months in N/H (Anodic scan).

The photographs shown in figure I-Ic shows the surface of copper specimens after 11 months of immersion in normal hot water (40-50°C) . The photograph I represent the copper specimens after anodic polarisation while Ic shows both cathodic and anodic polarisation and also unmounted specimens. Similar corrosion product was observed on all the specimens, ie a black layer was observed on the surface of the specimens underneath the green/brown corrosion product.

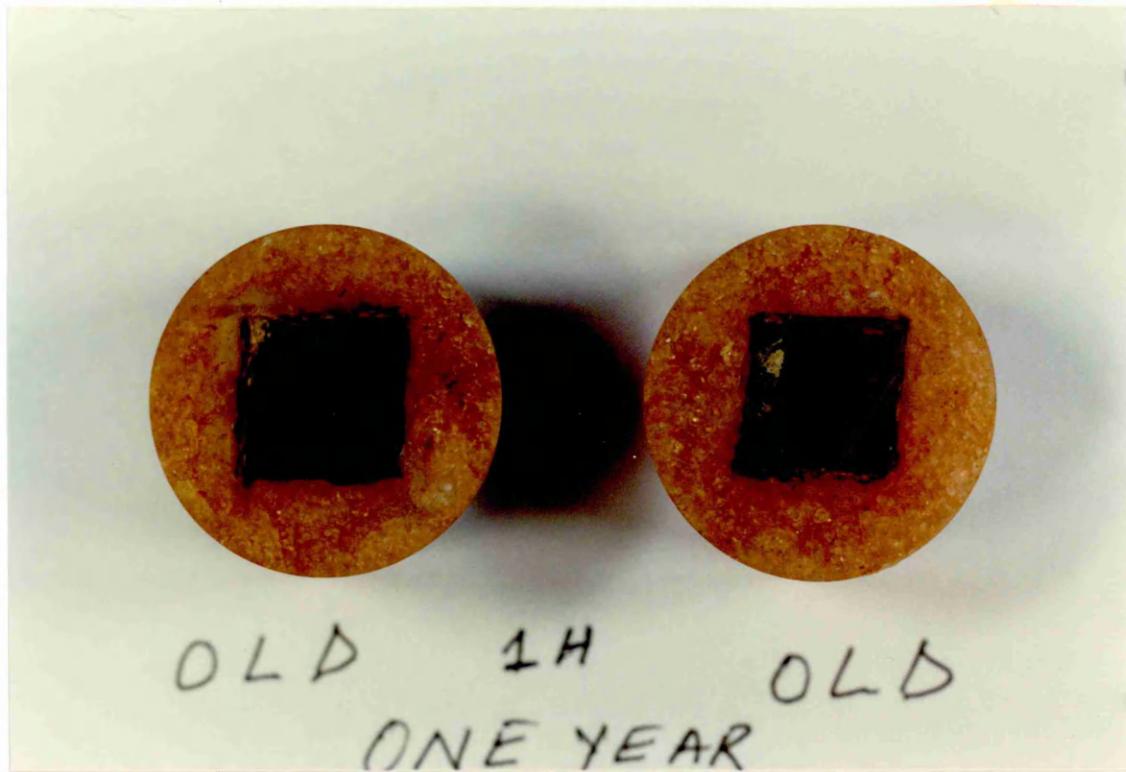
Photograph 1H shows the surface of old copper specimens after one year in H/W(60) Left anodic

The photographs in 1H-2H shows the copper specimens after one year of immersion in hot water at 60°C. The 1H shows old copper (B1) while the 2H represents the new copper (B3). The specimens given on the left represents the specimens subjected to anodic polarisation while the right side shows the specimens subjected to both cathodic and anodic polarisation.

Similar corrosion product was observed on these specimens in hot water at 60°C as were observed in normal hot water, i.e. a black layer was observed underneath the green/brown corrosion product. On two unmounted copper specimens (one of each grade) some small spots were observed which may be indicating the initiation of pits on these specimens.

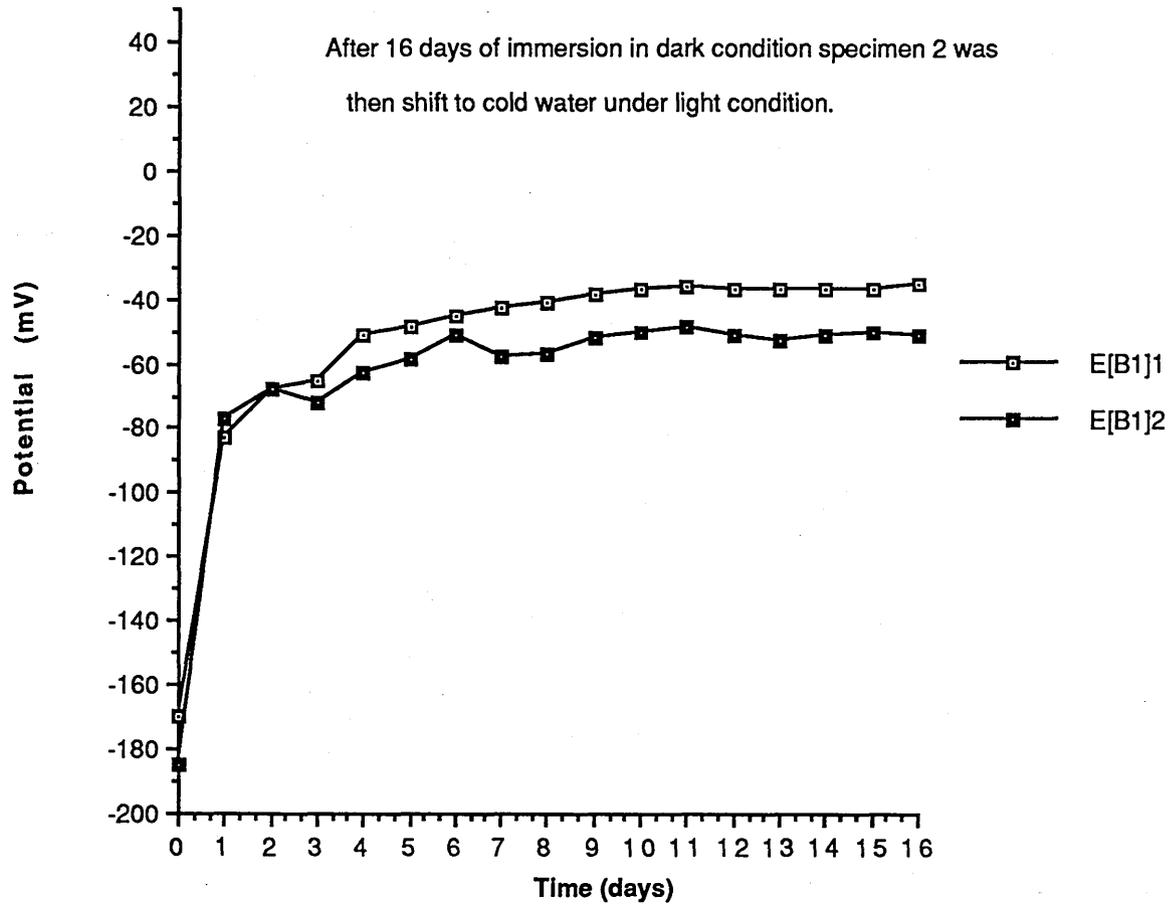
Figure 18

Trend in E_{corr} of two old copper specimens with respect to in dark condition.

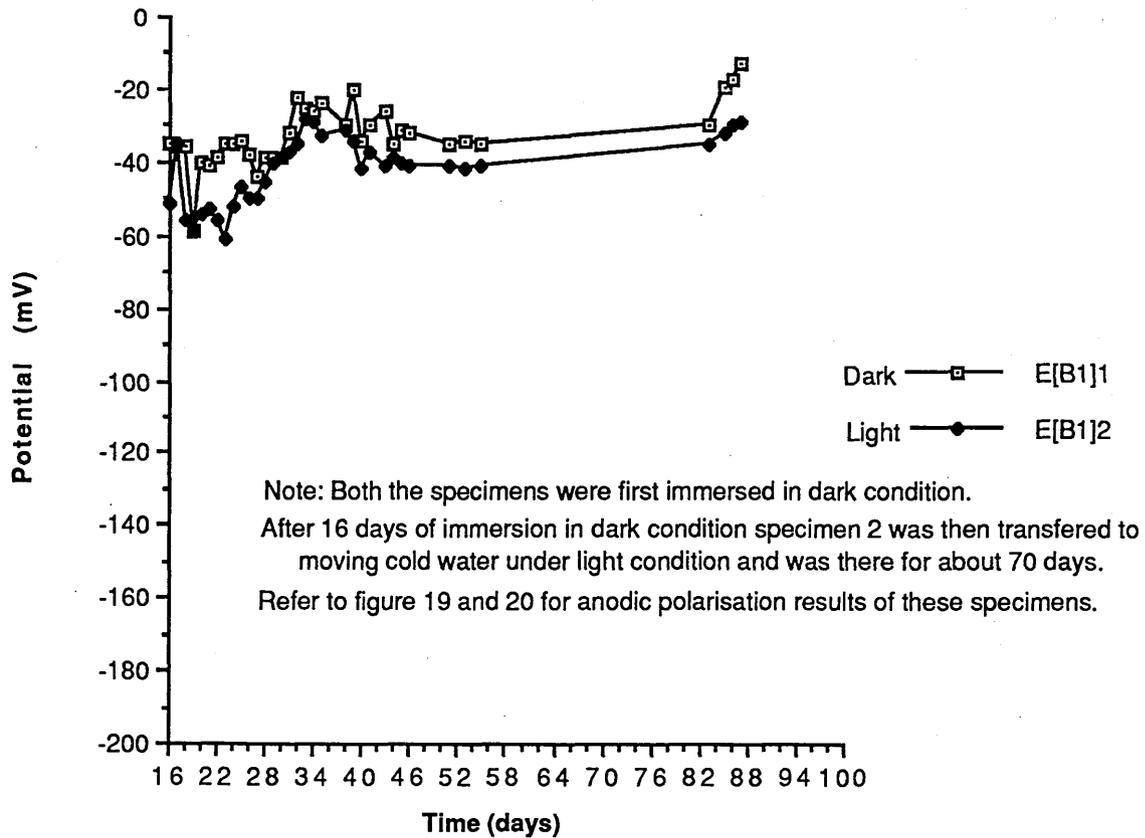
Figure 18a

Trend in E_{corr} old copper specimens under different conditions.

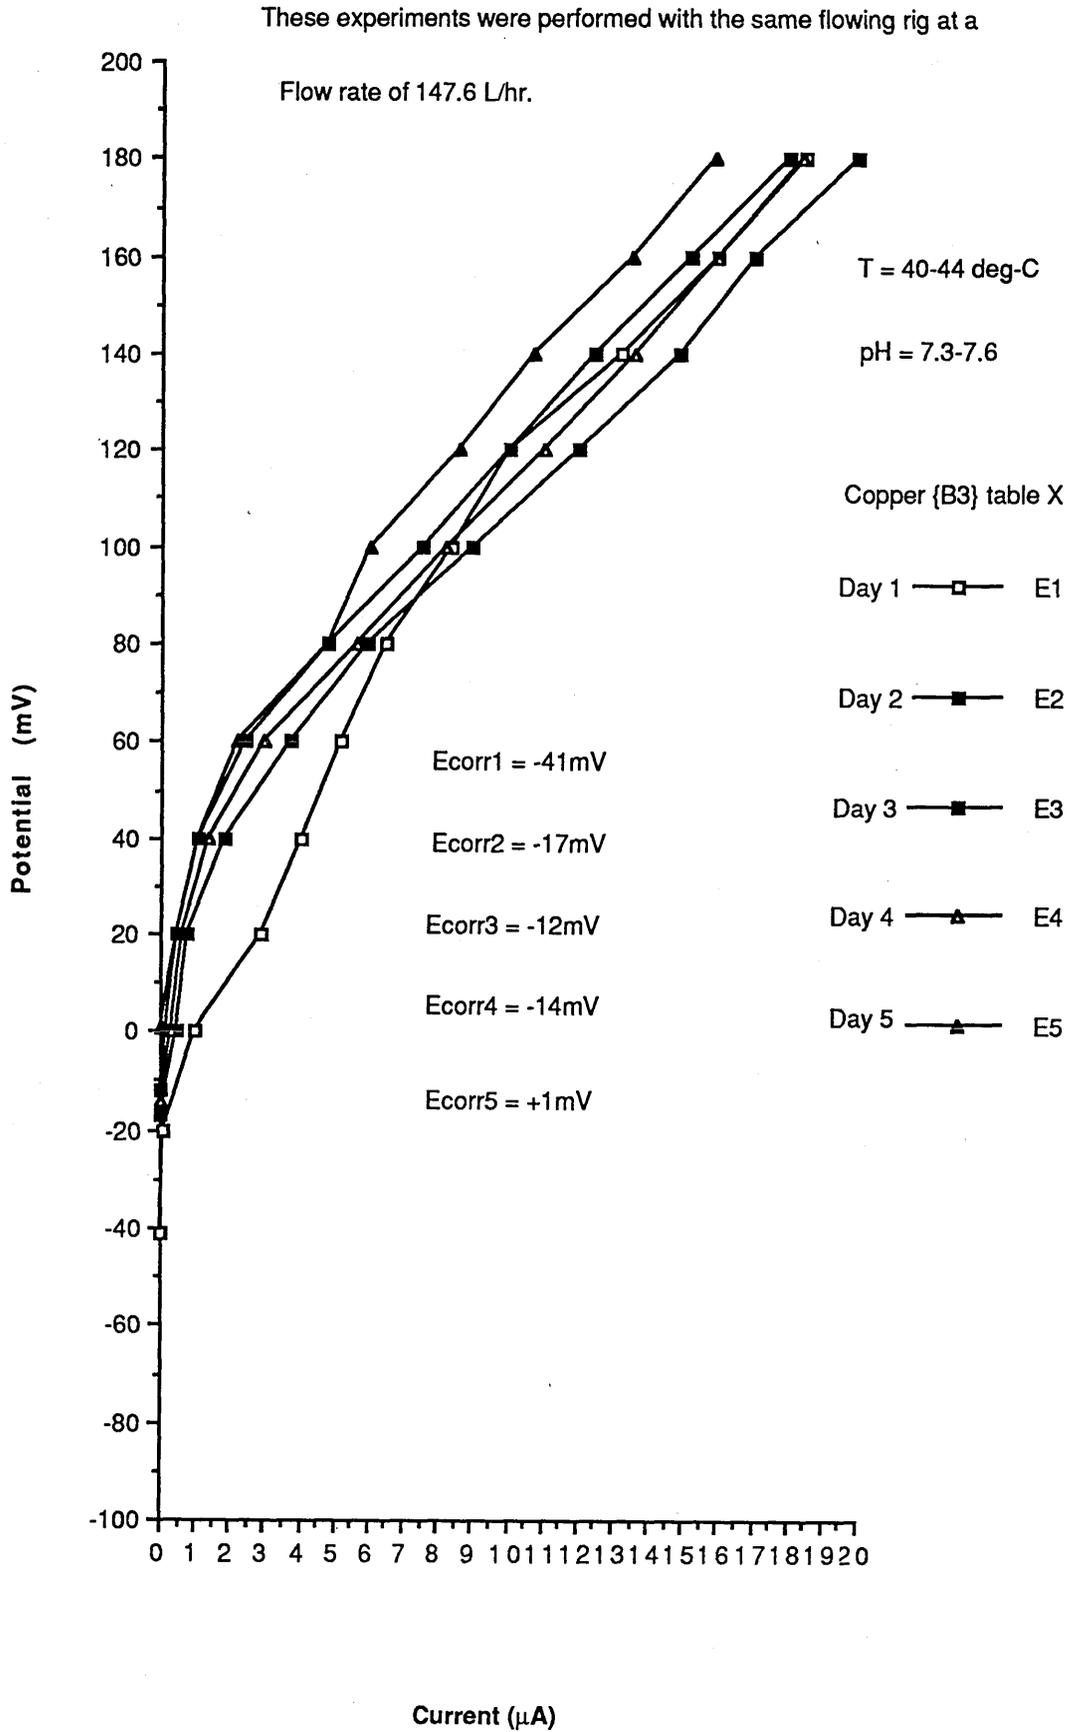
These experiments were carried out with the flowing rig at flow rate

of 147.6 L/hr for all the specimens except for specimen 1, because the flow rate of specimen 1 was 78 L/hr.

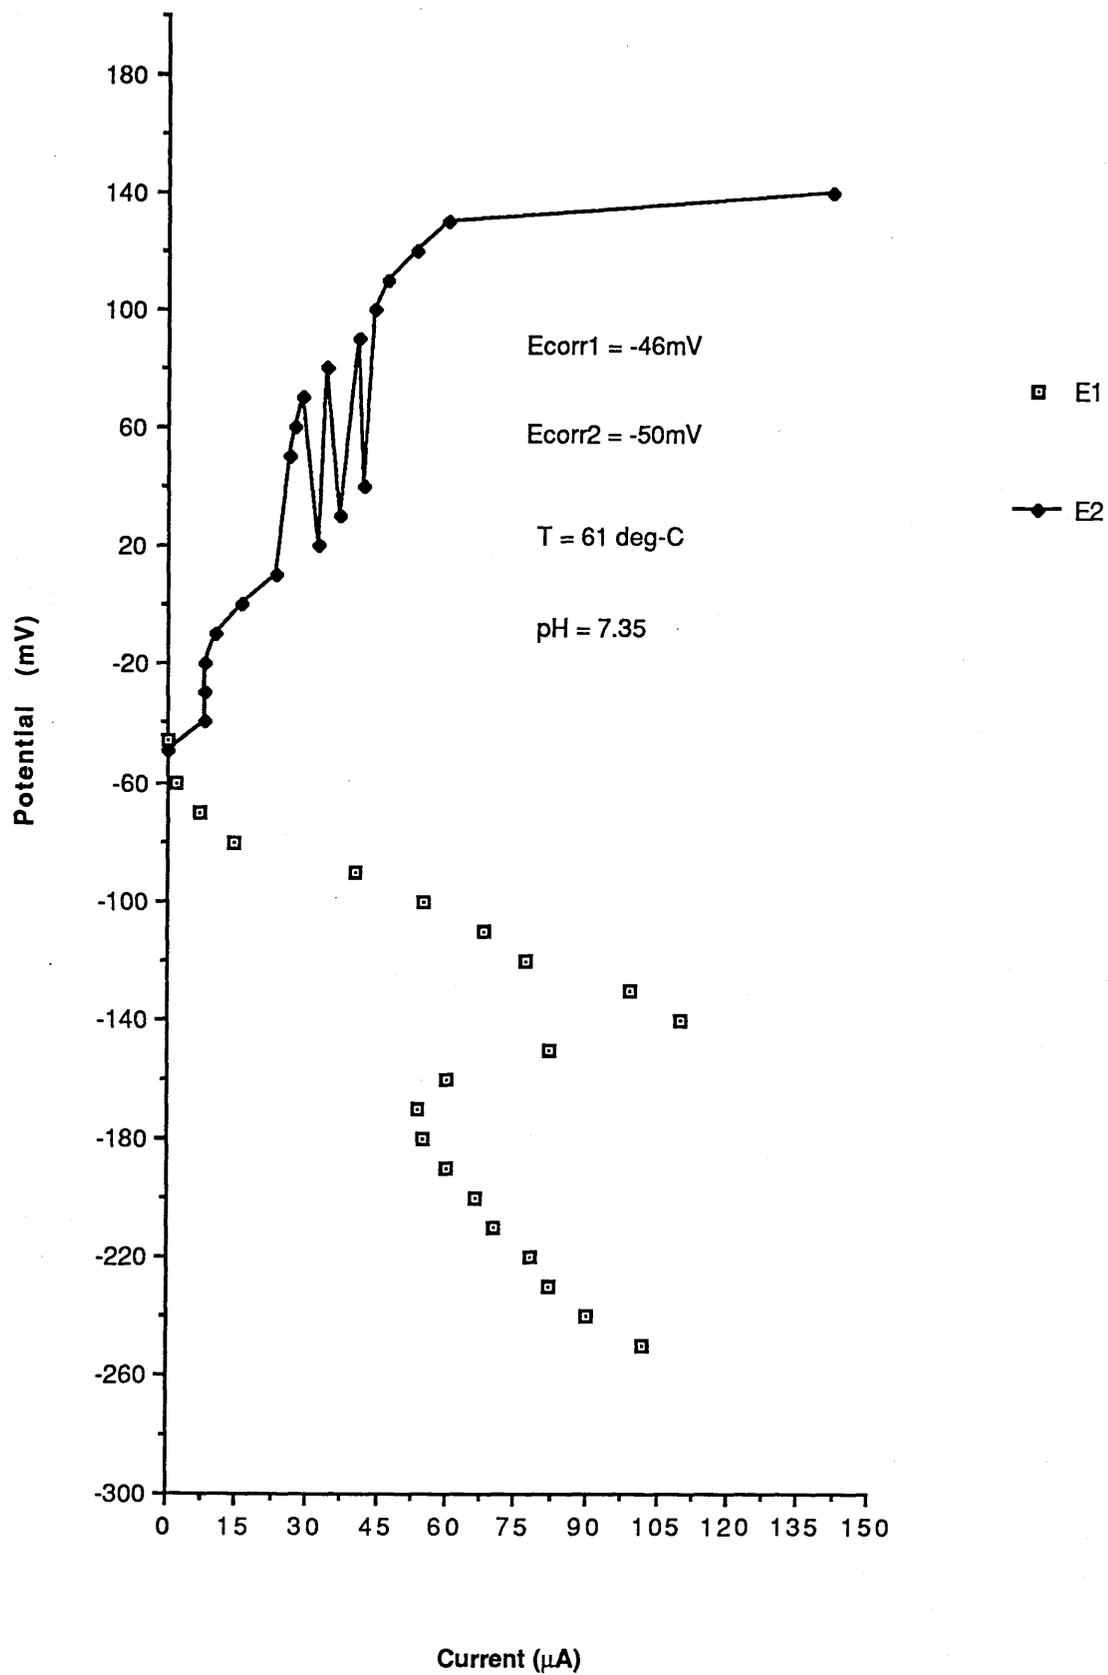
Cathodic scan followed by anodic scan of old copper specimen after immersion.

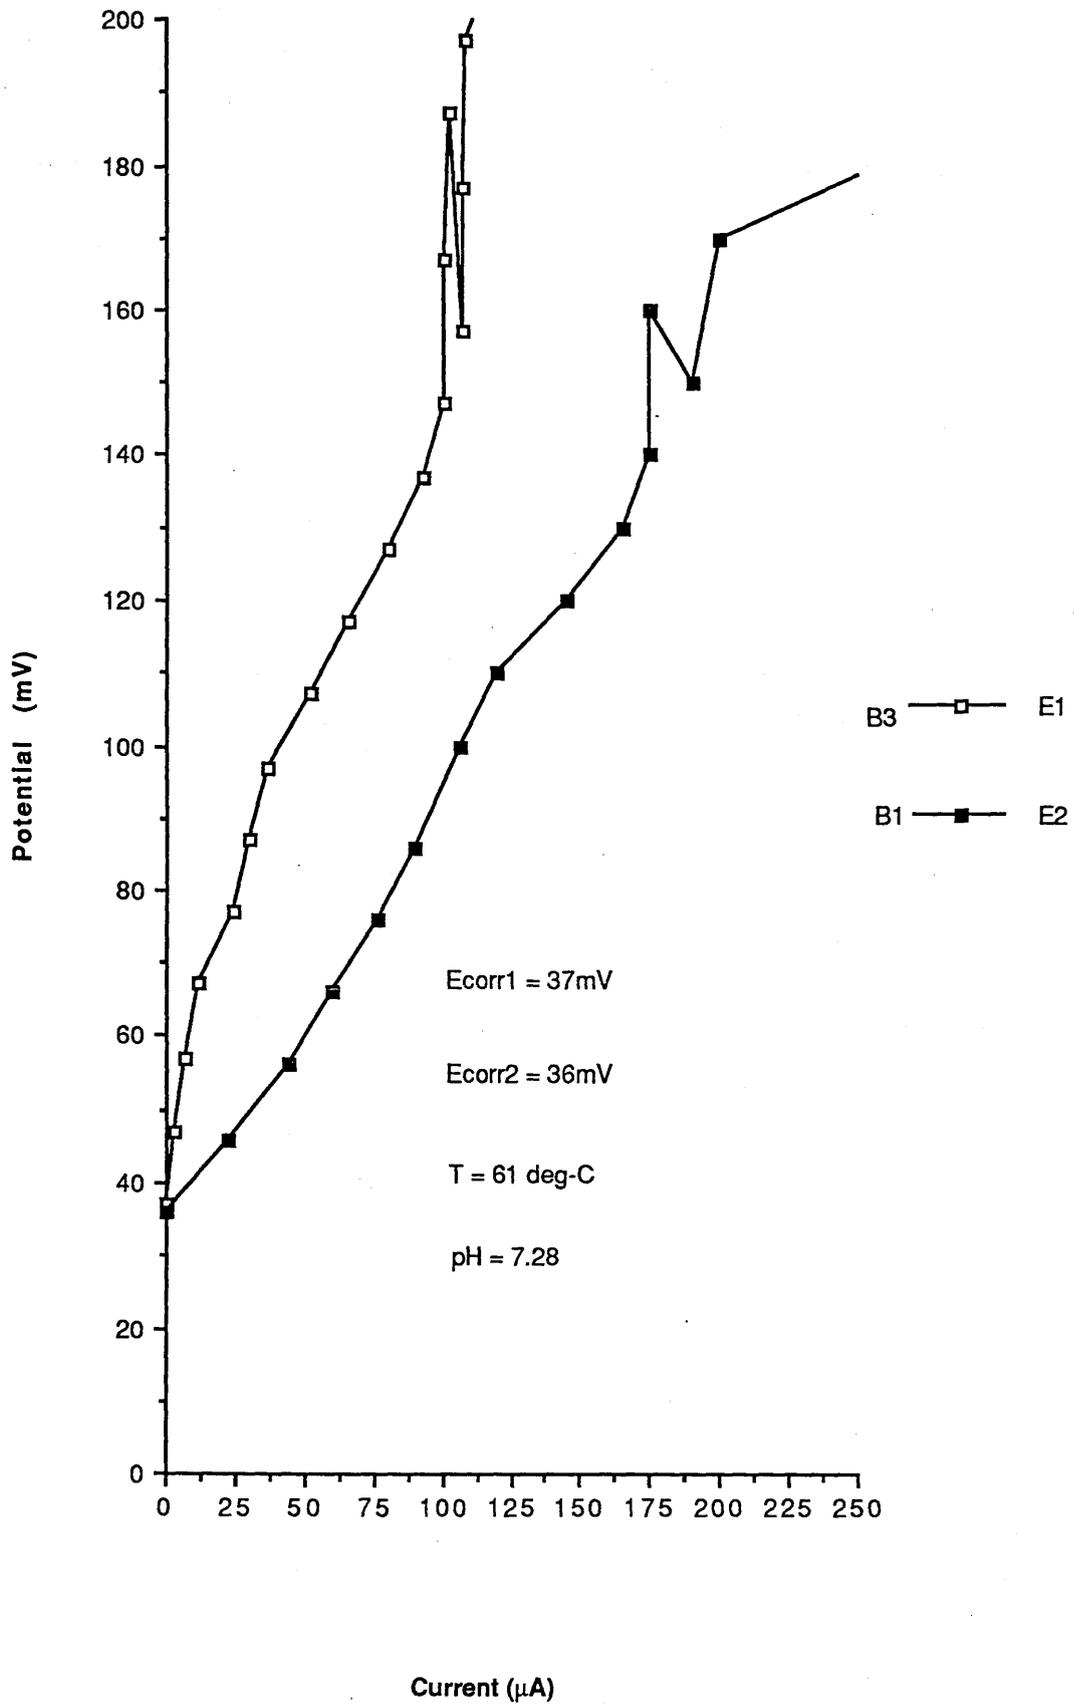
Anodic scan of both grades of copper specimens after five months of immersion without prior polarisation.

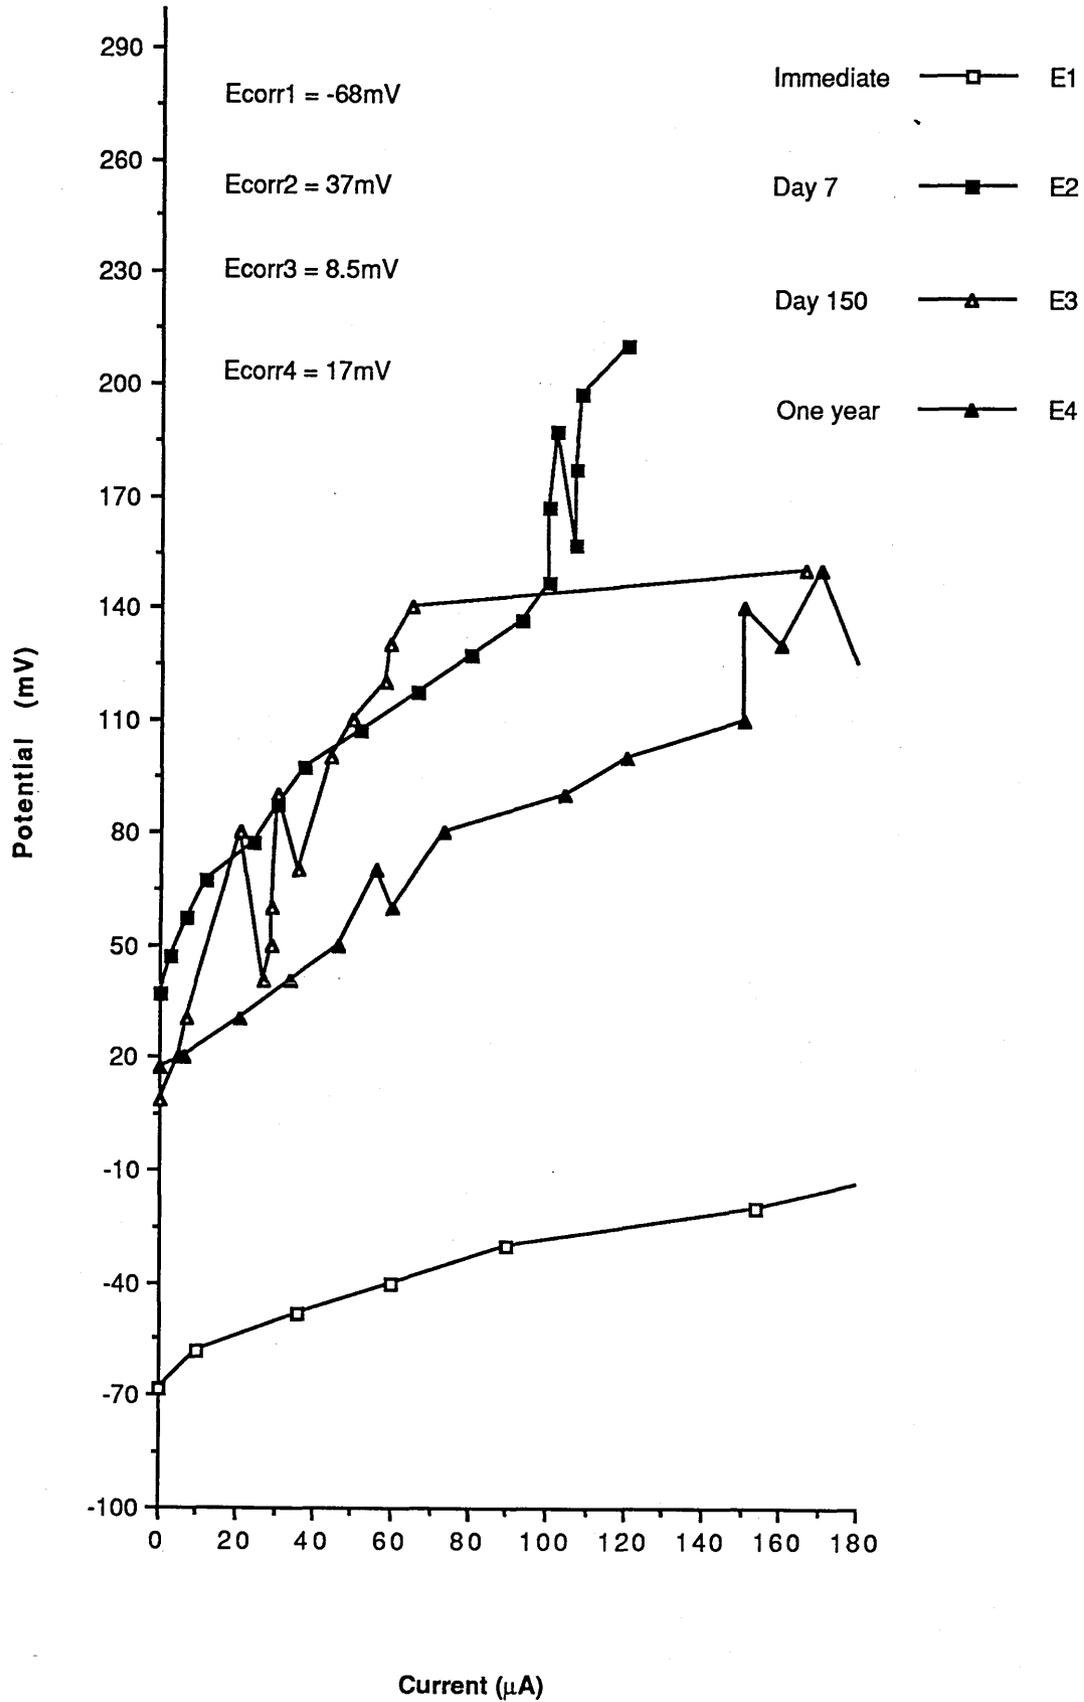
Performance of old copper [B1] with response to time.
