A STUDY FOR THE CONSERVATION OF THE
MEDINA OF CONSTANTINE WITH SPECIAL
REFERENCE TO THE SIDI AL-KETTANI
MADRASA.

Fatima Chergui
(State Architect)

THESIS SUBMITTED IN FULFILMENT OF THE DEGREE
OF MASTER IN CONSERVATION STUDIES AT THE
MACKINTOSH SCHOOL OF ARCHITECTURE

SEPTEMBER 1988

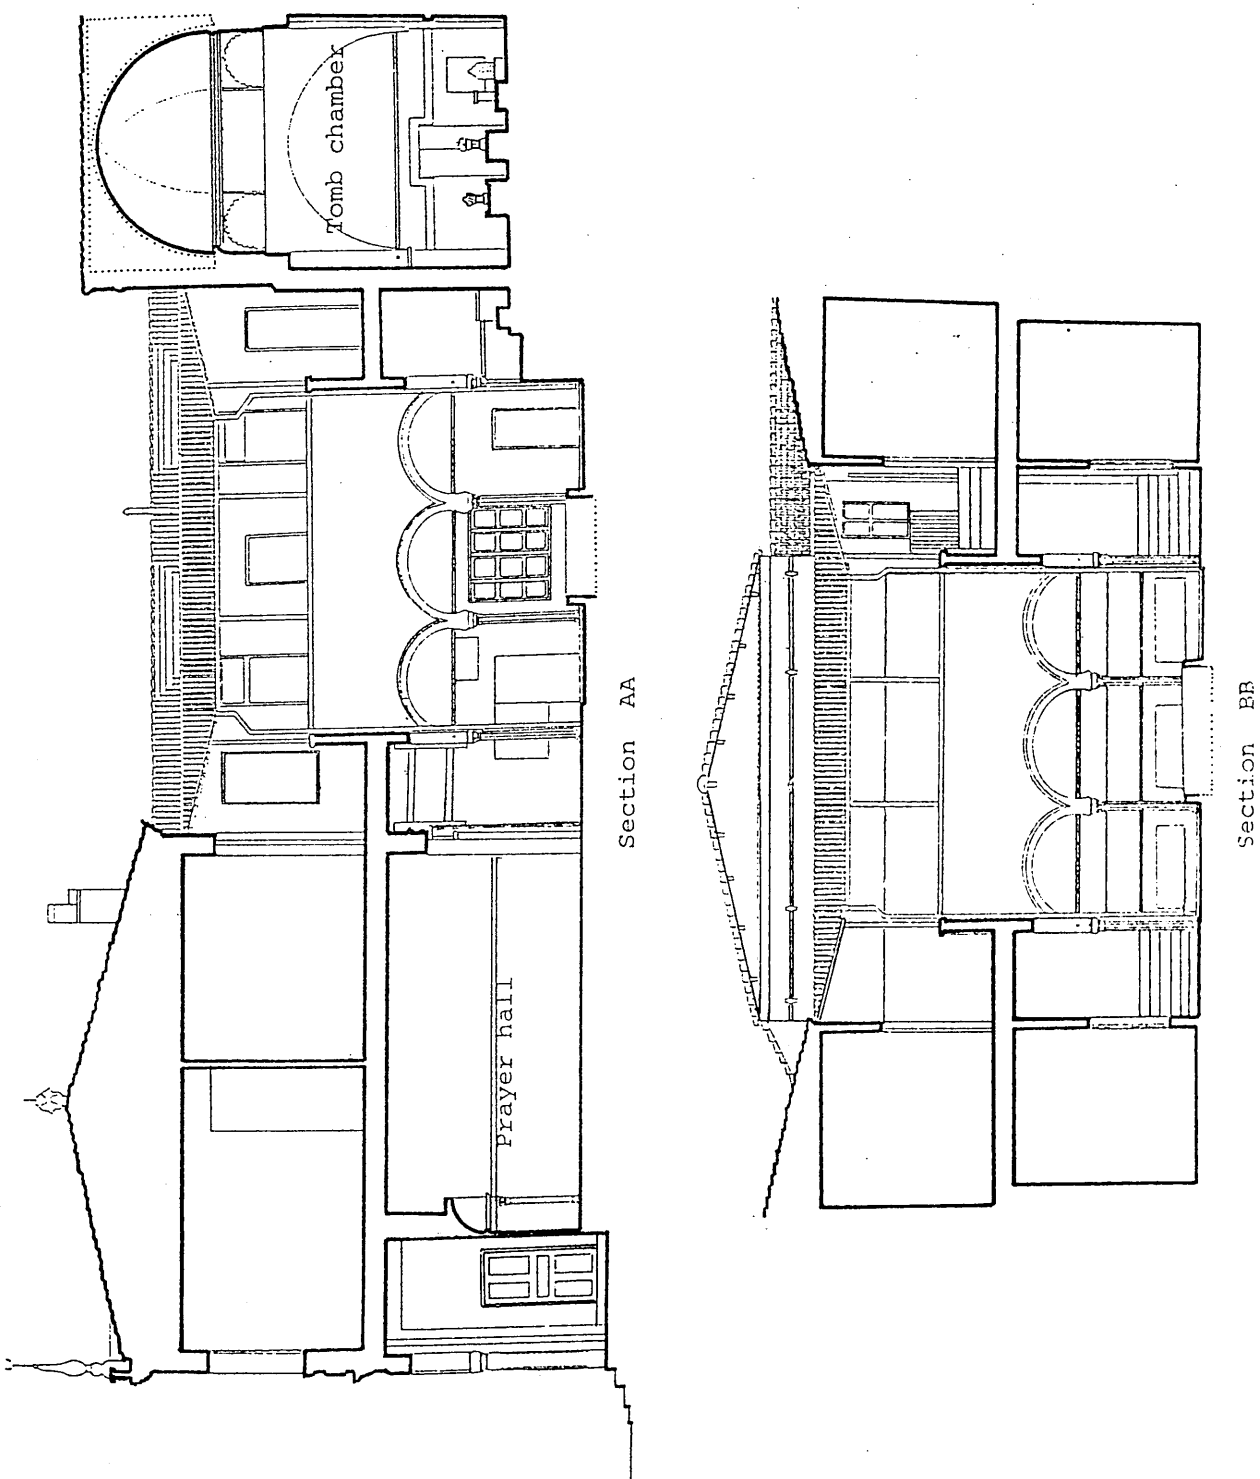
Scale 1:200

Figure I5 - Sidi al-Kettani madrasa sections.

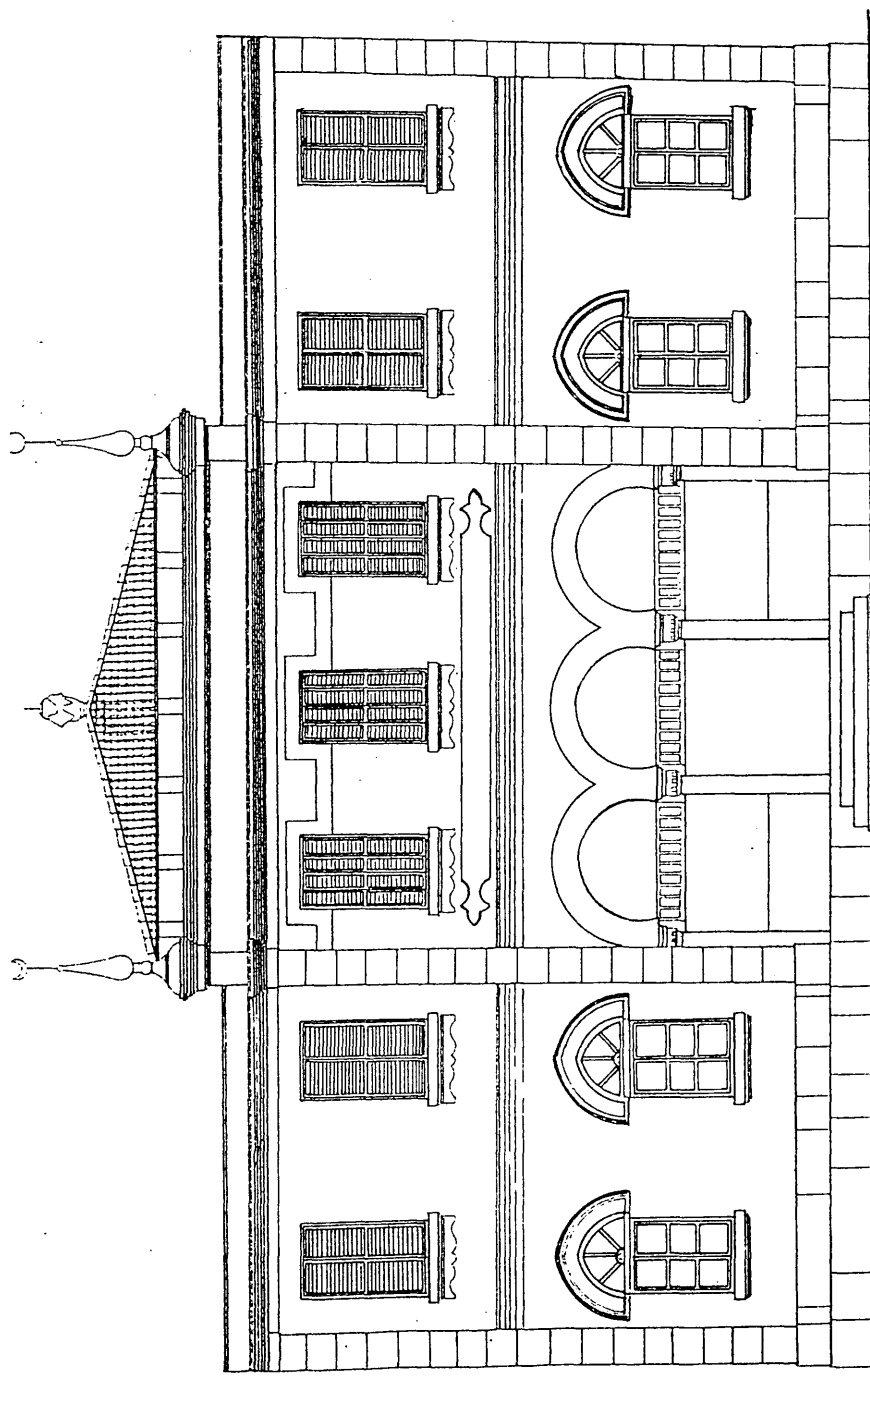
Scale 1:100

Figure I6 - Sidi al-Kettani madrasa
Elevation

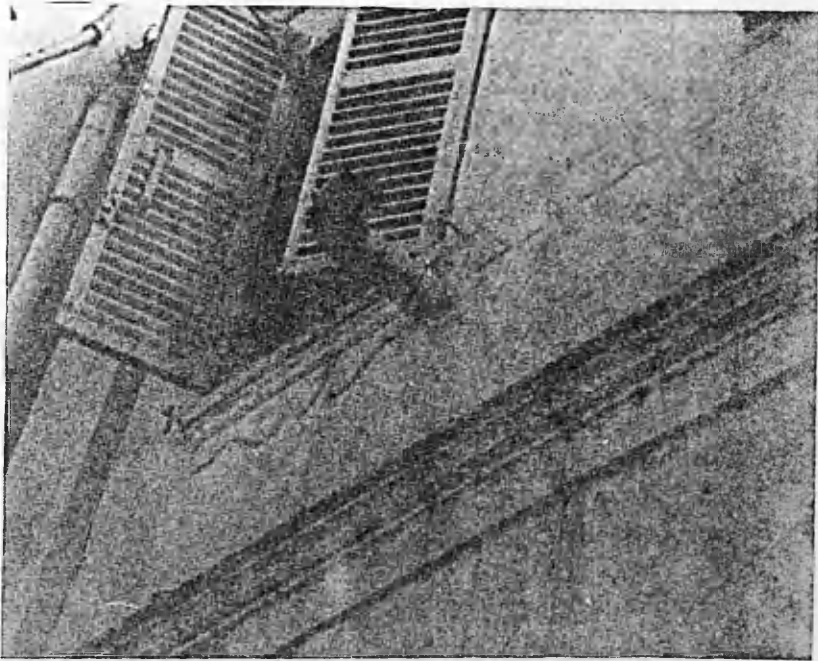
The stonework of the facade appears to be in sound condition. Only minor repairs are required. Fine cracks are apparent at the south end and mouldings under some window sills are lost because of damage caused by the insertion of metal flues for gas fires.

Plate 46b - Sidi al-Kettani madrasa facade:
metal flue pipe has caused some
damage to the moulding under some
window sills.

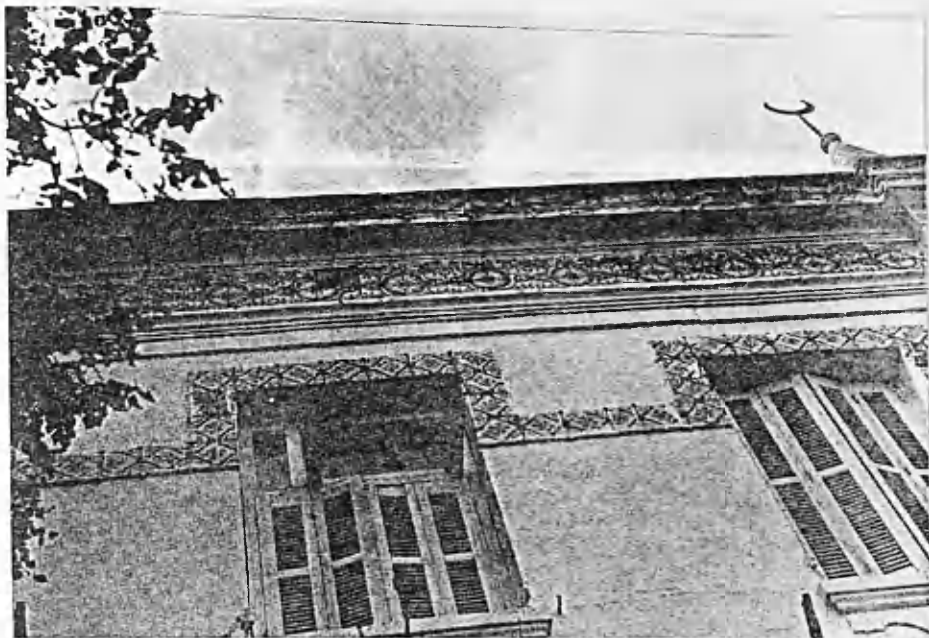
One window frame at the ground floor level is missing, and one at the first floor level is damaged. Tiles around the upper floor windows at either end of the facade are missing, as are finials at either end of the parapet.

Plate 46c - Missing tiles on the parapet wall.

Upper part of the window adapted to accommodate an air conditioning unit.

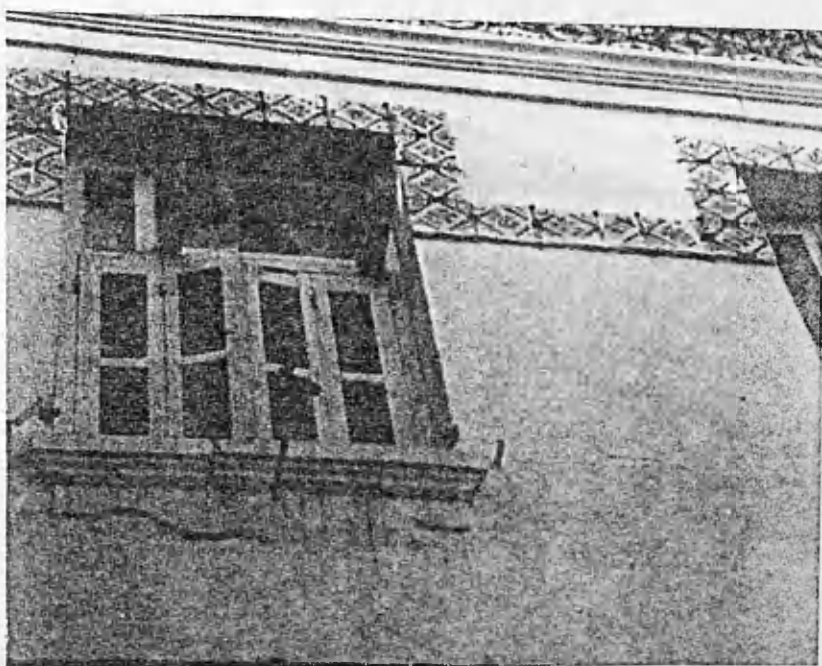
Plate 46d - Damaged moulding under window sill
badly repaired.

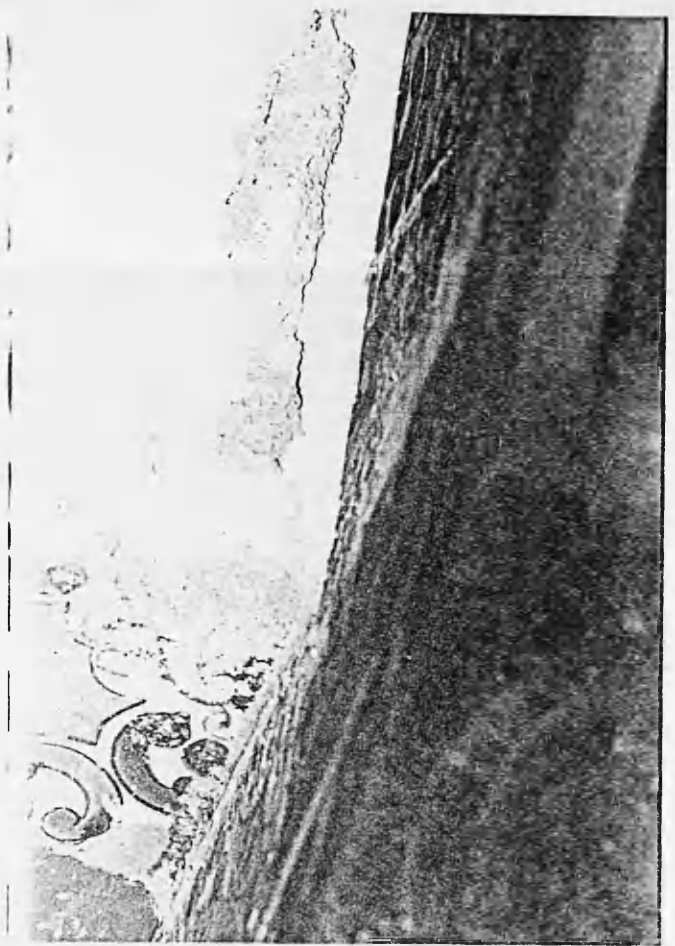
The Prayer hall is located between the two entrance corridors and is entered from the courtyard through a carved wooden door, similar to that of Room 1:1, surmounted by a panel of open mashrabiyya (plate 51a and fig 18 and fig 19). The prayer hall contains a mihrab with a fluted conch and tiled decoration in good condition (plate 52a,b) in its eastern wall. (A small hole pierced in its lower part to allow cleaning water to be drained from the hall into the vestibule has caused some damage to the adjoining tiles). A tiled dado, 1.55m high, runs around all four walls (plate 53b). The west wall has six tiles missing and their place filled with plaster and pieces of broken tiles, some of which are completely unlike any others found in the madrasa. Tiles on the south and east walls are loose and in danger of falling (see plate 46). The hall is lit by four windows, two with low sills in the east wall and two with high sills in the west wall. The north-east window sill has one tile missing and shows signs of water penetration with consequent damage to the tiles, which are delaminating under the action of chemical efflorescence (plate 55a,55b and 55c). Traces of a rectangular hole are visible

Plate 55 a - Prayer hall: damage to the plaster and tiles caused by rising damp.

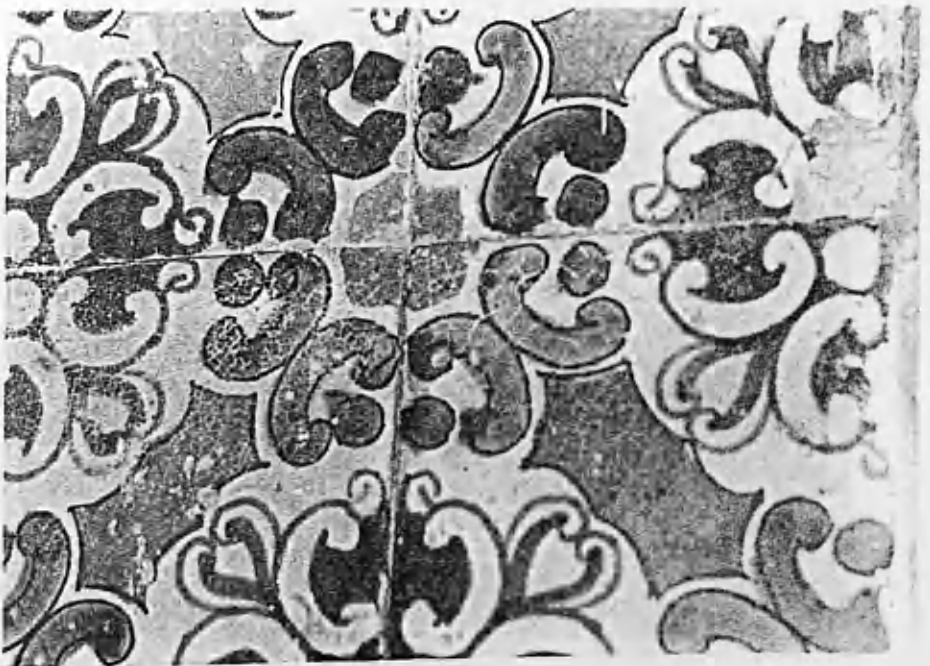
Plate 55 b - Prayer hall: chemical efflorescence is evident on the surface of the tiles.

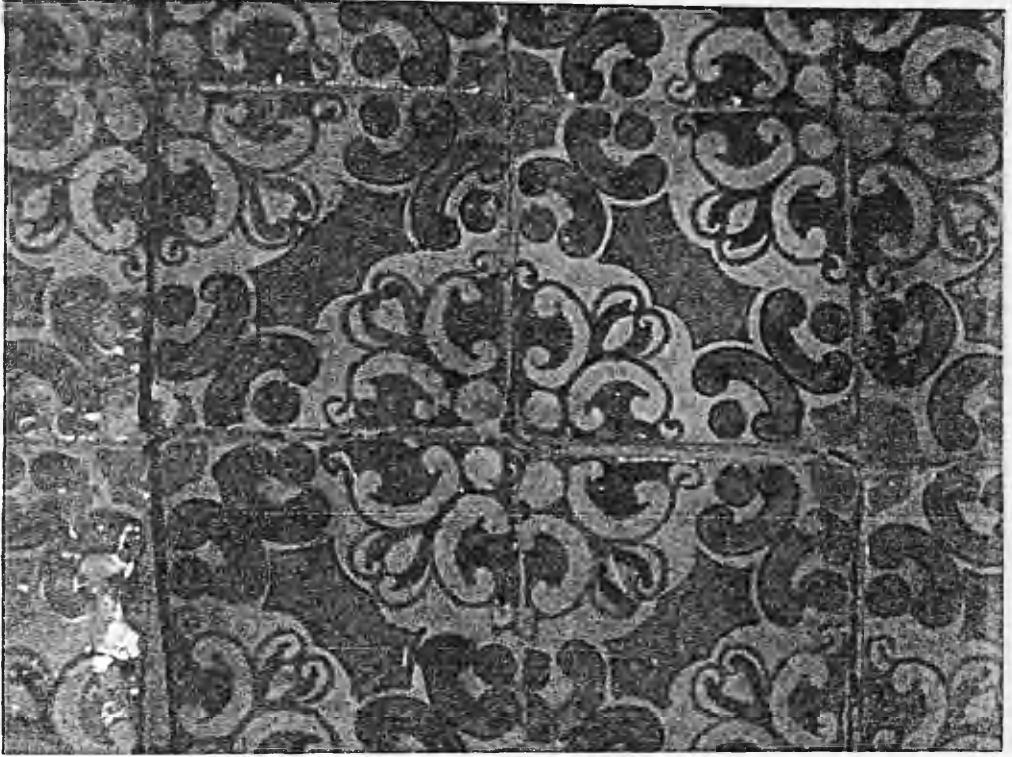
Plate 55 c - Prayer hall: tiles are loose and detached from the wall.

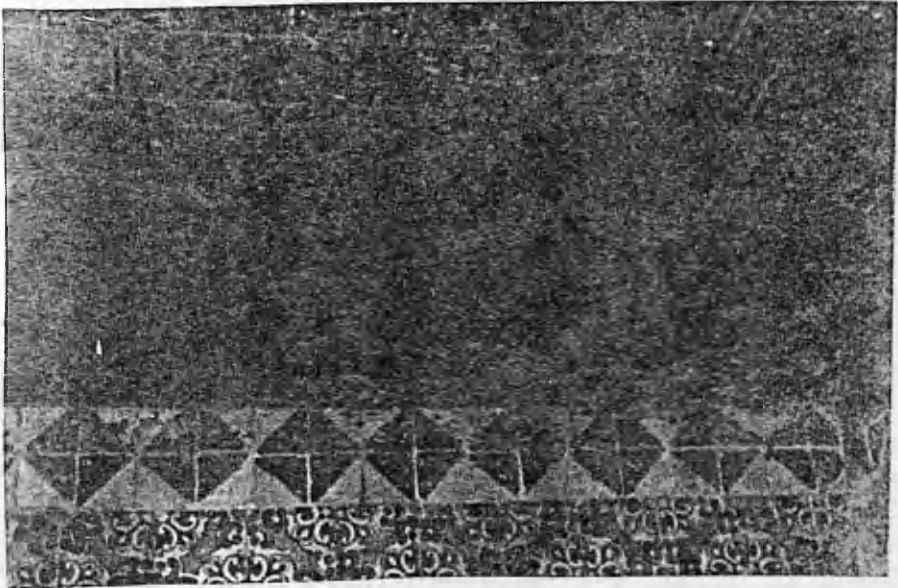
immediately inside the entrance door. This hole was dug recently, presumably during the conversion of the madrasa into a Hygiene laboratory. The floor is covered with red tiles in very bad condition, mostly broken into small pieces (plate 55d).

Plate 55d - Prayer hall: floor cladding is in poor condition.

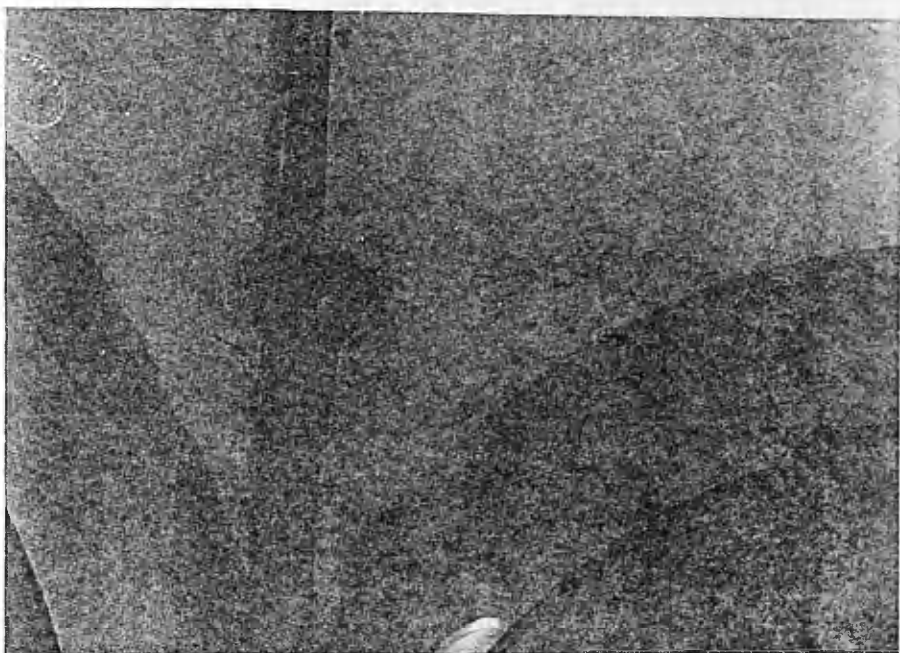
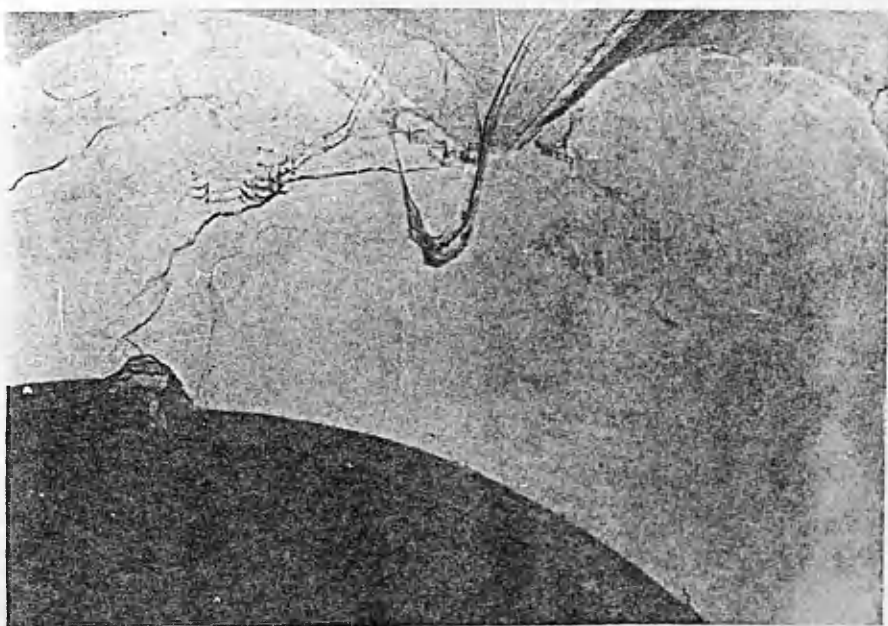
The courtyard. Nearly square in plan, the courtyard is surrounded by an arcaded portico (plate 50a, 50b and fig 13a). The floor of the west portico is raised and protected by a tiled balustrade set between four marble columns (see plate 49a). The wall forming the lower part of the balustrade seems to be original for it incorporates the same marble slabs and polychrome tiles found in the madrasa. The screen of pierced concrete blocks forming the upper part of the balustrade appears to be a recent addition; an old print (plate 59a) shows a wooden balustrade. The southern arch of this west portico has a crack 2cm wide at the crown, which extends diagonally across the wall above (plate 56a).

Plate 56a -Courtyard:crack at the crown of
the southern arch of the west portico.

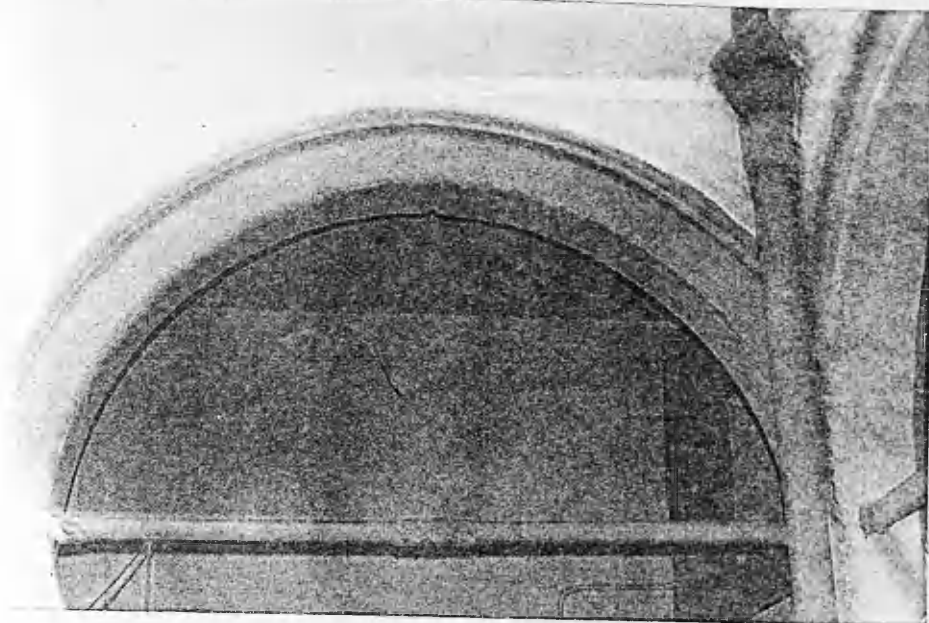
The absence of supporting arches in the four corners of the portico (visible in the old print, but presumably removed during the French restoration) has caused cracks to appear in the four corners. Two wooden frames have been erected to support the south-east and south-west corners, but one of these (south-east) is distorted, indicating continuing movement in the structure.

Plate 56b - Courtyard:the south-east wooden frame
in the background.

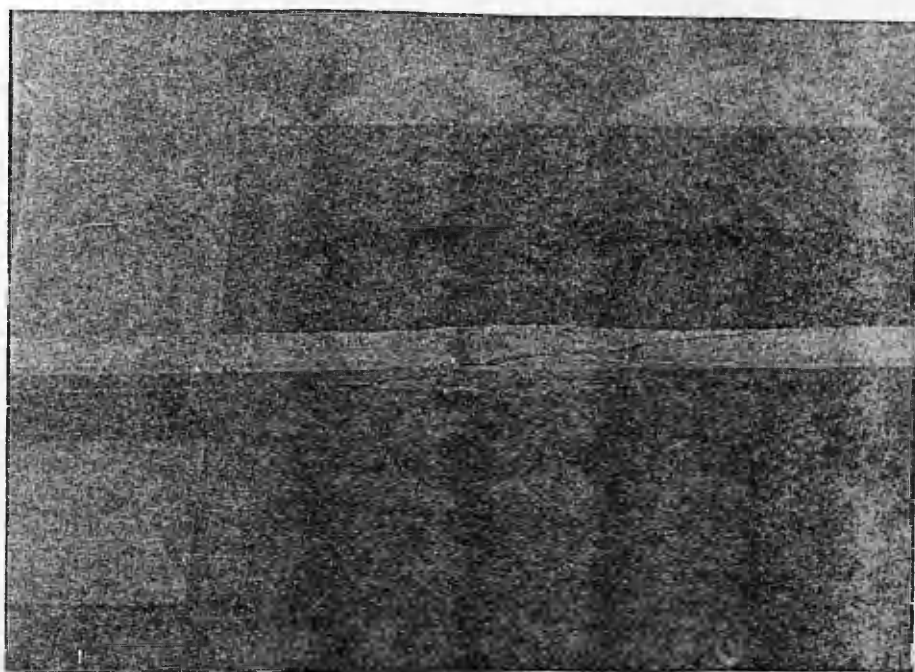
Plate 56 c - Courtyard:wooden tie beam cracked
in the middle.

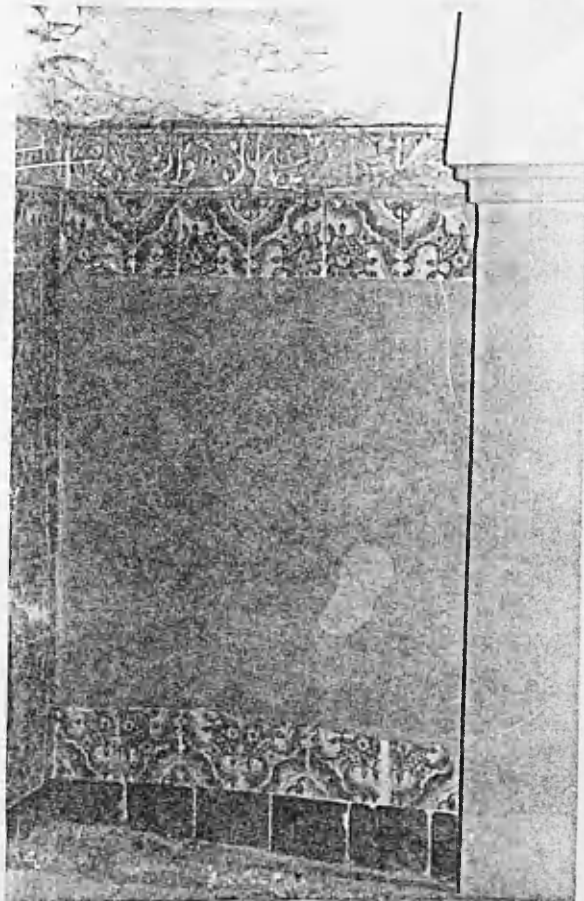
Plate 59f - Tomb chamber:areas of missing tiles
have been plastered.

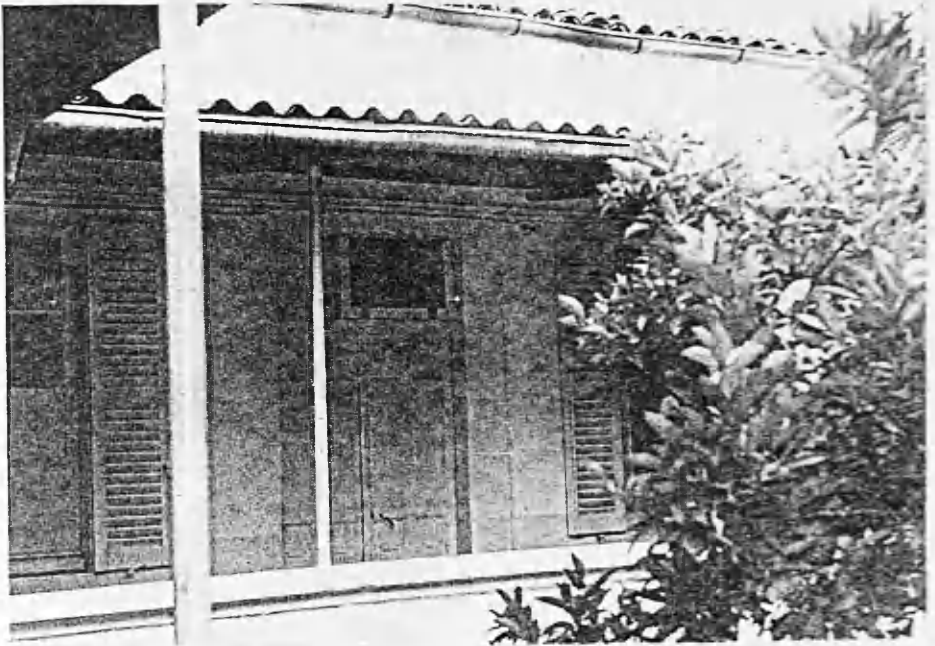
Plate 60a - Upper floor gallery: the upper part of the door (room 2:3) has been adapted to accommodate an air conditioning unit.

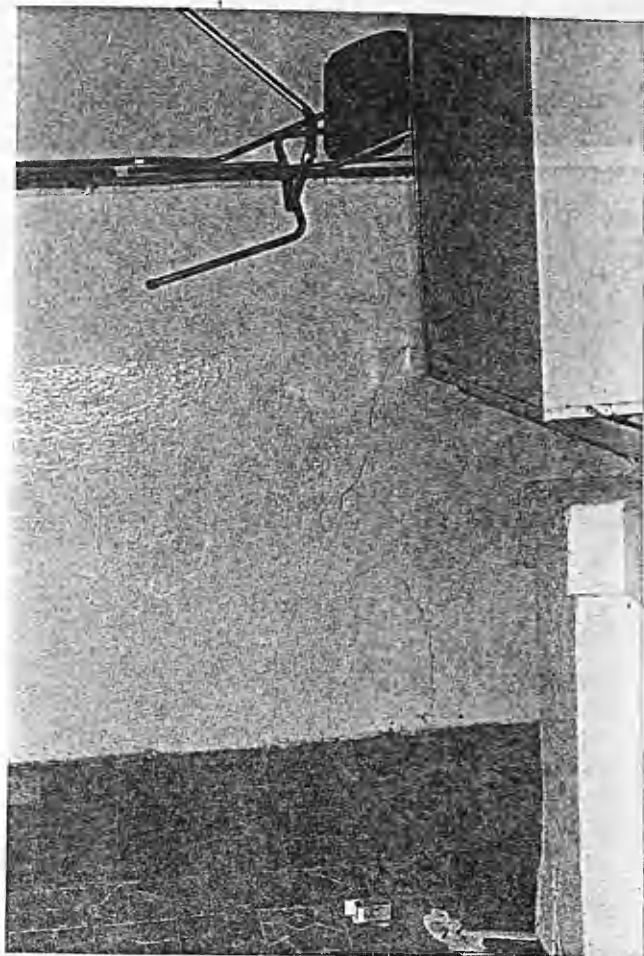
Plate 60c - Upper gallery;
cracks are evident
on the tomb chambe
and on the floor,
caused by the
heavy water tank.

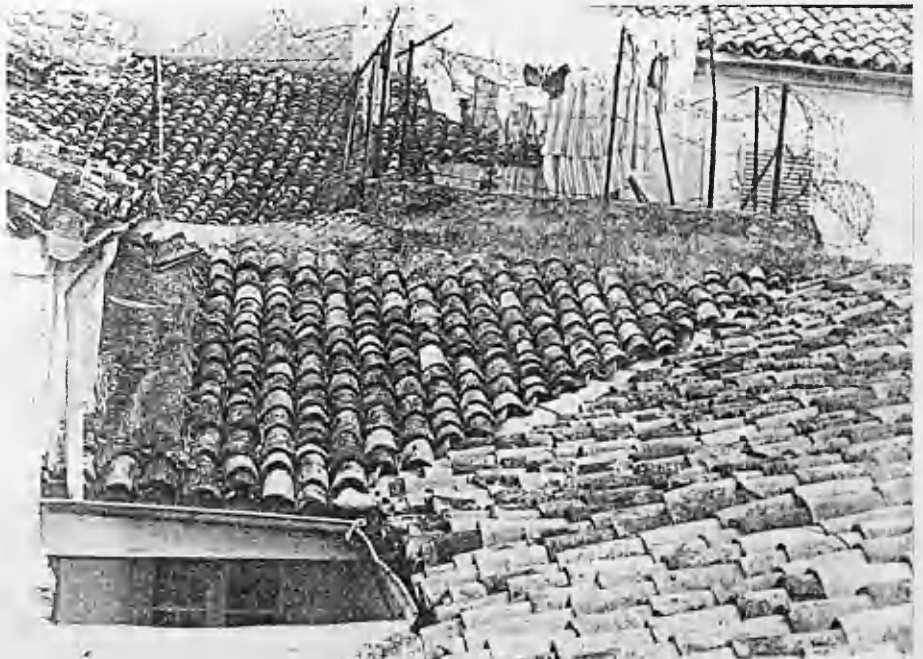
Plate 6Ib - Zin gutters are in poor condition.

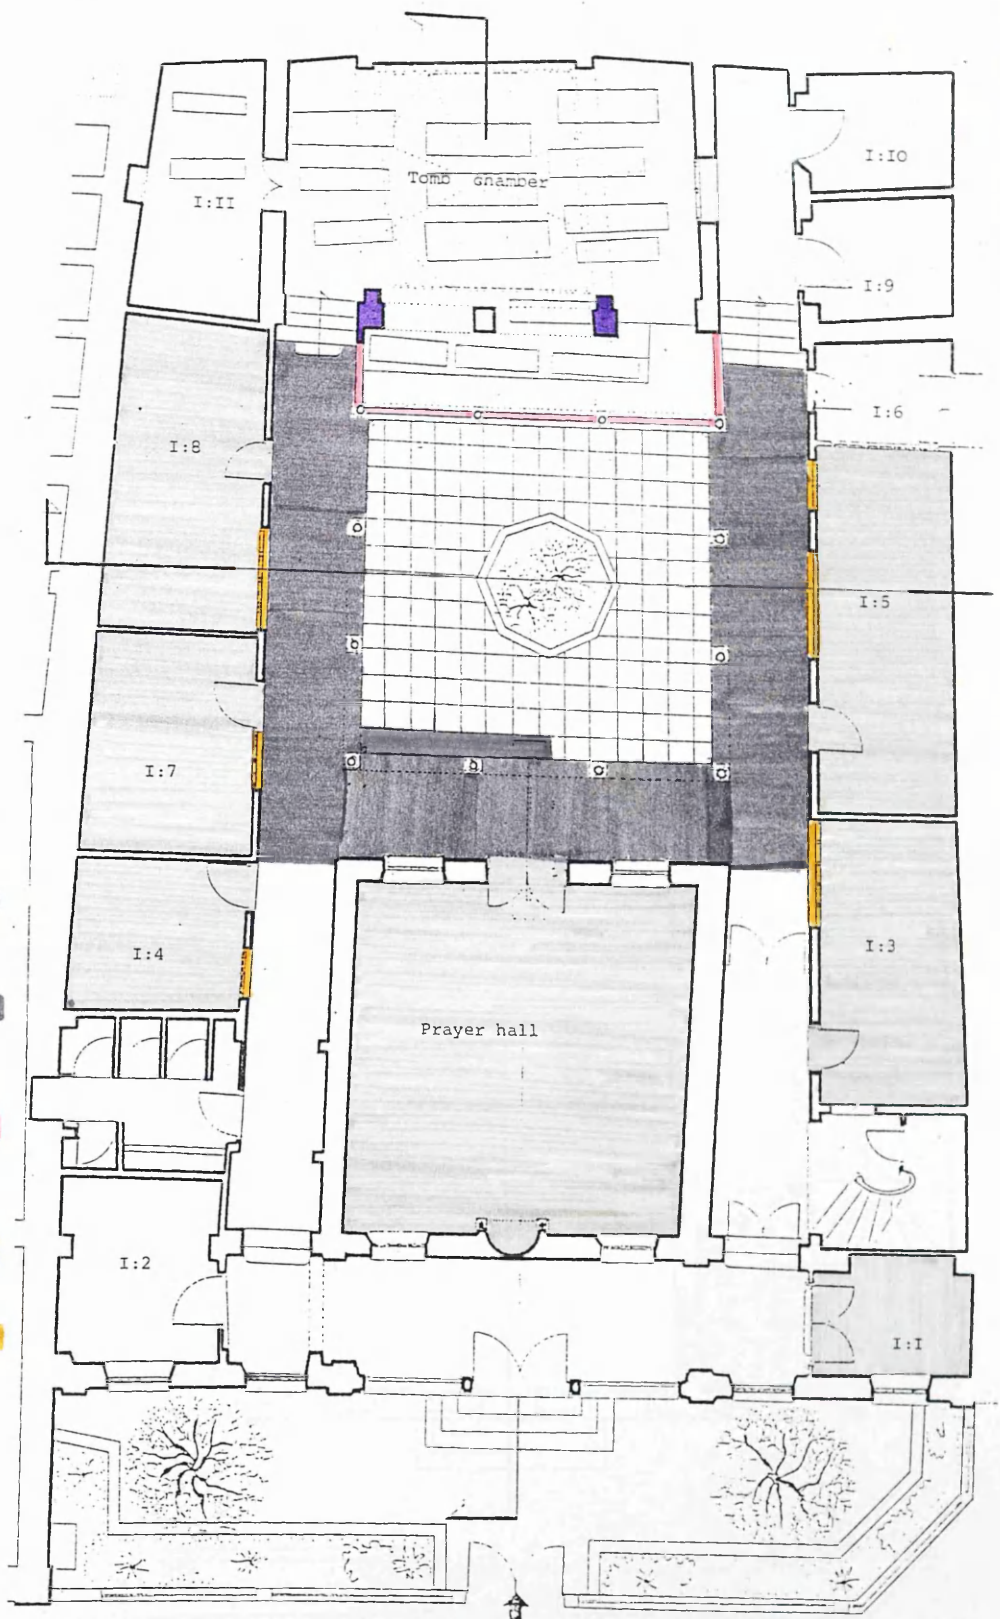
Figure 19a

GROUND FLOOR PLAN
SHOWING CONDITION
AND REPAIRS.

Concrete coating to be
removed.

New wooden windows to
be fitted (see fig 22).

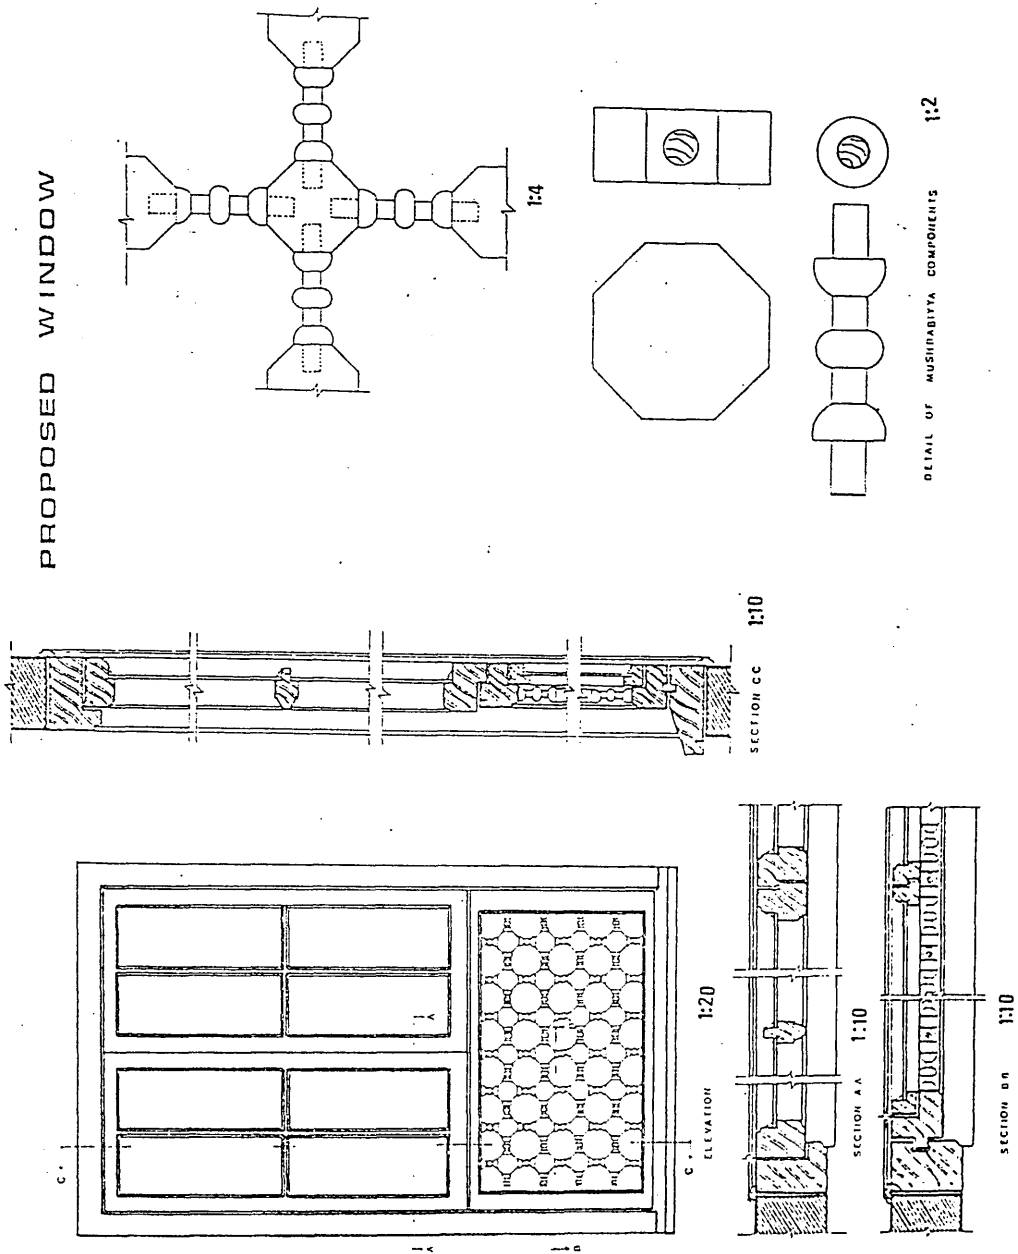
Figure 22 -Proposed window.
