THE PALACE OF SALAH BEY IN THE MEDINĀ OF CONSTANTINE
CONSERVATION AND RESTORATION

LAKHDAR, GHARBI
(State Architect)

THESIS SUBMITTED IN FULFILMENT OF
THE DEGREE OF MASTER IN CONSERVATION STUDIES
AT THE MACKINTOSH SCHOOL OF ARCHITECTURE

SEPTEMBER 1988

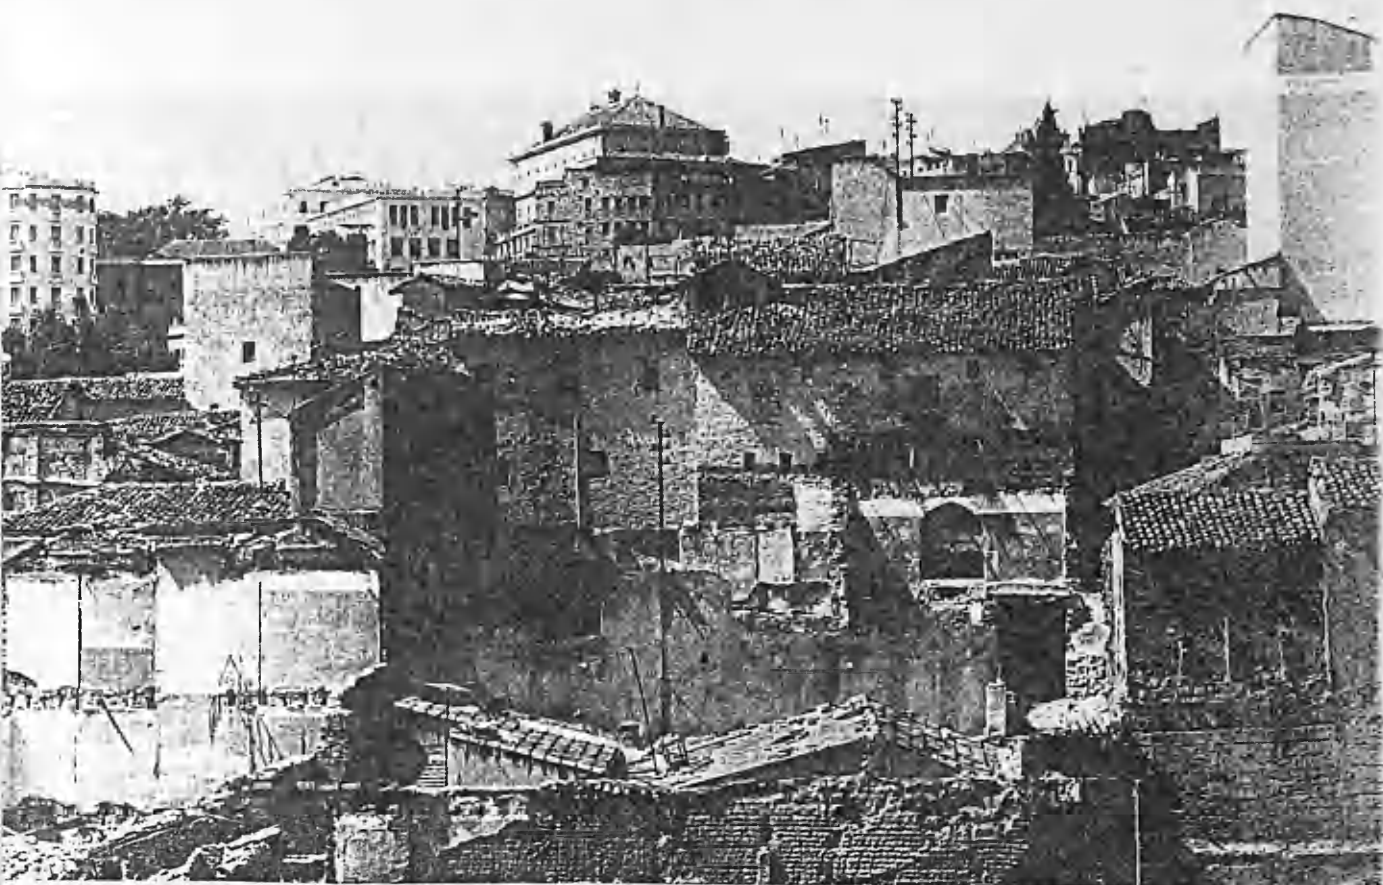
Plate 4- view of part
of the medina
showing the
degradation
of the dwellings.

continuous degradation of these dwellings (pl 4), the medina still contains some houses that are of historical and architectural value and worthy of saving and conserving rather than being allowed to fall into ruin.

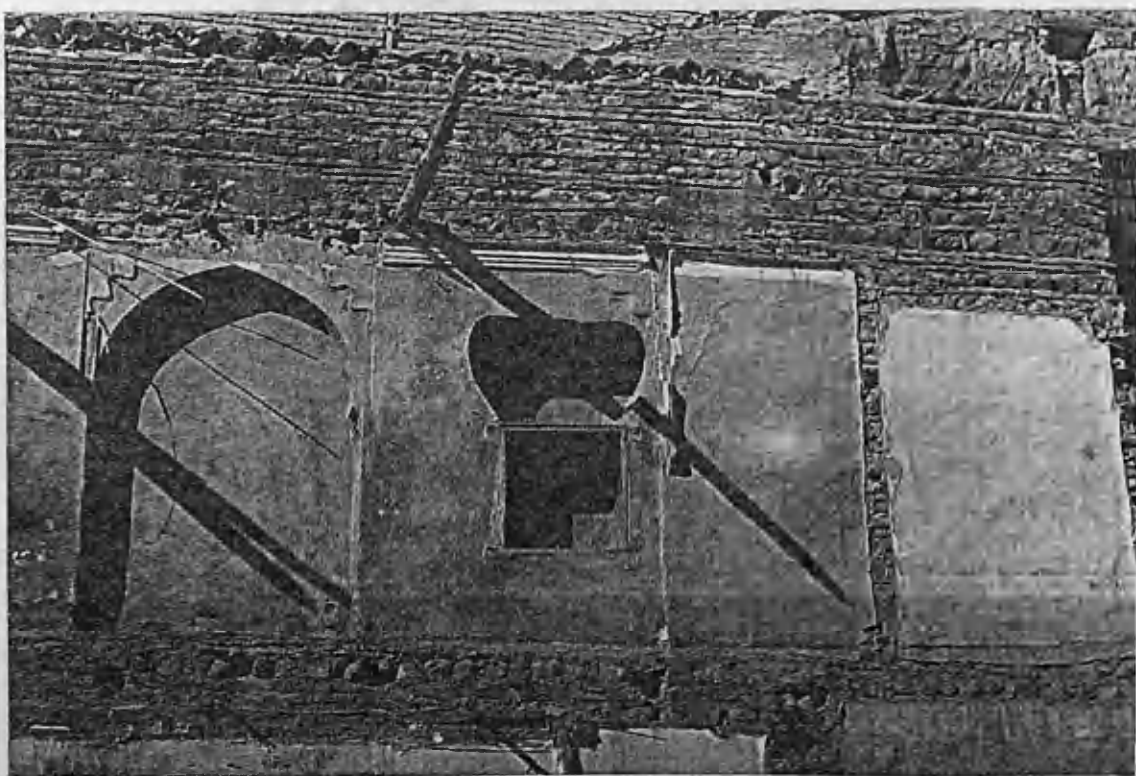
Plate 13 - Polychrome tiles decorating the courtyard galleries
their irregularity is among their most endearing and
characteristic aspects.

For the most part we find that walls, from the foundations up to a height of two metres, are constructed of dressed stone, above which are one, two or three courses of baked bricks alternating with courses of field stones up to the eaves (see pl 12). In general, the principal supporting walls inside the buildings are of the same materials as the external walls at the same level. The thickness of both walls at ground floor level may reach 0.4 metres for one storey houses and frequently exceeds 0.7 metres for two or three story houses. The internal walls are always rendered with plaster or mortar and whitewashed. In rich houses the internal walls, including those of the courtyard, are usually lined with polychrome glazed tiles to a height of about 1.5m (pl 13).

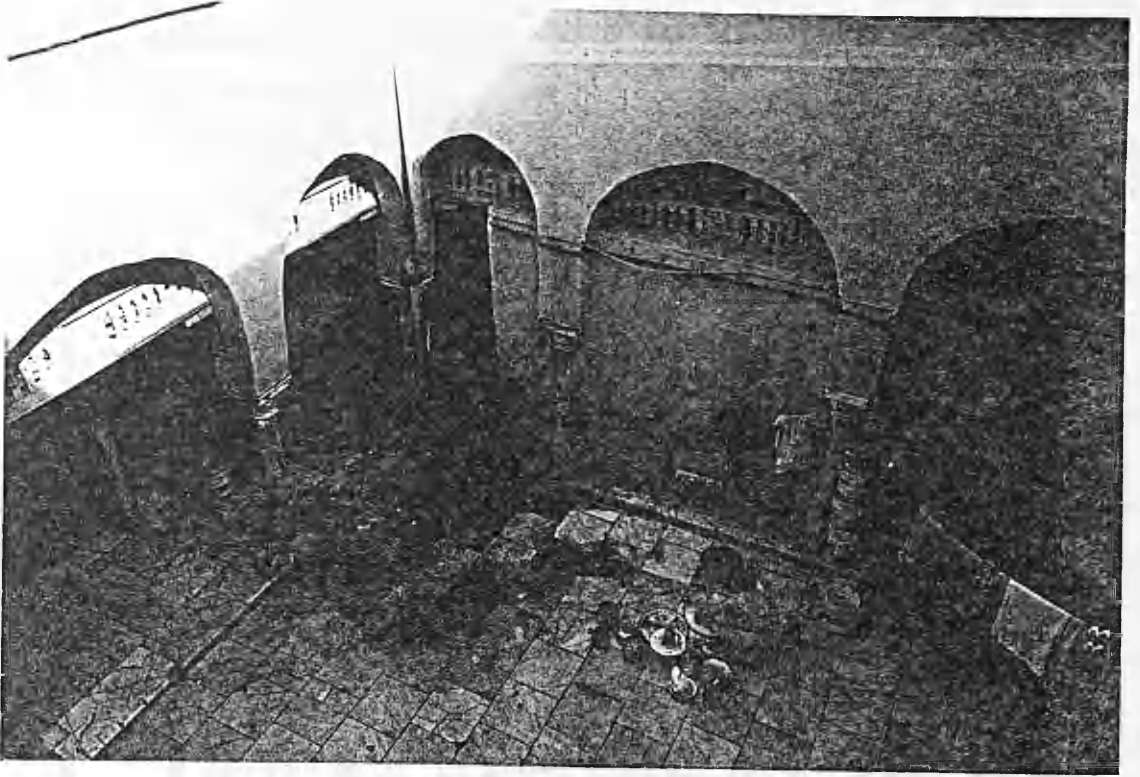
View of the courtyard: Note missing marble slabs and blocked arcades.

Missing floor slabs at the north and west side and in the south-west corner of the courtyard to be replaced. Any damaged slabs to be removed, repaired, or if necessary replaced by new slabs to match the existing. Defective paving joints to be repointed with lime mortar.

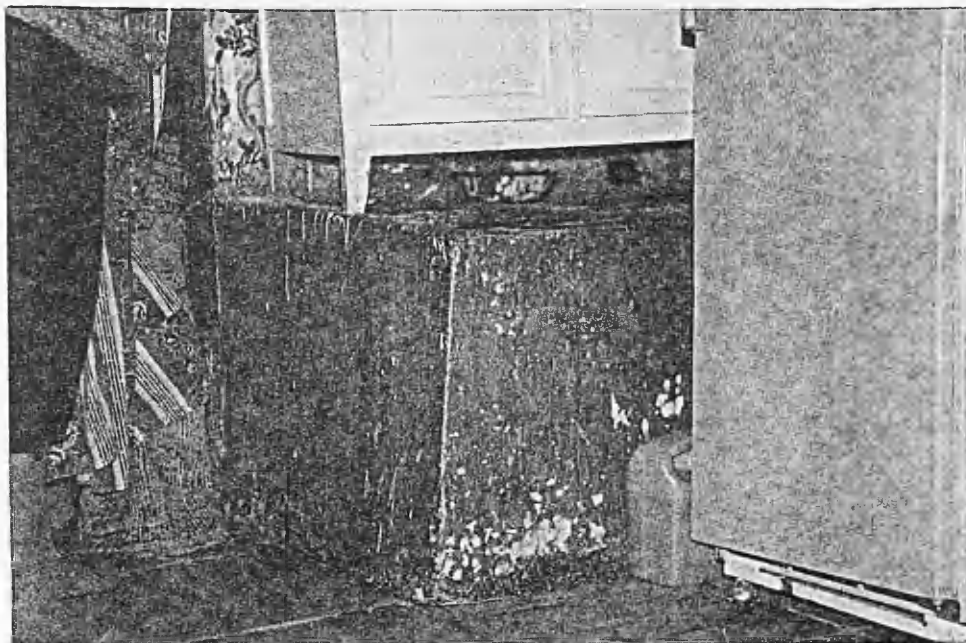
was partitioned. The majlis is also paved with marble slabs like those in the courtyard. In the north-east corner of the room (A13) sits an elevated brick structure 61cm high (see pl 23a), which appears to be a later insertion whose purpose is not known. The present occupants claim that it covers the opening to a secret passage leading to the mosque of Sidi al-Kettani built by Salah Bey (see above, p. 75). The majlis and the kbu are decorated with a dado of polychrome tiles of the same pattern (pl 23b). The tiles on the north wall of the majlis are now missing and on the west wall some of these have been rearranged in a confused pattern. The line of an arch is discernible above the north wall of the kbu, suggesting that this wall may originally have been open. However, since the tile dado running around the south and east walls continues on the north wall, it is reasonable to assume that this wall is original. In that case it is difficult to explain the presence of the arch. Unfortunately, detailed inspection of the conjunction between the north and east walls was prevented by the presence of a tall, heavy wardrobe in this corner of the kbu. Light in the kbu is provided by a large rectangular window in its east wall. The most distinctive feature of the majlis and the kbu is a carved wooden ceiling, which has no obvious parallel among others in the medina of Constantine (pl 24a). To north and south of the kbu are the

- (a) North-east corner of the majlis. View of the elevated brick structure.
- (b) West wall of the majlis. Original missing tiles have been replaced by new ones (left).

(a) The modern elevated brick structure in the north-east corner of room A7 to be removed, the floor underneath to be cleaned and paved with marble slabs to match existing. Missing slabs in the recess (kbu) to be replaced (see plan A).

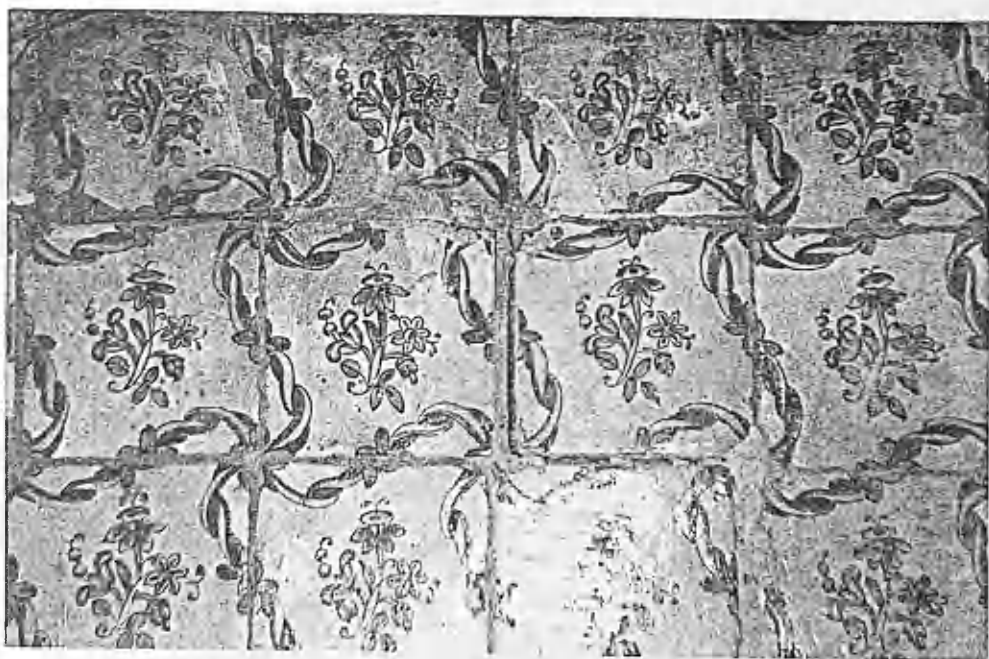
Upper floor gallery. (Above) walls used to be covered with this type of tiles.

(Below) original wooden balustrade has been replaced by a concrete one.

Concrete balustrade to be removed and replaced with wooden one (see fig 28).

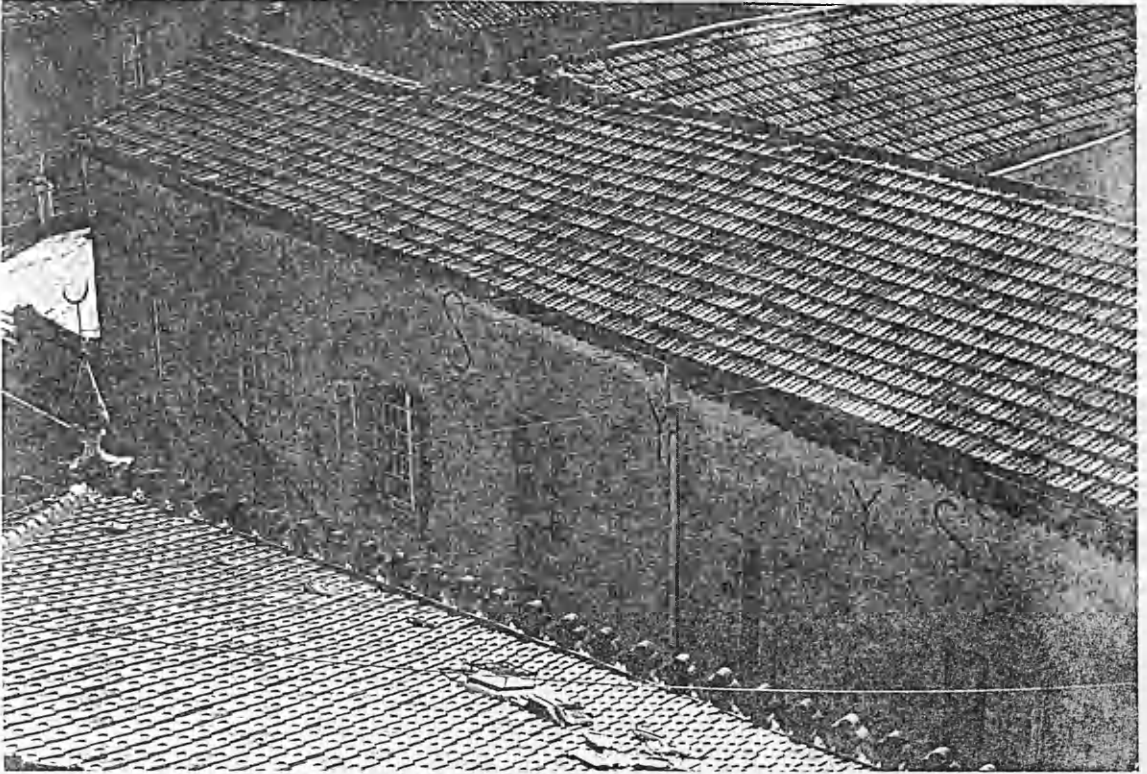
Rainwater from the roof is discharged inside and outside the palace by way of zinc gutters and downpipes. The gutters and downpipes are in sound condition except for the gutter on the north side which is partly missing (see pl 36).

Plate 36 North frontage: Missing rain gutter.

Zinc gutter partly missing
to be replaced.

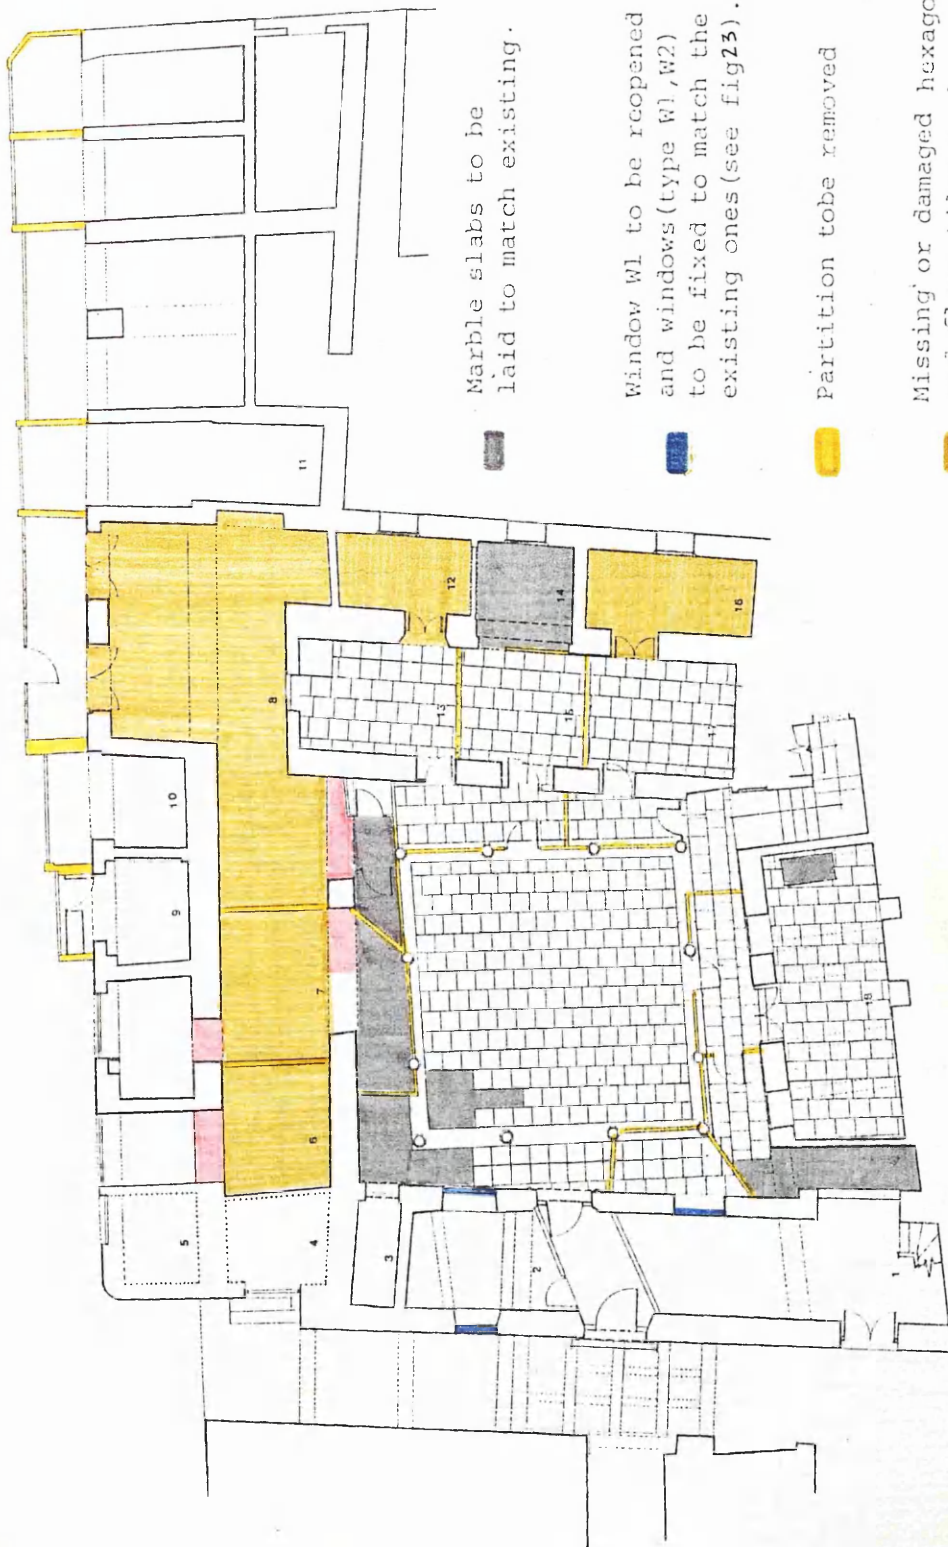
GROUND FLOOR PLAN

SHOWING CONDITION AND
REPAIRS.

Later partition walls (see plans A, B, C: orange colour) to be removed, the floors underneath to be cleaned and reinstated to match existing floors. Damaged wall rendering at the west side of the arcade at ground floor level to be

(b) Damaged hexagonal red tiles in rooms A12 and A16 to be removed, the floors cleaned and the tiles bedded on lime mortar to match existing.

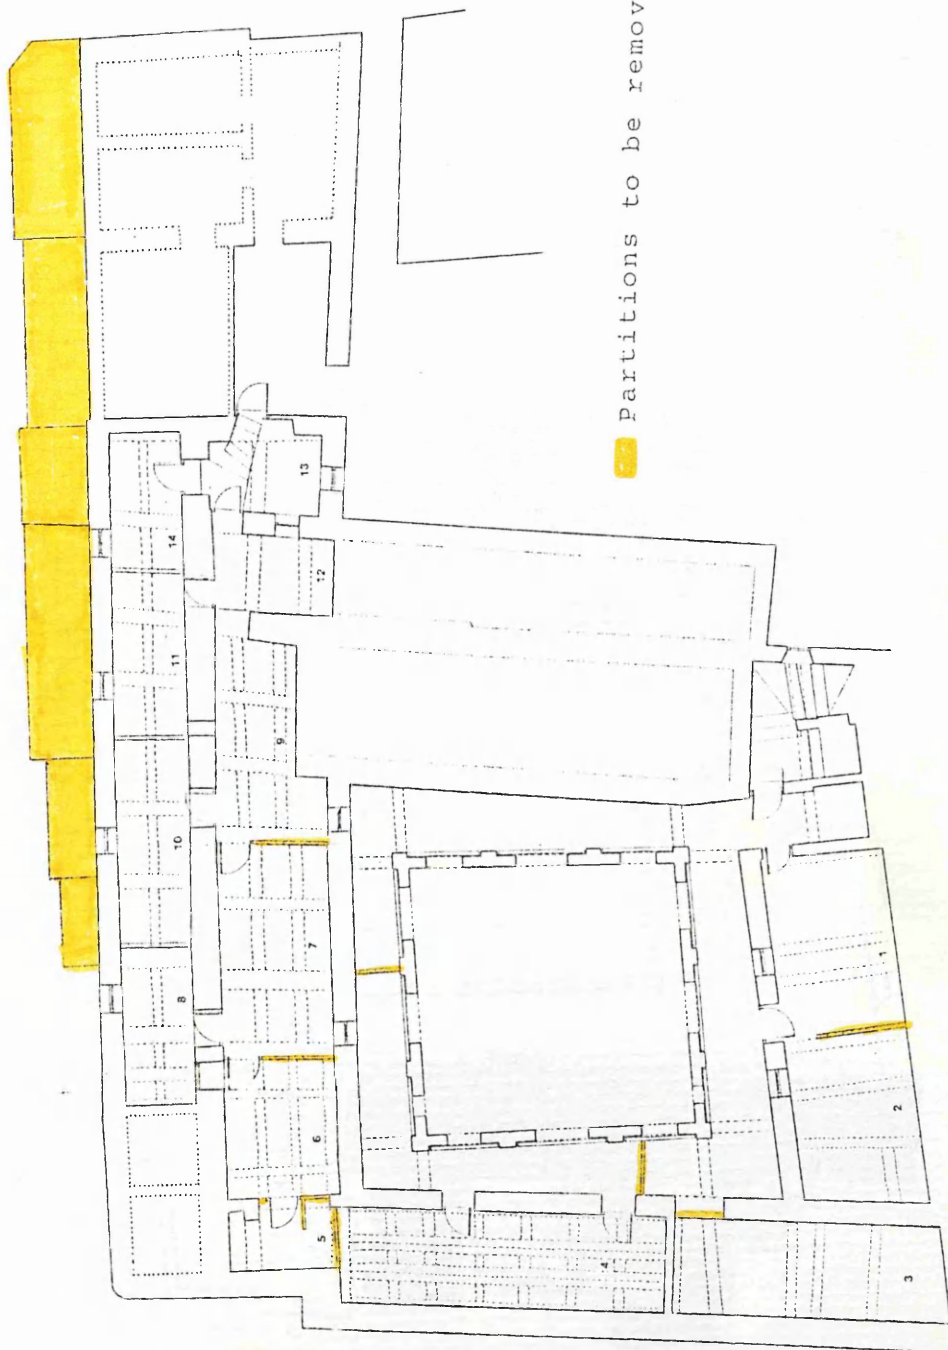
Mezzanine plan

Partitions to be removed.

showing conditions and repairs.

The mortar floor of the mezzanine to be carefully rechecked. The composition of the flooring mortar to be analysed, and any damaged areas to be cleaned and made good with matching mortar. The gallery floorboards to be protected by a traditional natural varnish. While the original materials used to varnish woodwork in the palace are not known, Revault has recorded traditional materials used in Tunisia and in Cairo, which may serve as a guide to traditional practice in Constantine.

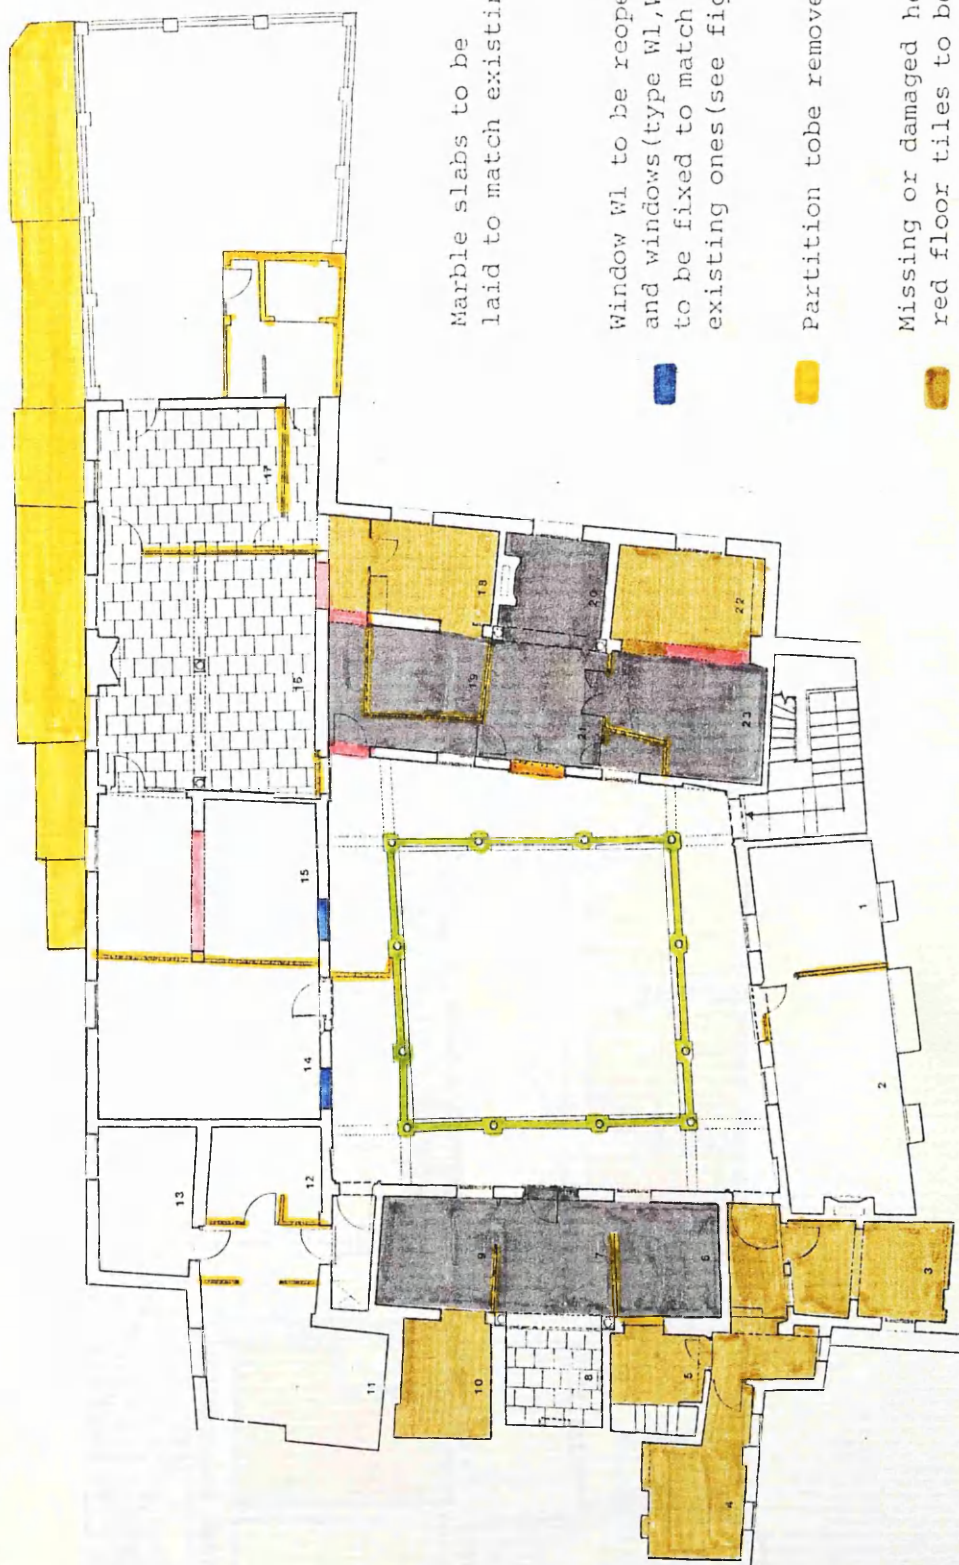
FIRST FLOOR PLAN

SHOWING CONDITION AND
REPAIRS.

Modern granolithic floor tiles in rooms C19, C20, C21 and C23, on the east side of the gallery to be removed, the floors cleaned and new marble slabs, 500x500mm, bedded on lime mortar to match the existing. Missing marble slabs in rooms C6, C7 and C9 to be replaced to match those of the (Kbu) (C8). Missing hexagonal red tiles in rooms C18 and C22 on the east side and missing tiles in rooms C3, C5 and C10 on the west side of the gallery to be replaced to match the existing. Floors at the south and north sides to be retained.

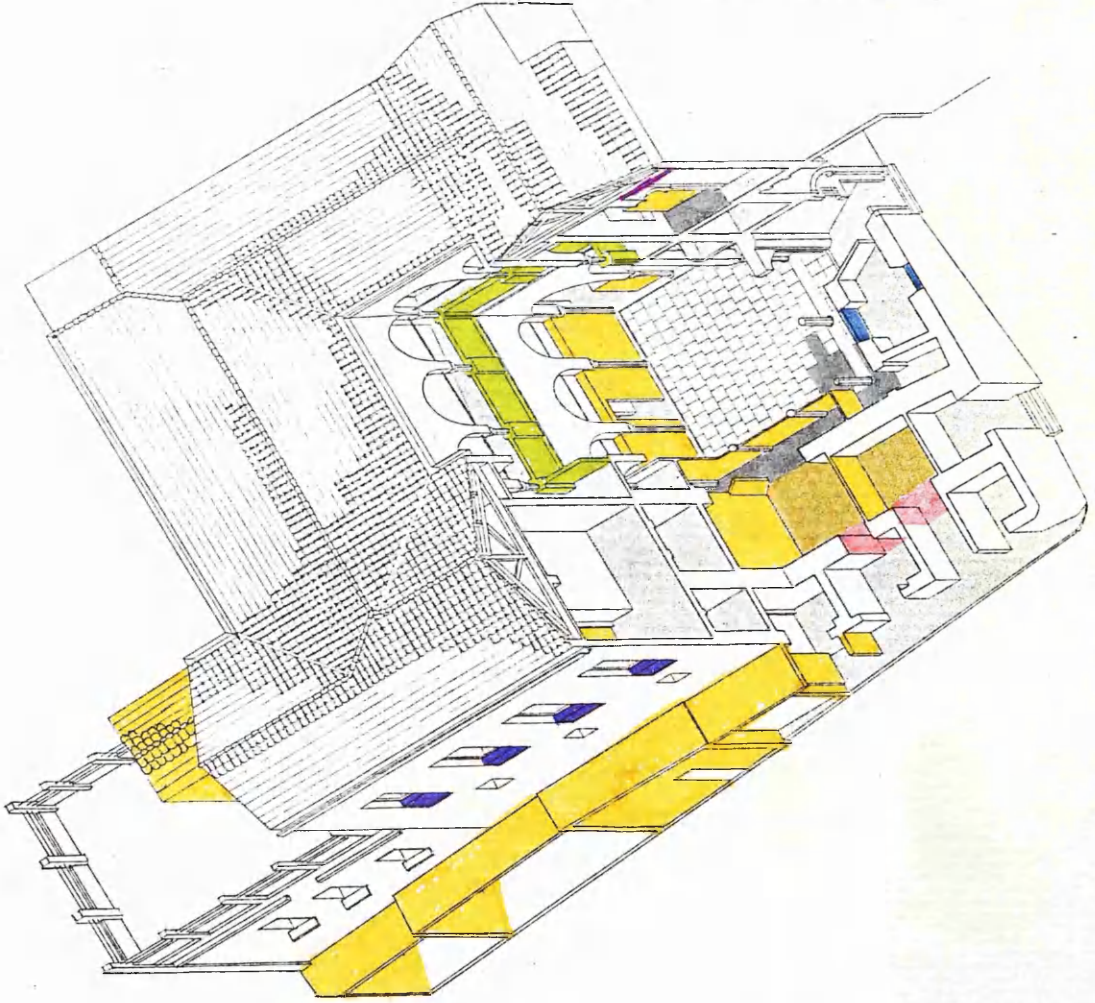
AXONOMETRIC PROJECTION
SHOWING CONDITION AND
REPAIRS.

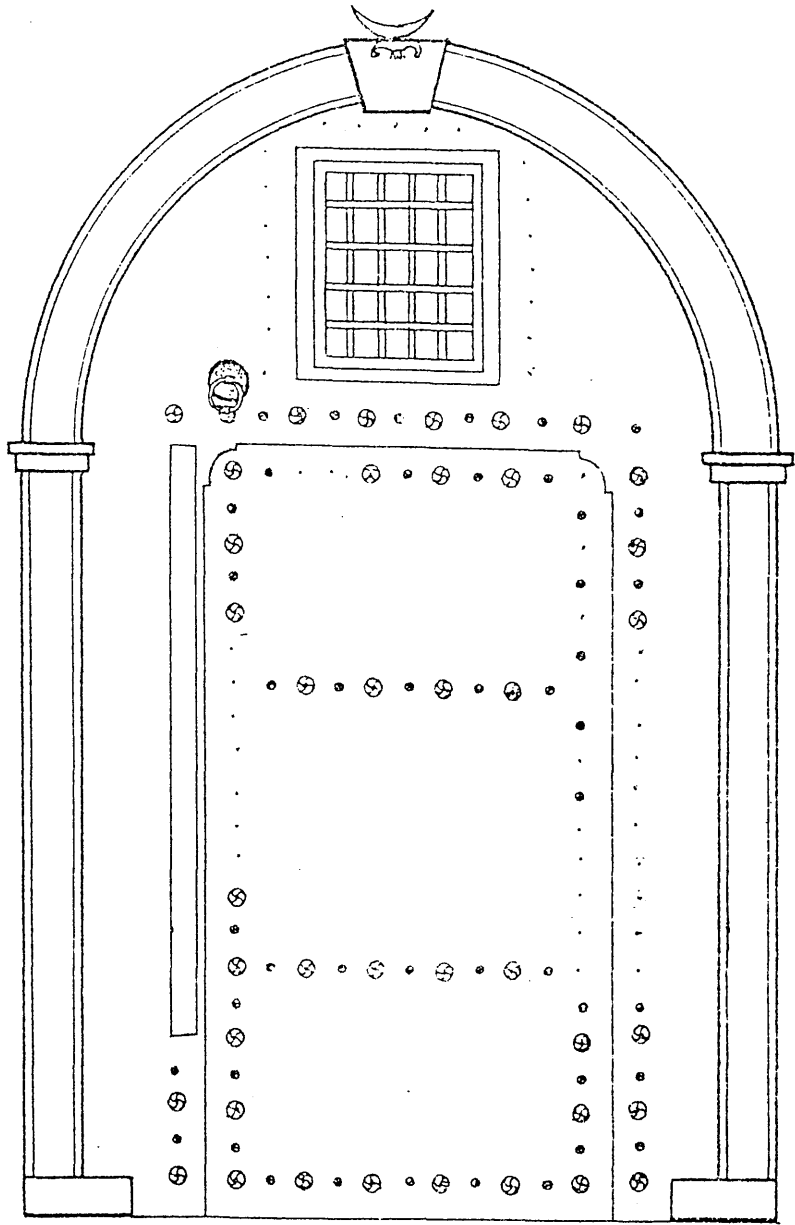
Figure 20 - Entrance doorway.

The original door knocker has been moved to the top left-hand corner of the door (see fig 20) and should be replaced in its original position (see fig 21).

to match the original finish. The new wooden plate on the left-hand side of the door frame to be removed and missing fluted brass knobs to be restored to match the existing ones (see fig 19). Door furniture to be replaced in its original positions (see fig 21).

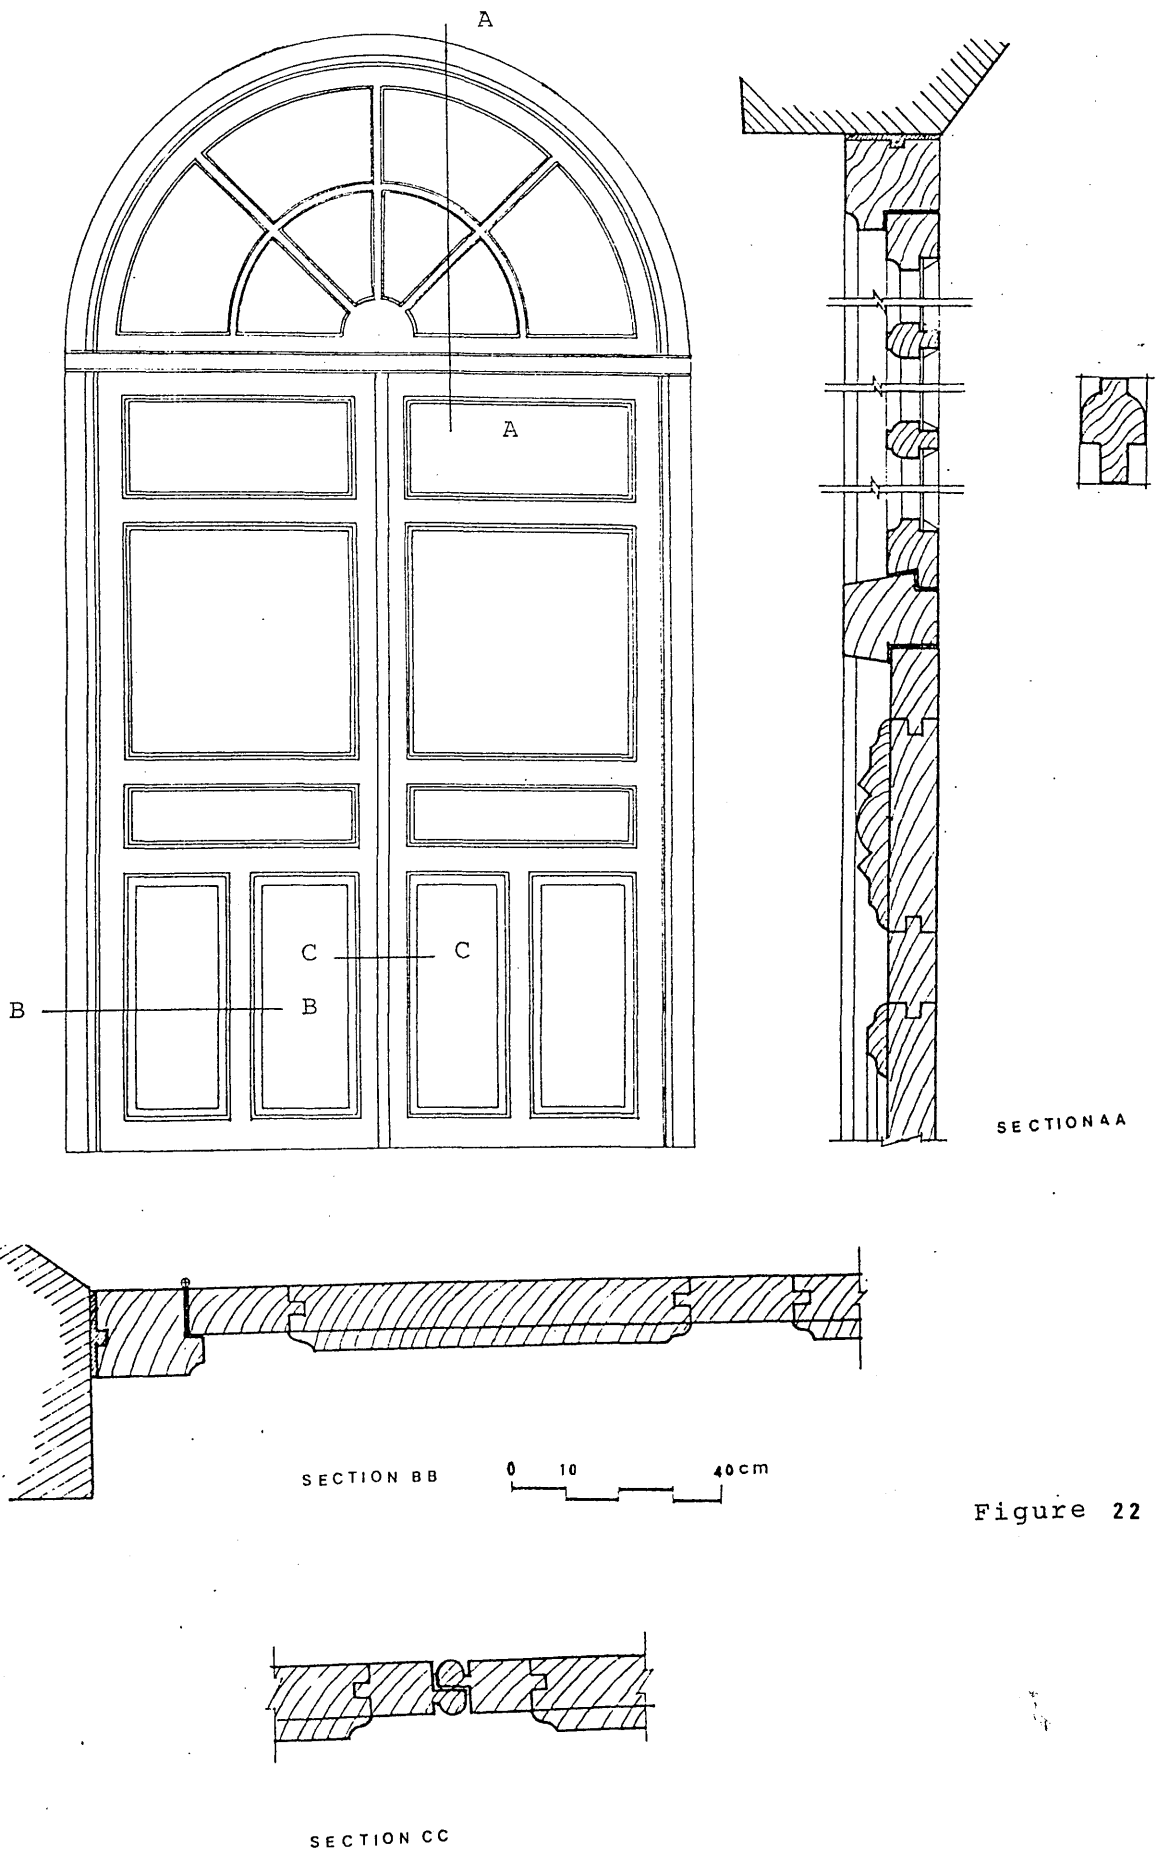
Figure 22

PROPOSED WINDOW (TYPE 2)

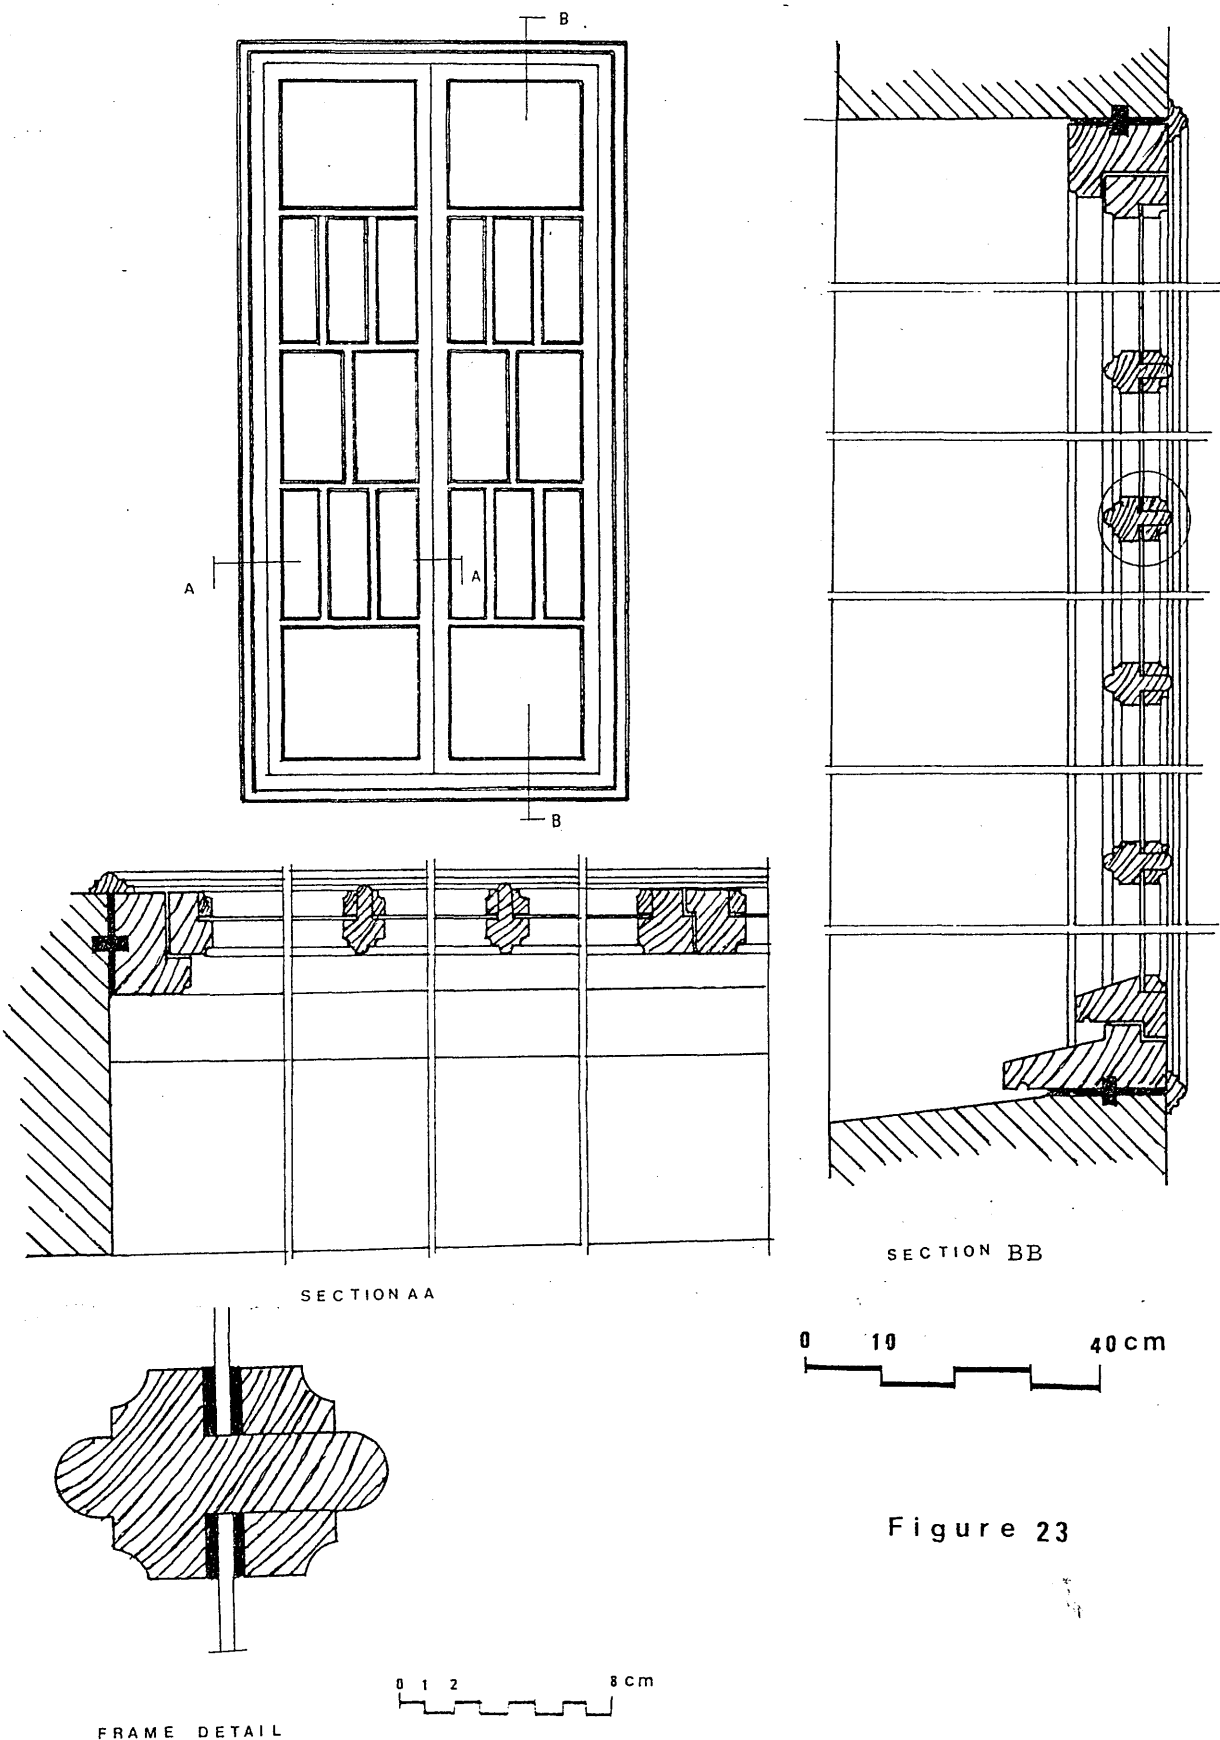
Figure 23

PROPOSED WINDOW W1

Window W1 to be reopened and windows (types W1, W2) to be fixed to match existing (see fig 23).

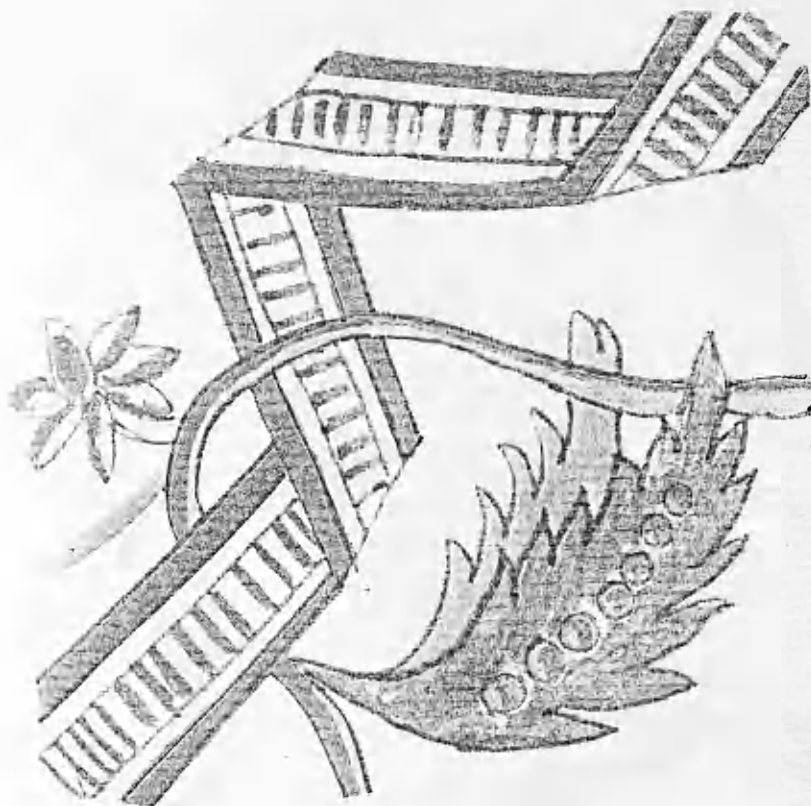
Figure 28_a:missing tiles on the north wall of room A13

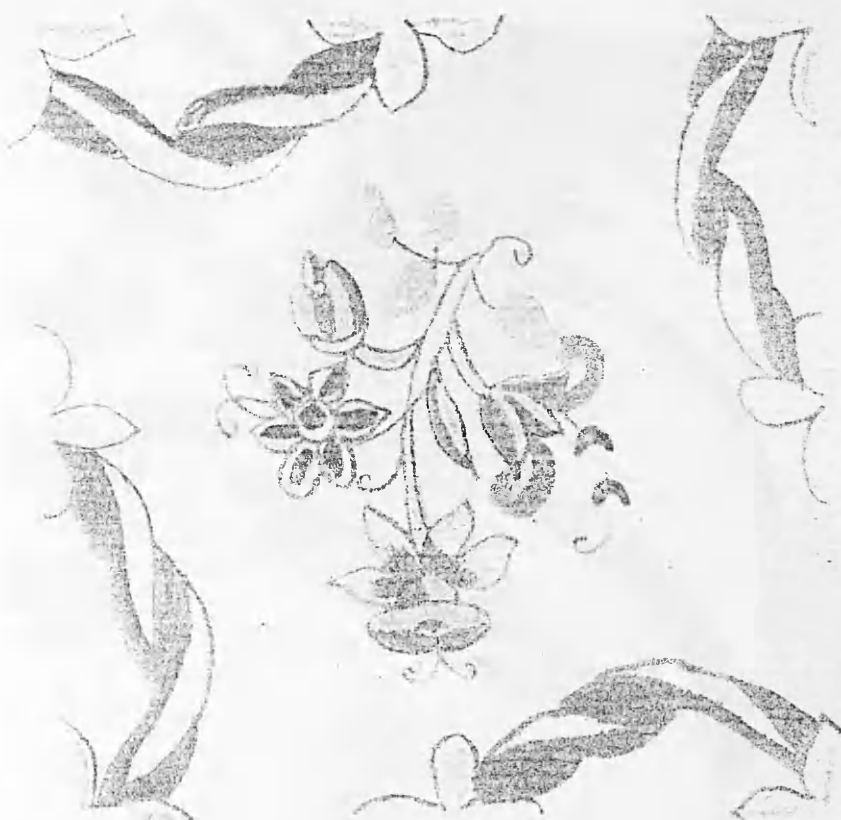
Missing tiles at the upper floor gallery.

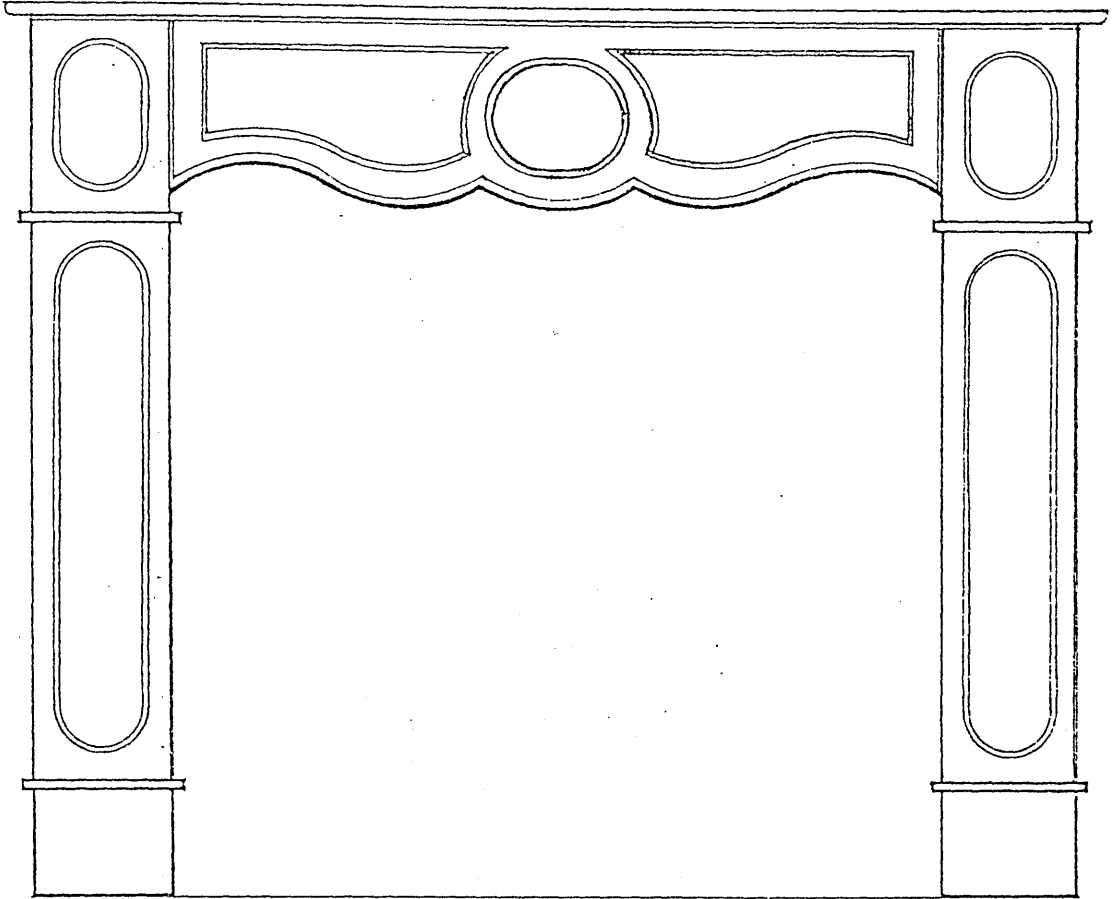
Figure 32 a :Fireplace recorded in rooms c20,c8,c2.

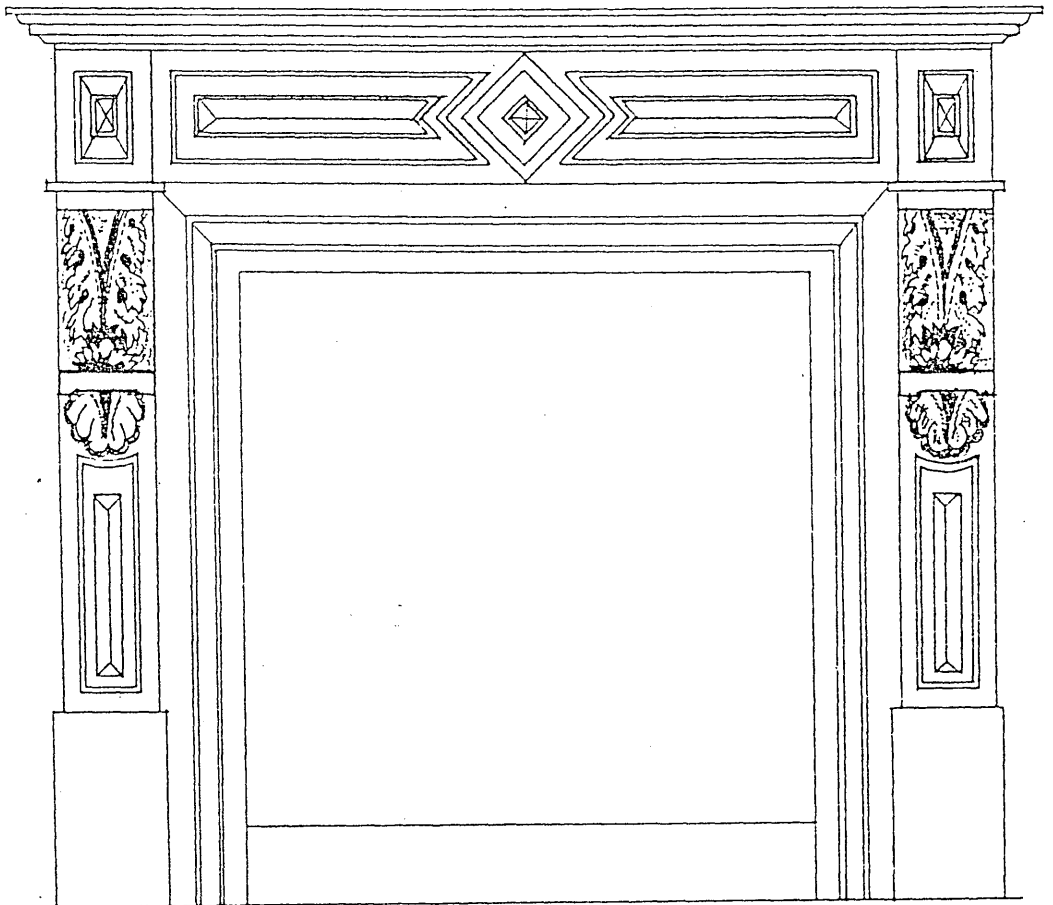
Figure 32 b :fireplace recorded in room cl6

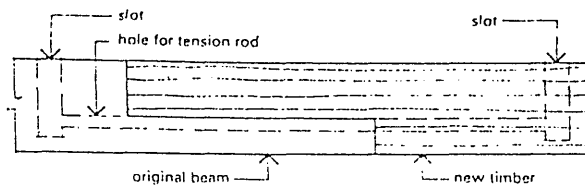
Repair technique of end of beam affected by wet rot

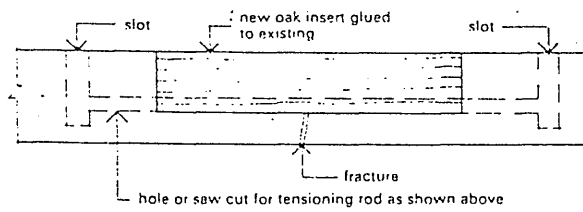
Repair technique for beam failure under tension

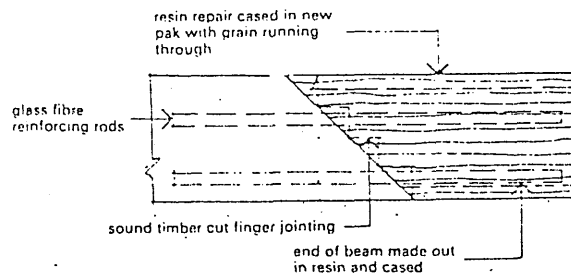
Repair technique to rotten beam end using fibreglass rod reinforcement and polyester resin
