**AN ULTRASONOGRAPHIC STUDY OF MUSCULOSKELETAL
INJURIES AND MAMMARY GLAND TUMOUR IN SMALL
ANIMALS**

A thesis submitted to the Faculty of Veterinary Medicine,
University of Glasgow.

For the Degree of Doctor of Philosophy

Division of Veterinary Anatomy,
Department of Veterinary Preclinical Studies,
School of Veterinary Medicine,
University of Glasgow,
March, 1999

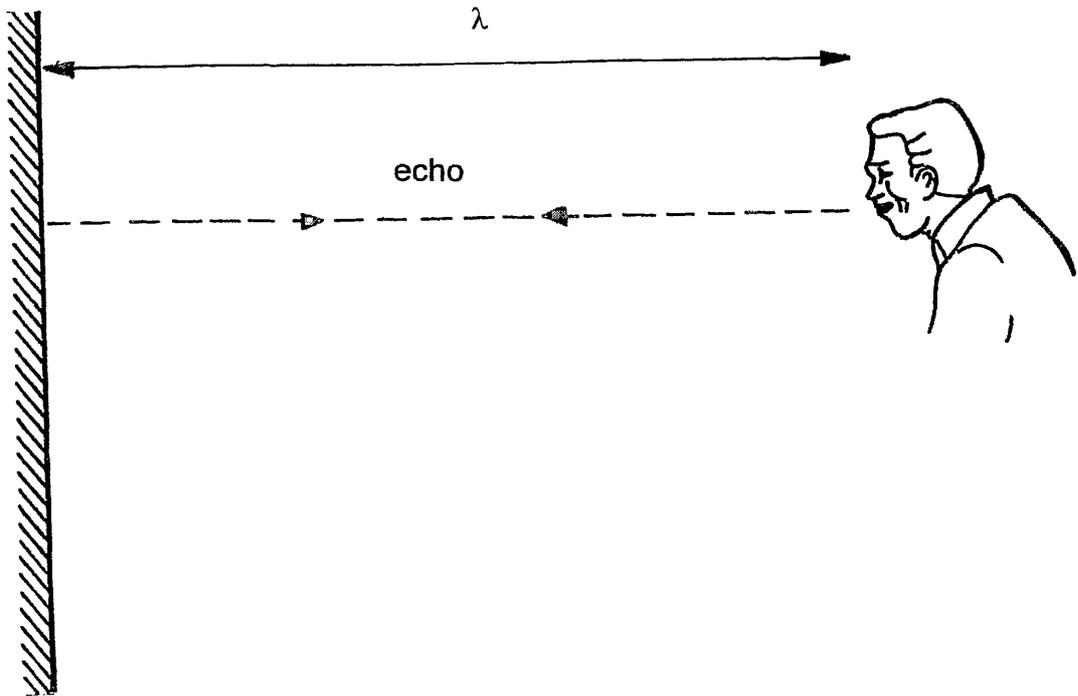
Figure 1.1 A man shouts 'hello' towards canyon. The pulse-echo technique is based on the principle that the distance of a reflector (canyon) from a sound source (man) can be calculated by timing the return of an echo, provided that the speed of sound is known.

Ultrasonography is based on the pulse echo principle. A man stands on one side of a canyon and shouts “Hello” toward the other side producing a “pulse” that travels through the air at the sound speed of approximately 741 miles an hour (figure 1.1). Once it hits the opposite wall of the canyon, the reflected pulse called “echo” travels back to the man at the same speed of sound, and after a short times, he hears the echo. The pulse and echo can be used to calculate how far it is to the other side of the canyon providing that the speed of sound is known. This can be done by simply measuring the time it took for the pulse to be echoed back, times speed of sound and then dividing by two as this represent two trips across the canyon (Shirly *et al*, 1978; Bartrum and Craw, 1983).

Basically ultrasound imaging uses this same pulse-echo principle. A short pulse of ultrasound is discharged into the body and travels through the tissues at a constant speed until it encounters a reflecting surface. The reflected beam is received by the ultrasound scanner, which has been keeping tract of the time and converting it to a distance in the same manner as the man and his calibrated stopwatch (Bartrum and Craw, 1983).

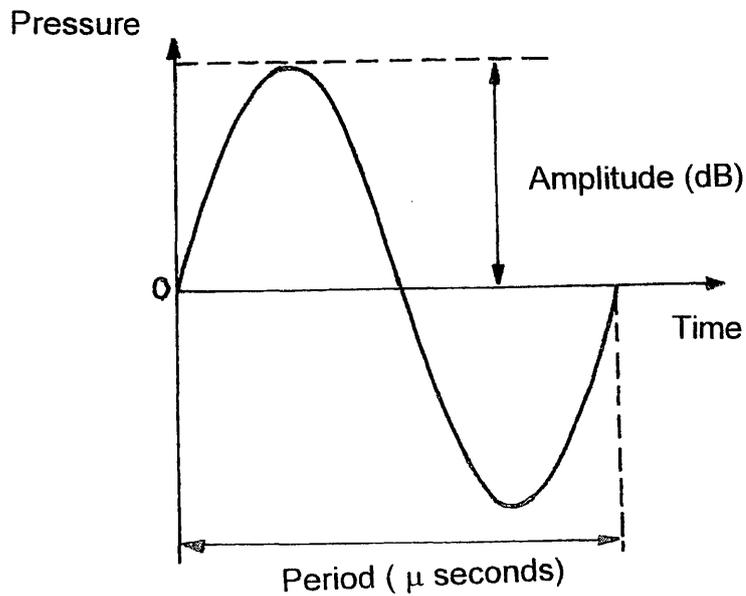
Velocity (metre per second) = speed of the sound

Frequency (MHz) = $\frac{1}{\text{period}}$

Figure 1.2 Common parameters of sound beam and the unit in which they are commonly expressed.

Audible sound has a range in frequency from 16 to 20,000 cycles per second (hertz), while ultrasound is defined as sound frequency above the normal hearing range, approximately 20,000 hertz (Rantanen and Ewing, 1981). The sound, is actually a series of repeating pressure waves as shown in figure 1.2. The **period** is the time it takes to complete a single cycle. The **amplitude** is the peak pressure or height of the wave which measure the strength or “loudness”

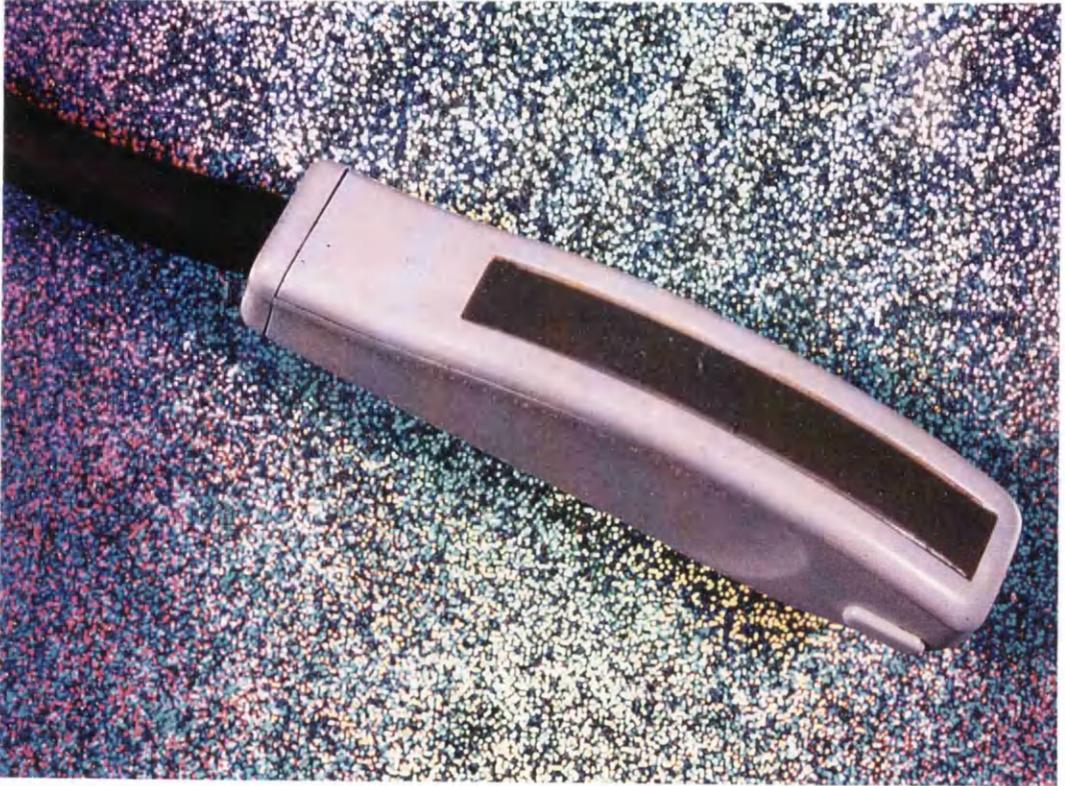
Figure 2.1 A 7.5 MHz linear array transducer used in this study.

A 7.5 MHz linear array transducer (figure 2.1) was used throughout this study. For the ultrasonographic imaging of the muscles of normal greyhound cadavers both the 7.5 MHz linear array and 3.5 MHz linear-convex transducers were used. The 3.5 MHz linear-convex transducer was used as a comparison. The 7.5 MHz frequency transducer was then selected on the basis of the size and depth of object under examination. The 7.5 MHz transducer produced better resolution on muscle imaging in greyhound cadavers as compared to the 3.5 MHz frequency linear-convex transducer. The axial and lateral resolution were 0.5 and 1 mm respectively for the 7.5 MHz transducer.

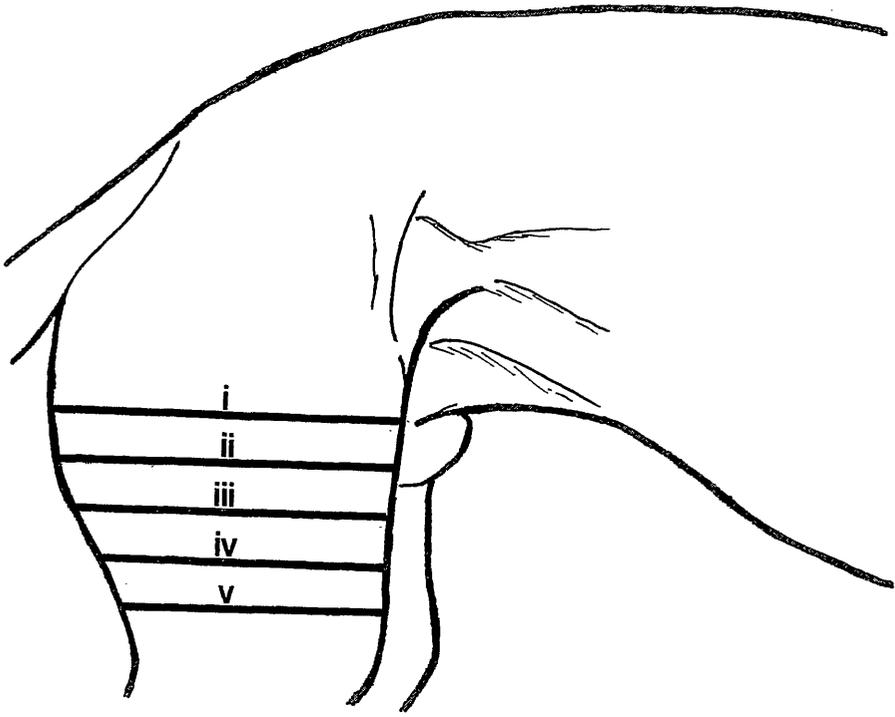
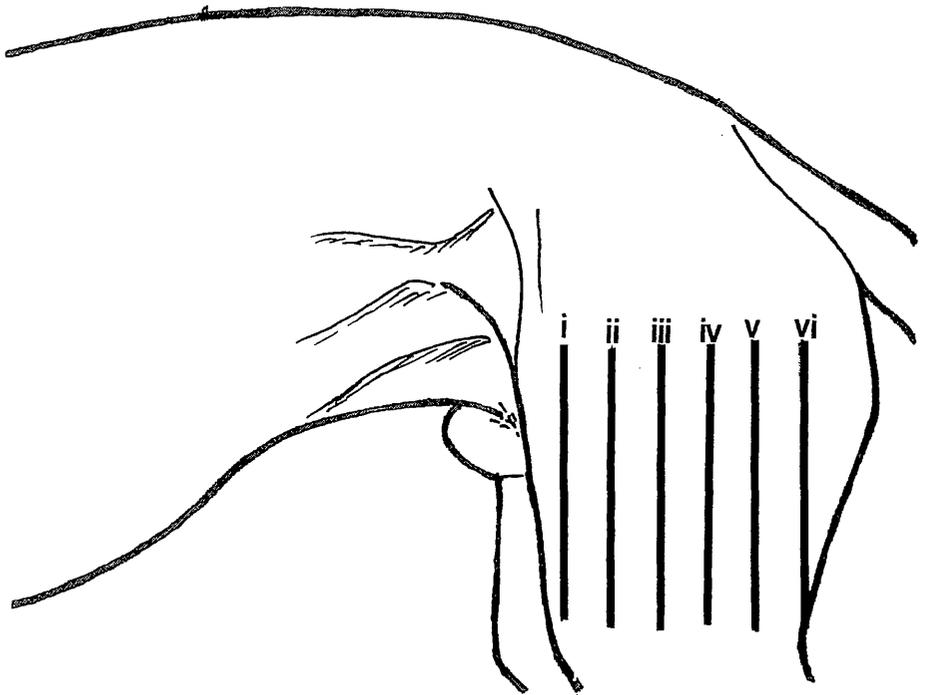
Figure 3.1 Schematic diagram of the lateral aspect of thigh region of right and left hind limbs. The area of thigh region is marked and identified by numbers on both lateral and medial aspects. The scanning was done following to the marked lines. **A**, Transverse scan of the lateral aspect of the right thigh. **B**, Longitudinal scan of the lateral aspect of the left thigh.

For the thigh muscle scanning, the right and left thighs were marked transversely and longitudinally respectively with a permanent marker pen on both lateral and medial aspects of the thigh at two centimetre interval as illustrated in figure 3.1. The marked lines were then identified by numbers. For the brachial and scapula regions, the areas for scanning were marked transversely perpendicular to the body of the humerus and the spine of scapula respectively at two centimetre intervals and identified by numbers (as illustrated in figure 3.2). Similarly, the ventral abdominal region was marked transversely across the mid-line at two centimetre intervals from the pubic brim to the level of the xiphoid cartilage and identified by numbers.

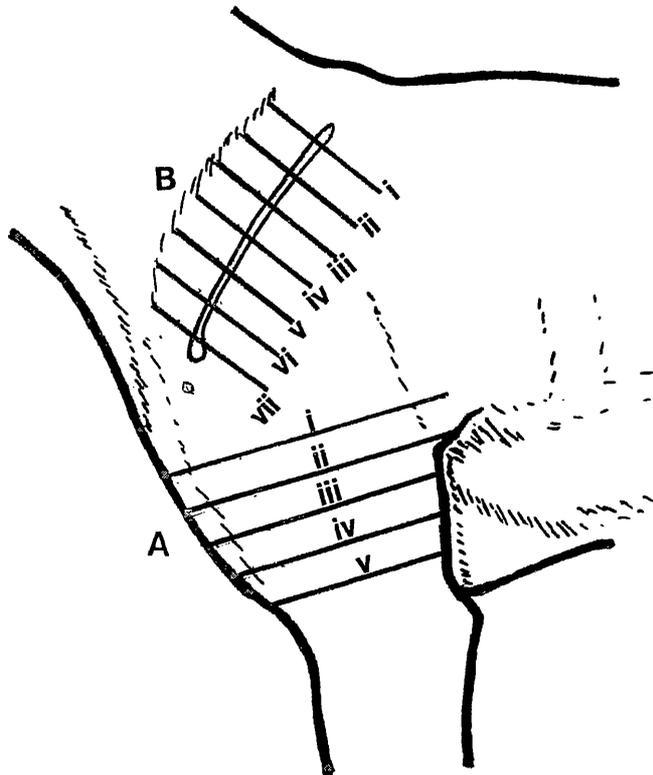
Figure 3.2 Schematic diagram of the lateral aspect of the brachium and scapular regions. The scanning levels are marked by numbers on both the scapular and brachial regions. **A**, levels of ultrasonographic scans of the brachial region. **B**, levels of ultrasonographic scans of the scapular region.

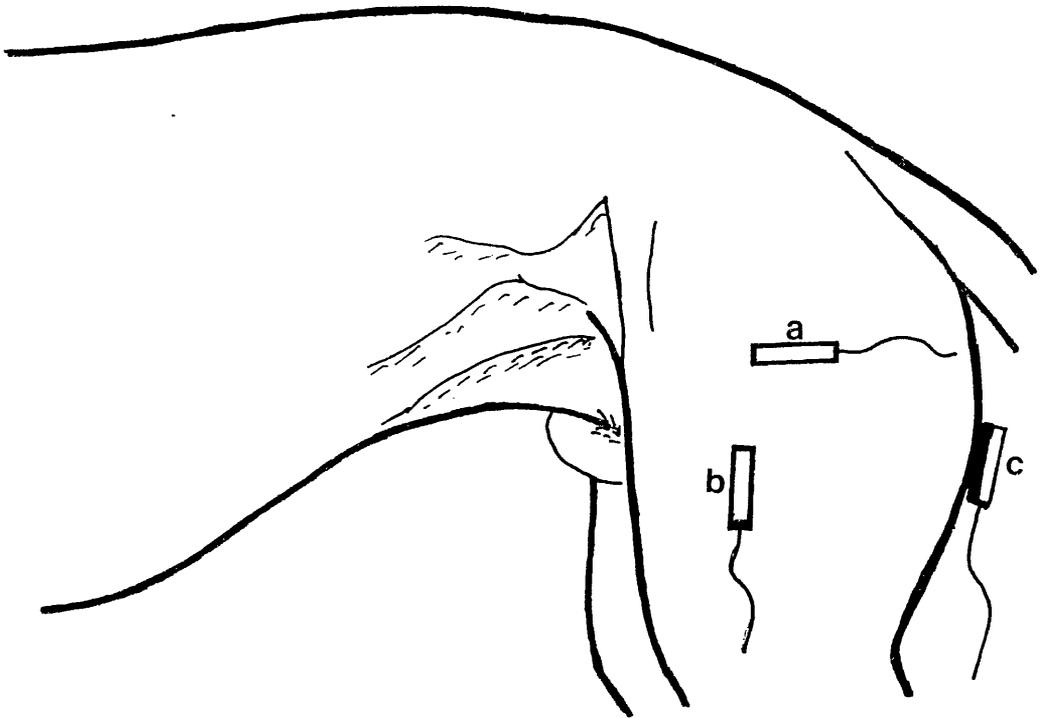
Figure 3.3 Illustrated diagram of scanning technique used in this study. a. Transverse scan, b. Longitudinal scan, c. Sagittal scan.

To scan the thigh muscles, the transducer was moved slowly but firmly from caudal to cranial aspect in transverse scans, and from proximal towards distal in longitudinal scans according to the marked lines on both lateral and medial aspects. The sagittal scans were performed sagittally from proximal to distal on the caudal aspect. The scanning technique for thigh region (transverse, longitudinal and sagittal scan) is illustrated in figure 3.3. The hind limb was slightly extended during scanning by traction of the pes. The scanned images of each level were identified by number according to the number of the marked lines.

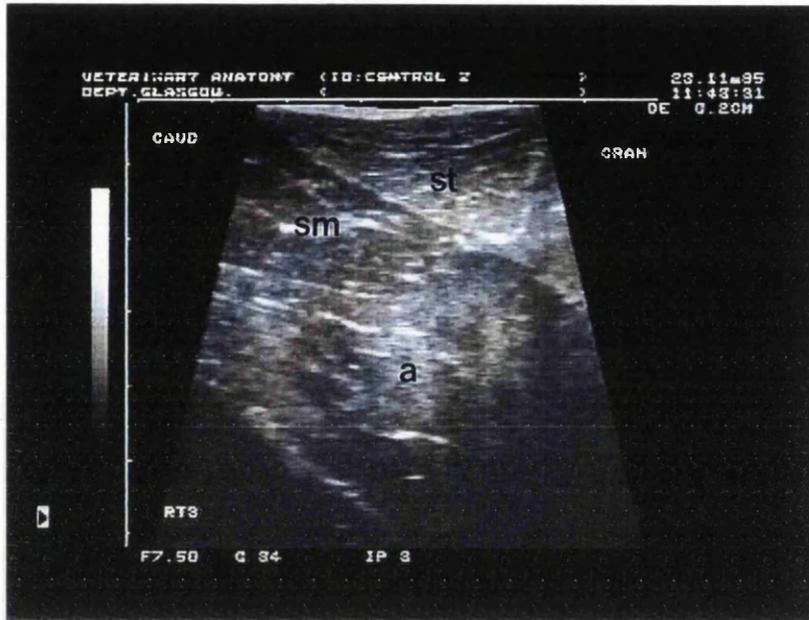
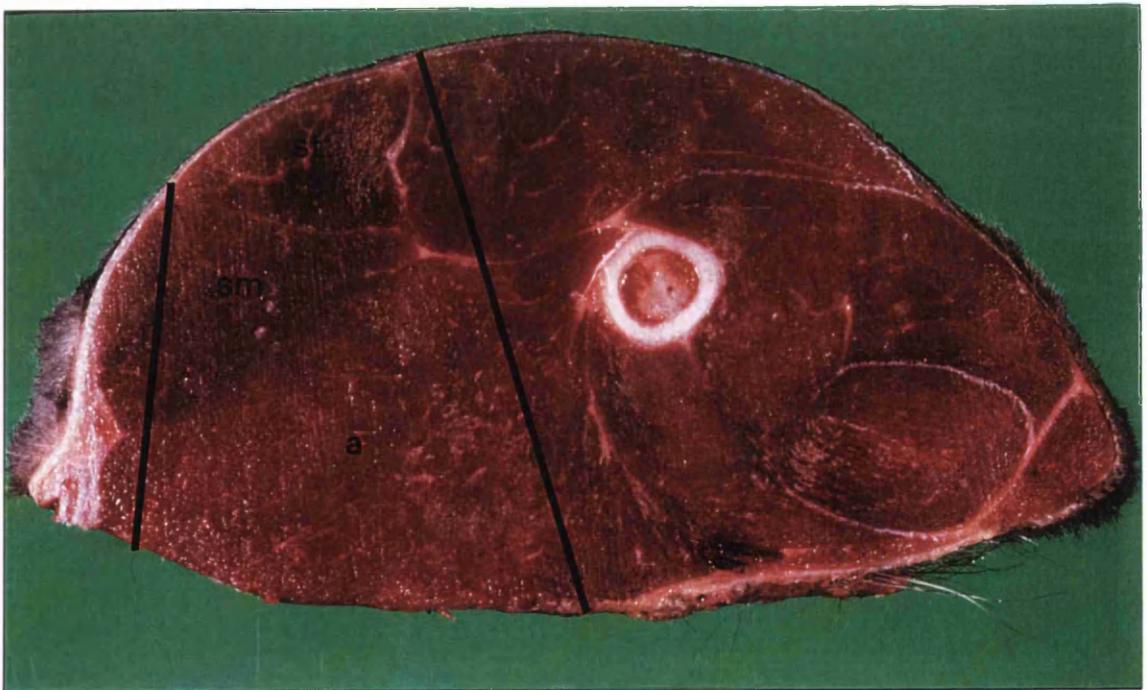
Figure 3.4 A (i)

Figure 3.4 Serial transverse scans of the normal thigh muscle on (A) caudo-lateral aspect and (B) cranio-medial aspect using a 7.5 MHz transducer and their correlation with the gross anatomy sections. The ultrasonographic appearance of normal skeletal muscle imaged transversely is of poorly organised fine echoes scattered throughout the hypoechoic muscle parenchyma. The fine echoes are corresponding to the fibroadipose septa. The muscle groups are well separated by the connective tissue fascia (perimysium) surrounding them. The overall increase in echogenicity of the muscle echotexture in B is due to the high gain setting. The images correlate well with the gross anatomy sections. **sm**, m. semimembranosus, **st**, m. semitendinosus, **bf**, m. biceps femoris, **a**, m. adductor, **g**, m. gracilis, **sr**, m. sartorius, **rf**, m. rectus femoris, **vm**, m. vastus medialis, **vi**, m. vastus intermedius, **vl**, m. vastus lateralis, **f**, femur.

Skeletal muscles of the normal greyhound cadavers imaged ultrasonographically in general showed the same characteristics. Serial ultrasonographic images of the thigh muscle scanned transversely from the lateral and medial aspects correlated well with the thigh gross anatomy sections (figure 3.4). The ultrasonographic images of brachial muscles scanned transversely on the lateral aspect and their correlation with the cross sections are shown in figure 3.5, and the scapular muscles scanned transversely across the spine of the scapula and longitudinally parallel to the spine of scapula are shown in figure 3.6 and 3.7 respectively. Sagittal scans of the brachial muscles are shown in figure 3.8. Normal skeletal muscle imaged ultrasonographically appeared as an homogeneously hypoechoic structure with fine echoes scattered throughout the muscle parenchyma. Each muscle group could be identified, separated by a thin hyperechoic structure which was actually the connective tissue fascia. The normal skeletal muscle imaged transversely perpendicular to the muscle fibres appeared homogeneously hypoechoic with poorly organised fine echoes corresponding to the fibroadipose septa scattered throughout the muscle parenchyma (figures 3.4, 3.5 and 3.6). In longitudinal image along the muscle fibres, skeletal muscle appeared as homogenous fine parallel echoes scattered throughout the hypoechoic muscle parenchyma (figures 3.9 and 3.10). As in the transverse scan, the muscle groups were separated by the thin hyperechoic layers of connective tissue fascia. The bone appeared as a strong hyperechoic image with complete acoustic shadowing distally when the transducer was correctly inclined (figure 3.11).

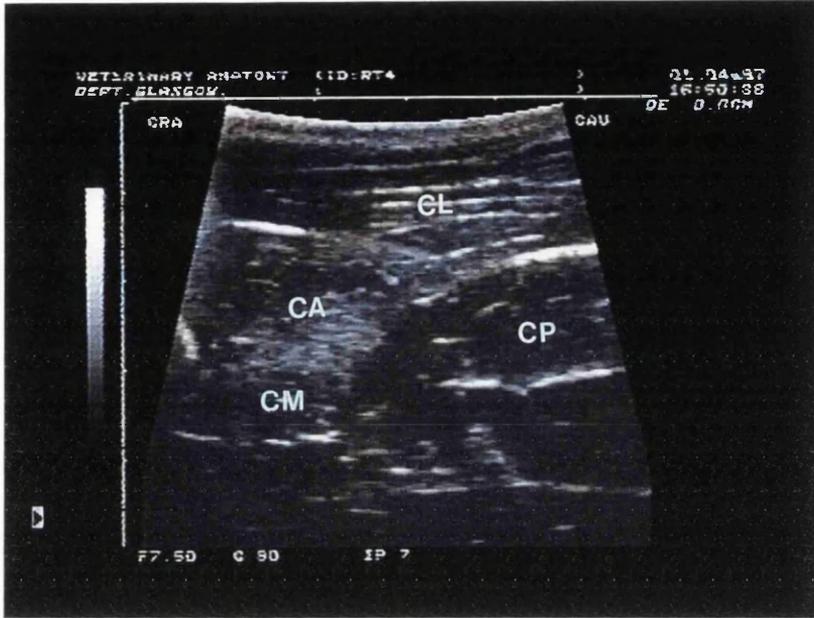
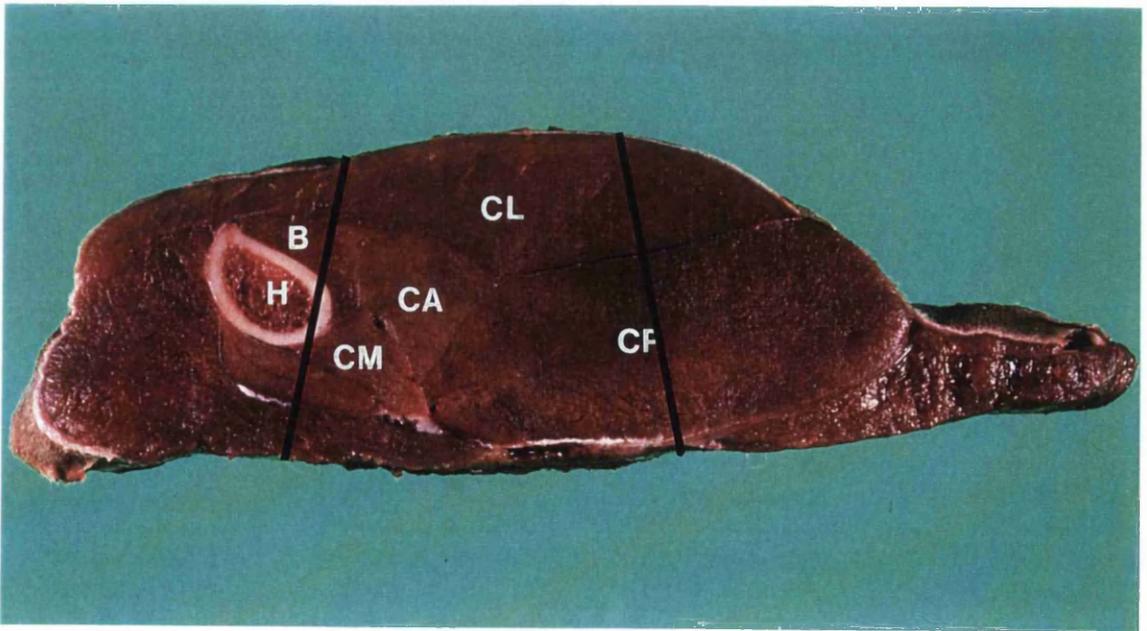
Figure 3.5 (i)

Figure 3.5 Transverse scans of the normal brachial musculature on the lateral aspect of the left fore limb. Note that the muscle structure appears hypoechoic with disorganised fine echoes scattered throughout the muscle parenchyma. The images correlate well with the gross anatomy sections. m. triceps brachii; **CL**, caput lateralis, **CP**, caput longus, **CM**, caput medialis, **CA**, caput accessorius, **H**, humerus, **B**, m. brachialis.

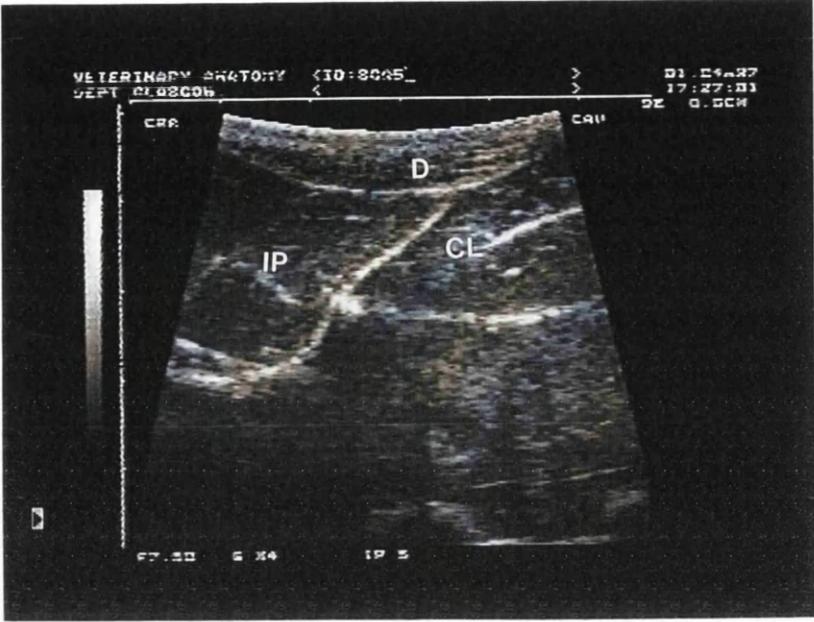
Figure 3.6a

Figure 3.6 Transverse scans of the normal muscle of the scapular region (**a,b,c,d**) and their correlation with gross anatomy sections (**e**). Note that the skeletal muscle imaged transversely appears hypoechoic with fine echoes scattered throughout the muscle parenchyma. **SC**, spine of scapula, **S**, body of scapula, **SP**, m. supraspinatus, **IP**, m. infraspinatus, **D**, m. deltoideus, **CP**, m. caput longus, **T**, m. trapezius.

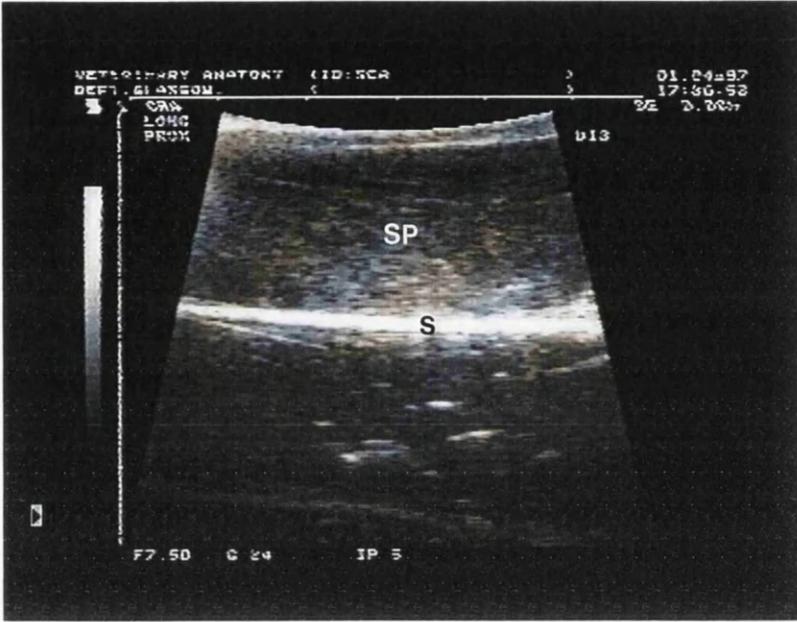
Figure 3.7a

Figure 3.7 Ultrasonographic images of normal muscles of the scapular region scanned longitudinally, parallel to the spine of the scapula. **a**, m. supraspinatus, **b**, m. infraspinatus. Note the thick line of hyperechoic material in **b** is actually the connective tissue fascia as demonstrated in the gross anatomy section in figure 3.6e. **S**, body of scapula, **SP**, m. supraspinatus, **IP**, m. infraspinatus.

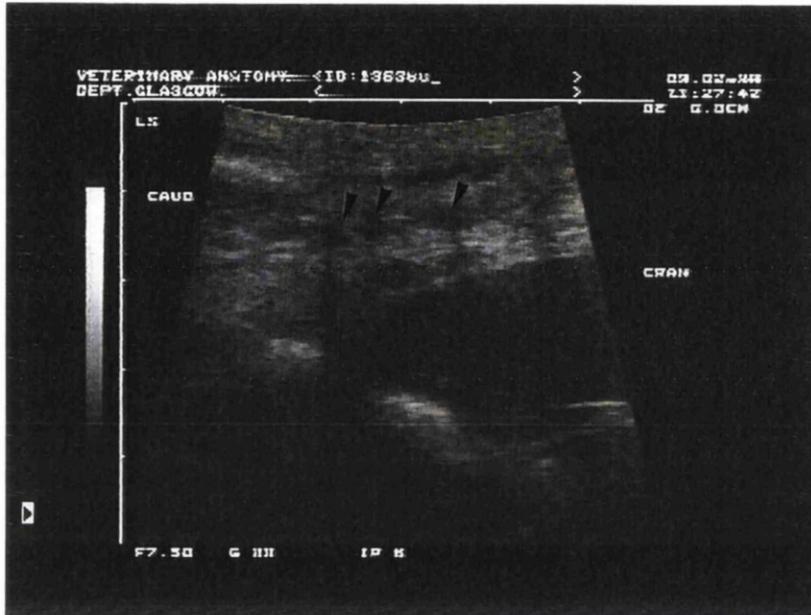
Figure 4.20 Longitudinal scan of the ventral abdominal wound on day 11 post-operation demonstrates a disorganised hypoechoic to echogenic structure representing the area of muscle damage with intermittent acoustic shadowing artefacts emanating from the ill-define hypoechoic areas (arrow heads). These hypoechoic areas are actually the original sites of the suture material and have been filled by serum and cellular debris.

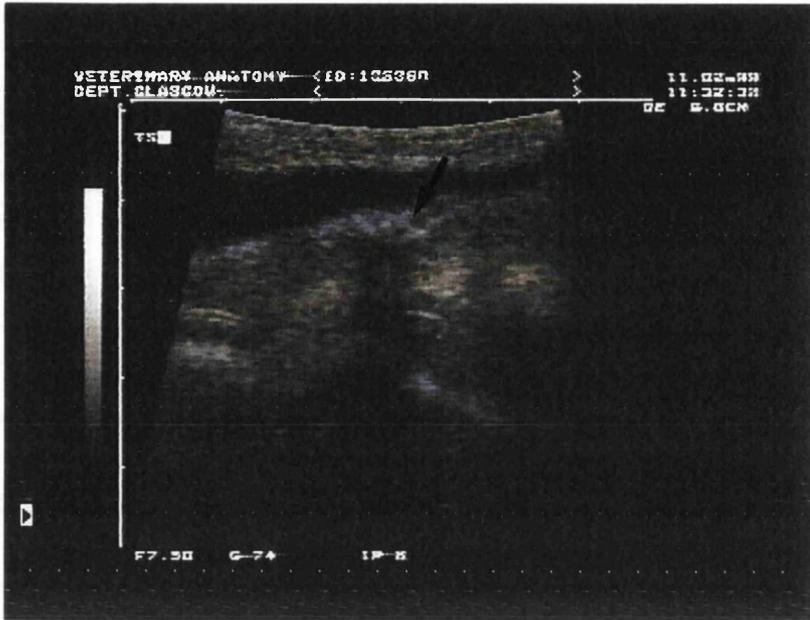
Figure 4.21a

Figure 4.21 Transverse scan of the ventral abdominal wound on day 13 post-operation demonstrates a disorganised echogenic area (arrow) casting an acoustic shadowing artefact (a). The area surrounding the surgical site appears more organised than on the previous scan. Note also the fluid filled area is still present appearing anechoic with acoustic enhancement artefact. A small portion of fibrous tissue formation (small arrow) can be seen protruding into the haematoma (b).

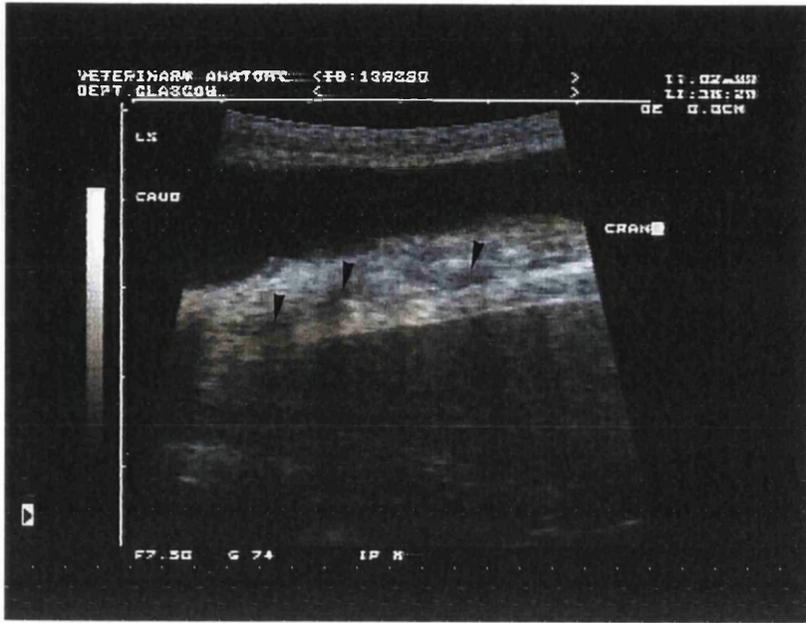
Figure 4.22a

Figure 4.22 Longitudinal scans of the ventral abdominal wound on day 13 post-operation demonstrate a disorganised echogenic area representing the muscle damage with the presence of fibrous tissue formation. Small hypoechoic areas (arrow heads) which are casting intermittent acoustic shadowing artefact are still visible but appear smaller than on the day 11 examination. These hypoechoic areas represent the sites of suture material undergoing reabsorption. A small portion of fibrous tissue protruding into the fluid space can also be seen. Some echogenic material within this area in **b** is suggestive that the fluid space is consolidating. The overall increase in echogenicity in **a** is due to acoustic enhancement artefact caused by the fluid accumulation.

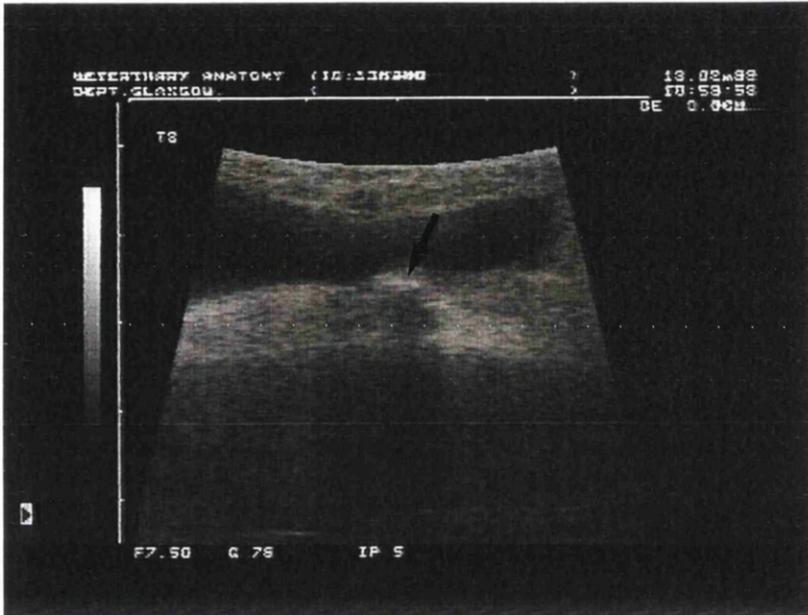
Figure 4.23 Transverse scan of the ventral abdominal wound on day 15 post-operation demonstrates a disorganised hyperechoic area (arrow) with acoustic shadowing artefact. Fibrous tissue appears to have an hyperechoic appearance compared to the image on the day 13 post-operation. The large fluid accumulation between the subcutaneous tissue and the rectus abdominis muscle is still present.

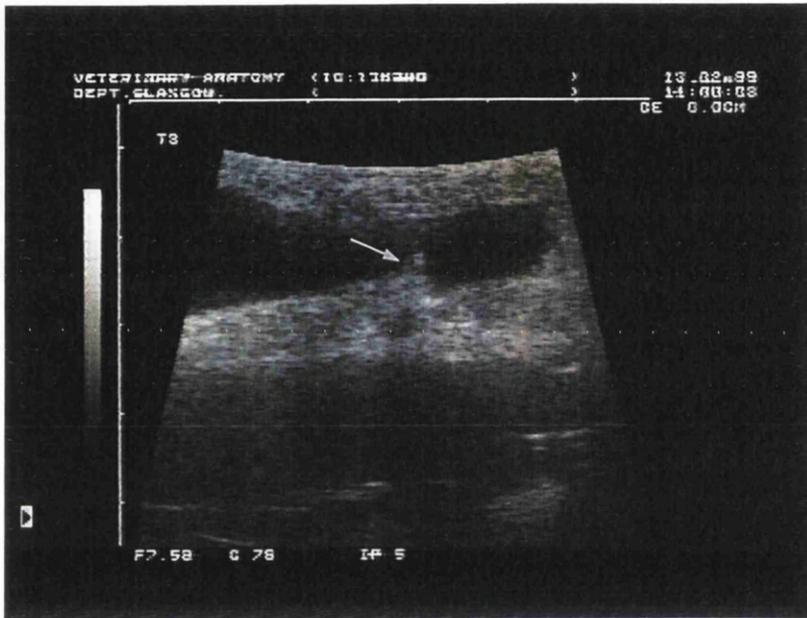
Figure 4.24 Transverse scan of the ventral abdominal wound on day 15 post-operation demonstrates a small portion of fibrous tissue (arrow) protruding into the fluid space. It appears hyperechoic and is increasing in size. Note that the presence of echogenic material within the fluid indicates that there is consolidation taking place.

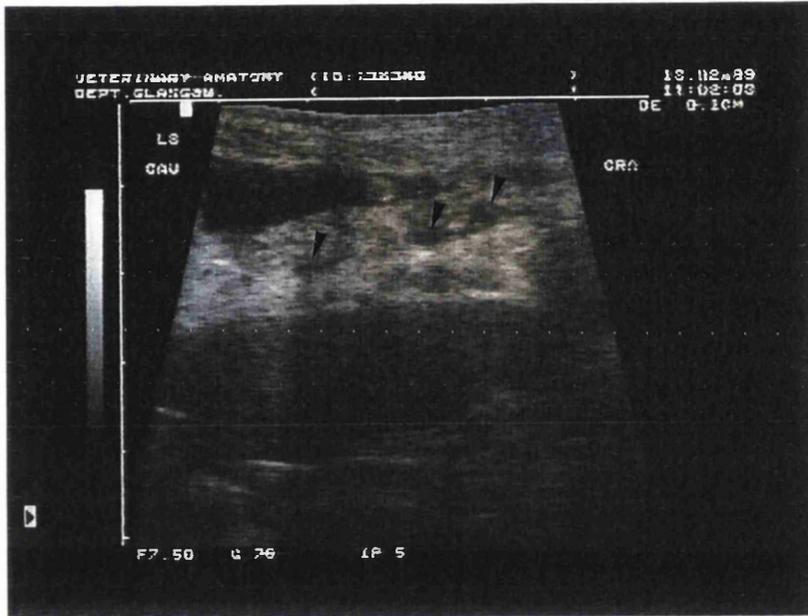
Figure 4.25 Longitudinal scan of the ventral abdominal wound on day 15 post-operation demonstrates a disorganised hyperechoic structure with the presence of some hypoechoic areas producing acoustic shadowing artefacts (arrow heads). These small hypoechoic areas within the muscle were actually the site of suture material being reabsorbed and are visible on ultrasound. The disorganised hyperechoic structure is due to the presence of fibrous tissue formation.

Ultrasonographic examination of the wound on a longitudinal scan demonstrated a disorganised hyperechoic structure with the presence of some hypoechoic areas producing acoustic shadowing artefact (figure 4.25). These small hypoechoic areas within the muscle represented the original sites of suture material and were still visible on ultrasound. The disorganised hyperechoic structure was due to the presence of fibrous tissue formation.

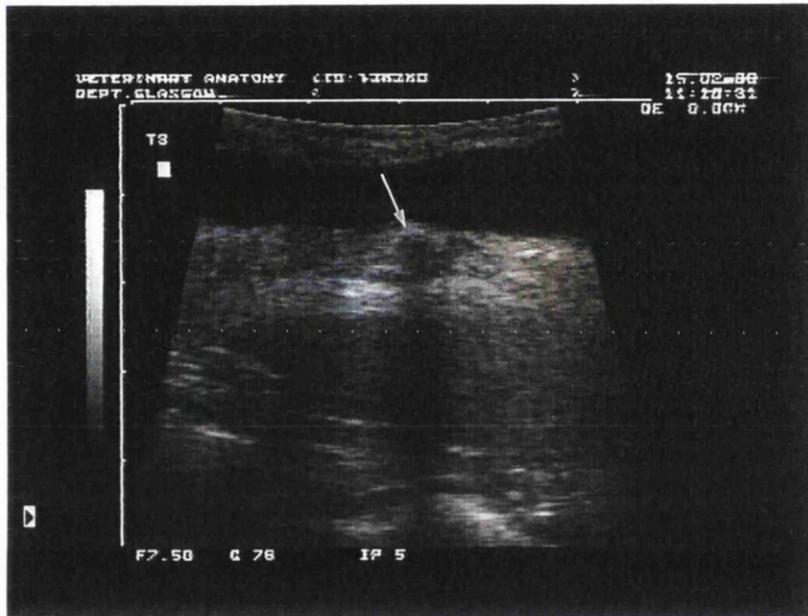
Figure 4.26 Transverse scan of the ventral abdominal wound on day 17 post-operation demonstrates a disorganised hyperechoic area (arrow) with acoustic shadowing artefact. The wound appears somewhat smaller than on the day 15 examination. The large fluid accumulation is still present and appears as in the previous scan.

Ultrasonographic examination of the ventral abdominal wound on day 17 post-operation on a transverse scan demonstrated that the wound appeared as a disorganised hyperechoic area with acoustic shadowing artefact (figure 4.26). The overall dimensions of the wound appeared to be smaller than on the day 15 examination. The large fluid accumulation was still present and appeared as in the previous scan. The fibrous tissue protruding into the fluid space area had increased in size and appeared hyperechoic (figure 4.27). This protruding fibrous tissue was moving during scanning. Aspiration was performed on the swelling and clear straw coloured serosanguinous fluid was removed. A longitudinal scan of the surgical site (wound) demonstrated a disorganised hyperechoic area representing the area of muscle damage and the presence of fibrous tissue formation (figure 4.28). The small hypoechoic areas with acoustic shadowing artefacts could still be seen. The animal was discharged from the clinic on the following day and the owner reported that the wound continued to heal satisfactorily and the swelling remained reduced in size.

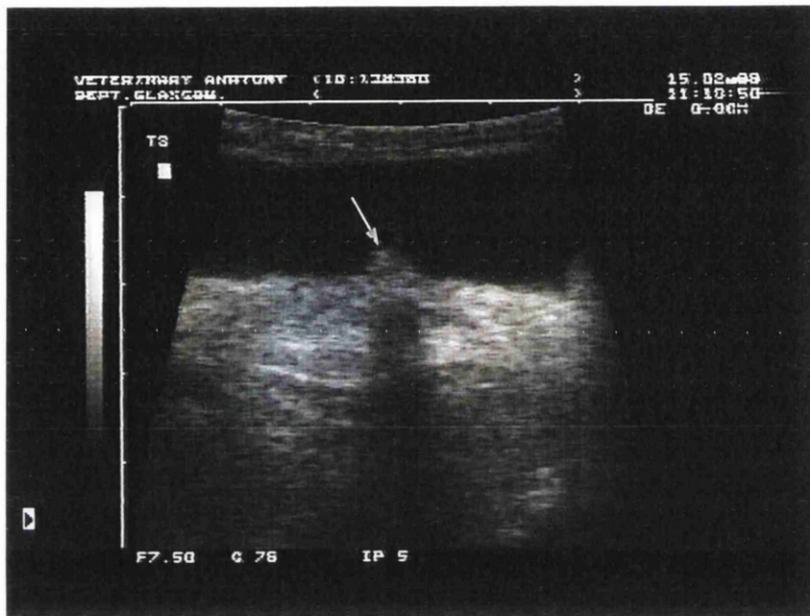
Figure 4.27 Longitudinal scan of the ventral abdominal wound on day 17 post-operation demonstrates the fibrous tissue (arrow) protruding into the fluid filled area and is increasing in size compare to the previous scan. It appears hyperechoic.

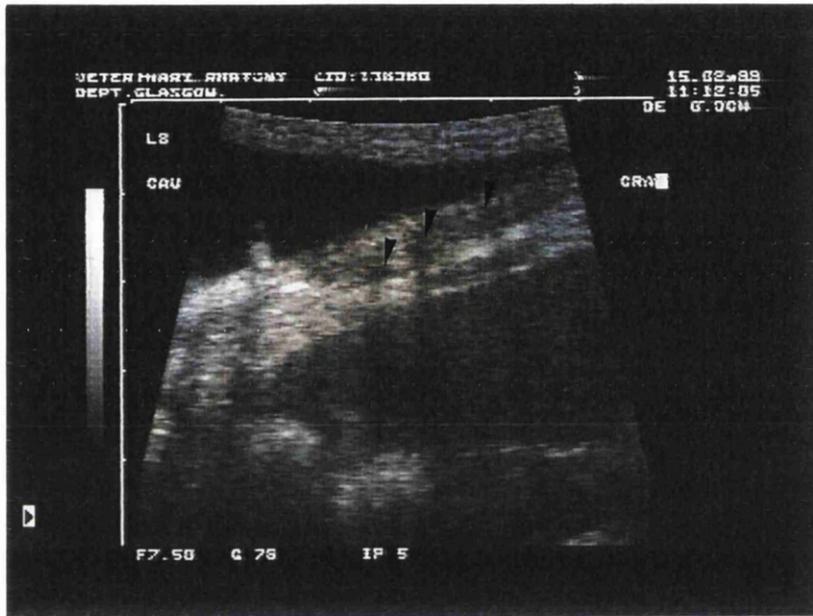
Figure 4.28 Longitudinal scan of the ventral abdominal wound on day 17 post-operation demonstrates a disorganised hyperechoic area representing the area of muscle damage and the presence of fibrous tissue formation. Note also that the small hypoechoic areas (arrow heads) with acoustic shadowing artefacts are still visible.

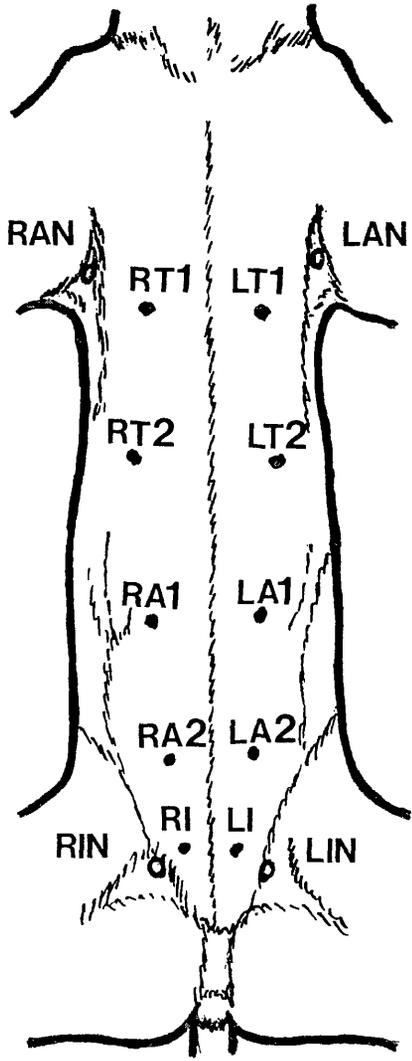
Figure 5.1 Identification of the mammary glands and the regional lymph nodes (axillary and superficial inguinal).

LAN	-	left axillary lymph node
LT1	-	left cranial thoracic mammary gland
LT2	-	left caudal thoracic mammary gland
LA1	-	left cranial abdominal mammary gland
LA2	-	left caudal abdominal mammary gland
LI	-	left inguinal mammary gland
LIN	-	left superficial inguinal lymph node
RAN	-	right axillary lymph node
RT1	-	right cranial thoracic mammary gland
RT2	-	right caudal thoracic mammary gland
RA1	-	right cranial abdominal mammary gland
RA2	-	right caudal abdominal mammary gland
RI	-	right inguinal mammary gland
RIN	-	right superficial inguinal mammary gland

All the mammary glands and the regional lymph nodes (axillary and superficial inguinal) on both sides were identified as shown in figure 5.1. The scanning was carried out in a semi-dark room. Each dog was placed on the table in dorsal recumbency during examination. Excessive hair around the teats and at the axillary and inguinal areas was removed using hair clippers. The mammary glands and the regional lymph nodes were examined physically by means of palpation prior to scanning. They were gently palpated using the tips of fingers and thumb. An acoustic coupling gel was then applied prior to scanning. Ultrasonographic imaging was performed using an ultrasound scanning unit (TOSHIBA Capasee) equipped with 7.5 MHz curvilinear array transducer. The same machine and transducer were used throughout the study.

lymph node (RIN) as shown in figure 5.1. For each mammary gland, the scanning was done transversely both cranial and caudal to the teat and sagittally on both lateral and medial sides of the teat with the transducer's crystal face held perpendicular to and in contact with the skin. The transducer was moved gently for about 3-5 cm away from the teat in both transverse and sagittal planes depending on the size of the dog. To image the superficial inguinal lymph node, the transducer was placed in the inguinal region just caudal and lateral to the inguinal mammary gland with the hind limb elevated. The femoral artery and vein were used as a marker to locate the superficial inguinal lymph node. Similarly, to image the axillary lymph node, the transducer was placed in the axillary region with the fore limb elevated. The axillary artery and vein were used as a marker to locate the axillary lymph node. The transducer was adjusted caudally and cranially until the lymph node was identified. The lymph nodes were assessed ultrasonographically for their size and echogenicity. Echogenicity of the lymph nodes was compared with that of the surrounding fatty tissue and described as being hypoechoic or isoechoic. Measurements where appropriate were obtained by freezing the images on the scanner monitor and then measured using the electronic calliper. Time taken to complete each examination was recorded. The result and comments on each dog were referred to the consulting surgeon for further action. After three to five months the animals were re-called for re-scanning to see whether there was evidence of tumour tissue remaining after surgery. All the scanned images were recorded on super VHS tape during examinations using a Panasonic VHS video recorder. The recorded images were later reviewed. The best images were labelled and thermal copies were printed during the review.

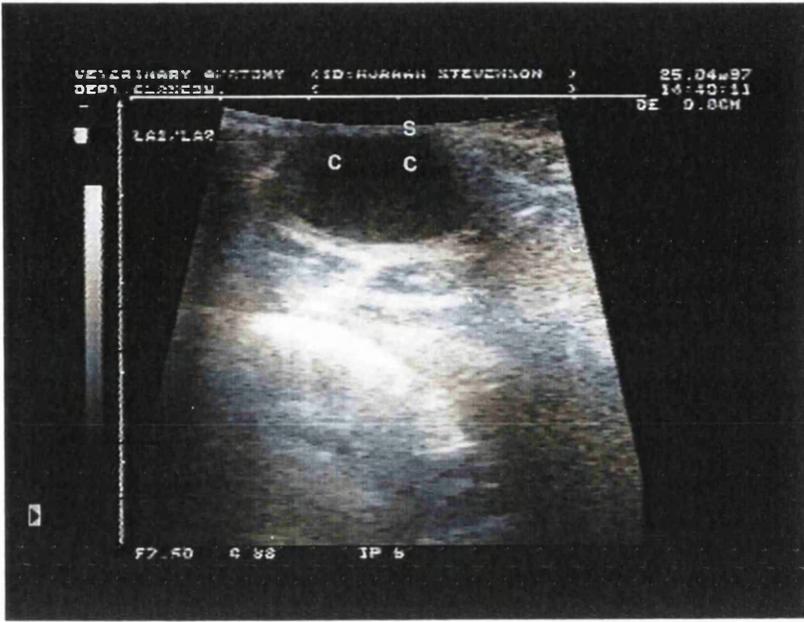
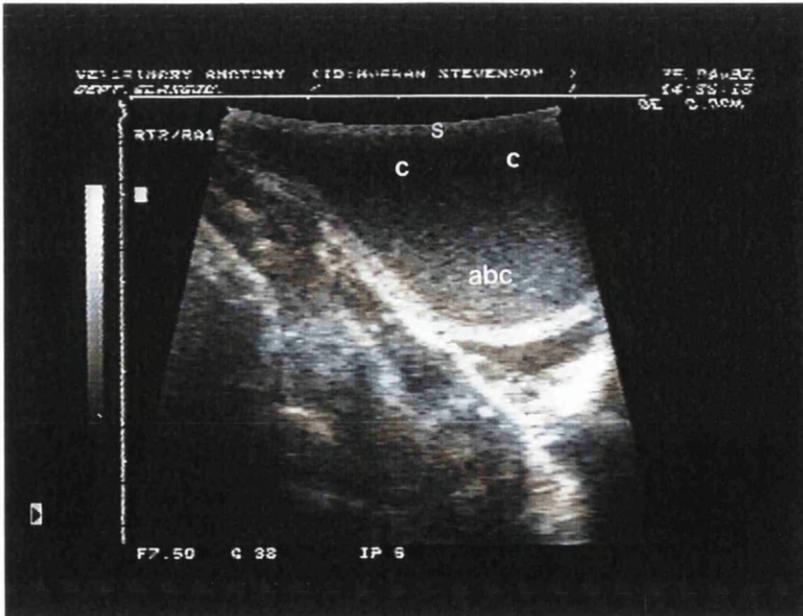
Figure 5.2 Ultrasonographic appearance of the masses (a) between LA1 and LA2, and (b) between RT2 and RA1 in one and half year old bitch (case 22). Note the mass between LA1 and LA2 appears cystic and well encapsulated and the mass between RT2 and RA1 appears to have more organised echotexture and is well encapsulated which suggests abscess formation. **s**, skin, **c**, cyst, **abc**, abscess

Two bitches (cases 20 and 21) were presented in this study with suspicion of having mammary tumours but later were found to be free of mammary tumours by both palpation and ultrasonography. Case 20 was presented because there was a firm swelling at the xyphoid area but ultrasonographic examination found that it did not involve mammary tissue but demonstrated a well encapsulated firm swelling which produced an image of homogenous echotexture at the xyphoid area. Case 21 was presented with swollen masses between LA1 and LA2 and between RT2 and RA1 which were found not to involve mammary tissue on palpation and ultrasonographic examination. The swelling between LA1 and LA2 appeared cystic and well encapsulated with flocculent content and the mass between RT2 and RA1 appeared to have a more organised echotexture and be well encapsulated which suggested abscess formation (figure 5.2).

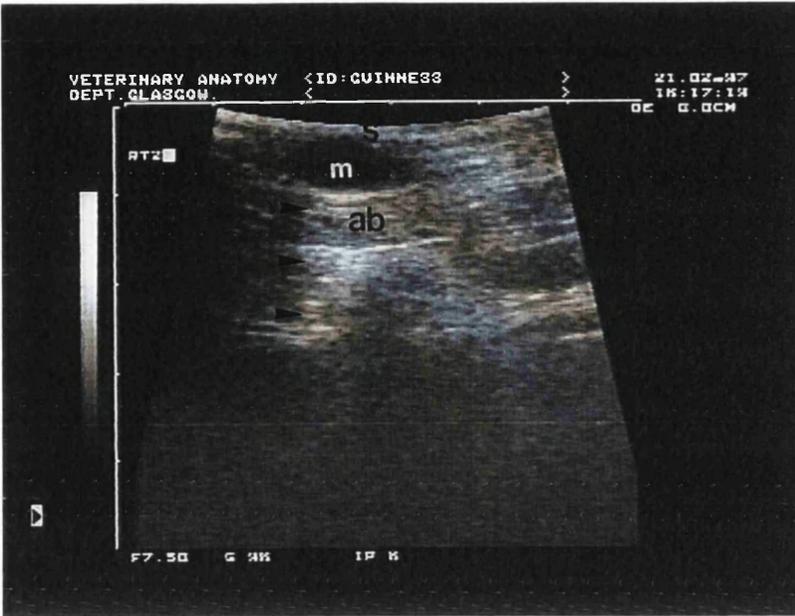
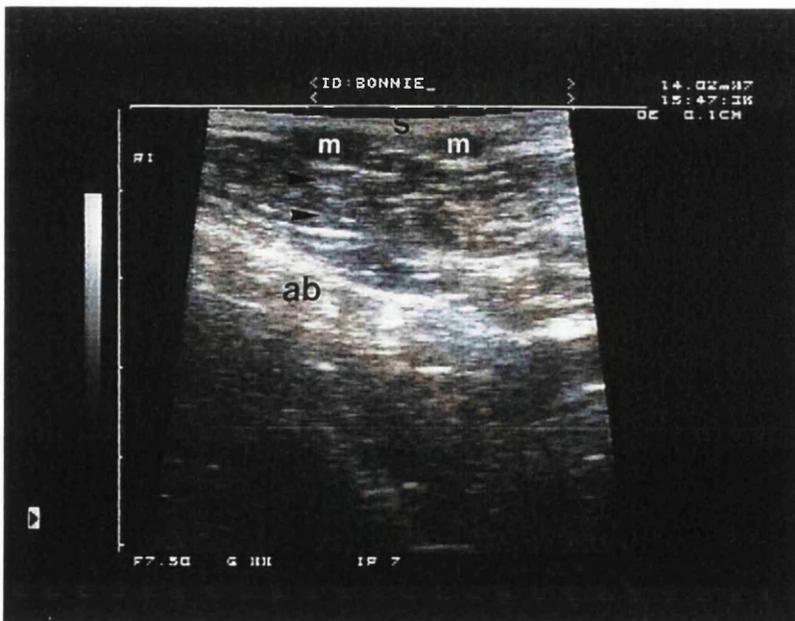
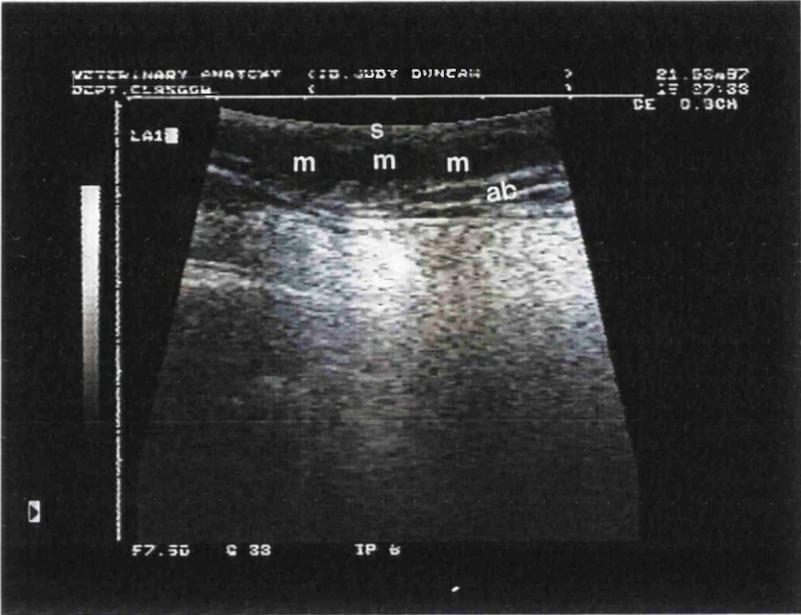
Figure 5.3 Ultrasonographic appearance of the mammary tumours representing group one (**a**, **b**, **c**). The areas of tumour tissue are small and appear anechoic to hypoechoic with ill-defined margins. They produce acoustic enhancement artefact (arrow heads). **s**, skin, **ab**, abdominal muscle, **m**, tumour tissue.

For the purpose of this study, the tumours found in the mammary gland were classified into three groups according to their ultrasonographic appearance. Group one was represented by areas of tumour tissue which appeared anechoic to hypoechoic (figure 5.3). The tumour masses were small and varied from 0.4 cm to 1.3 cm in diameter (average 0.8 cm) with an ill-defined margin. Group two was represented by areas of tumour tissue appearing as areas of mixed echotexture. They are hypoechoic relative to surrounding tissues but contain
