**AN ULTRASONOGRAPHIC STUDY OF MUSCULOSKELETAL
INJURIES AND MAMMARY GLAND TUMOUR IN SMALL
ANIMALS**

A thesis submitted to the Faculty of Veterinary Medicine,
University of Glasgow.

For the Degree of Doctor of Philosophy

Division of Veterinary Anatomy,
Department of Veterinary Preclinical Studies,
School of Veterinary Medicine,
University of Glasgow,
March, 1999

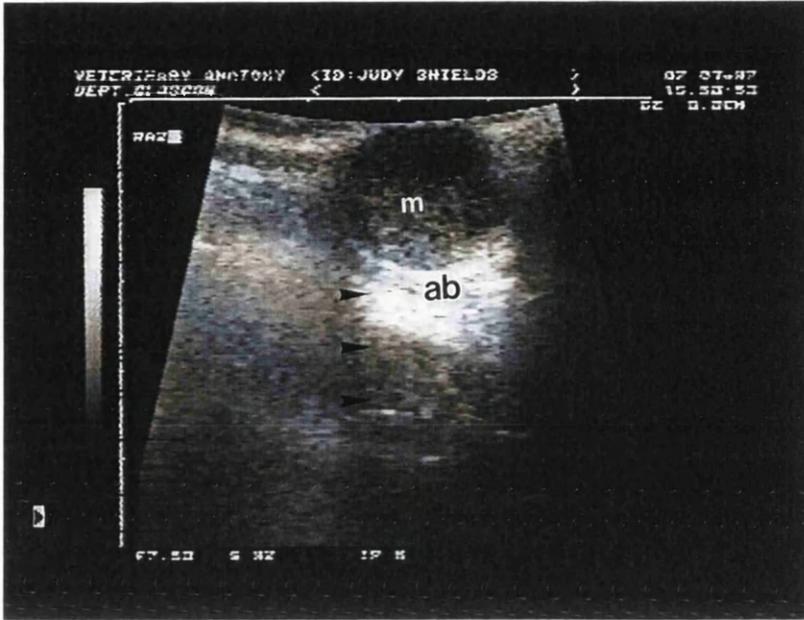
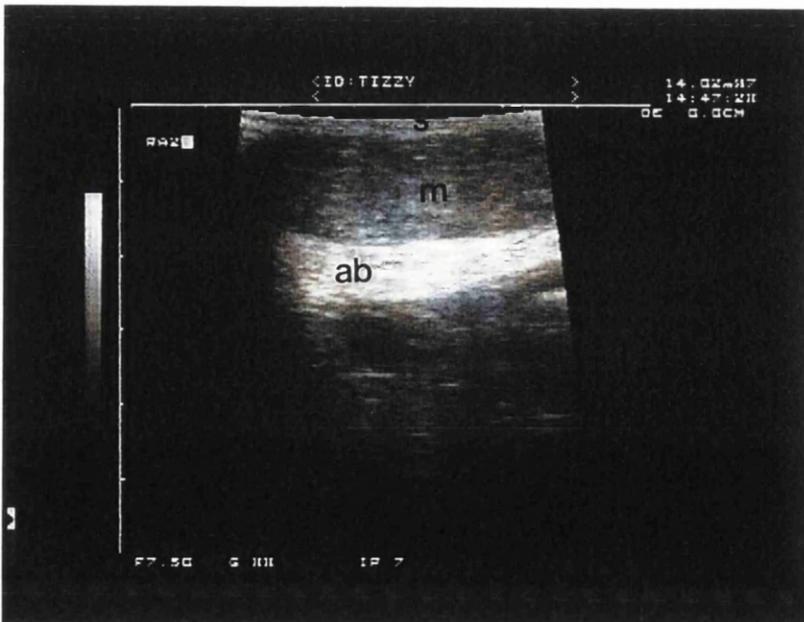
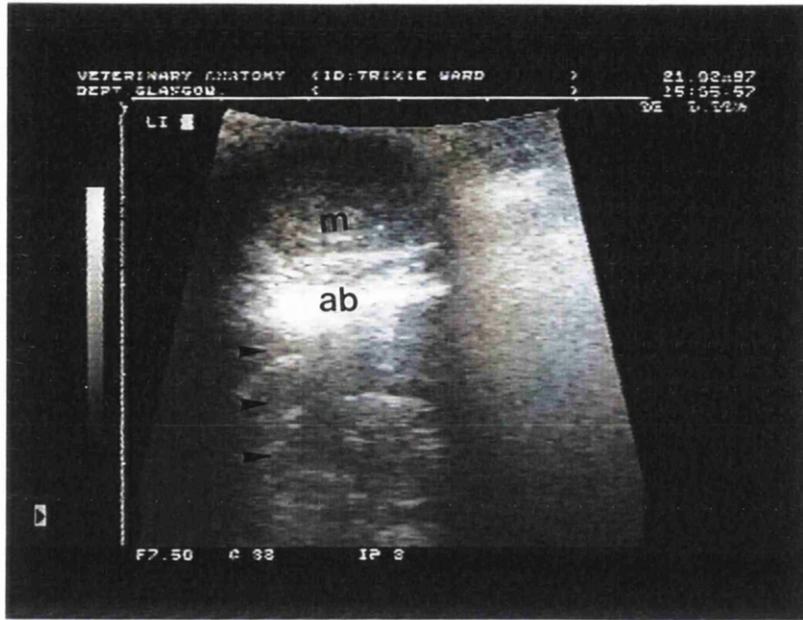
Figure 5.4 Ultrasonographic appearance of the mammary tumours representing group two (**a**, **b**, **c**). The areas of tumour tissue are large and appear as areas of mixed echotexture. They are hypoechoic relative to the surrounding tissues but contain hyperechoic speckling scattered throughout the parenchyma. Note also that the tumour tissue produces acoustic enhancement artefact (arrow heads). **s**, skin, **m**, tumour tissue, **ab**, abdominal muscle.

hyperechoic speckling scattered throughout the parenchyma (figure 5.4). They varied in size from 0.5 cm to approximately 5.0 cm in diameter. Group three was represented by areas of tumour tissue which were large and appeared hyperechoic (figure 5.5a). In many cases they contained discrete anechoic regions indicating cystic structures (figure 5.5b,c). The tumour masses were large and varied from 2.0 cm to approximately 5.0 cm in diameter with well-defined margins. Acoustic enhancement artefact was the most prominent feature for all groups of tumour masses as in figure 5.2 and 5.3. Tumour masses with calcification were found in cases 23 and 26, and appeared as disorganised hyperechoic accumulations with acoustic shadowing within the hypoechoic masses (figure 5.6). The incidence of mammary gland tumours classified ultrasonographically is given in table 5.6. Group one was the most commonly encountered tumour while group three was the least commonly encountered tumour in this study.

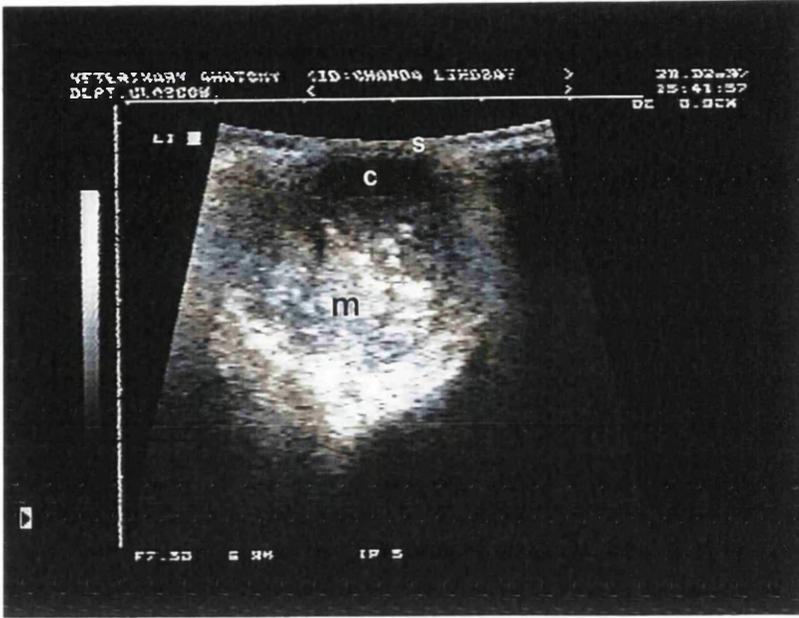
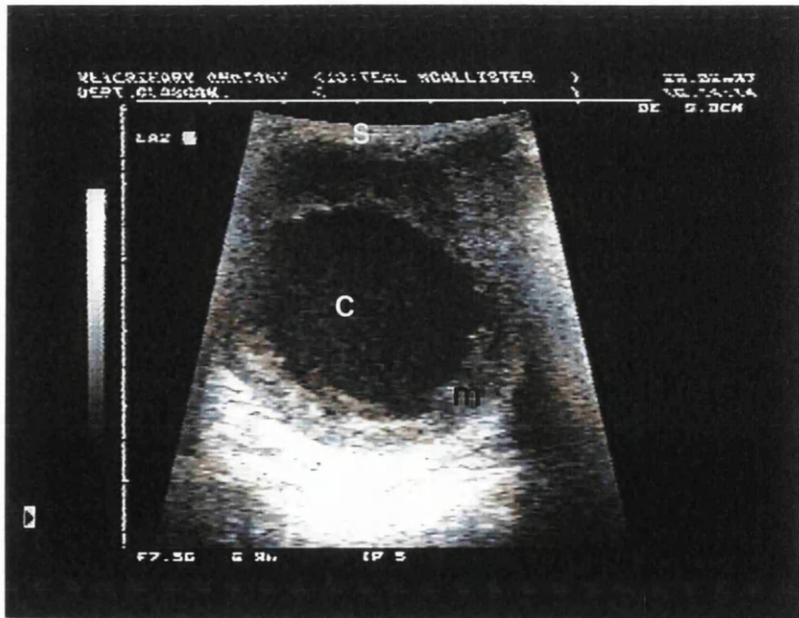
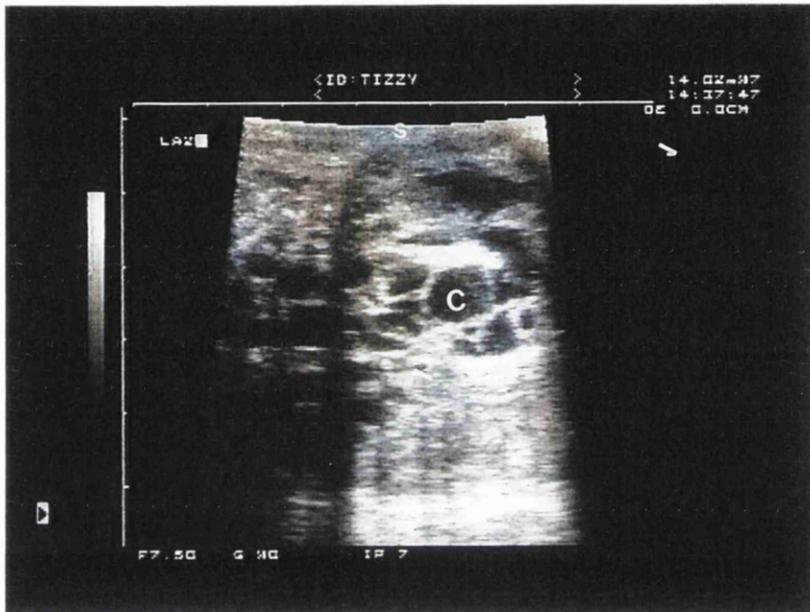
Figure 5.5 Ultrasonographic appearance of the mammary tumours representing group three (**a**, **b**, **c**). The areas of tumour tissue are large and appear hyperechoic. In many cases they contained discrete anechoic regions indicating cystic structures. **s**, skin, **m**, tumour tissue, **c**, cyst.

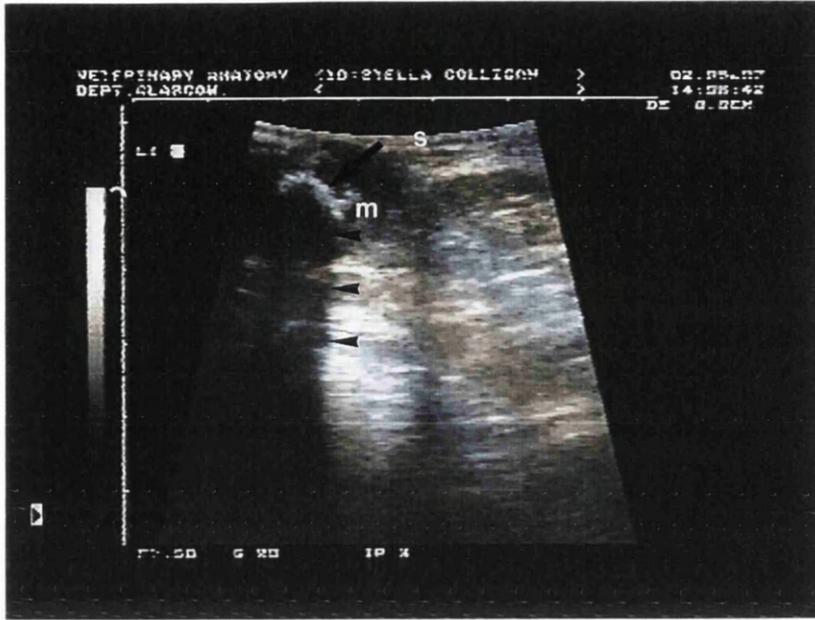
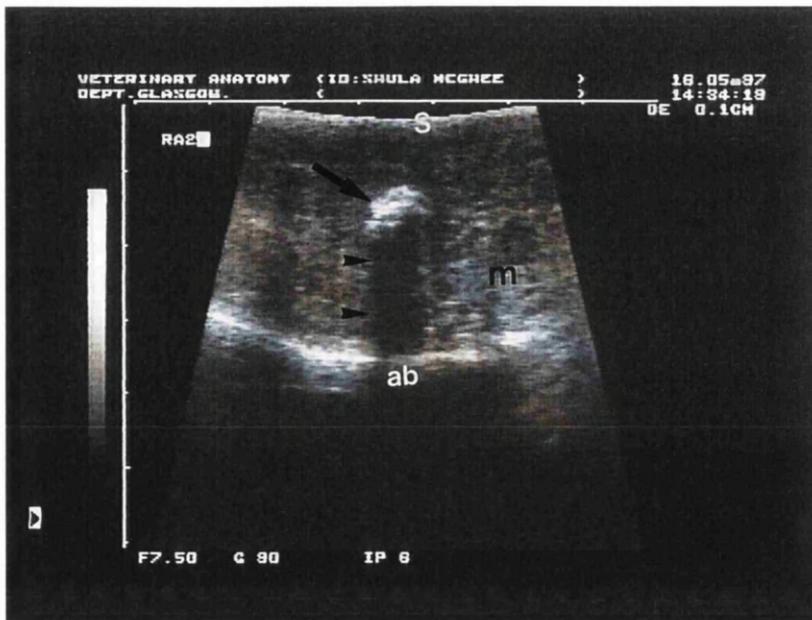
Figure 5.6 Ultrasonographic images of (a) tumour of the left inguinal mammary gland in case 23, and (b) tumour of the right caudal abdominal mammary gland in case 26. Note the hyperechoic accumulations of calcified tumour tissue (arrow) with acoustic shadowing within the hypoechoic parenchyma mass (arrow heads). The mammary tumours were removed by surgery in both cases. The rescan result three months later showed no tumour mass was found in case 23. Unfortunately, case 26 failed to return for a rescan. **s**, skin, **m**, tumour tissue, **ab**, abdominal muscle.

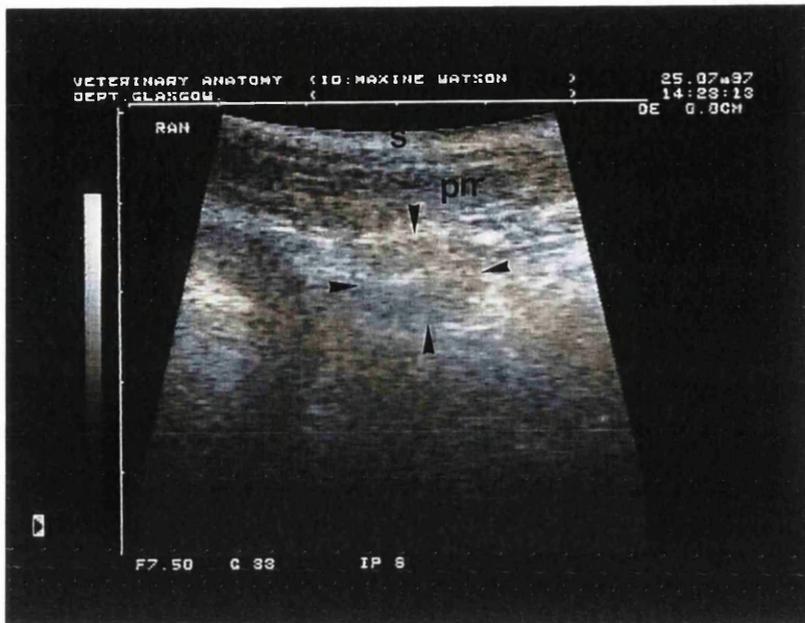
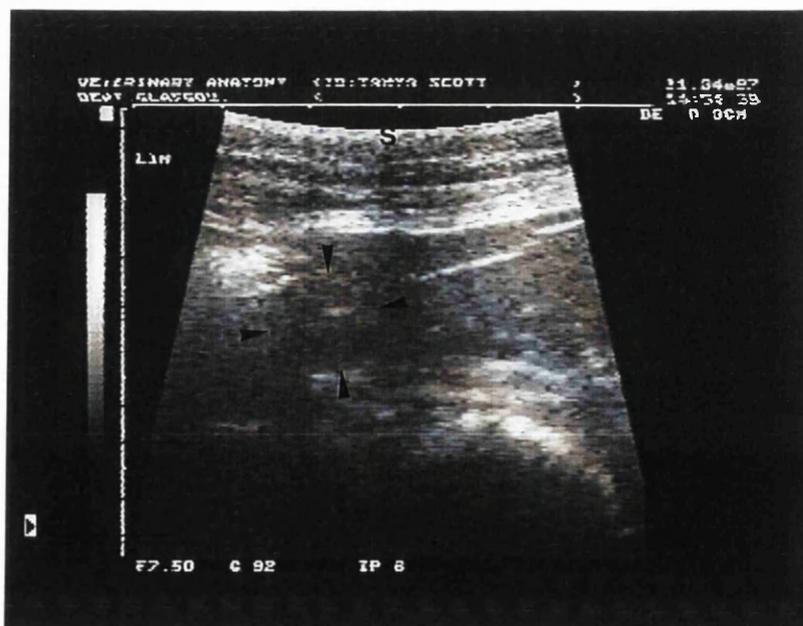
Figure 5.7 Ultrasonographic images of the normal (a) right axillary lymph node, RAN in case 19, and (b) left superficial inguinal lymph nodes, LIN in case 17. The normal superficial lymph nodes appear rounded and isoechoic to hypoechoic structures relative to the surrounding soft tissue (arrow heads). **s**, skin, **pm**, pectoral muscle.

The normal axillary and superficial inguinal lymph nodes imaged ultrasonographically appeared as round hypoechoic to isoechoic structures relative to surrounding soft tissues (figure 5.7). The enlarged abnormal regional lymph nodes found in this study were varied in echogenicity from homogeneously hypoechoic structures (figure 5.8a,b), mixed echotexture (figure 5.8c) to more echogenic echotexture relative to surrounding soft tissues (figure 5.8d).

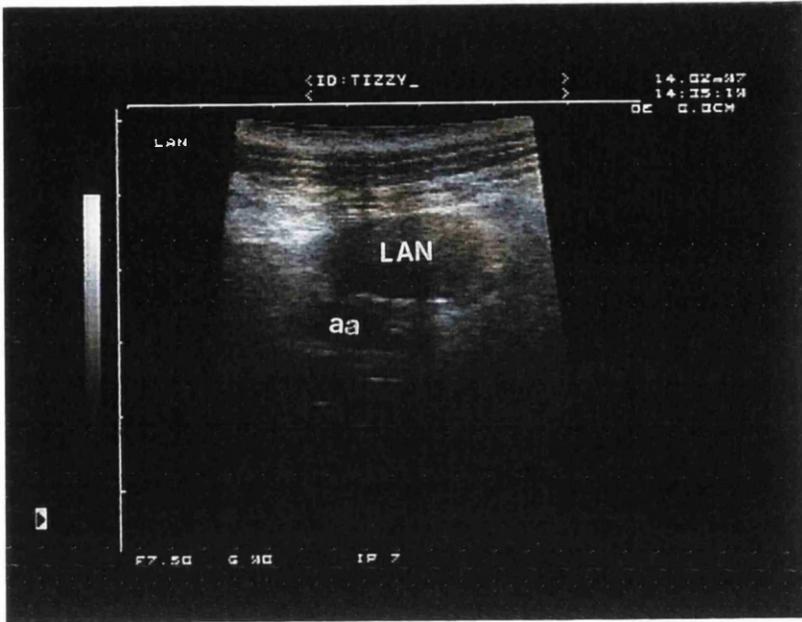
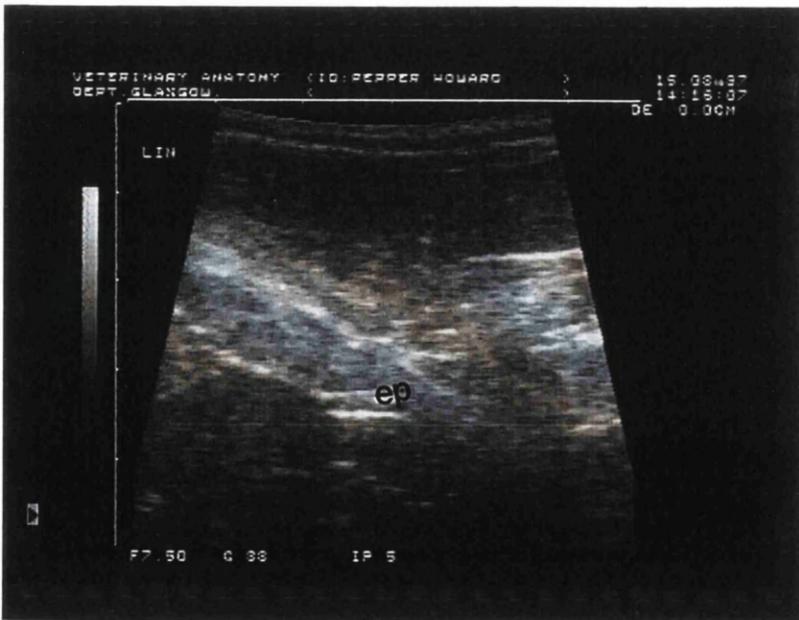
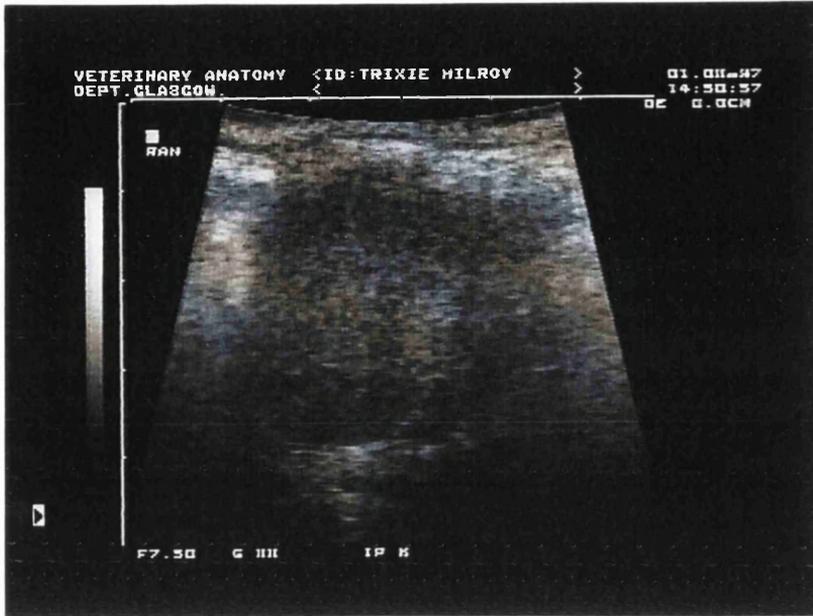
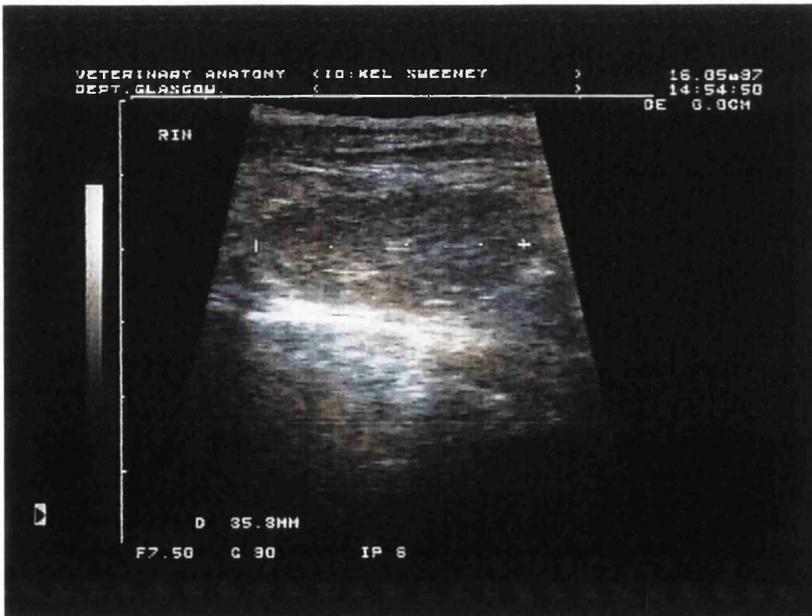
Figure 5.8 Ultrasonographic images of the abnormal enlarged left axillary lymph nodes, LAN in case 3 (a) and left superficial inguinal lymph node, LIN in case 6 (b). They appear as homogeneously hypoechoic structures relative to surrounding tissue. The right axillary lymph node, RAN in case 24 (c) appears to have a mixed echotexture with some anechoic areas, and the right superficial inguinal lymph node, RIN in case 25 (d) appears to have a more echogenic echotexture relative to its surroundings. **s**, skin, **aa**, axillary artery, **ep**, external pudendal artery.

Results of the re-scan and time interval between first scan and re-scan are given in table 5.3. Out of the 17 bitches re-scanned, six bitches had not undergone surgery, and the results of the re-scan after approximately three to five months showed findings similar to the previous scan in four bitches, while in two bitches (cases 6 and 18) the findings were dissimilar. In case 6, tumour of the LA1 and LA2 had increased in size from 1.0 cm (LA1) and 0.5 cm (LA2) to 1.6 cm for LA1 and 0.8 cm for LA2 (figure 5.9a,b), and the superficial inguinal lymph node (RIN) was found to be enlarged on re-scan (figure 5.9c). In case 18, small new superficial tumour masses size 0.7 cm and 0.4 cm in diameter were found in LA2 and RA1 respectively by both palpation and ultrasonography (figure 5.10). Fourteen cases had undergone surgery to remove the mammary gland tumours and the results of the re-scan failed to demonstrate any new tumour tissue in 11 cases, while in three cases (19, 22 and 25) the tumour tissues were still detected on both palpation and ultrasound examination. In cases 19 and 22, not all of the mammary gland tumours detected ultrasonographically were removed during surgery, resulting in positive findings on the rescan. In case 25, all the mammary gland tumours were removed but not the enlarged RAN. The re-scan image showed that the RAN was increased in size and had become more echogenic (figure 5.8d).

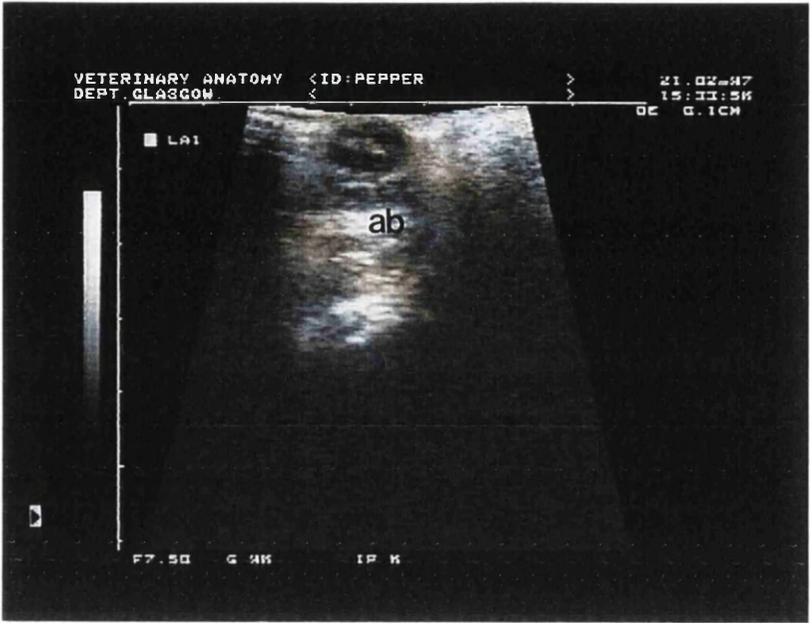
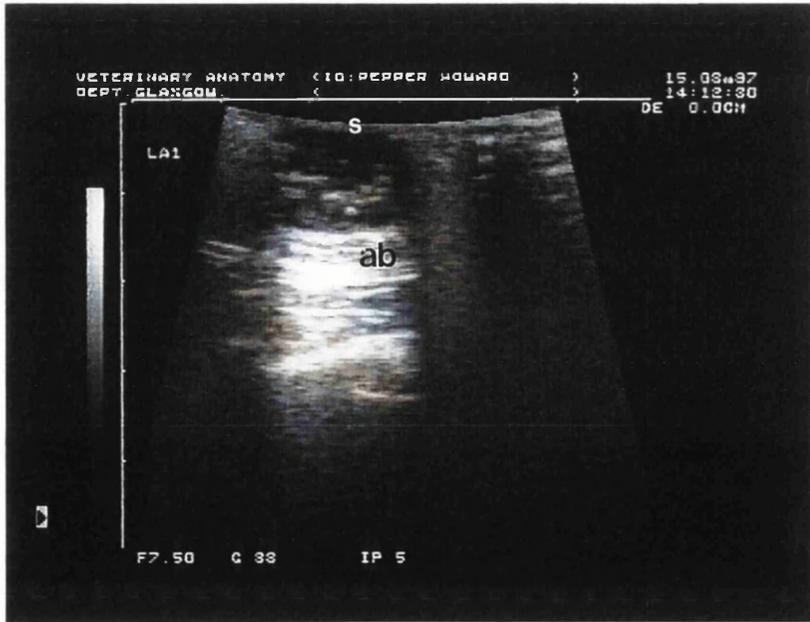
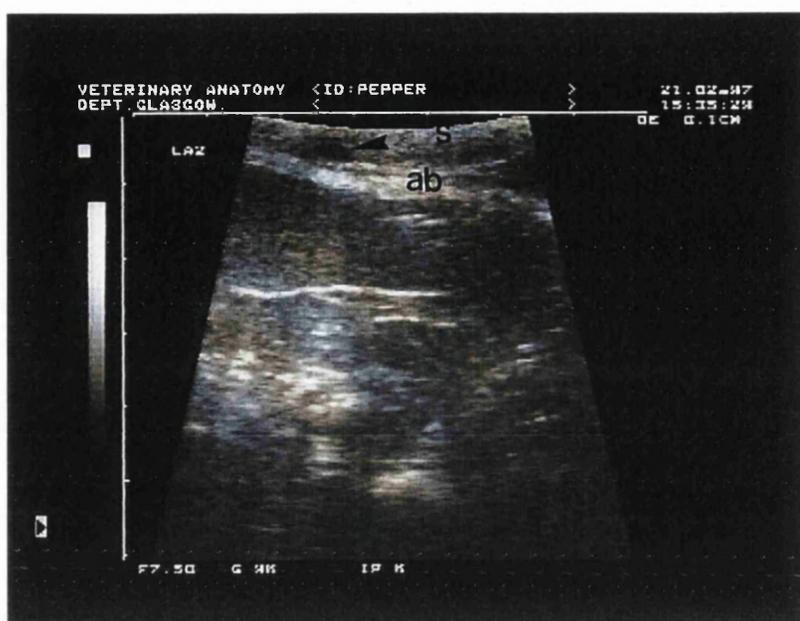
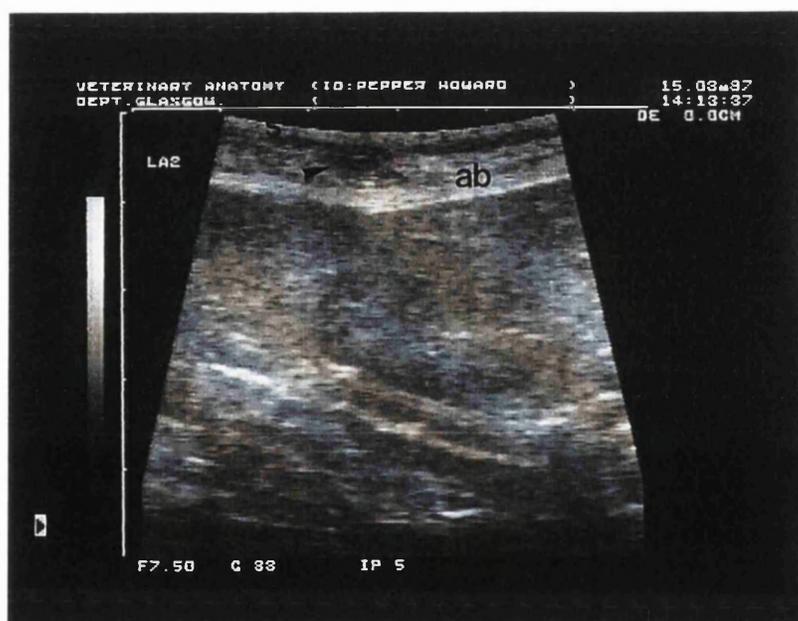
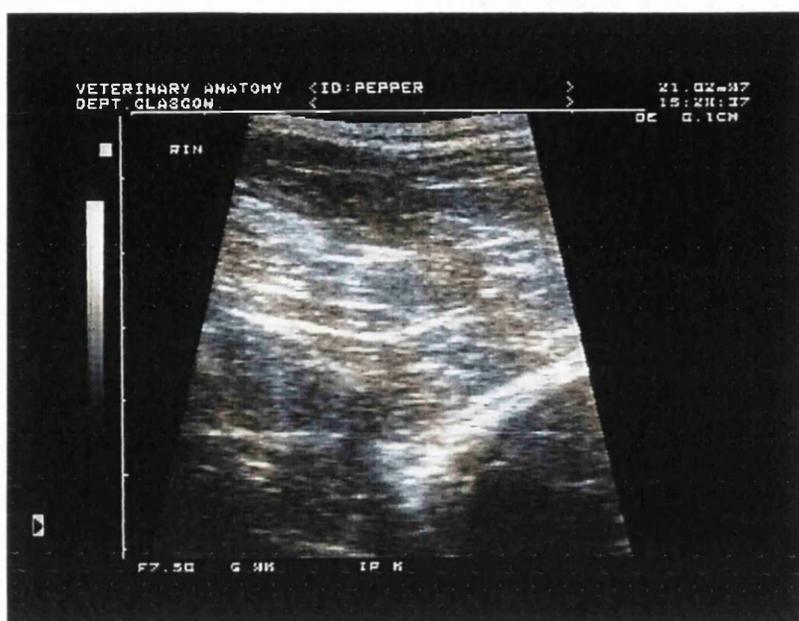
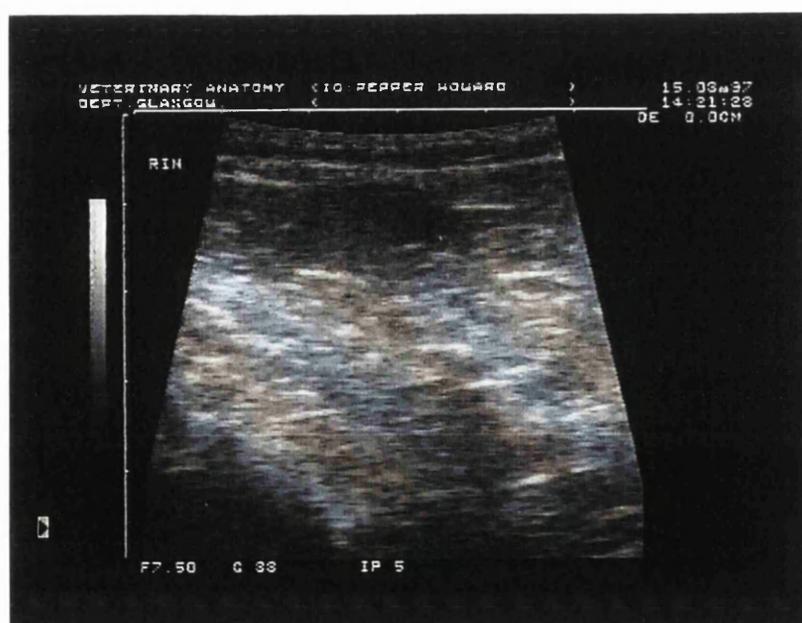
Figure 5.9 Ultrasonographic images of the left cranial abdominal mammary gland, LA1 (**a**, **a1**), left caudal abdominal mammary gland, LA2 (**b**, **b1**) and right superficial inguinal lymph node, RIN (**c**, **c1**) in a 12 year old cross breed dog with clinical evidence of mammary gland tumours (case 6). The tumour tissues have increased in size on the rescans from 1.0 cm (**a**) to 1.6 cm (**a1**) in LA1, and from 0.5 cm (**b**) to 0.8 cm (**b1**) in LA2 (arrow head). The echogenicity has not changed. The RIN is normal (1.4 cm in diameter) on the first scan (**c**) but is found to be enlarged (2.5 x 1.0 cm) (**c1**) on the rescans and appearing homogeneously hypoechoic with an ill defined margin. **s**, skin, **ab**, abdominal muscle.

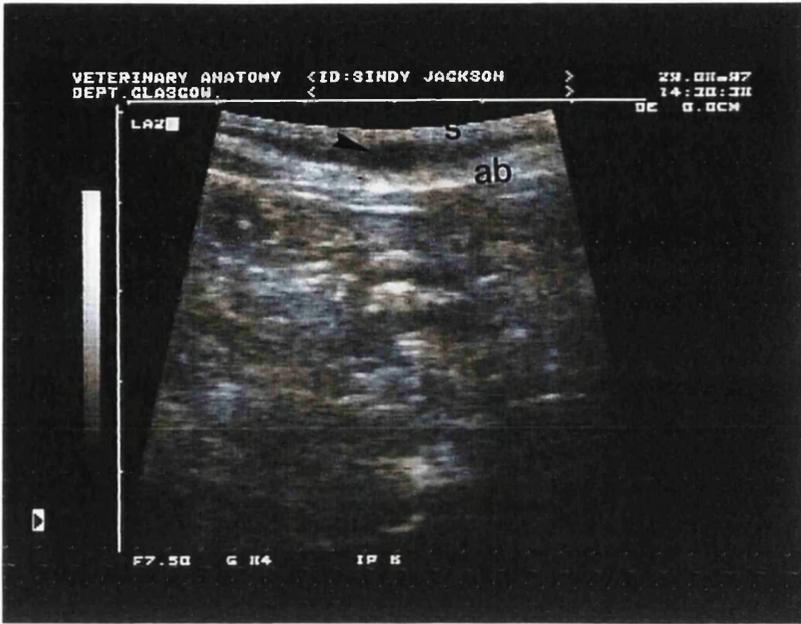
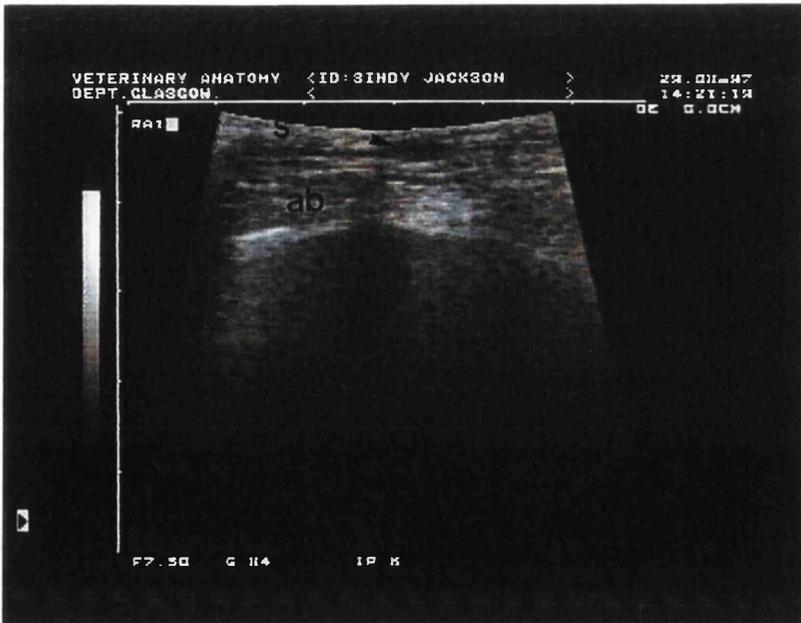
Figure 5.10 Ultrasonographic images of the tumour tissues in the left caudal abdominal mammary gland, LA2 (a) and the right cranial abdominal mammary gland, RA1 (b) in a nine year old bitch (case 18). Small areas of tumour tissue (arrow head) were detected on the rescan and appearing hypoechoic with an ill-defined margin. **s**, skin, **ab**, abdominal muscle.

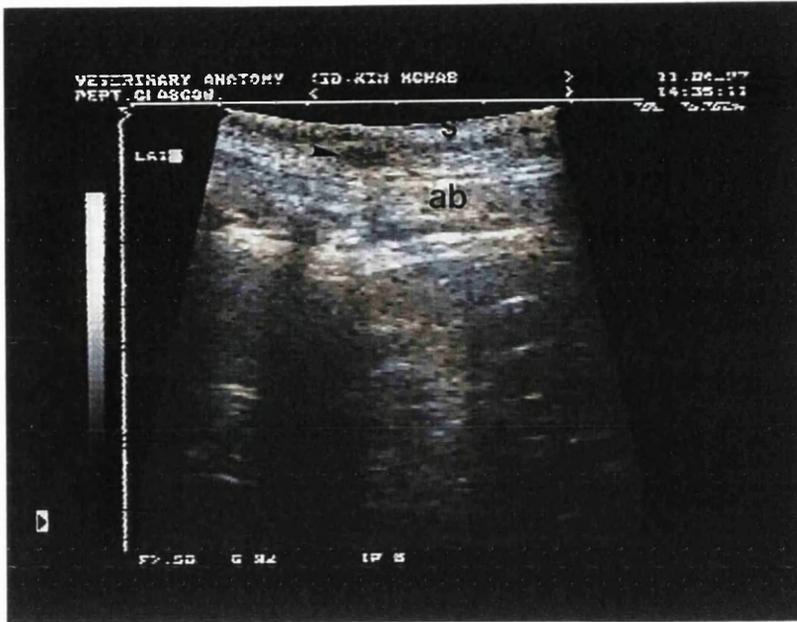
Figure 5.11a

Figure 5.11 Ultrasonographic images of the tumour tissues in the left cranial abdominal mammary gland, LA1 in case 16 (a) and the right cranial abdominal mammary gland, RA1 in case 10 (b) which were not detected by palpation. Note the areas of tumour tissue are small (arrow head) and appear hypoechoic with an ill-defined margin. **s**, skin, **ab**, abdominal muscle.

The ultrasonographic images of the mammary tumour tissue not detected on palpation appeared hypoechoic with an ill-defined margin (figure 5.11). They were small in size (0.4 cm to 1.3 cm) and were classified as being of group one type. Six regional lymph nodes which were found to be enlarged and hypoechoic with an ill defined margin on the first scan were found to be negative on re-scan after the mammary gland tumours had been removed. The approximate time taken for scanning each dog was 15 minutes with a major portion of time being spent on imaging the axillary and superficial inguinal lymph nodes.

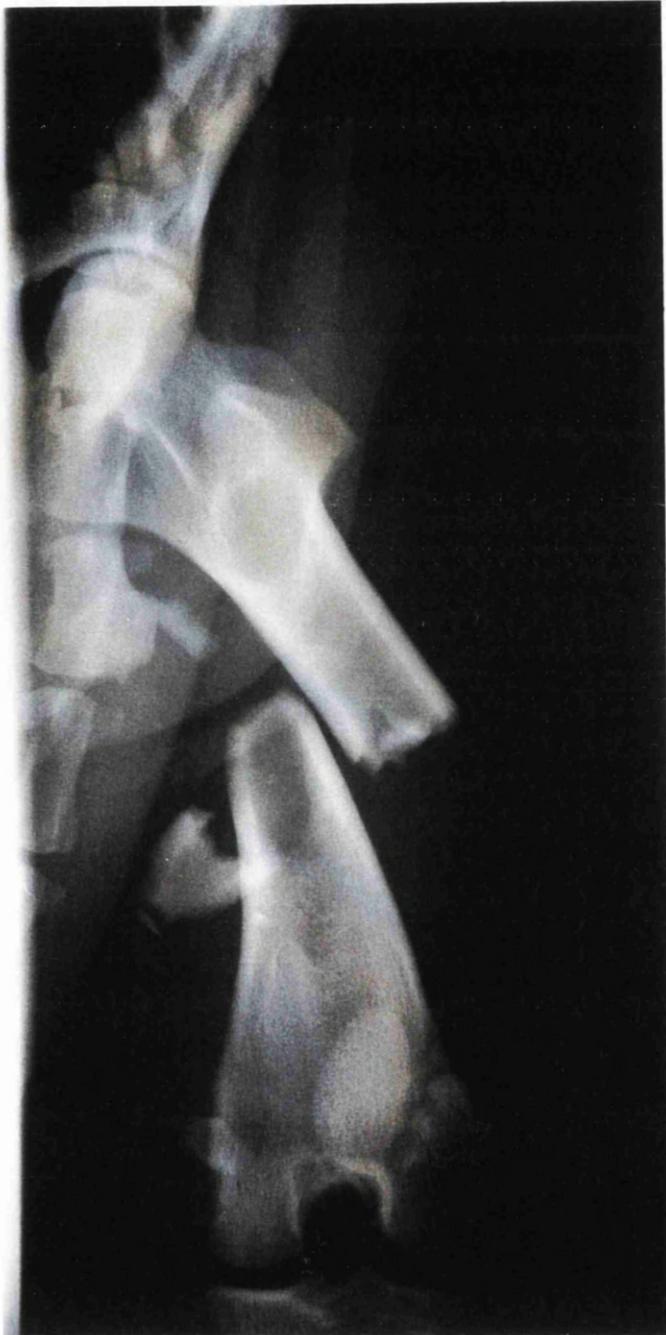
Figure 6.1.1 A 16 months old English Pointer was hit by a car. There is a comminuted fracture involving the mid-shaft of the left femur with caudo-proximal displacement of the distal fragment.

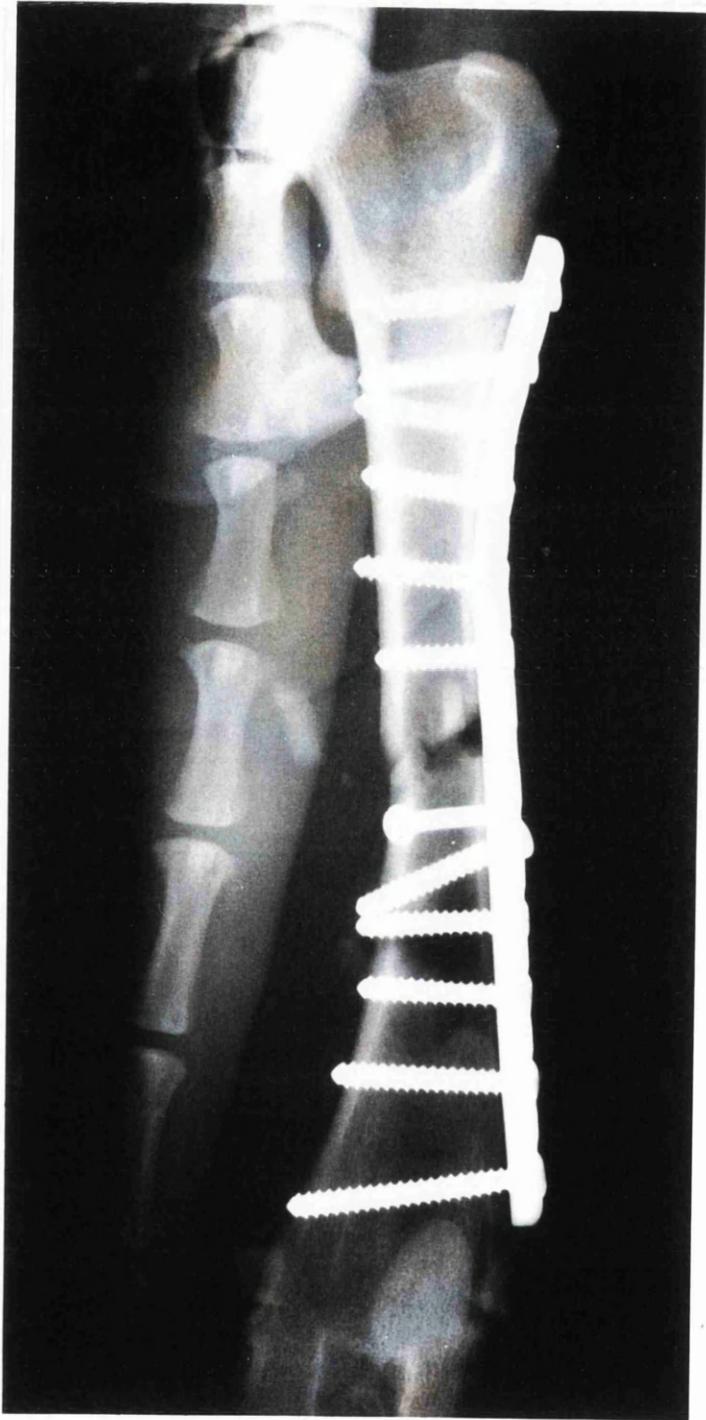
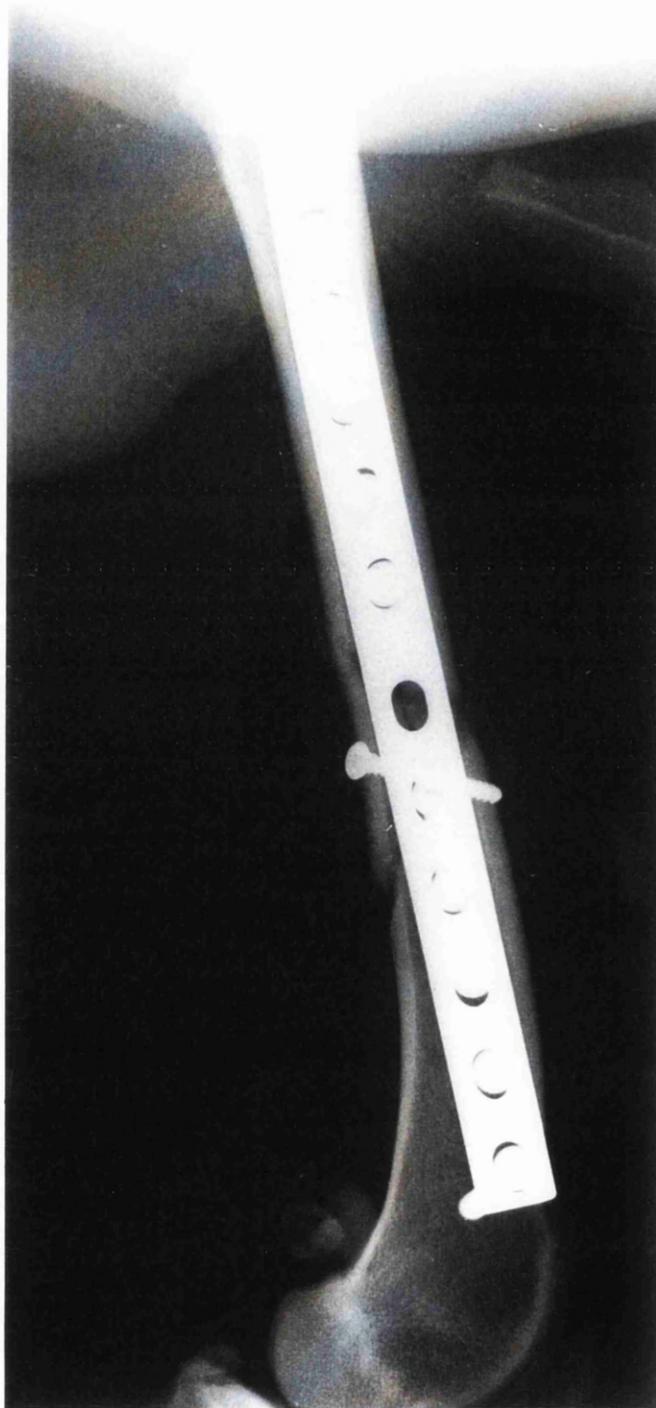
Figure 6.1.2 Radiographs obtained immediately after fracture repair, **a**, cranial view, and **b**. lateral view, show that the comminuted fracture has been repaired using one lag screw in addition to a bone plate and 11 screws. One small fragment remains cranio-medially displaced. There is a small gap at the fracture site.

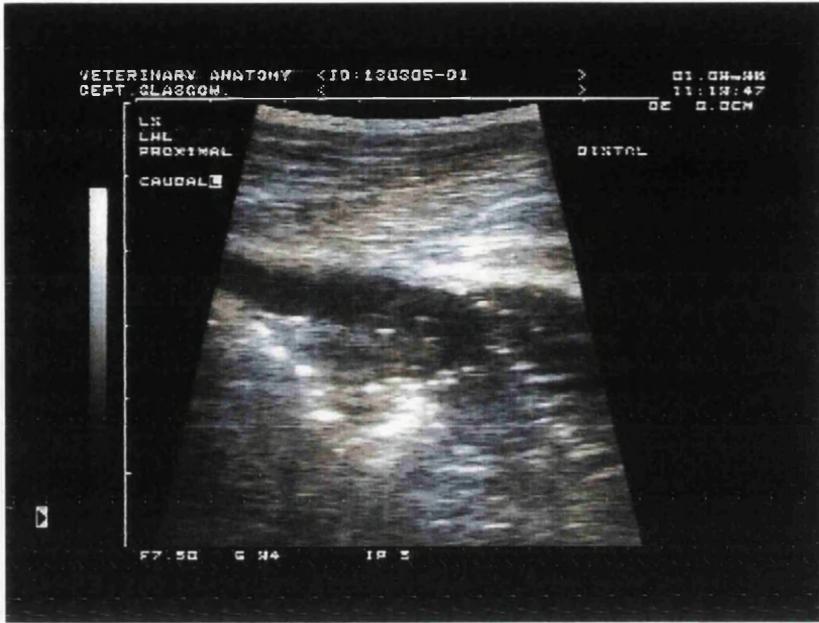
Figure 6.1.3 A large haematoma within the muscle caudal to the femur imaged 24 hours after surgery. Ultrasonographic examination revealed a large hypoechoic area with some hyperechoic dots present at the base of the haematoma which may represent the connective tissue fascias.

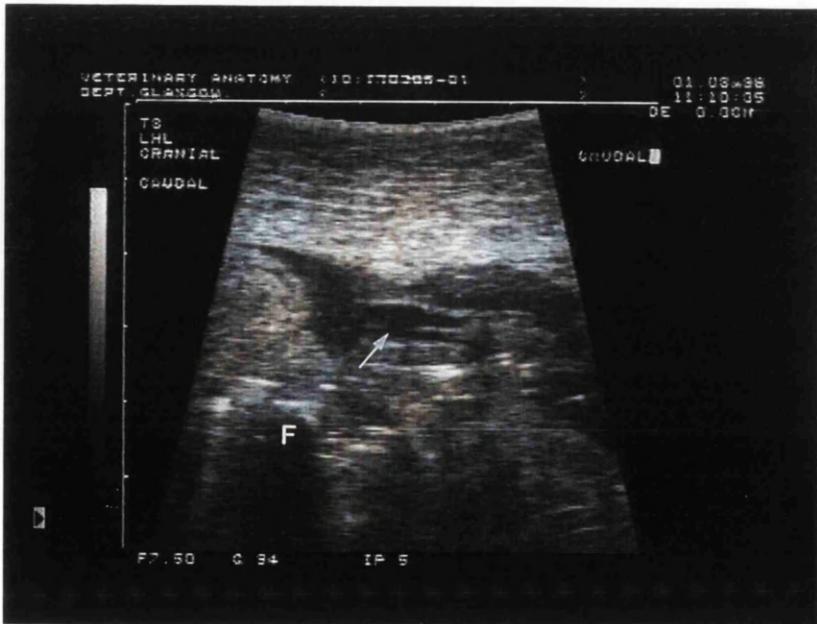
Figure 6.1.4 The ruptured blood vessel (arrow) can be seen within the large haematoma imaged 24 hours after surgery and was pulsating during scanning. F, femur

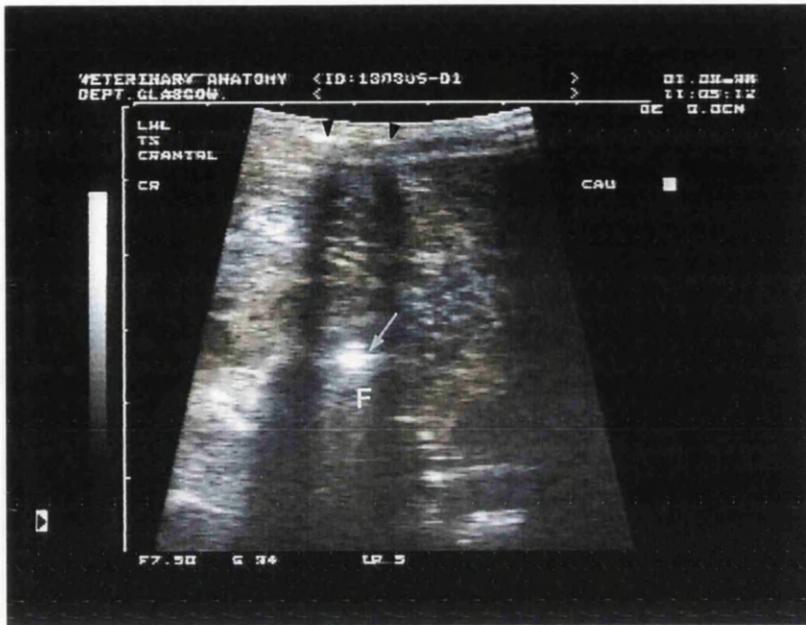
Figure 6.1.5 Suture materials within the muscle near the skin surface scanned on day one after surgery appear as thin hyperechoic lines (arrow heads) and produce acoustic shadowing artefacts. Note also the hyperechoic bone plate attached to the femur (arrow). F, femur

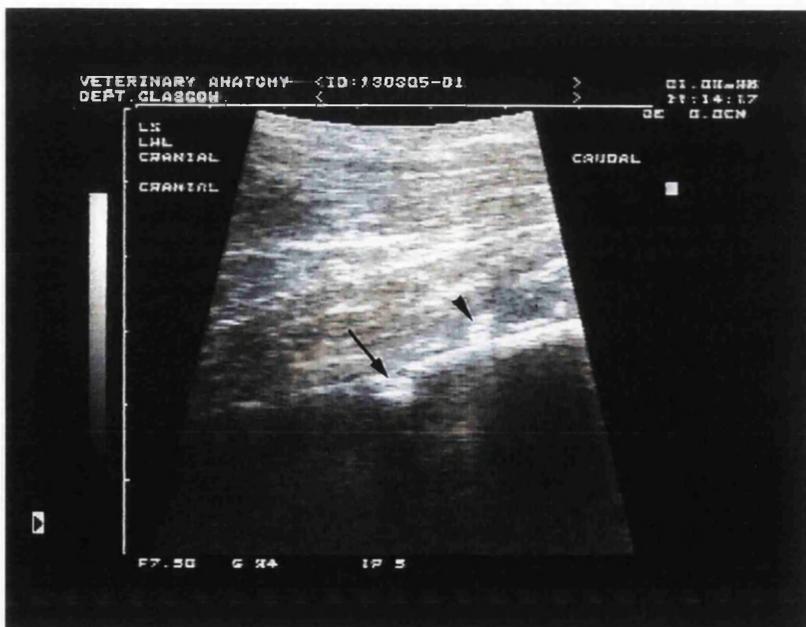
Figure 6.1.6 Longitudinal scan from the cranial aspect of the femur 24 hours after surgery demonstrates the fracture site which appears as discontinuity of the smooth bone surface (arrow). A small gap is present at the fracture site. The screw is also imaged some distance away from the fracture site (arrow head).

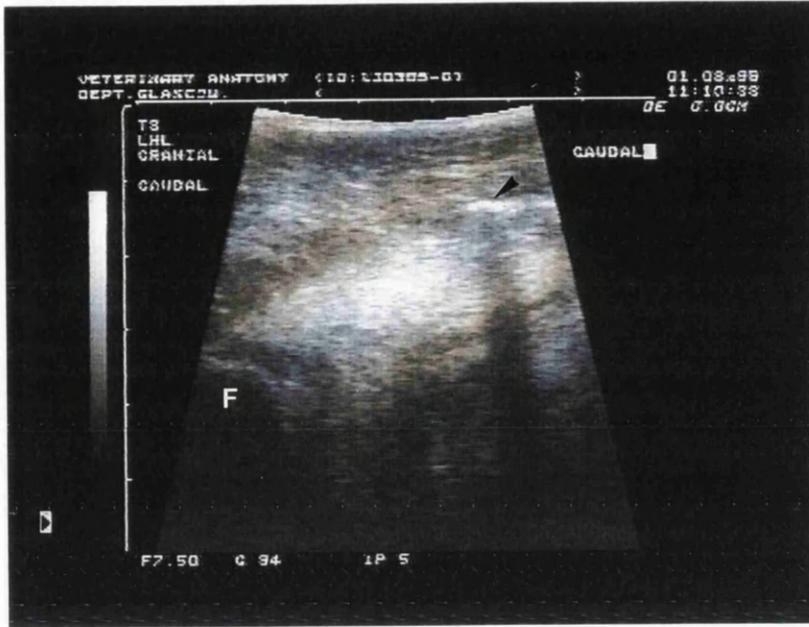
Figure 6.1.7 The small bone fragment within the muscle placed caudal to the femur (arrow head) imaged 24 hours after surgery appears hyperechoic and is producing acoustic shadowing artefact. F, femur

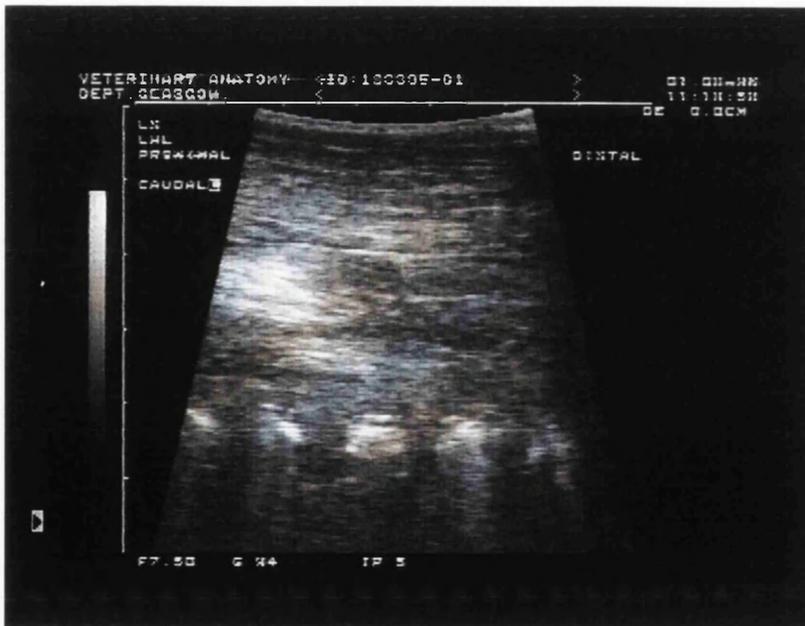
Figure 6.1.8 Longitudinal scan from the caudal aspect of the femur 24 hours after surgery demonstrates the intermittent hyperechoic line which represents the screws used in the bone fracture reduction.

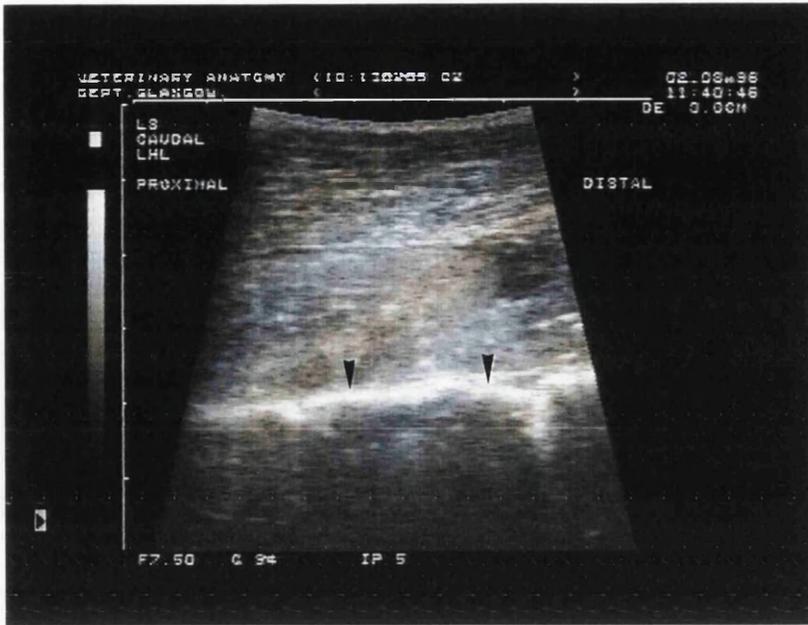
Figure 6.1.9 Longitudinal scan from the caudal aspect of the femur 48 hours after surgery demonstrates the fracture site which appears hyperechoic. The overall hyperechoic appearance of the femoral surface is likely due to the high gain setting. Note also the bone fragment, attached to the main bone, can be recognised (arrow heads).

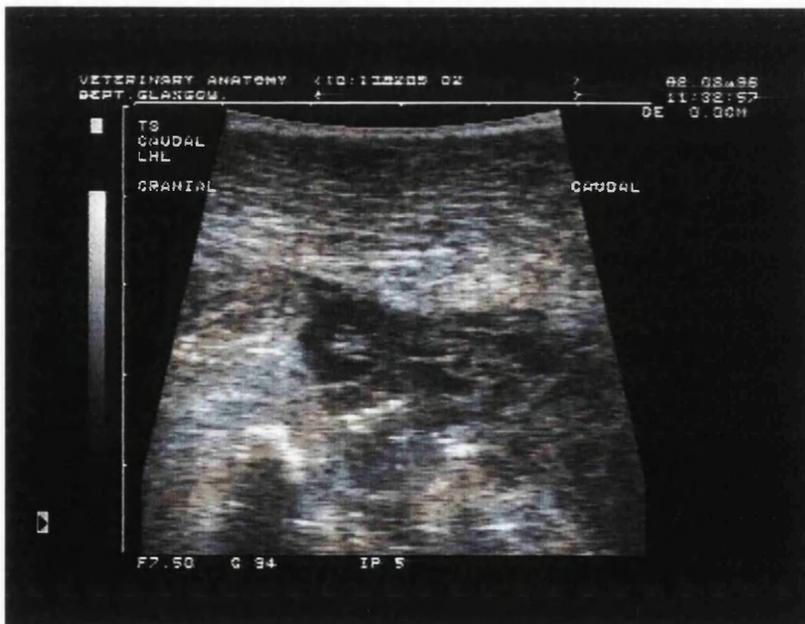
Figure 6.1.10 The large haematoma within the muscle scanned on day two post-operation appears as a disorganised hypoechoic area with the presence of echogenic material within the haematoma area.

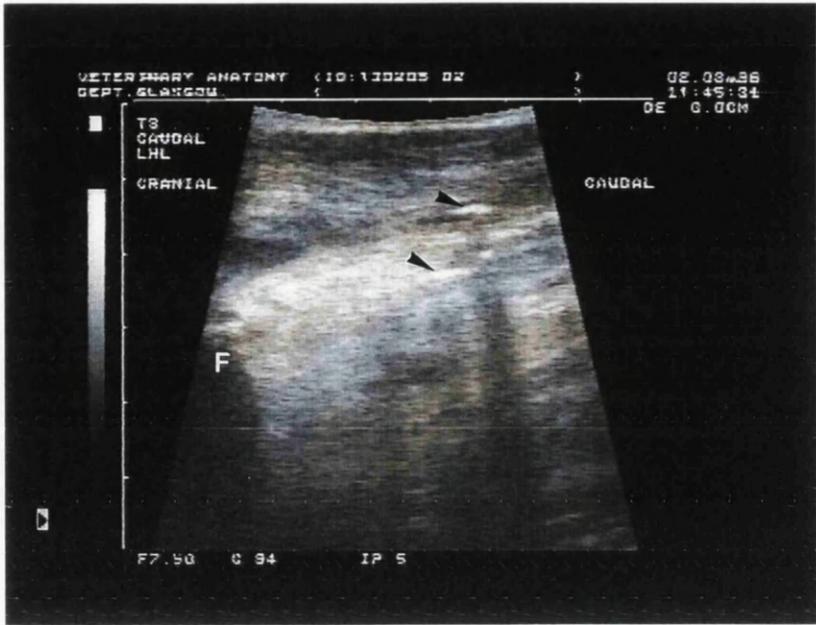
Figure 6.1.11 Transverse scan from the caudal aspect of the femur 48 hours post-operation demonstrates the two small bone fragments placed caudal to the femur (arrow heads). Note that the two small bone fragments appear hyperechoic with acoustic shadowing artefacts. They also appear smaller than on the day one examination. F, femur

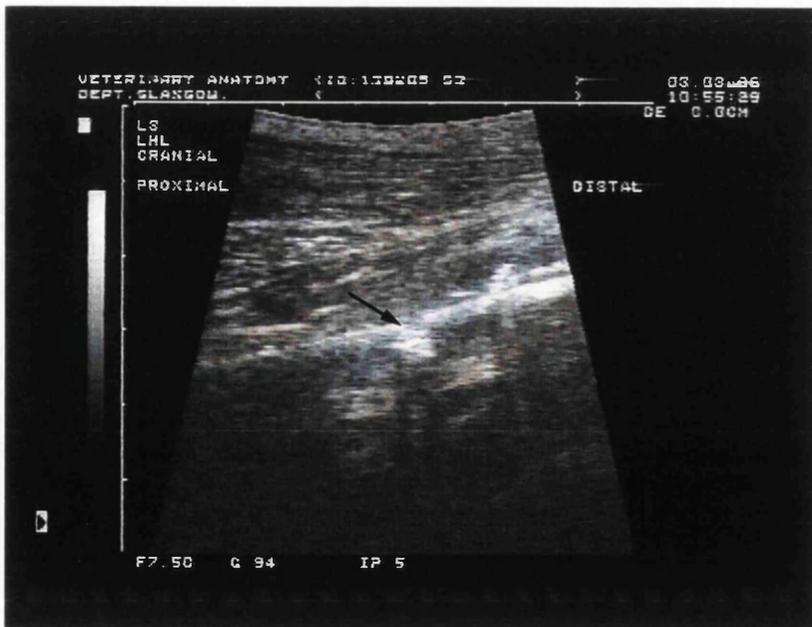
Figure 6.1.12 Longitudinal scan from the cranial aspect of the femur on day three post-operation demonstrates the fracture site (arrow) which still has no periosteal reaction detected.

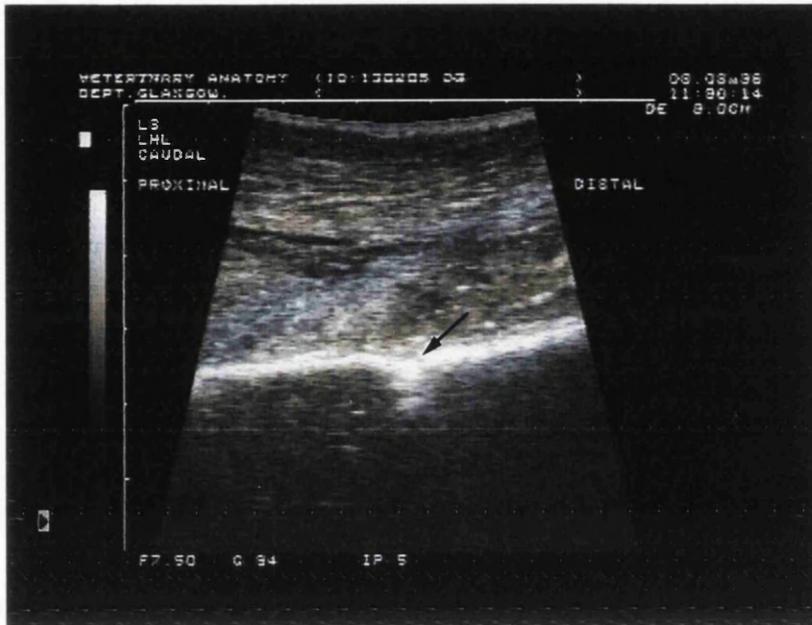
Figure 6.1.13 Longitudinal scan from the caudal aspect of the femur on day three post-operation demonstrates the fracture site which appears to have some periosteal reaction as shown by the hyperechoic appearance (arrow). Note also the area of muscle damage above the femur that appears disorganised and has lost its normal ultrasonographic characteristics.
