**AN ULTRASONOGRAPHIC STUDY OF MUSCULOSKELETAL
INJURIES AND MAMMARY GLAND TUMOUR IN SMALL
ANIMALS**

A thesis submitted to the Faculty of Veterinary Medicine,
University of Glasgow.

For the Degree of Doctor of Philosophy

Division of Veterinary Anatomy,
Department of Veterinary Preclinical Studies,
School of Veterinary Medicine,
University of Glasgow,
March, 1999

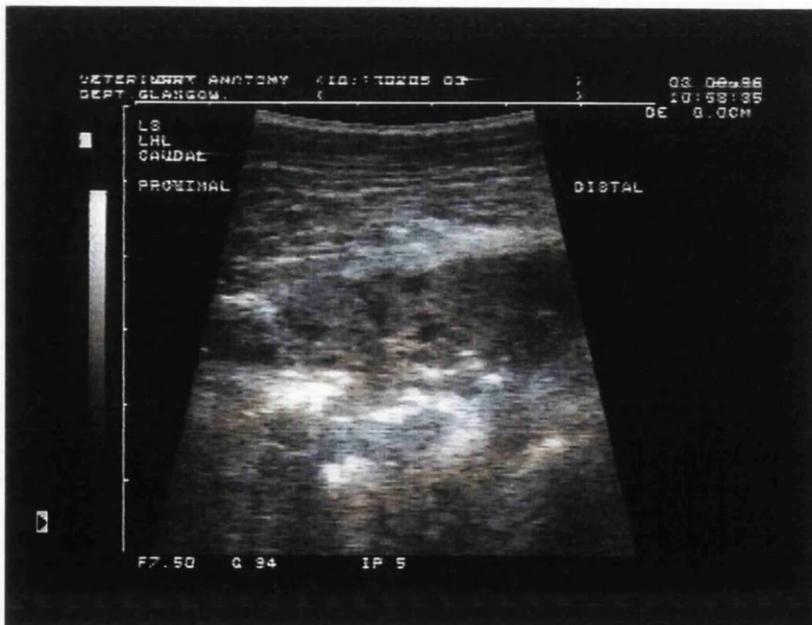
Figure 6.1.14 Ultrasonographic image of the haematoma within the muscle on day three post-operation. Note the haematoma has become more organised with the presence of more echogenic areas.

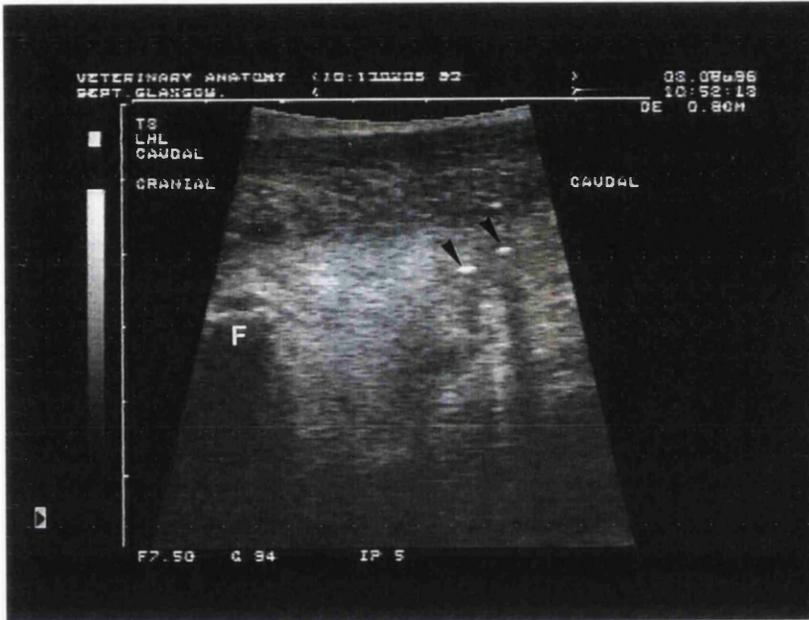
Figure 6.1.15 Ultrasonographic image from the caudal aspect of the femur on day three post-operation demonstrates the two small bone fragments (arrow heads) which appear as hyperechoic dots with acoustic shadowing artefacts. They appear smaller than on the day two examination. Note also the hypoechoic area surrounding the two small bone fragments which indicate the lysis process. **F**, femur

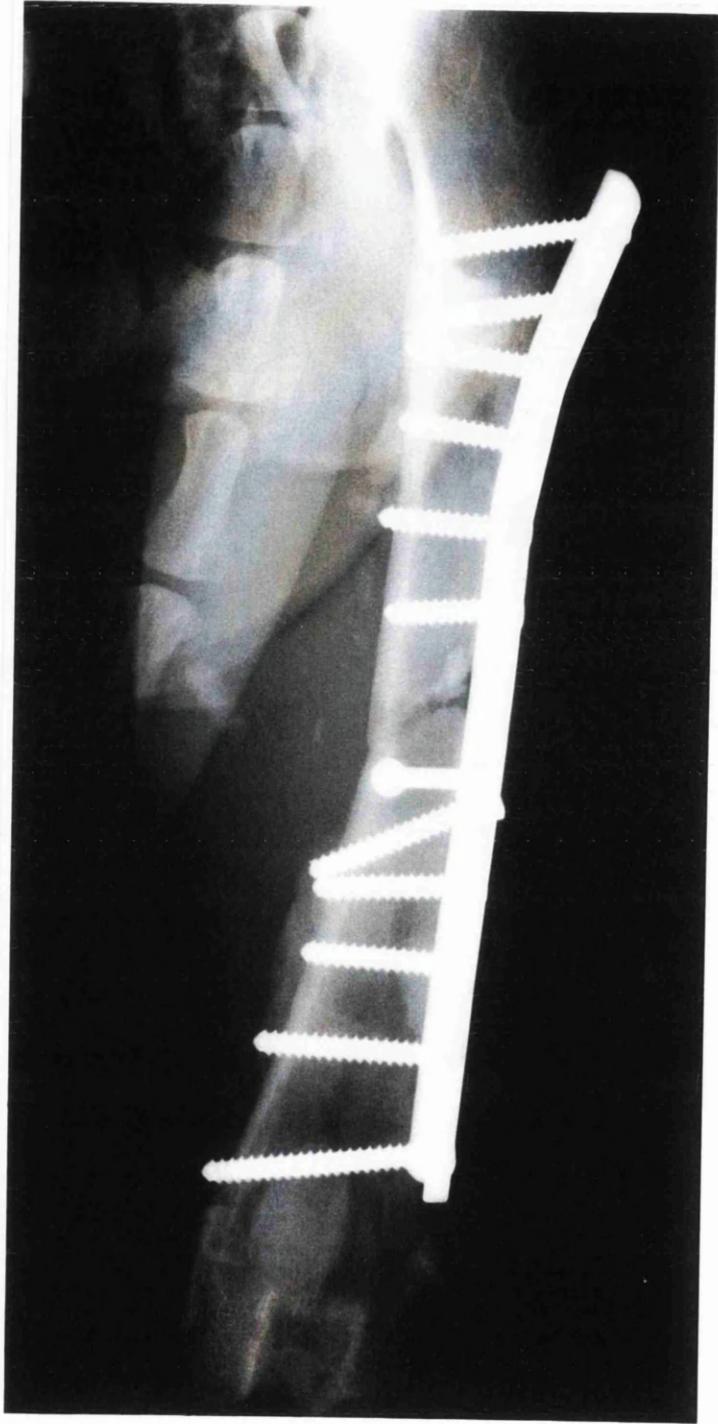
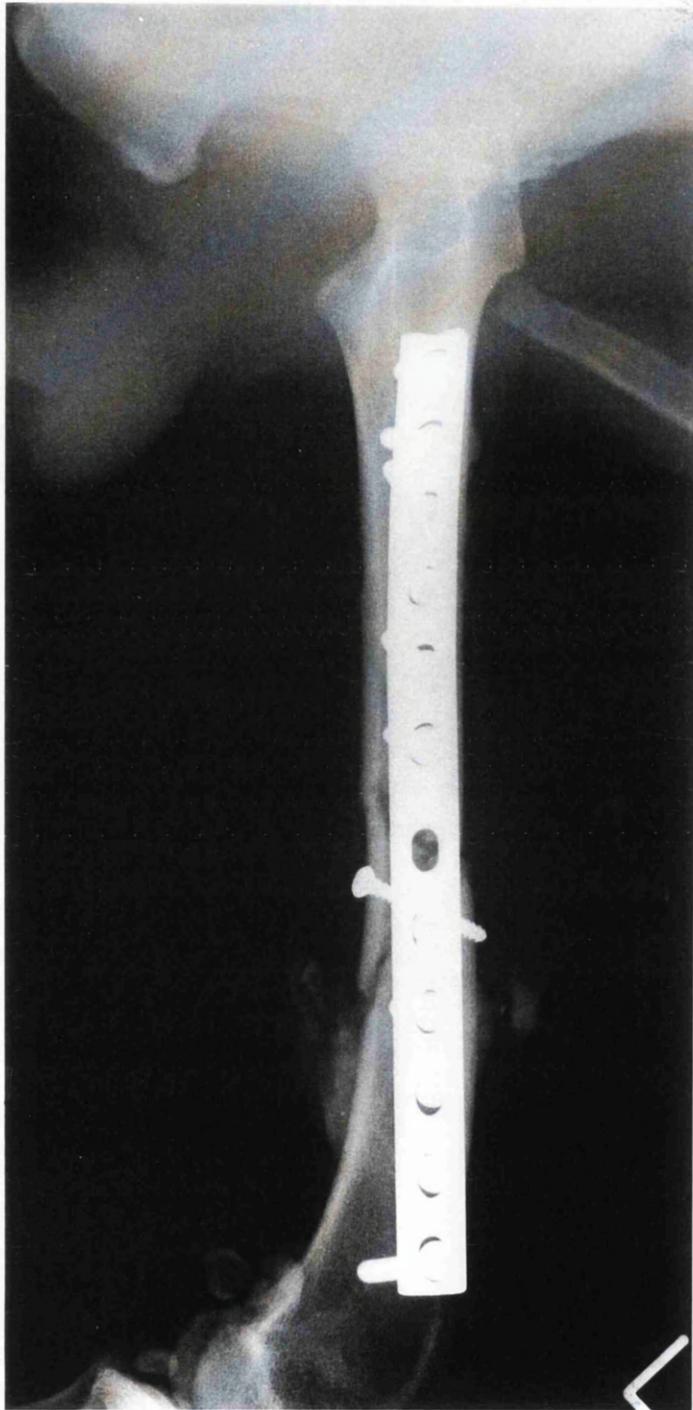
Figure 6.1.16 Radiographs obtained at day 21 (three weeks) after fracture repair, **a**, cranial view, **b**, lateral view. The fracture has apparently healed with minimal callus formation at the fracture site. Callus is forming mostly at the distal end of the fracture site, particularly caudally where the proliferative appearance is suggestive of local periosteal reaction associated with local soft tissue swelling. A small amount of poorly defined periosteal reaction is present proximo-cranially some distance away from the fracture site. No evidence of implant loosening or instability is seen.

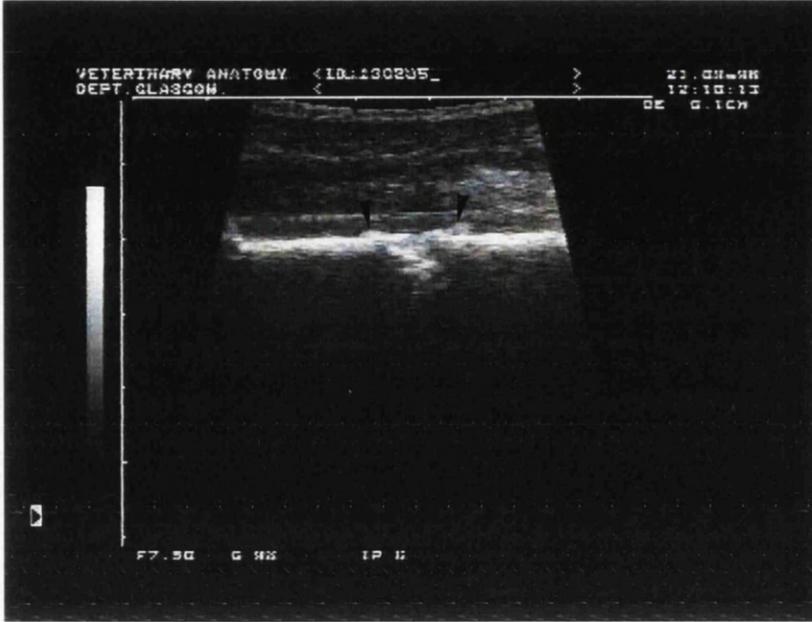
Figure 6.1.17 Longitudinal scan from the cranio-medial aspect of the femur on day 21 post-operation demonstrates the fracture site with some periosteal reaction. Soft callus formation is detected on both sides of the fracture site (arrow heads) and gives a characteristic hyperechoic appearance.

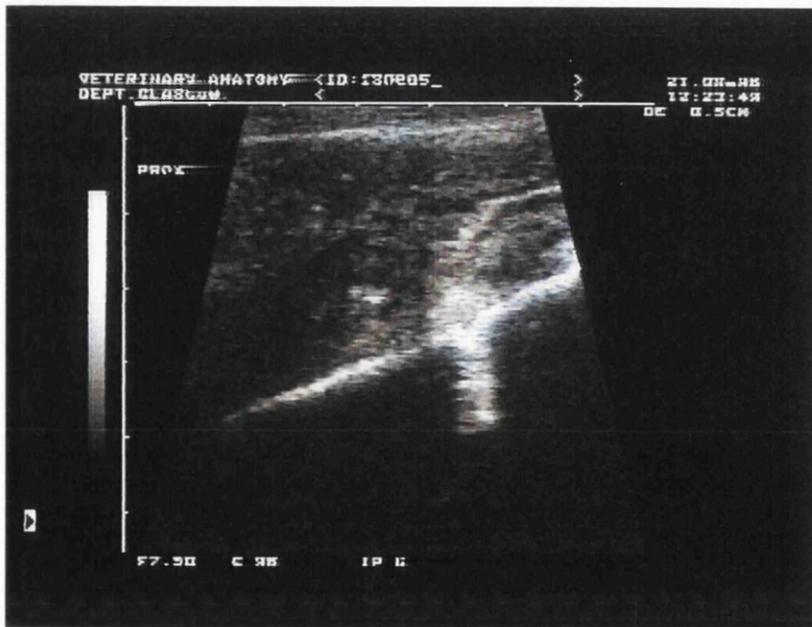
Figure 6.1.18 Longitudinal scan from the caudal aspect of the femur on day 21 post-operation shows the hyperechoic area at the fracture site which indicate the periosteal and soft tissue reactions. Note also the muscle damage above the femur appearing as a disorganised hypoechoic area.

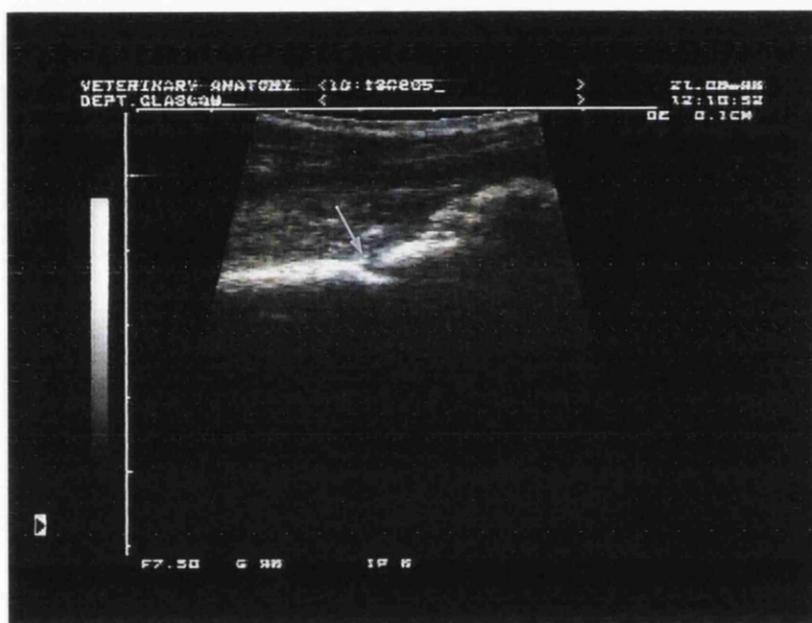
Figure 6.1.19 Longitudinal scan from the caudal aspect of the femur on day 21 after fracture repair demonstrates the callus formation which appears as bulging hyperechoic material. Note also the fracture site can be seen as a notch on the femoral surface (arrow).

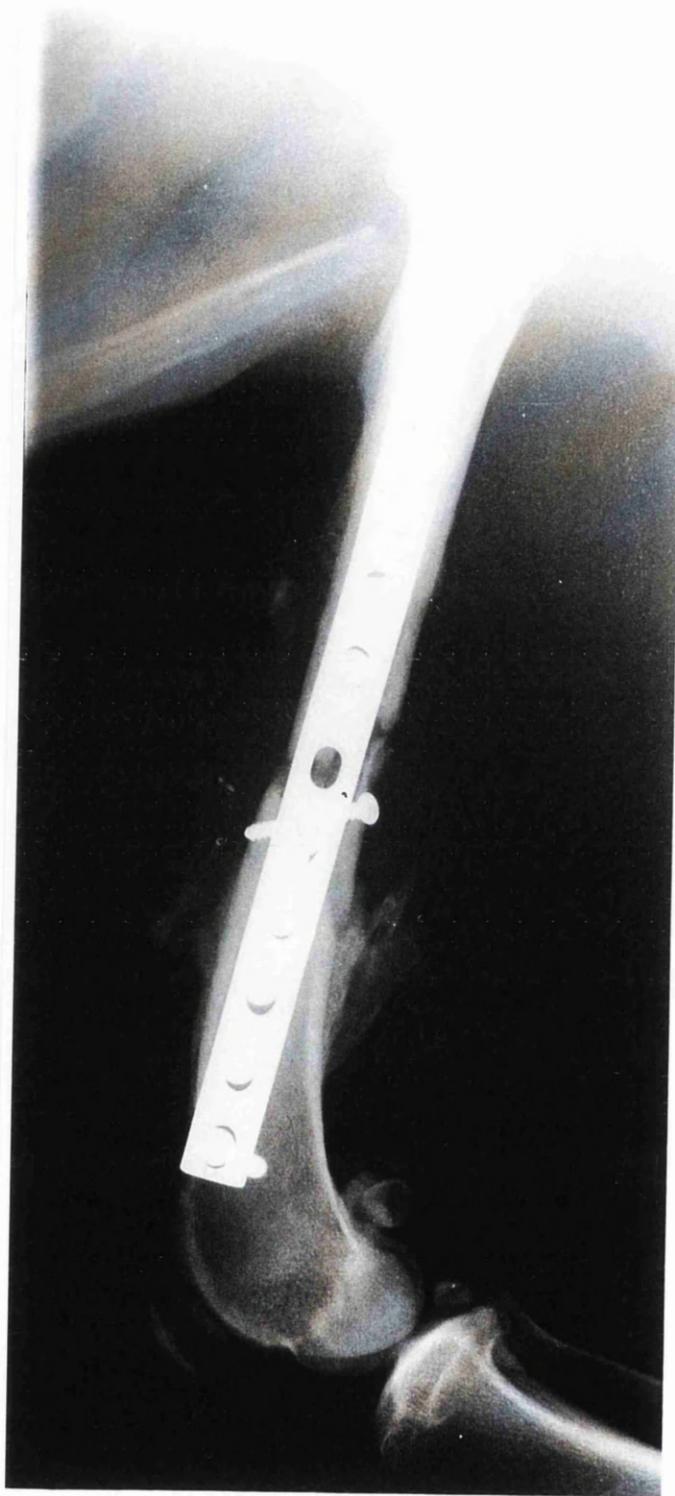
Figure 6.1.20 Radiographs obtained at day 43 (six weeks) after fracture repair, **a**, cranial view, **b**, lateral view. Callus is beginning to obliterate the fracture lines and the areas of periosteal reaction seen on the third week have become well defined in appearance with the exception of a small area craniodistally which still has poorly defined margins.

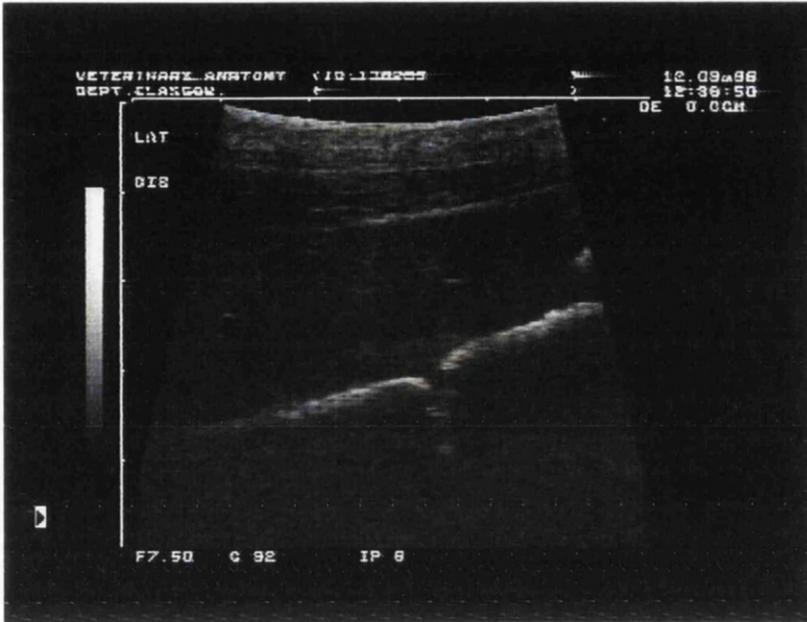
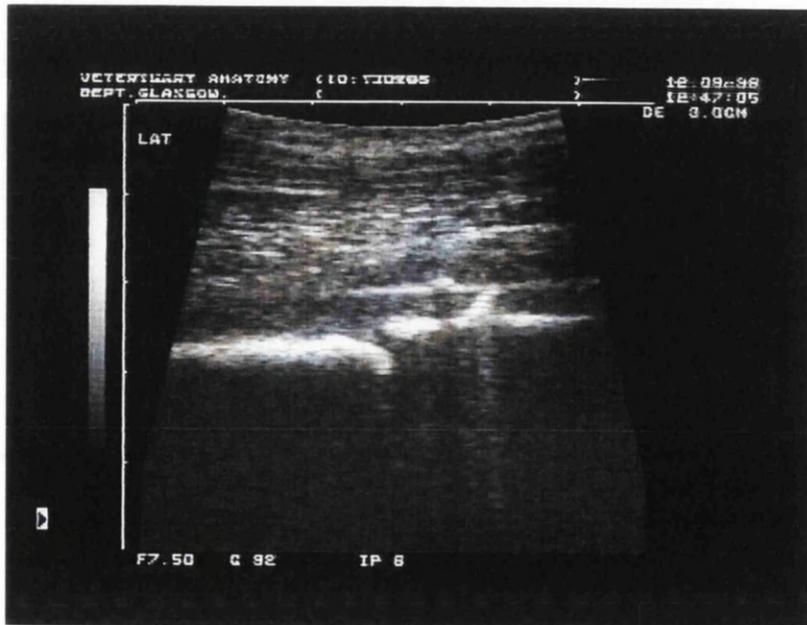
Figure 6.1.21 Longitudinal scan of the femur on day 43 post-operation. A small gap could still be seen at the fracture site on caudal aspect image **(a)**. However, some echogenic material can be detected within the fracture gap. The distal fragment appeared slightly more elevated than the proximal fragment on cranial aspect scan **(b)**.

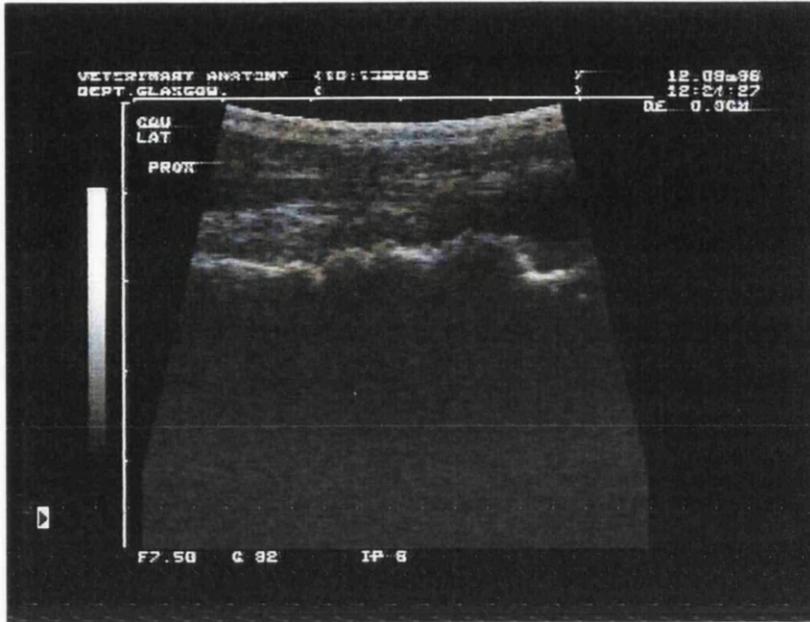
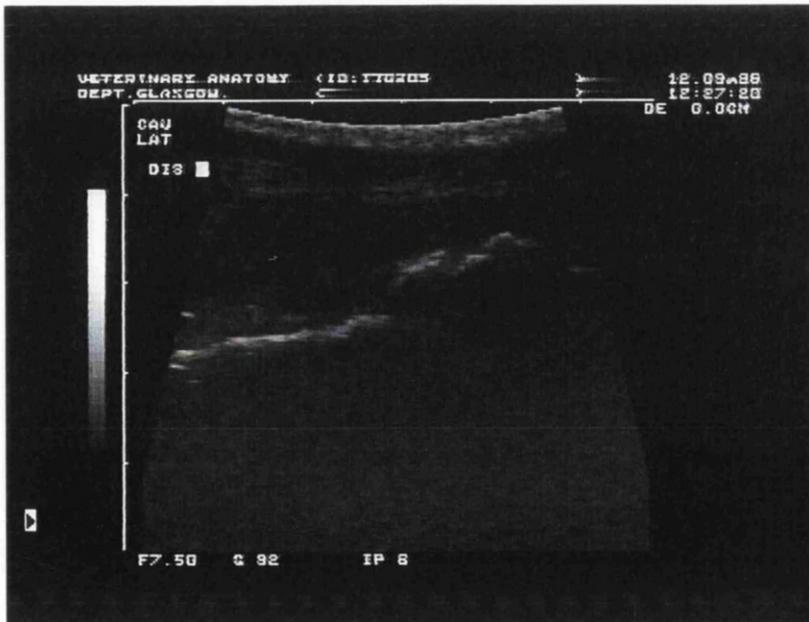
Figure 6.1.22 Longitudinal scan from the caudal aspect of the femur on day 43 post-operation demonstrates the hyperechoic appearance of the callus formation. **a**, proximal and **b**, distal portions. Note also that the mature callus has formed some distance away from the fracture site on both sides.

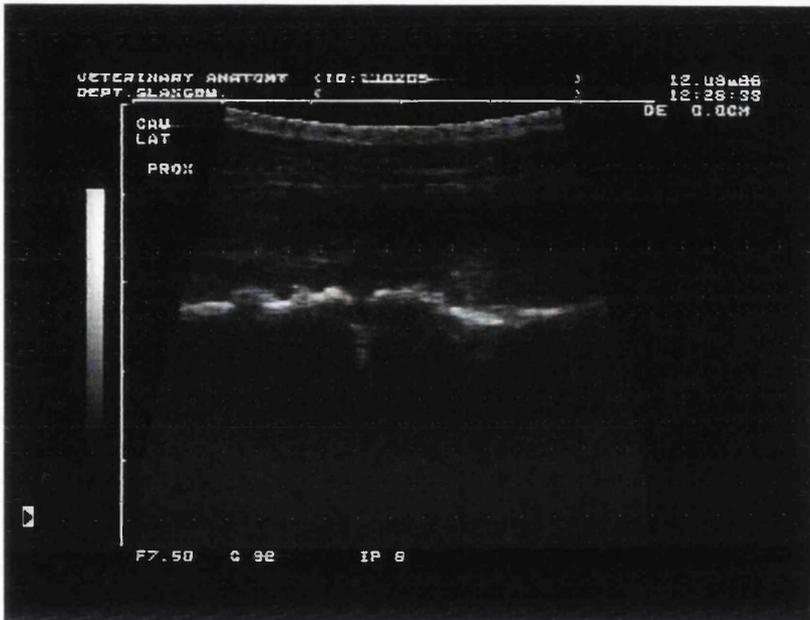
Figure 6.1.23 Longitudinal scan from the caudal aspect of the femur on day 43 post-operation. Note there was soft callus formation present at the fracture site which appears as a woven hyperechoic material adhered to the femoral surface. Fracture gap is still visible.

Figure 6.1.23	Longitudinal scan from the caudal aspect of the femur on day 43 post-operation demonstrates the soft callus at the fracture site which appears as a woven hyperechoic material adhering to the femur (case 1).	209
Figure 6.1.24	Radiographs obtained at day 48 after fracture repair. The bone plate has fractured at the level of the empty screw hole (case 1).	210
Figure 6.1.25	Radiographs obtained immediately after fracture re-alignment show that repair has been performed with a larger 11 holes plate and 11 screws (case 1).	211
Figure 6.1.26	Longitudinal scan from cranial aspect of the femur on day 48 post-operation demonstrates the proximal fragment with the plate attached to it (case 1).	212
Figure 6.1.27	Longitudinal scan from the lateral aspect of the femur on day 48 post-operation demonstrates the discontinuity of the hyperechoic line (case 1).	212
Figure 6.1.28	Longitudinal scan from the medial aspect of the femur on day 48 post-operation reveals the large gap in between the two fragments (case 1).	213

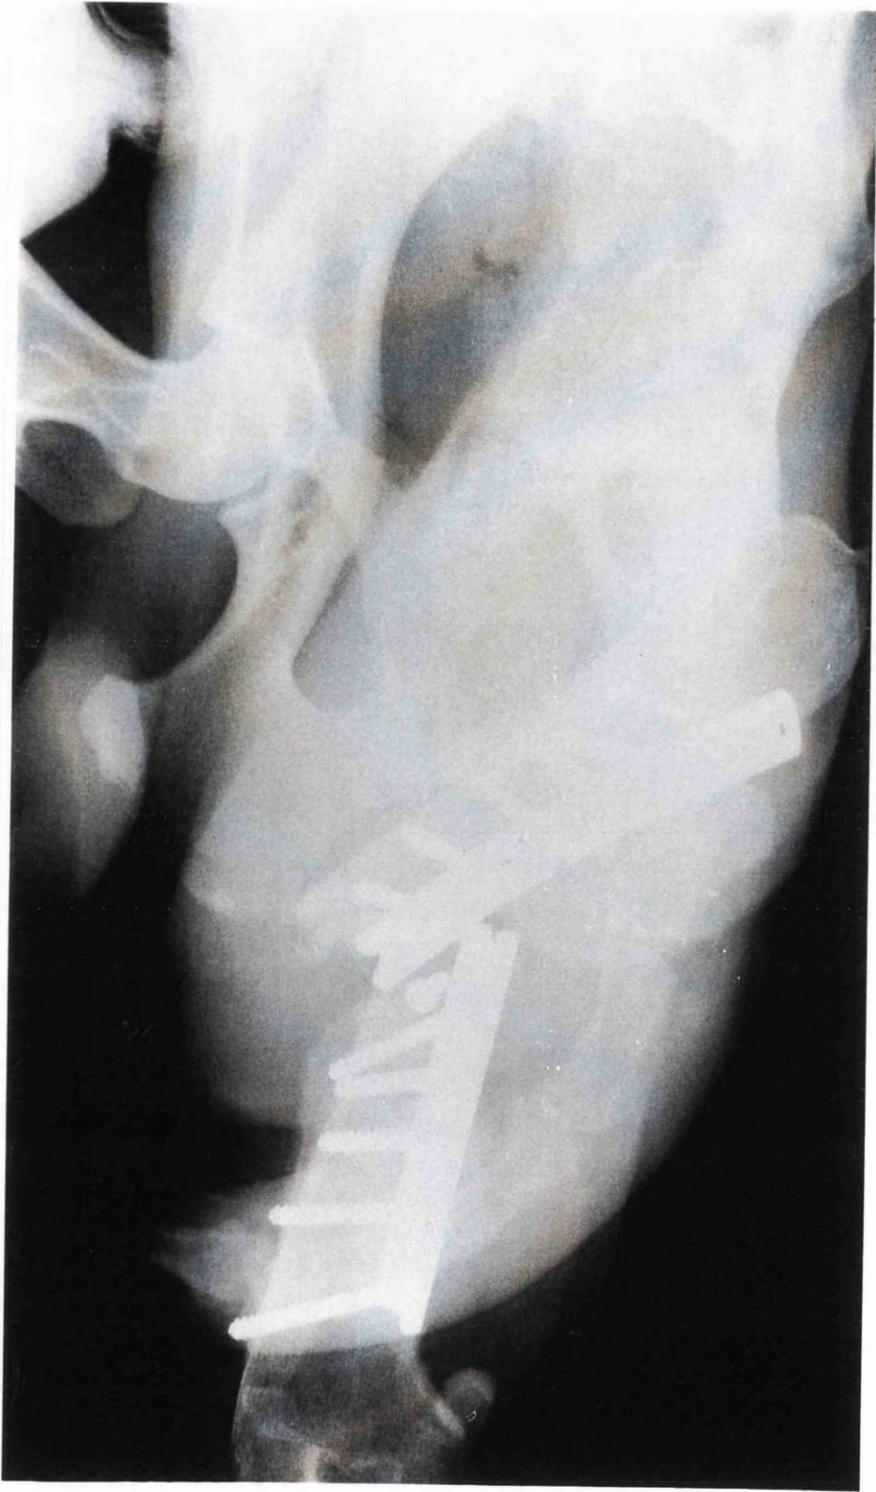
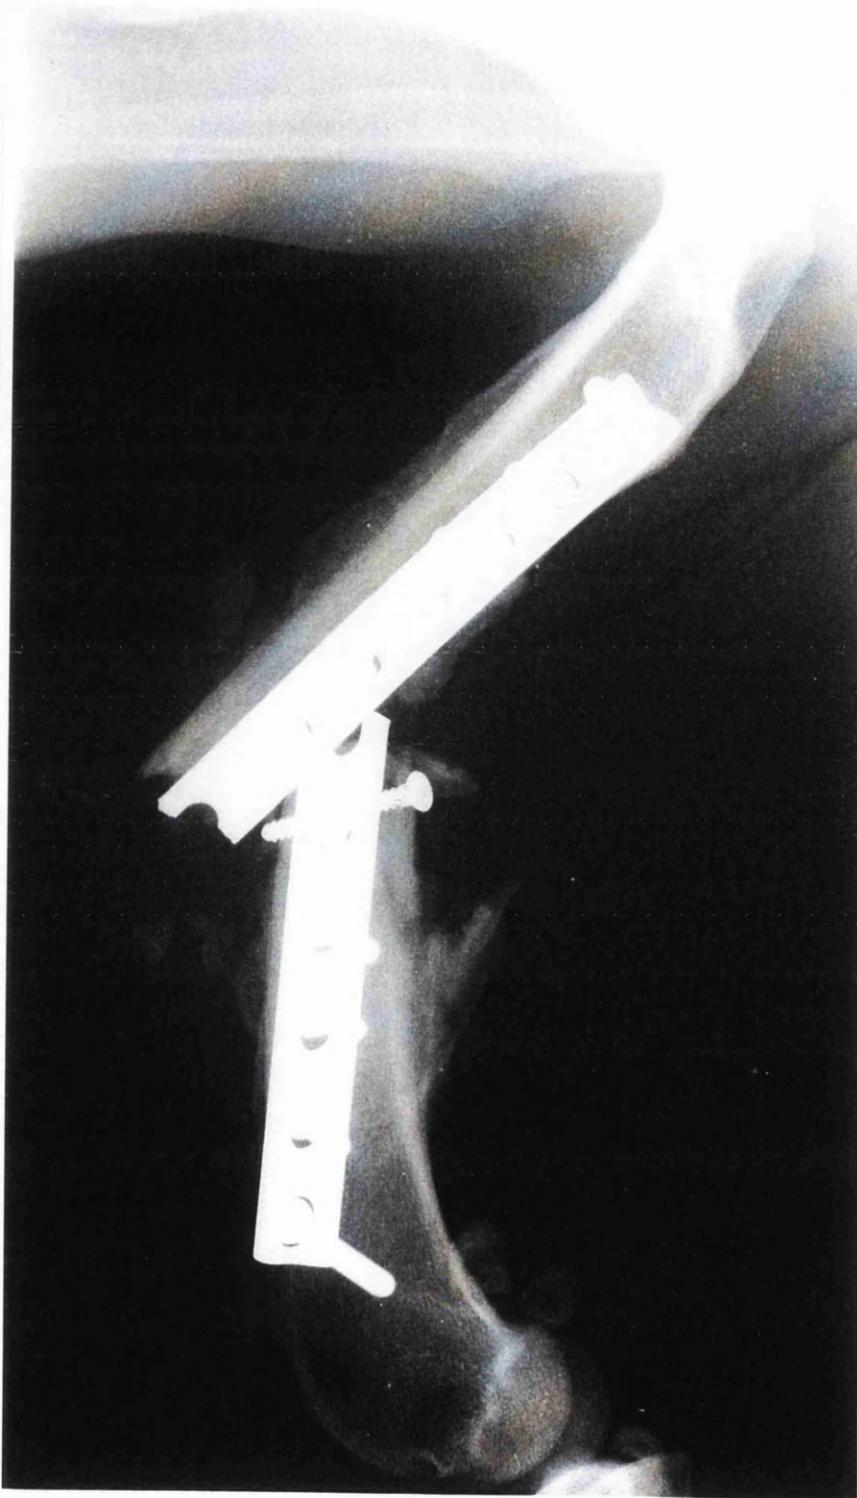
Figure 6.1.24 Radiographs obtained at day 48 (seven weeks) after fracture repair, **a**, cranial view, **b**, lateral view,. The bone plate has fractured at the level of the empty screw hole and fracture site, giving overriding of the fragments.

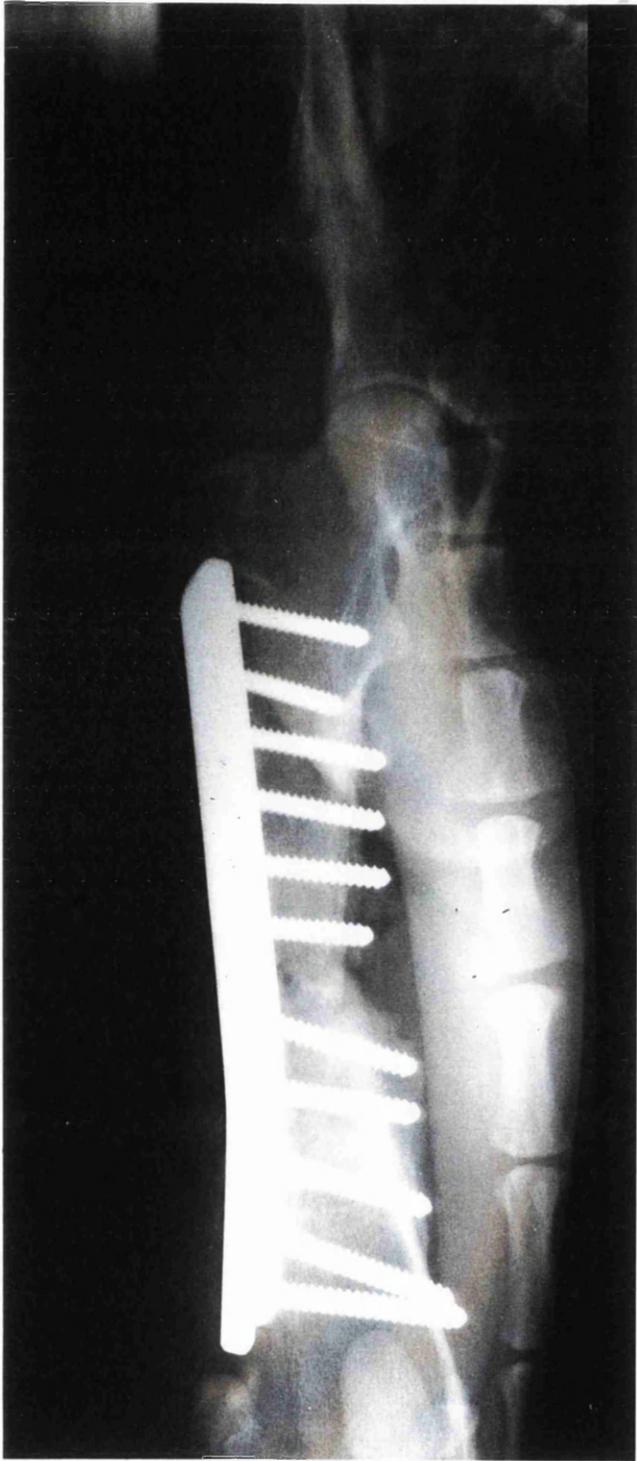
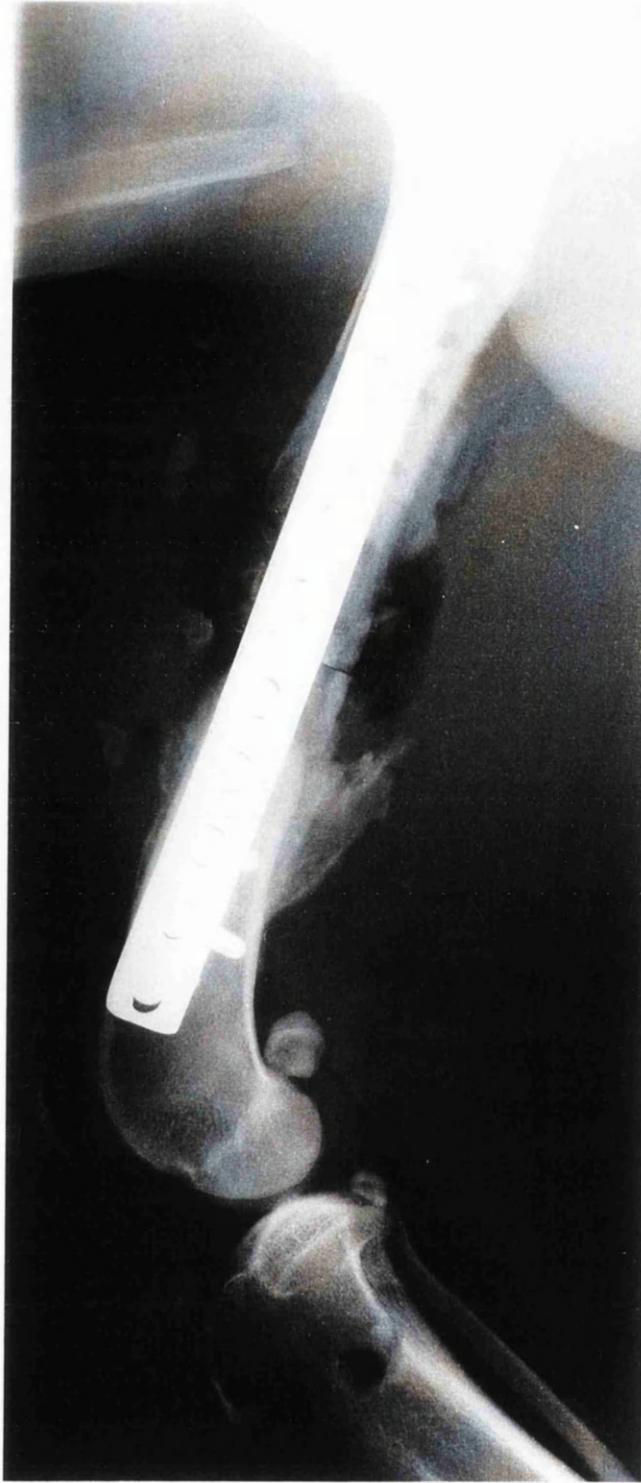
Figure 6.1.25 Radiographs obtained immediately after fracture re-alignment, **a**, cranial view, **b**, lateral view show the repair has been performed with a larger 11 holes plate and 11 screws. The repair results in good reduction. A large haematoma is present at the fracture site.

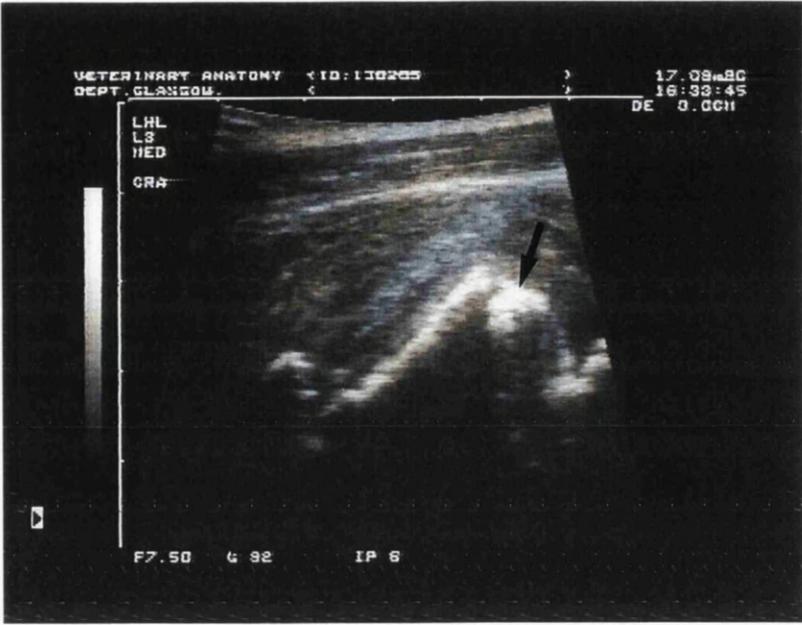
Figure 6.1.26 Longitudinal scan from the cranial aspect of the femur on day 48 post-operation demonstrates the proximal fragment with the plate attached to it protruding into the muscle cranially. The hyperechoic area at the end of the fragment (arrow) indicates the periosteal and soft tissue reactions.

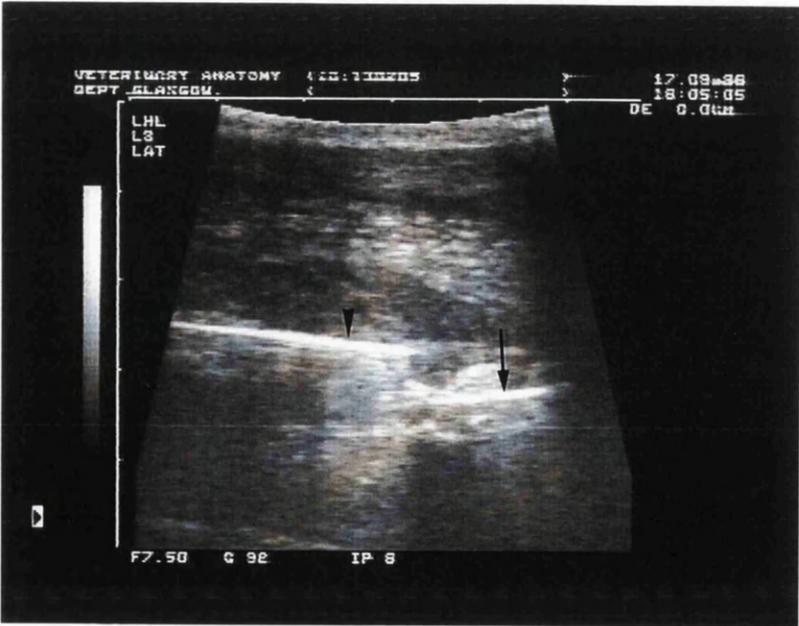
Figure 6.1.27 Longitudinal scan from the lateral aspect of the femur on day 48 post-operation demonstrates the discontinuity of the hyperechoic straight line with the distal portion (arrow head) appearing to override the proximal portion (arrow).

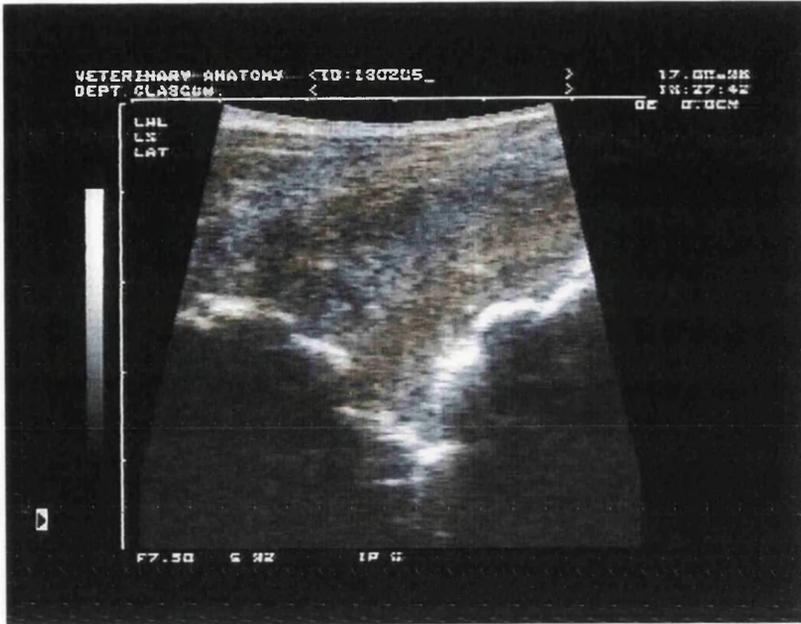
Figure 6.1.28 Longitudinal scan from the medial aspect of the femur on day 48 post-operation reveals the large gap in between the two fragments. There is massive callus formation at the end of both fragments.

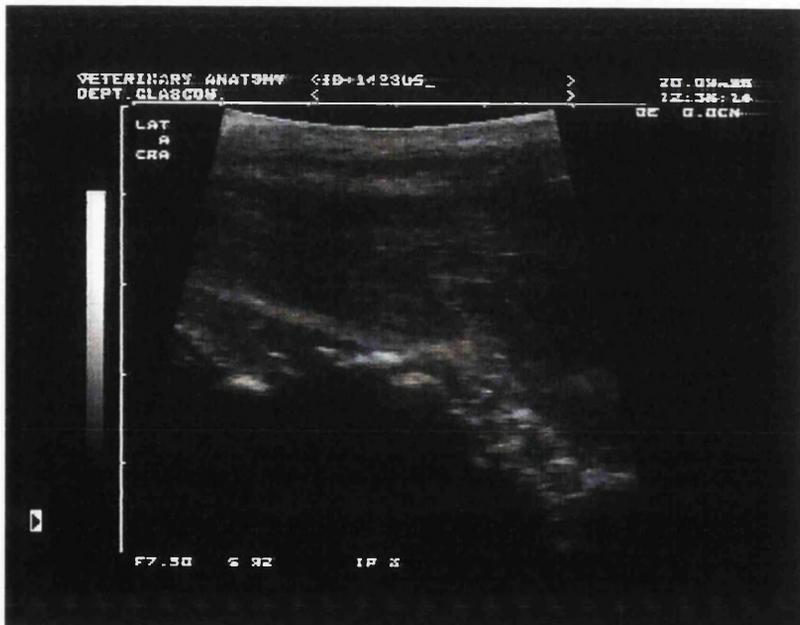
Figure 6.1.29 Longitudinal scan from the lateral aspect of the femur on day two after fracture re-alignment demonstrates the excessive callus formation at distal part of the femur. Note also the area of soft tissue reaction and the area of muscle damage which appears hyperechoic and disorganised hypoechoic respectively.

Figure 6.1.29	Longitudinal scan from the lateral aspect of the femur on day two after fracture re-alignment demonstrates the excessive callus formation at the distal part of the femur (case 1)	213

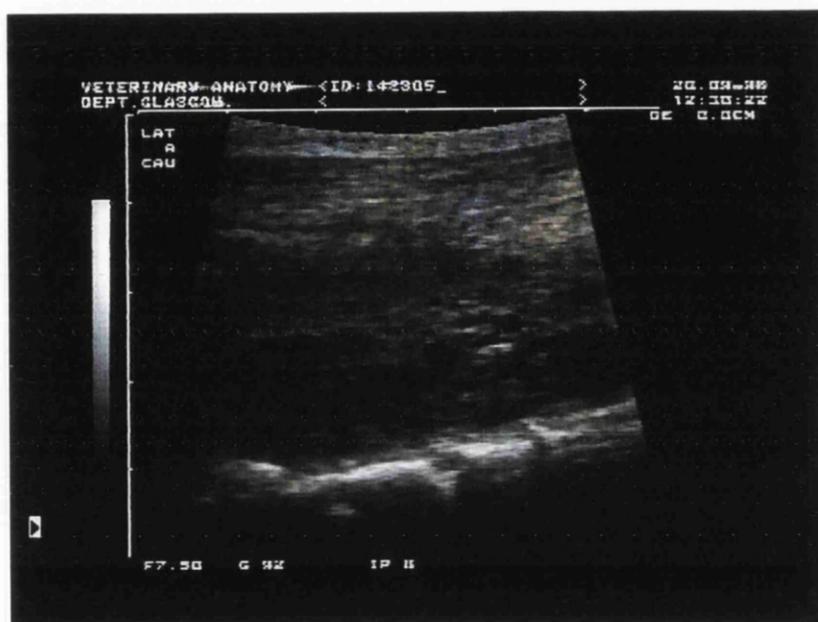
Figure 6.1.30 Longitudinal scan from the caudo-lateral aspect of the femur on day two after fracture re-alignment demonstrates the femoral surface with a few notches indicating the site of the screws which had been placed before the plate had broken off. Note also the area of muscle tissue damage above the femur appearing as disorganised hypoechoic areas. A hyperechoic layer on the femoral surface (periosteum) can be seen which indicates the soft tissue reaction.

Figure 6.1.30	Longitudinal scan from the caudo-lateral aspect of the femur on day two after fracture re-alignment the demonstrates the femoral surface with a few notches indicating the site of the screws which had been placed before the plate had broken off (case 1).	214
Figure 6.1.31	Radiographs obtained at day 40 after fracture re-alignment. The implant is intact, but is associated with subtle areas of lucency around the screws (case 1).	215
Figure 6.1.32	Longitudinal scan from the caudo-lateral aspect of the femur on day 40 after fracture re-alignment demonstrates excessive callus formation which appears hyperechoic (case 1).	216
Figure 6.1.33	Longitudinal scan from medial aspect of the femur on day 40 after fracture re-alignment demonstrates the fracture site which has already been bridged by mature callus (case 1).	216
Figure 6.1.34	Longitudinal (a) and transverse (b) scans from lateral aspect of the femur on day 40 after fracture re-alignment demonstrate the excessive callus formation (case 1).	217

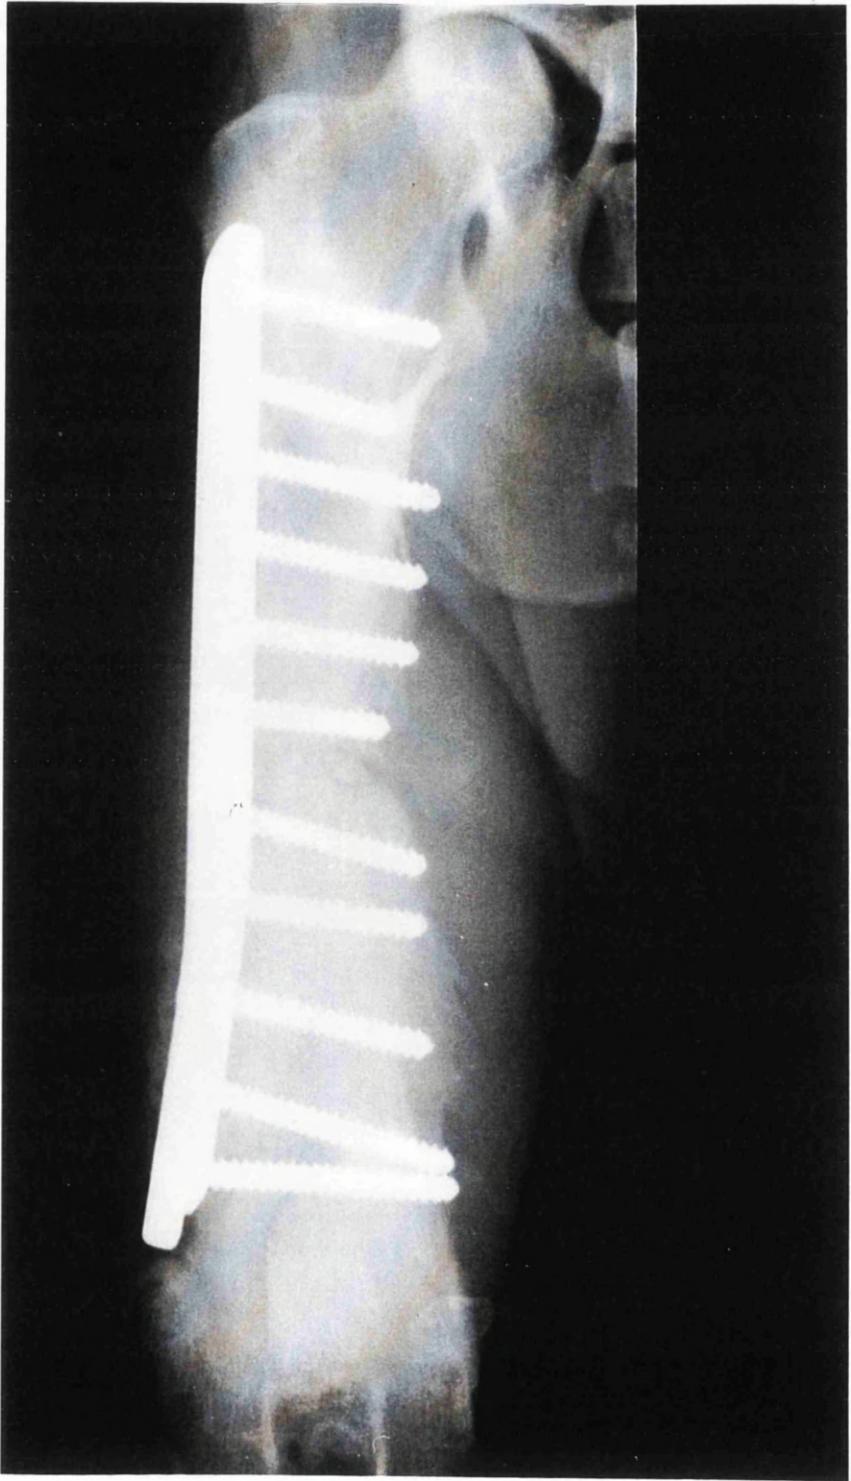
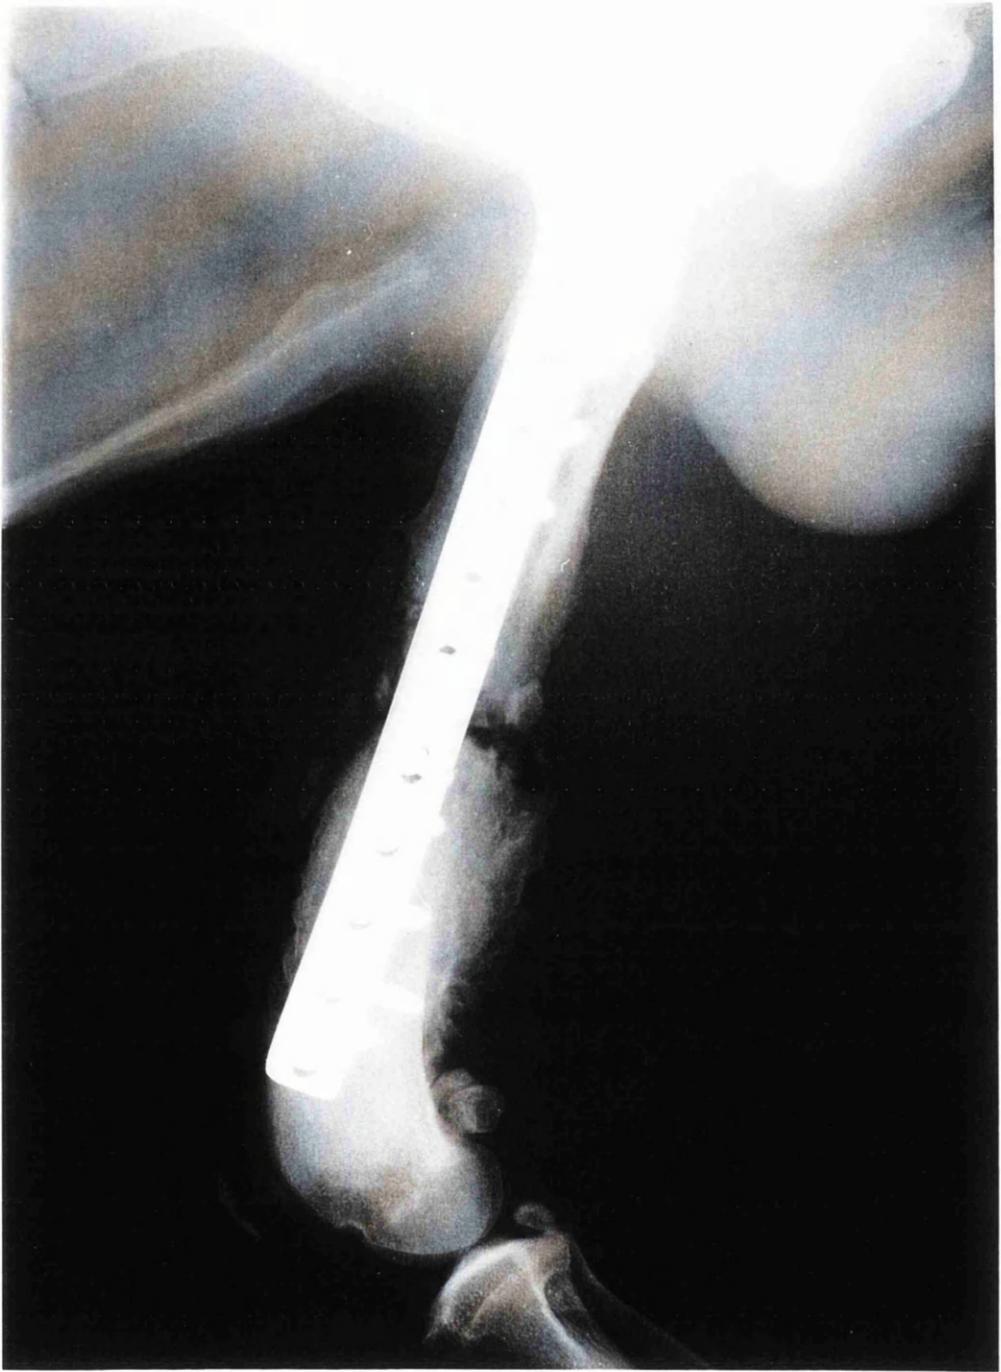
Figure 6.1.31 Radiographs obtained at day 40 (six weeks) after fracture re-alignment, **a**, cranial view, **b**, lateral view. The implant is intact, but is associated with subtle areas of lucency around the screws. The periosteal reaction is so extensive and variable in thickness that this could be artificial. Bony callus is not visible at the fracture site.

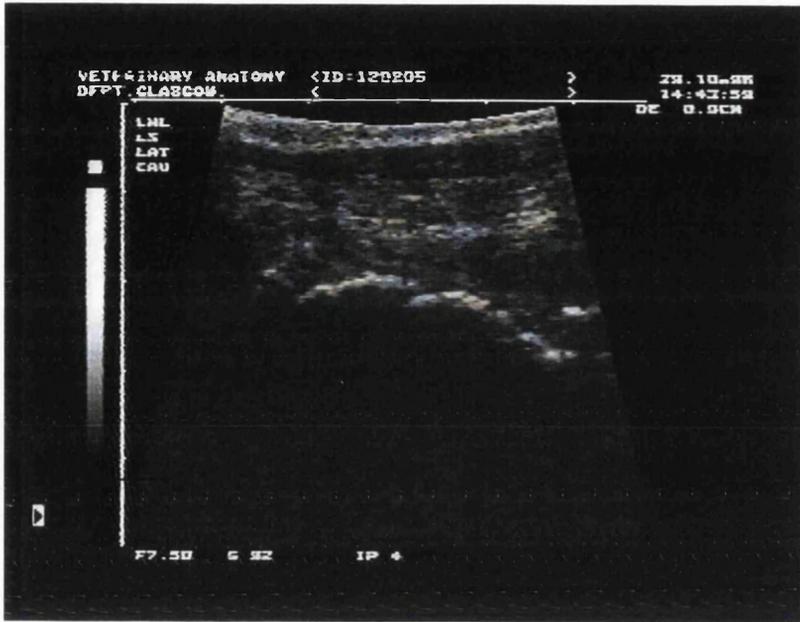
Figure 6.1.32 Longitudinal scan from the caudo-lateral aspect of the femur on day 40 after fracture re-alignment demonstrates the excessive callus formation which appears hyperechoic so that nothing could be seen distally.

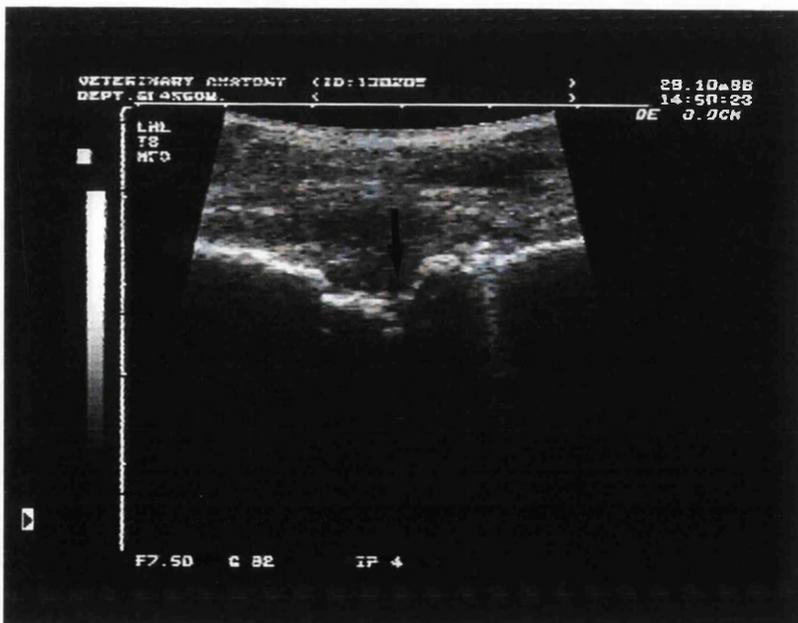
Figure 6.1.33 Longitudinal scan from the medial aspect of the femur on day 40 after fracture re-alignment demonstrates the fracture site (arrow) which has already been bridged by mature callus. Note also there are some hyperechoic materials present at the fracture site.

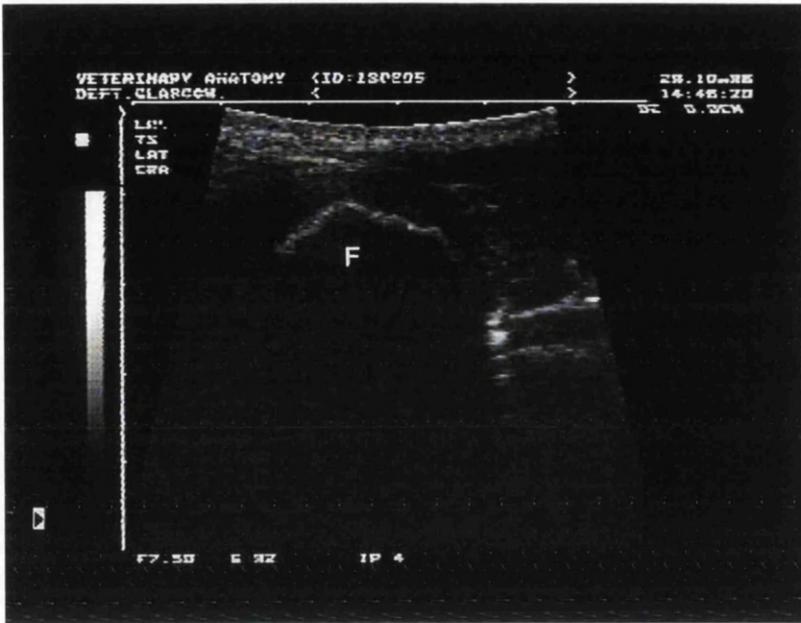
Figure 6.1.34a

Figure 6.1.34 Longitudinal and transverse scans from the lateral aspect of the femur on day 40 after fracture re-alignment demonstrates the excessive callus formation. Note that the diameter of the femur appears enlarged on transverse scan (a), and the uneven femoral surface on longitudinal scan (b). Area of muscle damage appears as a disorganised hypoechoic pattern. F, femur.

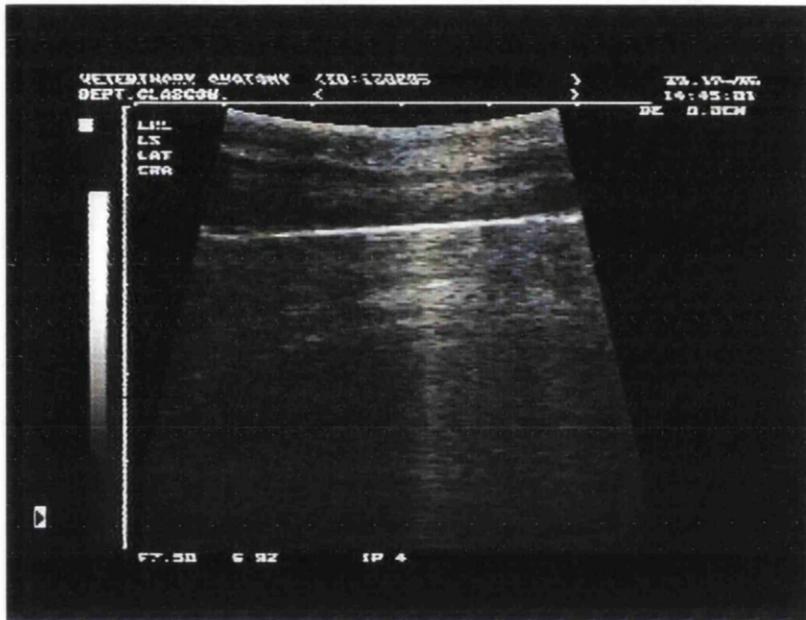
Figure 6.1.35 Longitudinal scan from the lateral aspect of the femur on day 40 after fracture re-alignment. Note that the bone plate adhered to the femur appears as a straight hyperechoic line.
