**AN ULTRASONOGRAPHIC STUDY OF MUSCULOSKELETAL
INJURIES AND MAMMARY GLAND TUMOUR IN SMALL
ANIMALS**

A thesis submitted to the Faculty of Veterinary Medicine,
University of Glasgow.

For the Degree of Doctor of Philosophy

Division of Veterinary Anatomy,
Department of Veterinary Preclinical Studies,
School of Veterinary Medicine,
University of Glasgow,
March, 1999

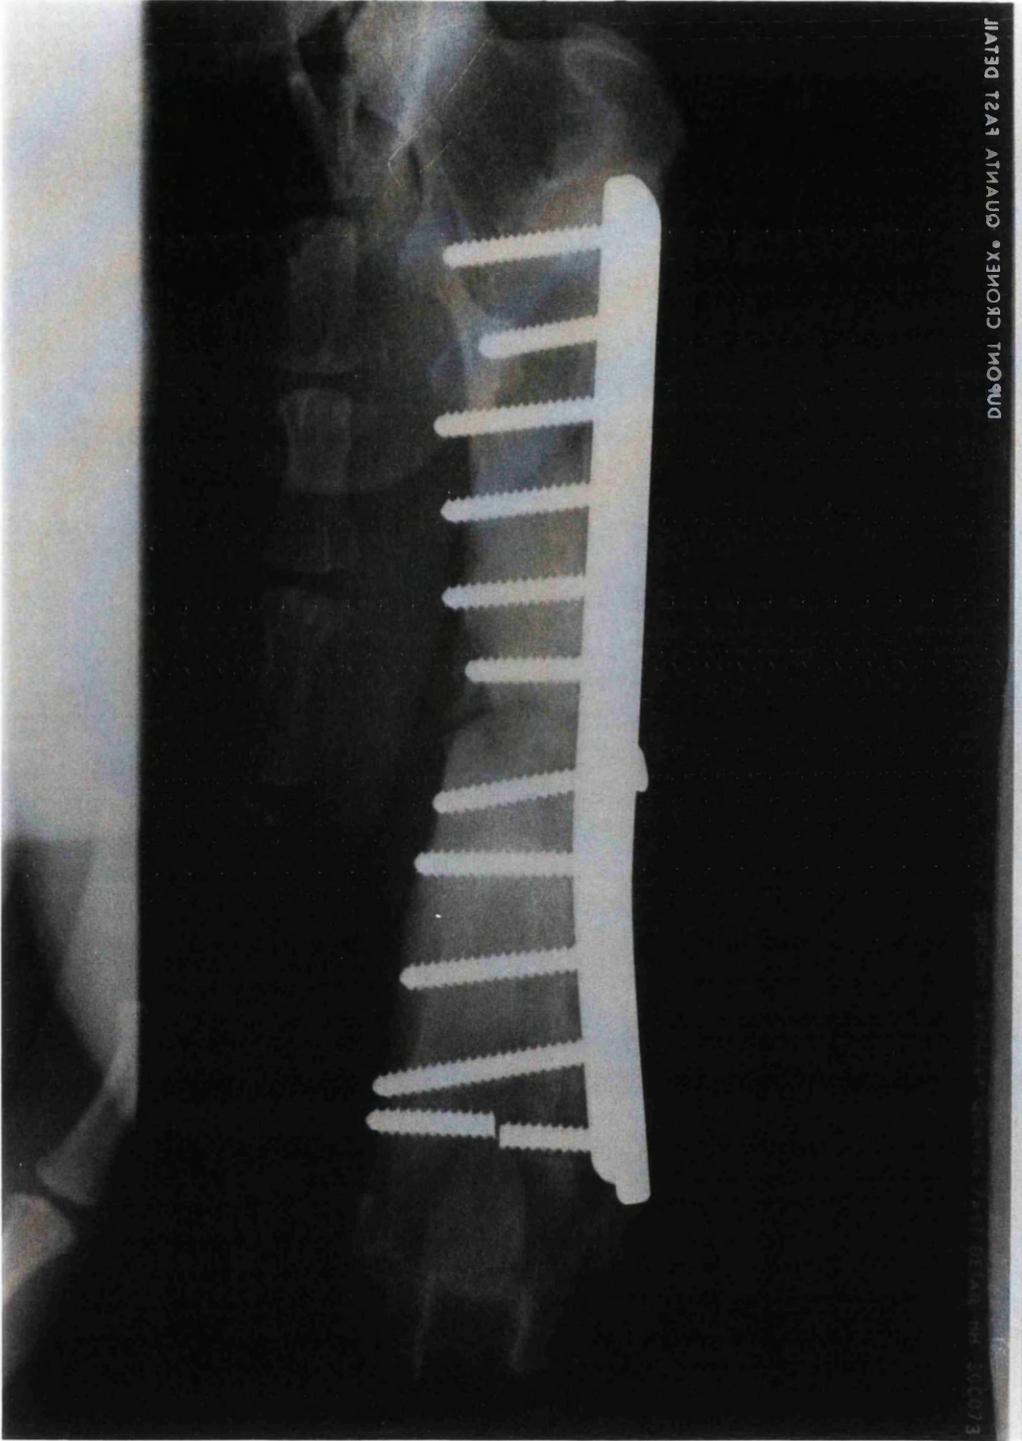
Figure 6.1.38 Radiographs obtained at day 138 after fracture re-alignment show a satisfactory healing process where the callus has bridged the fracture gap. **a**, cranial view, **b**, lateral view. However, the fracture gap is still visible but the size is reduced. The screws are in place.

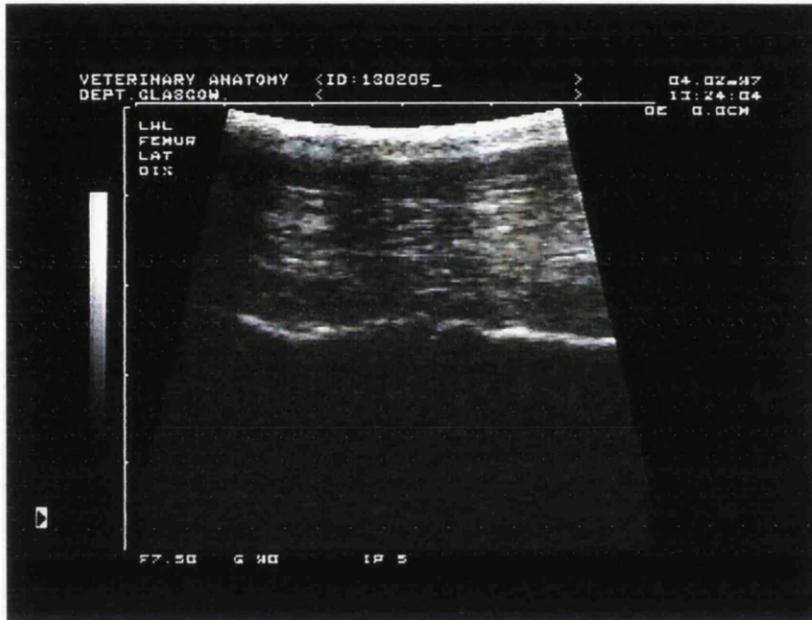
Figure 6.1.39 Longitudinal scan from the lateral aspect of the femur on day 138 post-operation demonstrates the femoral surface which has become much smoother. The fracture site can still be recognised as a small notch (arrow). Note that the muscle structure has returned to its normal ultrasonographic characteristic. The shadowing artefacts within muscle are due to the hair on the skin surface.

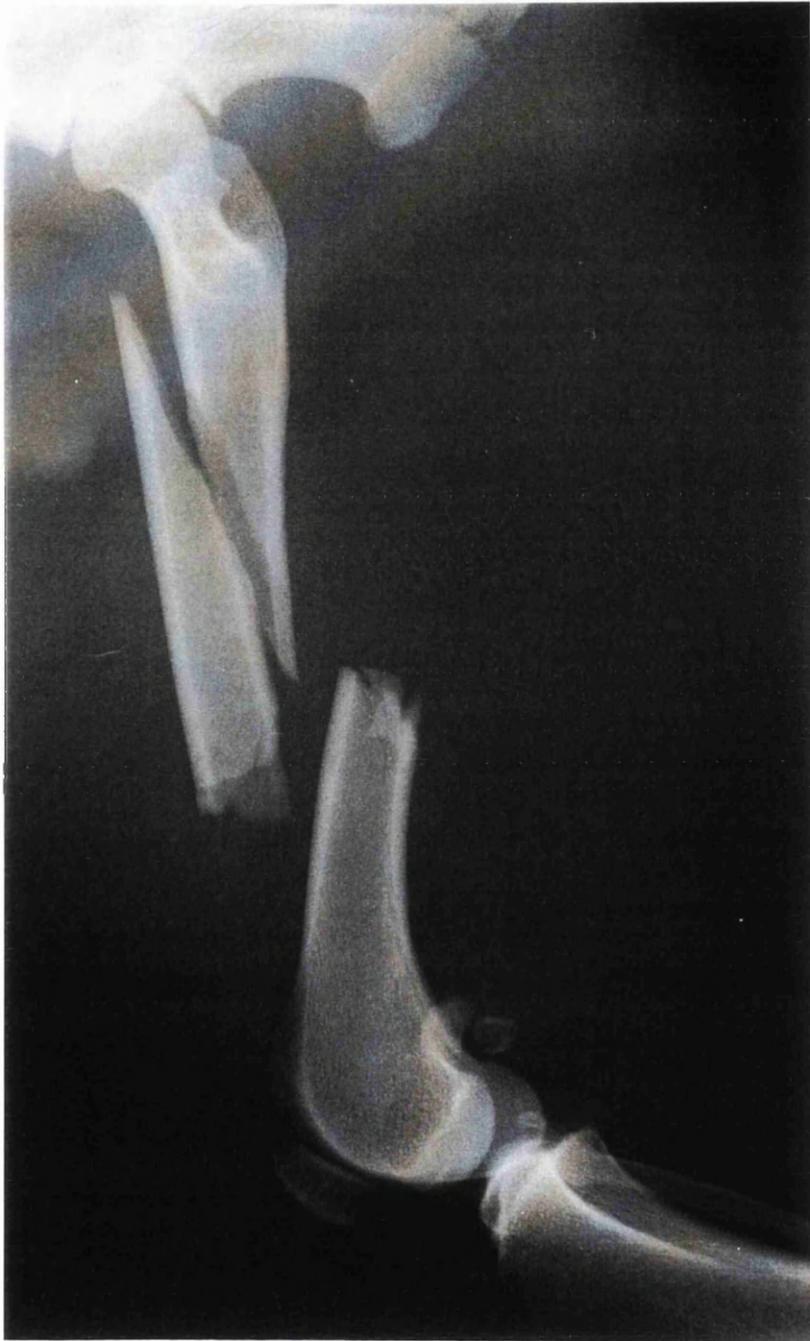
Figure 6.2.1 A three years old female Border Collie was hit by a car. There is a comminuted fracture involving the mid-shaft of the femur with a large butterfly fragment. This is a complete closed fracture.

A 3.7 year old female Border collie, weight 20 kg, with a suspicion of having femoral fracture was referred to the Glasgow University Veterinary Hospital. The dog had been involved in a road traffic accident and had been taken to the clinic immediately after the accident. The dog had been struck from behind on the right side and was unconscious for a while after the accident. Upon physical examination the dog was pale and tachycardiac and had no pedal withdrawal on the right limb and was in extreme pain. Radiographs taken following physical examination demonstrated a complete closed fracture of the mid-shaft of the right femur (figure 6.2.1). There was a comminuted fracture with a large butterfly fragment.

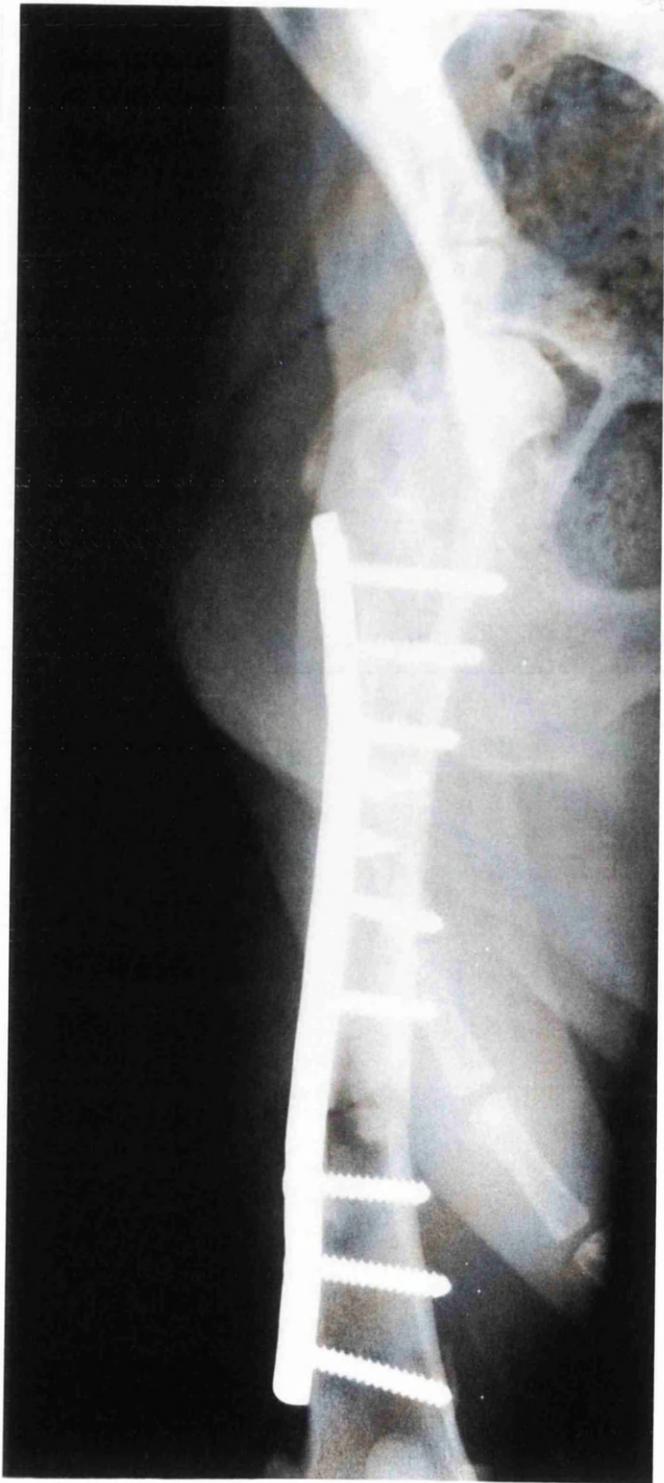
Figure 6.2.2 Radiographs obtained immediately after fracture repair. **a**, cranial view, **b**, lateral view. The comminuted fracture has been repaired with a 10 holes plate and eight screws plus two lag screws. There is blood accumulation in the muscle caudo-distally. The fracture lines are clearly visible.

Radiographs taken immediately after the fracture repair showed good alignment with the fracture lines clearly visible (figure 6.2.2). There was a small bone fragment left in the muscle caudal to the distal femur. Blood accumulation (haematoma) was present near the fracture site which had developed after the

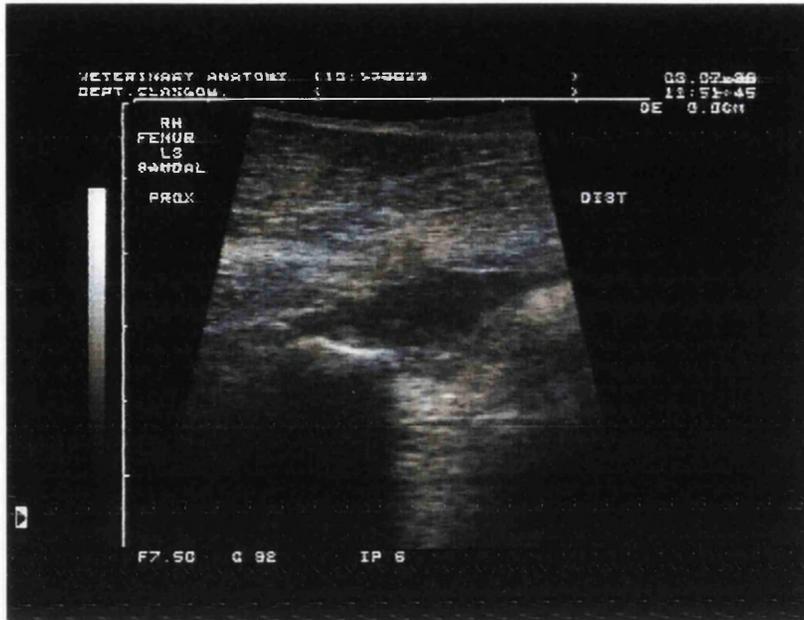
Figure 6.2.3a

Figure 6.2.3 Ultrasonographic images of the large haematoma within the muscle near the fracture site which developed 24 hours after surgery. **a**, longitudinal scan and **b**, transverse scan. The haematoma within the muscle appears hypoechoic with acoustic enhancement artefact. Note also the plate adhering to the bone appears hyperechoic producing comet tail artefact (**b**). **F**, femur

Ultrasonographic examination demonstrated a large haematoma within the muscle near the fracture site on both longitudinal and transverse scans as shown by the hypoechoic area (figure 6.2.3a,b). The bone with the plate attached appeared as a short hyperechoic line on transverse scan and produced comet tail artefact (figure 6.2.3b). The small bone fragment within muscle caudal to the distal femur appeared hyperechoic with acoustic shadowing (figure 6.2.4). The fracture site at the distal third of the femur was difficult to locate on day one after operation because of the large haematoma formation near the fracture site. Suture materials used to close the muscle appeared as hyperechoic short lines on longitudinal scans of the femur (figure 6.2.5a), and as intermittent lines on transverse scans of the femur on the day two examination (figure 6.2.5b). They produced comet tail artefacts.

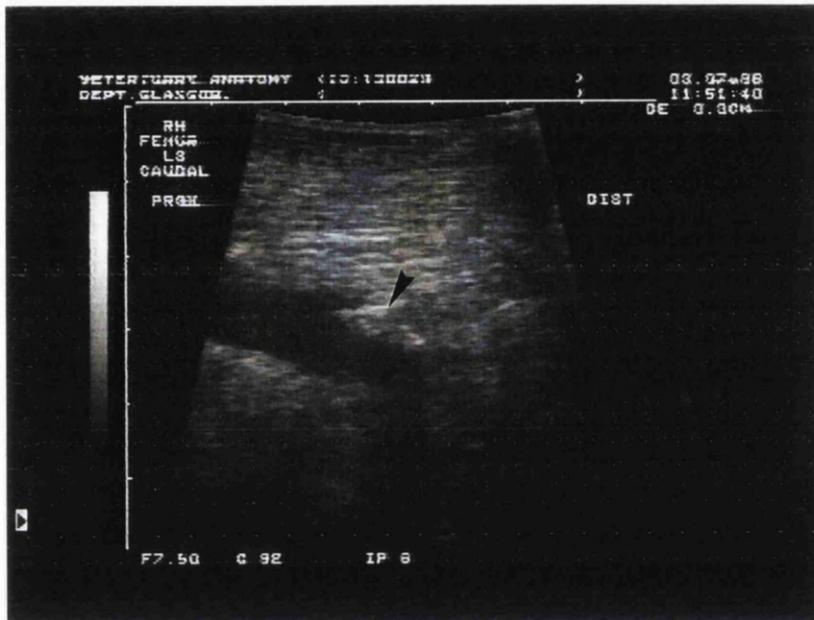
Figure 6.2.4 The bone fragment remaining in the muscle (arrow head) imaged 24 hours after surgery appears hyperechoic with acoustic shadowing artefact. Note the haematoma area on the left side of the fragment.

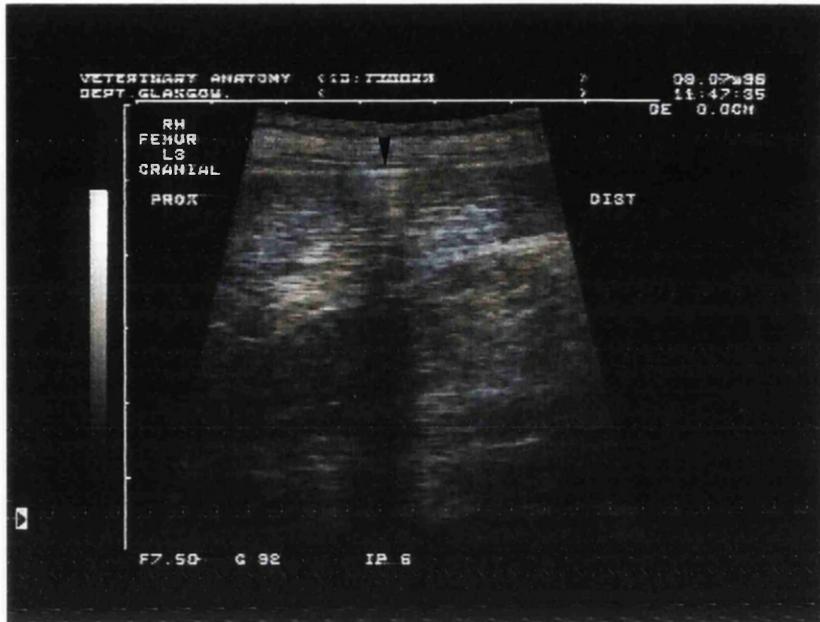
Figure 6.2.5a

Figure 6.2.5 Suture material within the muscle (arrow heads) imaged ultrasonographically appears as an hyperechoic short line on the longitudinal scan (a), and as an intermittent hyperechoic line on a transverse scan (b). They are producing comet tail artefacts.

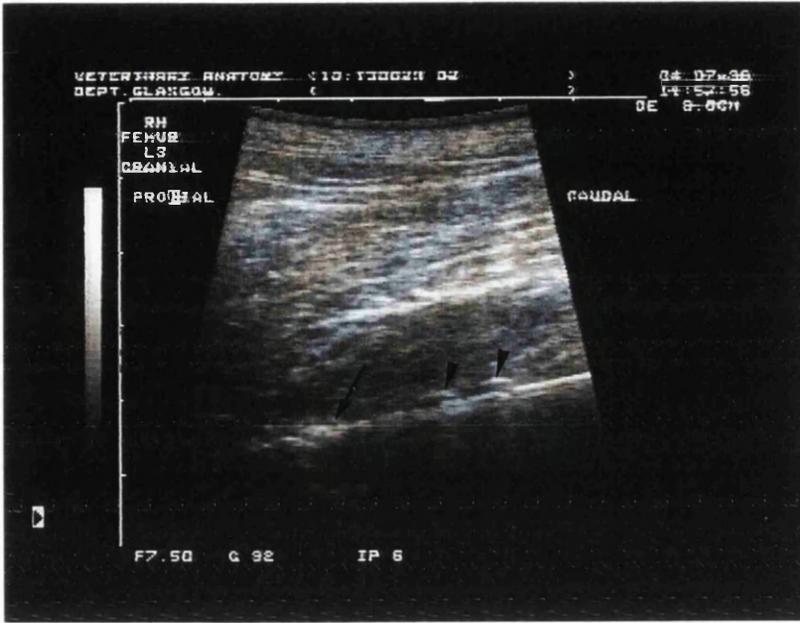
Figure 6.2.6 Longitudinal scan from the cranial aspect of the femur on day two post-operation demonstrates the fracture site (arrow) with an hyperechoic appearance indicating soft tissue and periosteal reactions. The two screws (arrow heads) used to fix the large fragment in place appear hyperechoic with comet tail artefact some distance from the fracture site.

The fracture site at the proximal end of the femur was imaged on the day two examination. There was some periosteal reaction which could be seen at the fracture site as demonstrated by the area of increased echogenicity (figure 6.2.6). The two lag screws used to fix the large fragment were imaged on the day two examination and appeared hyperechoic with comet tail artefacts (figure 6.2.6). Only the screws head were imaged on the cranio-lateral scan. The fracture site at the distal third of the femur was imaged but no area of periosteal reaction could be detected. A small, irregular and well defined hypoechoic area

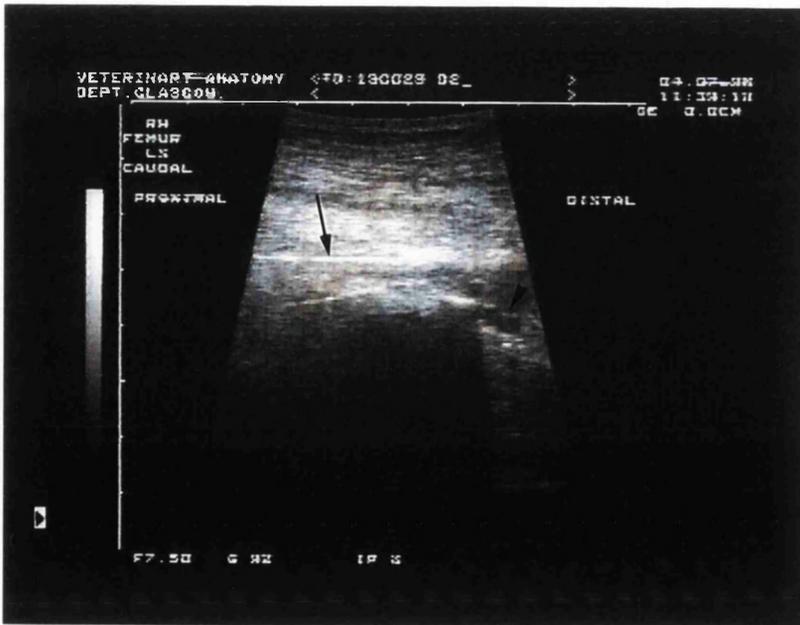
Figure 6.2.7 Longitudinal scan from the caudal aspect of the femur on day two post-operation demonstrates a small, irregular and well defined hypoechoic area (arrow head) with acoustic enhancement artefact at the end of the proximal fragment. The hyperechoic straight line (arrow) is the bone plate. Note also the discontinuity of the proximal fragment which indicates the presence of a gap at the fracture site.

casting acoustic enhancement artefact was detected at the distal third of the femoral fracture site as shown in figure 6.2.7. There was a gap left at the distal third of the femoral fracture site as shown by the discontinuity of the femoral surface as scanned longitudinally on caudo-lateral aspect of the femur (figure 6.2.7). This had been shown by a less dense area at the distal third of the femoral fracture site on the cranio-caudal view radiograph. A small bone fragment was identified cranial to the femur within the biceps femoris muscle, but was not demonstrated on radiographs (figure 6.2.8). It appeared as a hyperechoic area with acoustic shadowing artefact. The bone plate that adhered to the femur appeared as an hyperechoic straight line and produced reverberation artefact when the sound beam was directly perpendicular to the plate's long axis (figure 6.2.9a). Sometimes it appeared as intermittent hyperechoic lines with distal comet tail artefacts (figure 6.2.9b). The haematoma appeared hypoechoic with some faint echogenic materials present (figure 6.2.10).

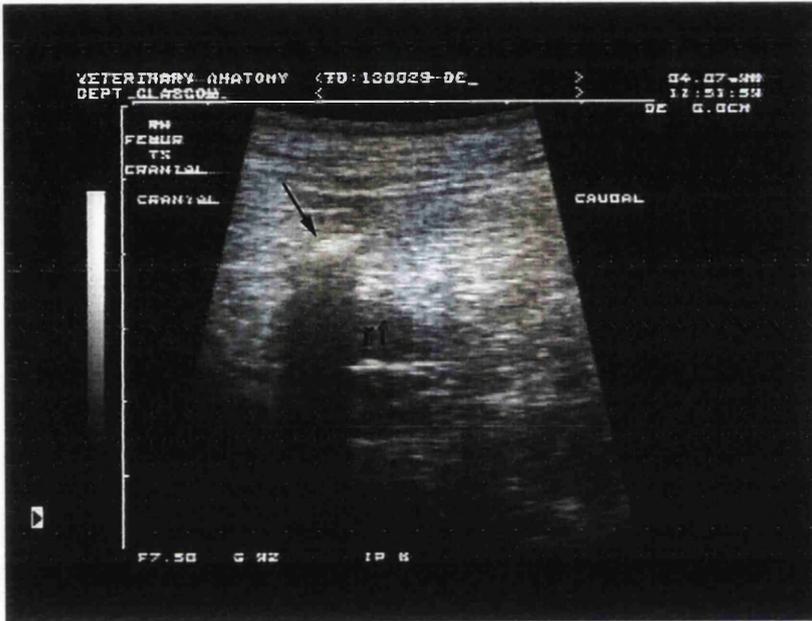
Figure 6.2.8 The small bone fragment (arrow) placed cranial to the femur within the biceps femoris muscle imaged 48 hours after the surgery appears hyperechoic and is producing acoustic shadowing artefact. This small fragment was not visualised on radiography. **rf**, m. rectus femoris

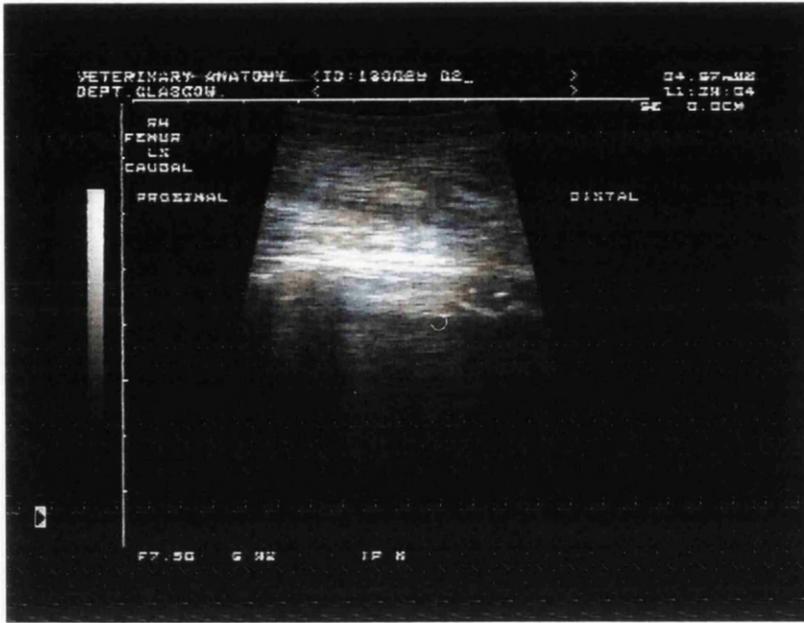
Figure 6.2.9a

Figure 6.2.9 Longitudinal scans from the lateral aspect (a) and from caudal aspect (b) of the femur demonstrate the bone plate with screws that attach to the femur. The bone plate appears as an hyperechoic straight line producing reverberation artefact on the lateral aspect image (a), and appears as an intermittent hyperechoic line with comet tail artefact on the caudal aspect image (b).

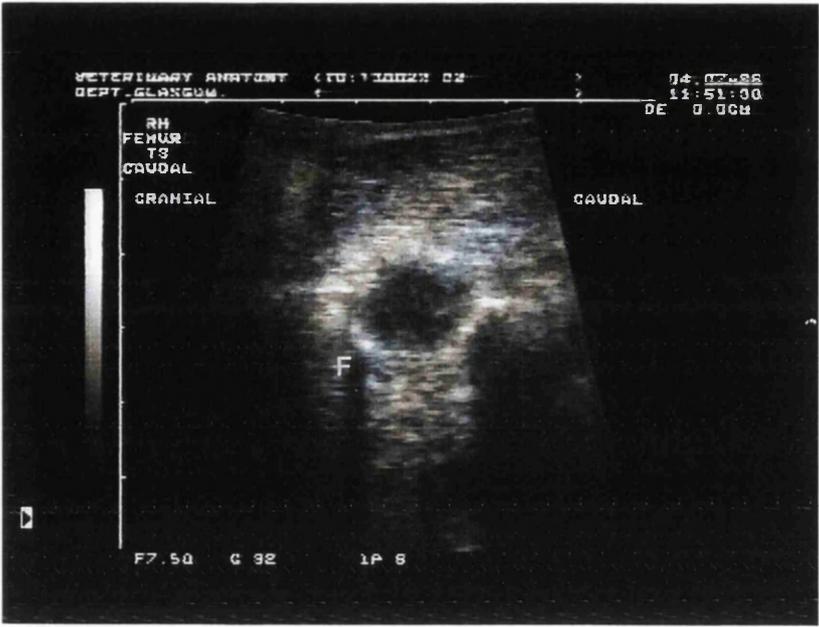
Figure 6.2.10 The haematoma within the muscle near fracture site imaged 48 hours after surgery appears as an hypoechoic area with some echogenic material present. F, femur.

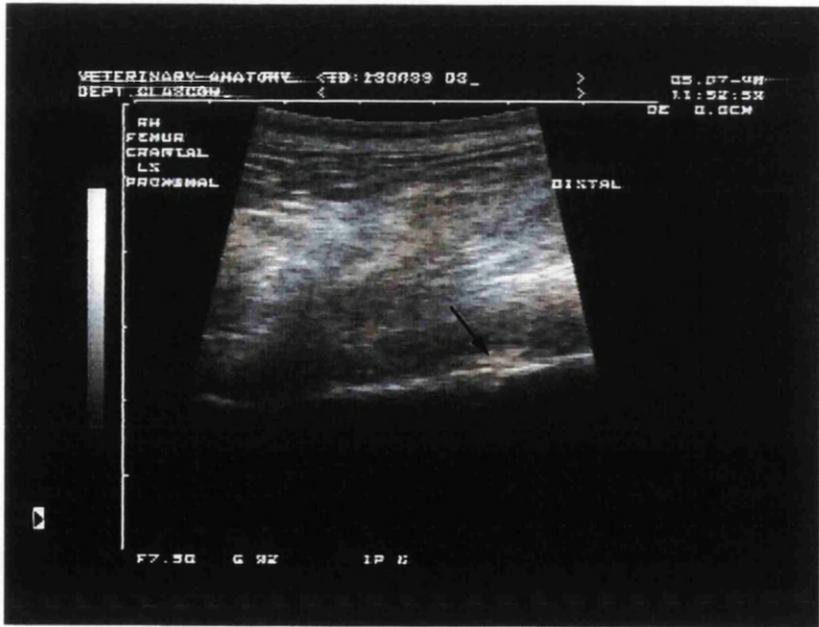
Figure 6.2.11 Longitudinal scan from the cranial aspect of the femur on day three post-operation demonstrates the fracture site (arrow). Note that the hyperechoic appearance at the fracture site and the presence of some echogenic material indicates periosteal and soft tissue reactions.

The ultrasonographic image of the fracture site at the proximal end from the cranial aspect appeared as in day two examination (figure 6.2.11). The haematoma was slowly becoming more echogenic as compared to the previous scans (figure 6.2.12). The small bone fragment placed within the biceps femoris muscle cranial to the femur appeared hyperechoic with acoustic shadowing artefact (figure 6.2.13). There was an hypoechoic area surrounding the small bone fragment which indicated the lysis process. The small bone fragment appeared smaller than on the day two examination. The small, irregular and well defined hypoechoic area seen in day two at the distal third of the femoral fracture site had increased in size and appeared as an ill-defined hypoechoic area (figure 6.2.14).

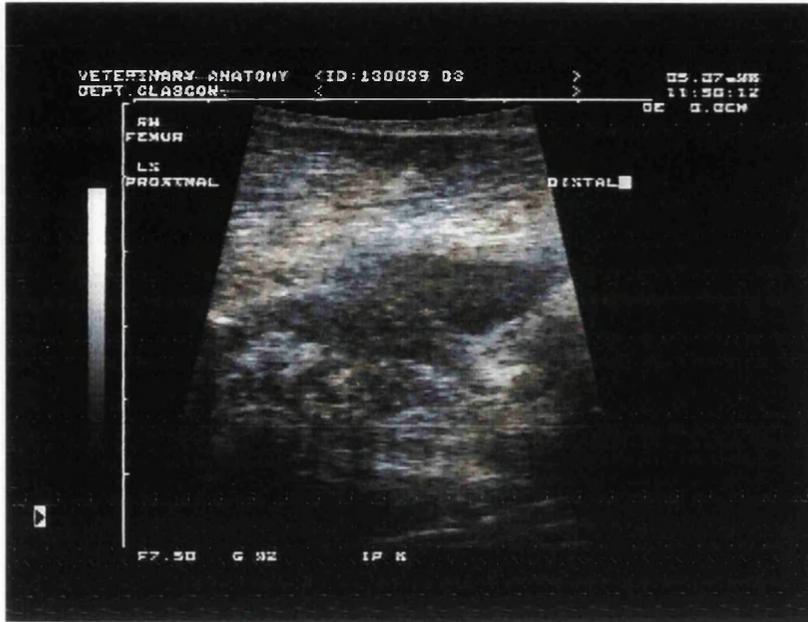
Figure 6.2.12 The large haematoma within the muscle near the fracture site scanned on day three post-operation appears hypoechoic with the content becoming more echogenic than on the day two examination. This indicates that the haematoma is resolving.

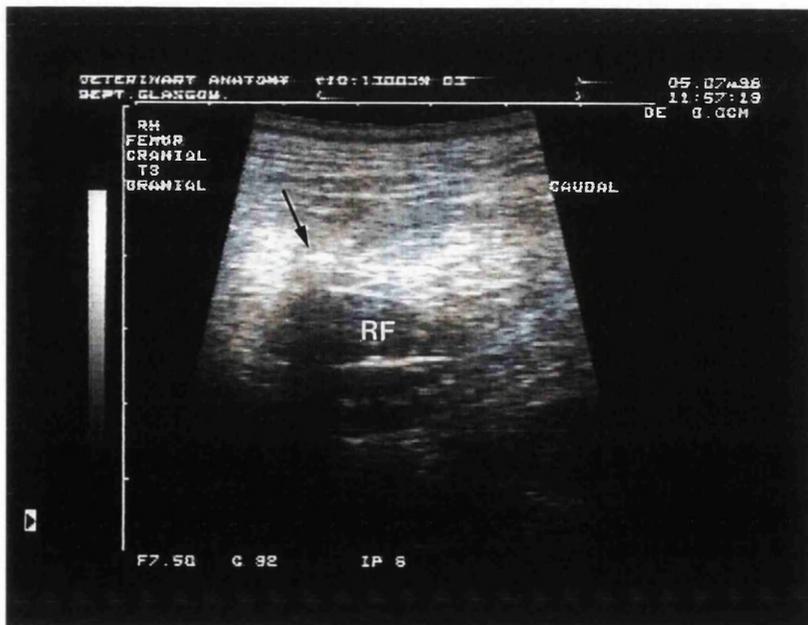
Figure 6.2.13 A small bone fragment (arrow) is lying within the biceps femoris muscle cranial to the femur as scanned on day three post-operation. Note the bone fragment appears hyperechoic with acoustic shadowing artefact and has become smaller than on the day two examination. The hypoechoic area surrounding the bone fragment indicates a lysis process. **rf**, m. rectus femoris.

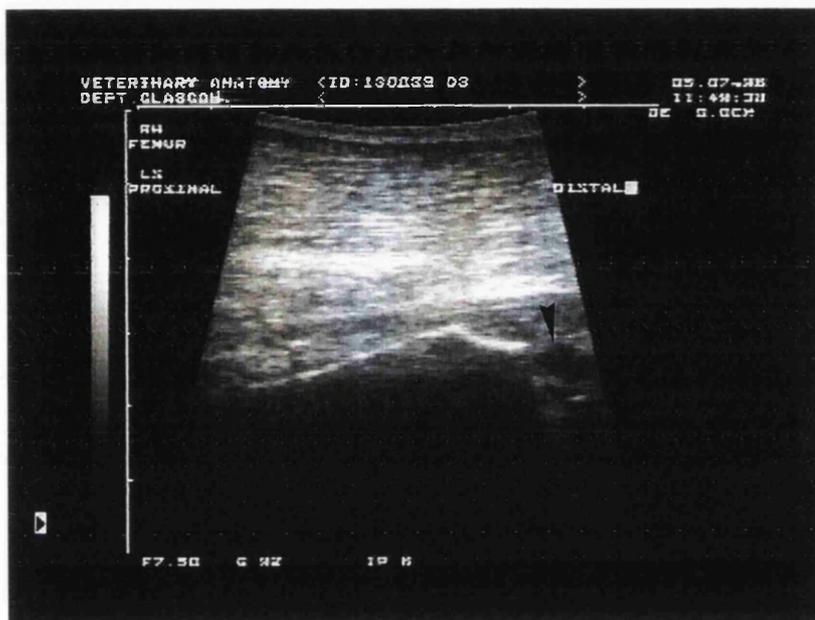
Figure 6.2.14 Longitudinal scan from the caudal aspect of the femur on day three post-operation demonstrates an ill-defined hypoechoic area (arrow head) which appears bigger than on the day two examination.

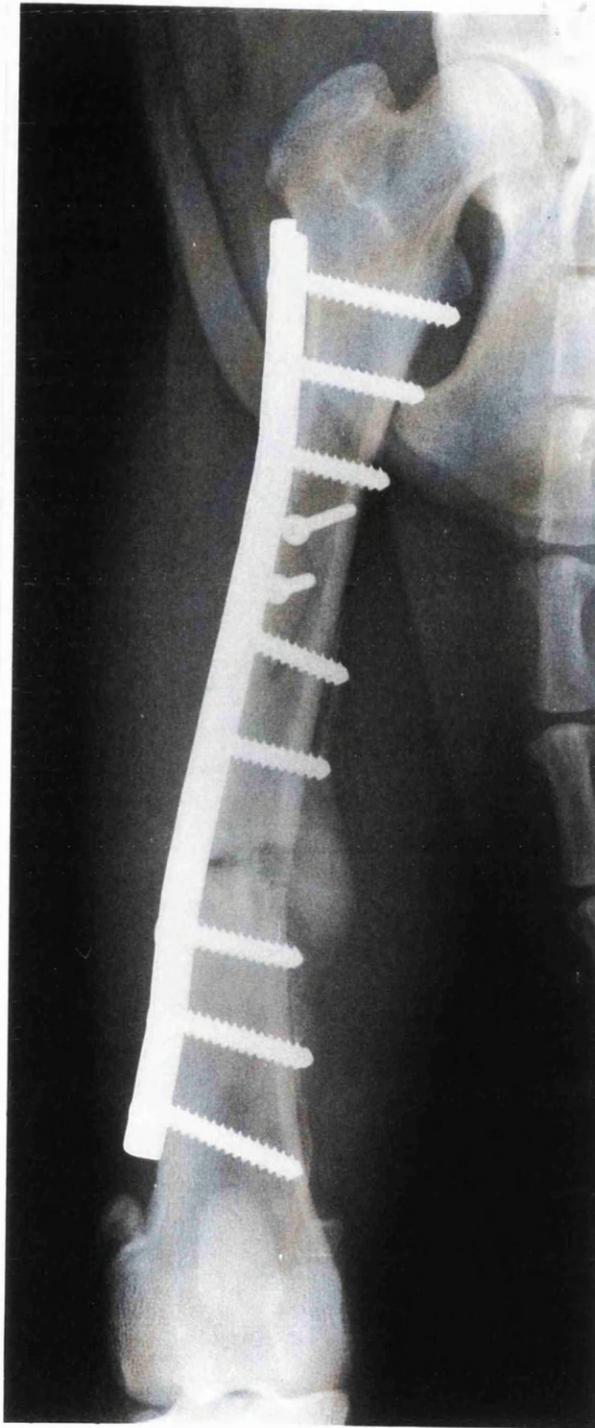
a

Figure 6.2.15 Radiographs obtained at six weeks after fracture repair. **a**, cranial view, **b**, lateral view. Callus formation is bridging the fracture gap. The fracture lines at both the distal third and proximal end of the femur are still visible. The wispy periosteal reaction proximal and distal to the distal third fracture site may represent damage to the periosteum at surgery. There is no evidence of implant instability.

Radiographs taken on day 42 (six weeks) after fracture repair demonstrated the exuberant smooth callus formation bridging the fracture gap (figure 6.2.15). The fracture lines at the proximal and distal third of the femur were still visible radiographically. The wispy periosteal reaction proximal and distal to the fracture site at distal third of the femur may represent damage to the periosteum at surgery. There was no evidence of implant instability.

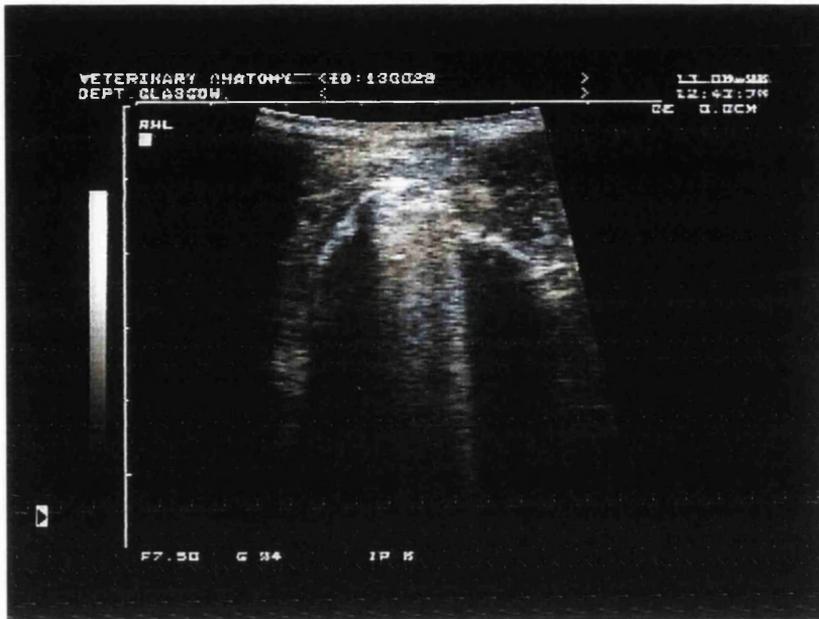
Figure 6.2.16 Transverse scan from the lateral aspect of the femur on day 42 post-operation shows extensive callus formation on both sides of the bone plate. Note also that the bone plate and screw that are adhering to the femur appears hyperechoic and are producing comet tail artefacts.

Ultrasonographic examination on day 42 (six weeks) after fracture repair demonstrated the exuberant callus formation at the fracture site both on transverse and longitudinal scans (figure 6.2.16). No fracture line could be detected at this stage, but the fracture site at the distal third of the femur could still be recognised as shown by a small notch on the callus formation at the fracture site (figure 6.2.17). Mature callus had bridged the fracture gap at this stage. The mature callus appeared hyperechoic with an uneven rough surface and produced acoustic shadowing. It has ultrasonographic characteristics similar to normal bone tissue. There was no haematoma detected in the muscle. The muscle structure had returned to its normal characteristic. Ultrasonographically, the fractured bone was healed satisfactorily with no complication.

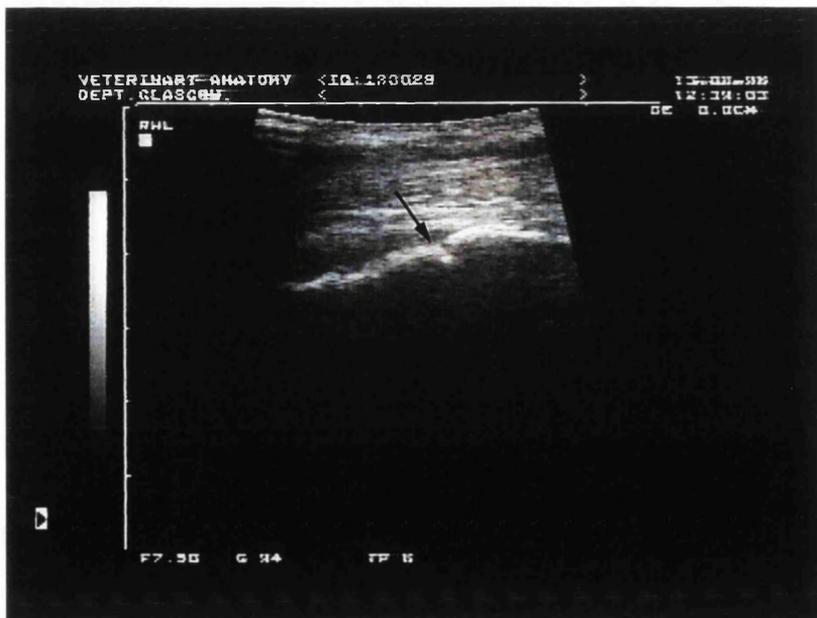
Figure 6.2.17 Longitudinal scan from the cranial aspect of the femur on day 42 post-operation demonstrates the bulging femoral surface which is due to the mature callus. Note also that the fracture site can still be identified as a small notch (arrow). The fracture site has been completely bridged by the mature callus. The remodelling process is in progress at this stage.

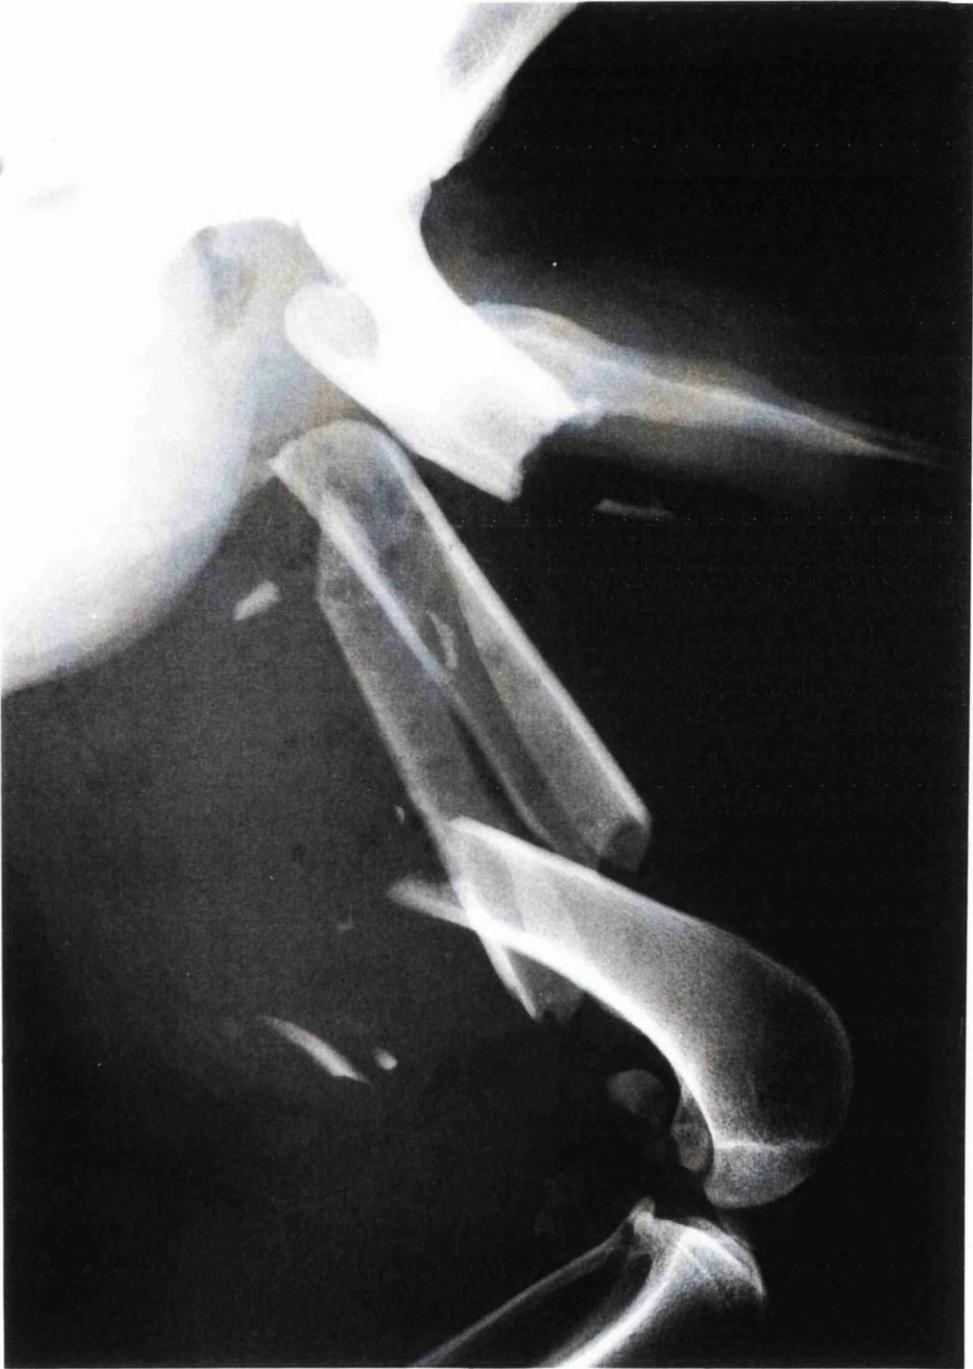
Figure 6.3.1 A three year old German Shepherd with a comminuted fracture of the left femur. The femur fracture had been sustained with significant displacement of the fragments after a road traffic accident one week previously.

A three year old male German Shepherd, weight 28 kg, with a suspicion of having a femoral fracture was admitted to the Glasgow University Veterinary Hospital. The dog had been hit from behind in a road traffic accident one week previously. Radiographic examination carried out before the fracture repair was done showed a multiple comminuted and segmented fracture of the left femur (figure 6.3.1). The fracture had been sustained with a significant displacement of the fragments. There was also a marked tissue reaction.

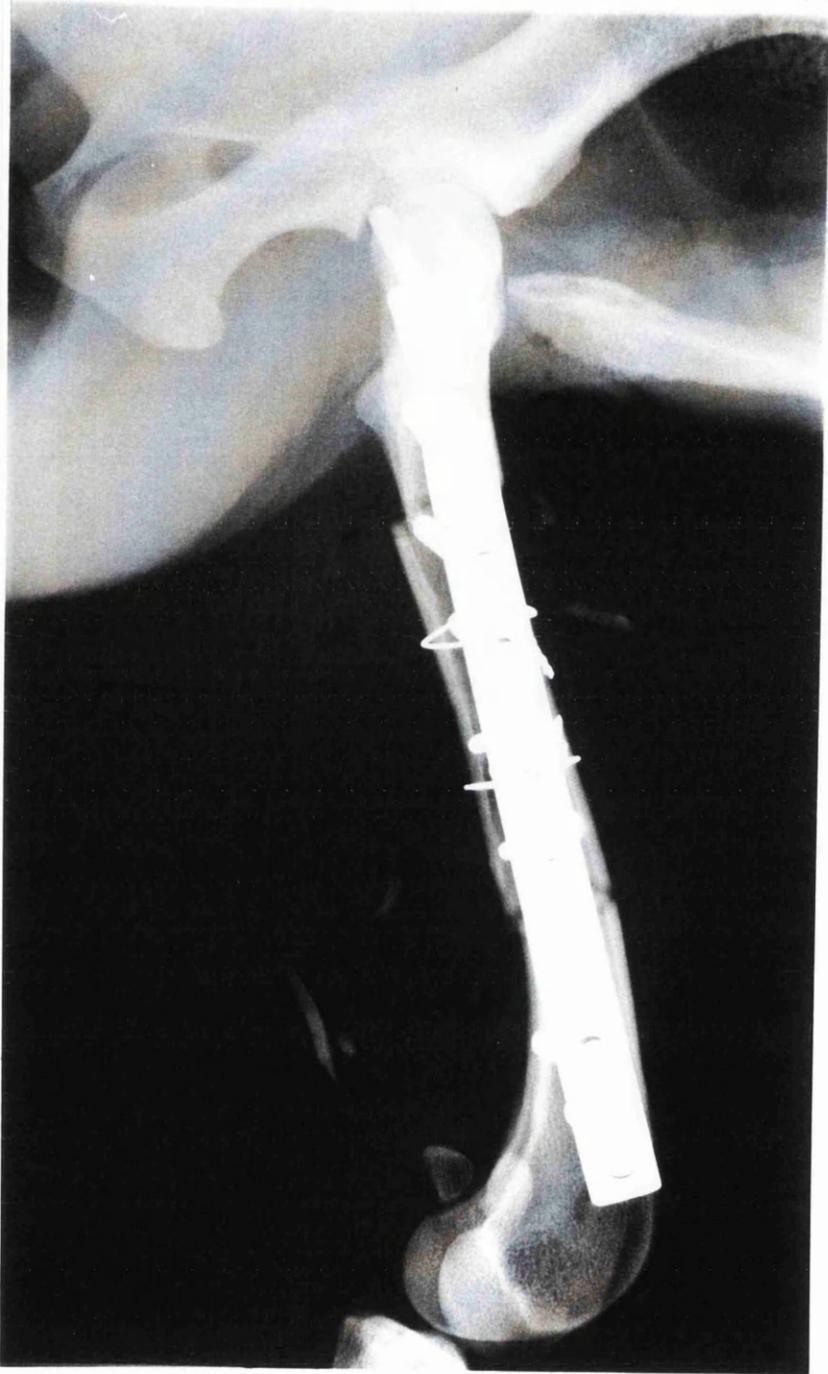
Figure 6.3.2 Radiographs obtained immediately after fracture repair. The repair process has resulted in good fracture reduction. **a**, lateral view, **b**, cranial/caudal view. A standard 4.5 mm 10 holes plate was used to stabilise the fracture following transverse osteotomy both at proximal and distal fracture sites. Two lag screws and two cerclage wires were used in addition to the bone plate. A number of small bone fragments remain in the muscle.

Radiographs taken immediately after the fracture reduction showed the repair process had resulted in a good reduction but a number of small fragments remained in the muscle (figure 6.3.2).

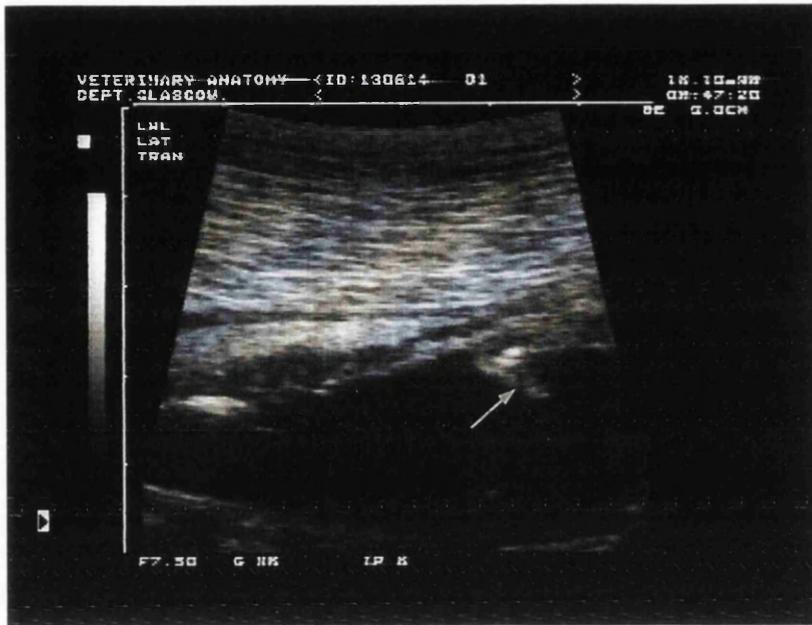
Figure 6.3.3a

Figure 6.3.3 Longitudinal scan of the thigh from the lateral aspect 24 hours after fracture repair demonstrating a large, clear anechoic area within the muscle which represents the area of haematoma (a). Note also the presence of “bell clapper” sign (arrow) in (a) which indicate the muscle tear. The small bone fragment remaining in the muscle (arrow) appears hyperechoic with acoustic shadowing artefact (b).

Ultrasonographic examination revealed a large haematoma within the muscle which appeared as a large, clear anechoic area (figure 6.3.3a). There was a “bell clapper” sign at the upper wall of the haematoma suggesting a muscle tear. One small bone fragment was found within the muscle near the haematoma area and appeared hyperechoic with acoustic shadowing artefact (6.3.3b). The metal plate adherent to the bone appeared as a straight hyperechoic line and produced a reverberation artefact (figure 6.3.4). The screw used in the fracture reduction appeared hyperechoic and produced a comet tail artefact. The fracture site at the distal third scanned longitudinally from the cranial aspect appeared as a vertical hyperechoic line across the femur with the presence of a small gap (figure 6.3.5a). The soft tissue reaction could be seen at the fracture site appearing as an hyperechoic area. The fracture site at the proximal third of the femur appeared as discontinuity of the hyperechoic straight line of the bone but there was no gap present (figure 6.3.5b). The small bone fragment lying superficial to the femur appeared hyperechoic with acoustic shadowing artefact. The fracture site was clearly seen from the medial aspect scan with the presence of a fracture gap (figure 6.3.6). There was also a bone fragment immediately superficial to the fracture site which appeared as an hyperechoic short line structure. The soft tissue and periosteal tissue reactions were detected at the fracture site and in the nearby area and appeared as an hyperechoic area. The muscle had lost its normal ultrasonographic appearance and appeared as a disorganised hypoechoic region. The screws used to fix the fragment near the fracture site appeared hyperechoic with comet tail artefacts. The screws were protruding into the muscle on medial aspect of the femur. Soft tissue reactions were detected around the screws and appeared as disorganised hyperechoic areas (figure 6.3.7). The area of muscle damage above the femur appeared as a disorganised hypoechoic region relative to the area of normal muscle on a transverse scan (figure 6.3.8). The fracture site imaged on a

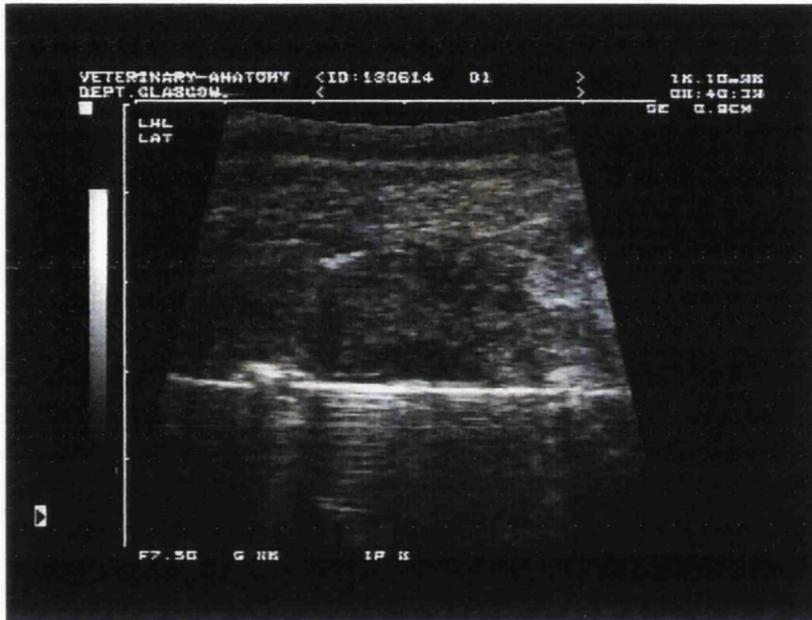
Figure 6.3.4 The bone plate adhering to the femur appears as a straight hyperechoic line and produces reverberation artefact on the longitudinal scan. Note also the area of muscle damage overlying the bone plate appearing as a disorganised hypoechoic region of the imaged muscle.

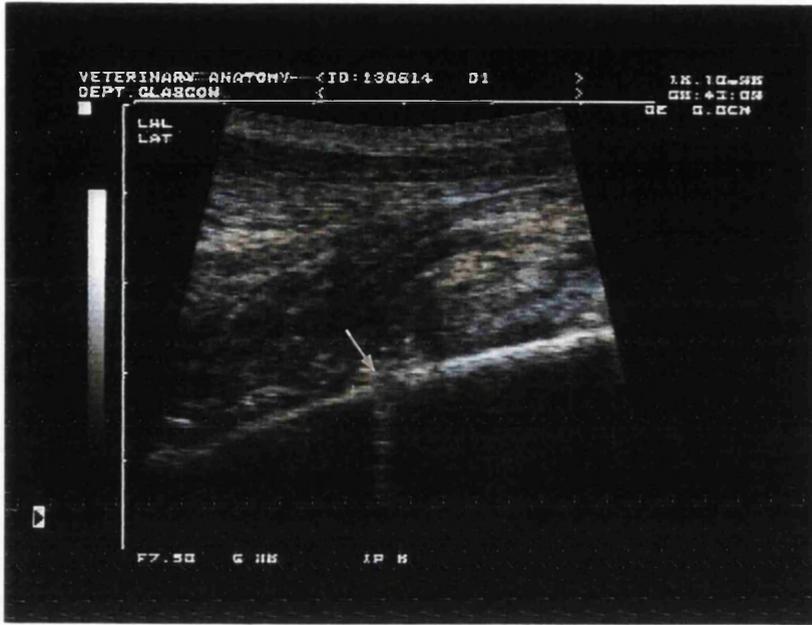
Figure 6.3.5a

Figure 6.3.5 Longitudinal scans from the cranial aspect of the femur 24 hours post-operation show the fracture site (arrow) at the distal third of the femur (a) and at the proximal third of the femur (b). The distal third fracture site appears as a hyperechoic line with the presence of a small gap, and the proximal third fracture site appears as discontinuity of the femoral surface. The hyperechoic area at the fracture site in (a) suggests a soft tissue reaction. The area of muscle damage above the femur appears as a disorganised hypoechoic region. One small bone fragment (arrow head) imaged superficial to the femur appears hyperechoic with acoustic shadowing (b).

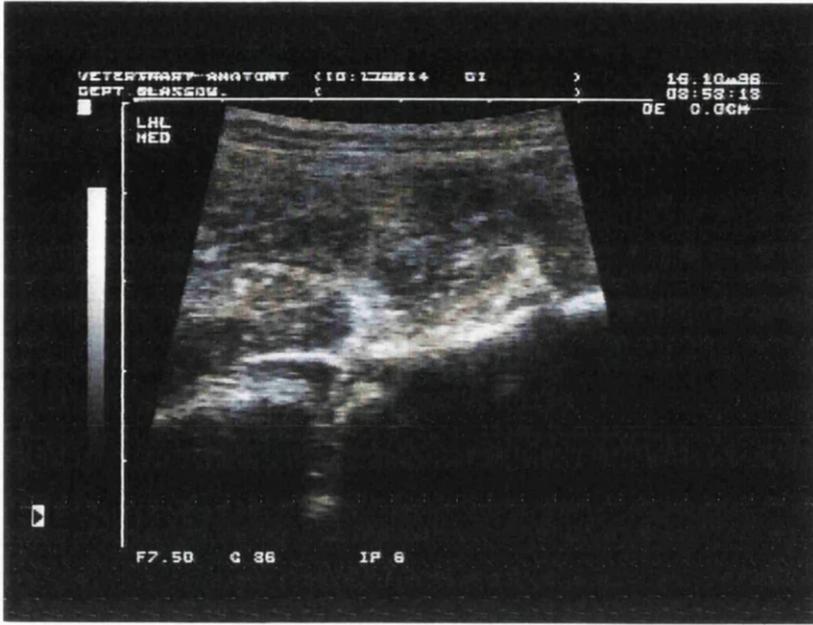
Figure 6.3.6 Longitudinal scan from the medial aspect of the femur 24 hours post-operation shows the fracture site with the presence of a gap. Note also the small hyperechoic bone fragment at the fracture site. The area of soft tissue and periosteal tissue reactions appear as disorganised hyperechoic regions at the fracture site and nearby area.

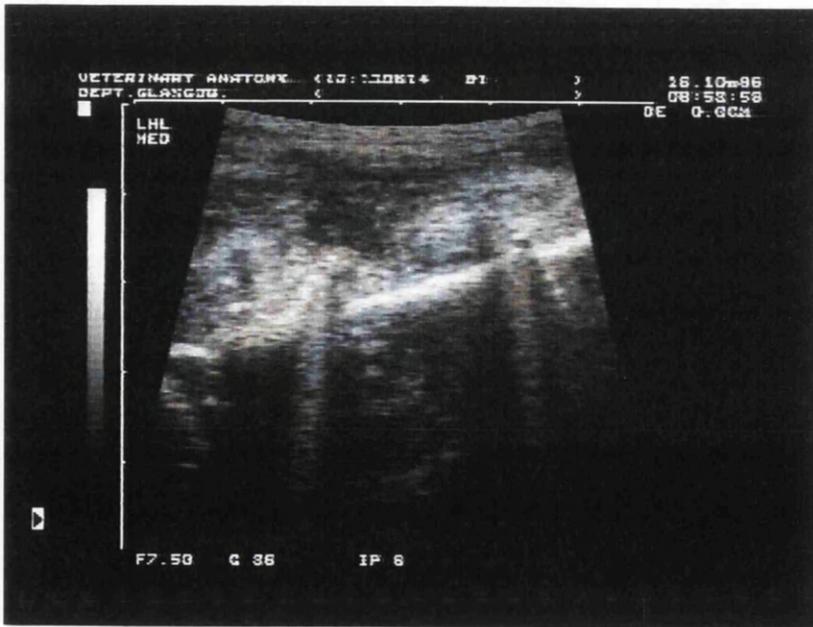
Figure 6.3.7 Longitudinal scan of the femur from the medial aspect shows the area of soft tissue reaction around the screws which appear as disorganised hyperechoic regions.
