**AN ULTRASONOGRAPHIC STUDY OF MUSCULOSKELETAL
INJURIES AND MAMMARY GLAND TUMOUR IN SMALL
ANIMALS**

A thesis submitted to the Faculty of Veterinary Medicine,
University of Glasgow.

For the Degree of Doctor of Philosophy

Division of Veterinary Anatomy,
Department of Veterinary Preclinical Studies,
School of Veterinary Medicine,
University of Glasgow,
March, 1999

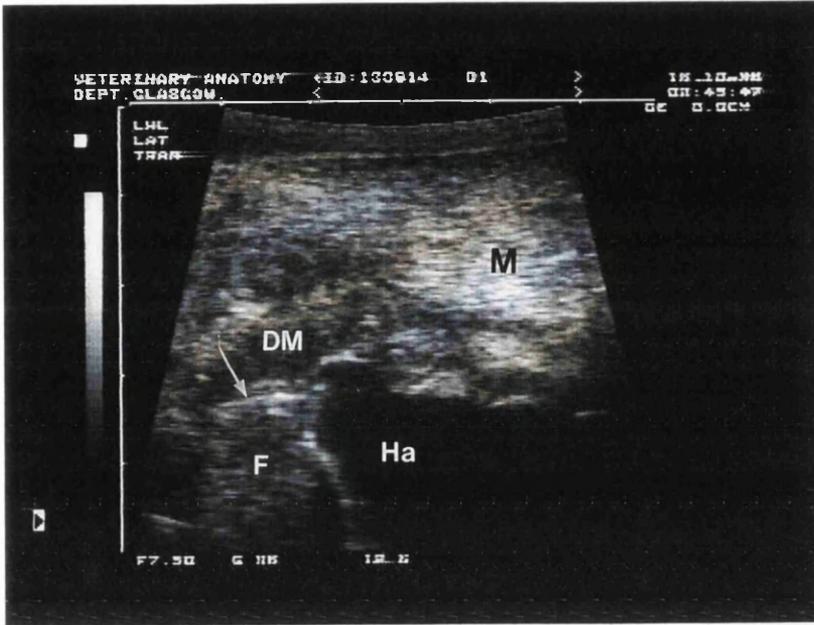
Figure 6.3.8 Transverse scan of the femur from the lateral aspect 24 hours post-operation demonstrates the area of muscle damage which appears as a disorganised hypoechoic region (DM) as compared to the normal muscle (M). Note also the bone plate (arrow) adherent to the femur appearing as an hyperechoic structure with reverberation artefact. **M**, normal muscle, **DM**, damage muscle, **Ha**, haematoma area, **F**, femur.

Ultrasonographic examination revealed a large haematoma within the muscle which appeared as a large, clear anechoic area (figure 6.3.3a). There was a “bell clapper” sign at the upper wall of the haematoma suggesting a muscle tear. One small bone fragment was found within the muscle near the haematoma area and appeared hyperechoic with acoustic shadowing artefact (6.3.3b). The metal plate adherent to the bone appeared as a straight hyperechoic line and produced a reverberation artefact (figure 6.3.4). The screw used in the fracture reduction appeared hyperechoic and produced a comet tail artefact. The fracture site at the distal third scanned longitudinally from the cranial aspect appeared as a vertical hyperechoic line across the femur with the presence of a small gap (figure 6.3.5a). The soft tissue reaction could be seen at the fracture site appearing as an hyperechoic area. The fracture site at the proximal third of the femur appeared as discontinuity of the hyperechoic straight line of the bone but there was no gap present (figure 6.3.5b). The small bone fragment lying superficial to the femur appeared hyperechoic with acoustic shadowing artefact. The fracture site was clearly seen from the medial aspect scan with the presence of a fracture gap (figure 6.3.6). There was also a bone fragment immediately superficial to the fracture site which appeared as an hyperechoic short line structure. The soft tissue and periosteal tissue reactions were detected at the fracture site and in the nearby area and appeared as an hyperechoic area. The muscle had lost its normal ultrasonographic appearance and appeared as a disorganised hypoechoic region. The screws used to fix the fragment near the fracture site appeared hyperechoic with comet tail artefacts. The screws were protruding into the muscle on medial aspect of the femur. Soft tissue reactions were detected around the screws and appeared as disorganised hyperechoic areas (figure 6.3.7). The area of muscle damage above the femur appeared as a disorganised hypoechoic region relative to the area of normal muscle on a transverse scan (figure 6.3.8). The fracture site imaged on a

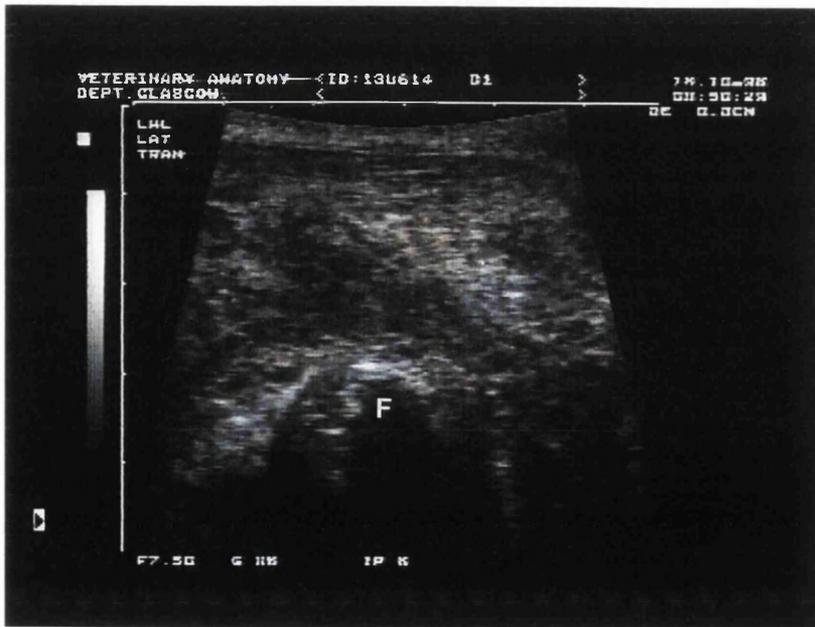
Figure 6.3.9 A fracture site imaged on a transverse scan 24 hours post-operation shows the fracture gap which appears as a 'V' shape. The area of muscle damage above the femur appears as disorganised hypoechoic structure. **F**, femur.

transverse scan appeared as a 'V'-shape fracture gap present on the femoral surface (figure 6.3.9). The ruptured blood vessel within the large haematoma was detected (figure 6.3.10). It was pulsating during ultrasonographic examination. A small blood vessel within the muscle imaged in cross section appeared as a small, well defined round hypoechoic area with edge shadowing artefacts (figure 6.3.11).

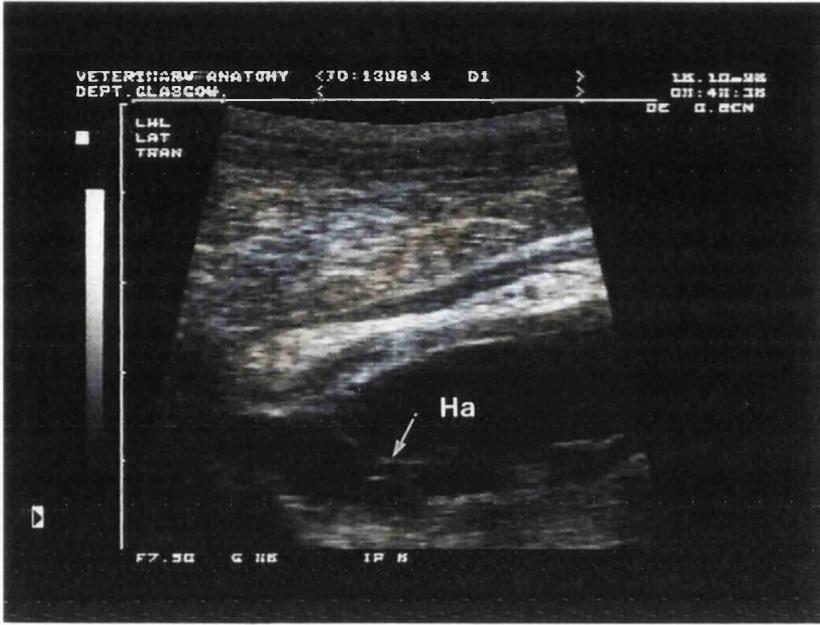
Figure 6.3.10 The ruptured blood vessel can be seen within the large haematoma 24 hours post-operation (arrow). It was pulsating during examination. **Ha**, haematoma area.

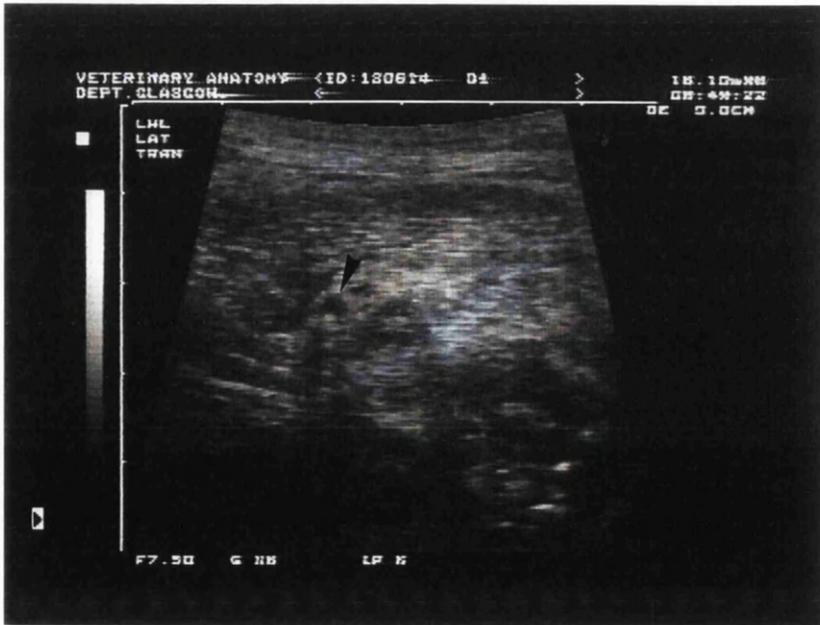
Figure 6.3.11 The small blood vessel (arrow head) on transverse scan appears hypoechoic with edge shadowing artefact.

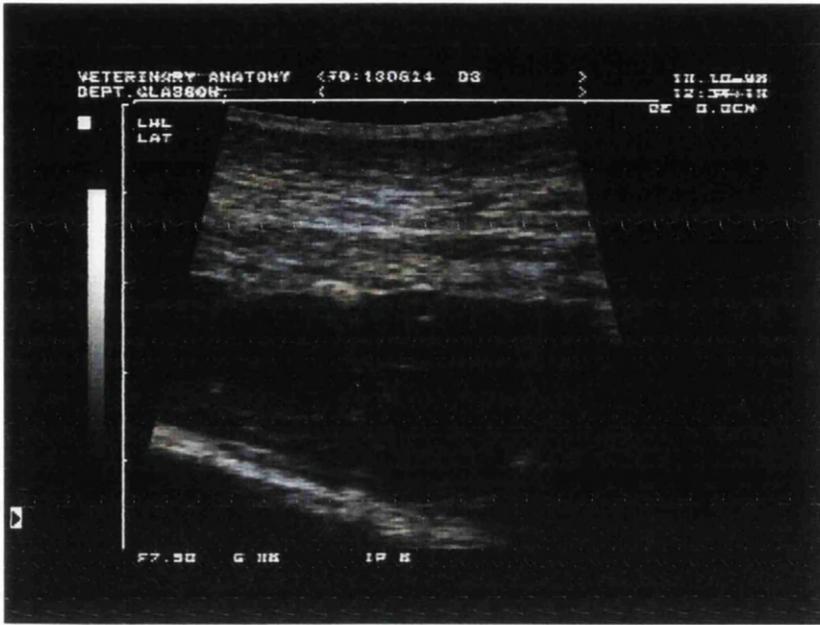
Figure 6.3.12 A large haematoma imaged on day three post-operation appears anechoic with the presence of some echogenic material inside.

The large haematoma evident with a clear margin within the muscle still persisted on the day three examination and appeared anechoic but with some echogenic materials present (figure 6.3.12). The periosteal tissue reaction could be seen on the femoral surface as an hyperechoic area. The fracture site imaged from medial aspect of the femur demonstrated the disorganised hyperechoic structure area on the femoral surface and around the fracture site suggesting the presence of soft tissue and periosteal tissue reaction (figure 6.3.13). The soft callus formation could be seen within the fracture gap appearing hyperechoic and trying to bridge the gap. The area of extensive muscle damage caudal to the femur appeared as a disorganised mixture of anechoic and echogenic areas on the caudo-medial aspect scan (figure 6.3.14). Soft callus formation was detected at the distal third fracture site on a cranial aspect scan and appeared as hyperechoic material adherent to the bone surface adjacent to the fracture site (figure 6.3.15). The periosteal tissue reaction could also be seen on the femoral surface around the fracture site. The small fracture gap had become shallow due to callus formation. The femur appeared slightly bent at the area of the proximal third fracture site on a longitudinal scan from the caudal aspect (figure 6.3.16). The hyperechoic layer on the femoral surface suggested a periosteal tissue reaction. The fracture site at the distal third of the femur imaged on a transverse scan showed a fracture gap which appeared hyperechoic due to periosteal tissue reaction (figure 6.3.17). Soft callus formation could be seen as an hyperechoic structure adhered to the bone

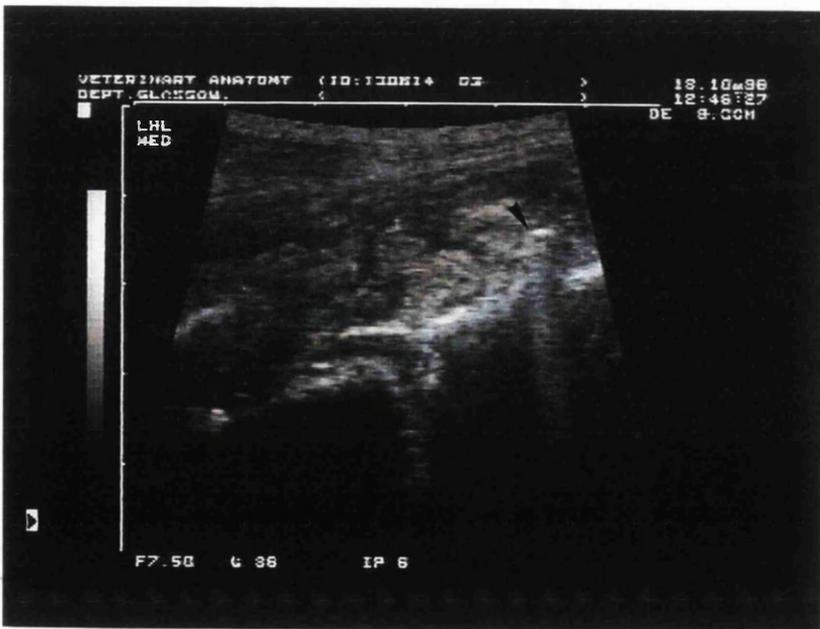
Figure 6.3.13 Ultrasonographic image of the fracture site from the medial aspect on day three after fracture repair demonstrates the fracture gap with the presence of soft callus formation. The presence of a disorganised hyperechoic area around the screws and on the femur suggests an area of soft tissue and periosteal reaction. The screw (arrow head) appears hyperechoic with comet tail artefact.

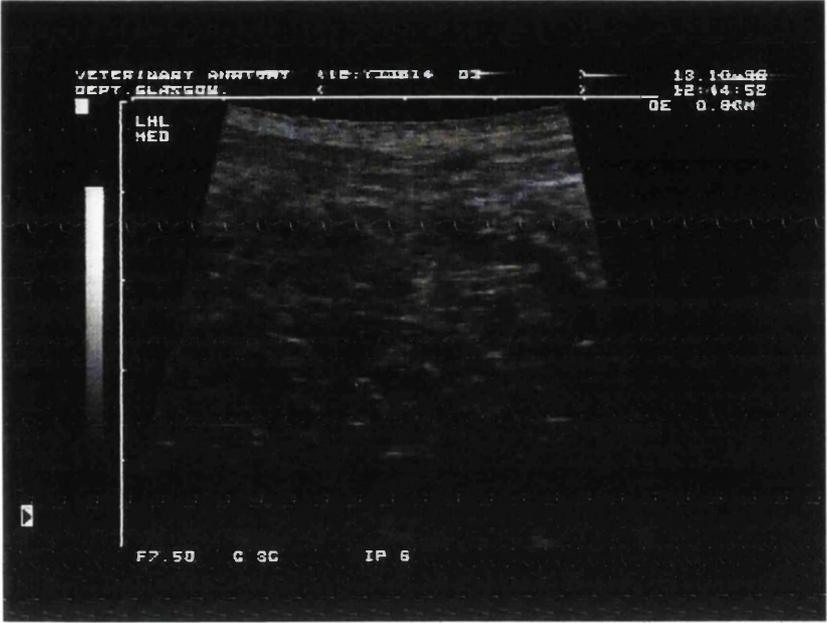
Figure 6.3.14 The mixture of anechoic and echogenic structures represents the area of extensive muscle damage imaged from the medial aspect of the thigh on day three after fracture repair.

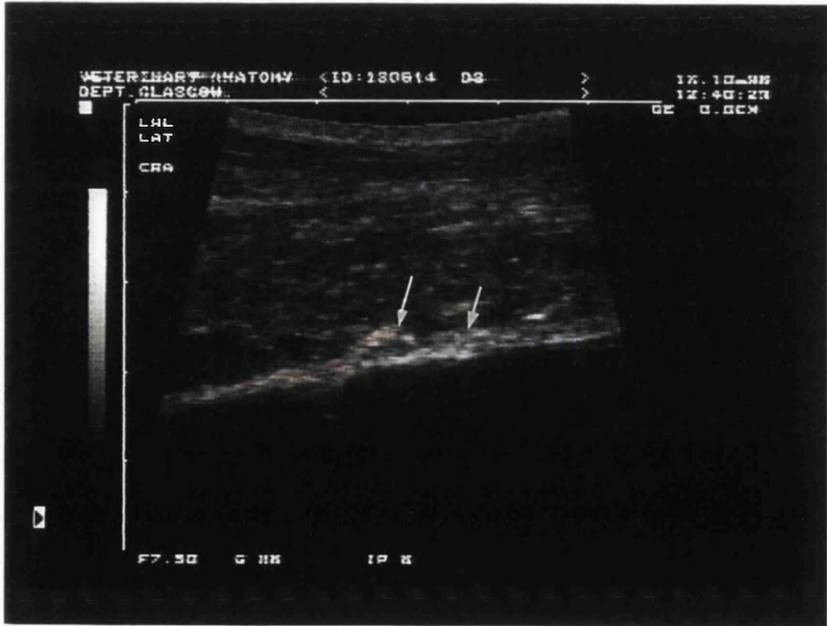
Figure 6.3.15 Longitudinal scan from the cranial aspect of the femur on day three after fracture repair shows the fracture site at the distal third of the femur with the soft callus formation (arrows). Note that the soft callus formation appears as hyperechoic material adhering to the femoral surface adjacent to the fracture site. There is also a layer of periosteal tissue reaction on the femoral surface which appears hyperechoic. The fracture gap is becoming shallow due to the callus formation.

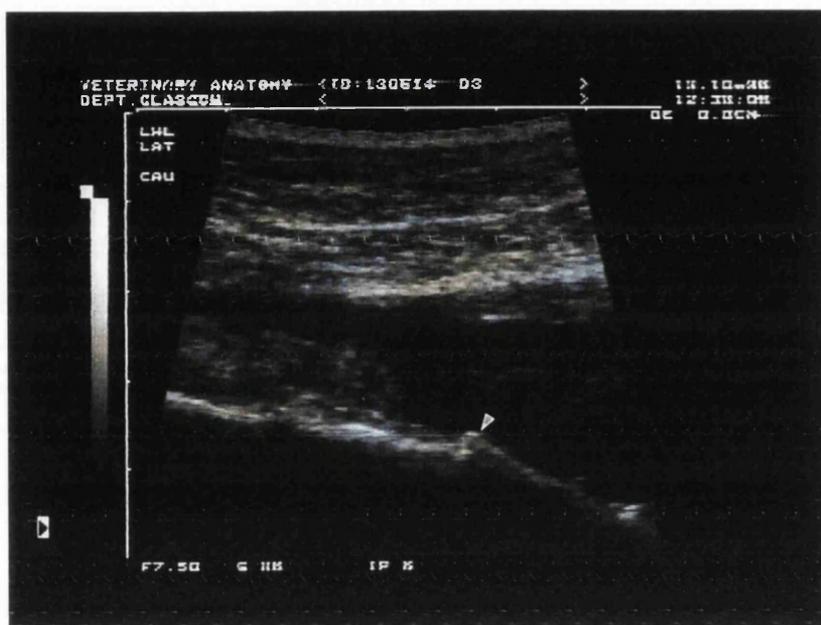
Figure 6.3.16 Longitudinal scan from the caudal aspect of the femur on day three after fracture repair shows the femur which is slightly bent at the proximal third fracture site (arrow head). Note also the hyperechoic area on the femoral surface suggesting a periosteal tissue reaction.

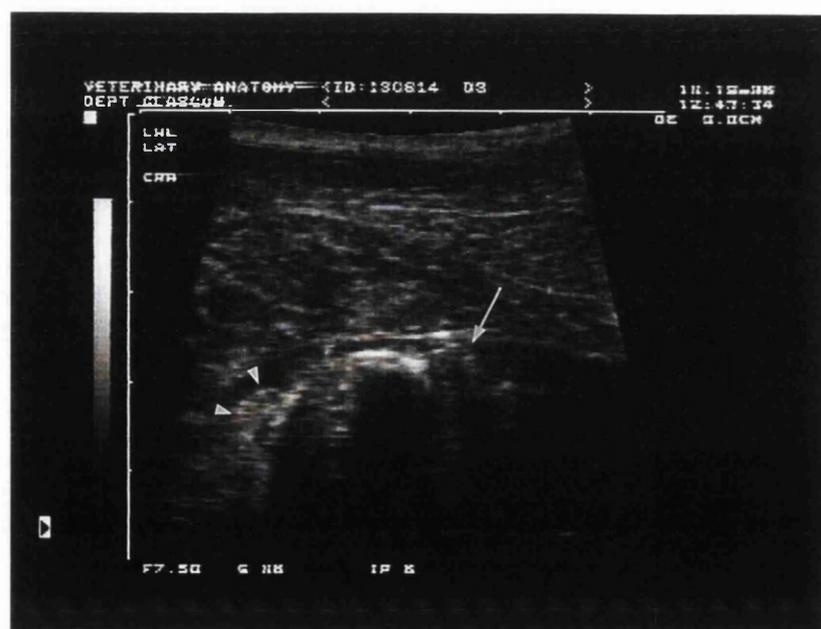
Figure 6.3.17 Transverse scan of the distal third fracture site from the cranial aspect of the femur on day three post-operation shows the fracture site which appears hyperechoic due to periosteal tissue reaction and soft callus formation. The soft callus formation appears as hyperechoic material adhering to the bone surface on the cranial side of the femur (arrow heads). The fracture gap appears smaller than on the previous examination. The bone plate with screw (arrow) appears hyperechoic with comet tail artefact.

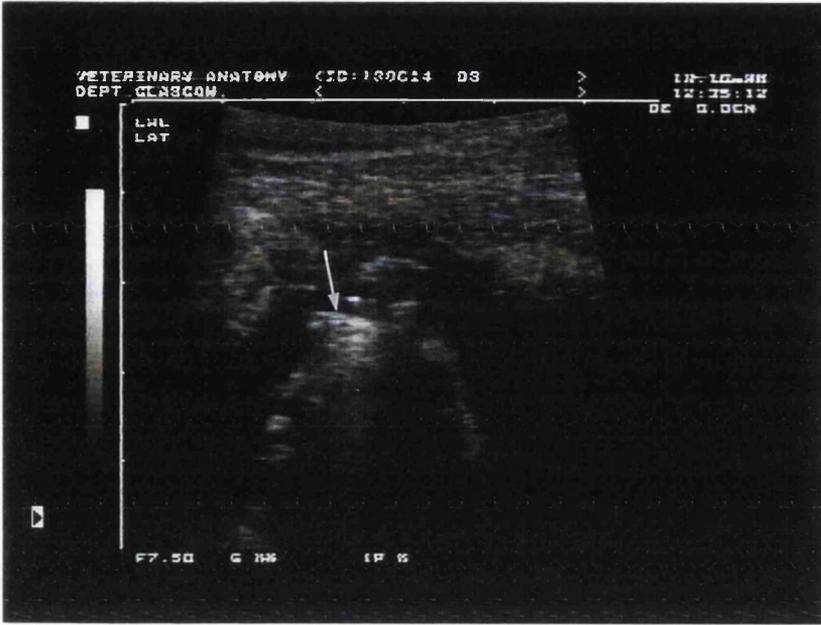
Figure 6.3.18 Transverse scan of the femur from the lateral aspect on day three post-operation shows the abnormal, enlarged and roughened surface of the femur. The bone plate (arrow) appears hyperechoic producing reverberation artefact.

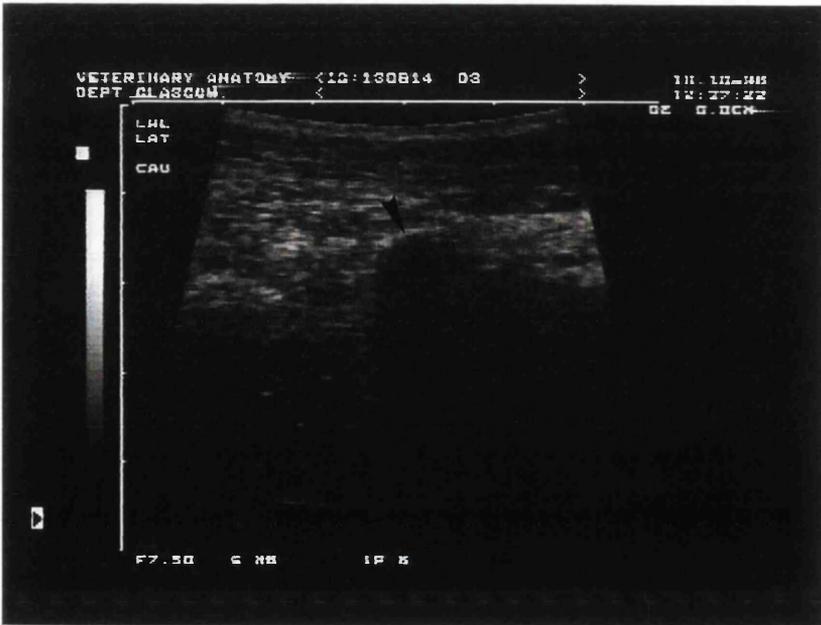
Figure 6.3.19 Longitudinal scan from the caudal aspect of the femur on day three post-operation demonstrates the bone fragment (arrow head) which remains in the muscle and appears hyperechoic with clear acoustic shadowing artefact.

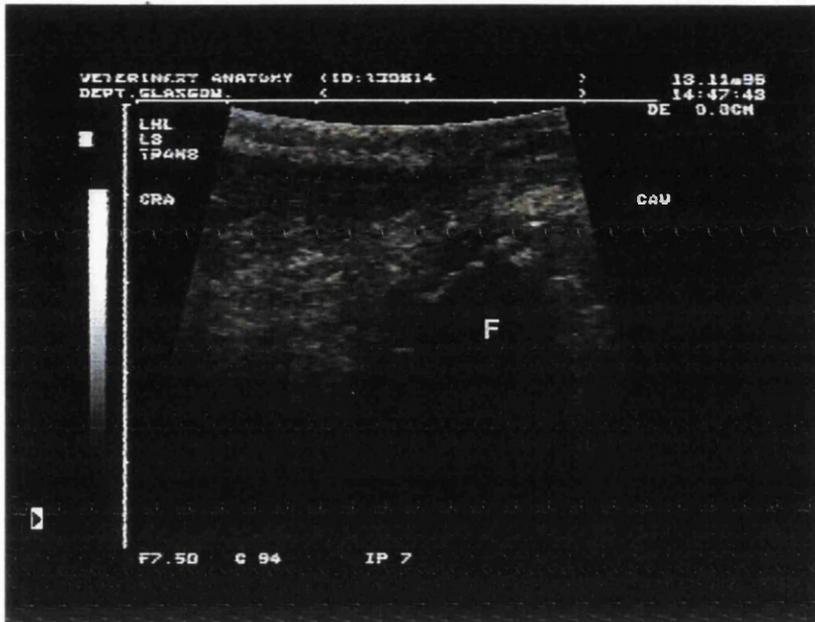
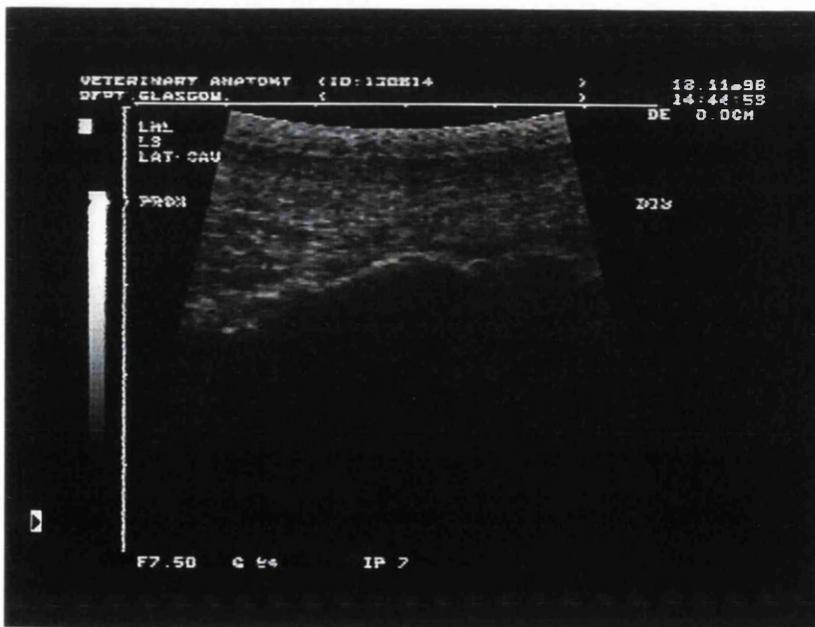
Figure 6.3.20 Ultrasonographic examination of the femur on day 34 post-operation demonstrate the excessive callus formation both on transverse (a) and longitudinal (b) scans. The mature callus appears hyperechoic and produces acoustic shadowing artefact. F, femur.

Ultrasonographic examination at the mid shaft of the femur demonstrated the excessive callus formation both on transverse and longitudinal scans and appeared as a rough hyperechoic surface with acoustic shadowing artefact (figure 6.3.20a and 6.3.20b). The femur has lost its normal smooth hyperechoic appearance. The fracture site at the distal third of the femur could still be seen when scanned from the cranio-lateral aspect and appeared as a notch on the bone surface (figure 6.3.21). The fracture site appeared to have been bridged by the mature callus and a fracture gap was no longer detectable on a longitudinal scan from the cranio-lateral aspect. The femoral surface appeared smooth at both sides of the fracture site seen from the cranio-lateral aspect and suggested a remodelling process had occurred. A transverse scan of the proximal fracture site from the cranio-lateral aspect showed the fracture gap which still persisted and appeared hyperechoic (figure 6.3.22). On the medial aspect, the fracture gap could still be seen as discontinuity of the femoral surface (figure 6.3.23). However, the fracture gap had become shallow due to callus formation. A large hyperechoic structure casting a complete acoustic shadowing artefact was found adjacent to the femur on a transverse scan from the lateral aspect (figure 6.3.24a and 6.3.24b). This structure was apparent some distance away from the mid-femur, and it came to lie closer to the femur distally (figure 6.3.24b). The bone plate that adhered to the femur appeared hyperechoic and produced reverberation artefact, while the screws appeared

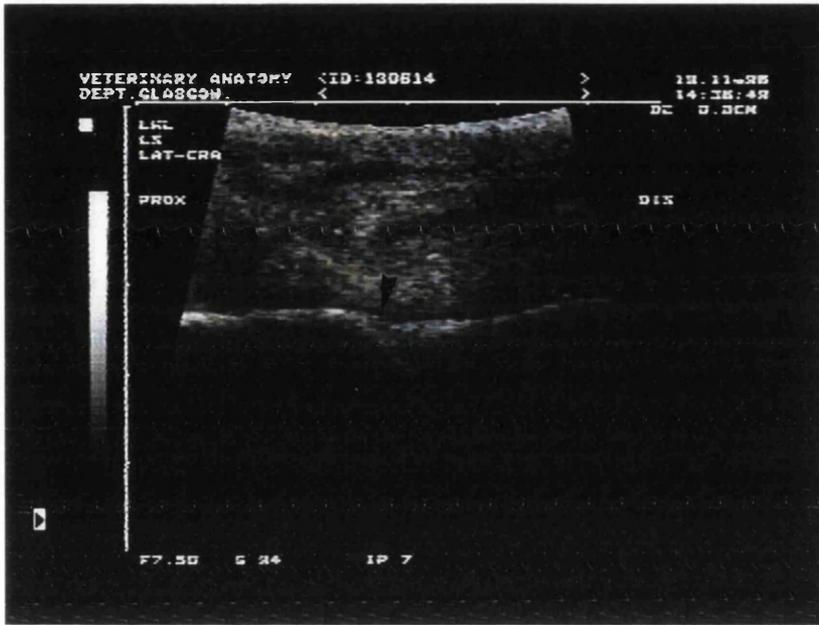
Figure 6.3.21 Longitudinal scan from the cranio-lateral aspect of the femur on day 34 post-operation shows the distal third fracture site (arrow head) which has been completely bridged by the bony callus. It appears as a small notch on the bone surface. No fracture gap can be seen on cranio-lateral aspect.

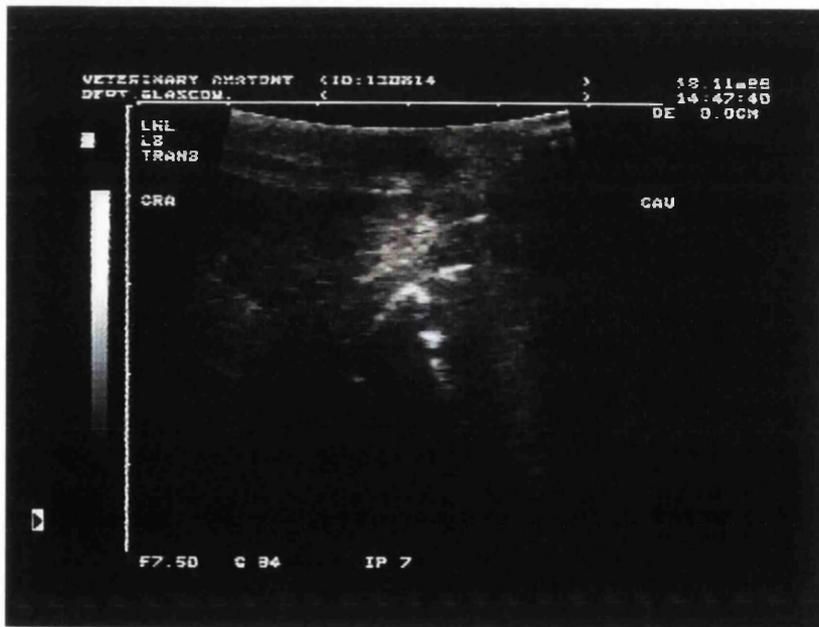
Figure 6.3.22 Transverse scan on the cranial aspect of the femur on day 34 post-operation shows the fracture site which still persists and appears hyperechoic. The fracture site has become smaller than in the previous scans.

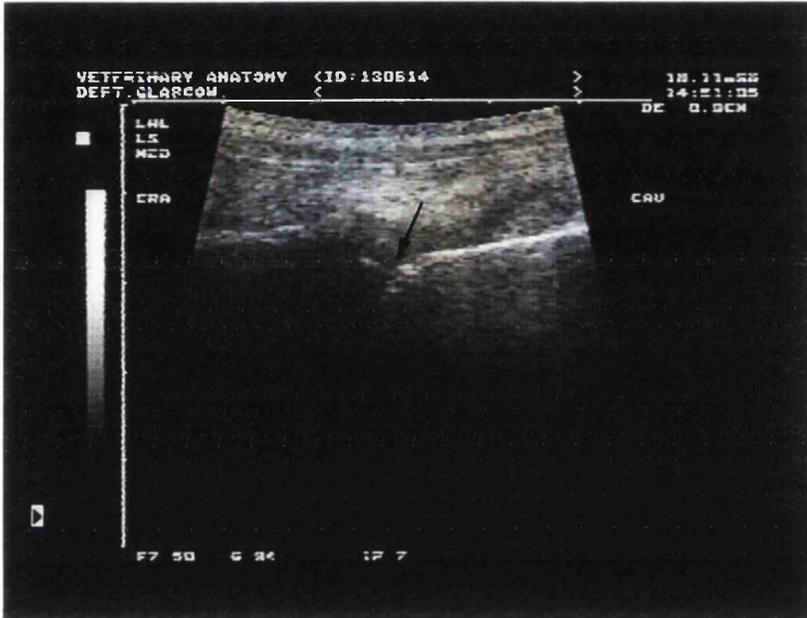
Figure 6.3.23 Longitudinal scan of the femur from the medial aspect on day 34 post-operation demonstrates the fracture gap (arrow) which has become shallow due to the callus formation.

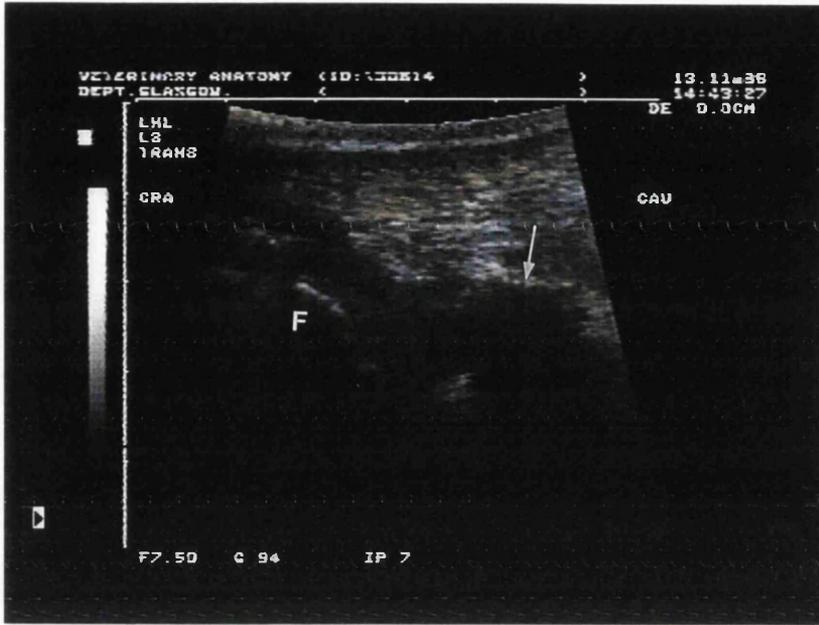
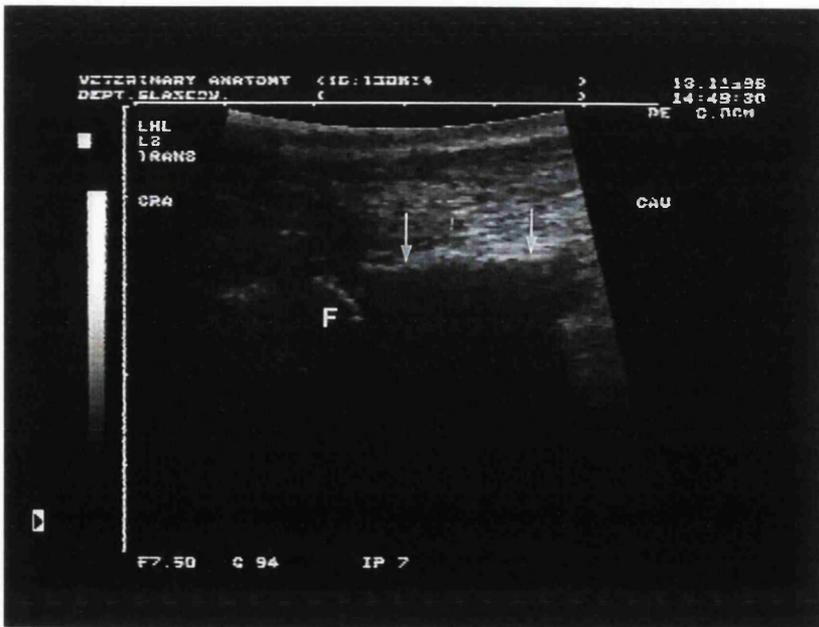
Figure 6.3.24 Transverse scans from the lateral aspect of the femur on day 34 post-operation demonstrate the hyperechoic material (arrow) which casts an acoustic shadow near the mid shaft of the femur (**a**). The structure appears bigger and closer to the femur when the transducer is moved distally (**b**). **F**, femur.

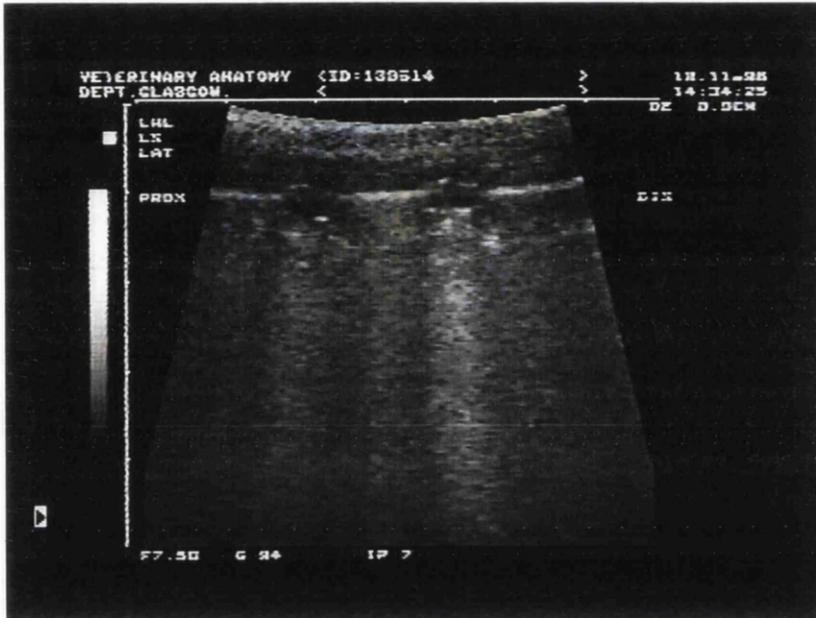
Figure 6.3.25 The bone plate adhering to the femur appears hyperechoic with reverberation artefact while the screws appear hyperechoic and produce comet tail artefacts.

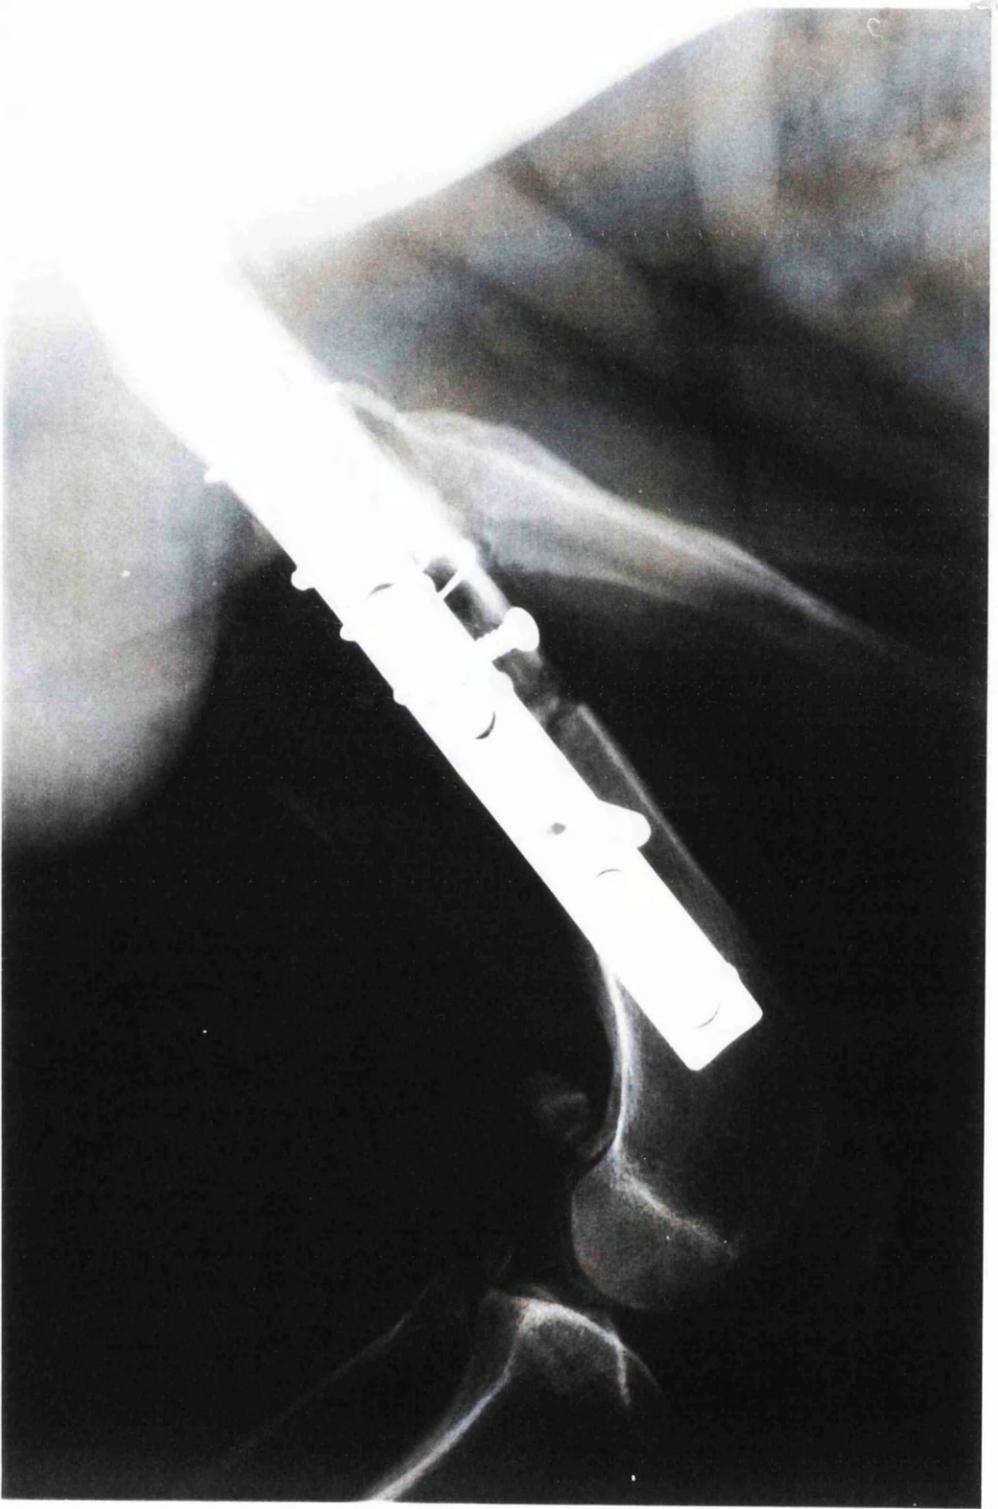
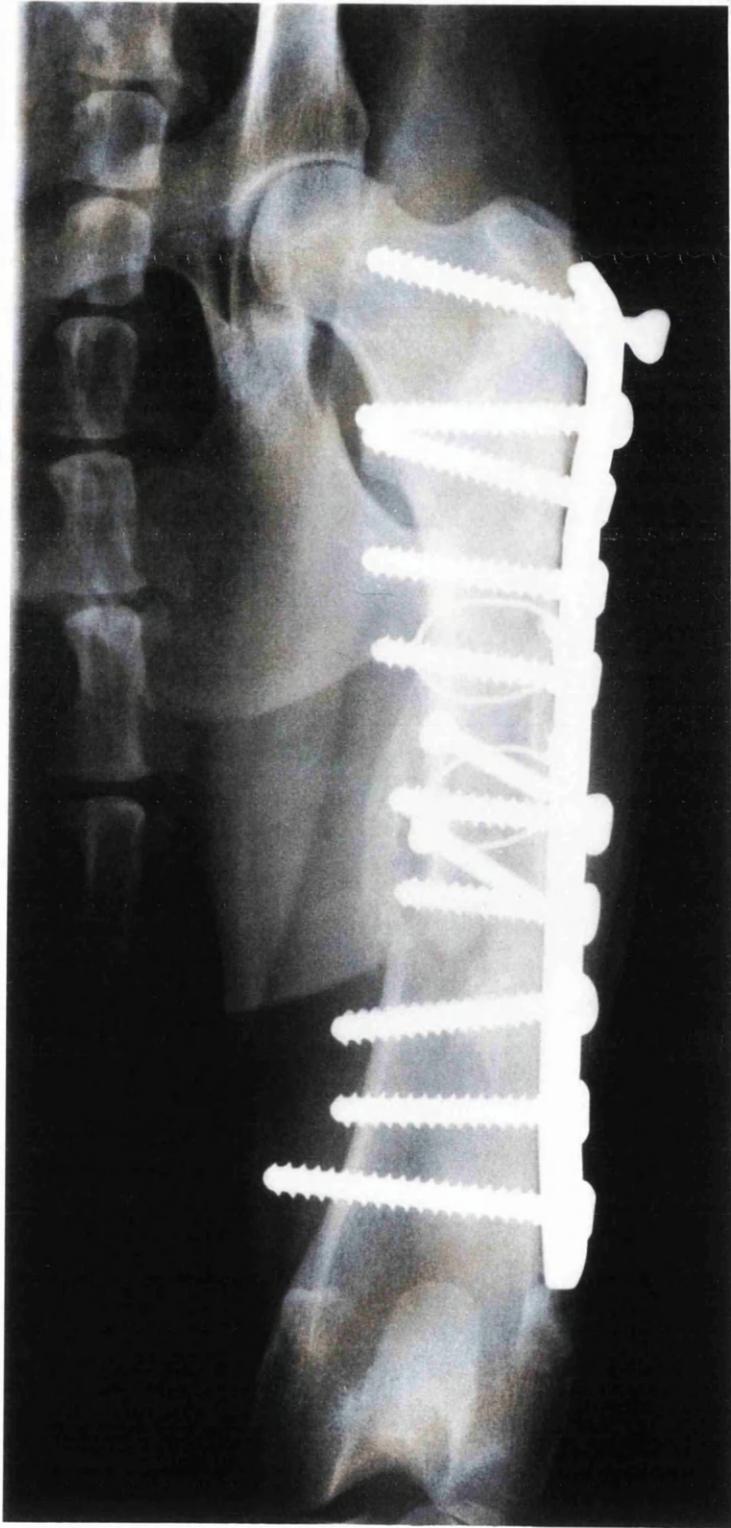
Figure 6.3.26 Radiographs obtained at day 62 after fracture repair. **a**, lateral view, **b**, cranial view. The fracture line is still visible radiographically, and the most proximal screw is coming adrift which indicates the failure of the implant at the proximal end. Callus formation is found at the medial side of the mid-femoral shaft

Radiographs taken on day 62 (9 weeks) after fracture repair showed that the fracture line was still visible, and the most proximal screw was coming adrift which indicate the failure of the implant at the proximal end. On the cranial view the callus formation was found at the medial side of the mid femoral shaft (figure 6.3.26).

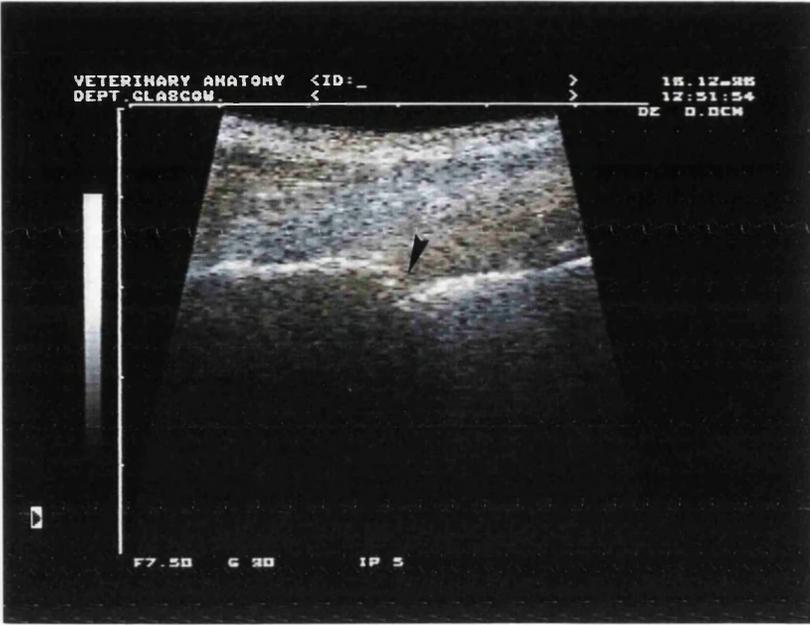
Figure 6.3.27 Longitudinal scan of the femur from the medial aspect on day 62 after fracture repair shows the fracture site (arrow head) which can still be recognised as a small notch. The fracture gap has already been bridged by the mature callus.

Ultrasonographic examination demonstrated the fracture site which had been bridged completely by the mature callus (figure 6.3.27). The fracture site could still be detected as a defect on the bone surface. A transverse scan of the mid shaft of the femur revealed the excessive callus formation around the femur which resulted in a rough and uneven femoral surface (figure 6.3.28). On the medial aspect, the fracture site appeared as a disorganised hypoechoic area with a mottled hyperechoic structure indicating callus formation (figure 6.3.29). The area of muscle damage had returned to its normal ultrasonographic appearance. Ultrasonographically, the fracture healing was occurring satisfactorily.

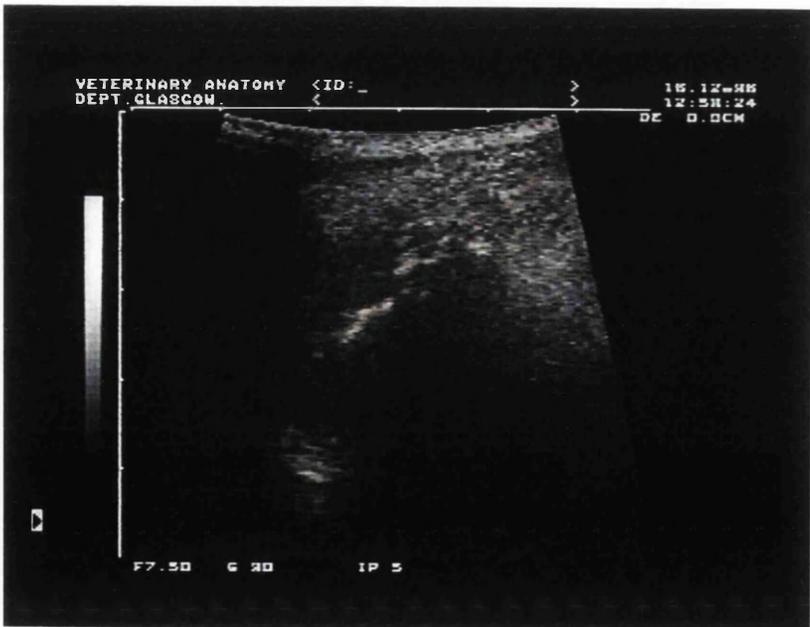
Figure 6.3.28 Transverse scan at the mid-femur from the medial aspect on day 62 after fracture repair shows the excessive callus formation which appears as a rough and uneven femoral surface.

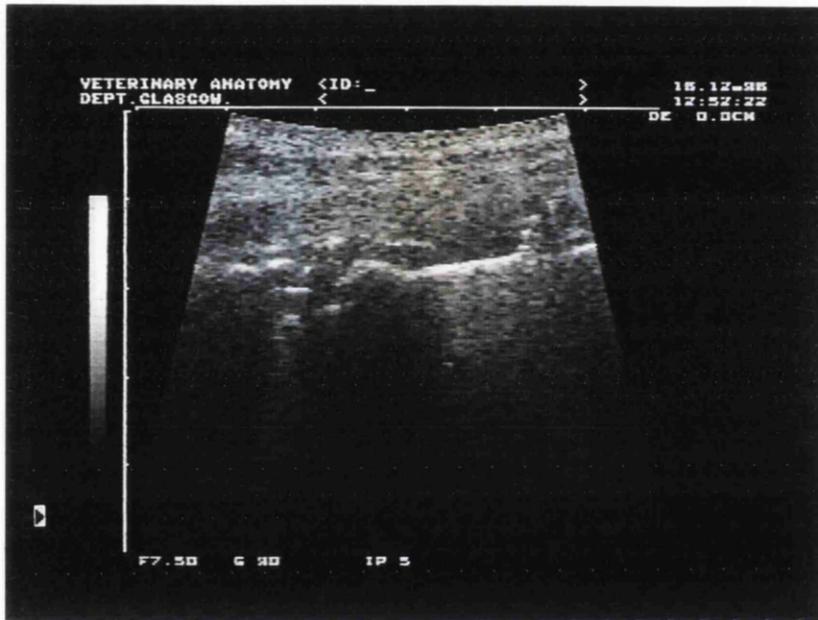
Figure 6.3.29 Longitudinal scan from the medial aspect of the femur on day 62 after fracture repair shows the fracture site area which appears as a disorganised hypoechoic area with a mottled hyperechoic texture suggesting the bony callus formation.

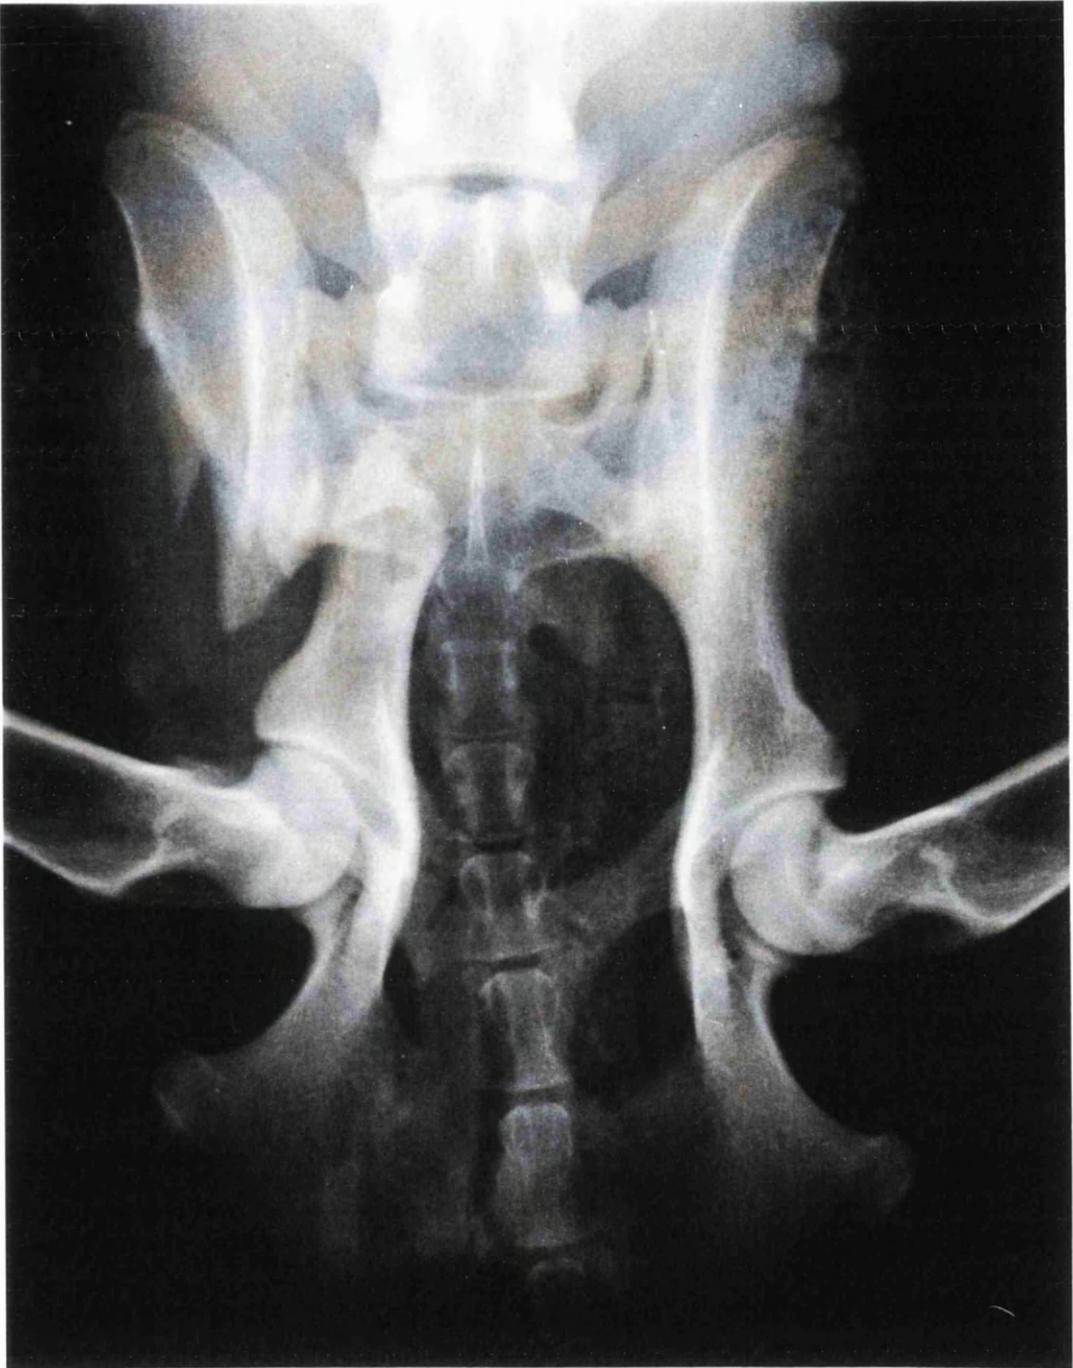
Figure 6.4.1 Radiograph of the one year old Doberman having a comminuted pelvic fracture involving the pubis, ilium and ischium. There is some medial displacement of the caudal part of the ilium. This animal was also suffering from pneumothorax and pneumomediastinum.

Radiographic examination showed that the right side of the ilium was fractured with severe over-riding and reduction of the pelvic canal diameter (figure 6.4.1). The fracture was comminuted and difficult to reduce. Surgery was performed by a lateral approach to the ilial shaft with the aim of reducing the fracture and increasing the pelvic canal diameter. A skin incision was made along the length of the right ilium. The gluteal muscles were separated and after dissection down to the ilial shaft the gluteals were retracted and the proximal and distal segments were levered together. A Dynamic Compression Plate (DCP) was used in this case. The DCP was applied to the contour of the bone. A successful result was obtained using a 6 holes 2.7 DCP and the pelvic diameter was returned to normal. Three screws were placed on either side of the fracture. To close the wound, vicryl 2.0 was used to close the fascia in a continuous pattern. The subcutaneous tissue was closed in a continuous pattern using vicryl 2.0, and the skin was closed using ethilon 2.0 in a simple interrupted pattern.

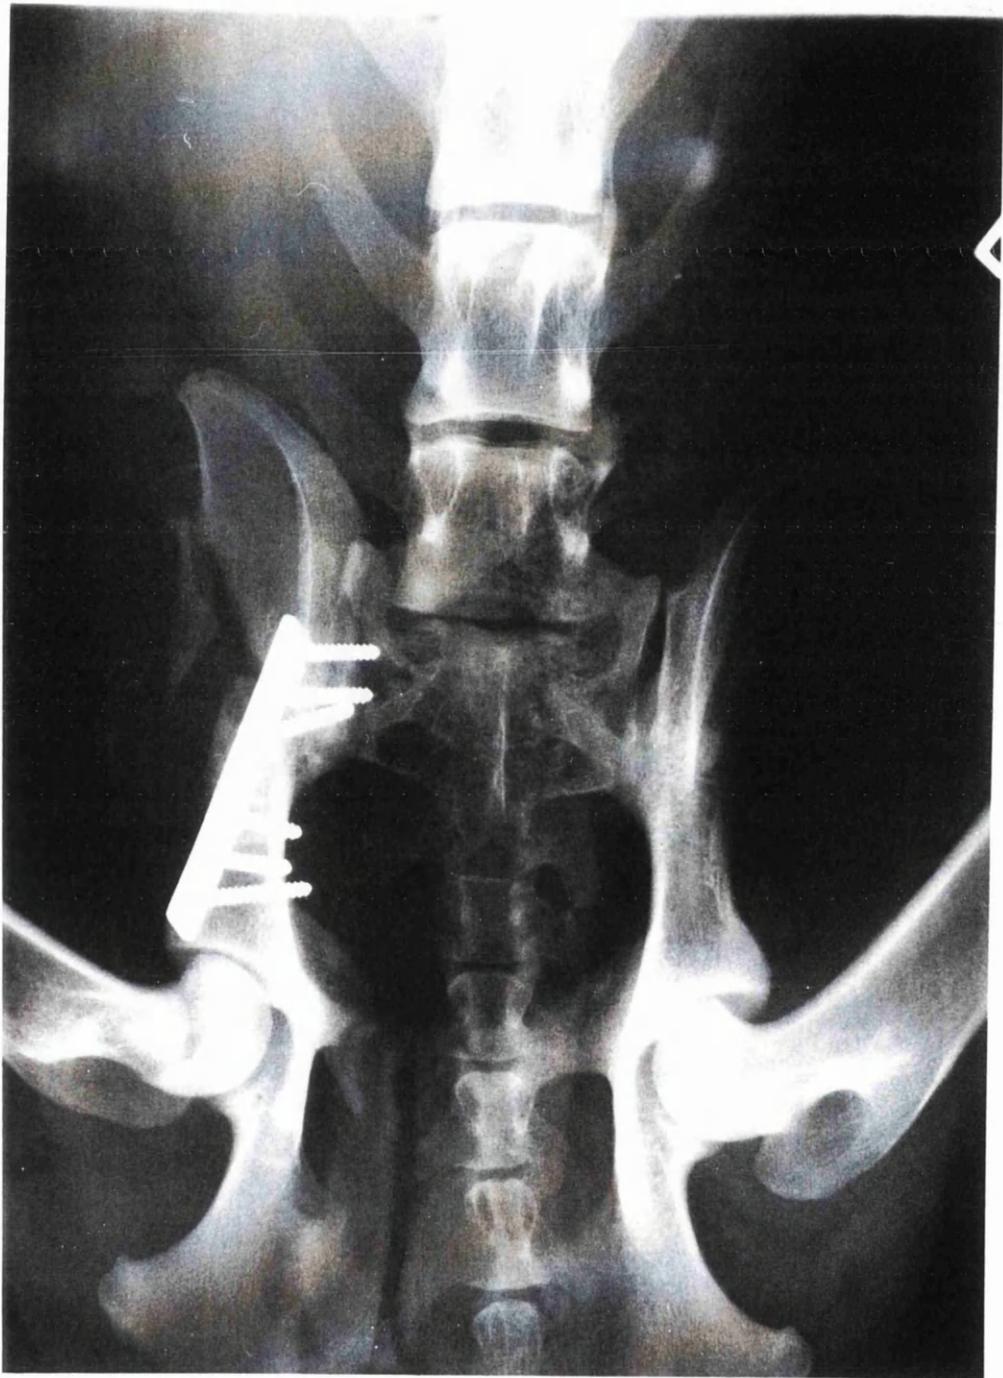
b

Figure 6.4.2 Radiographs obtained immediately after fracture repair. **a**, lateral view, **b**, ventral view. The ilial shaft fracture has been stabilised using a six hole plate and screws. The fracture line is clearly visible. A triangular fragment is present cranioventrally in **b**.

Radiographs taken immediately after the fracture repair showed the ilial fracture had been stabilised using a 6 holes DCP and 6 screws (figure 6.4.2). A triangular fracture was present cranioventrally.
