**AN ULTRASONOGRAPHIC STUDY OF MUSCULOSKELETAL
INJURIES AND MAMMARY GLAND TUMOUR IN SMALL
ANIMALS**

A thesis submitted to the Faculty of Veterinary Medicine,
University of Glasgow.

For the Degree of Doctor of Philosophy

Division of Veterinary Anatomy,
Department of Veterinary Preclinical Studies,
School of Veterinary Medicine,
University of Glasgow,
March, 1999

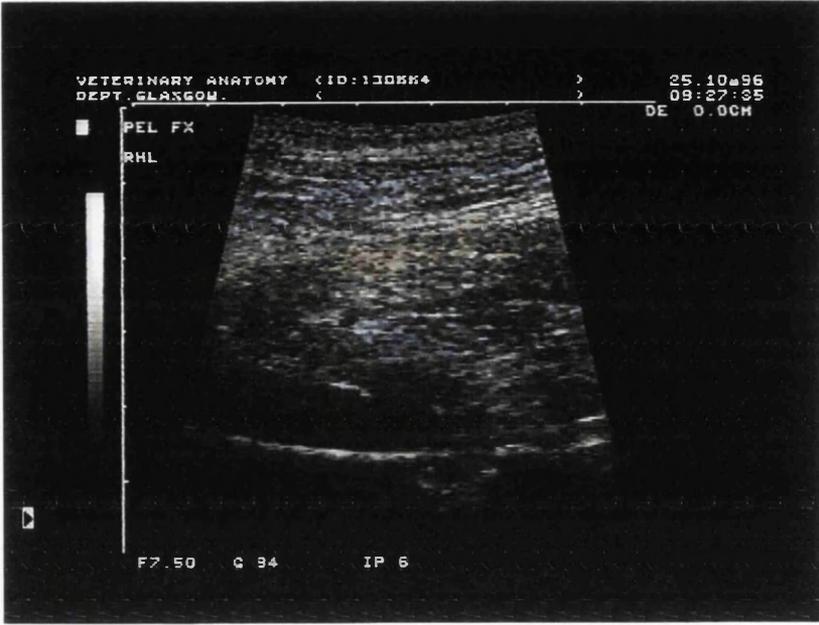
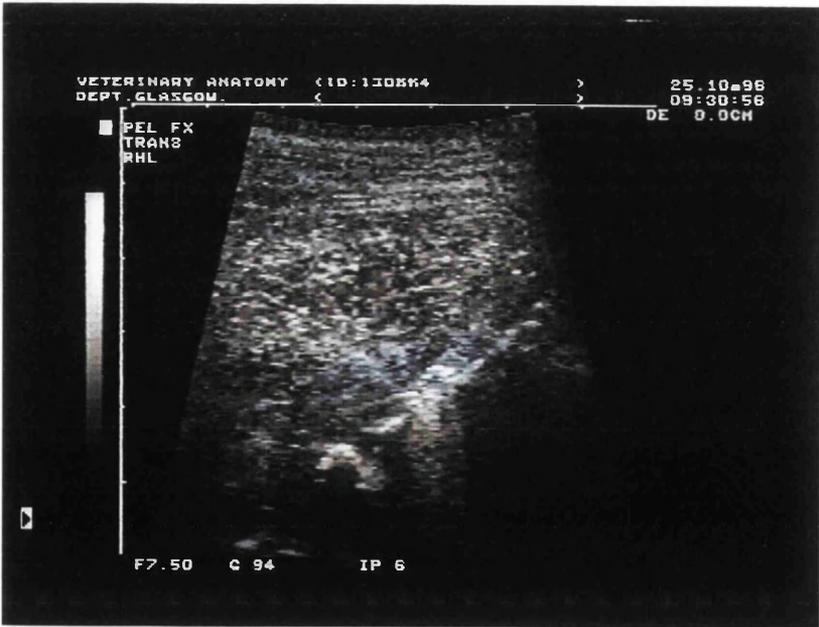
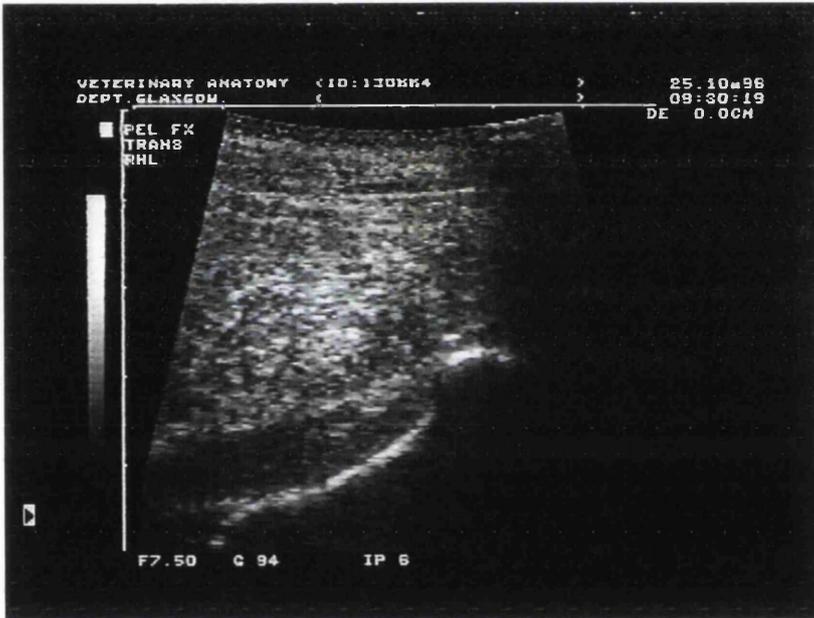
Figure 6.4.3 Ultrasonographic images of the shaft of ilium 24 hours post-operation demonstrate the fracture site. **a**, longitudinal scan **b**, transverse scan, **c**, transverse scan of the normal part of ilium. The fracture site appears as discontinuity of the bone surface with the presence of the fracture gap in **a**. The fracture site appears as a hole on the ilial shaft surface near to the bone plate in **b**. Note also the bone plate which is adhering to the bone appears hyperechoic with reverberation artefact in **b**. The normal part of the ilium appears as a smooth hyperechoic surface in **c**.

Ultrasonographic examination on day one after fracture repair demonstrated the fracture site both on longitudinal and transverse scans. The fracture site appeared as discontinuity of the ilial shaft with the presence of a fracture gap on longitudinal scan (figure 6.4.3a). On transverse scan, the fracture site could be recognised as a defect on the ilial shaft surface which appeared as a hole near to the bone plate (figure 6.4.3b). This could be compared with the normal part of the ilial shaft bone which appeared as a smooth hyperechoic surface (figure 6.4.3c). There was no periosteal tissue reaction detected at this stage. The bone plate and screws adhering to the ilial shaft appeared hyperechoic and produced comet tail artefacts. The area of muscle damage above the ilium appeared as a disorganised hypoechoic structure relative to the surrounding normal muscle (figures 6.4.4a and 6.4.4b). Suture materials within the muscle appeared as intermittent hyperechoic lines with comet tail artefacts (figure 6.4.5).

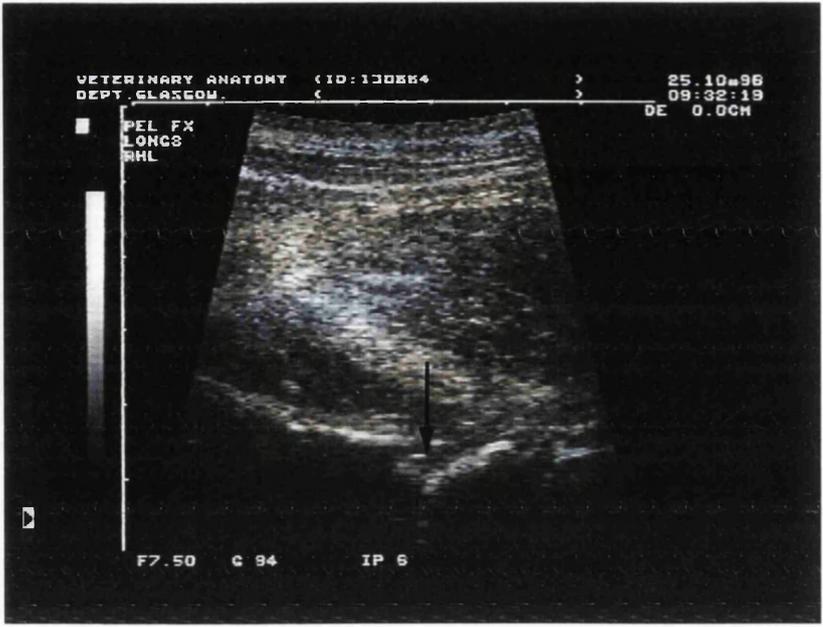
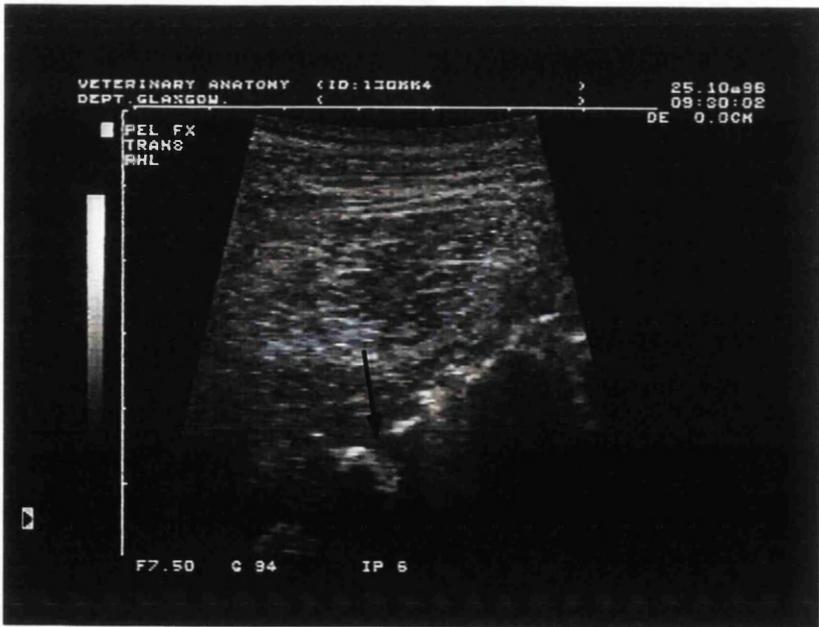
Figure 6.4.4 The area of muscle damage imaged ultrasonographically 24 hours after fracture repair appears as a disorganised hypoechoic structure (arrow) both on longitudinal (a) and transverse (b) scans. Note also the fracture site with the presence of a gap on both images which appears as discontinuity of the bone.

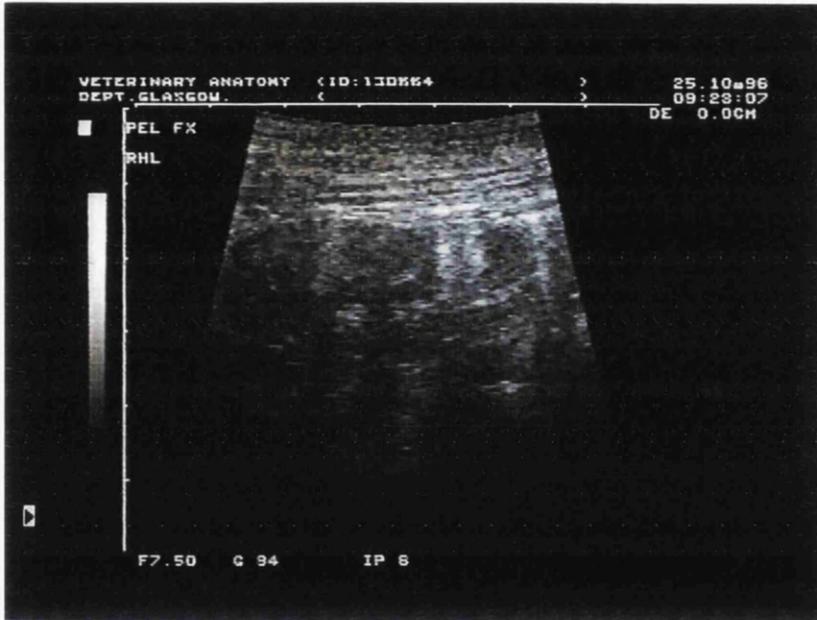
Figure 6.4.5 Suture materials within the muscle imaged ultrasonographically 24 hours after fracture repair appear hyperechoic with comet tail artefacts.

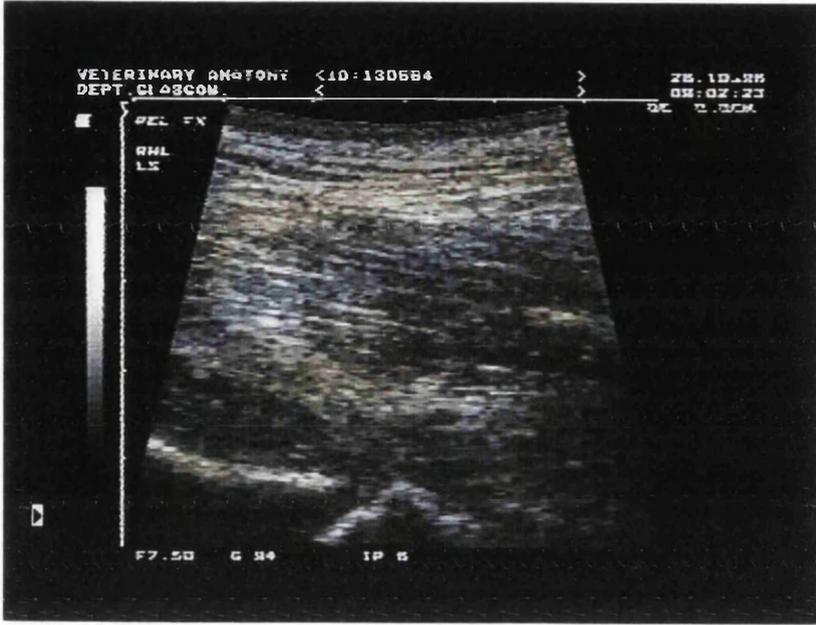
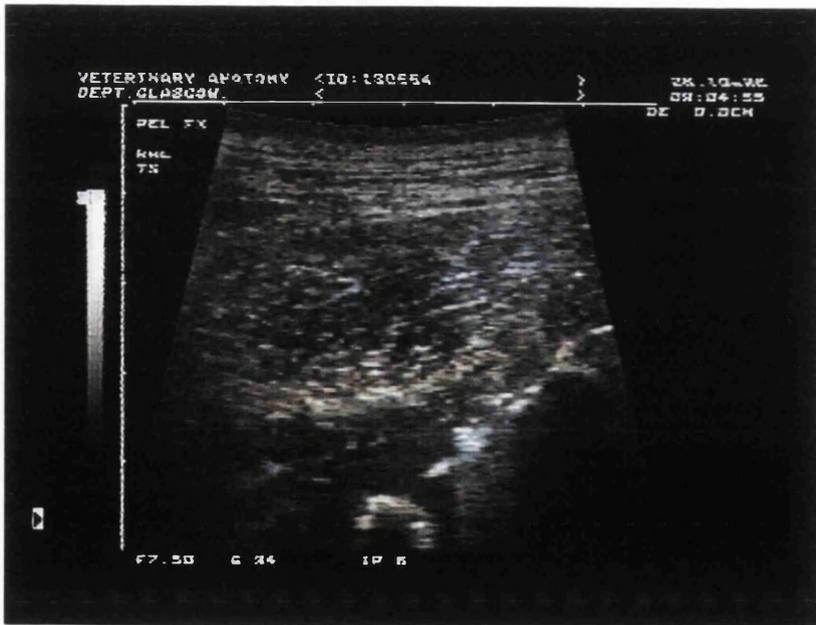
Figure 6.4.6 The fracture site imaged on day two after fracture repair both on longitudinal (a) and transverse (b) scans appears similar to the day one examination. The fracture site is clearly seen with no changes detected. The area of muscle damage still persists and appears as a disorganised hypoechoic structure.

Ultrasonographic examination on day two post-operation demonstrated the fracture site which appeared as on the day one examination both on longitudinal and transverse scans (figure 6.4.6a and 6.4.6b). The fracture sites on both planes were clearly seen with no changes detected. The area of muscle damage above the ilial shaft still persisted and appeared as a disorganised hypoechoic structure. The haematoma above the ilial bone surface appeared homogeneously hypoechoic (figure 6.4.7). The bone plate and screws appeared as an intermittent hyperechoic line and produced comet tail artefacts (figure 6.4.8). Suture materials within the muscle appeared as intermittent hyperechoic lines with comet tail artefacts as seen on the day one examination.

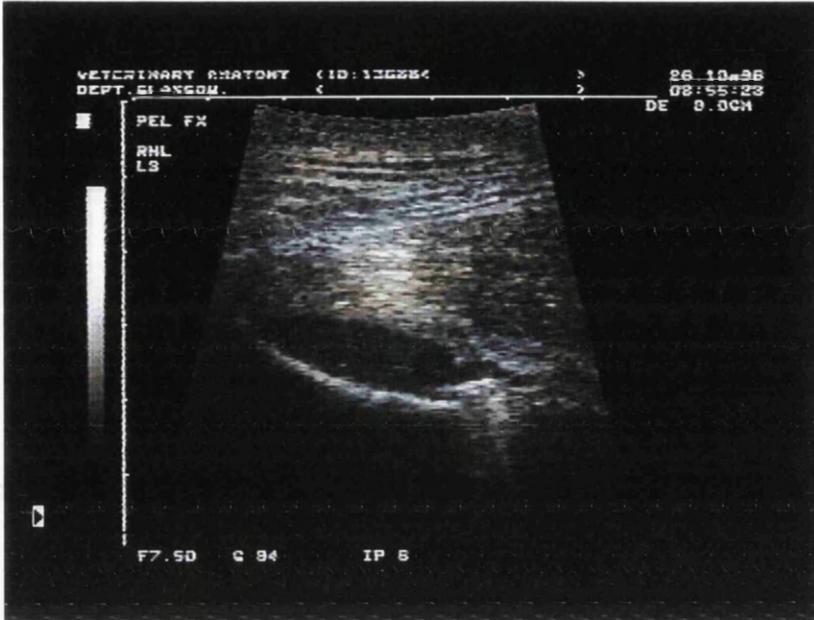
Figure 6.4.7 Longitudinal scan on the ilial shaft on day two after fracture repair shows the haematoma area which appears homogenous hypoechoic above the ilial bone.

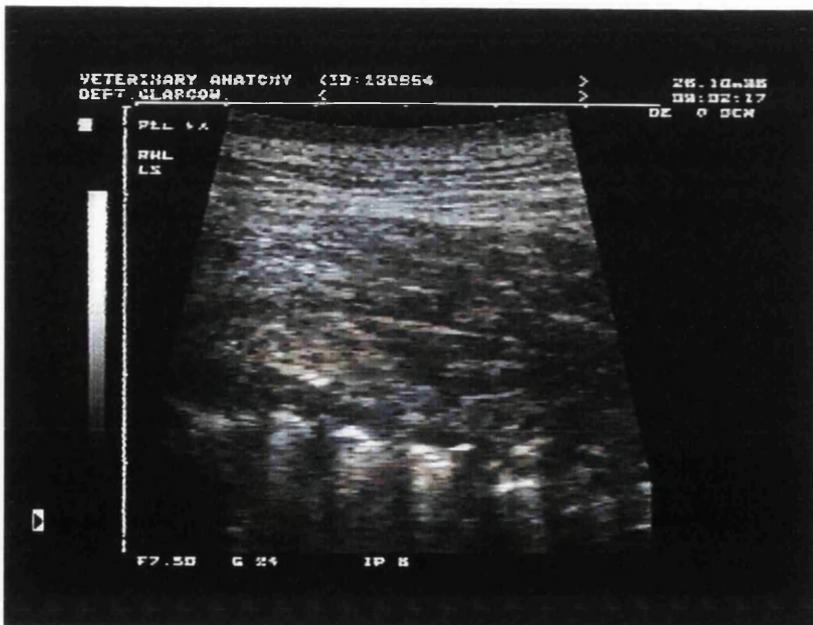
Figure 6.4.8 The bone plate with screws attached to the ilium appears as an intermittent hyperechoic line with comet tail artefacts on longitudinal scan. Note also the area of muscle damage appears as a disorganised hypoechoic structure.

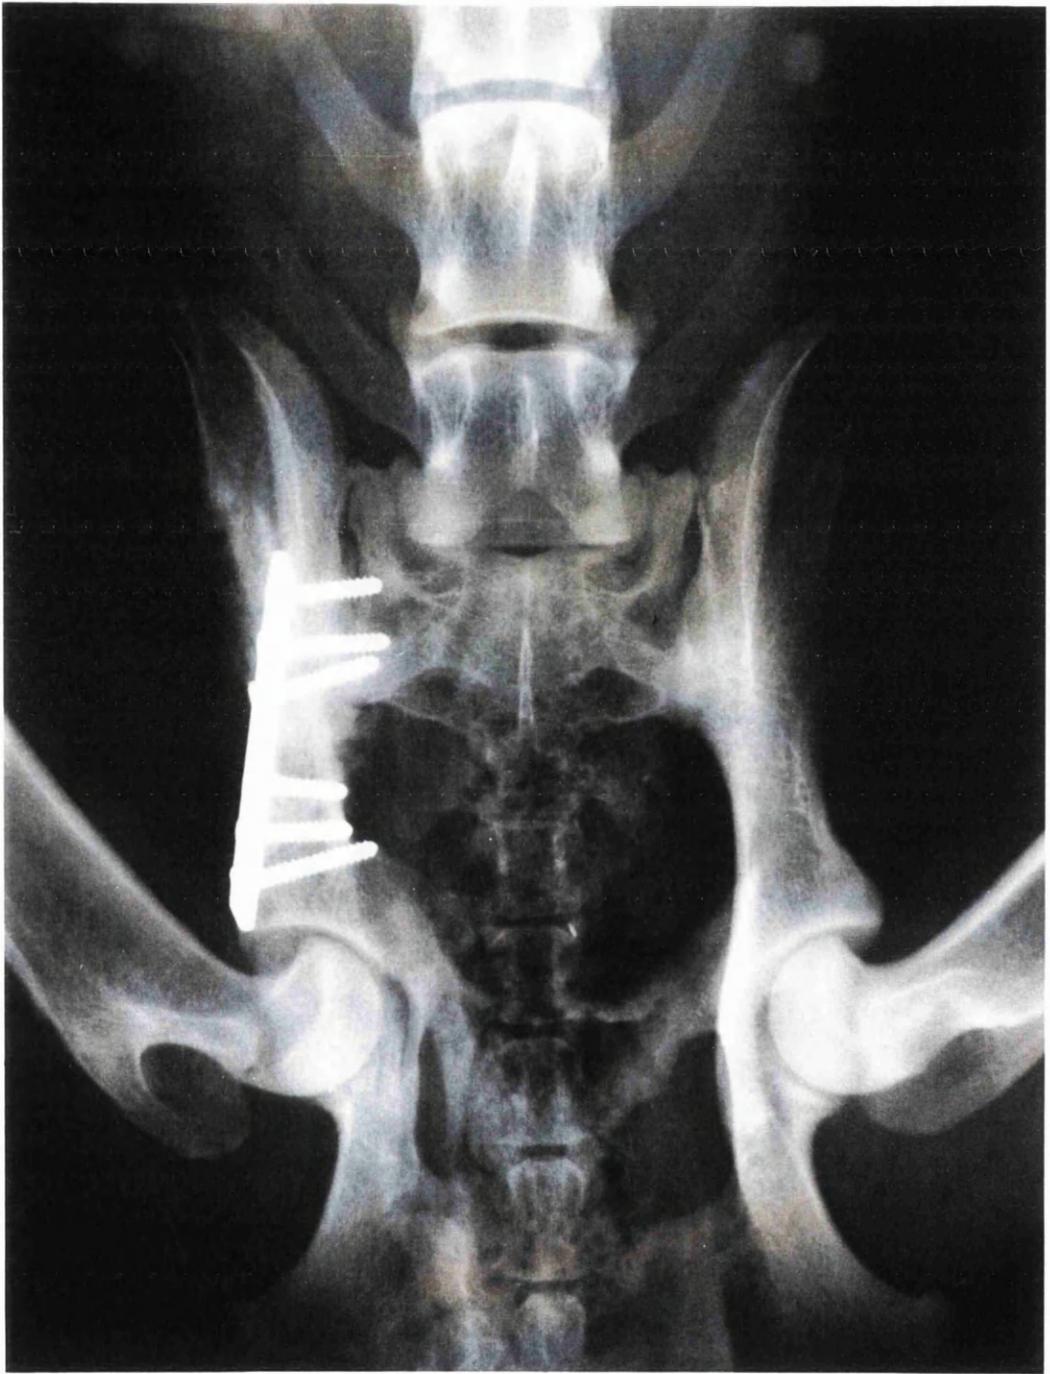
b

Figure 6.4.9 Radiographs taken at day 40 after fracture repair show that the fracture site is satisfactorily healed. **a**, lateral view, **b**, ventro-dorsal view. Callus formation is bridging the fracture gap. There is no indication of implant loosening. The plate is in place and secure.

Radiographs taken at day 40 after fracture repair showed that the fracture site had healed satisfactorily (figure 6.4.9). The callus formation had bridged the fracture gap. There was no indication of implant loosening. The plate was in place and was secure.

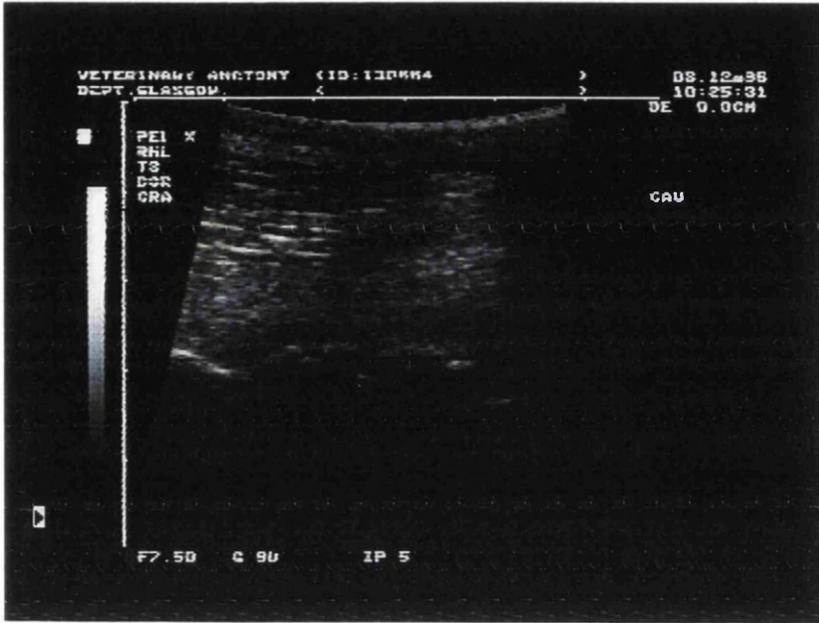
Figure 6.4.10 Longitudinal scan of the shaft of ilium on day 40 after fracture repair demonstrates the excessive callus formation which appears hyperechoic with a rough and uneven surface of the ilium. The actual fracture site has already been bridged by the mature callus and can no longer be detected largely due to the excessive callus formation at the fracture site area. The acoustic shadowing appearing in the image is due to air trapped in the hair on the skin surface.

Ultrasonographic examination demonstrated the excessive callus formation on the ilial shaft (figure 6.4.10). The fracture site could not be detected at this stage largely due to the excessive callus formation at the fracture site area which resulted in a bulging and uneven surface of the ilial shaft. The muscle structure has returned to its normal ultrasonographic appearance. The bone plate was still in place and appeared hyperechoic with reverberation artefact (figure 6.4.11). Ultrasonographically, the fracture site appeared to have healed satisfactorily.

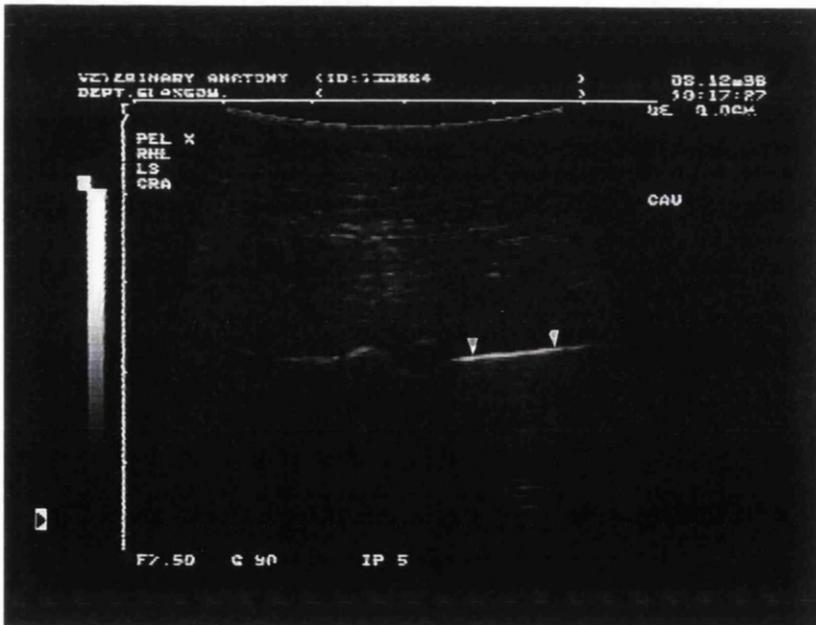
Figure 6.4.11 Longitudinal scan of the shaft of ilium on day 40 after fracture repair shows the bone plate (arrow heads) which appears hyperechoic with reverberation artefact.

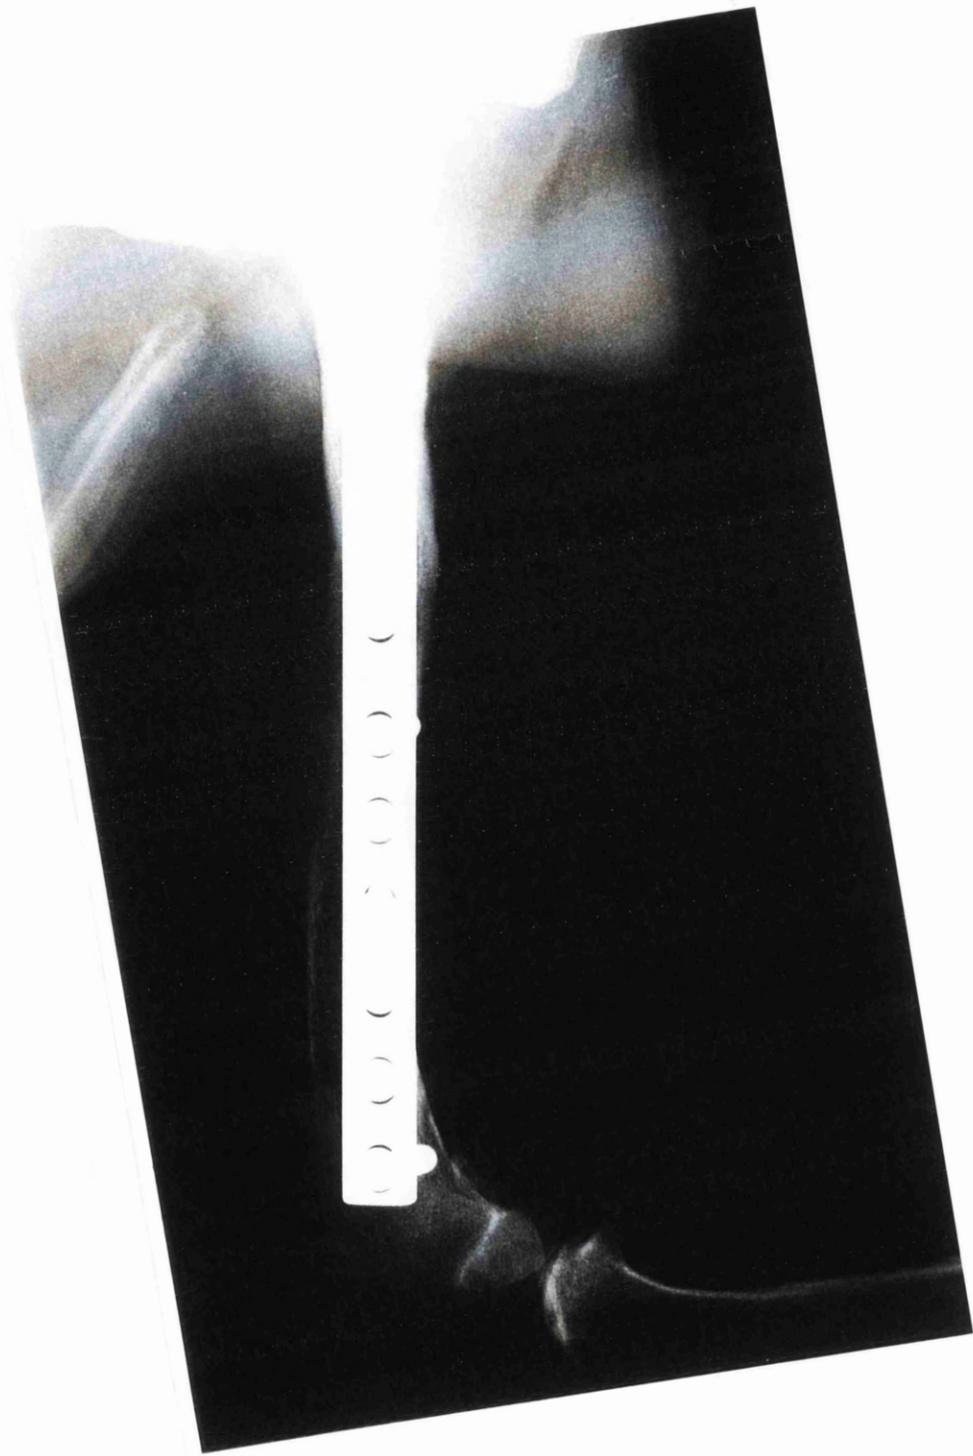
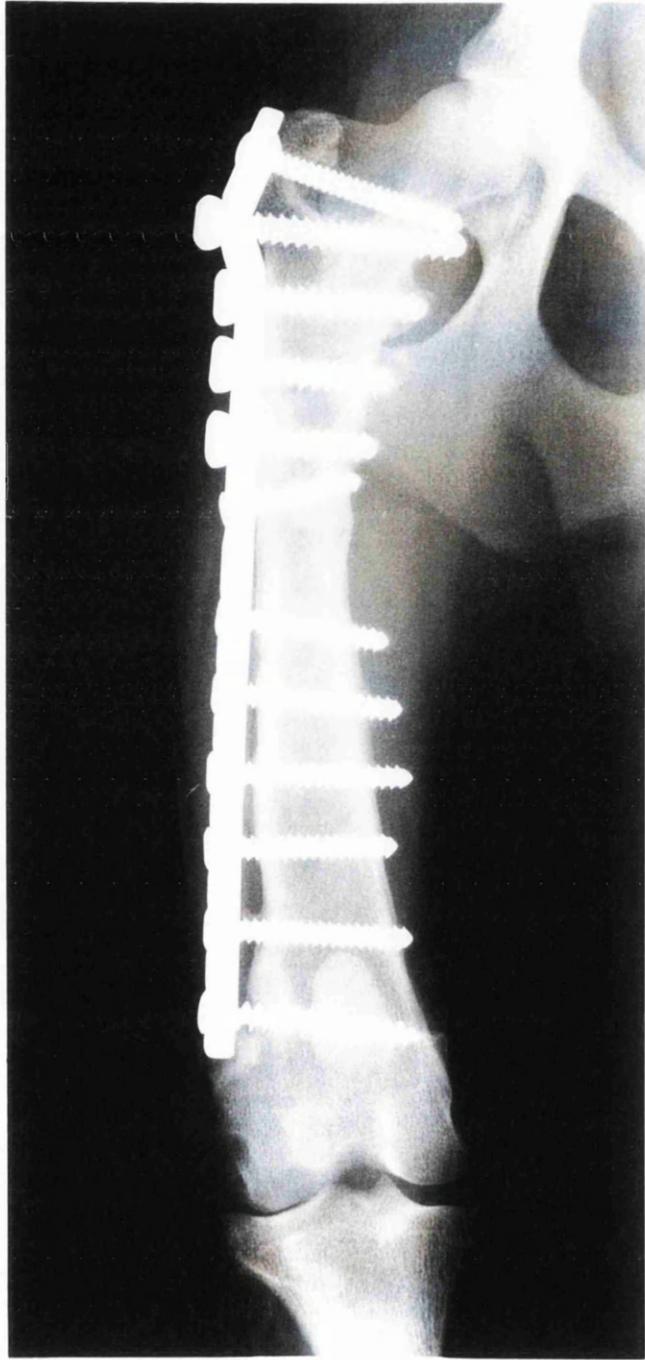
Figure 6.5.1 Radiographs obtained at approximately seven and a half months after fracture repair. **a**, lateral view and **b**, cranial view. The femur has become smooth and the fracture line is no longer visible. There is no evidence of implant instability and cortical remodelling is occurring. The screws in the proximal plate from the second to the fourth holes are larger (4.5 mm) than the distal ones (3.5 mm) (**b**).

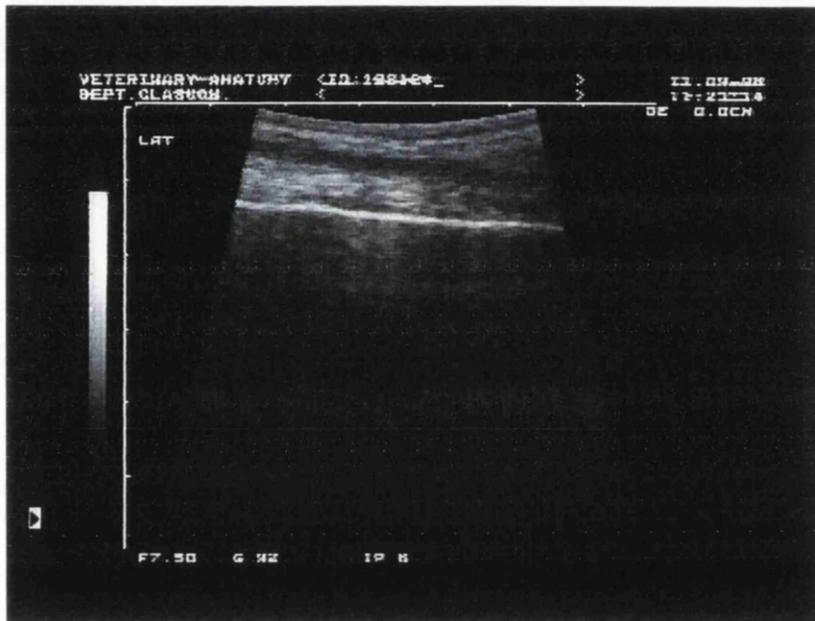
Figure 6.5.2 Longitudinal scan of the femur at approximately seven and a half months after fracture repair demonstrates the smooth hyperechoic bone surface. The fracture site is undetectable.

Ultrasonographic examination at seven and half months post-operation (prior to implant removal) demonstrated the smooth hyperechoic bone surface (figure 6.5.2). The fracture could not be recognised anymore and the bone had returned to its normal ultrasonographic appearance. The bone plate and screws that attached to the femur appeared hyperechoic with reverberation and comet tail artefacts respectively (figure 6.5.3a and 6.5.3b). A longitudinal scan from lateral aspect revealed that the screws at the proximal part of the plate appeared higher than the plate level (figure 6.5.3a), and that the screws at the distal part of the plate appeared almost at the same level as the bone plate (figure 6.5.3b). This was actually due to the fact that the screws used at the proximal part of the plate (from second to fourth holes) were larger (45 mm) than the distal ones (35

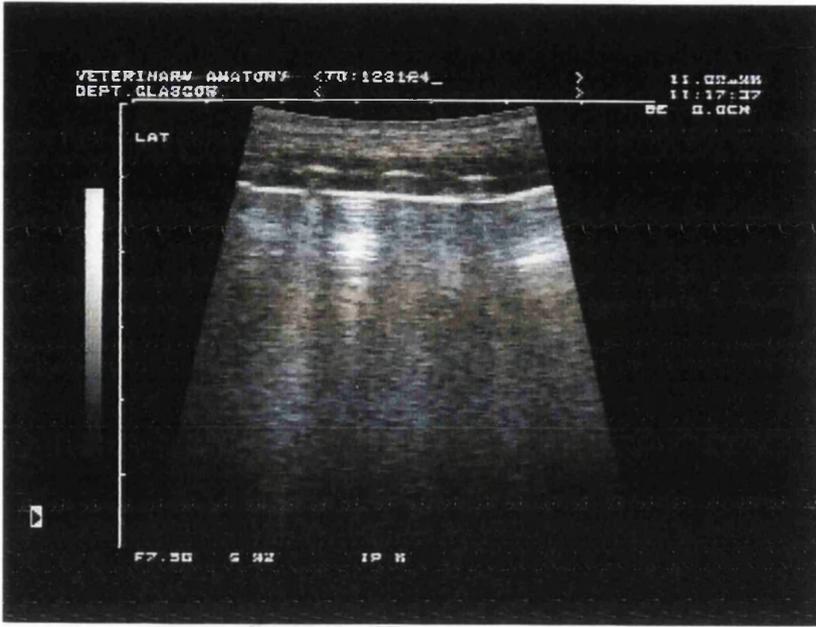
Figure 6.5.3a

Figure 6.5.3 Longitudinal scans of the femur from the lateral aspect one day before implant removal demonstrate the bone plate with screws. **a**, proximal part, **b**, distal part. Both are hyperechoic but the bone plate produces reverberation artefact while the screws produce comet tail artefacts. The screws at the proximal part appear higher than the plate level (**a**), and appear almost the same level with the plate (**b**). This is because the screws used at the proximal part of the plate (from hole two to hole four) are larger than at the distal one.

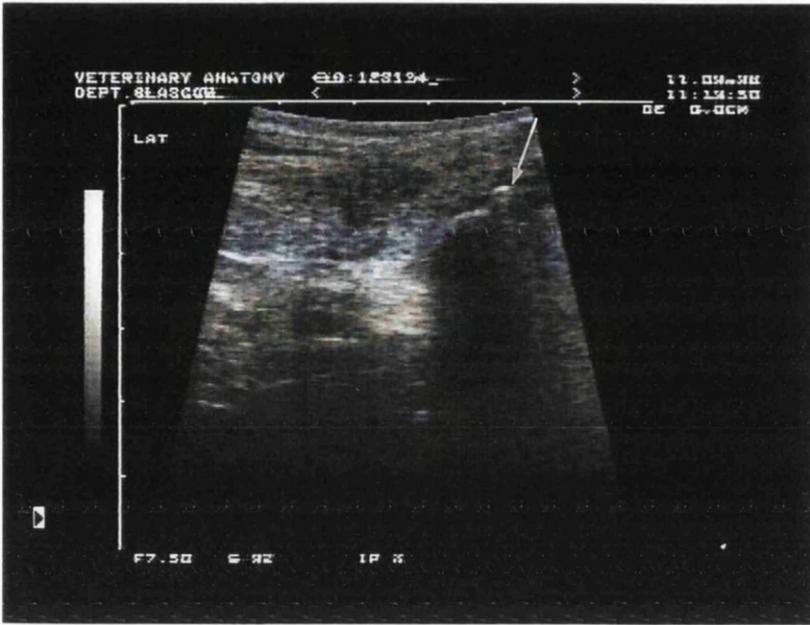
Figure 6.5.4 Transverse scan of the femur from the cranio-lateral aspect one day before implant removal shows a round, smooth hyperechoic femoral surface with the bone plate on the lateral side (arrow). Note also the hyperechoic area of muscle beside the femur which suggests an area of muscle atrophy. There are hypoechoic areas in the muscle as well.

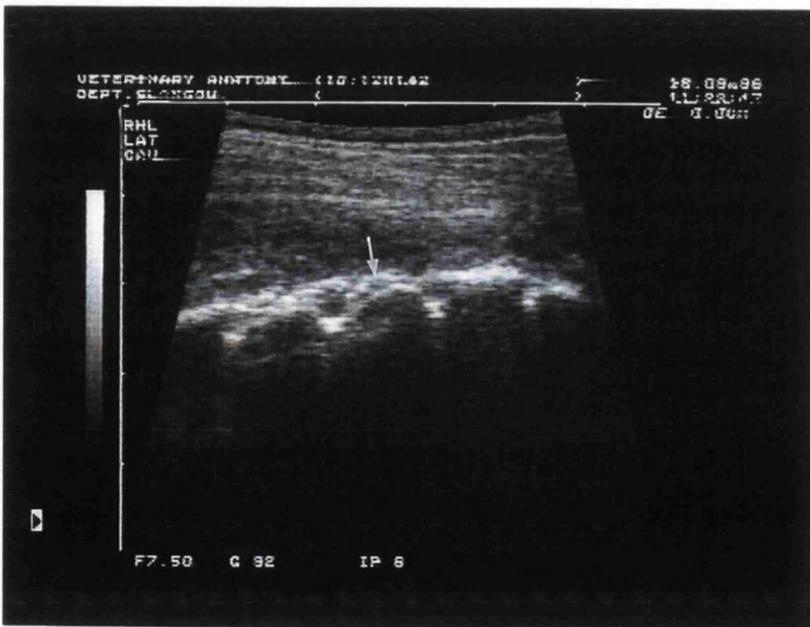
Figure 6.5.5 Longitudinal scan of the femur from the caudo-lateral aspect on day two after implant removal shows the femoral surface with a number of holes in it. These holes actually represent the site of the screws before the implant was removed. The holes and the surrounding area appear hyperechoic which suggests periosteal reaction. Some soft callus formation can be seen as an hyperechoic structure on the bone surface (arrow).

Ultrasonographic examination demonstrated the femur which appeared as an hyperechoic straight line with the presence of holes in it (figure 6.5.5). The holes on the femur were actually the previous sites of the screws before the implant was removed. The hyperechoic appearance around and within the holes suggested periosteal tissue reaction. Some soft callus formation was detected and appeared as an hyperechoic structure on the bone surface. Suture materials within the muscle appeared as intermittent hyperechoic lines with comet tail artefacts (figure 6.5.6). The area of muscle damage appeared as a disorganised hypoechoic area relative to the surrounding normal appearance of muscle. A transverse scan of the femur in this case did not produce much additional information. However, the hole on the femoral surface could be seen as a small notch (figure 6.5.7) The area of muscle damage appeared hypoechoic relative to the surrounding tissue. The muscle near the femur appeared hyperechoic suggested an area of muscle atrophy. Clinically, the animal was showing good use of the affected limb and the implant removal was successful.

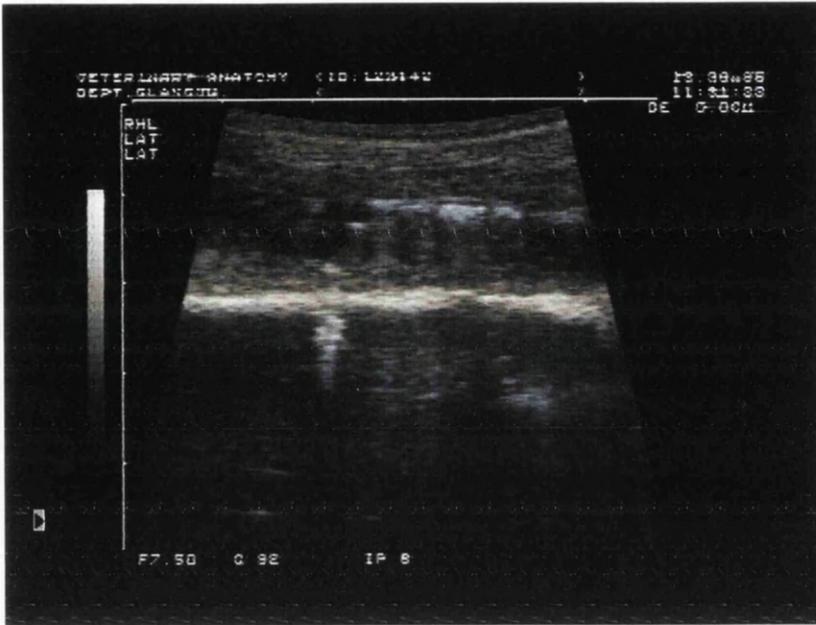
Figure 6.5.6 Suture material within the muscle imaged on day two after implant removal appears as hyperechoic intermittent lines with comet tail artefacts. Note also the area of muscle damage appearing as a disorganised hypoechoic structure.

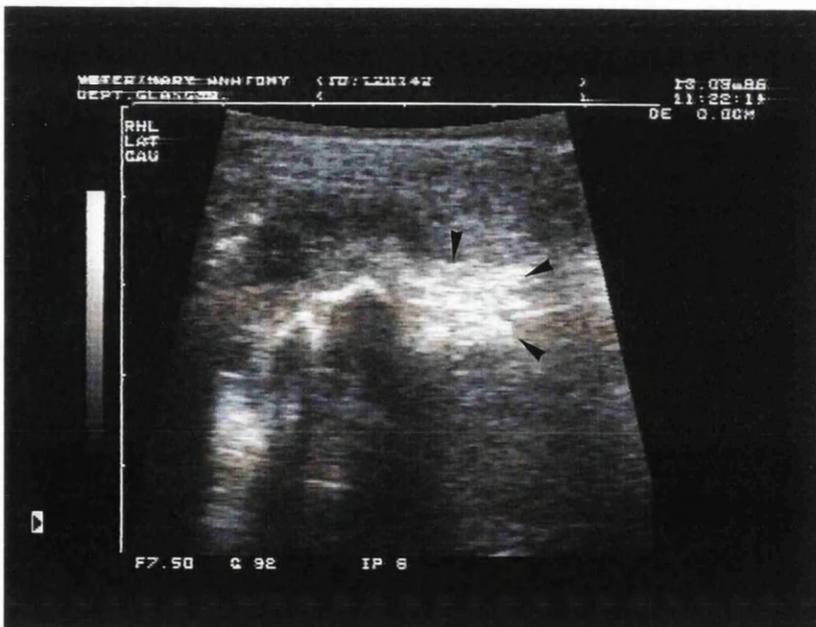
Figure 6.5.7 Transverse scan from the caudo-lateral aspect of the femur on day two after implant removal shows the femur with a small hole on its surface. The area of muscle damage above the femur appears as a disorganised hypoechoic structure. The hyperechoic appearance of the muscle (semitendinosus) beside the femur suggests an area of muscle atrophy (arrow heads).

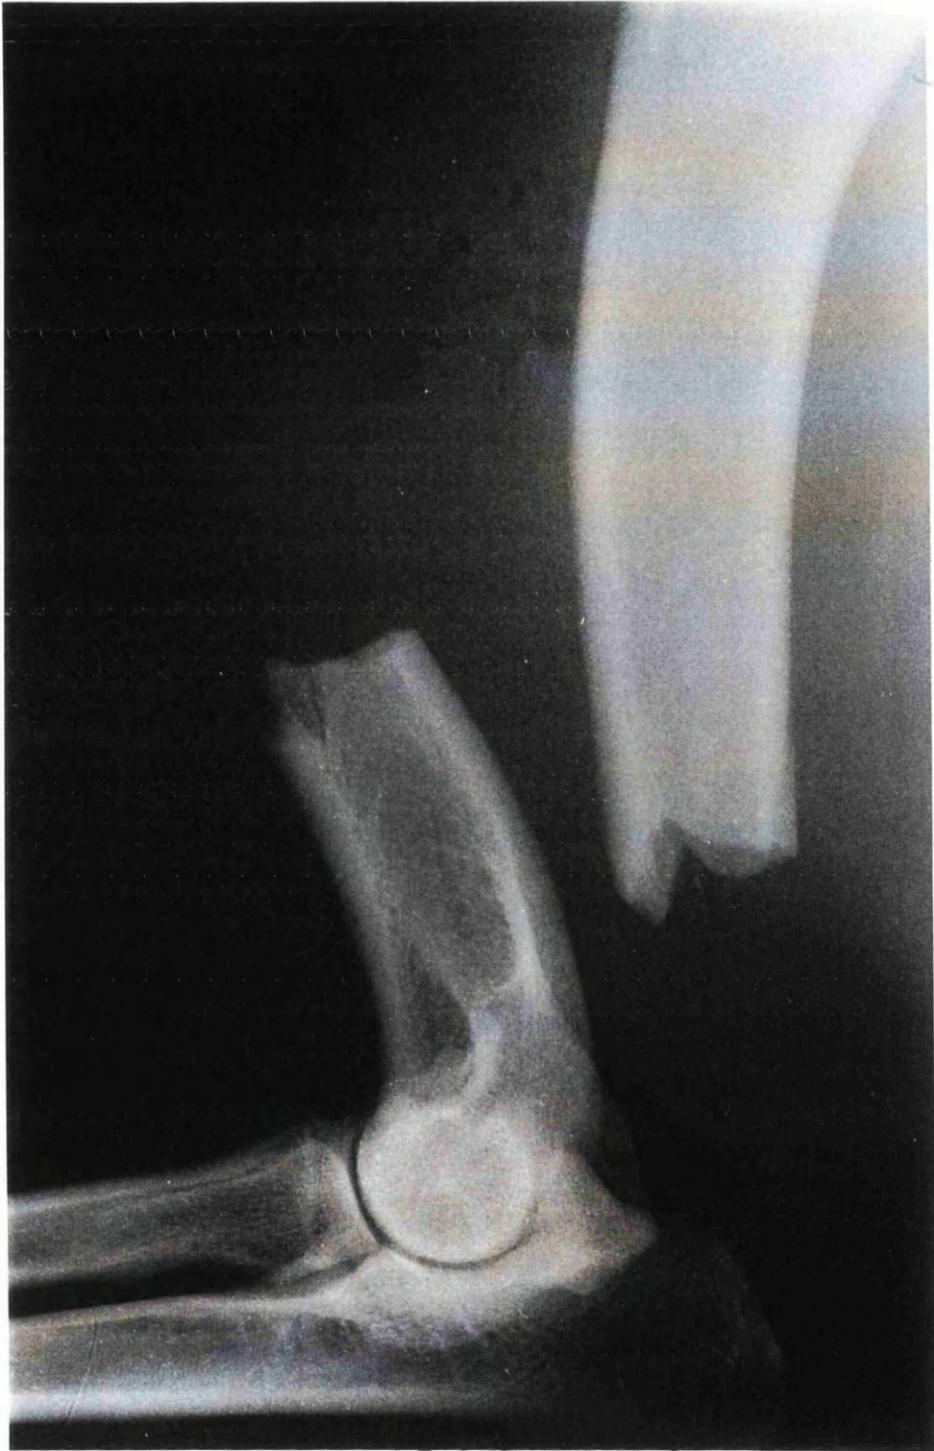
Figure 6.6.1 Radiograph of the one year old Cross bred dog with transverse fracture of the distal third of the right humerus. This is a complete closed fracture of the humerus.

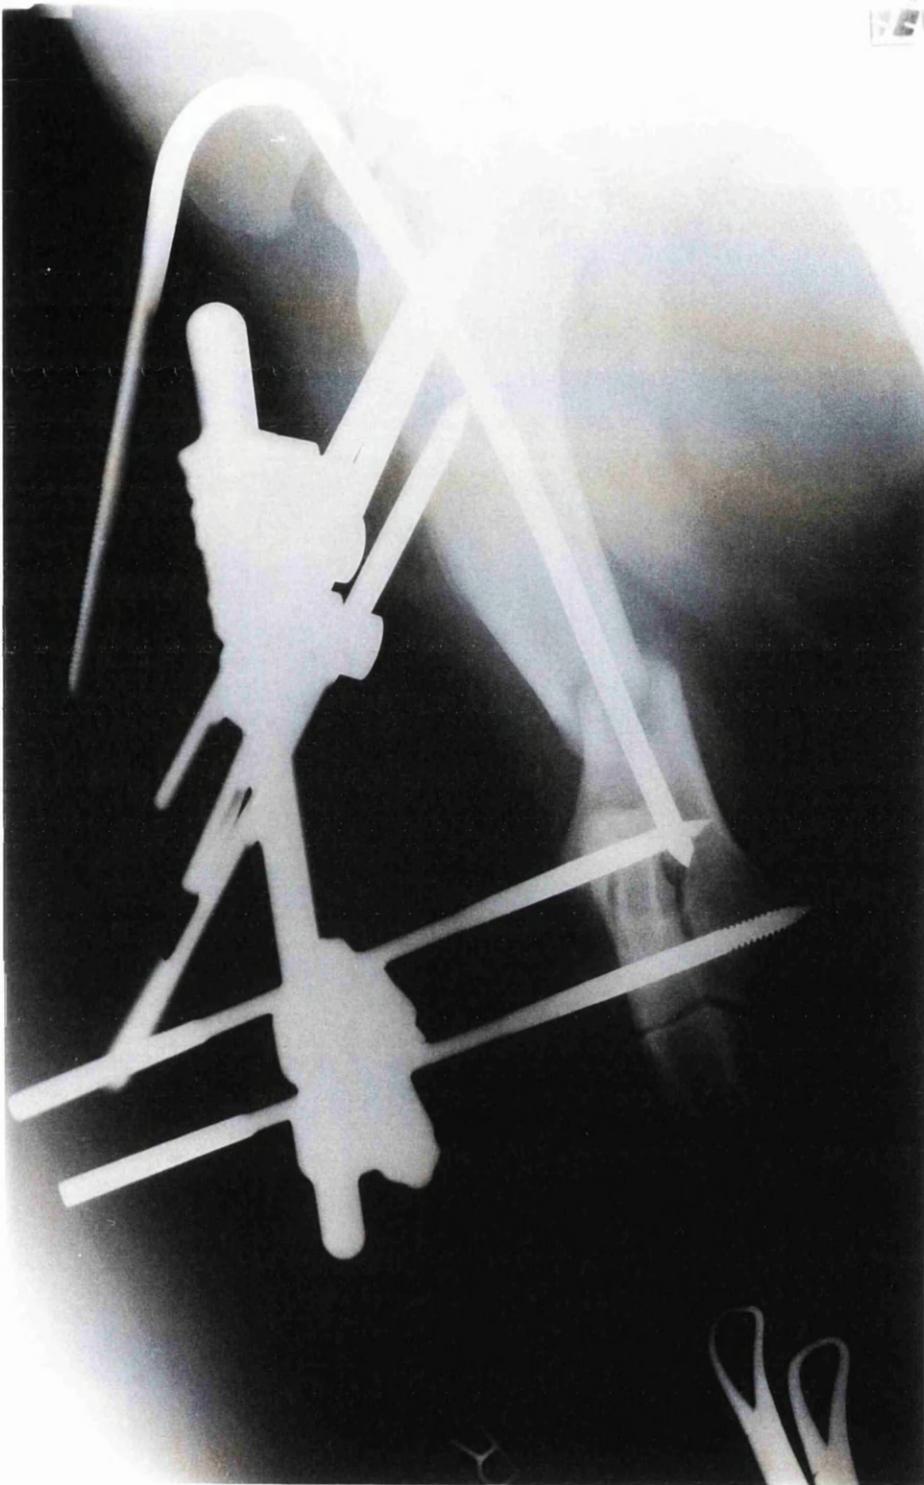
Figure 6.6.2 Radiograph obtained immediately after fracture repair shows the fracture has been stabilised with an intramedullary pin and tied in to a five pins lateral type I ESF. The repair process is resulting in reasonable reduction with the humerus only slightly misaligned at the fracture site.

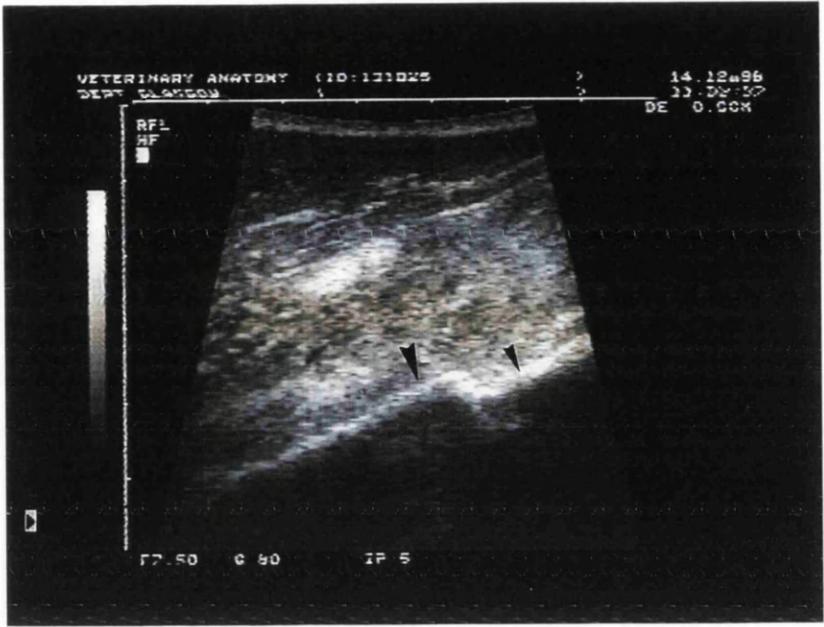
Figure 6.6.3 Longitudinal scan of the humerus from the cranial aspect 24 hours after fracture repair shows the fracture site which appears as if there are two levels of bone. The proximal and distal fragments are not well aligned. Note that the distal fragment (large arrow head) appears elevated compared to the proximal fragment (small arrow head).

Ultrasonographic examination of the humeral fracture demonstrated the fracture site which was not well aligned (figure 6.6.3). The distal fragment appeared elevated compared to the proximal fragment. During scanning, the transducer was carefully adjusted to image the fracture site. There was no fracture gap present at the fracture site. The area of muscle damage scanned longitudinally appeared as a disorganised hypoechoic region relative to the surrounding normal muscle structure (figure 6.6.4). Fluid accumulation within the muscle which had resulted from surgical interference appeared anechoic. A transverse scan of the humerus demonstrated an hyperechoic image surrounding the fracture site which suggested an area of periosteal and soft tissue reaction (figure 6.6.5). On transverse scan the humerus has lost its normal rounded appearance at the area of the fracture site. The area of muscle damage

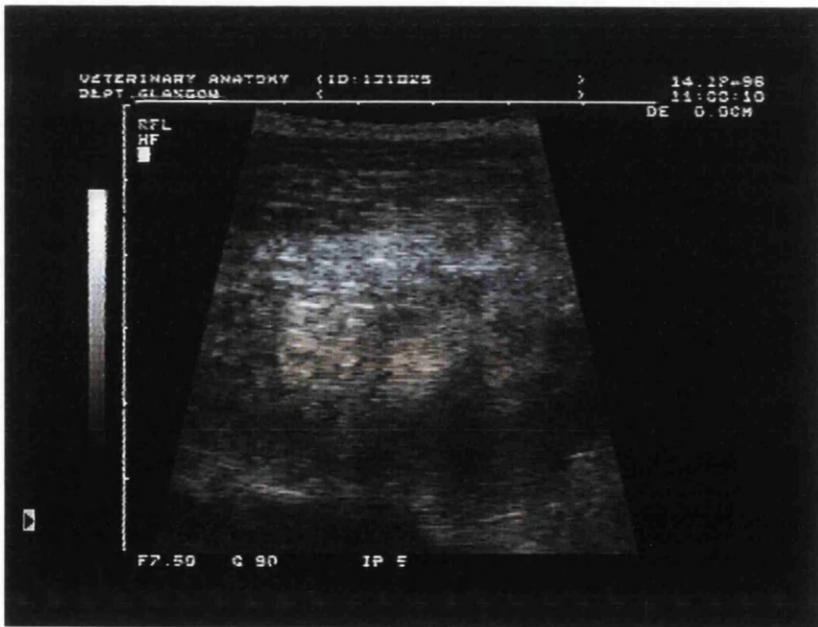
Figure 6.6.4 The area of muscle damage imaged ultrasonographically 24 hours after fracture repair appears as disorganised hypoechoic area as compared to the normal muscular regions.

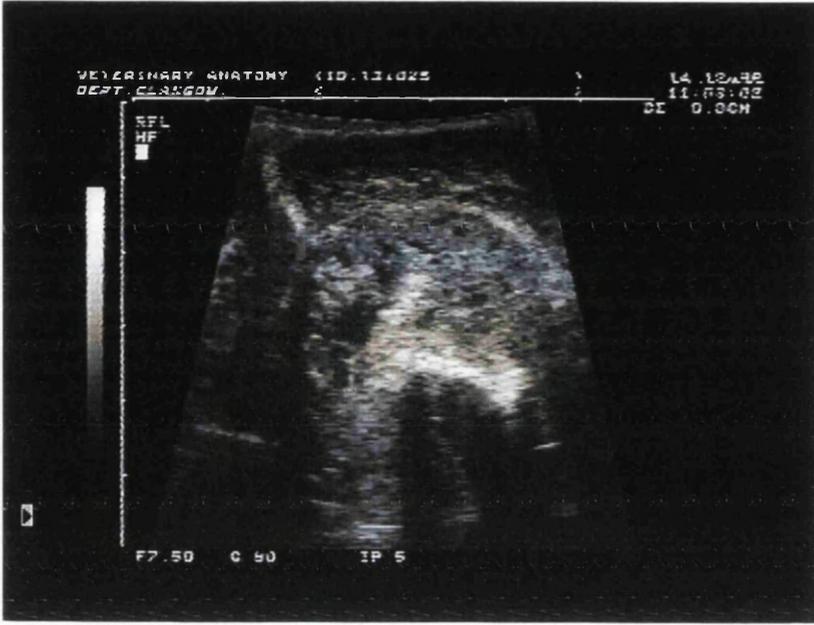
Figure 6.6.5 Transverse scan of the humerus from the cranial aspect 24 hours after fracture repair demonstrates the fracture site which appears as a defect on the bone surface. The humerus has lost its normal rounded appearance. The area of hyperechoic appearance surrounding the humerus suggests periosteal and soft tissue reaction. The area of muscle damage appears as a disorganised mixture of hypoechoic and hyperechoic structures superficial to the humerus.

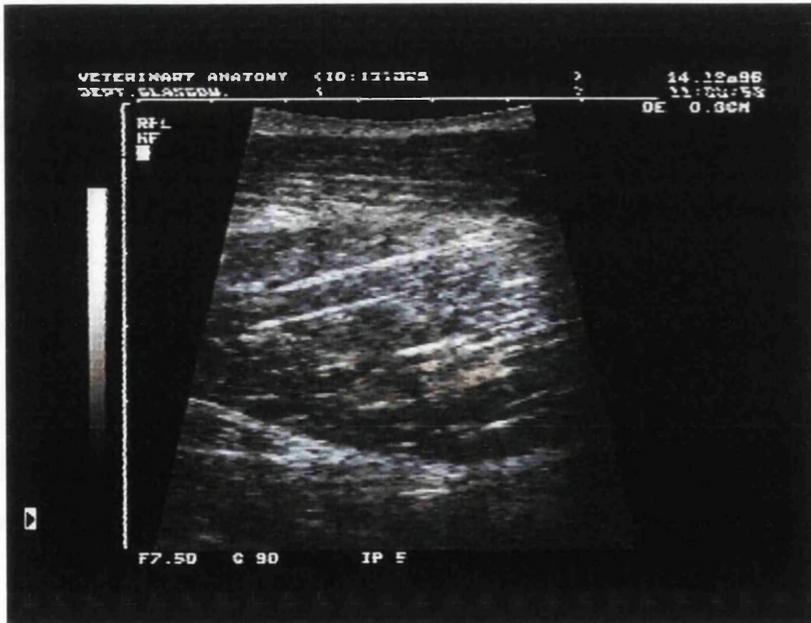
Figure 6.6.6 Longitudinal scan of the brachial muscle demonstrates the normal ultrasonographic appearance of the triceps muscle which produces a “feather - like” appearance.

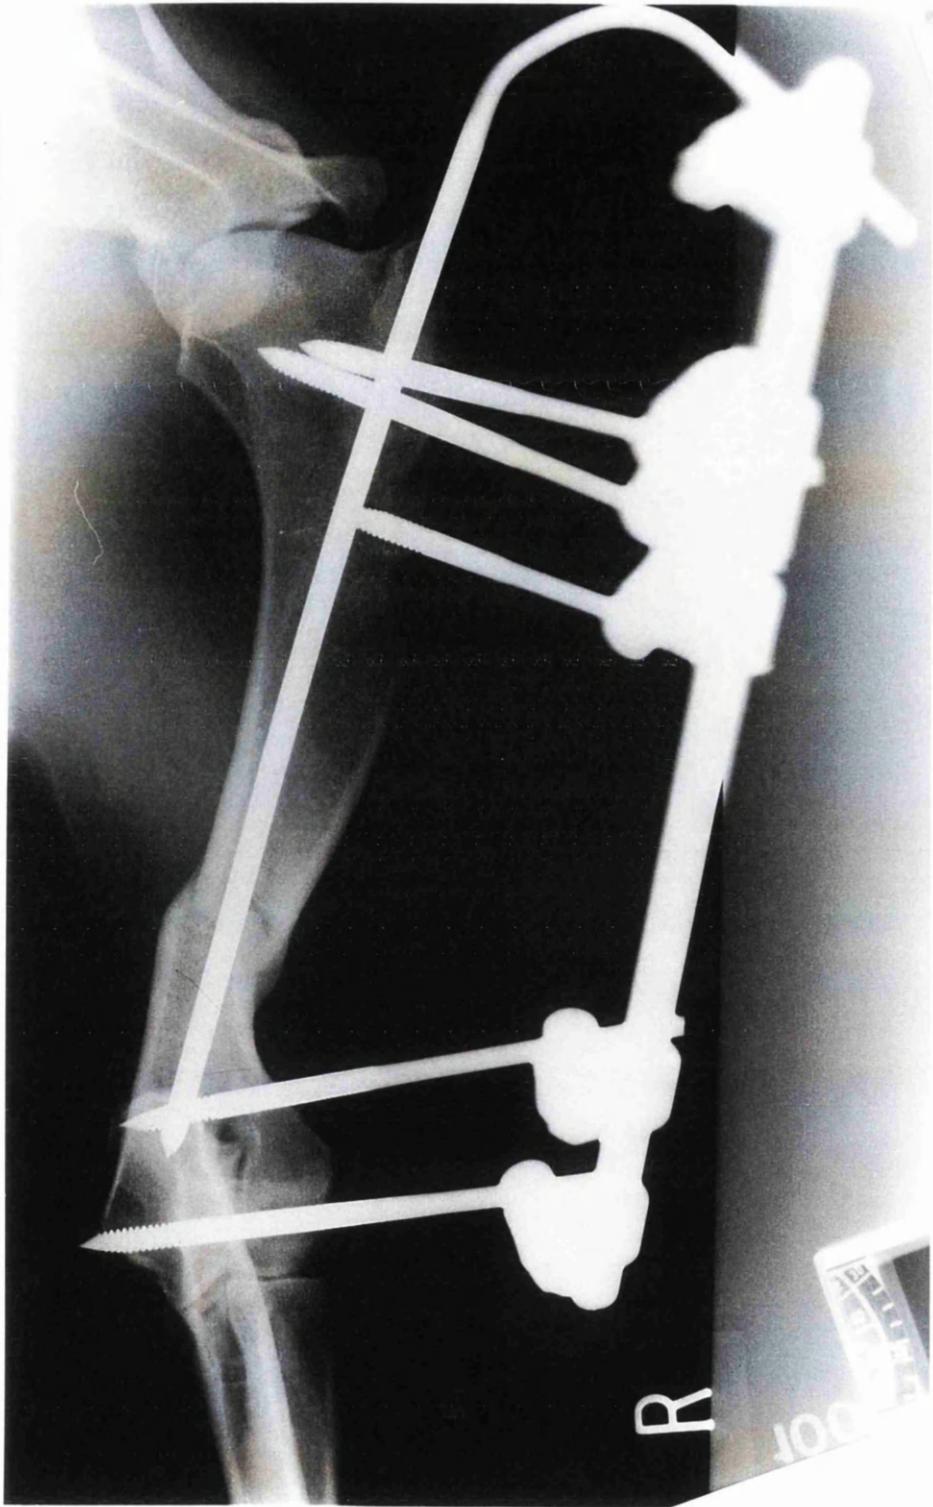
Figure 6.6.7 Radiograph taken at day 44 after fracture repair shows the callus formation is bridging the fracture site and the periosteal reaction has stimulated new bone that is already showing evidence of remodelling. The fracture line is still visible radiographically.

Radiographs taken at day 44 after fracture repair showed that the callus formation had bridged the fracture site and the periosteal reaction had stimulated new bone that was already showing evidence of remodelling (figure 6.6.7). However, the fracture line was still visible radiographically.
