**AN ULTRASONOGRAPHIC STUDY OF MUSCULOSKELETAL
INJURIES AND MAMMARY GLAND TUMOUR IN SMALL
ANIMALS**

A thesis submitted to the Faculty of Veterinary Medicine,
University of Glasgow.

For the Degree of Doctor of Philosophy

Division of Veterinary Anatomy,
Department of Veterinary Preclinical Studies,
School of Veterinary Medicine,
University of Glasgow,
March, 1999

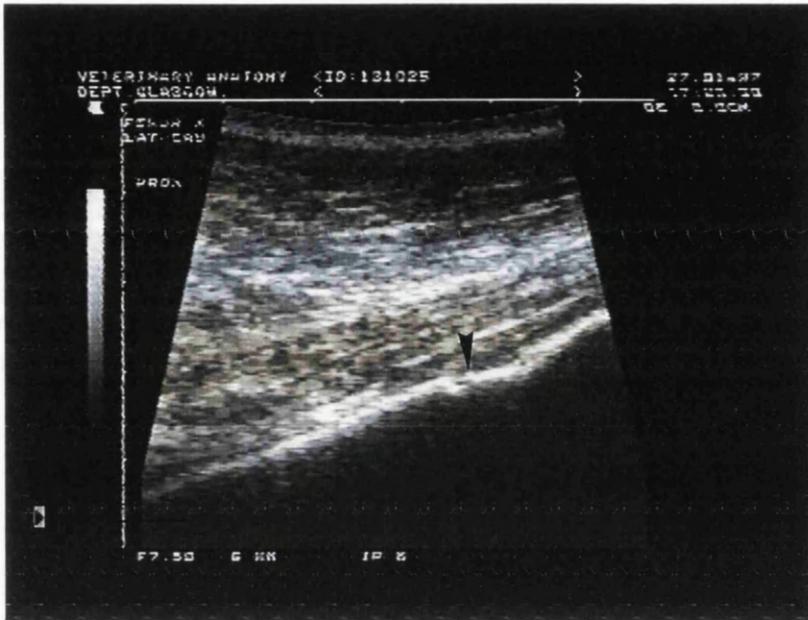
Figure 6.6.8a

Figure 6.6.8 Longitudinal scans of the humerus from the caudo-lateral aspect (a) and the medial aspect (b) on day 44 after fracture repair show the smooth, hyperechoic humeral surface. The fracture site has been bridged by the bony callus and appears as a defect on the bone surface (arrow head). Note also the area of muscle damage has returned to its normal ultrasonographic appearance.

Ultrasonographic examination demonstrated the fracture site which had been bridged by the bony callus (figure 6.6.8a). No excessive callus formation was found on the humerus. The humerus appeared as a smooth hyperechoic bone surface with a small notch and a slight bend of the bone at the fracture site on longitudinal scan from the caudo-lateral aspect. The fracture site scanned from the medial aspect appeared as a small notch on the hyperechoic humeral surface (figure 6.6.8b). On the lateral aspect, the proximal fragment appeared elevated from the distal fragment. The area of muscle damage had returned to its normal ultrasonographic appearance.

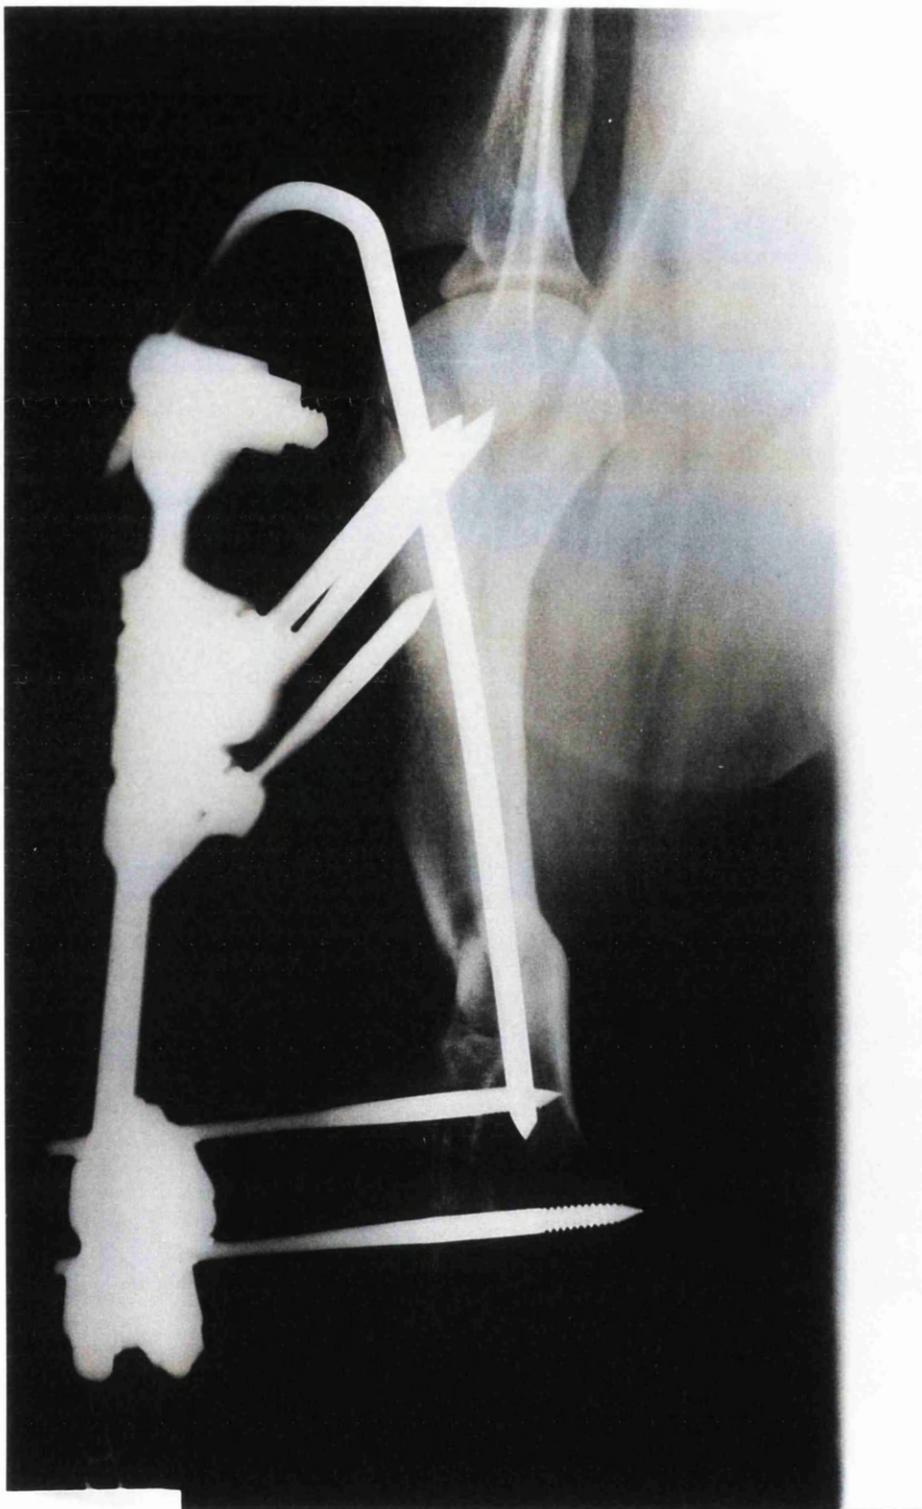
Figure 6.6.9 Radiograph taken at day 73 after fracture repair shows the fracture line which has been completely bridged by the new bone tissue. The fracture line is no longer visible. There is a mild lysis around some of the pins. The healing process has not resulted in a straight bone because of the early defect at the fracture site during the repair process.

Radiographs taken at day 73 after fracture repair showed that the fracture line has been completely bridged by the new bone tissue (figure 6.6.9). Thus, the fracture line was no longer visible. There was a mild lysis around some of the pins. The healing process had not resulted in a straight bone because of the early defect at the fracture site which resulted during the repair process. However, the fracture was completely healed. The intramedullary pin and external fixator were removed at this time.

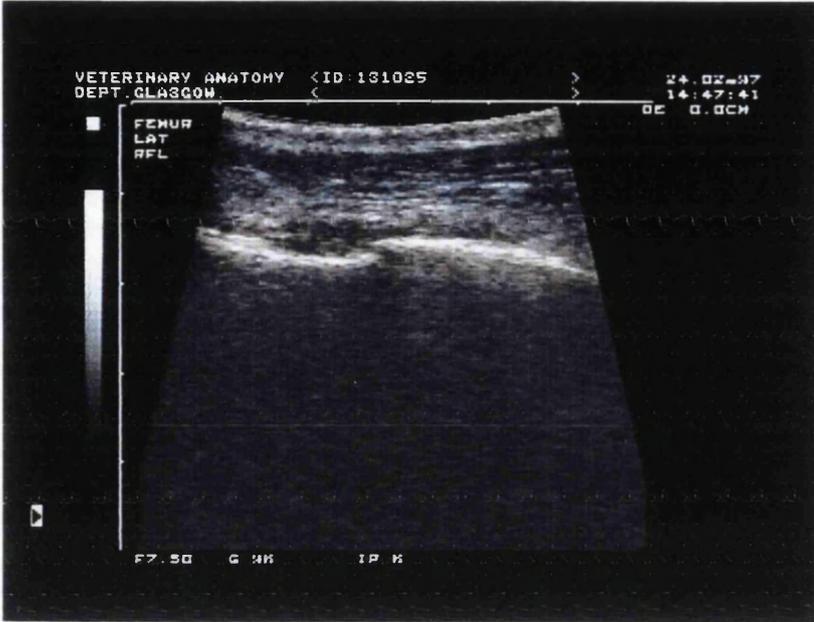
Figure 6.6.10a

Figure 6.6.10 Ultrasonographic examination of the humerus on day 73 after fracture repair. **a**, longitudinal image, **b**, transverse image. The humerus has returned to its normal ultrasonographic appearance in both images with a slight bend at the fracture site on a longitudinal scan. **H**, humerus.

Ultrasonographic examination demonstrated a smooth surface of the humerus both on longitudinal and transverse scans (figure 6.6.10a and 6.6.10b) suggesting a successful remodelling process. The humeral surface appeared smoother than on the day 44 examination. The humerus appeared slightly bent at the fracture site area on longitudinal scan from the lateral aspect. The muscle structure appeared to have a normal ultrasonographic characteristic. The fractured bone had healed satisfactorily.

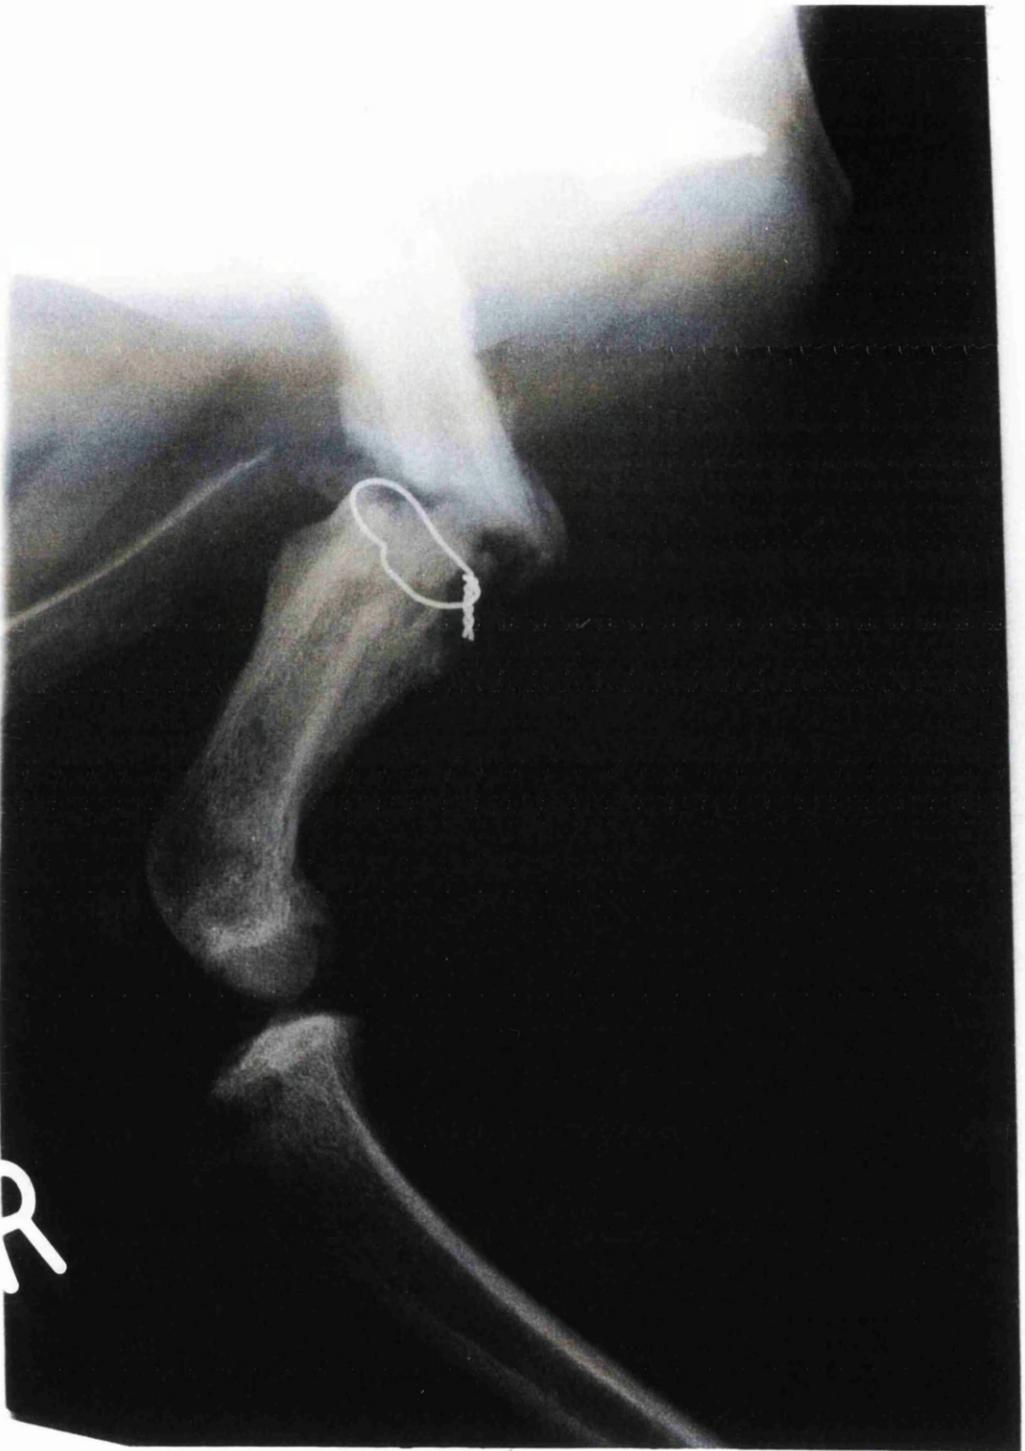
Figure 6.7.1 A three year old Jack Russell Terrier with a nonunion fracture of the mid shaft femur with proliferative new bone and a cerclage wire.

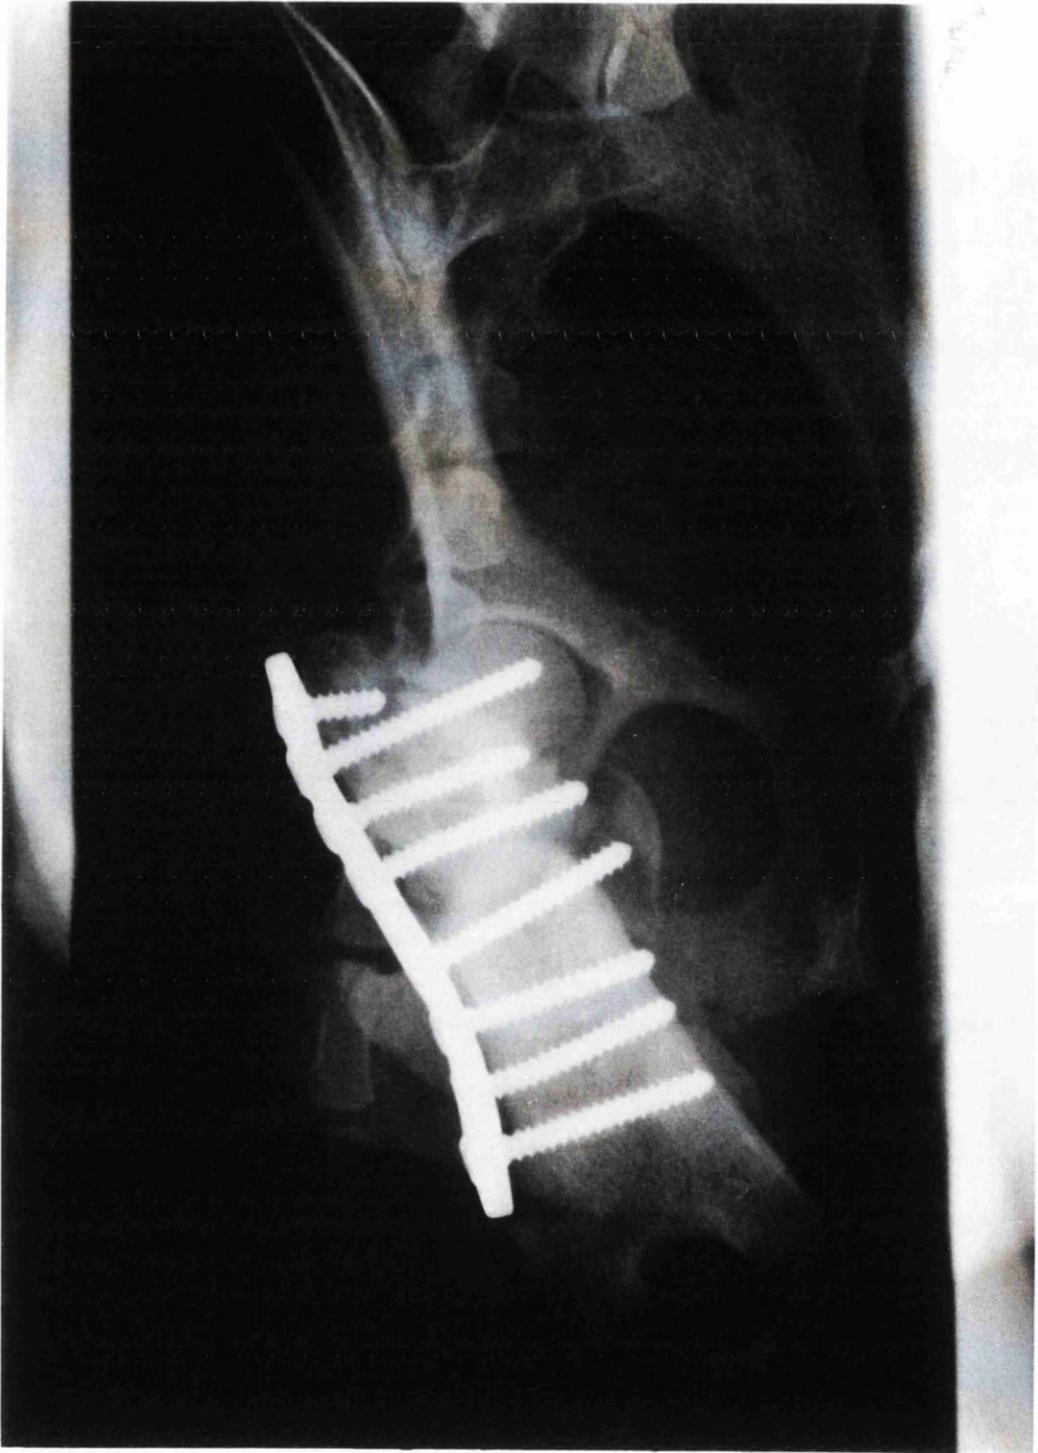
Figure 6.7.2 Radiographs obtained immediately after the reunion process show the fragments have been fixed with a plate and screws. **a**, lateral view, **b**, cranial view. The osteotomy and corrective plating was carried out approximately one month after referral. There was no fracture gap present and the two fragments were well apposed. Proliferation of new bone was present around the femur.

Radiographs taken immediately after fracture repair showed that the fracture has been reduced and fixed with a plate and screws (figure 6.7.2). There was no

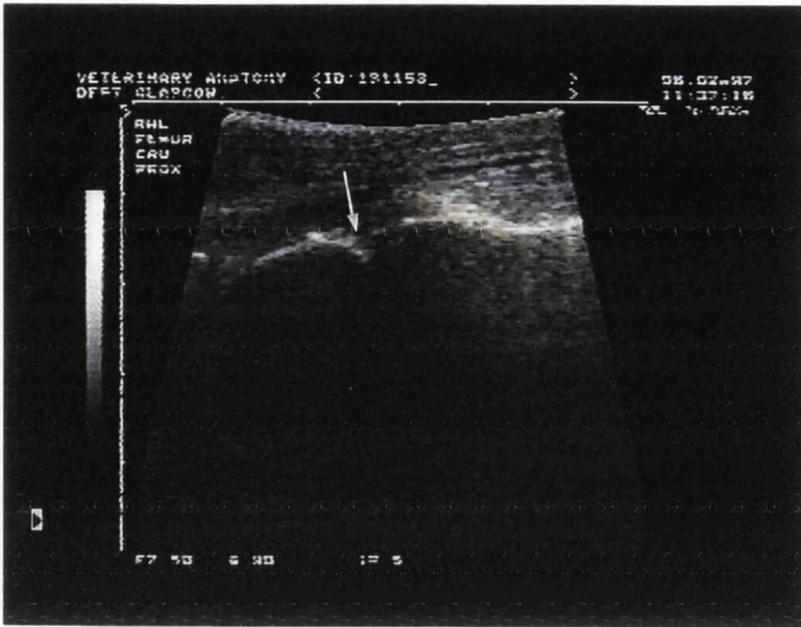
Figure 6.7.3 Longitudinal scan of the femur from the caudal aspect 24 hours after reunion shows the fracture site which appears as a shallow notch on a bulging bone surface (arrow).

Ultrasonographic examination demonstrated the fracture site which appeared as a shallow notch on a bulging surface (figure 6.7.3). The excessive callus formation around the fracture site before the reunion process had been carried out produced the image of an uneven and bulging bone surface. The bone plate was evident as it adhered to the femur when scanned transversely, appearing hyperechoic with reverberation artefact. The fracture site was not imaged on the cranial aspect scan due to the excessive callus formation which had developed after the repair process had been first carried out. The image only showed the bony callus bulging up from the femoral surface and it appeared hyperechoic with acoustic shadowing artefact (figure 6.7.4). A longitudinal scan from the medial aspect revealed the femur as slightly bent at the fracture site (figure 6.7.5). The femur appeared abnormal on a transverse scan, it was big and flat due to the excessive callus formation (figure 6.7.6). The bone plate appeared hyperechoic with reverberation artefact.

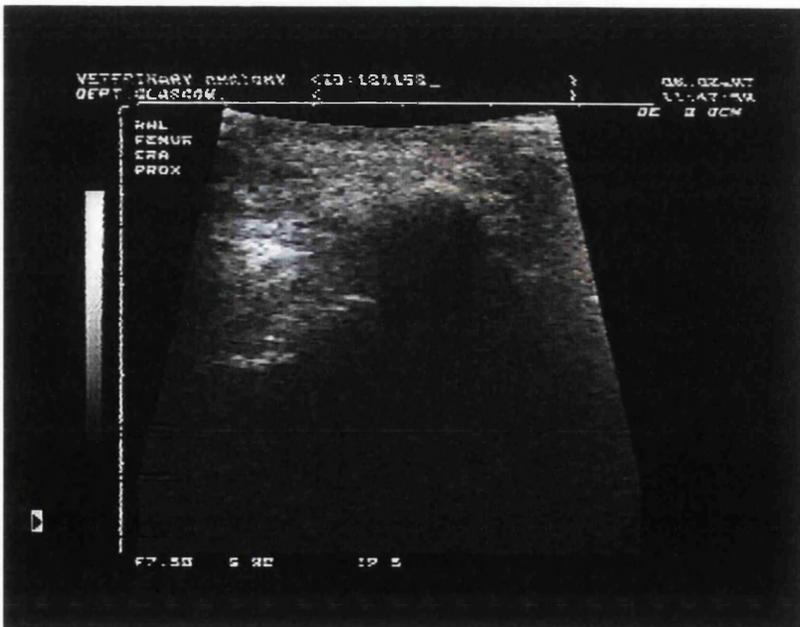
Figure 6.7.4 Longitudinal scan of the femur from the cranial aspect 24 hours after reunion shows the bony callus is bulging up from the bone surface and appears hyperechoic with acoustic shadowing artefact.

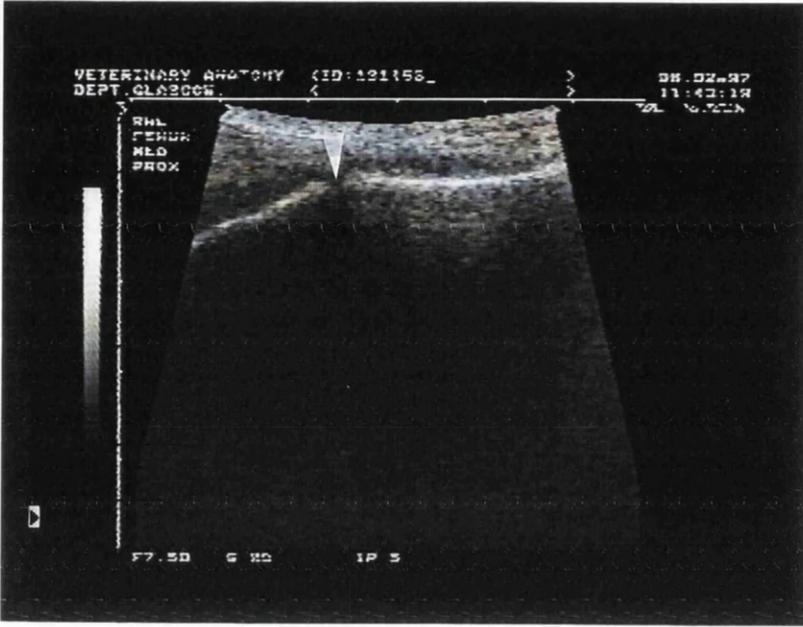
Figure 6.7.5 Longitudinal scan of the femur from the medial aspect 24 hours after reunion demonstrates the femur which is slightly bent at the fracture site (arrow head).

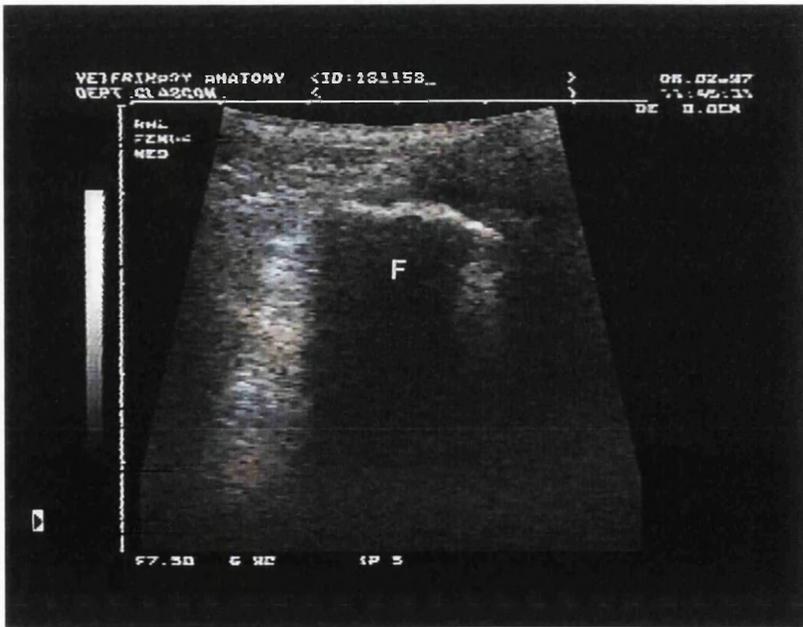
Figure 6.7.6 Transverse scan of the femur from the medial aspect 24 hours after reunion shows the femur with a hyperechoic flat bone surface with acoustic shadowing artefact. The abnormal appearance of the femoral surface is due to the excessive callus formation. F, femur.

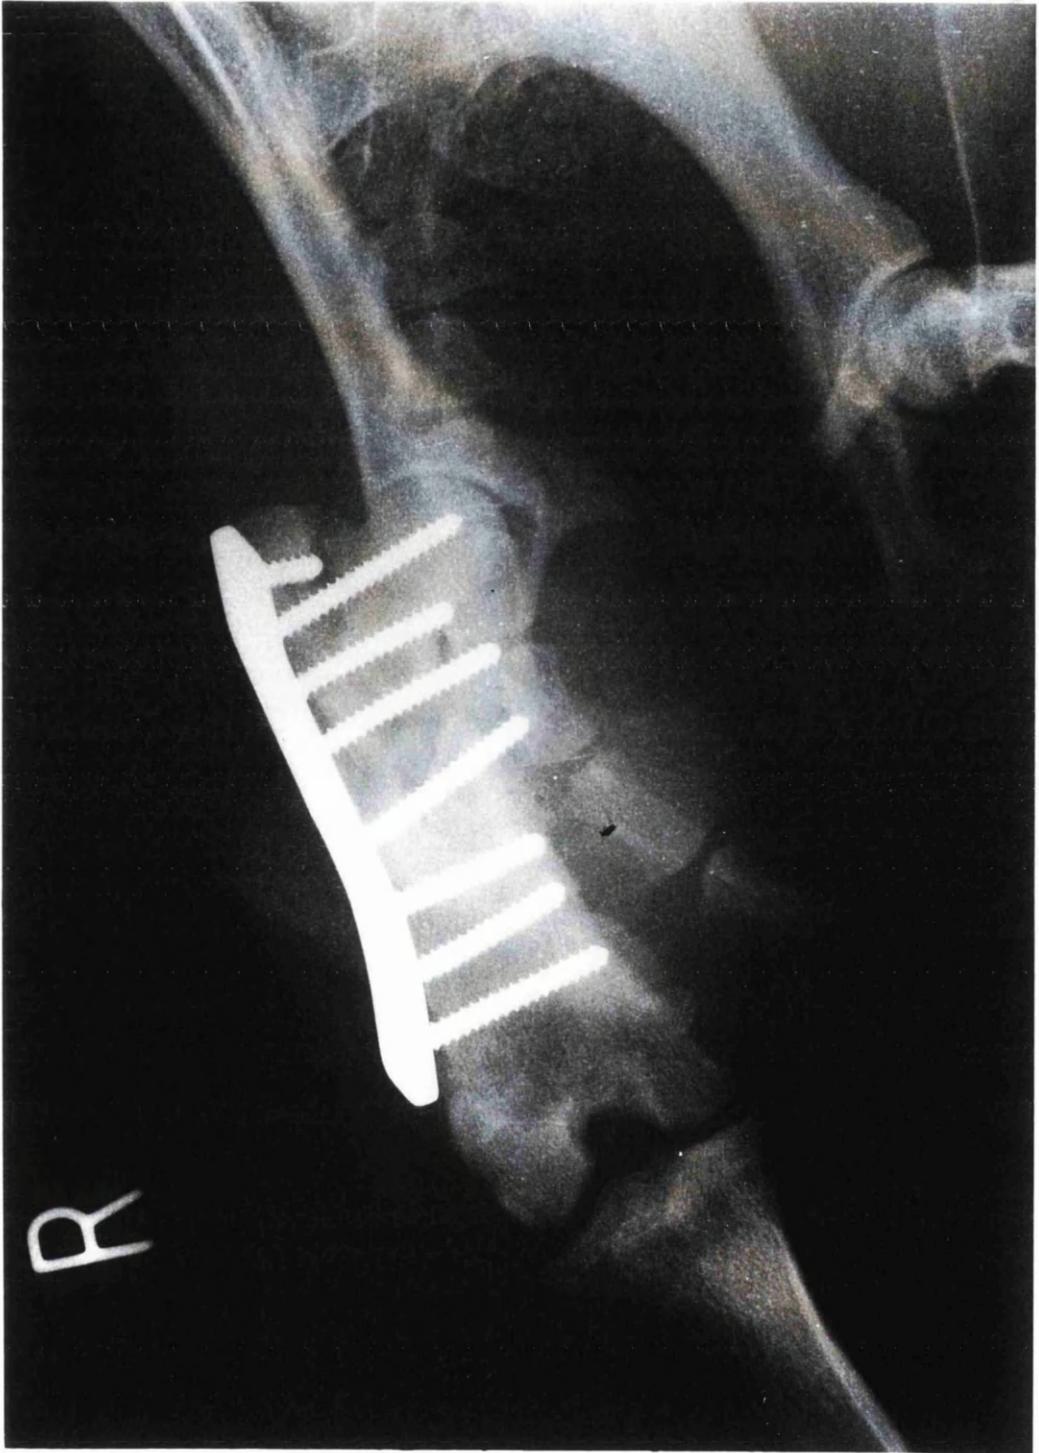
Figure 6.7.7 Radiographs obtained at day 27 after fracture repair show that the healing process appears to be progressing satisfactorily. **a**, lateral view, **b**, cranial view. No evidence of implant loosening or instability can be seen.

Radiographs taken at day 27 after fracture repair showed that the healing process appeared to be progressing satisfactorily (figure 6.7.7). No evidence of implant loosening or instability could be seen.

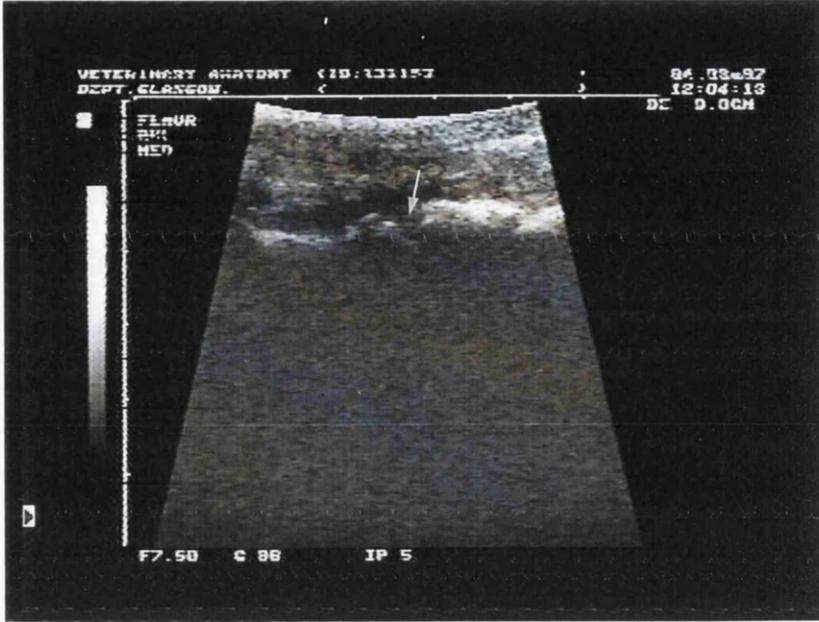
Figure 6.7.8 Longitudinal scan of the femur from the medial aspect on day 27 after reunion demonstrates the femur with a rough and uneven surface due to callus formation. Note that the fracture site can be recognised as a shallow notch (arrow).

Ultrasonographic examination from the medial aspect demonstrated the rough and uneven femoral surface due to callus formation (figure 6.7.8). The fracture site could still be recognised as a shallow notch on the uneven and rough femoral surface. It had been completely bridged by the mature callus. On the cranio-lateral scan, the femoral surface appeared less uneven and the fracture site was no longer detected (figure 6.7.9). This indicated the remodelling process was taking place. The bone plate appeared hyperechoic and produced reverberation artefact (figure 6.7.10a and 6.7.10b).

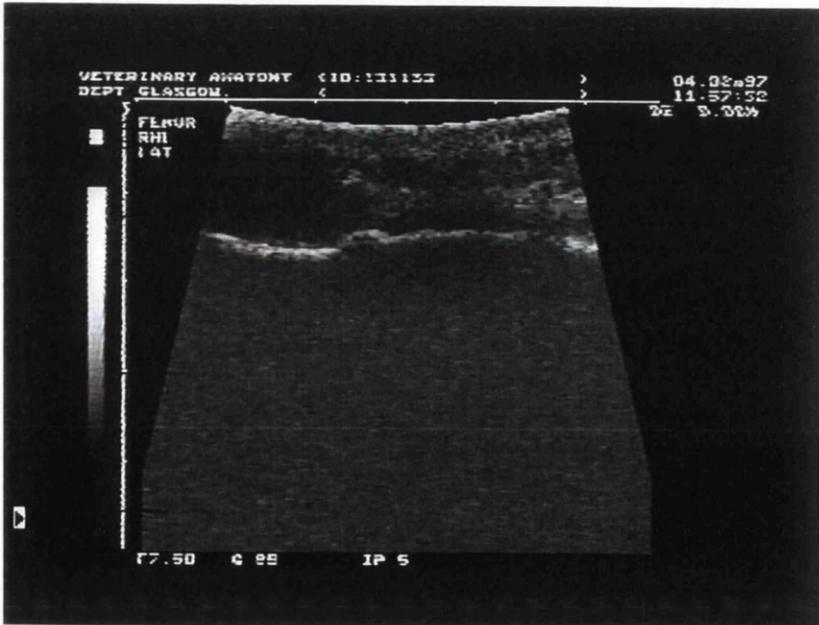
Figure 6.7.9 Longitudinal scan of the femur from the cranio-lateral aspect on day 27 after reunion shows the femoral surface which appears less uneven, and the fracture site is no longer detected. This indicates the remodelling process is taking place.

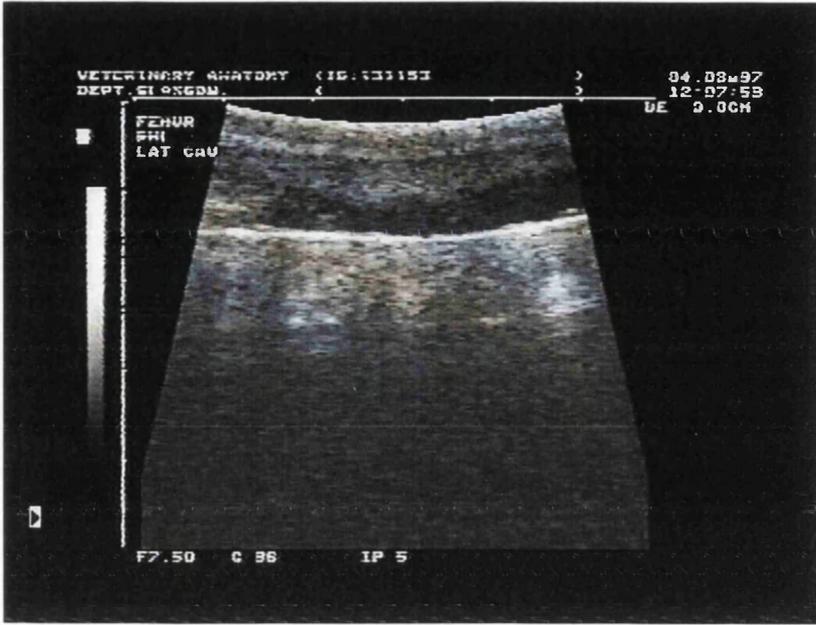
Figure 6.7.10a

Figure 6.7.10 The bone plate appears hyperechoic on an ultrasonographic scan and produces reverberation artefact. **a**, longitudinal scan, **b**, transverse scan.

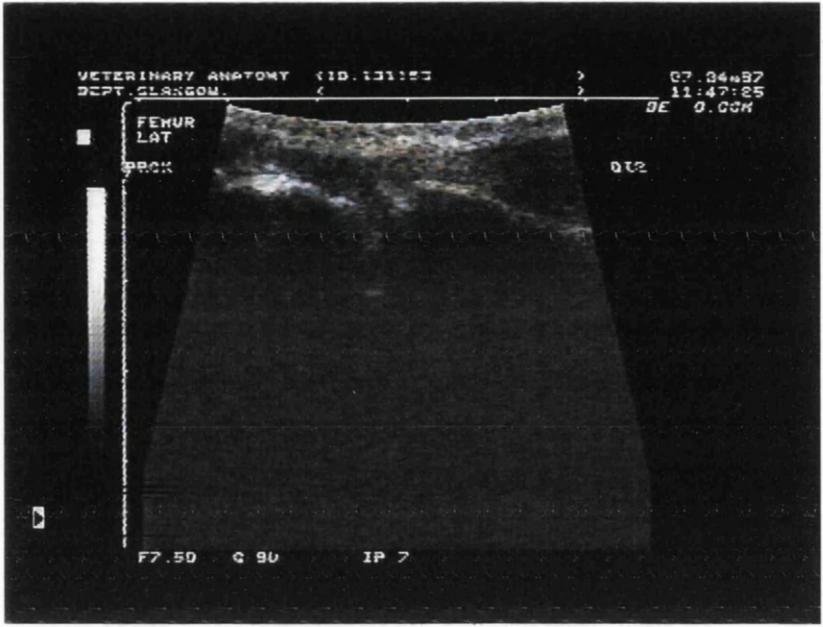
Figure 6.7.11 Longitudinal scan of the femur from the lateral aspect on day 61 after reunion demonstrates the fracture site which appears as a shallow notch on the femoral surface. The mature callus is bridging the fracture site completely.

Ultrasonographic examination demonstrated the fracture site which had been completely bridged by the mature callus (figure 6.7.11). The fracture site could still be recognised ultrasonographically and appeared as a shallow notch on the femoral surface. The bulging bone area had reduced in size and appeared smoother than the previous scan suggesting a remodelling process. On the medial aspect scan, the femur appeared slightly bent at the fracture site area as seen on day one after reunion process (figure 6.7.12). The bone plate and screws appeared hyperechoic with reverberation artefacts. The distal part of the plate appeared slightly elevated from the femoral surface (figure 6.7.13). This could suggest that the screws were loosening at the distal portion. Muscle tissue had a normal ultrasonographic appearance. Ultrasonographically, the fracture site had healed satisfactorily.

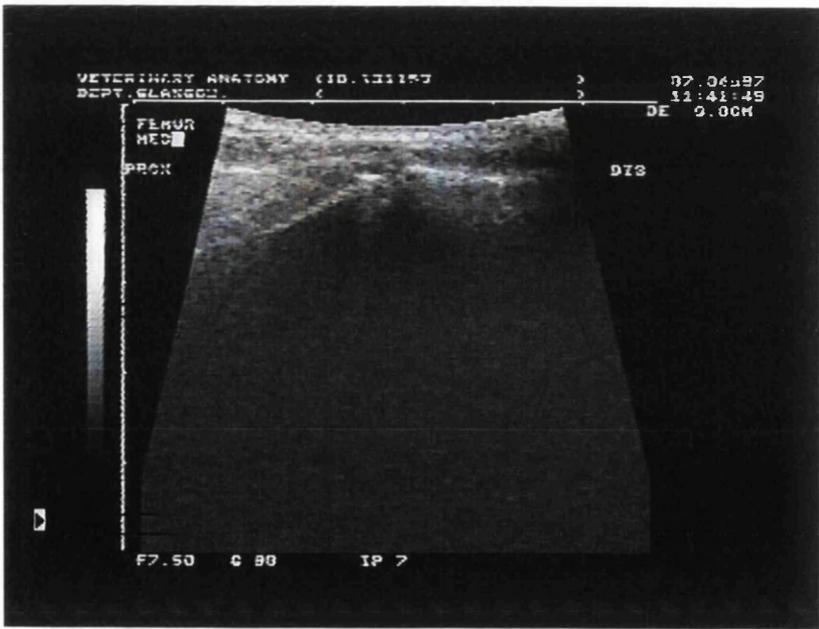
Figure 6.7.12 Longitudinal scan of the femur from the medial aspect on day 61 after reunion shows the femur which appears slightly bent at the fracture site area.

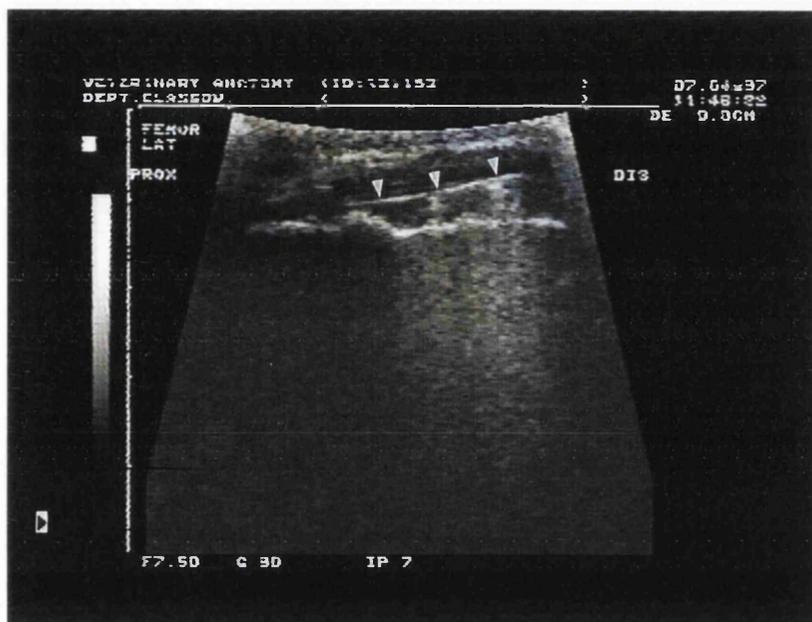
Figure 6.7.13 Longitudinal scan of the femur from the lateral aspect on day 61 after reunion demonstrates the distal part of the plate (arrow heads) which appears elevated from the femoral surface. This may indicate the screws loosening at the distal portion.

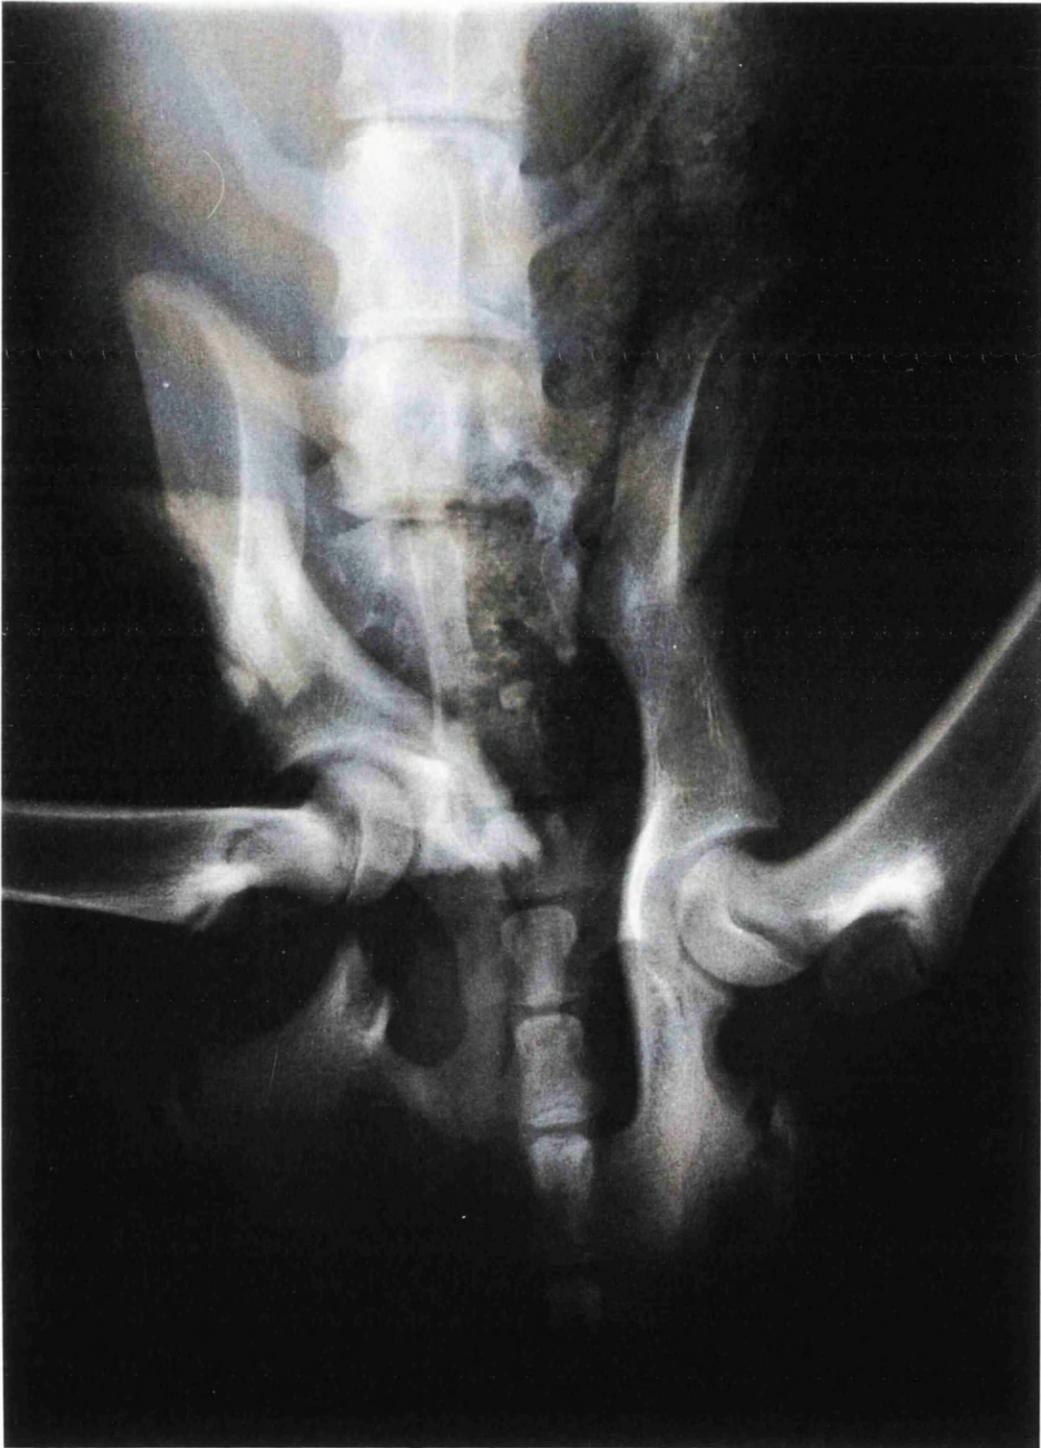
Figure 6.8.1 A seven months old male Border Collie with fractures of the right hemipelvis and the sacroiliac luxation of the left hemipelvis. Note that the right acetabular fragment appears to be “free” and markedly impacted into the pelvic canal.

A seven month old male Border Collie, weight 12 kg, was referred to the Glasgow University Veterinary Hospital after having been involved in a road traffic accident. The dog had fractures of the right hemipelvis and a sacroiliac luxation of the left hemipelvis. On clinical examination the animal showed a poor anal reflex and poor anal tone but apparently normal urinary control. A sciatic nerve deficit was identified in the left limb. Radiographs taken before fracture repair showed the right acetabular fragment to be "free" and markedly impacted into the pelvic canal (figure 6.8.1).

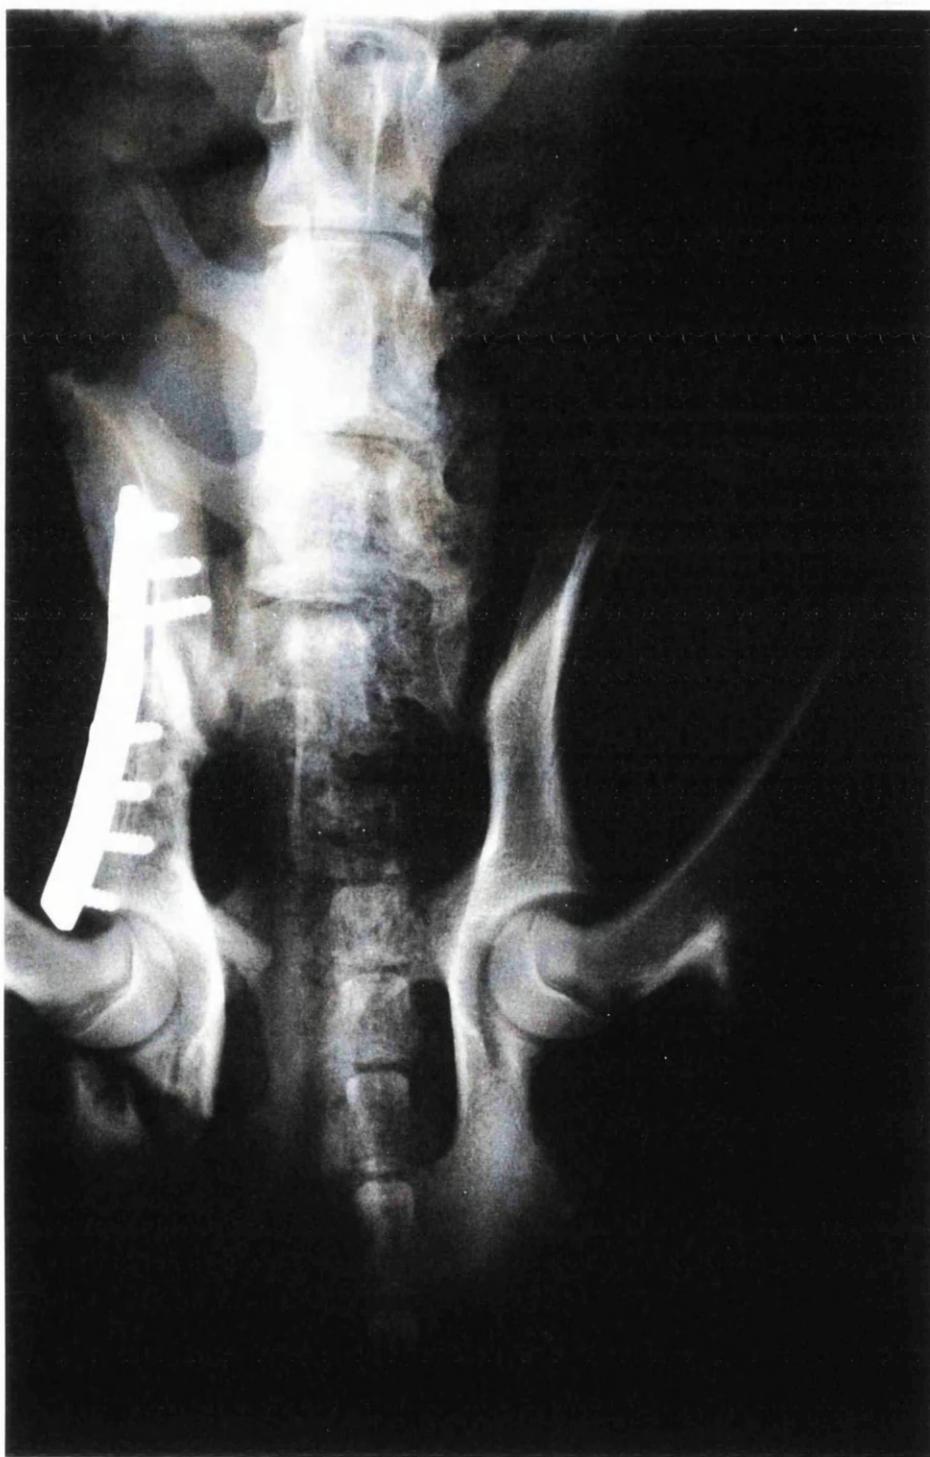
Figure 6.8.2 Radiographs taken immediately after the fracture repair show that the medial displacement of the iliac shaft has been corrected and the pelvic canal reopened. **a**, lateral view, **b**, ventral view. The fracture is reduced using a 2.7 cm eight holes DCP (Dynamic Compression Plate) aligned on the ilium. The caudal iliac fragment has been first drilled, taped and screwed (4 screws in total), then the cranial fragment attached to the plate by 3 screws. The fourth hole has been left open as it lies over the fracture site. The medial displacement of the ilial shaft has been corrected reopening the pelvic canal.

The right ilium had been plated with an eight hole 2.7 mm DCP (Dynamic Compression Plate). Reduction of the fracture was good, although post-operation radiographs showed an under-reduction of the ischial fracture due to slight under-contouring of the plate (figure 6.8.2). The acetabular fragment had been pulled back into a more normal position.

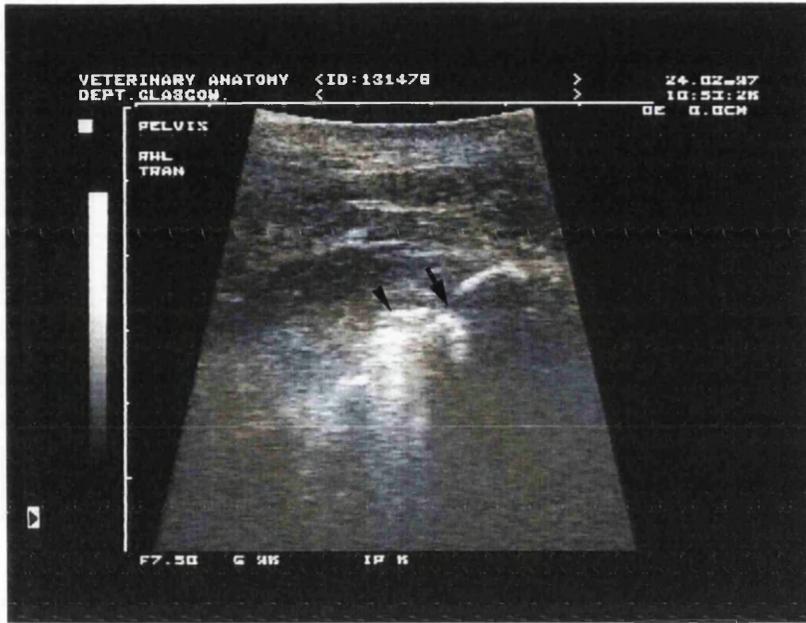
Figure 6.8.3 Transverse scan of the shaft of ilium on day three after fracture repair demonstrates the fracture site with a small fracture gap (arrow) near to the bone plate (arrow head). There is no soft callus formation detected.

Ultrasonographic examination of the ilial shaft on a transverse scan demonstrated the fracture site with the presence of a small gap near to the bone plate (figure 6.8.3). It appeared as discontinuity of the shaft of the ilium when imaged in cross section. The fracture site could be seen as a defect on the ilial shaft on a longitudinal scan. The presence of soft callus formation was detected and appeared as an hyperechoic structure in the area of the fracture (figure 6.8.4). The bone plate with screws appeared hyperechoic and produced comet tail artefacts. The disorganised hyperechoic structure area superficial to the ilium suggested an area of soft tissue reaction (figure 6.8.5). The area of muscle damage appeared disorganised and hypoechoic.

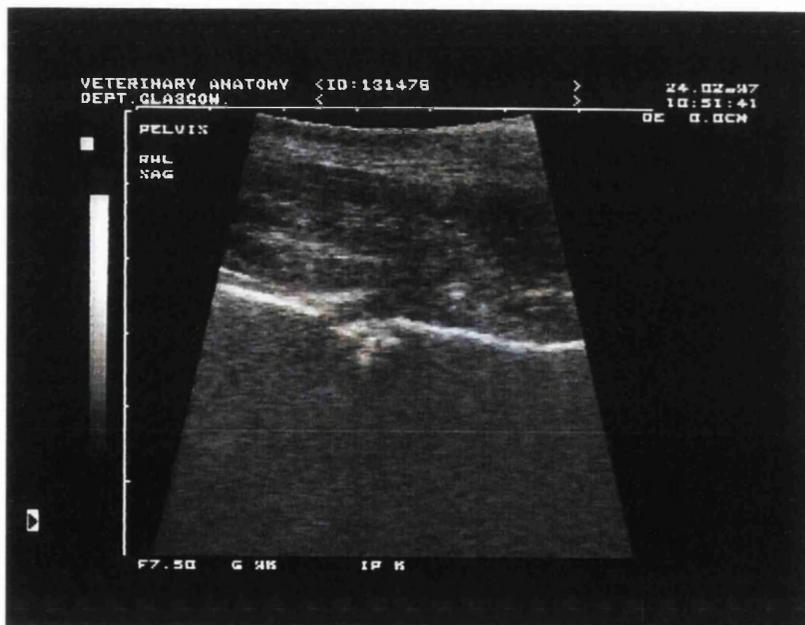
Figure 6.8.4 Longitudinal scan of the shaft of ilium on day three after fracture repair shows the fracture site which appears as a defect of the ilial shaft surface. Note the hyperechoic material at the fracture site suggesting the presence of soft callus formation. The area of muscle damage appears disorganised and hypoechoic.

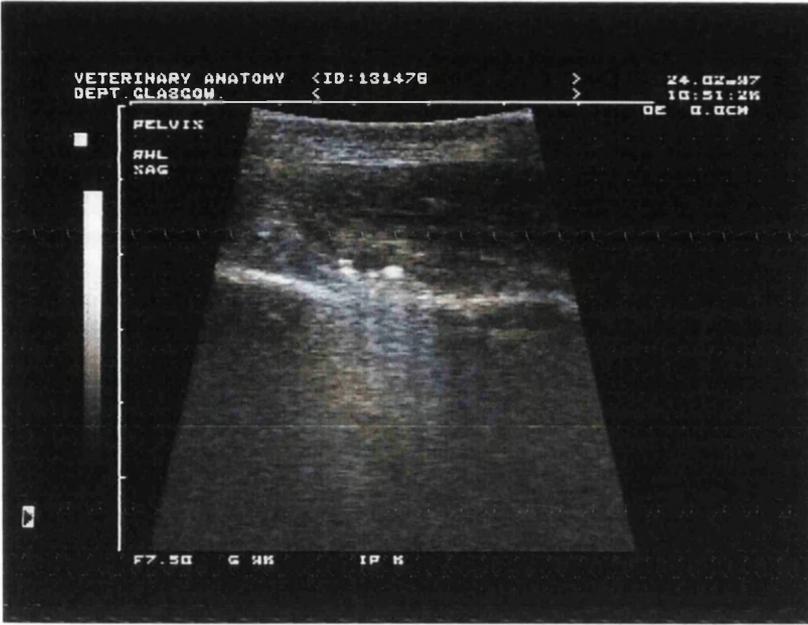
Figure 6.8.5 Longitudinal scan of the ilial shaft on day three after fracture repair shows the bone plate with screws which appear hyperechoic with reverberation artefact. Note also the area of disorganised hyperechoic structure superficial to the bone surface suggesting soft tissue reaction.

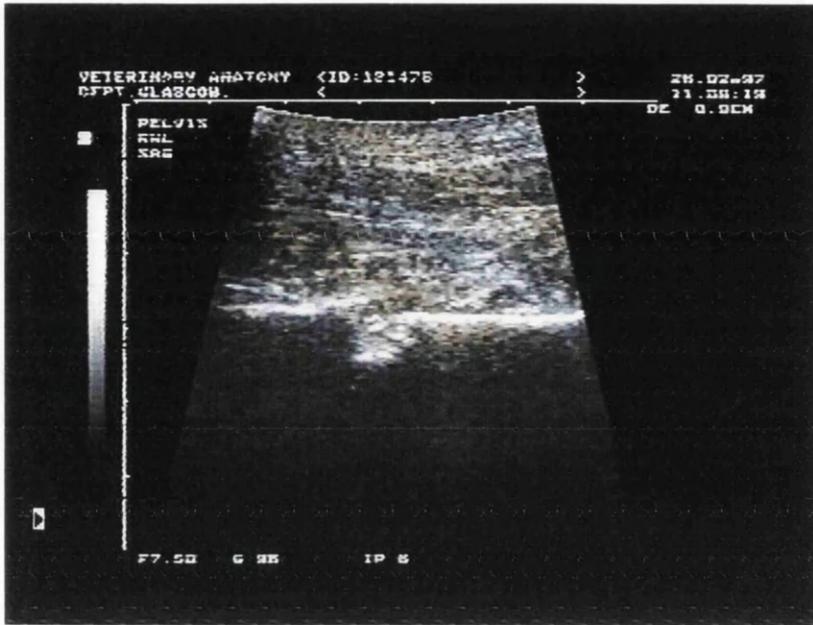
Figure 6.8.7 Longitudinal scan of the ilium on day five after fracture repair shows the fracture site with a small gap. The hyperechoic material at the fracture site suggests soft callus formation.

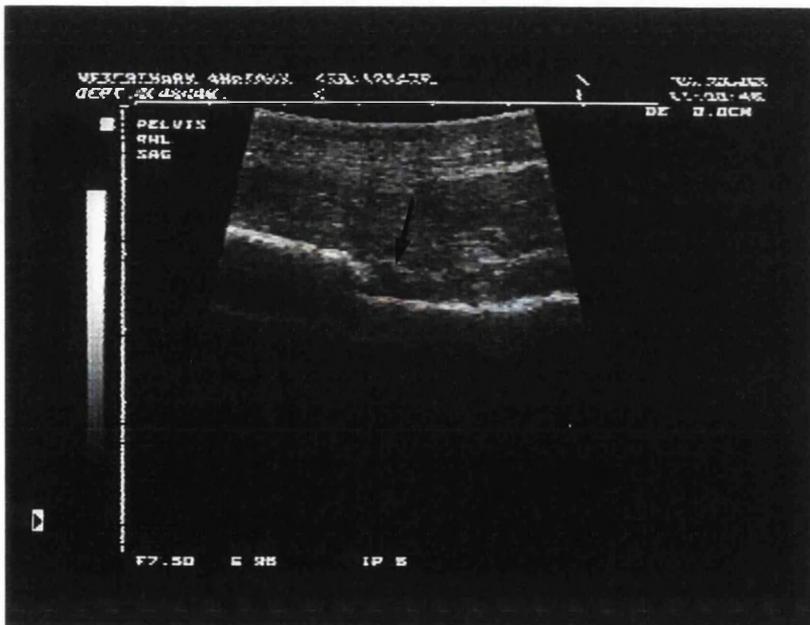
Figure 6.8.8 Longitudinal scan of the dorsal side of the shaft of ilium on day five after fracture repair demonstrates the fracture site with the proximal fragment appearing elevated from the distal fragment. There is no fracture gap seen at this site. The echogenic area at the proximal end fragment (arrow) suggests soft tissue reaction.

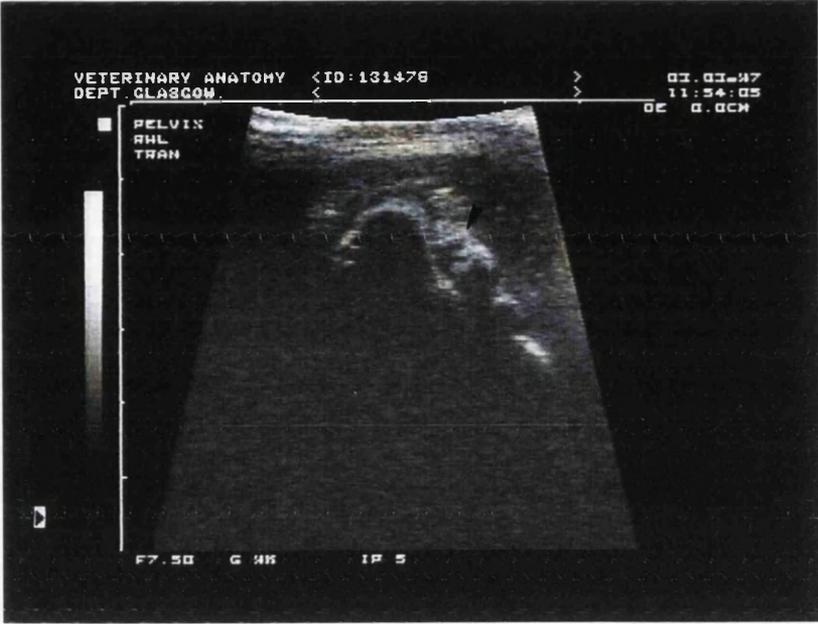
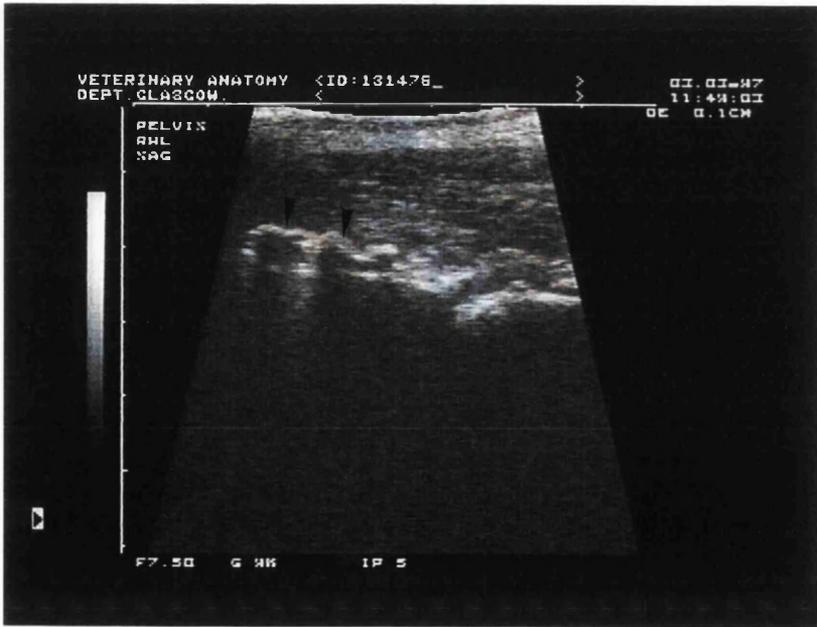
Figure 6.8.9 Ultrasonographic examination of the ilial shaft on day 10 after fracture repair. **a**, transverse scan, **b**, longitudinal scan. Both images demonstrate the presence of periosteal callus formation which is developing some distance away from the fracture site. The callus formation appears as clumping hyperechoic structures emerging from the bone surface and casting acoustic shadowing artefact. The soft callus formation seen on a transverse scan (**a**) appears as a disorganised hyperechoic structure with an ill-defined margin (arrow head) and produces no artefact. The bone surface underneath the soft callus formation in **b** (arrow heads) is still visible. The maturing callus appears similar to the bone tissue but it has an irregular surface and produces an abnormal image outline of the bone.
