**AN ULTRASONOGRAPHIC STUDY OF MUSCULOSKELETAL
INJURIES AND MAMMARY GLAND TUMOUR IN SMALL
ANIMALS**

A thesis submitted to the Faculty of Veterinary Medicine,
University of Glasgow.

For the Degree of Doctor of Philosophy

Division of Veterinary Anatomy,
Department of Veterinary Preclinical Studies,
School of Veterinary Medicine,
University of Glasgow,
March, 1999

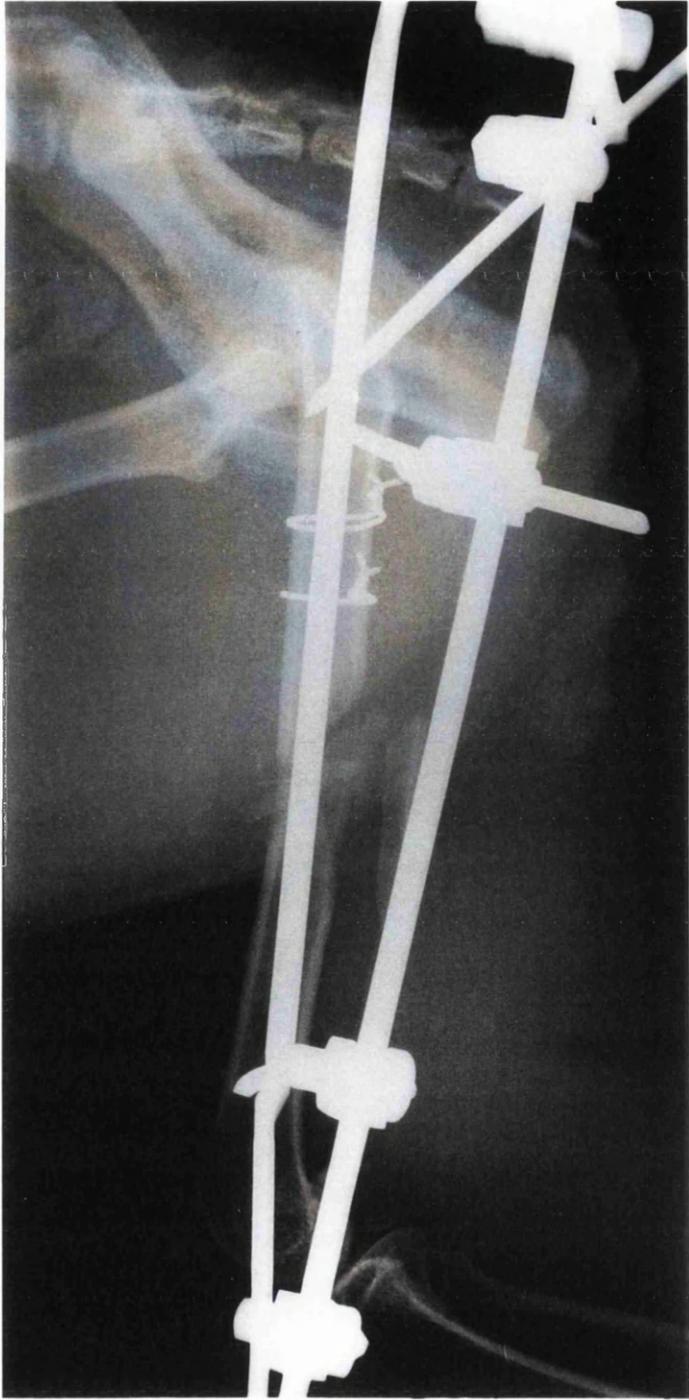
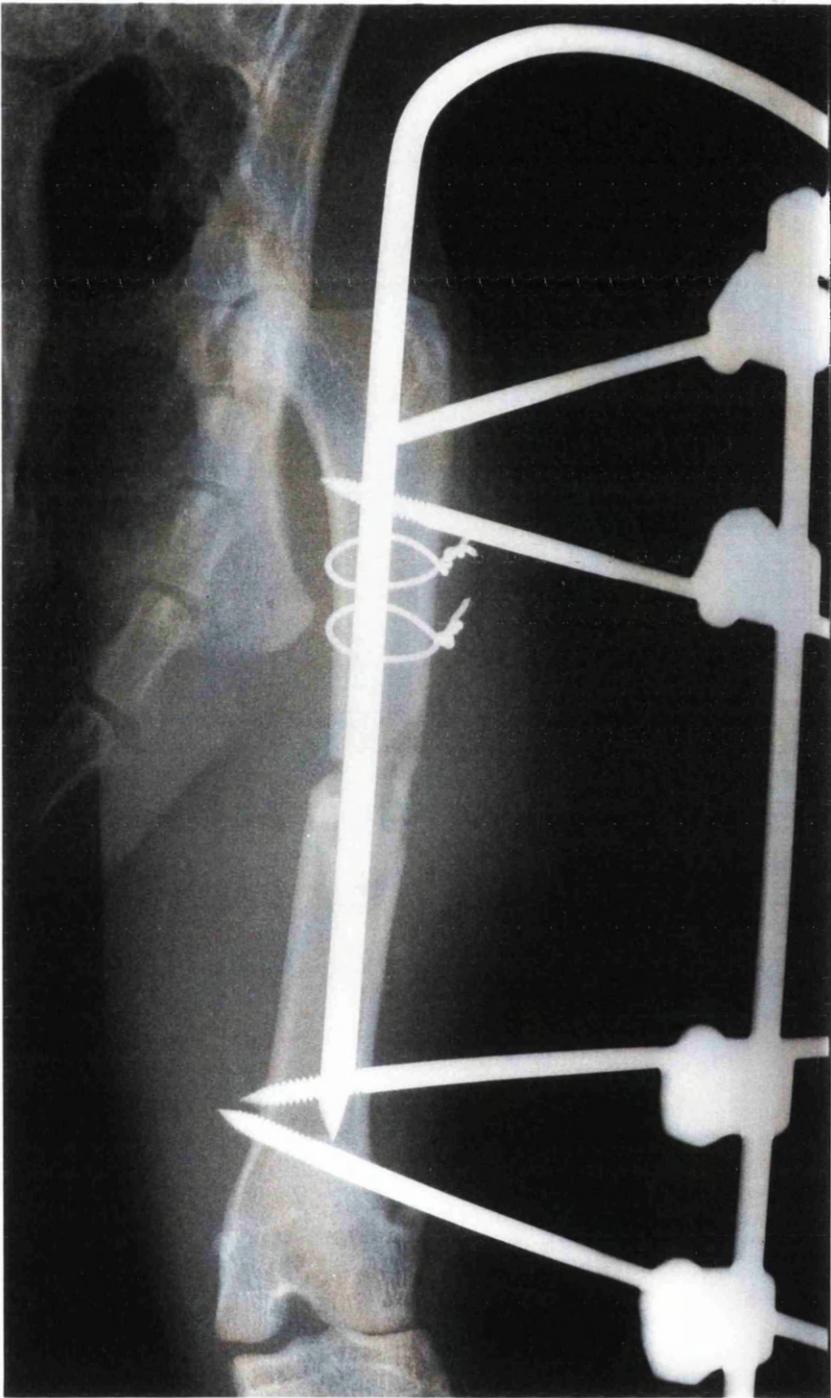
Figure 6.9.1 Radiographs obtained immediately after fracture repair show the comminuted femur fracture has been reduced and aligned with an intramedullary pin and I/E external fixator tied in. **a**, lateral view, **b**, cranial view. A piece of bone fragment remains, lying caudal to the femur at the fracture site. A small fragment of bone is seen positioned across the femur at the fracture site area on a lateral view.

Radiographs taken immediately after fracture repair showed that the comminuted femoral fracture had been reduced and aligned with an intramedullary pin and I/E external fixator tied in (figure 6.9.1). A piece of bone fragment was remaining in the muscle, being caudal to the fracture site. A small fragment of bone was seen lying across the femur at the fracture site area on lateral view.

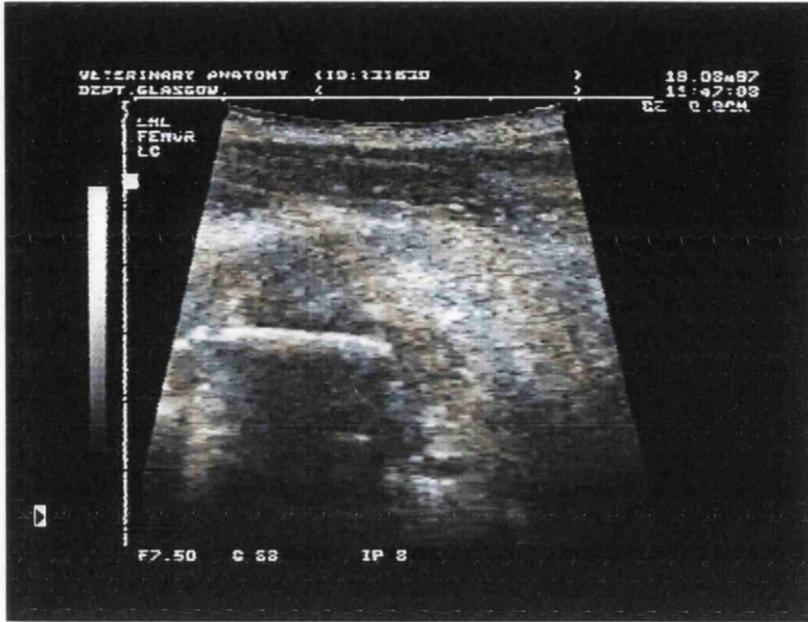
Figure 6.9.2 Longitudinal scan of the femur from the caudal aspect 24 hours after fracture repair shows the piece of bone fragment lying caudal to the fracture site. It appears as a straight hyperechoic line and produces acoustic shadowing artefact. This bone fragment is blocking out the image of the fracture site on the caudal aspect scan of the femur.

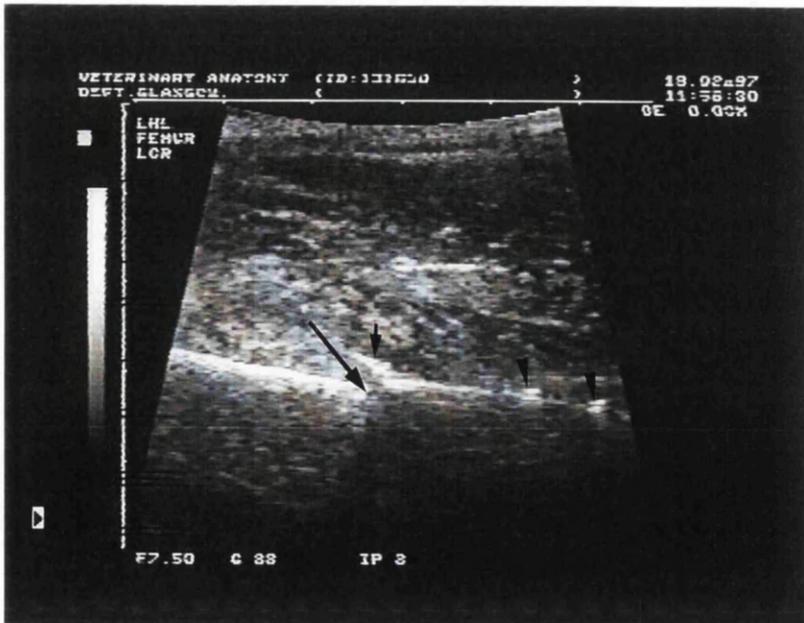
Figure 6.9.3 Longitudinal scan of the femur from the cranial aspect 24 hours after fracture repair demonstrates the fracture site (long arrow) which is well aligned and no significant fracture gap is present. The small hyperechoic structure (short arrow) protruding into the muscle from the bone surface at the fracture site is actually a small bone fragment. Note also that the two small hyperechoic spots are representing the cerclage wires (arrow heads).

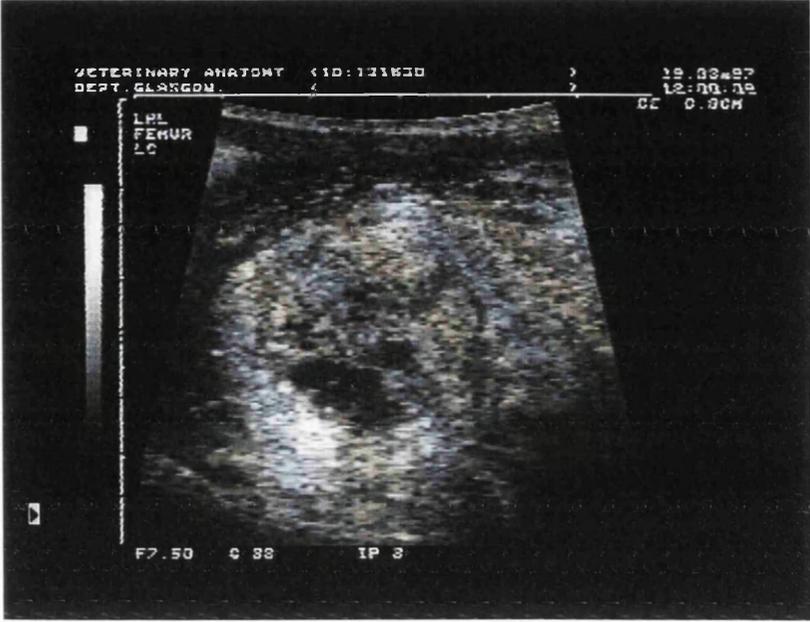
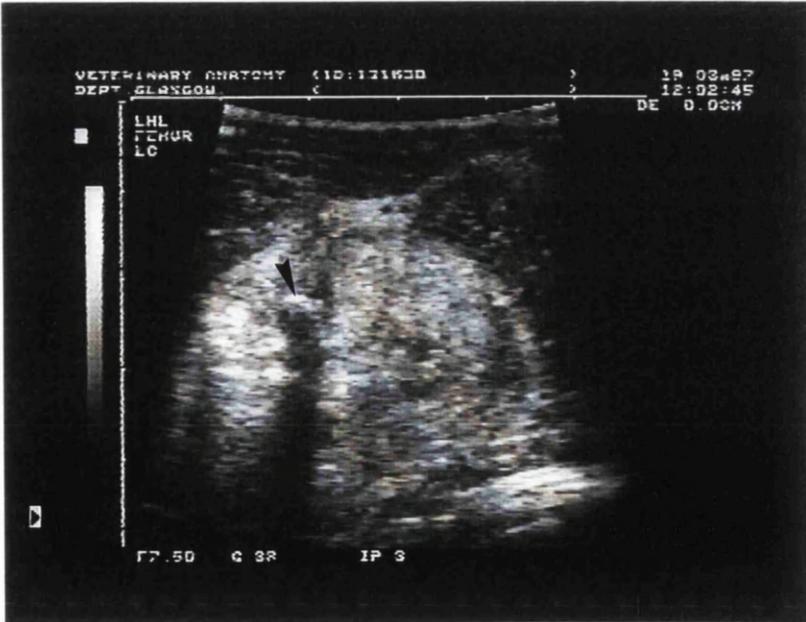
Figure 6.9.4 Ultrasonographic images of the area of extensive muscle damage caudal to the femur 24 hours after fracture repair. **a**, longitudinal scan from lateral aspect, **b**, transverse scan from caudal aspect. The area of muscle damage appears as a large, round hyperechoic structure with hypoechoic centre on longitudinal scan, and appears as a round area with a mixture of hyperechoic and hypoechoic structures on a transverse scan. Note also the fracture site area on the transverse scan (**b**), the bone fragment lying caudal to the fracture site (arrow head) appears hyperechoic with acoustic shadowing artefact.

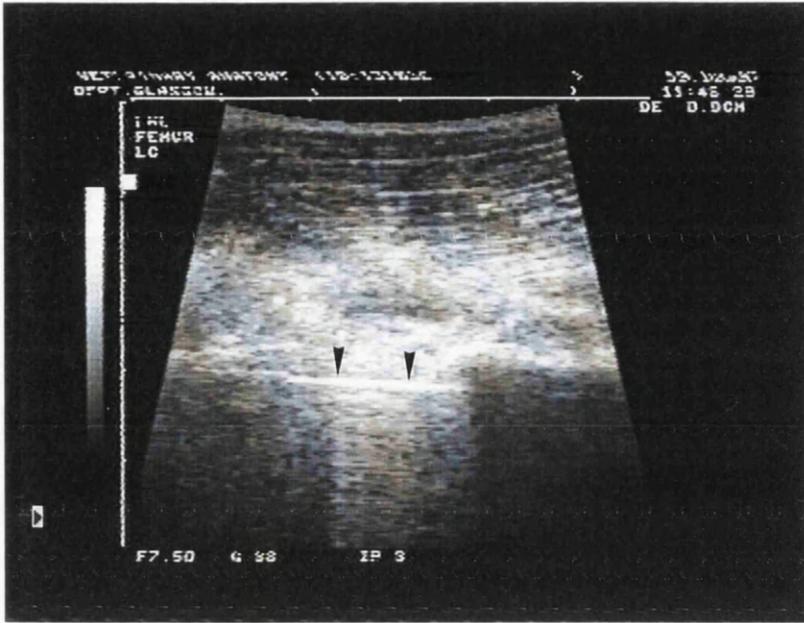
Figure 6.9.5 Longitudinal scan of the femur from the caudo-lateral aspect 24 hours after fracture repair demonstrates the intramedullary pin (arrow heads) which appears as a straight hyperechoic line and produces reverberation artefact. There is a large gap between the two fragments at the fracture site through which runs the intramedullary pin. The area of muscle damage superficial to the femur appears as disorganised hyperechoic structure.

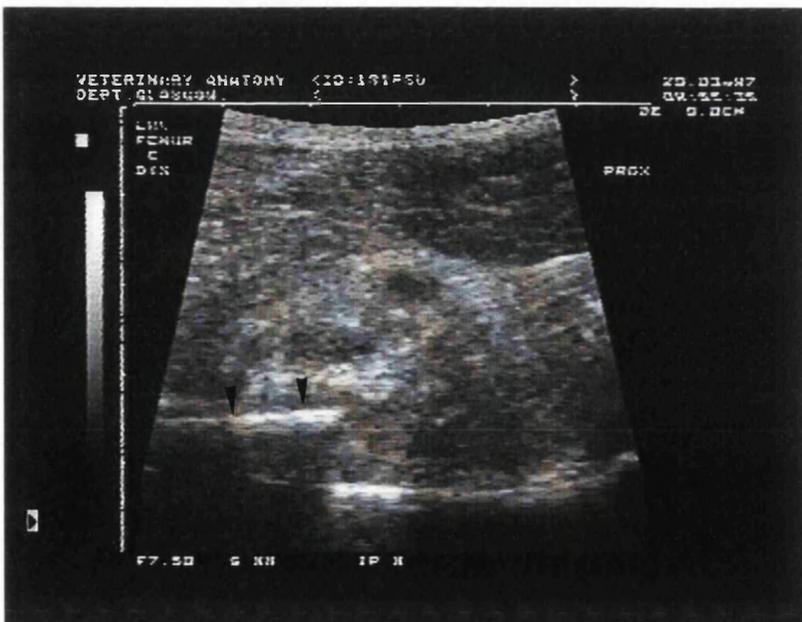
Figure 6.9.6 Longitudinal scan of the femur from the caudal aspect on day two after fracture repair demonstrates the piece of bone fragment (arrow heads) which appears as an hyperechoic line lying above the proximal fragment with acoustic shadowing artefact.

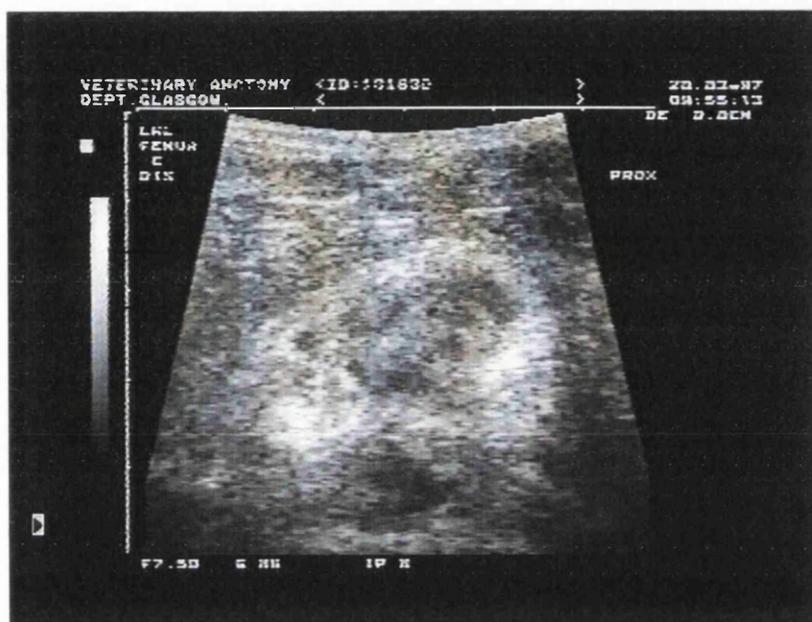
Figure 6.9.7 The area of muscle damage caudal to the femur scanned transversely on day two after fracture repair appears more echogenic and smaller than on the day one examination, but still remains round, disorganised and hyperechoic.

Ultrasonographic examination demonstrated the fracture site which appeared as on the day one examination. No soft callus formation was detected at this stage. The bone fragment lying caudal to the fracture site appeared as an hyperechoic short line above the proximal fragment (figure 6.9.6). The fracture site on transverse scan appeared as on the day one examination. No significant changes were seen. The area of extensive muscle damage caudal to the femur had become more echogenic but still appeared as a round, disorganised hyperechoic structure as seen on the day one examination (figure 6.9.7).

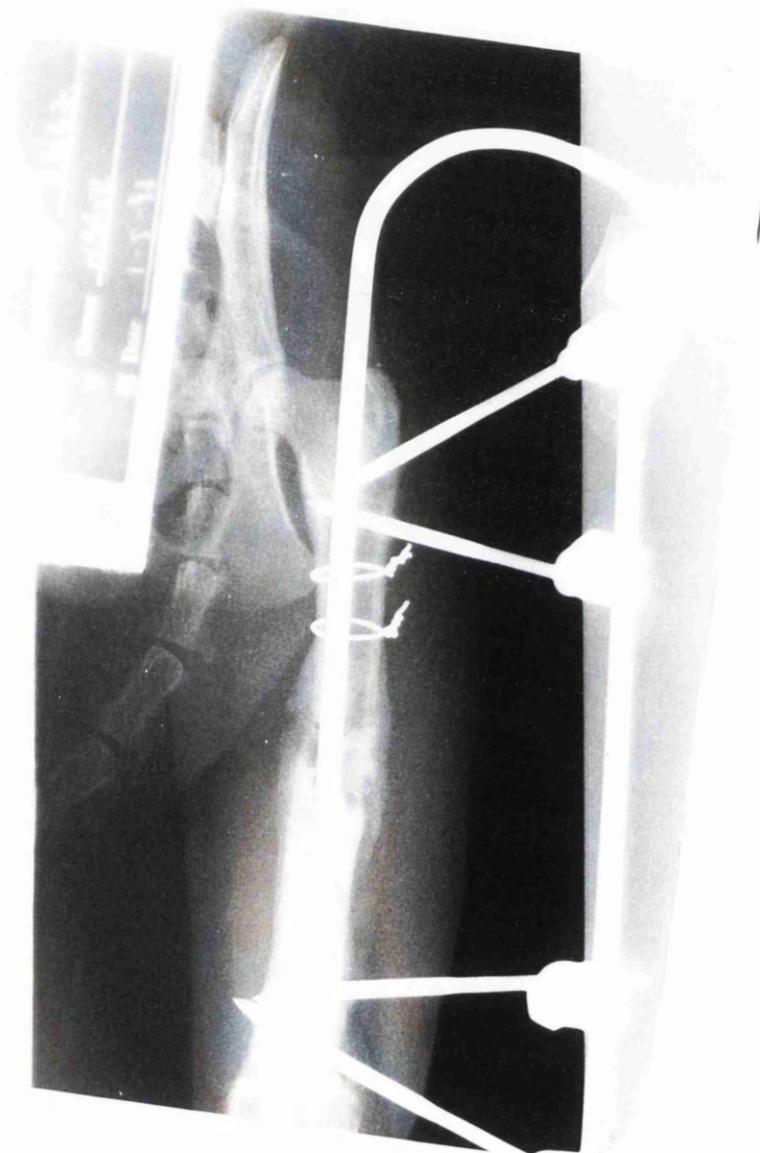
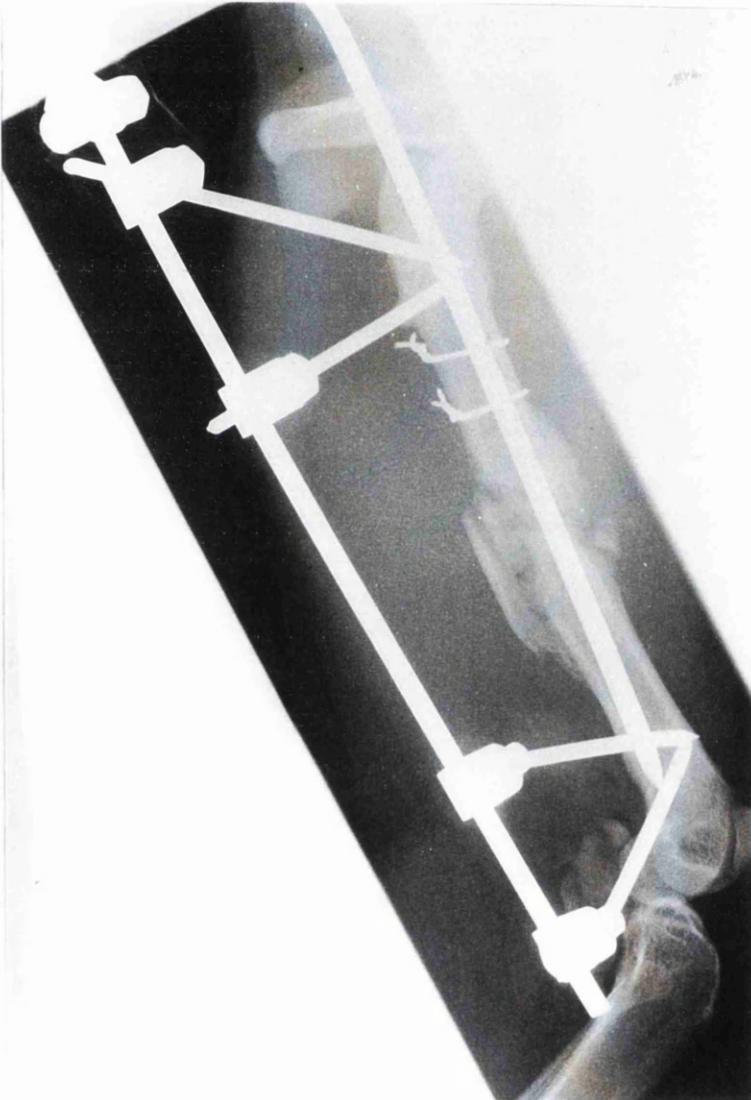
Figure 6.9.8 Radiographs taken at day 45 after fracture repair show the callus formation is bridging the fracture site and around the femoral shaft. **a**, cranial view, **b**, lateral view. This is suggestive of fracture healing. The fracture site is still visible. The bone fragment lying caudal to the femur has coalesced with the main fragment by bony callus.

Radiographs taken at day 45 after fracture repair showed the callus formation has bridged the fracture site and around the femoral shaft (figure 6.9.8). This was suggestive of fracture healing. The fracture site was still visible radiographically. The bone fragment lying caudal to the femur had coalesced with the main fragment by bony callus.

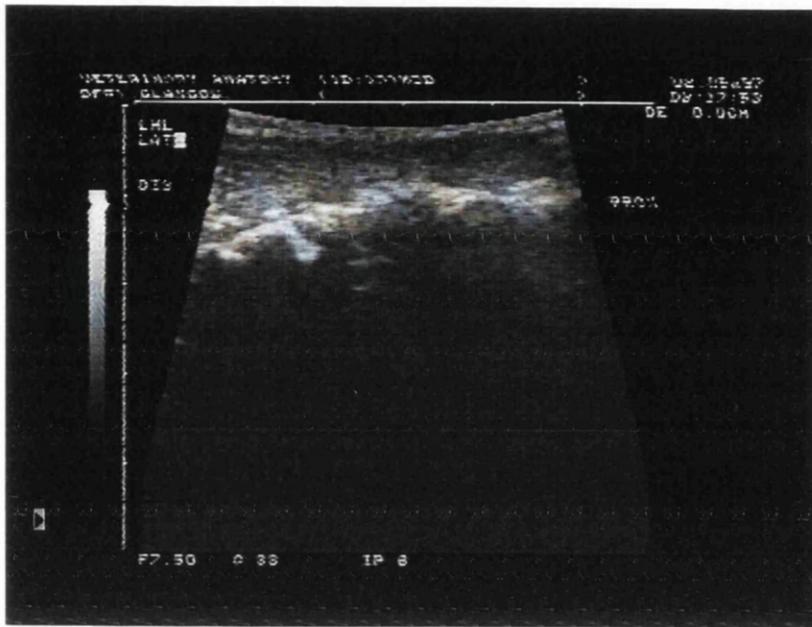
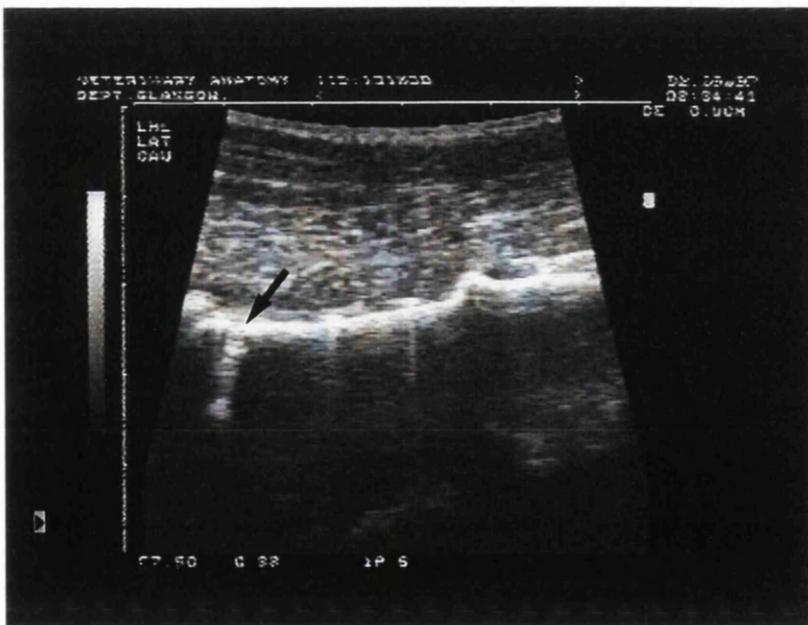
Figure 6.9.9 Longitudinal scans of the femur on day 45 after fracture repair demonstrate the femur with callus formation. **a**, lateral aspect, **b**, caudo-lateral aspect. The fracture site (arrow) still can be seen and appears as a vertical hyperechoic line and is occupied by the soft callus (**b**). The big fracture gap seen on the day two examination is no longer visible. The muscle structure has returned to its normal ultrasonographic structural appearance but is hyperechoic suggesting residual fibrosis.

Ultrasonographic examination from caudo-lateral aspect demonstrated the femur with callus formation (figure 6.9.9a). The fracture site was imaged and appeared as a vertical hyperechoic line which had been occupied by the soft callus (figure 6.9.9b). The large fracture gap seen on the day two examination was no longer detected. The femoral surface appeared uneven and rough at the area of fracture site both on longitudinal and transverse scans (figure 6.9.10a and

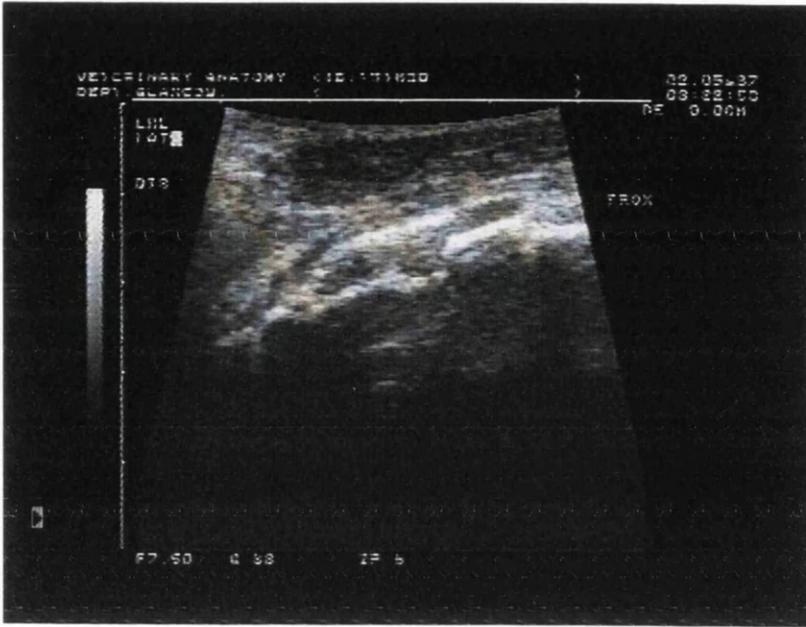
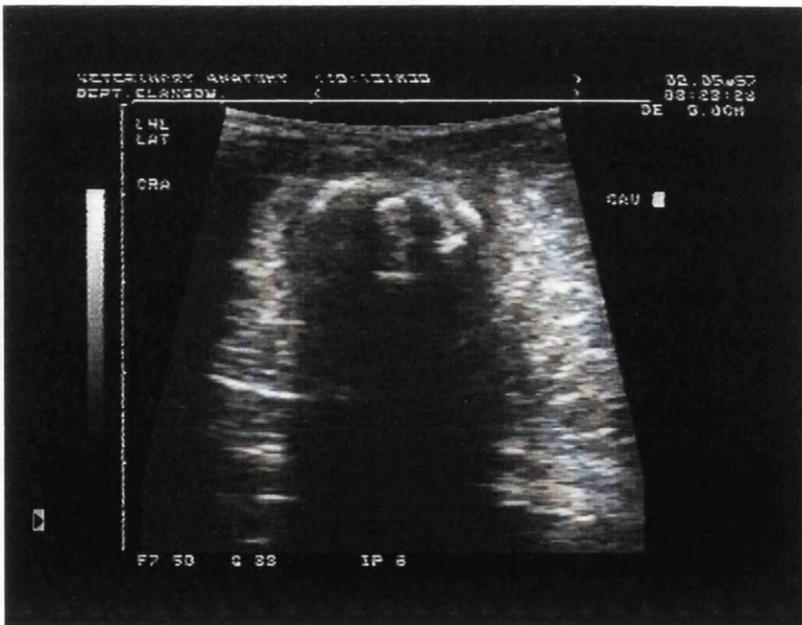
Figure 6.9.10 Ultrasonographic images of the femur at the fracture site area on day 45 after fracture repair show the femoral with an uneven and rough hyperechoic surface due to callus formation. **a**, longitudinal scan, **b**, transverse scan. The femur appears bigger than normal on the transverse scan. The fracture site still can be seen with the presence of a small gap which appears hyperechoic suggesting the presence of periosteal tissue reaction on a transverse scan.

6.9.10b). The femur appeared bigger than normal with a rough, rounded surface on a transverse scan. The fracture site could still be seen with the presence of a small gap which appeared hyperechoic suggesting the presence of periosteal tissue reaction. The loose bone fragment lying caudal to the fracture site as seen on the day one and two examinations had now coalesced with the main fragment by means of the mature callus. Thus, the large fracture gap was no longer visible. The area of muscle damage had returned to its normal muscle structure but with an increased hyperechoic appearance (figure 6.9.11a and 6.9.11b). This hyperechoic appearance was suggestive of the presence of fibrous tissue within the muscle. The muscle thickness had reduced in size as compared to the day two examination. This was shown by the decreased distance between the skin surface and the femur. Ultrasonographically, the fracture site was healing satisfactorily.

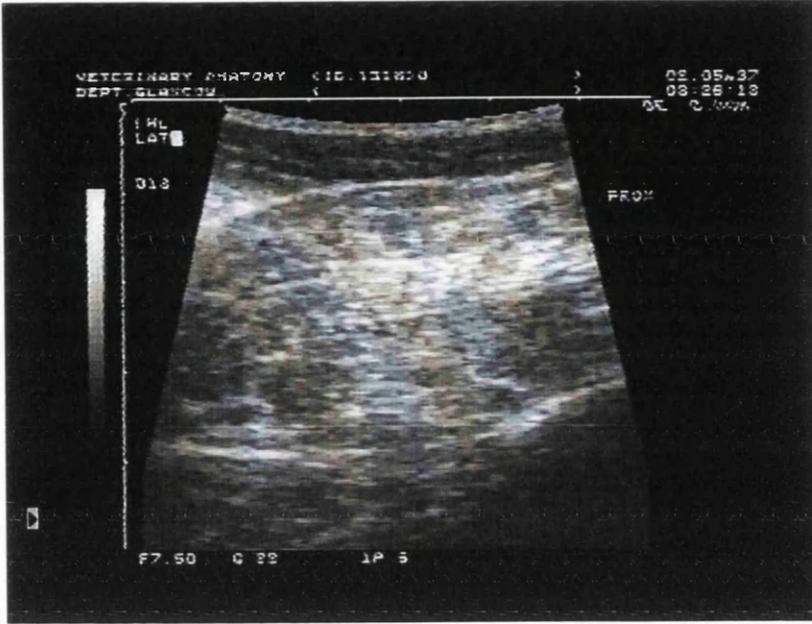
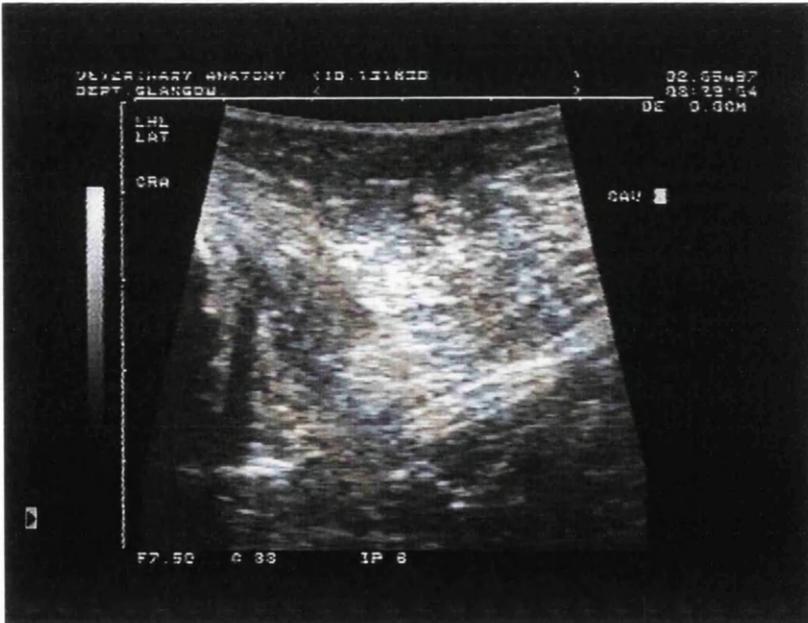
Figure 6.9.11 Ultrasonographic images of the muscle on day 45 after fracture repair demonstrate the previous area of muscle damage which has now returned to its normal muscle structure but has an hyperechoic appearance. **a**, longitudinal scan, **b**, transverse scan. The hyperechoic appearance is suggesting the presence of fibrous tissue within the muscle.

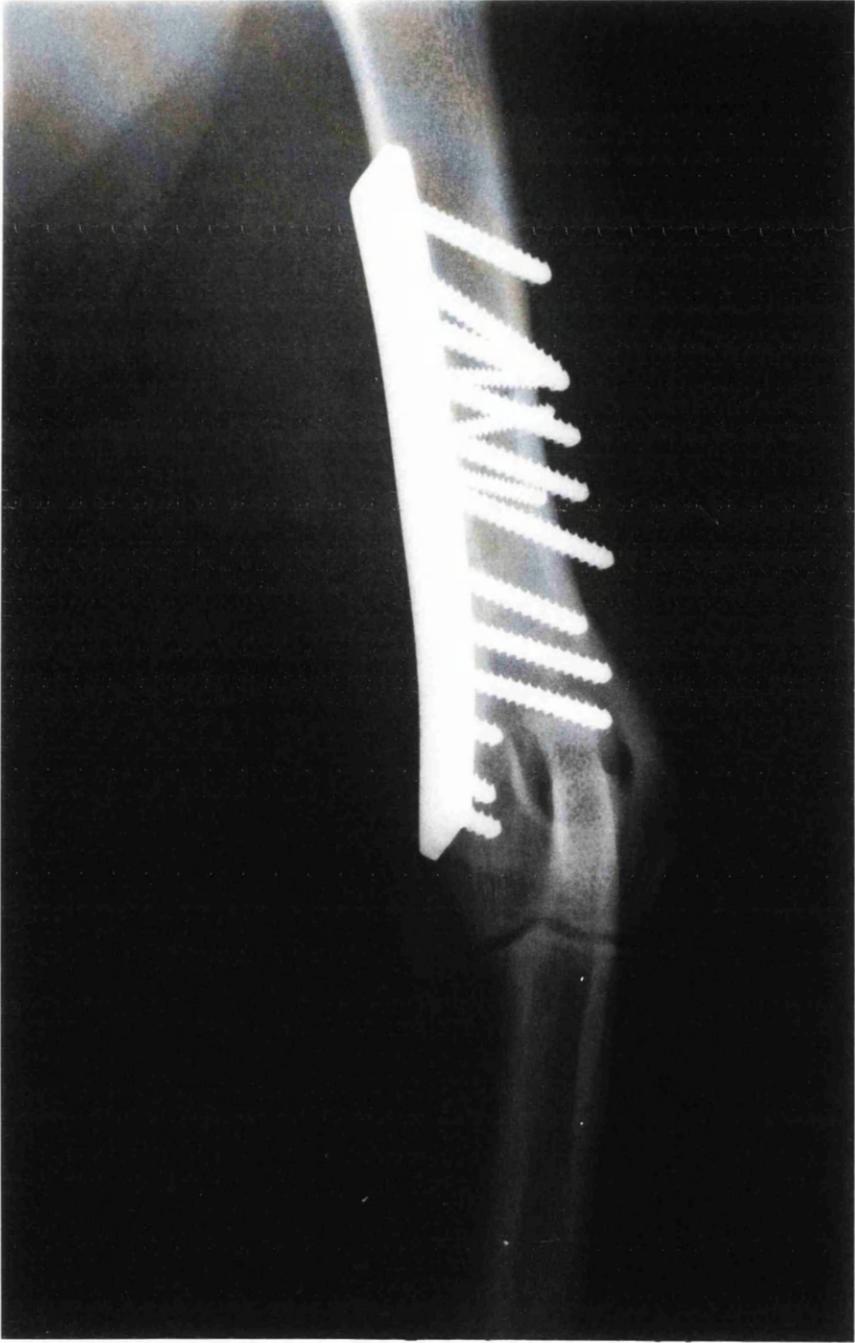
b

Figure 6.10.1 Radiographs obtained immediately after fracture repair demonstrate the fracture which has been reduced and immobilised with a plate and screws. **a**, lateral view, **b**, cranial view. The repair process has resulted in a good union and alignment of the fracture. There is no fracture gap present and the fracture line is hardly visible.

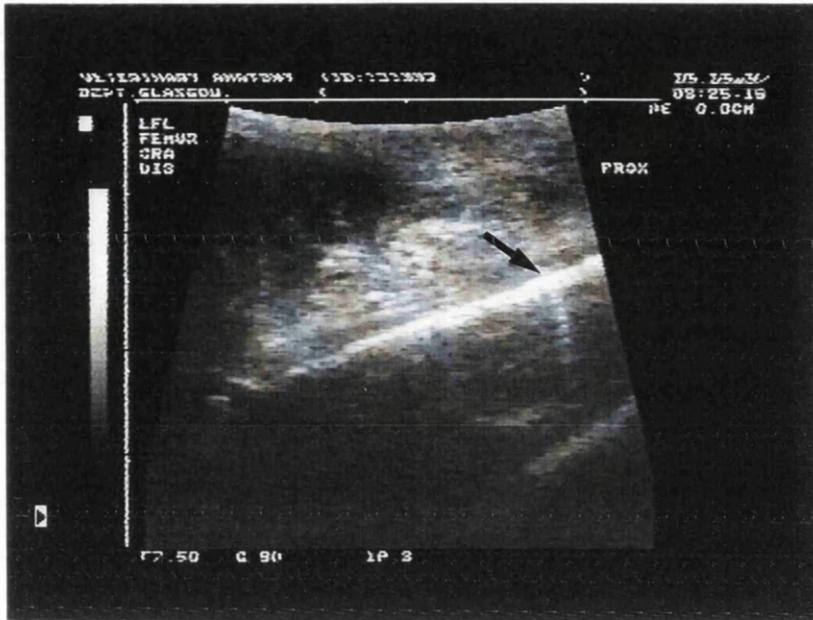
Figure 6.10.2 Longitudinal scan of the humerus from the cranial aspect on day three after fracture repair shows the fracture site which appears as a short hyperechoic vertical line across the humerus (arrow). The two fragments are well united and there is no obvious gap present. Note also an area of soft tissue reaction appearing disorganised and hyperechoic.

Ultrasonographic examination demonstrated the fracture site which appeared as a short hyperechoic vertical line on a longitudinal scan from the cranial aspect (figure 6.10.2). The two fragments were well united and there was no obvious gap present. A disorganised hyperechoic area imaged above the humerus suggested a soft tissue reaction. Soft tissue reactions were also found around the screws and appeared as disorganised hyperechoic structures (figure 6.10.3). The fracture site imaged from the caudo-lateral aspect appeared hyperechoic which suggested the presence of periosteal tissue reaction (figure 6.10.4). At this stage no callus formation could be detected at the fracture site. The area of soft tissue reaction imaged on a transverse scan appeared as a disorganised hyperechoic structure as previously seen on the longitudinal scan (figure 6.10.5). The fracture site was not clearly seen on a transverse scan but it could be recognised by the defective or abnormal appearance of the humerus.

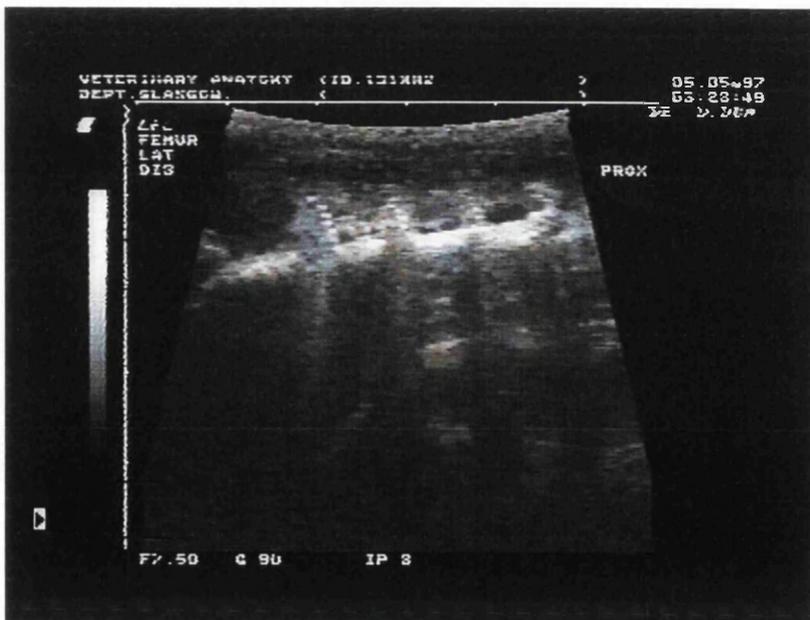
Figure 6.10.3 Longitudinal scan of the humerus from the lateral aspect on day three after fracture repair shows the soft tissue reaction around screws which appears disorganised and hyperechoic. The screws appear hyperechoic with comet tail artefacts.

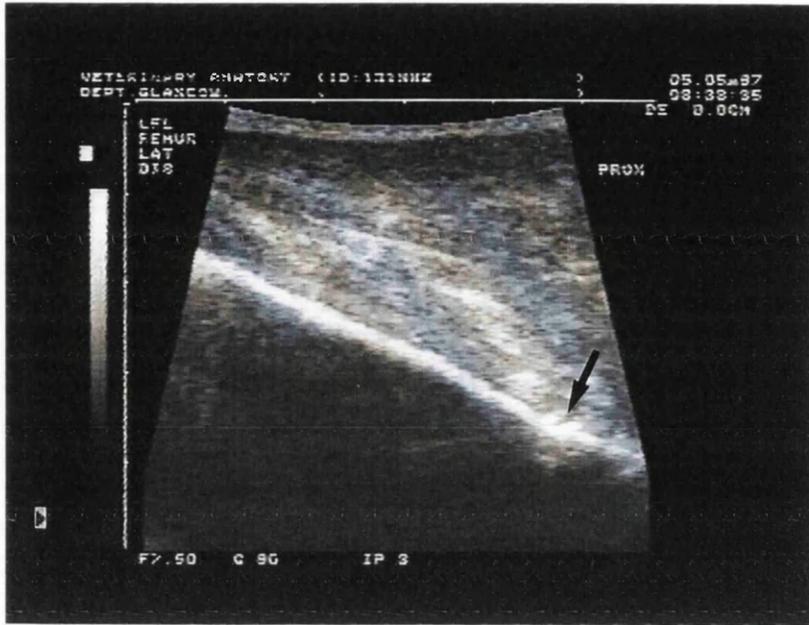
Figure 6.10.4 Longitudinal scan of the humerus from the caudo-lateral aspect on day three after fracture repair shows the fracture site (arrow) which appears hyperechoic suggesting the presence of periosteal tissue reaction. At this stage no callus formation can be detected at the fracture site.

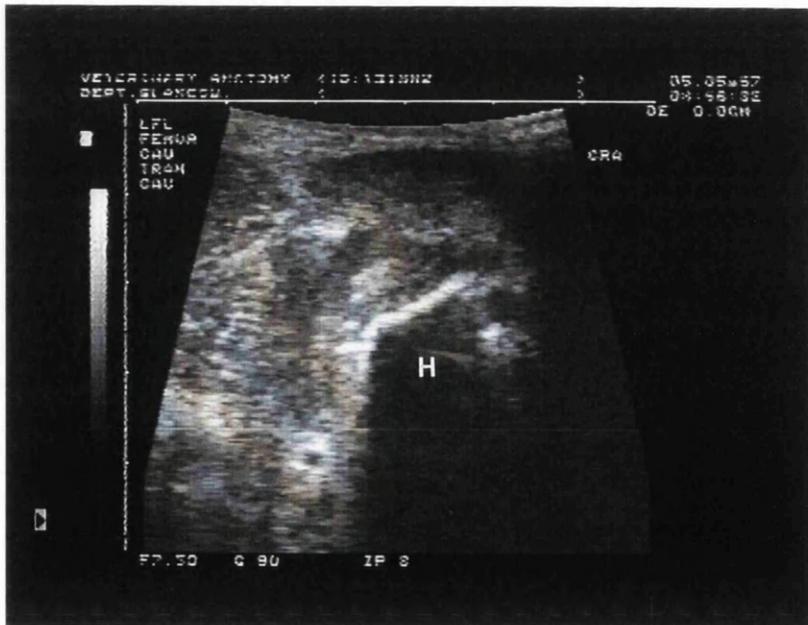
Figure 6.10.5 Transverse scan from the caudal aspect on day three after fracture repair shows the area of soft tissue reaction which appears as a disorganised hyperechoic structure. The fracture site is not clearly seen on a transverse scan but it can be recognised by the abnormal appearance of the humerus. **H**, humerus.

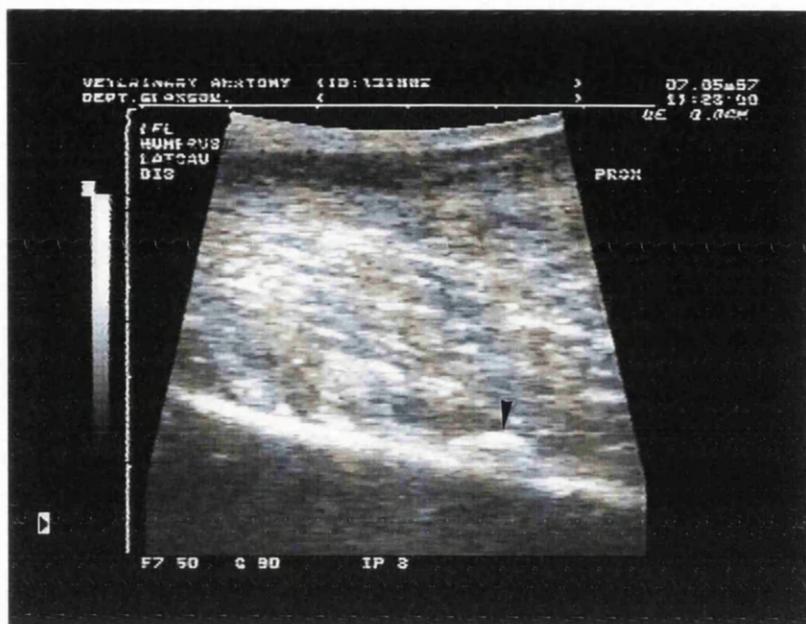
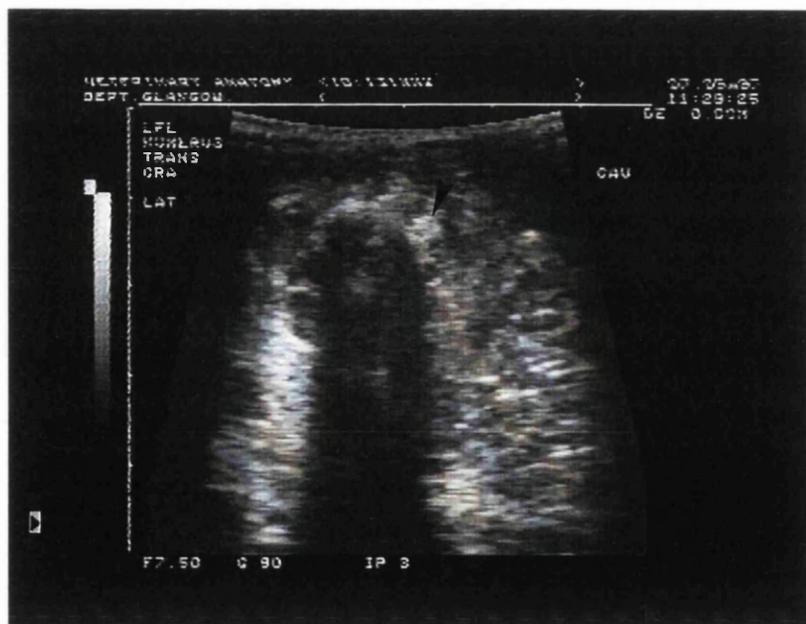
Figure 6.10.6 Ultrasonographic examination of the humerus on day five after fracture repair, **a**, longitudinal scan from the caudo-lateral aspect, **b**, transverse scan from the cranio-lateral aspect demonstrates soft callus formation (arrow head) which appears as hyperechoic material adhering to the periosteum at the fracture site area. The short hyperechoic vertical line at the fracture site as seen on the day three examination has disappeared. Note also that there is no shadow artefact produced by the soft callus.

Ultrasonographic examination demonstrated the humerus with some soft callus formation . The soft callus appeared as hyperechoic material adhering to the bone surface at the fracture site area (periosteum) (figure 6.10.6a and 6.10.6b). The short hyperechoic vertical line seen at the fracture site on the day three examination had disappeared. Soft callus formation was developing at the fracture site but produced no shadow artefact. The soft tissue reaction around the screws seen on the day three examination had become more distinct and appeared as disorganised hyperechoic structures (figure 6.10.7). An area of soft tissue reaction still appeared as a disorganised hyperechoic structure on the transverse scan as had been seen on the day three examination.

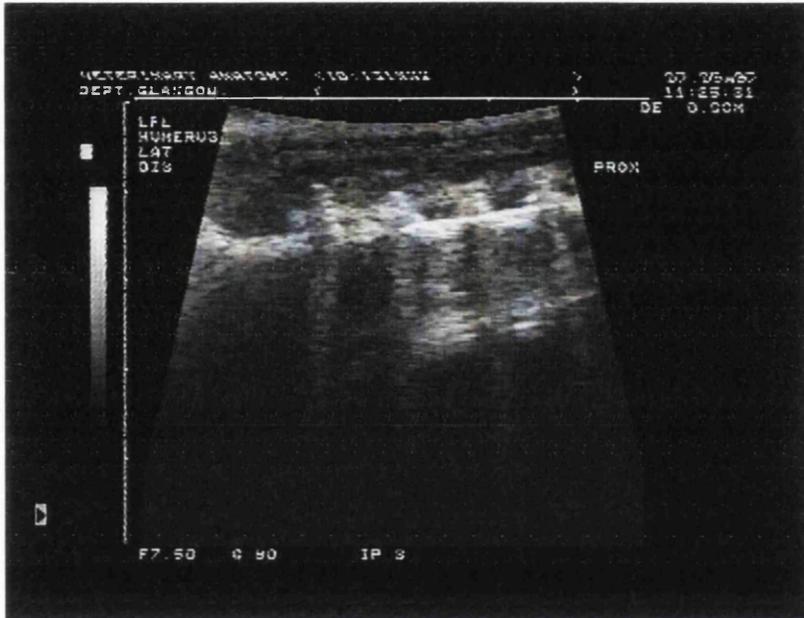
Figure 6.10.7 Longitudinal scan of the humerus from the lateral aspect on day five after fracture repair shows the soft tissue reaction around the screws appearing disorganised and hyperechoic.

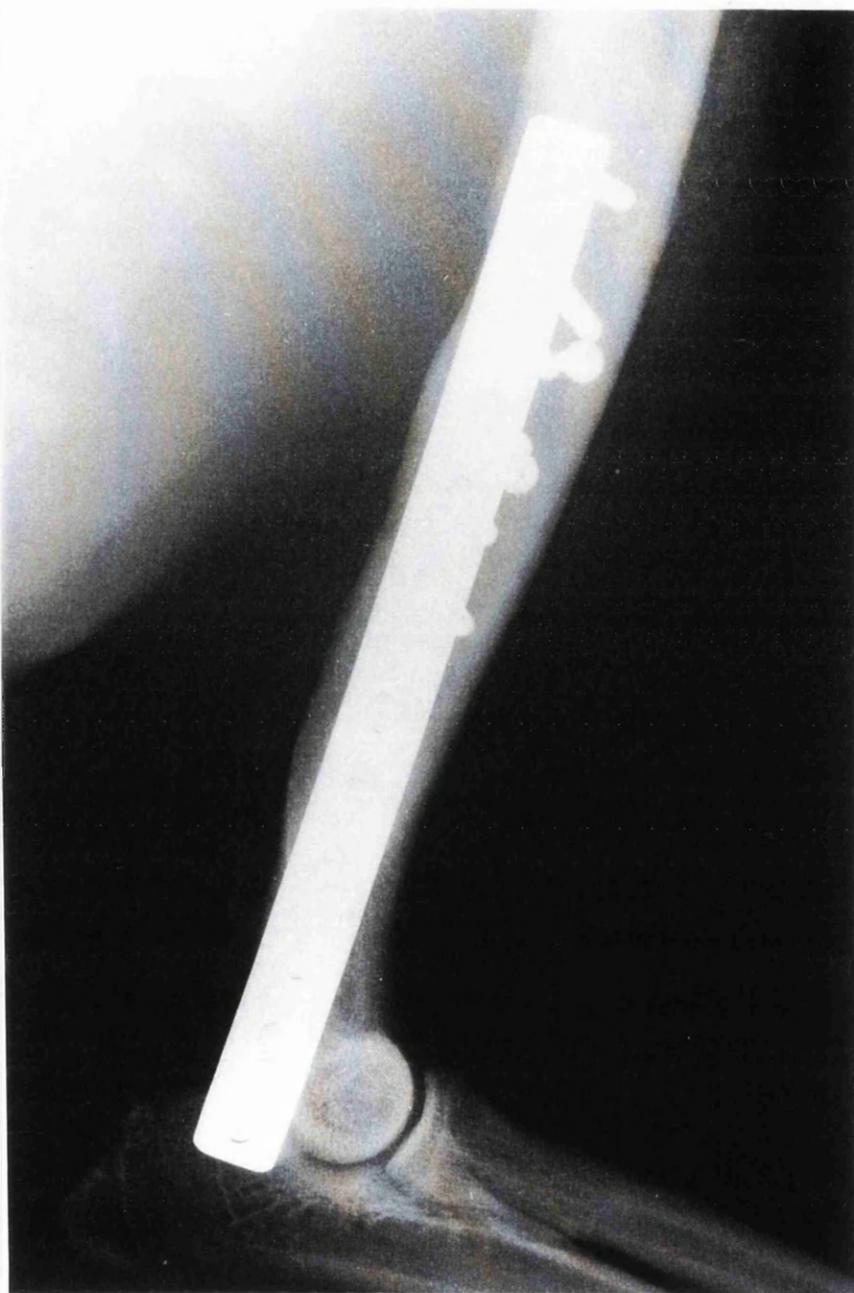
Figure 6.10.8 Radiograph taken on day 52 after fracture repair shows there is no more fracture line visible. The fracture site has been completely bridged by the mature callus which is remodelling. There is no evidence of lucency around the screws and the healing is excellent.

Radiographs taken on day 52 after fracture repair showed there was no fracture line visible. The fracture site had been bridged by the mature callus which was remodelling. There was no evidence of lucency around the screws and the healing process was good (figure 6.10.8).

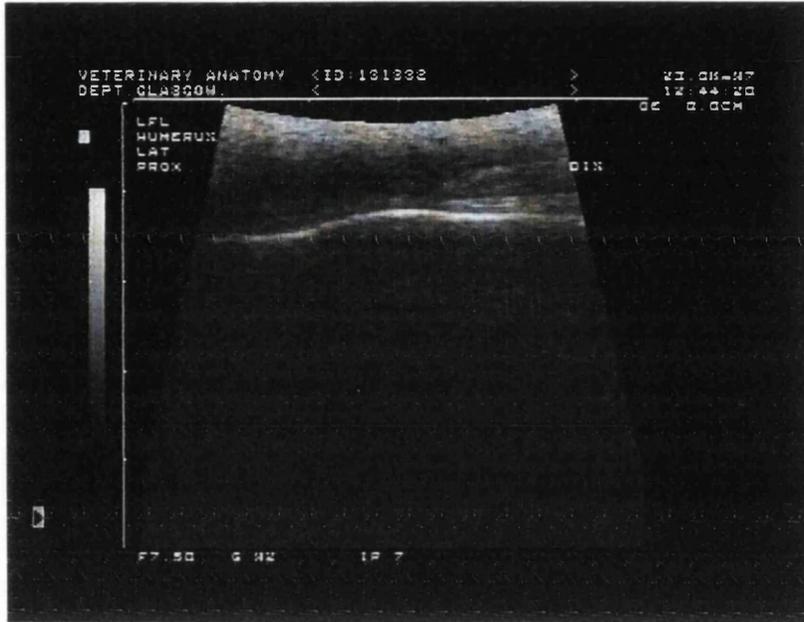
Figure 6.10.9 Longitudinal scan from the caudo-lateral aspect of the humerus on day 52 after fracture repair demonstrates the smooth, straight hyperechoic humerus with only a slight uneven bone surface which suggest that the bone is remodelling.

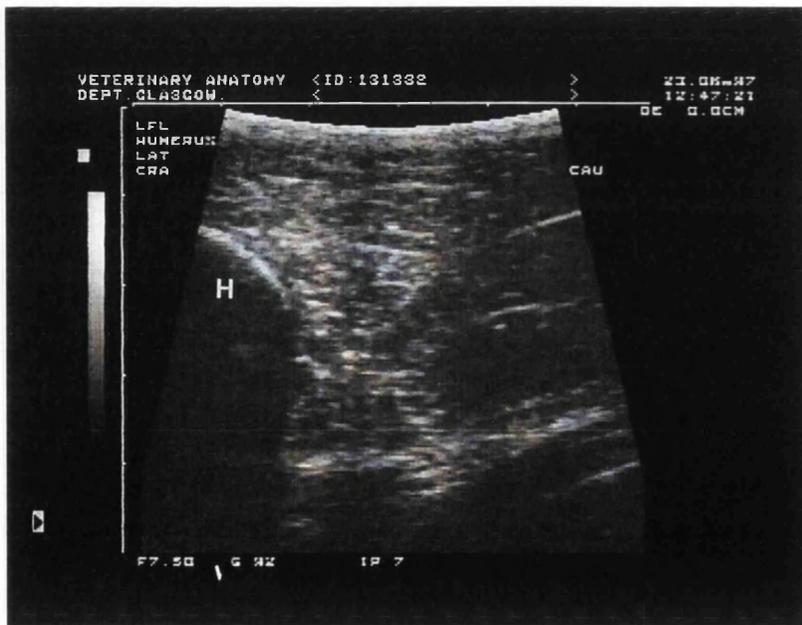
Figure 6.10.10 Transverse scan from the caudo-lateral aspect on day 52 after fracture repair shows the normal appearance of the muscle. There is no more soft tissue reaction found in the muscle. H humerus.

6.10.10). The size of the brachial muscle had reduced as shown by the decreased distance between the skin surface and the humerus. This was suggestive of muscle atrophy. Ultrasonographically, the healing process was good.

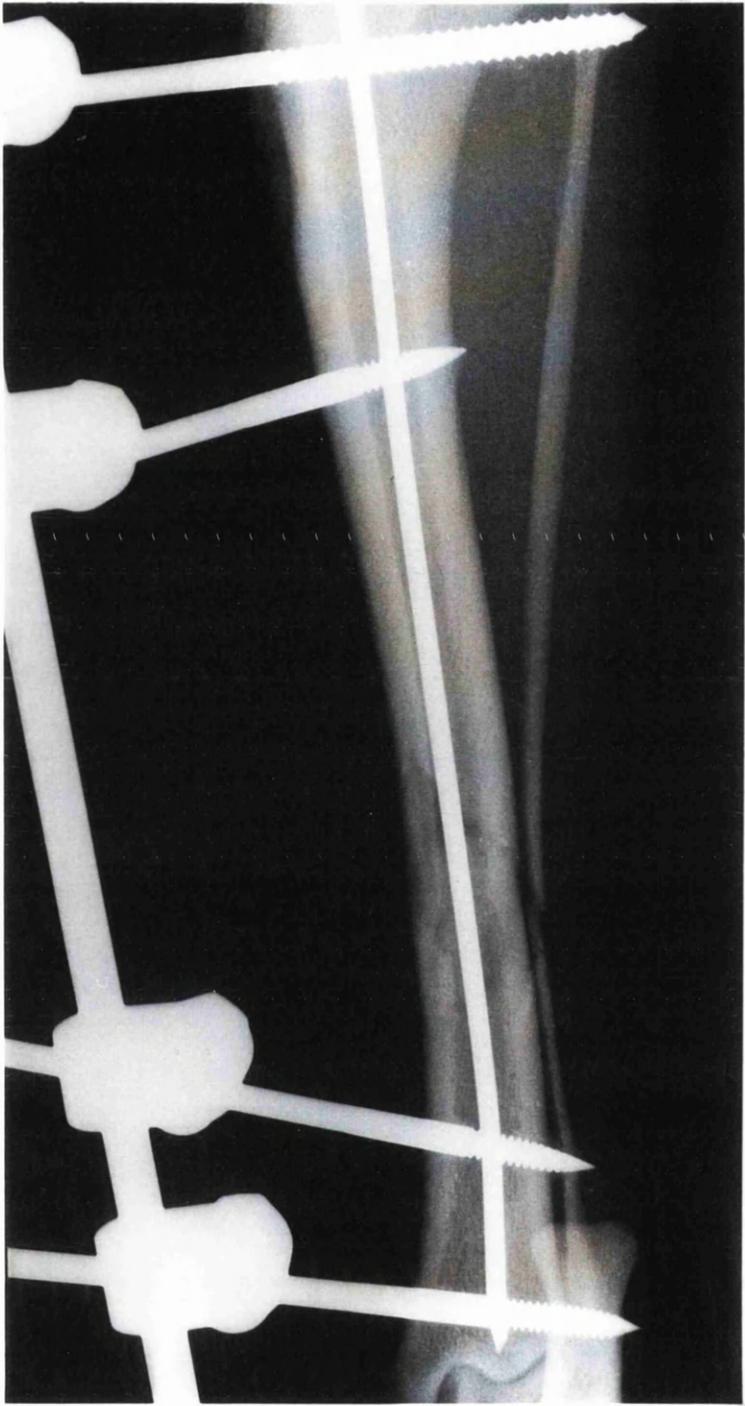
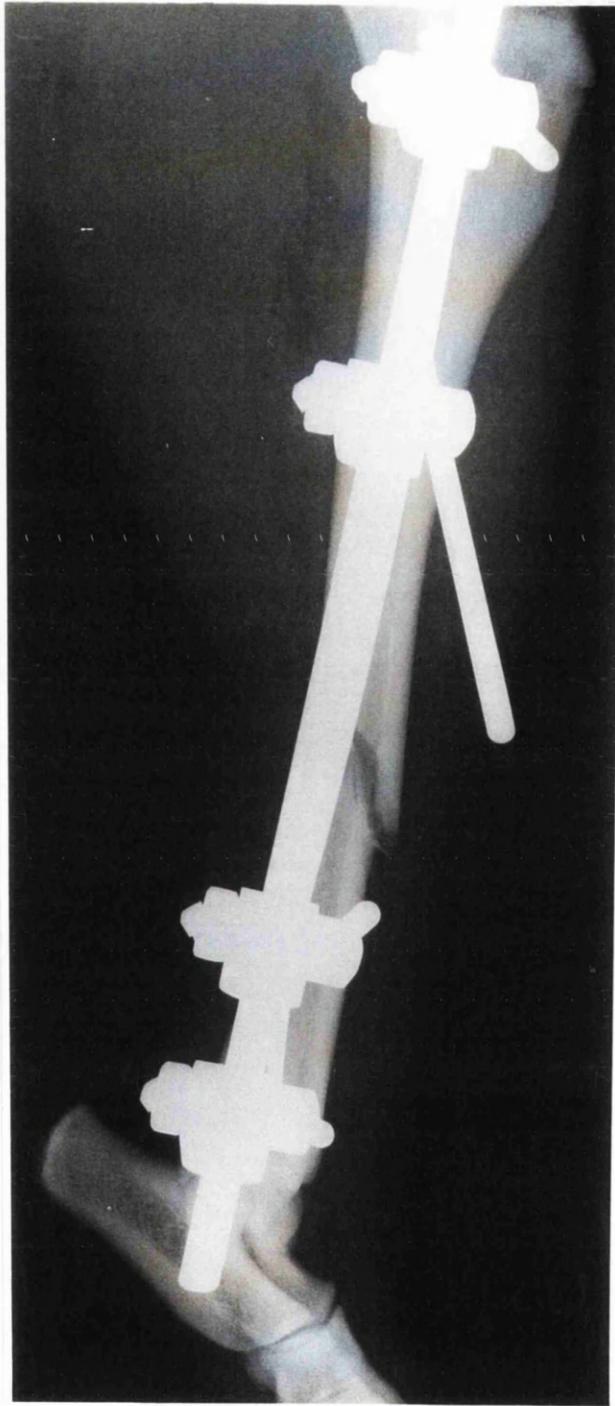
Figure 6.11.1 Radiographs taken immediately after fracture repair, **a**, cranial view, **b**, lateral view, show the tibial fracture which has been reduced and stabilised with an intramedullary pin and I/E fixator. The external fixator consists of two transfixing pins proximal to the fracture and two pins distal to the fracture. The fracture line is clearly visible. The repair process had resulted in good alignment.
