**AN ULTRASONOGRAPHIC STUDY OF MUSCULOSKELETAL
INJURIES AND MAMMARY GLAND TUMOUR IN SMALL
ANIMALS**

A thesis submitted to the Faculty of Veterinary Medicine,
University of Glasgow.

For the Degree of Doctor of Philosophy

Division of Veterinary Anatomy,
Department of Veterinary Preclinical Studies,
School of Veterinary Medicine,
University of Glasgow,
March, 1999

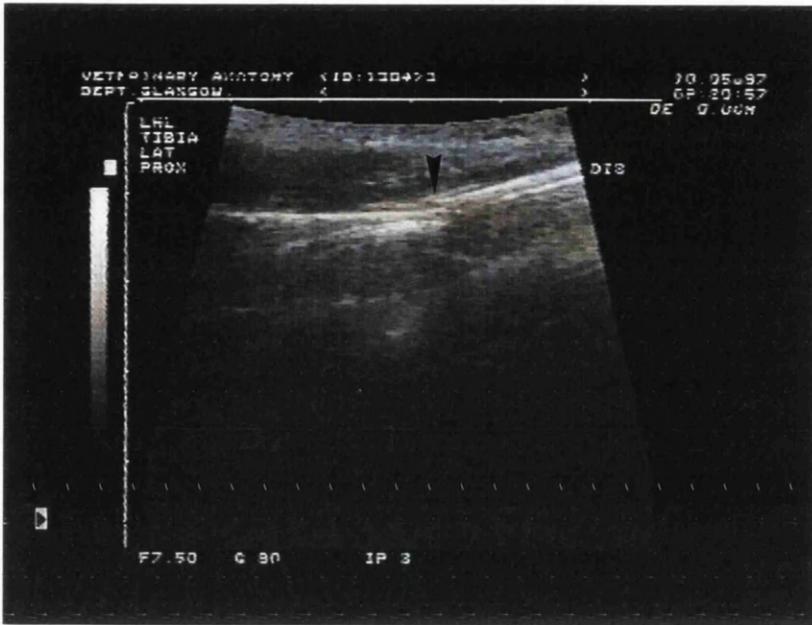
Figure 6.11.2 Longitudinal scan of the tibia from the lateral aspect on day three after fracture repair shows the fracture site (arrow head) which appears well aligned. There is a hyperechoic layer on the bone surface which indicates the presence of some periosteal tissue reaction.

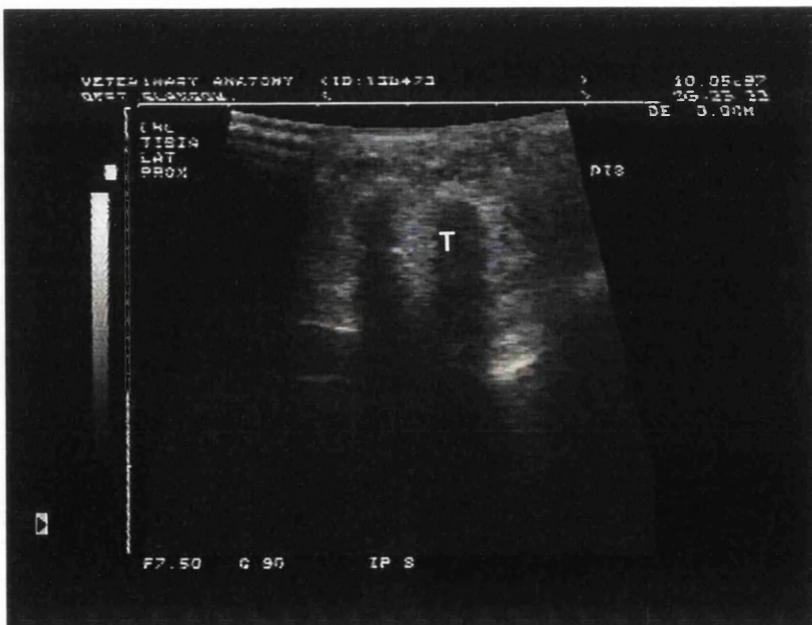
Figure 6.11.3 Transverse scan of the tibia from the lateral aspect on day three after fracture repair shows the tibia at the fracture site area with the presence of a gap. T, tibia.

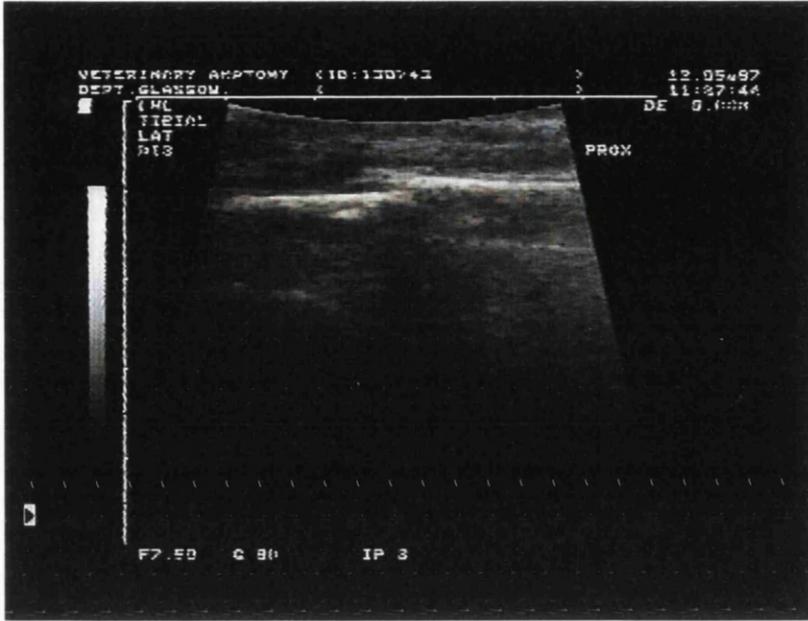
Figure 6.11.4 Longitudinal scan of the tibia from the lateral aspect on day five after fracture repair demonstrates the fracture site which appears as having the distal fragment overriding the proximal fragment. No callus formation is to be found.

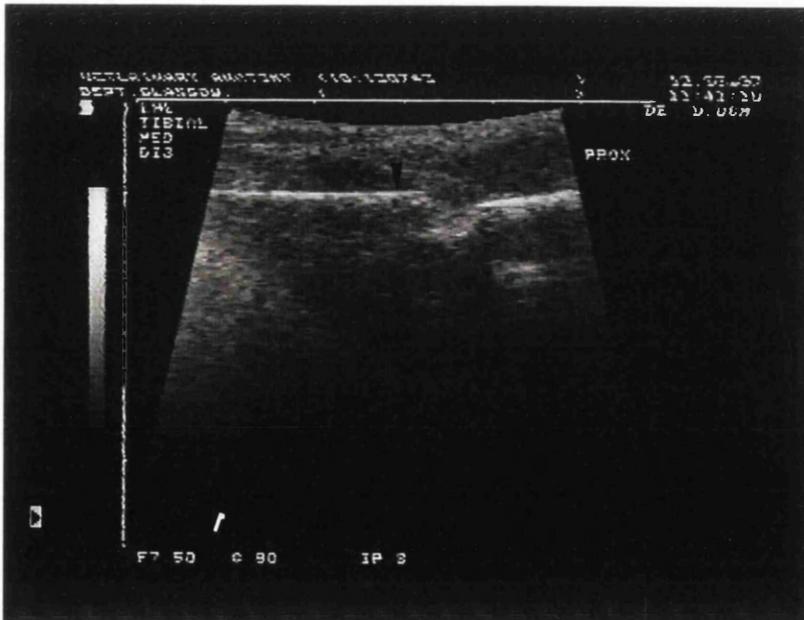
Figure 6.11.5 Longitudinal scan of the tibia from the medial aspect on day five after fracture repair shows the presence of fracture gap at the fracture site. The hyperechoic area of the fracture site suggests the present of periosteal tissue reaction. Note also that the distal fragment (arrow head) appears slightly elevated from the proximal fragment which is in agreement with the previous image.

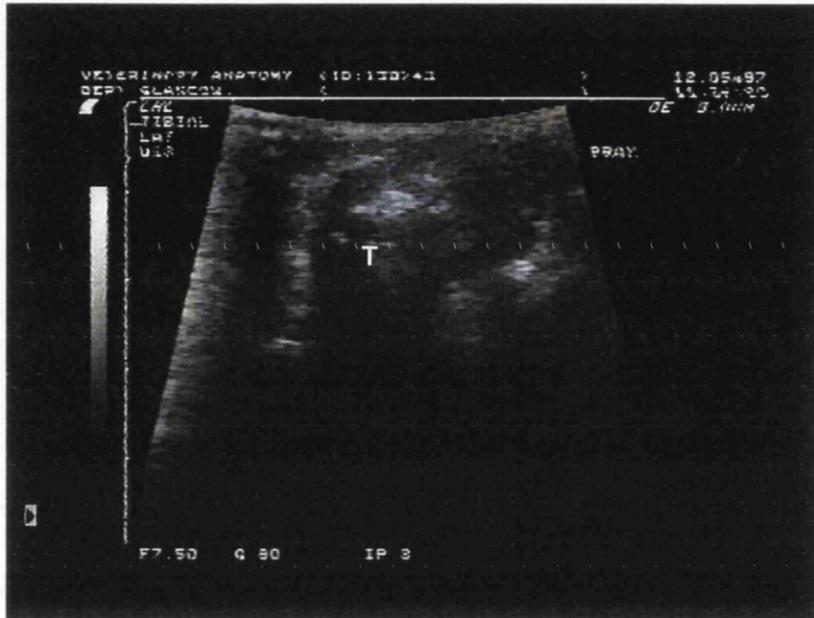
Figure 6.11.6 Transverse scan of the tibia from the lateral aspect on day five after fracture repair shows the fracture site with an hyperechoic appearance suggesting the periosteal tissue reaction. The fracture gap is still present. T, tibia.

Figure 6.11.6	Transverse scan of the tibia from the lateral aspect on day five after fracture repair shows the fracture site with an hyperechoic appearance suggesting periosteal tissue reaction (case 11).	346
Figure 6.11.7	Radiographs taken at day 56 after fracture repair show that the callus formation has completely bridged the fracture site (case 11).	347

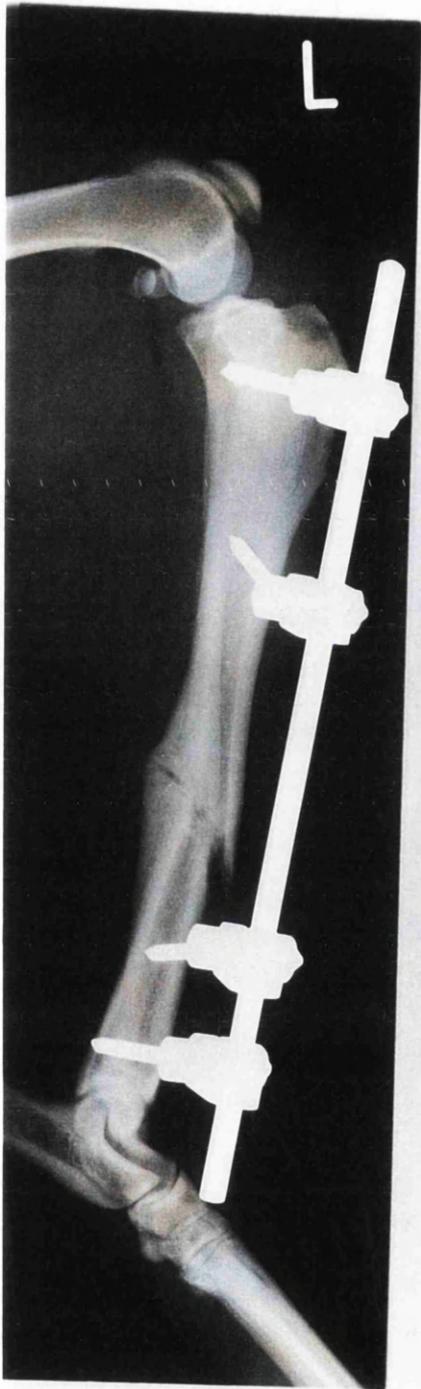
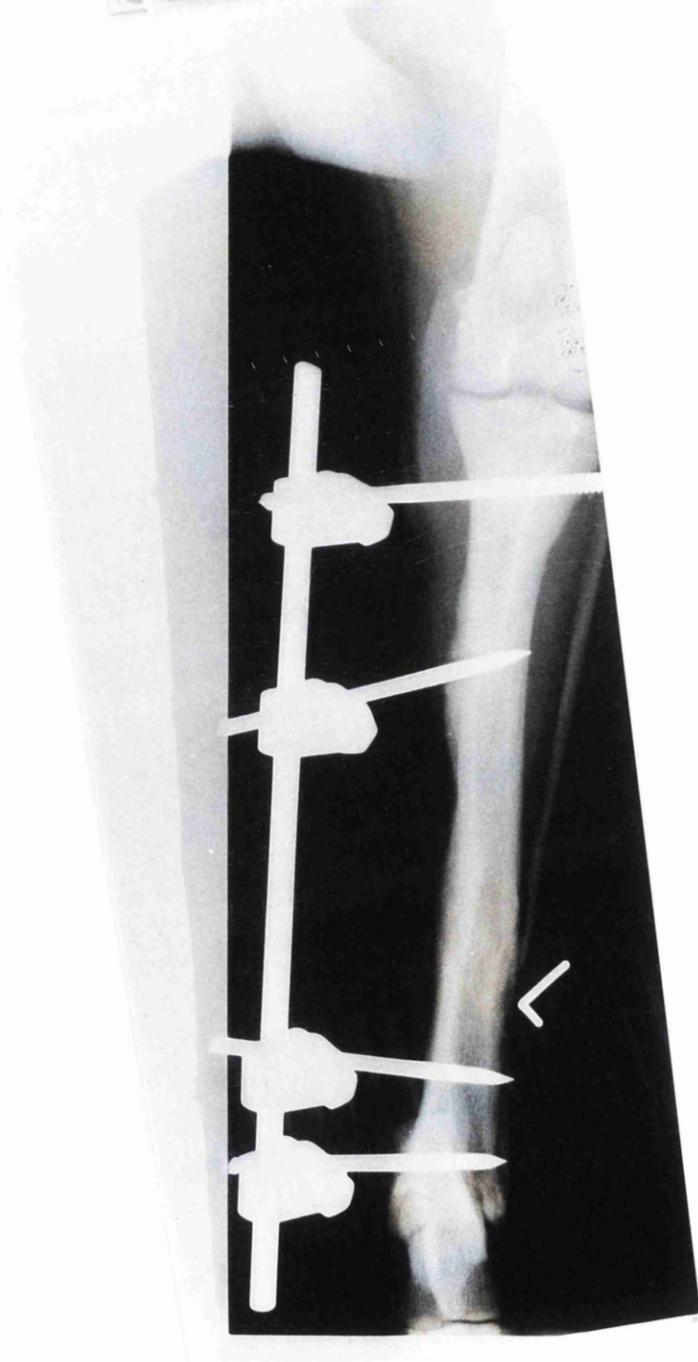
Figure 6.11.7 Radiographs taken at day 56 after fracture repair show that the callus formation has completely bridged the fracture site. **a**, lateral view, **b**, cranial view. The fracture line is much less evident at this stage (**a**). A slight curve of the shaft in a cranial direction is noted. Union of the fibula fracture is also evident.

Radiographs taken at day 56 after fracture repair showed that the callus formation had completely bridged the fracture site (figure 6.11.7). The fracture line was much less evident at this stage seen on a lateral view. A slight curve of the shaft in a cranial direction was noted. Union of the fibula fracture was also evident. The implant was removed at this time.

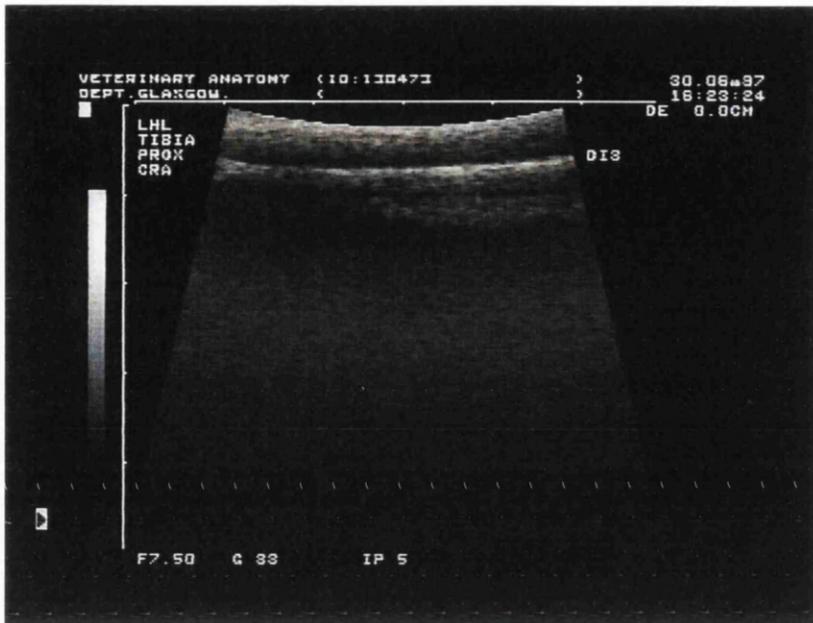
Figure 6.11.8a

Figure 6.11.8 Longitudinal scans of the tibia from the lateral aspect on day 56 after fracture repair (immediately after implant removal) demonstrate the tibia with a smooth hyperechoic appearance (**a**). There is no fracture site to be found during examination. The fracture site has been completely bridged by the mature callus and remodelled. One hole was found on the medial aspect of the tibia distally (**b**) and appears hyperechoic which suggest a soft tissue reaction. This hole is actually the site where the external fixator pin was placed before being removed.

Ultrasonographic examination immediately after the implant removal demonstrated the smooth hyperechoic appearance of the tibia (figure 6.11.8a). The fracture site had been completely bridged by the mature callus and remodelled. Thus, it was not found during examination. One hole was found on the bone surface distally and appeared hyperechoic which was believed to be due to soft tissue reaction (figure 6.11.8b). This hole was actually the site where the external fixator pin was placed before being removed. The tibia imaged on a longitudinal scan from the lateral aspect appeared slightly bent at the fracture site area (figure 6.11.9). A transverse scan from caudal aspect of the tibia showed the area of the fracture site with no gap present. Ultrasonographically, the healing process was satisfactory.

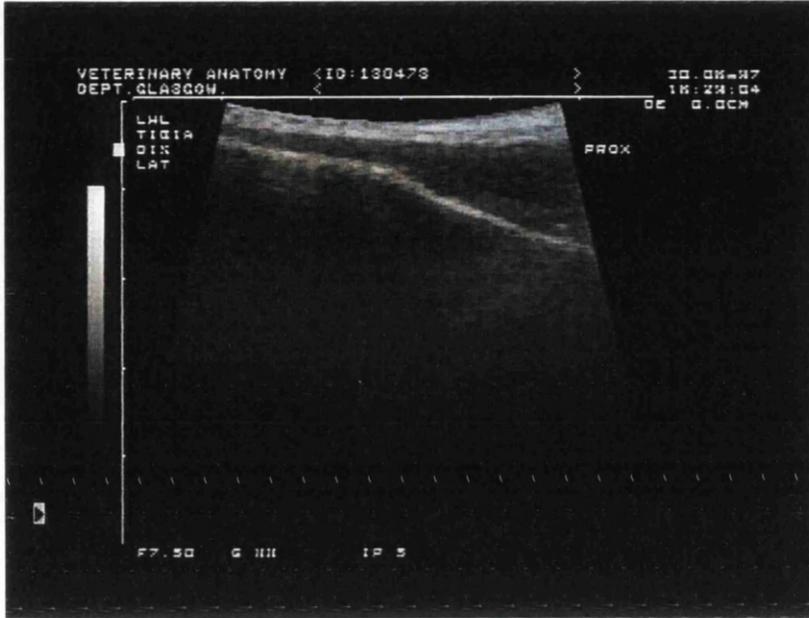
Figure 6.11.9 Longitudinal scan of the tibia from the caudal aspect on day 56 after fracture repair shows the tibia which appears slightly bent at the fracture site area.

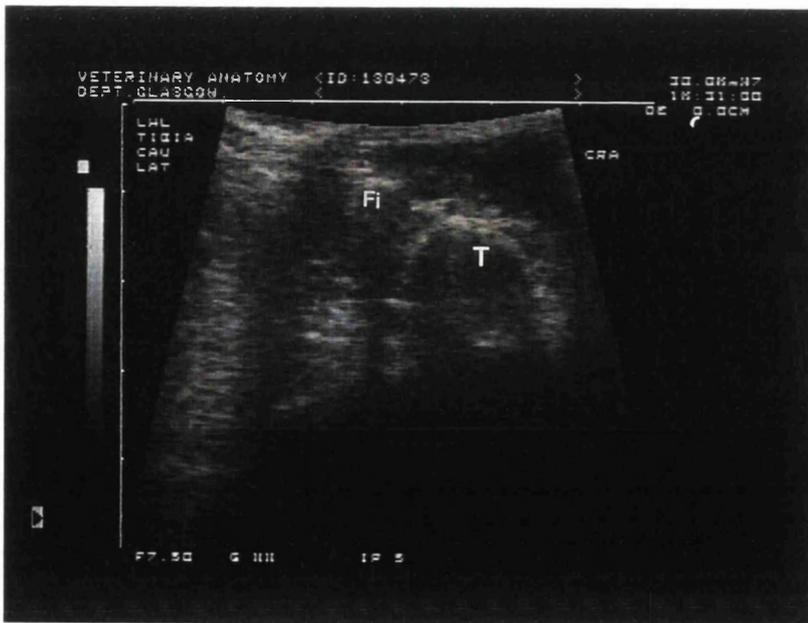
Figure 6.11.10 Transverse scan of the tibia from the caudal aspect on day 56 after fracture repair shows the tibia at the fracture site area. The fracture gap is no longer present. The tibia appears as a normal round hyperechoic structure. Note also that the fibula on lateral side of the tibia appears hyperechoic with acoustic shadowing artefact. T, tibia, Fi, fibula.

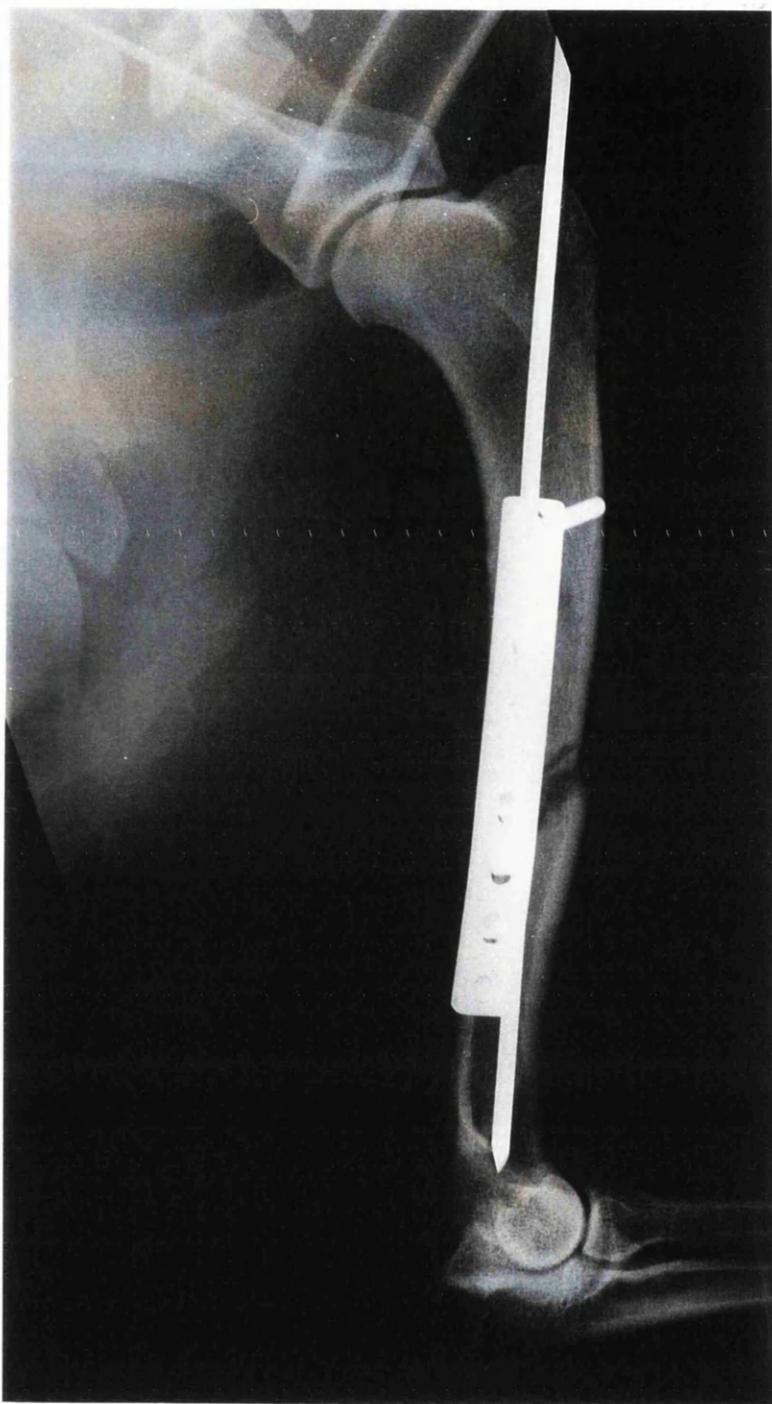
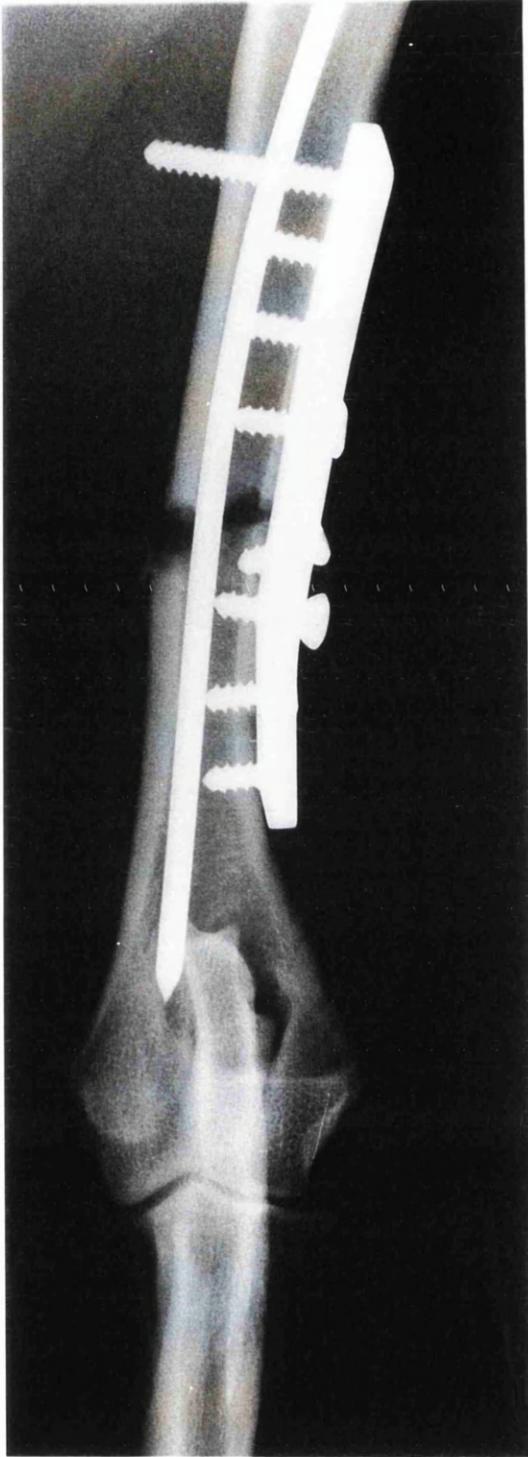
Figure 6.12.1 Radiographs obtained immediately after the fracture repair show the repair process resulting in a good alignment. **a**, lateral view, **b**, cranial view. The fracture is stabilised with an intramedullary pin plus an eight hole 2.7 mm plate applied to the lateral side of the humerus using monocortical screws. There is an open fracture gap medially.

A five year old female neutered Border Collie, weight 12.5 kg, was presented to the Glasgow University Veterinary Hospital with the complaint of left forelimb lameness after being kicked three days previously. Clinically, the animal had an obvious left forelimb lameness during examination and was holding the limb flexed. A fracture of the left humerus was palpable. Radiographs taken before repair showed that the dog had sustained a simple oblique fracture of the mid-shaft of the left humerus. Surgery was carried out and the fracture stabilised with a normograde intramedullary pin plus an eight hole 2.7 mm plate applied to the lateral side of the humerus using monocortical screws. Post-operation radiographs showed that the repair had resulted in a good alignment (figure 6.12.1). There was an open fracture gap medially.

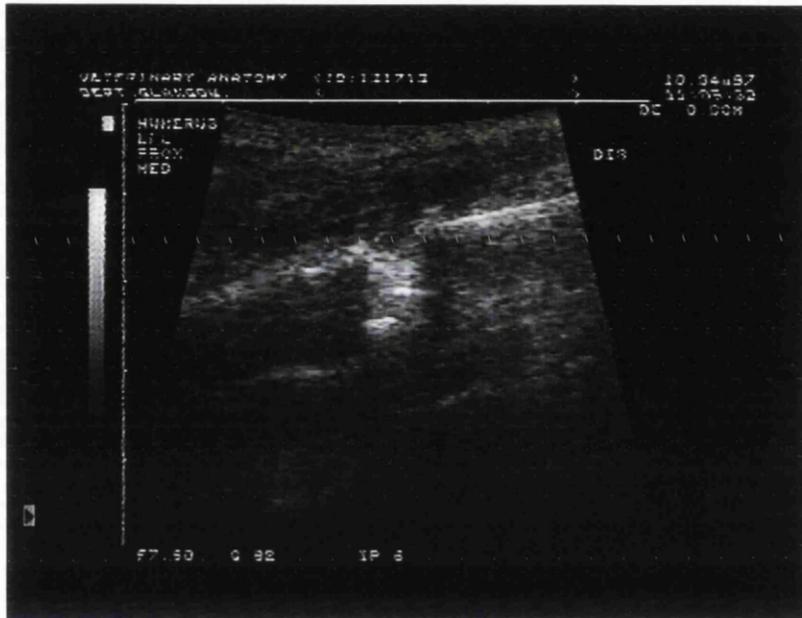
Figure 6.12.2 Longitudinal scan of the humerus from the medial aspect 48 hours after fracture repair demonstrates the fracture site which appears as discontinuity of the bone surface. There is a fracture gap present. The hyperechoic structure at the fracture site may indicate soft tissue reaction.

Ultrasonographic examination of the humerus scanned from the medial aspect demonstrated the fracture site which appeared as discontinuity of the bone surface with the presence of a fracture gap (figure 6.12.2). The hyperechoic structure at the fracture site suggested an area of soft tissue reaction. The fracture gap appeared smaller on the cranial side of the femur than on the medial side (figure 6.12.3a), and the gap was not shown on the caudal side of the femur (figure 6.12.3b). The distal fragment appeared slightly elevated from the proximal fragment on the caudal aspect scan. One screw was imaged some distance away from the fracture site with some periosteal tissue reaction at the screw base which appeared as hyperechoic material (figure 6.12.4). A transverse scan at the fracture site on the medial aspect showed the humeral bone surface with a space (fracture gap) and hyperechoic material which produced comet tail artefact (figure 6.12.5). The hyperechoic material was

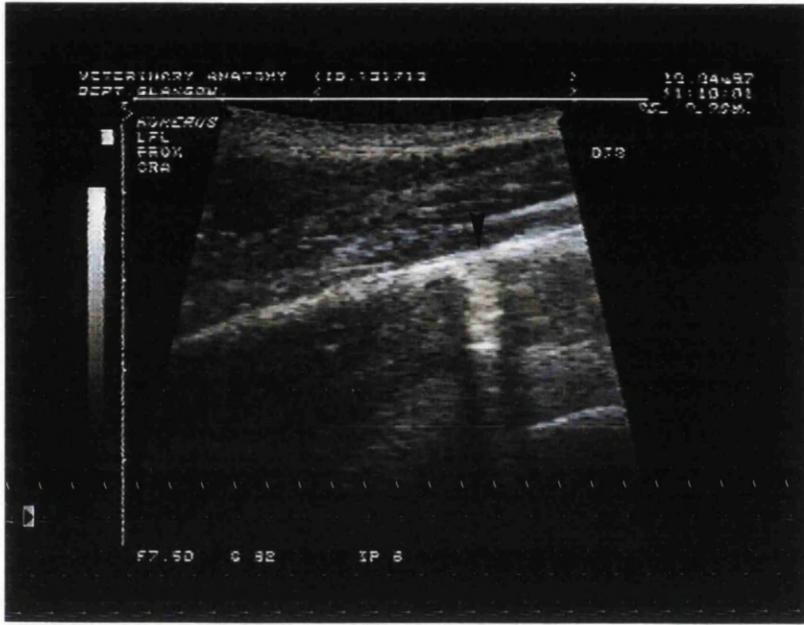
Figure 6.12.3a

Figure 6.12.3 Longitudinal images of the humerus from the cranial aspect 48 hours after fracture repair demonstrate the fracture site with a small gap (arrow head). **a**, cranial aspect, **b**, caudal aspect. The fracture gap on the cranial side of the humerus appears smaller than on the medial side, and there is no gap present on the caudal side of the femur. Note also that the proximal fragment (arrow head) appears slightly elevated from the proximal fragment on the caudal aspect scan (**b**).

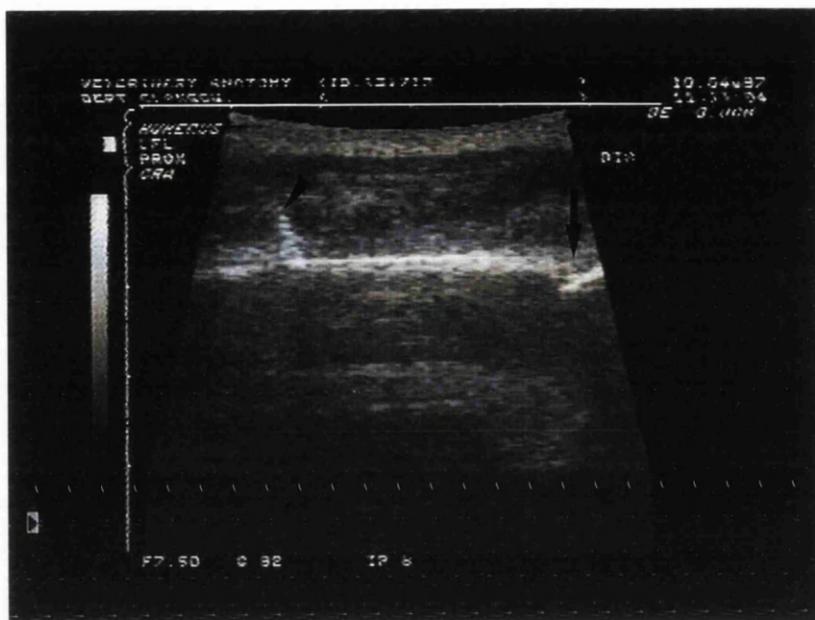
Figure 6.12.4 Longitudinal scan of the humerus from the medial aspect 48 hours after fracture repair shows a screw (arrow head) some distance away from the fracture site (arrow) with some periosteal reaction detected at the screw base appearing as hyperechoic material.

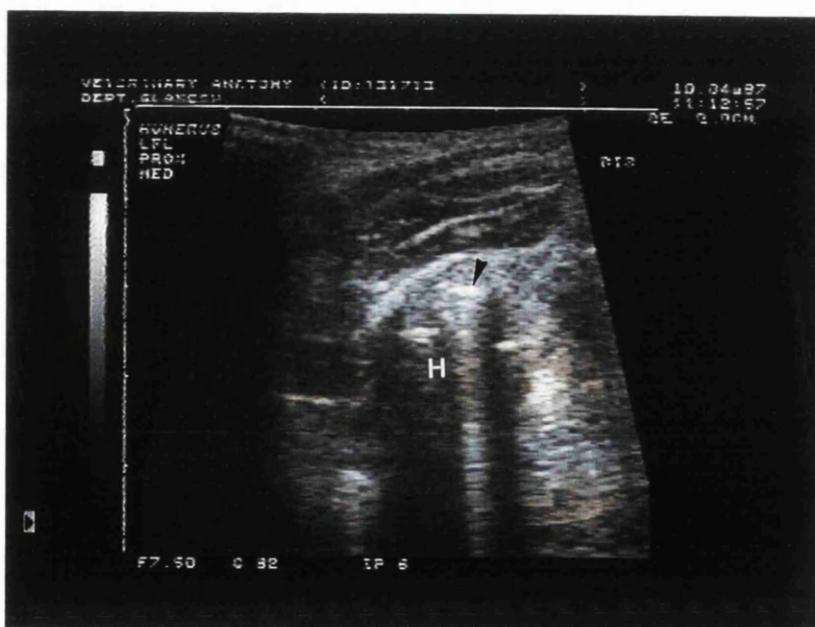
Figure 6.12.5 Transverse scan of the humerus from the medial aspect 48 hours after fracture repair shows the fracture site which appears hyperechoic suggesting a periosteal tissue reaction. The hyperechoic material (arrow head) with comet tail artefact is actually the intramedullary pin that was used in the fracture reduction. H, humerus.

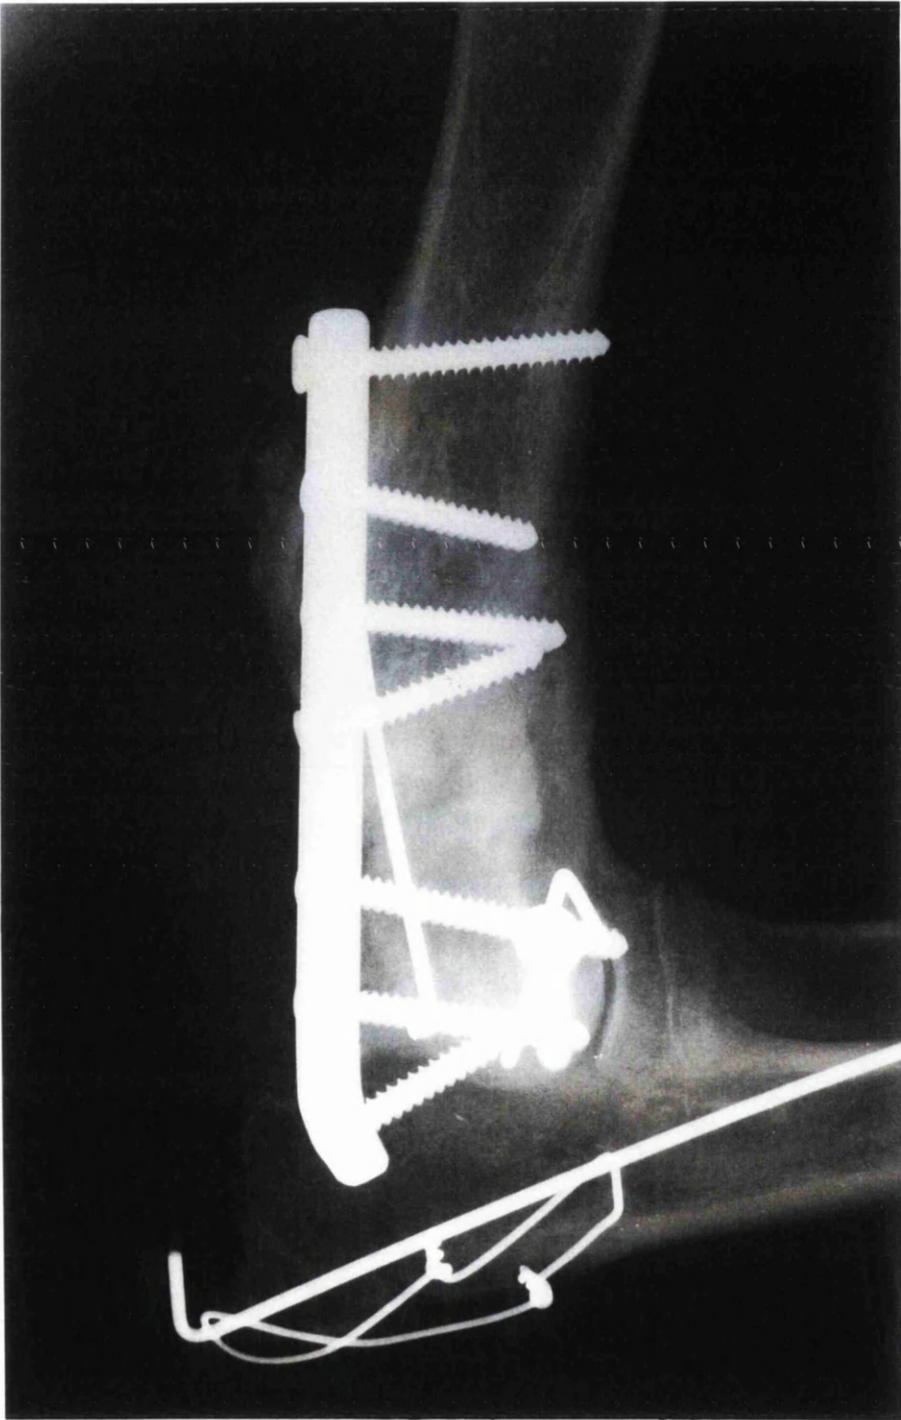
Figure 6.13.1 Radiographs obtained at day 32 after fracture repair demonstrate that the healing of the distal humerus fracture is progressing well with the presence of excessive callus formation.

An eight month old male Mastiff Neopolitan, weight 35 kg, was presented to the Glasgow University Veterinary Hospital with the suspicion of having an humeral fracture after it had been involved in a road traffic accident. Clinical and radiographic examination revealed that a Y-shape fracture of the right distal humerus had been sustained. The fracture was repaired using a transolecranon approach by a combination of lag screw, Kirschner wires and a 7 hole 3.5 mm Dynamic Compression Plate (DCP). The limb had been bandaged for 10 - 14 days. The dog was on a routine course of antibiotics and pain killers. Unfortunately, this dog also had a lateral luxation of the left patella as a consequential finding. This caused a definite clinical problem as it made it difficult for the dog to stand and ambulate since it was unable to bear weight at all on the right foreleg. Since the humerus was bandaged with Plaster of Paris (POP) after the surgery the post-operation ultrasonographic examination could not be carried out because the ultrasound beam could not penetrate the bandaging material. The animal came for an assessment approximately one month later. On examination the animal was non-ambulatory without support due to a complicating left hind limb lateral patella luxation. The right elbow had a very limited range of motion and showed marked thickening. Radiographic examination showed good progression of the fracture healing (figure 6.13.1).

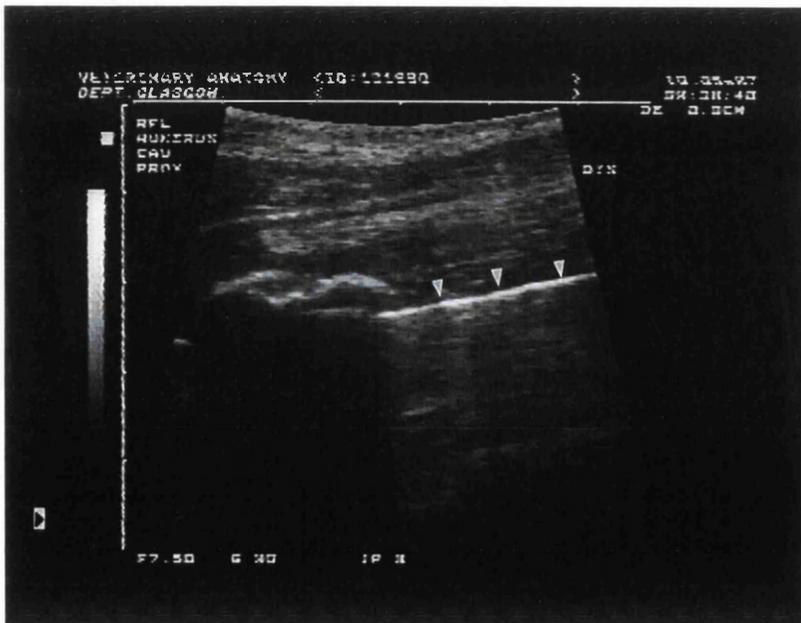
Figure 6.13.3 The bone plate adhering to the distal humerus appears as an hyperechoic straight line (arrow heads). The shadow appearing on the image is due to the hair on the skin.

Ultrasonographic examination of the fracture site area demonstrated the rough and uneven bone surface due to excessive callus formation (figure 6.13.2). The muscle structure appeared to have a normal ultrasonographic appearance. The fracture site was not detected which suggested that it had already been bridged by the bony callus. The bone plate adhering to the bone appeared as hyperechoic straight lines (figure 6.13.3).

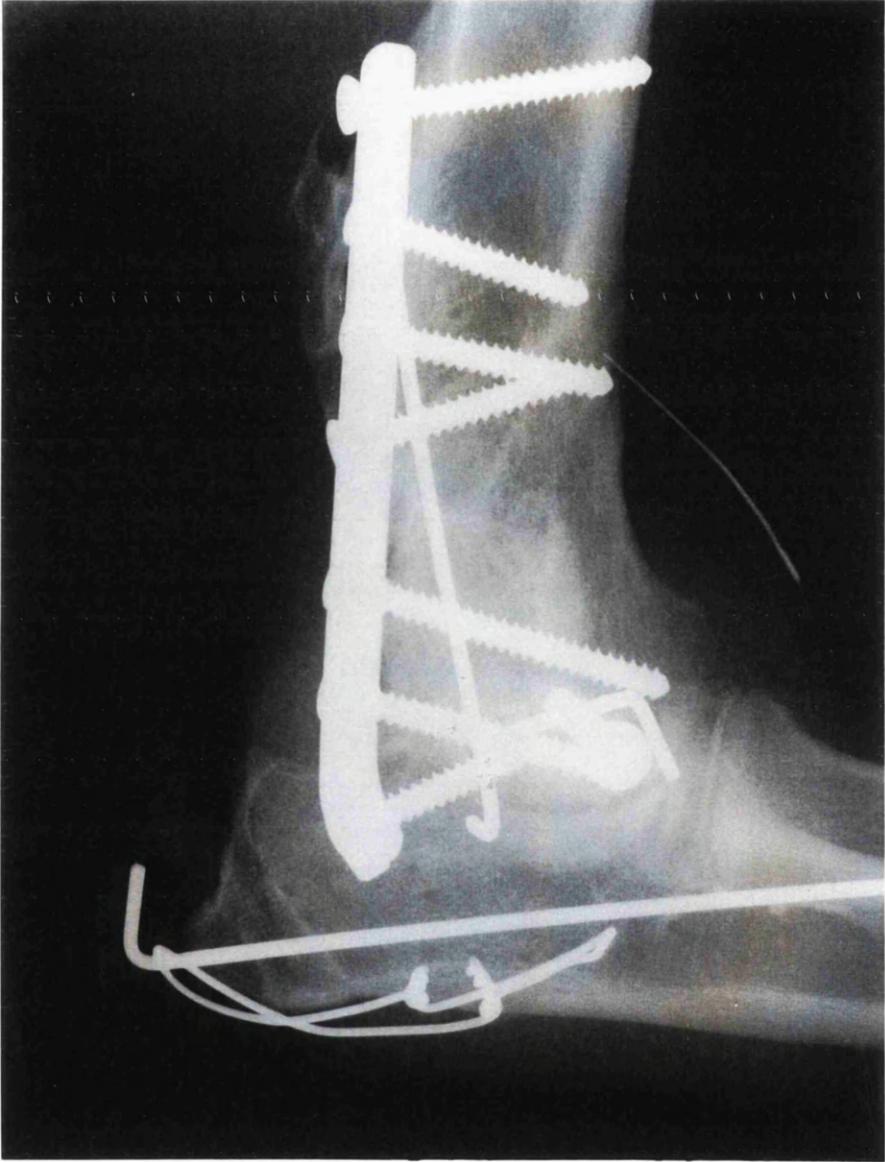
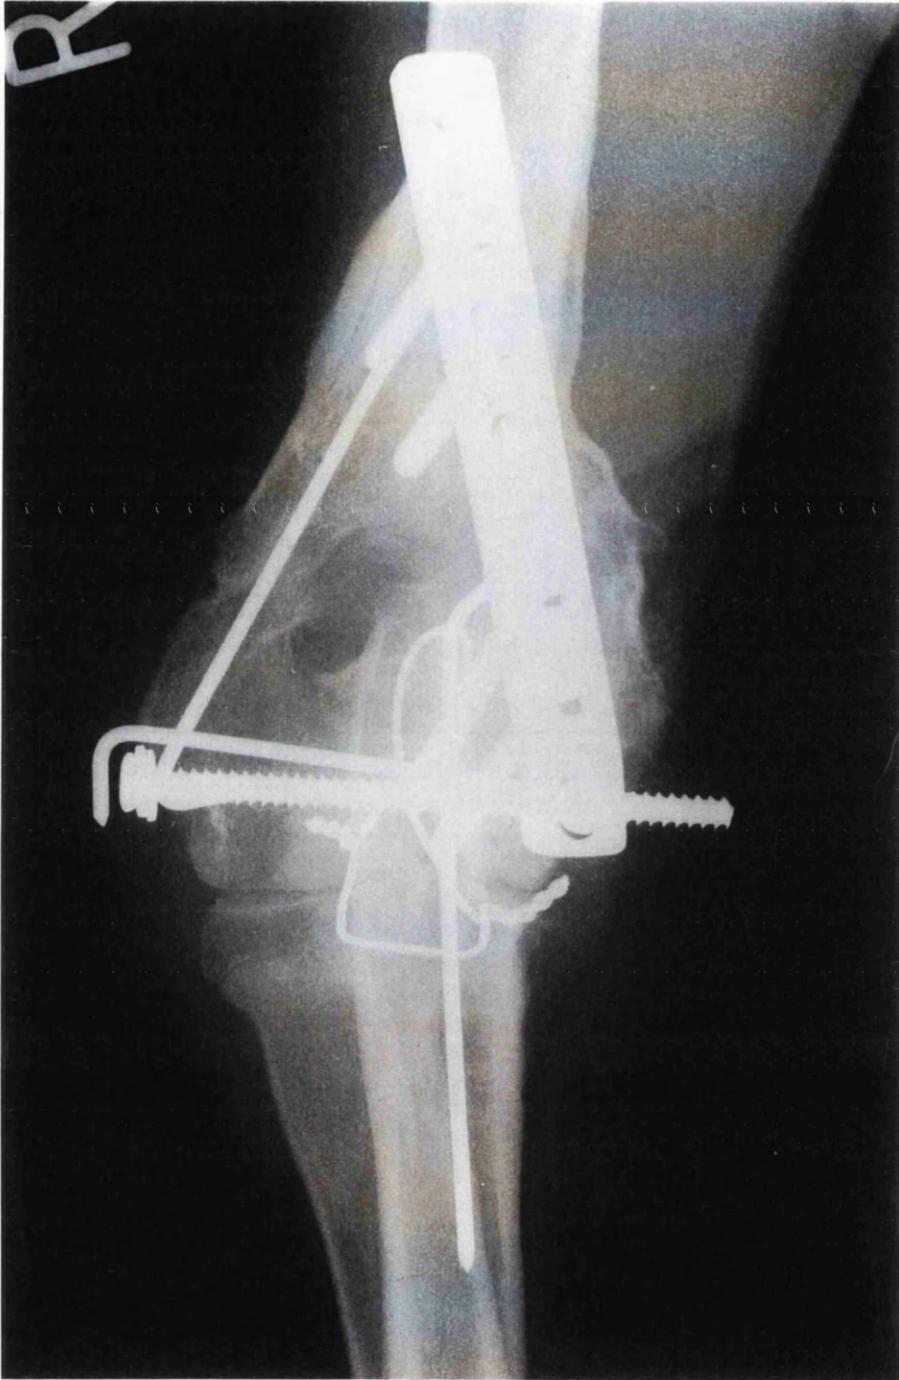
Figure 6.13.4 Radiographs obtained on day 61 after fracture repair show the proliferative callus has bridged the fracture site at the distal humerus. A minimal amount of lucency is noted under the distal part of the plate and around the second most distal screw. Fracture lines are no longer visible. **a**, lateral view, **b**, cranial view.

Radiographic examination on day 61 after fracture repair showed the proliferative callus had bridged the fracture site in the distal humerus. A minimal amount of lucency was noted under the distal part of the plate and around the second most distal screw. Fracture lines were no longer visible (figure 6.13.4).

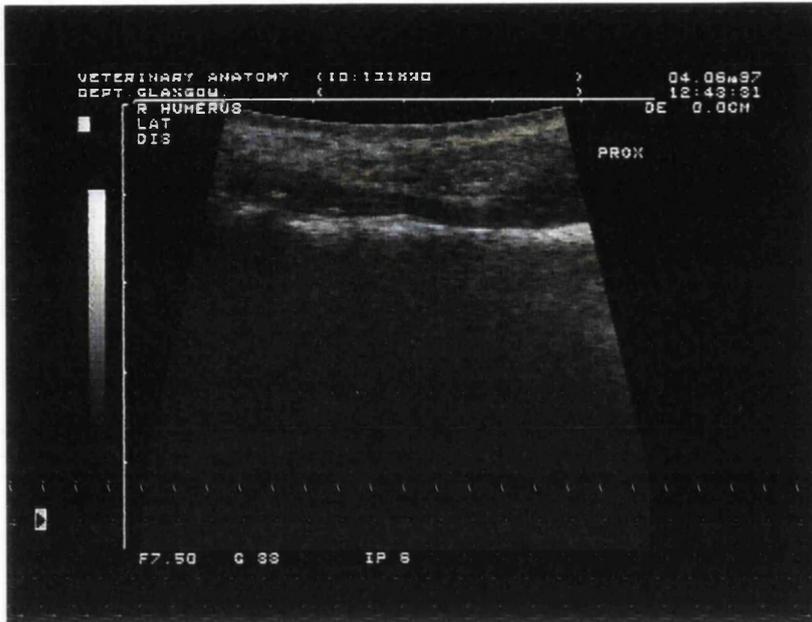
Figure 6.13.5a

Figure 6.13.5 Longitudinal scans of the distal humerus at the fracture site area on day 63 after fracture repair demonstrate the smooth bone surface. **a**, lateral aspect, **b**, cranial aspect, and **c**, caudal aspect. The smooth appearance of the bone surface compared to the scan of 36 days is suggestive of a successful remodelling process.

Ultrasonographic examination on day 63 after fracture repair demonstrated the humeral surface which appeared smooth on lateral, cranial and medial scans (figure 6.13.5a, 6.13.5b and 6.13.5c). The smooth appearance of the bone surface compared to the day 38, was suggestive of a successful remodelling process. However, on the caudal aspect scan of the fracture site area, the callus formation could still be seen appearing as an hyperechoic, uneven rough bone surface (figure 6.13.6). The bone plate was imaged from the caudal aspect and appeared hyperechoic with reverberation artefact. The disorganised hyperechoic structure area of muscle suggested an area of muscle damage.

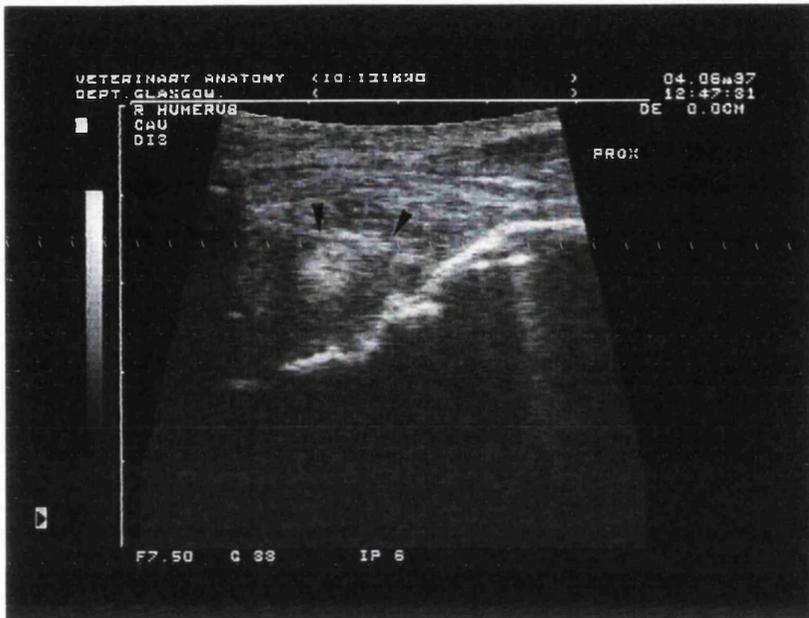
Figure 6.13.6 Longitudinal scan of the fracture site area from the caudal aspect on day 63 after fracture repair shows the callus which appears as an hyperechoic, uneven and rough bone surface. The disorganised hyperechoic structure area of muscle (arrow heads) may suggest an area of muscle damage.

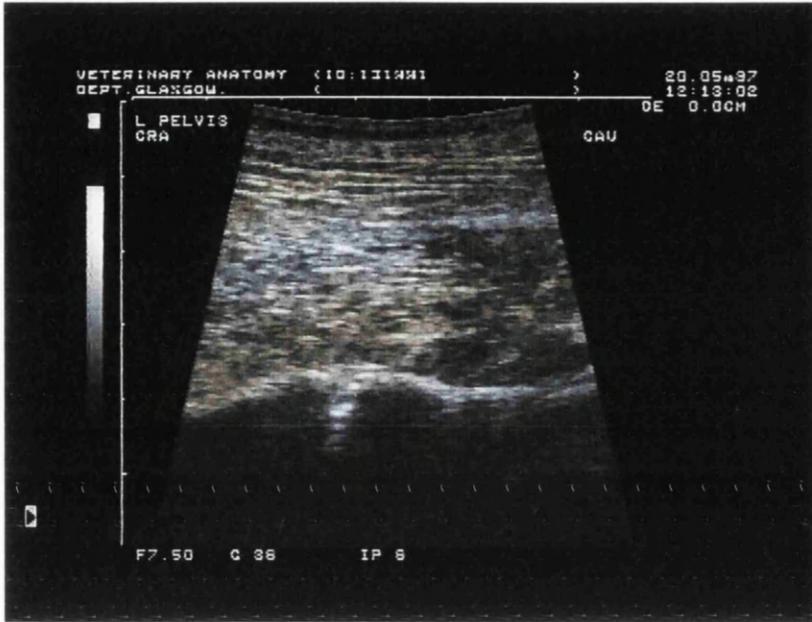
Figure 6.14.1 Longitudinal scan of the shaft of the ilium from the dorsal aspect on day four after fracture repair demonstrates the fracture site with the presence of a fracture gap. Note that the fracture site appears hyperechoic suggesting the presence of periosteal tissue reaction. The area of muscle damage above the ilium appear as a disorganised hypoechoic structure relative to the surrounding area.

Ultrasonographic examination of the pelvis demonstrated the fracture site which appeared as discontinuity of the bone of the ilial body (figure 6.14.1). The fracture gap was clearly seen. The fracture site appeared hyperechoic suggesting the presence of periosteal tissue reaction. The area of muscle damage above the ilium appeared as a disorganised hypoechoic structure relative to the surrounding region. The bone plate adhering to the ilium, scanned longitudinally, appeared as an hyperechoic straight line with reverberation artefact (figure 6.14.2). The fracture site appeared as discontinuity of the shaft of the ilium on a transverse scan image (figure 6.14.3). The area of muscle damage imaged on a transverse scan appeared as a disorganised hypoechoic area similar to that seen on the longitudinal scan.

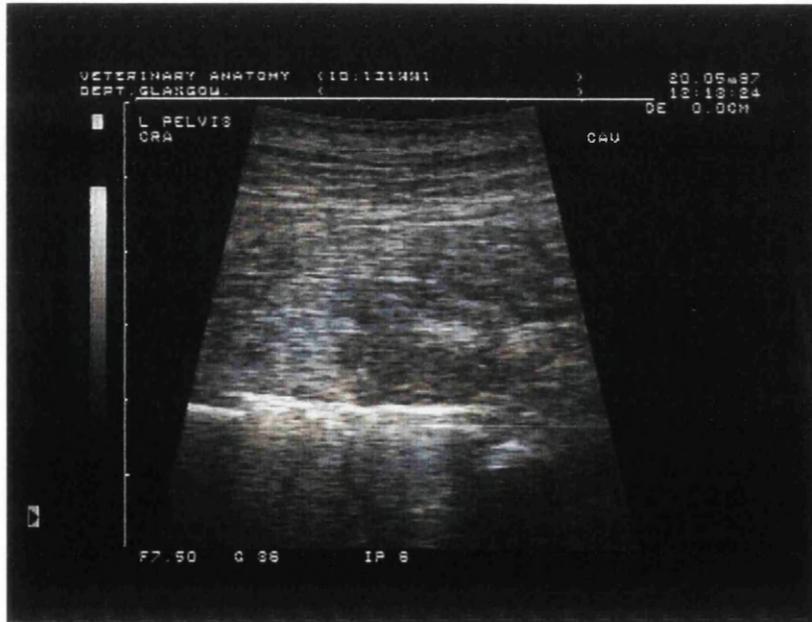
Figure 6.14.2 Longitudinal scan of the ilium on day four after fracture repair shows the bone plate which appears as an hyperechoic straight line and produces reverberation artefact.

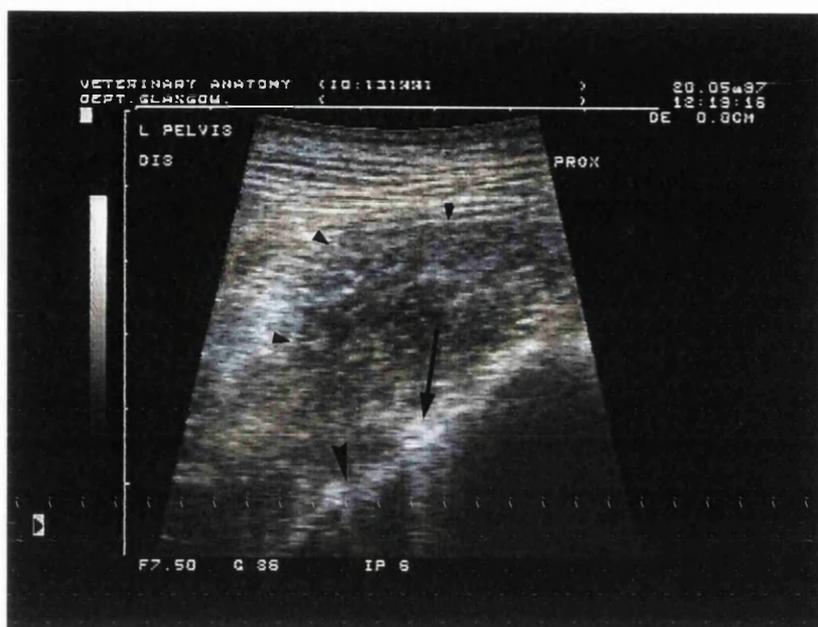
Figure 6.14.3 Transverse scan of the ilium on day four after fracture repair shows the fracture site (large arrow head) which appears as discontinuity of the bone in cross section. The area of muscle damage (small arrow heads) appears as a disorganised hypoechoic region relative to the surrounding. The bone plate and screws adhering to the ilium (arrow) appear hyperechoic with reverberation artefact.

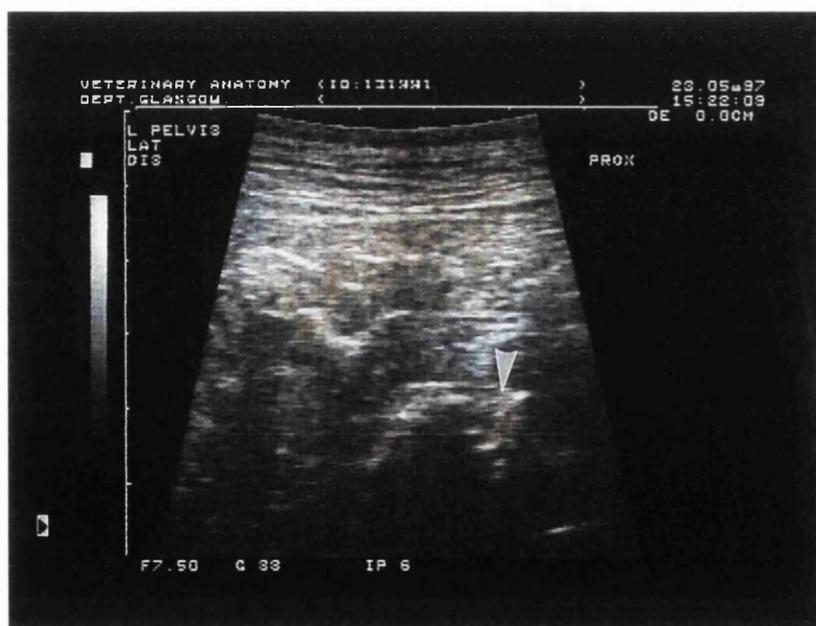
Figure 6.14.4 The fracture site imaged on a transverse scan from the dorsal aspect on day seven after fracture repair appears as a “V” shape gap (arrow head) No callus formation can be detected.

Ultrasonographic examination showed the fracture site which appeared as on the day four examination. There was no indication of callus formation. The fracture site appeared hyperechoic suggesting periosteal tissue reaction. The area of muscle damage above the ilium seen on the day four examination still appeared as an hypoechoic structure but had become more organised. The bone plate appeared as a straight hyperechoic line with reverberation artefact. The fracture site imaged on a transverse scan from the dorsal aspect appeared as a "V" shape gap and no callus formation was detected (figure 6.14.4).

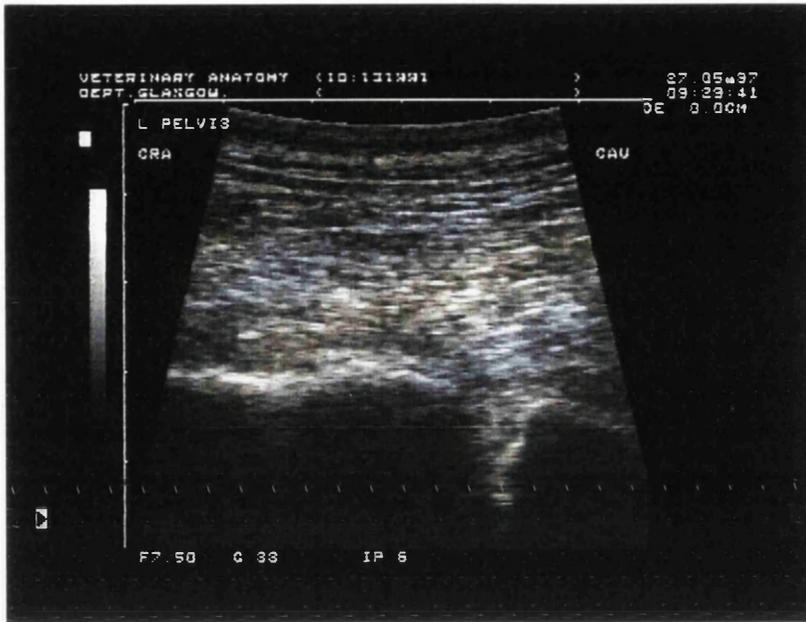
Figure 6.14.5a

Figure 6.14.5 Ultrasonographic examination of the ilium on day 11 after fracture repair demonstrates the fracture site with the gap still present both on (a) longitudinal and (b) transverse scans. The fracture site still appears hyperechoic with no indication of callus formation on a longitudinal scan. However, there is hyperechoic material within the fracture gap on the transverse scan which may suggest the early formation of periosteal callus. The area of muscle damage still appears as a disorganised hypoechoic area on transverse scan. The bone plate and screws are adherent to the ilium and appear hyperechoic producing reverberation and comet tail artefacts.

Ultrasonographic examination demonstrated the fracture site with the gap still present both on longitudinal and transverse scans. The fracture site still appeared hyperechoic with no indication of callus formation on the longitudinal scan (figure 6.14.5a). However, there was hyperechoic material within the fracture gap on the transverse scan which could suggest the early formation of a periosteal callus (figure 6.14.5b). The area of muscle damage could still be seen on the transverse scan and appeared as a disorganised hypoechoic area. The bone plate and screws adherent to the ilium appeared hyperechoic and produced reverberation and comet tail artefacts respectively.

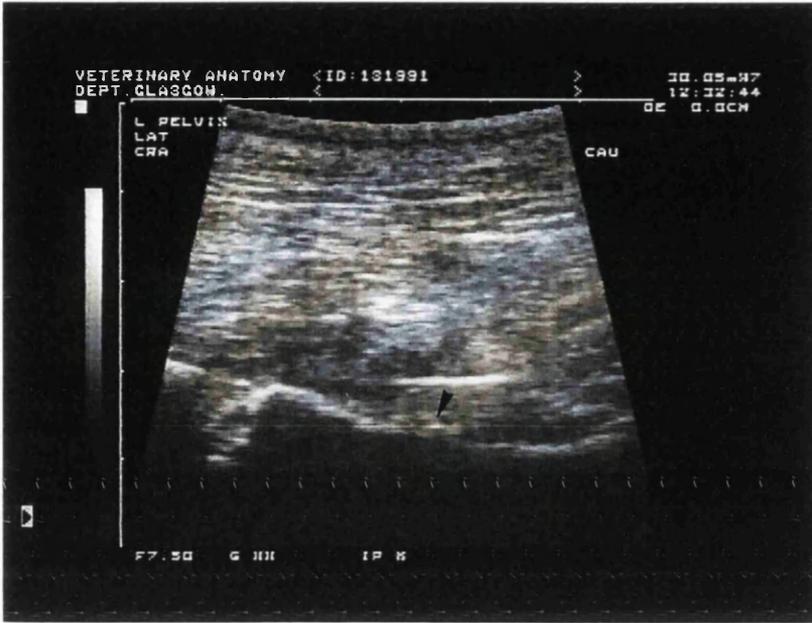
Figure 6.14.6 A longitudinal scan of the ilium on day 14 after fracture repair demonstrates the fracture gap with the presence of hyperechoic material within the gap which suggests soft callus formation. Soft callus formation is also detected on the bone surface near to the fracture site appearing as an hyperechoic structure (arrow head). The area of muscle damage above the ilium still appears as a disorganised hypoechoic region.

Ultrasonographic examination demonstrated the fracture gap with the presence of hyperechoic material within the gap which suggested soft callus formation (figure 6.14.6). There was no artefact seen distal to the hyperechoic material. Soft callus formation was detected on the bone surface near to the fracture site appearing as hyperechoic structures. The area of muscle damage above the
