**AN ULTRASONOGRAPHIC STUDY OF MUSCULOSKELETAL
INJURIES AND MAMMARY GLAND TUMOUR IN SMALL
ANIMALS**

A thesis submitted to the Faculty of Veterinary Medicine,
University of Glasgow.

For the Degree of Doctor of Philosophy

Division of Veterinary Anatomy,
Department of Veterinary Preclinical Studies,
School of Veterinary Medicine,
University of Glasgow,
March, 1999

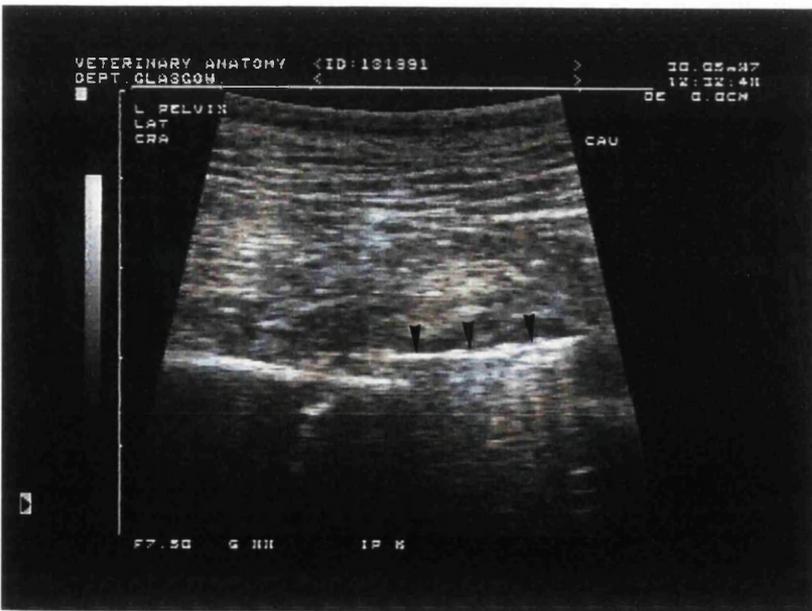
Figure 6.14.7 The hyperechoic bone plate with reverberation artefact (arrow heads), appears slightly elevated from the ilial shaft surface at the caudal end on a longitudinal scan on day 14 after fracture repair.

ilium still appeared as a disorganised hypoechoic area. The bone plate appeared hyperechoic with reverberation artefact and was slightly elevated from the ilial shaft surface at the caudal end (figure 6.14.7). A transverse scan of the ilium demonstrated soft callus formation at the fracture site which appeared hyperechoic (figure 6.14.8). The area of muscle damage still appeared hypoechoic but with more organised structure on the transverse scan.

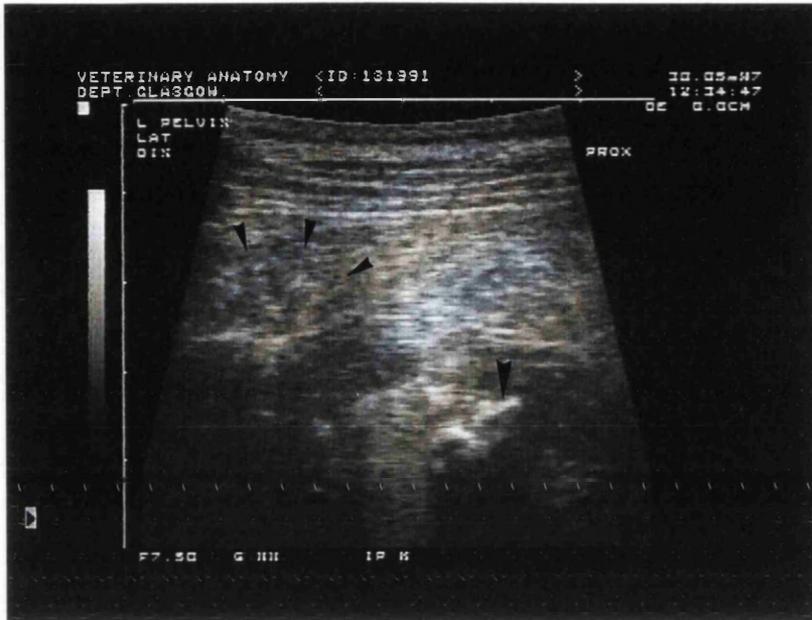
Figure 6.14.8 Transverse scan of the ilium on day 14 after fracture repair demonstrates the soft callus formation at the fracture site which appears as hyperechoic material (large arrow head). Note that the area of muscle damage still appears hypoechoic but with a more organised structure (small arrow heads).

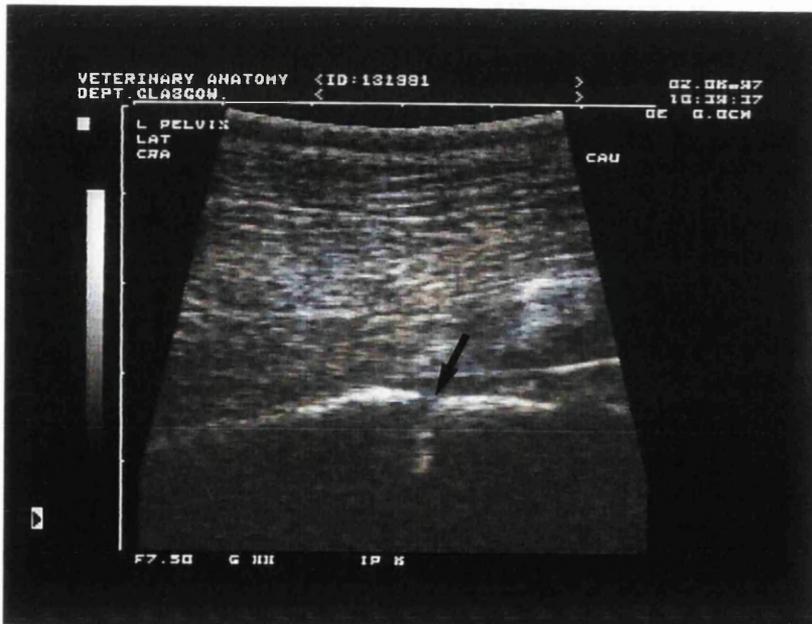
Figure 6.14.9 Longitudinal scan of the ilium on day 17 after fracture repair demonstrates the fracture site with the gap still clearly seen (arrow head) but it appears smaller than the previous scan which is due to the callus formation.

Ultrasonographic examination demonstrated the fracture site with the gap still able to be seen but it appeared smaller than in the previous scan due to the callus formation (figure 6.14.9). The soft callus formation on the bone surface near to the fracture site imaged on the day 14 examination had become enlarged and appeared as an hyperechoic structure (figure 6.14.10). It was more distinct than in the previous scan. The bone plate adherent to the ilium appeared hyperechoic with reverberation artefact as seen on day 14 after fracture repair. The area of muscle damage had become smaller and appeared hypoechoic with a more organised structure.

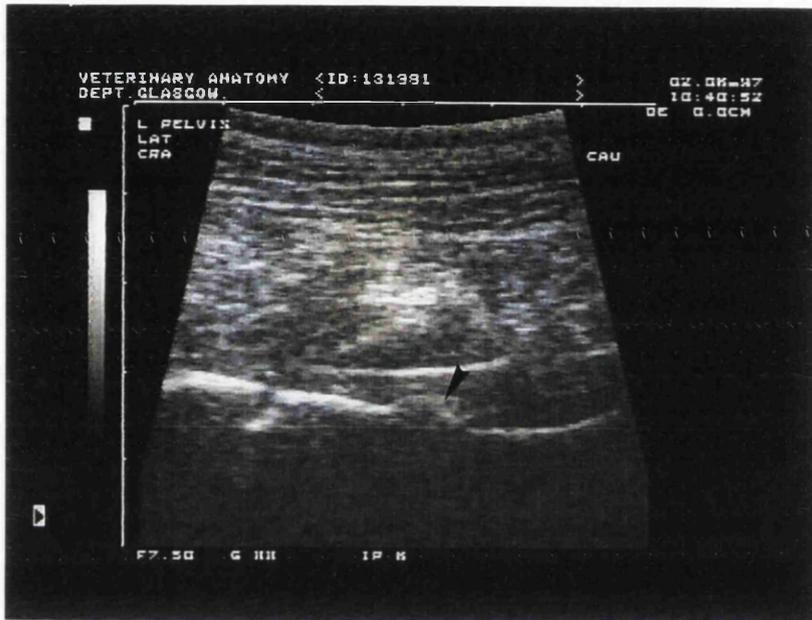
Figure 6.14.10 Longitudinal scan of the ilium on day 17 after fracture repair demonstrates soft callus formation on the bone surface near to the fracture site (arrow). It has enlarged and appears as a hyperechoic structure. It is clearer than in the previous image. The area of muscle damage has become smaller and appears hypoechoic with a more organised structure.

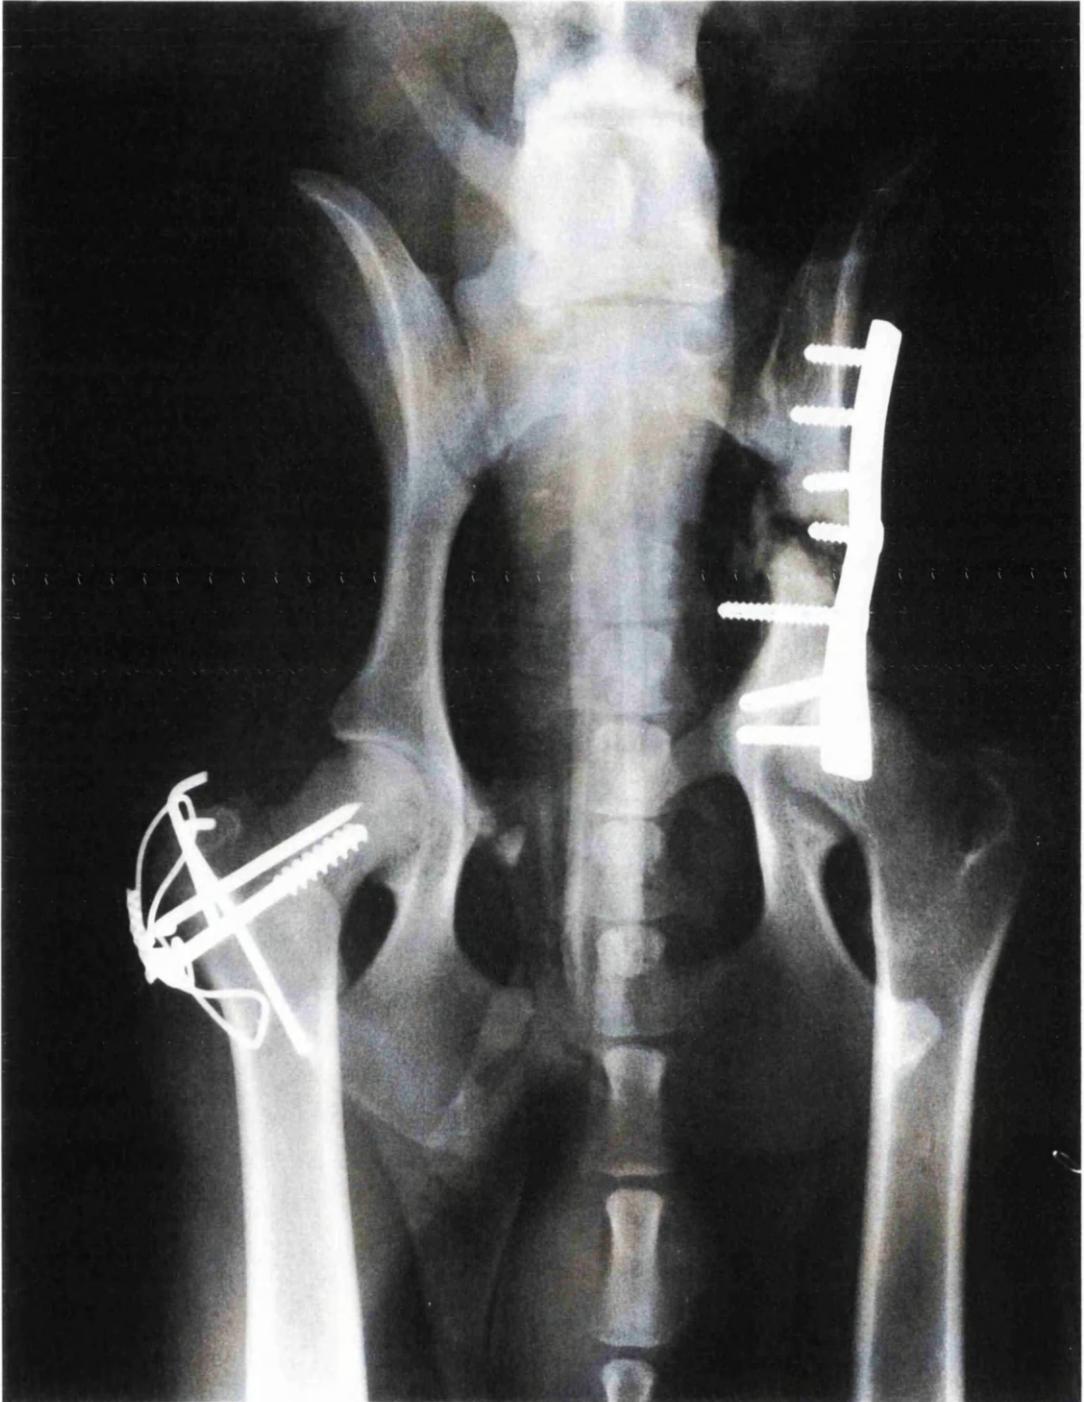
Figure 6.14.11 Radiographs taken at day 47 after fracture repair show there is a fracture gap present with the middle screw appearing to lie in the fracture site. The fifth screw extends 0.5 cm medial to the ilium. The fracture margins are indistinct and callus is evident. The fracture line of the femoral neck is seen with difficulty.

Radiographs taken at day 47 after fracture repair showed there was a fracture gap present with the middle screw appearing to lie in the fracture site. The fifth screw extended 0.5 cm medial to the ilium. The fracture margins were indistinct and a callus was evident. The fracture line of the femoral neck was barely visible (figure 6.14.11).

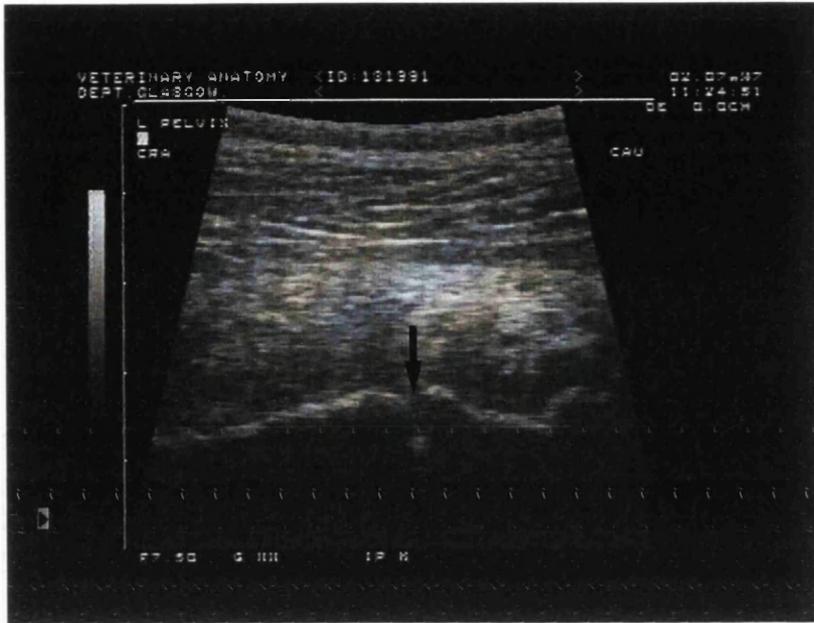
Figure 6.14.12 Longitudinal scan of the ilium on day 47 after fracture repair demonstrates the fracture site with the fracture gap still present but appears small and shallow (arrow). The callus formation can be seen at the fracture site and at the area near to the fracture site. The callus formation at the fracture site appears like a 'collar'. The muscle structure appears to have a normal ultrasonographic appearance.

Ultrasonographic examination demonstrated the fracture site with the fracture gap still evident but it appeared smaller and more shallow than the previous scan (figure 6.14.12). Callus formation could be seen at the fracture site and at the area near to the fracture site. The callus formation at the fracture site appeared like a 'collar'. The area of disorganised muscle damage had returned to its normal structure producing a normal ultrasonographic appearance of the muscle. The animal failed to return for the check up and thus, the follow up scans were not available.

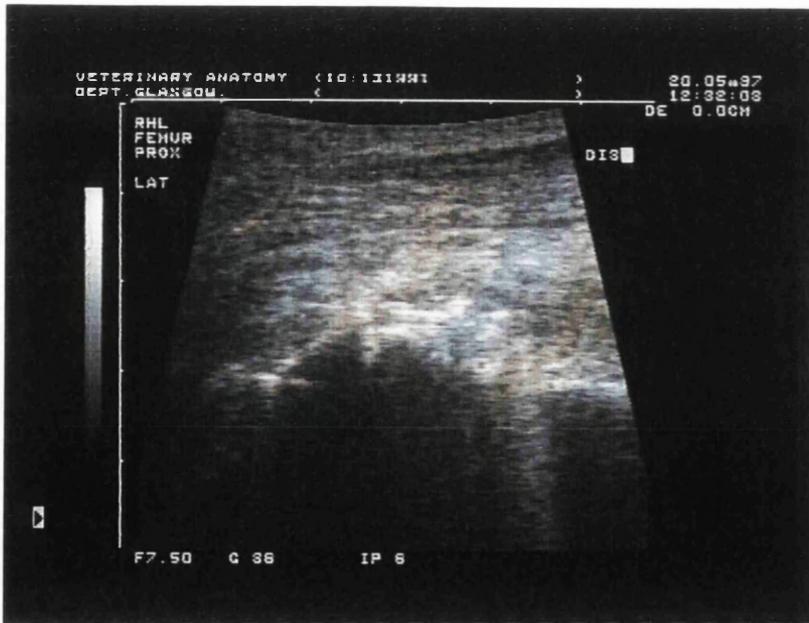
Figure 6.14.13 Longitudinal scan of the proximal end of the femur on day four after fracture repair demonstrates the hyperechoic material with the comet tail artefacts which represents the Kirschner wires and screws that had been used in the reduction procedure.

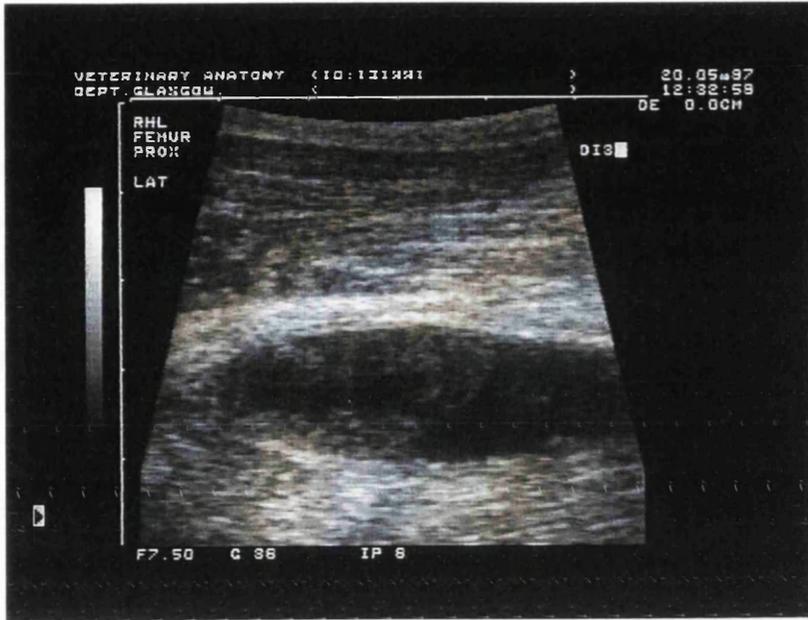
Figure 6.14.14a

Figure 6.14.14 A large haematoma caudal to the proximal femur, imaged on day four after fracture repair , **a**, longitudinal plane, **b**, transverse plane. Note that the area of the haematoma appears anechoic with some echogenic material present within. **F**, femur

Ultrasonographic examination failed to detect the fracture site at the femoral neck. The fact that site of the fracture was at the base of the femoral neck and the fracture site which was very well aligned with the fracture line was barely visible on radiograph helped to explain why ultrasonographic examination of this site failed to show the line of the fracture. However, ultrasonographic examination in this area demonstrated the Kirschner wires and screws used in the reduction procedure. These materials appeared hyperechoic and produced comet tail artefacts (figure 6.14.13). A large haematoma was found caudal to the proximal femur on the lateral aspect scans (figure 6.14.14a and 6.14.14b). The haematoma appeared anechoic with some echogenic material present within the area.

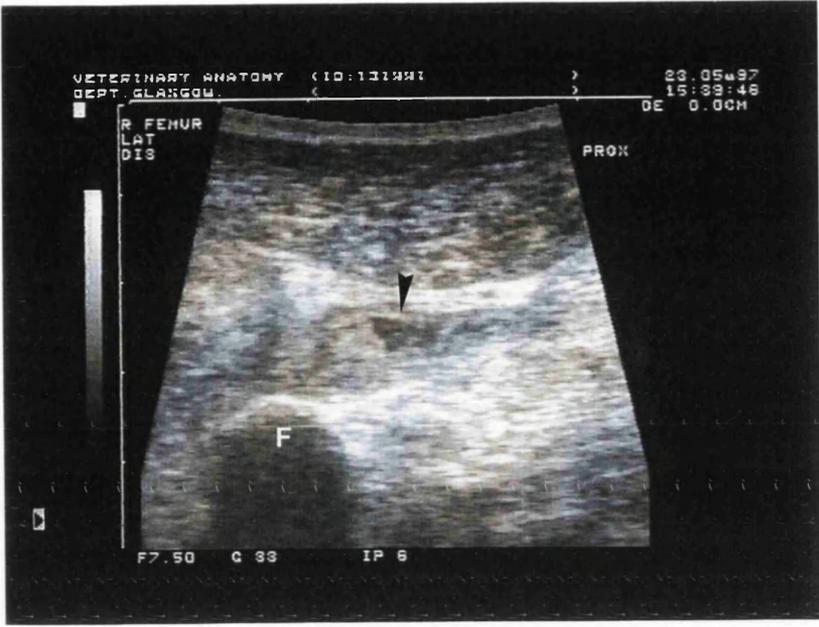
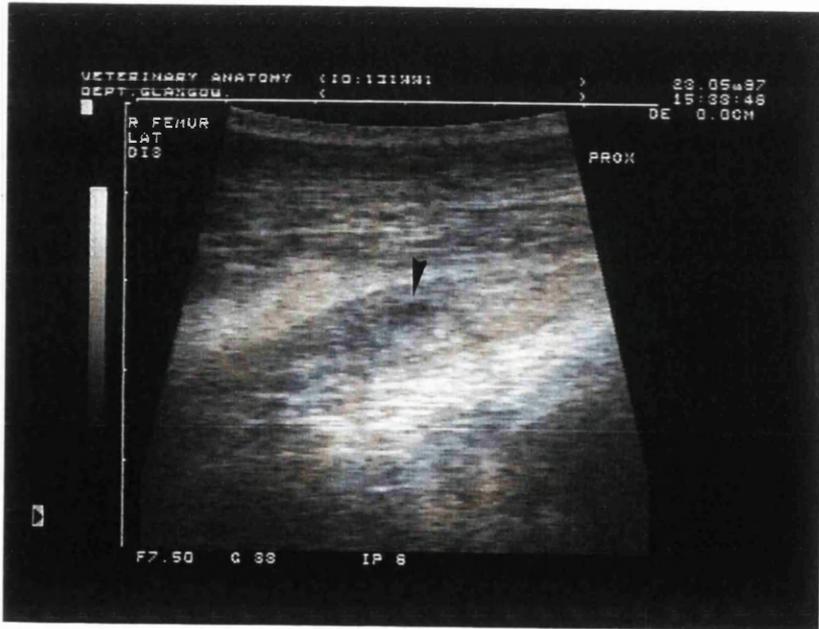
Figure 6.14.15a

Figure 6.14.15 Ultrasonographic images of the site of the haematoma on day seven after fracture repair show a small hypoechoic area (arrow head) surrounded by the hyperechoic structure area of the muscle. **a**, longitudinal scan, **b**, transverse scan. The haematoma has reduced to the extent that it has disappeared. **F**, femur.

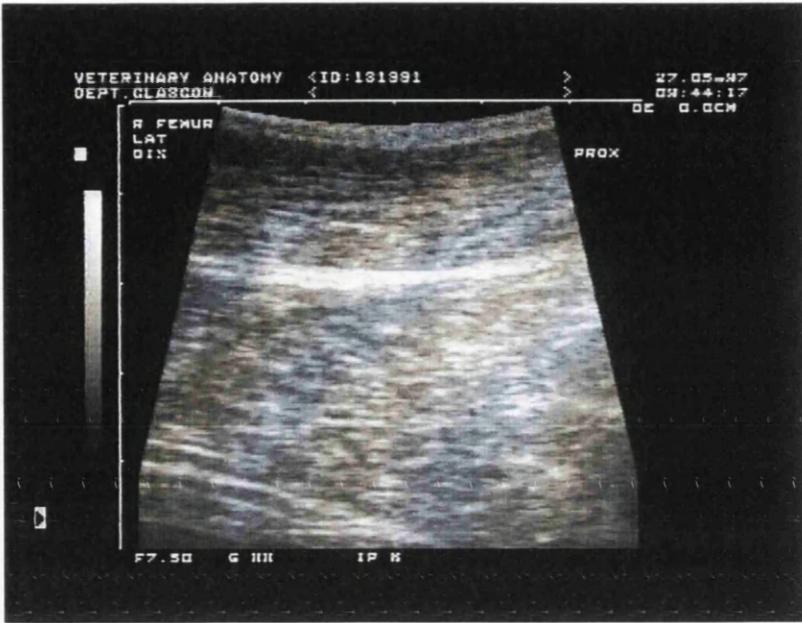
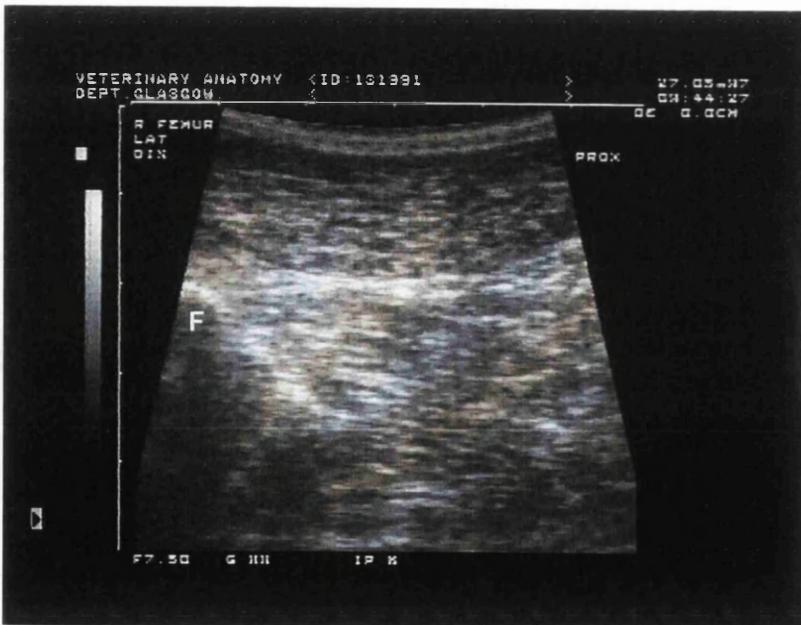
Figure 6.14.16a

Figure 6.14.16 Ultrasonographic images of the site of the muscle haematoma on day 11 after fracture repair demonstrate the normal ultrasonographic appearance of the muscle structure. **a**, longitudinal scan, **b**, transverse scan. **F**, femur

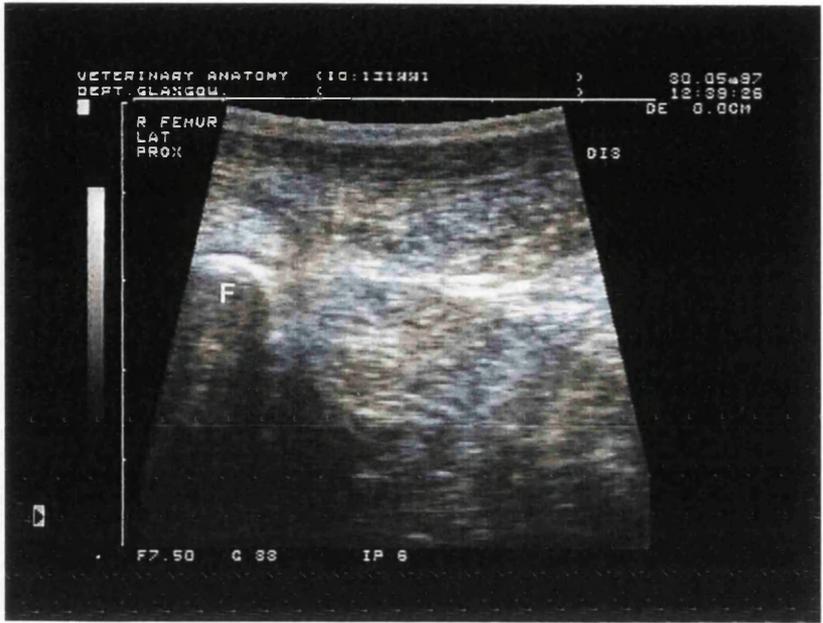
Figure 6.14.17 Transverse scan of the proximal femur at the site of muscle haematoma on day 14 after fracture repair demonstrates the normal ultrasonographic appearance of muscle. F, femur

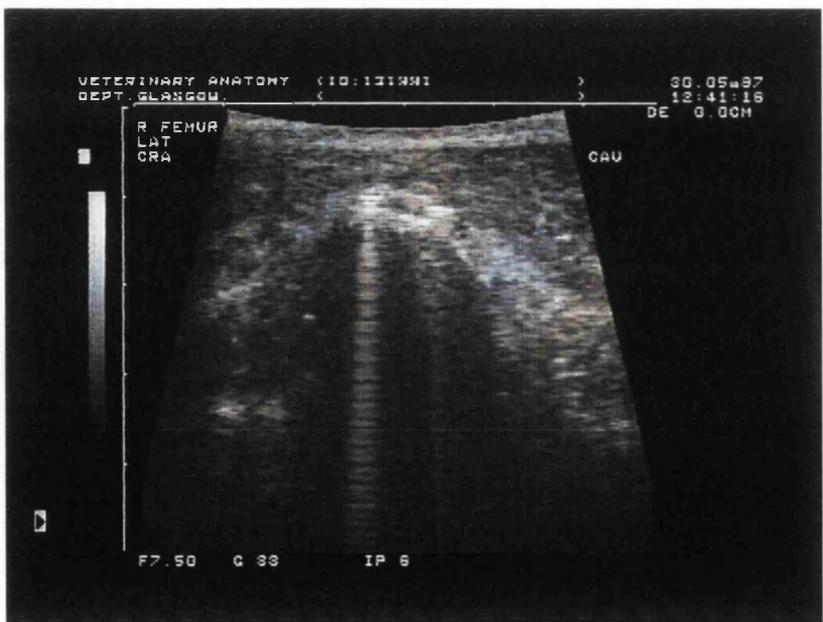
Figure 6.14.18 Ultrasonographic image of the metal material used in femoral neck fracture reduction appears hyperechoic and produces comet tail artefact.

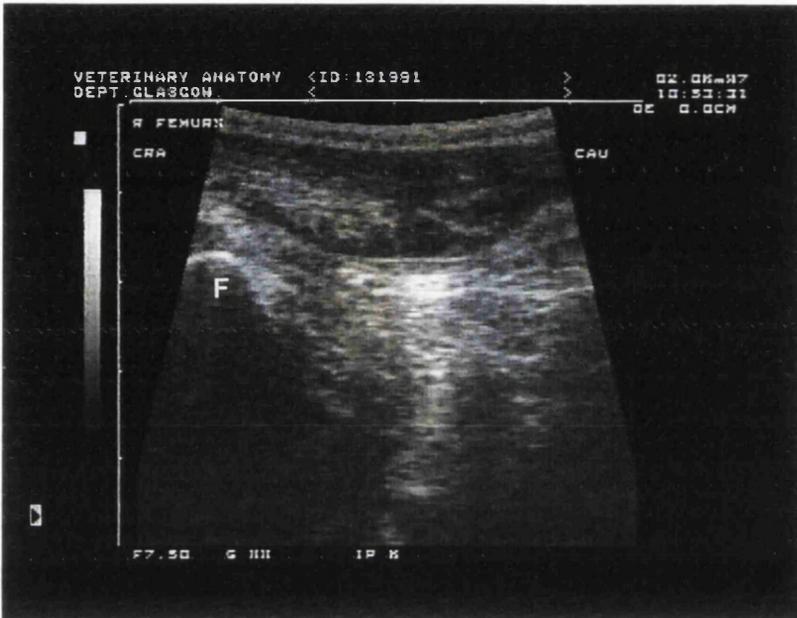
Figure 6.14.19 Transverse scan of the proximal femur at the site of muscle haematoma demonstrates the hyperechoic area. This appearance may be due to the presence of fibrous tissue within muscle. F, femur

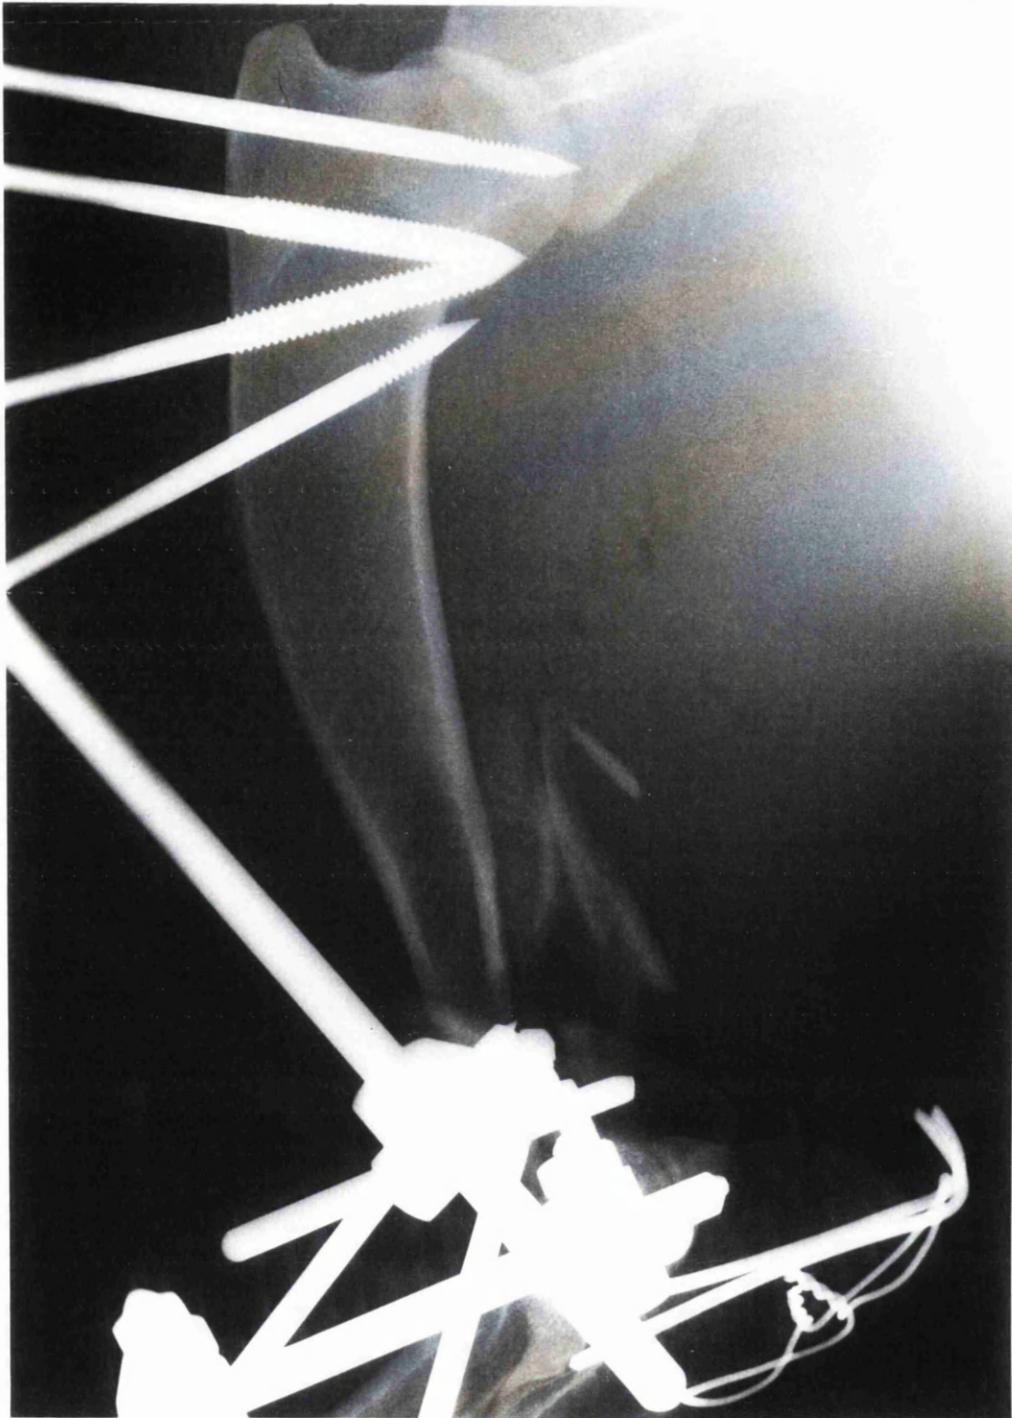
Figure 6.15.1 Radiograph obtained immediately after fracture repair shows the repair has been carried out using a combination of two external fixators with four pins in the proximal humerus, two in the lateral condyle and one in the medial condyle. The repair process is resulting in a good alignment.

An eight year old male Cocker Spaniel was presented to the Glasgow University Veterinary Hospital with a suspicion of having a humeral fracture, cause unknown. Radiographic examination revealed that a severely comminuted fracture of the distal shaft of the left humerus had been sustained, which was intracondylar and intra-articular. The distal portion of the fracture was caudoproximally displaced. Repair had been carried out using a combination of two external fixators with four pins in the proximal humerus, two in the lateral condyle and one in the medial condyle. The repair process had resulted in a good alignment (figure 6.15.1).

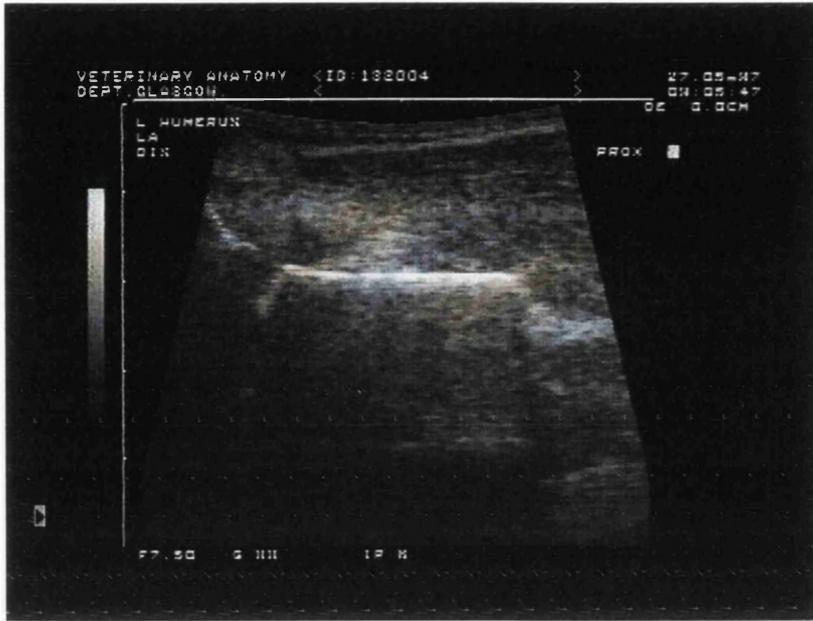
Figure 6.15.2 Longitudinal scan of the distal humerus at the fracture site area on day four after fracture repair shows a large bone fragment which appears hyperechoic with a smooth surface. There is no indication of callus formation.

Ultrasonographic examination of the distal humerus at the fracture site area demonstrated a large bone fragment which appeared hyperechoic with a smooth surface (figure 6.15.2). The proximal fragment of the humerus was imaged as not continuous with the distal fragment (figure 6.15.3). A transverse scan at the fracture site area demonstrated the humerus with the bone fragments caudally (figure 6.15.4). The disorganised hyperechoic structure of the muscle around the fracture site area suggested an area of soft tissue reaction. The suture material within the muscle was imaged and appeared hyperechoic with reverberation artefact (figure 6.15.5).

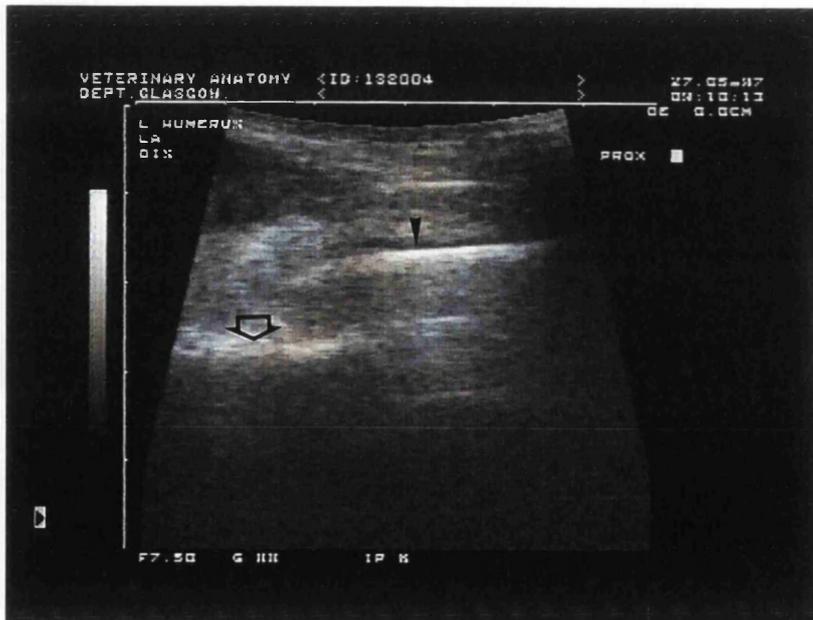
Figure 6.15.3 Longitudinal scan of the humerus from the lateral aspect on day four after fracture repair shows the proximal fragment (arrow head) and there is no continuity with the distal fragment (blank arrow).

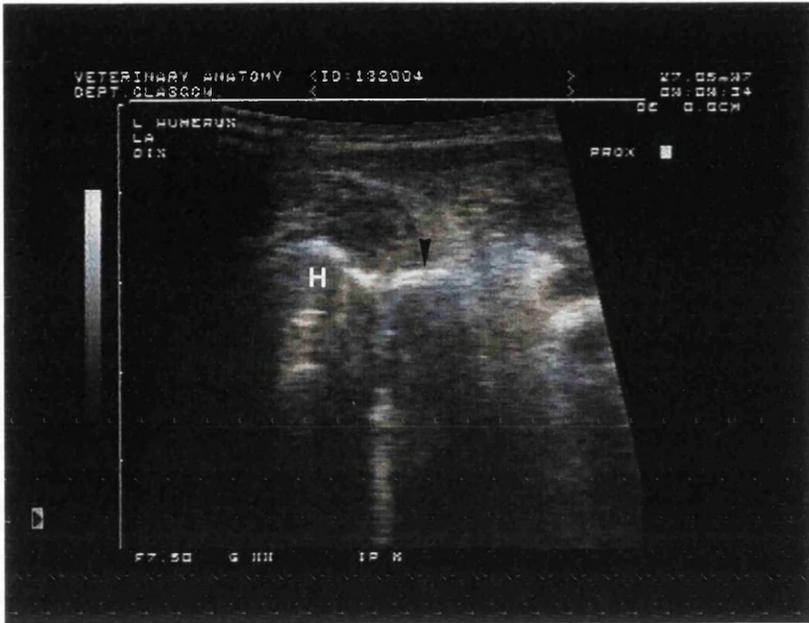
Figure 6.15.4 Transverse scan at the fracture site area from the lateral aspect on day four after fracture repair demonstrates the humerus with the bone fragments caudally (arrow head). Note also the disorganised hyperechoic structure of the muscle around the fracture site area suggesting an area of soft tissue reaction. H, humerus.

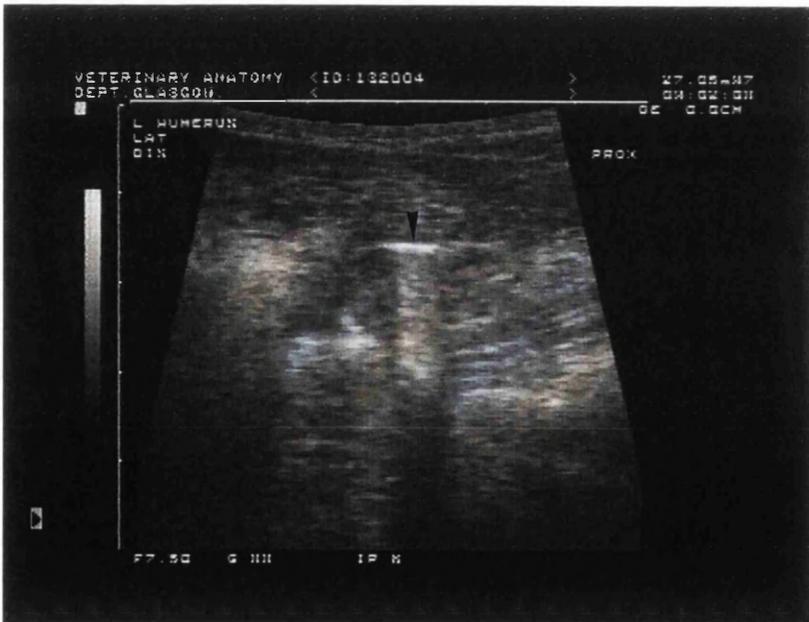
Figure 6.15.5 The suture material within the muscle (arrow head) appears hyperechoic with reverberation artefact.

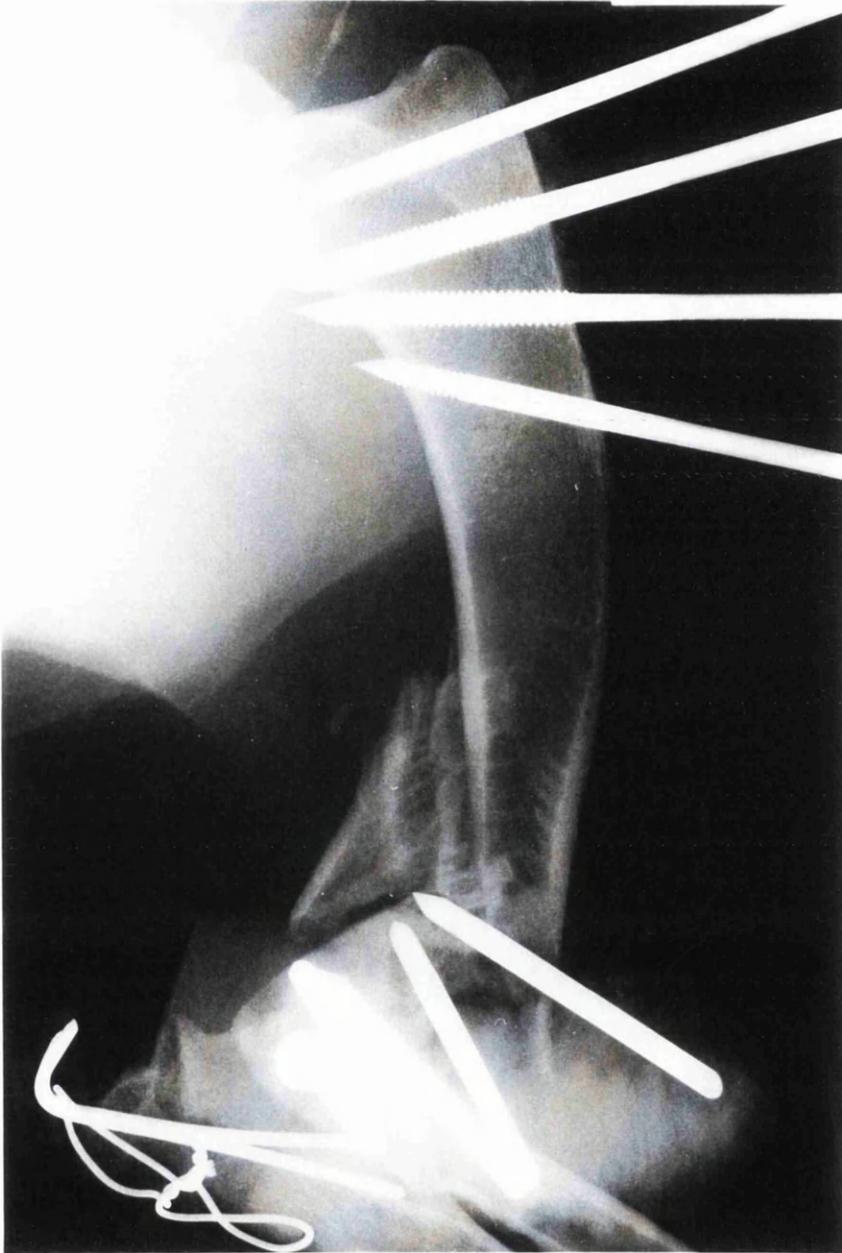
Figure 6.15.6 Radiograph taken at day 55 after fracture repair shows there is evidence of callus bridging the fracture gap between the two fragments. Proximally, there is some periosteal reaction and some lucency associated with the pin, indicating pin loosening due to infection or implant instability.

Radiographs taken at day 55 after fracture repair showed there was evidence of callus bridging the fracture gap between the two fragments (figure 6.15.6). Proximally, there was some periosteal reaction and some lucency associated with the pin, indicating pin loosening due to infection or implant instability.

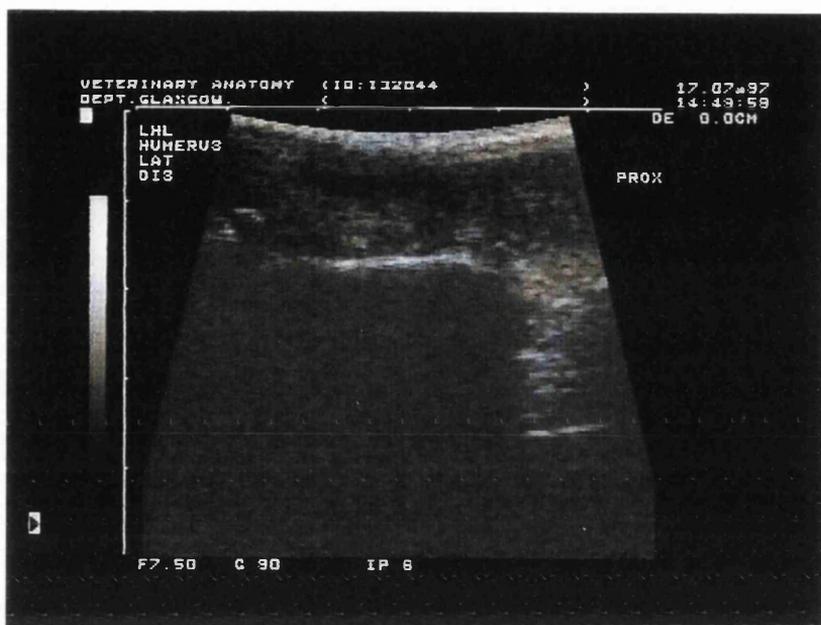
Figure 6.15.7 Ultrasonographic examination of the distal humerus from the lateral aspect on day 55 after fracture repair demonstrates the bone fragment which appears as in the day four examination.

Ultrasonographic examination of the distal humerus from the lateral aspect demonstrated the bone fragment which appeared as in the day four examination (figure 6.15.7). The distal humerus was found to be continuous on a caudo-lateral scan with no gap detected (figure 6.15.8). One pin was seen at the fracture site area with soft callus formation detected around the pin. This soft callus formation suggested that some pin movement had occurred. The bulging bone was suggestive of a healing process with callus formation. This suggested that the healing process was progressing well. However, the fracture site was detected on a lateral scan and appeared as a large notch (figure 6.15.9). There was no excessive callus formation detected at the fracture site. The muscle structure appeared to have a normal ultrasonographic appearance.

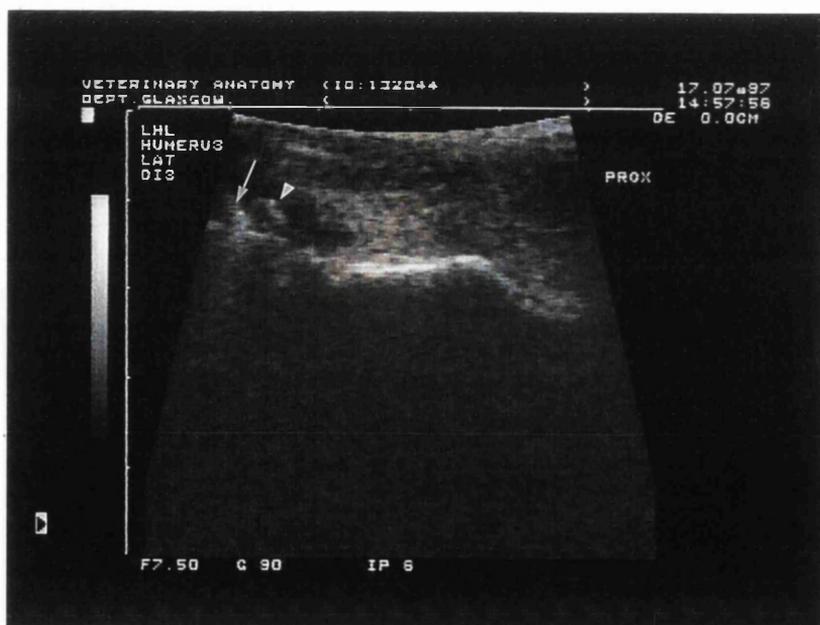
Figure 6.15.8 Longitudinal scan of the distal humerus from the lateral aspect on day 55 after fracture repair shows the bulging bone surface at the fracture site area. One pin is seen (arrow) and soft callus formation is detected around the pin (arrow head) which suggests there is some pin movement involved. The bulging bone is suggestive of a healing process with callus formation.

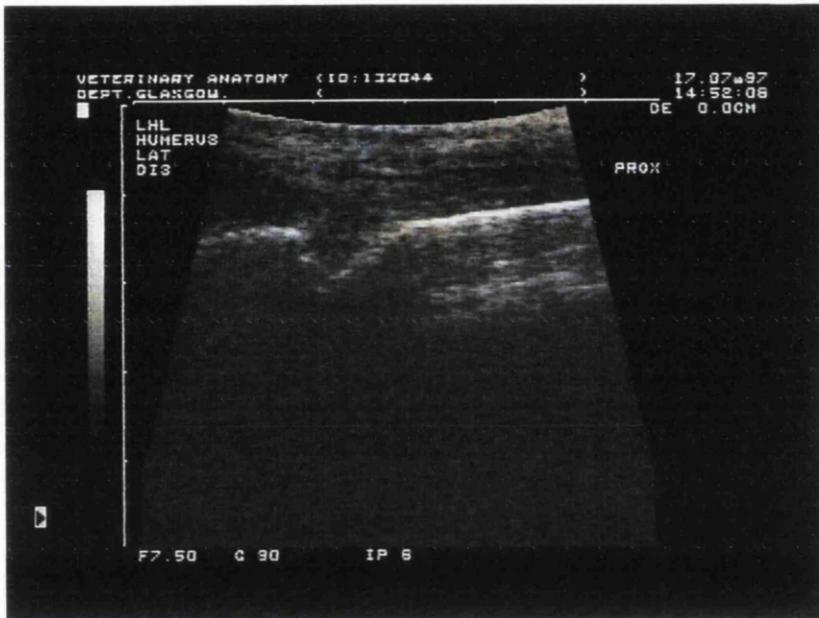
Figure 6.15.9 Longitudinal scan of the distal humerus on day 55 after fracture repair shows the fracture site which appears as a large notch. There is no excessive callus formation detected at the fracture site.

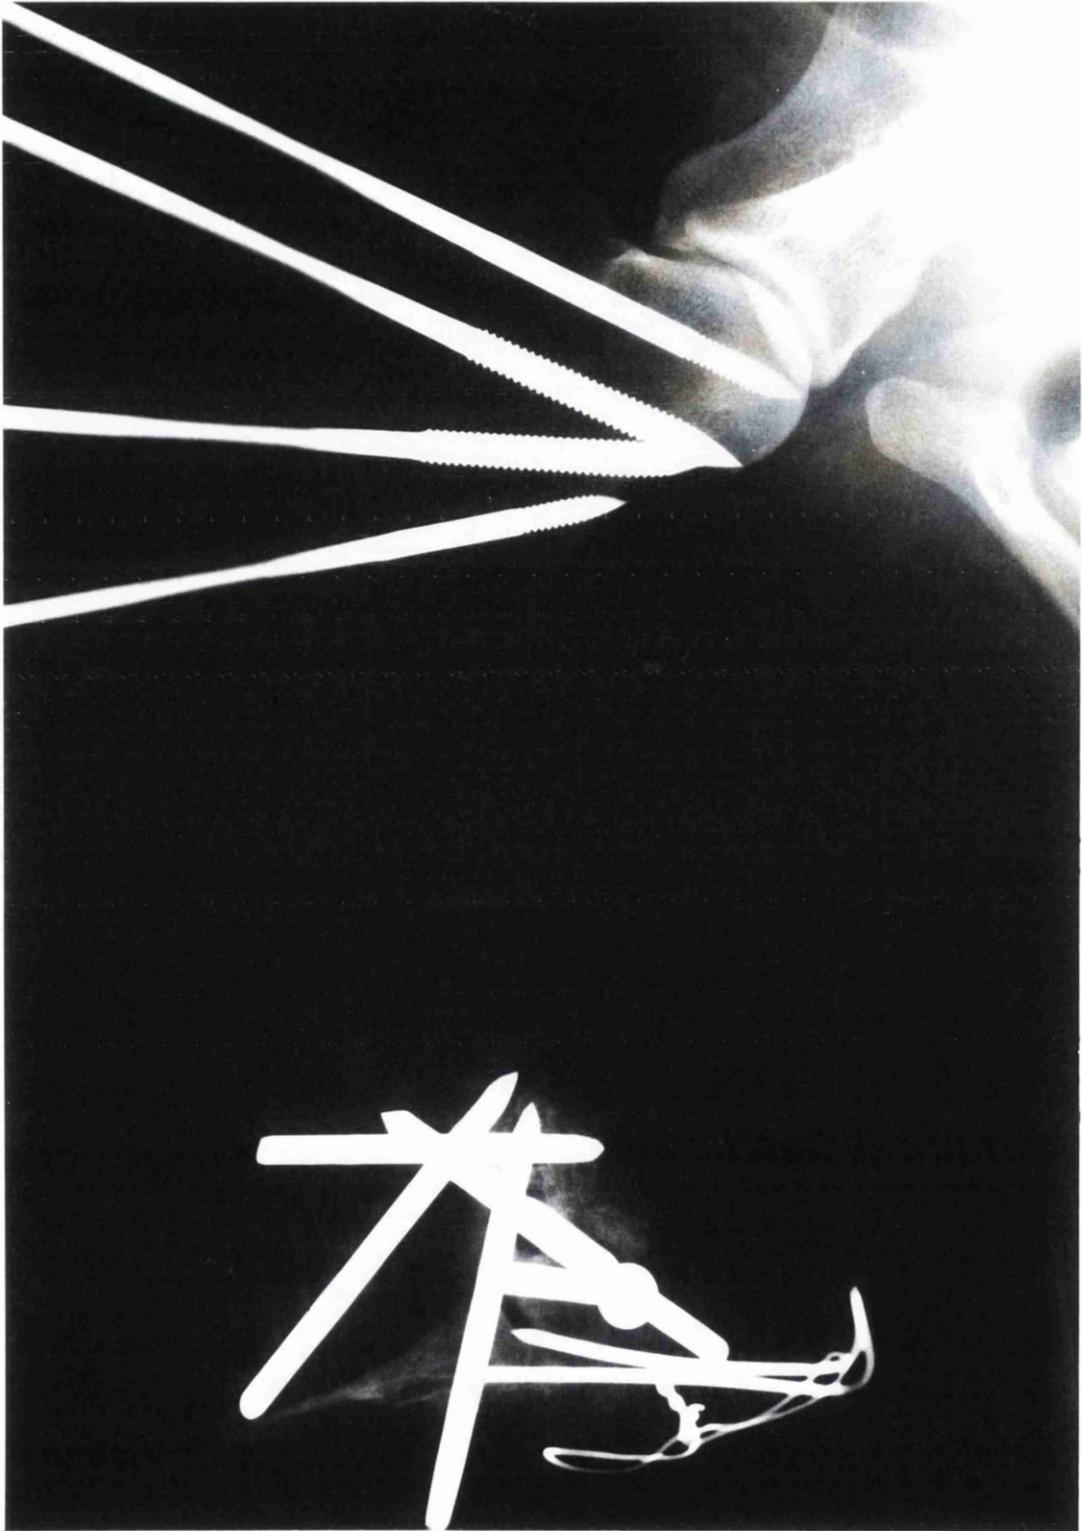
Figure 6.15.10 Radiograph taken at day 96 after fracture repair shows the healing process is progressing satisfactorily.

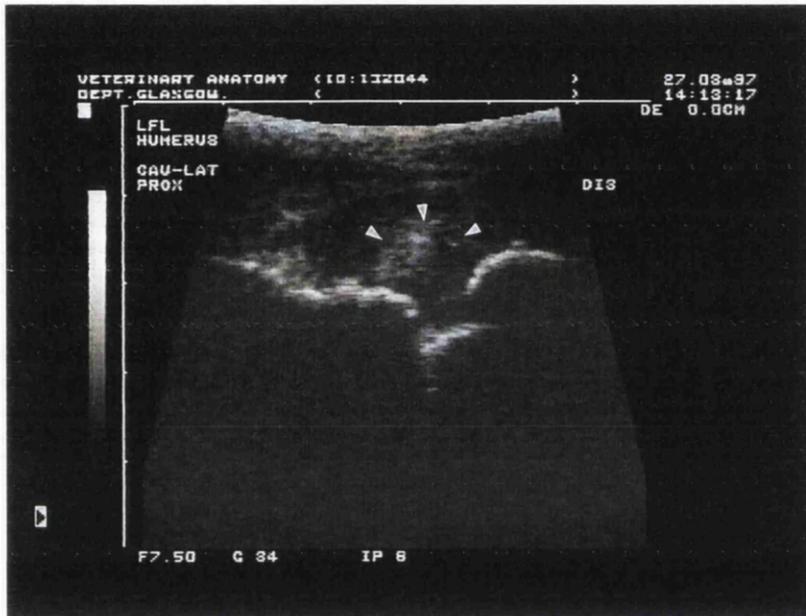
Figure 6.15.12 Longitudinal scan of the distal humerus on the caudo-lateral aspect of the fracture site area on day 96 after fracture repair shows the uneven bone contour, but the bone surface shows that a remodelling process is taking place as it is becoming smoother. The hyperechoic structure area in the muscle at the fracture site area (arrow heads) suggests the presence of fibrous tissue within the muscle.

A transverse scan at the fracture site area still showed the rough bone surface which was due to callus formation (figure 6.15.11a). The distal humerus had lost its normal shape as compared to the normal proximal humerus (figure 6.15.11b). Scanning on the caudo-lateral aspect of the fracture site area showed the uneven bone contour, but the bone surface showed that the remodelling process was taking place as it appeared to be becoming smoother (figure 6.15.12). The hyperechoic area in the muscle at the fracture site area suggested the presence of fibrous tissue within the muscle. The dog was not seen since then, and according to the clinician, the fixation device had been removed at the local veterinary clinic and the fractured humerus was healed satisfactorily.
