**AN ULTRASONOGRAPHIC STUDY OF MUSCULOSKELETAL
INJURIES AND MAMMARY GLAND TUMOUR IN SMALL
ANIMALS**

A thesis submitted to the Faculty of Veterinary Medicine,
University of Glasgow.

For the Degree of Doctor of Philosophy

Division of Veterinary Anatomy,
Department of Veterinary Preclinical Studies,
School of Veterinary Medicine,
University of Glasgow,
March, 1999

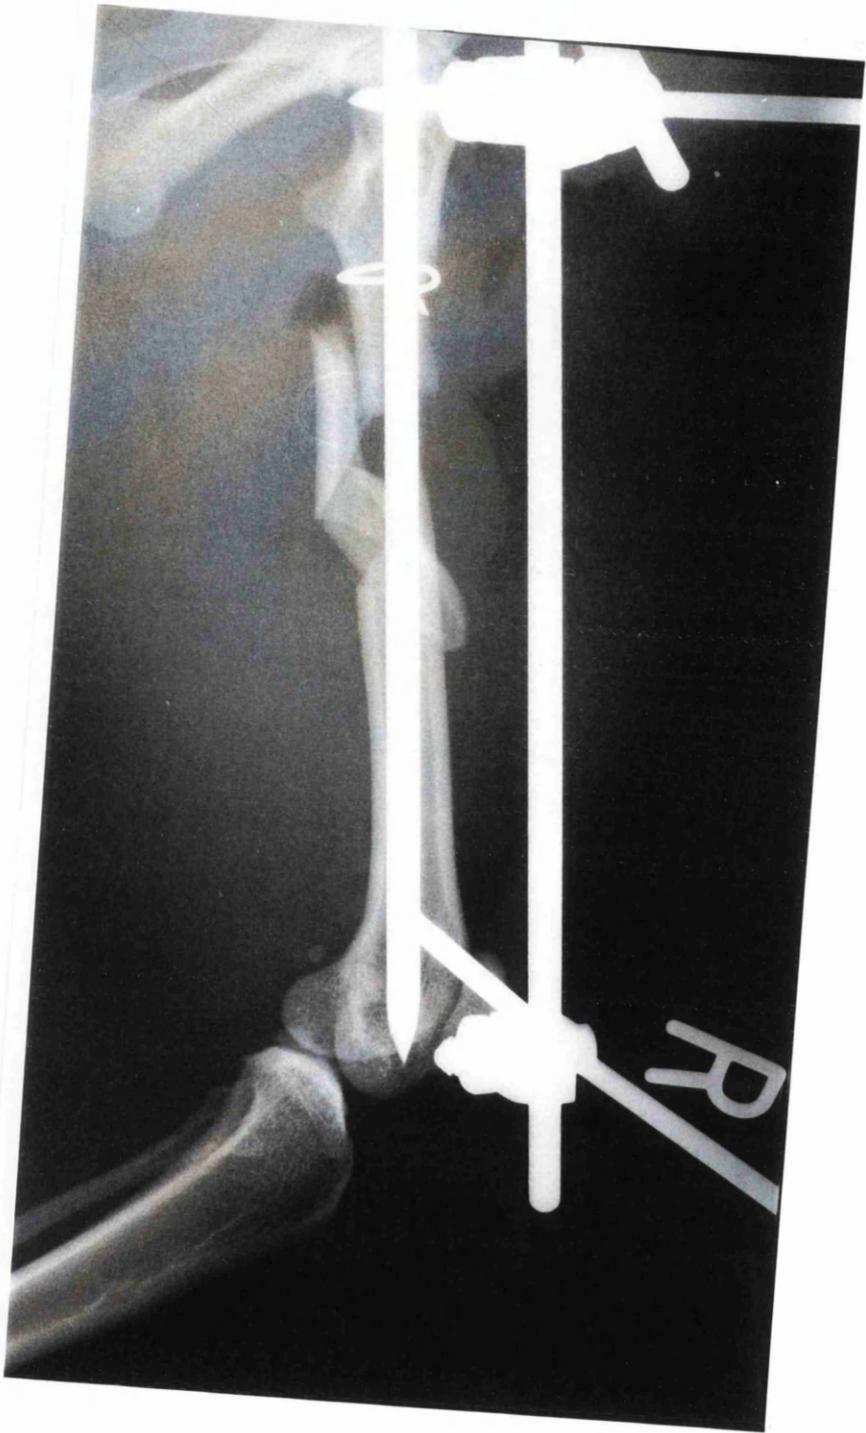
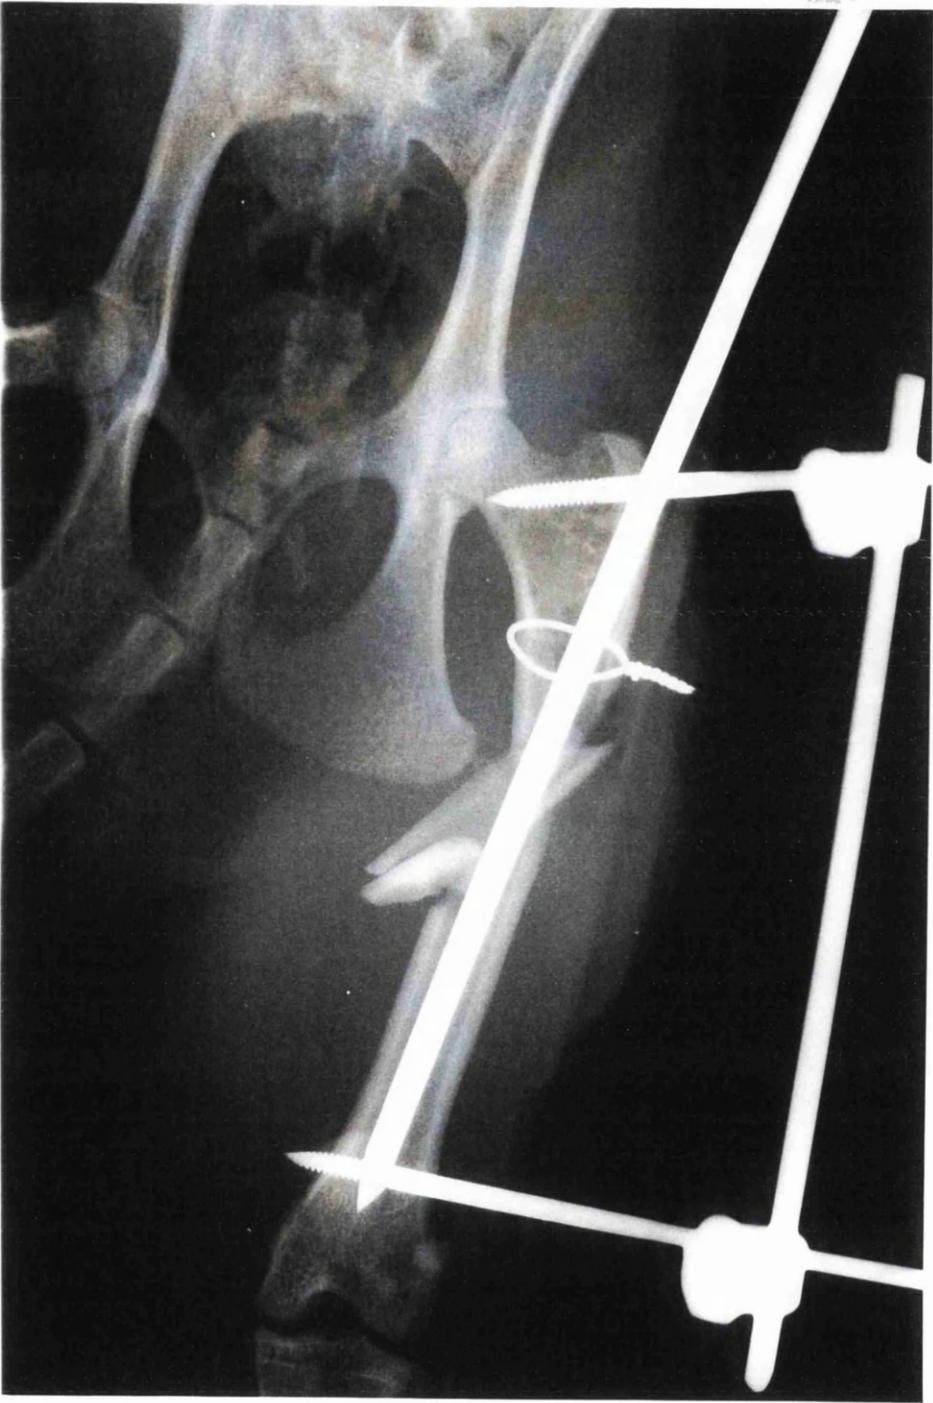
Figure 6.16.1 Radiographs obtained immediately after fracture repair show the fracture is stabilised with an intramedullary pin which is augmented with a tied-in type I external fixator. A fissure line is seen running vertically within the proximal fragment. The two main fragments remain loose. **a**, lateral view, **b**, cranial view.

A four year old domestic short hair neutered male cat, weight 4.5 kg, was presented to the Glasgow University Veterinary Hospital after having been involved in a road traffic accident four days previously. Radiographic examination revealed a comminuted mid shaft fracture of the right femur with proximocaudal displacement of the distal segment. A fissure line was seen running vertically within the proximal fragment. The fracture was stabilised with an intramedullary pin which was augmented with a tied-in type one external fixator. Post operation radiographs showed this to have been enclosed in a cerclage wire (figure 6.16.1). The two main fragments remained loose.

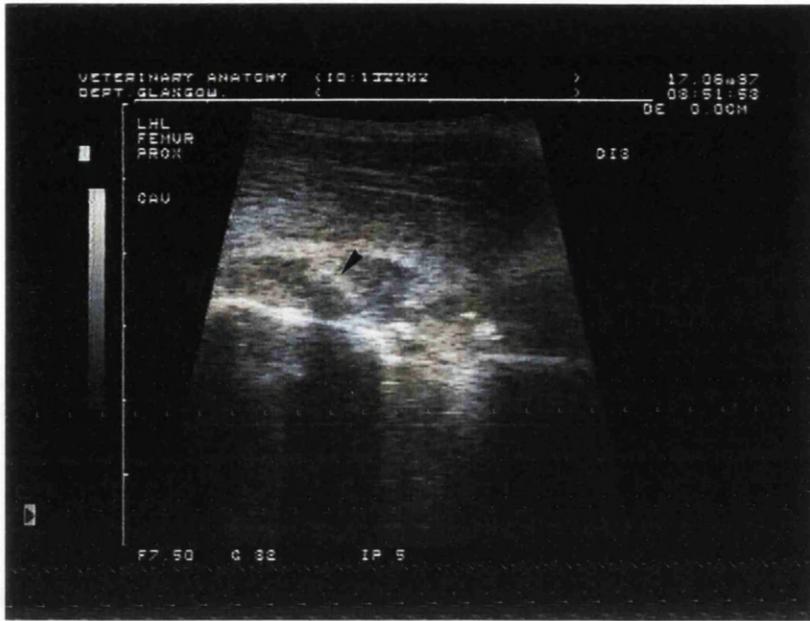
Figure 6.16.2 Longitudinal scan of the femur from the caudal aspect on day two after fracture repair demonstrates the fracture site area which appears hyperechoic suggestive of periosteal tissue reaction. The hyperechoic area surrounding the fracture site indicates an area of soft tissue reaction. One fragment with acoustic shadowing artefact (arrow head) is seen at the fracture site protruding into the muscle.

Ultrasonographic examination demonstrated the fracture site area which appeared hyperechoic suggesting periosteal tissue reaction (figure 6.16.2). The area of hyperechoic structure surrounding the fracture site suggested an area of soft tissue reaction. One fragment which appeared hyperechoic with acoustic shadowing artefact was imaged at the fracture site area. A large fracture gap was revealed when scanned longitudinally from the cranial aspect. It appeared as discontinuity of the two bone fragments (figure 6.16.3). The hyperechoic area at the fracture site and above the femur suggested the area of soft tissue reaction. On cranio-lateral scan, the large fracture gap was imaged connected by the intramedullary pin which appeared hyperechoic with reverberation artefact (figure 6.16.4). The loose bone fragment at the fracture site imaged on the medio-caudal aspect appeared as hyperechoic material with acoustic shadowing artefact and was protruding into the muscle (figure 6.16.5). The surrounding hyperechoic area suggested an area of soft tissue reaction. The large fracture gap also showed on the lateral aspect scan. The hyperechoic area on the bone

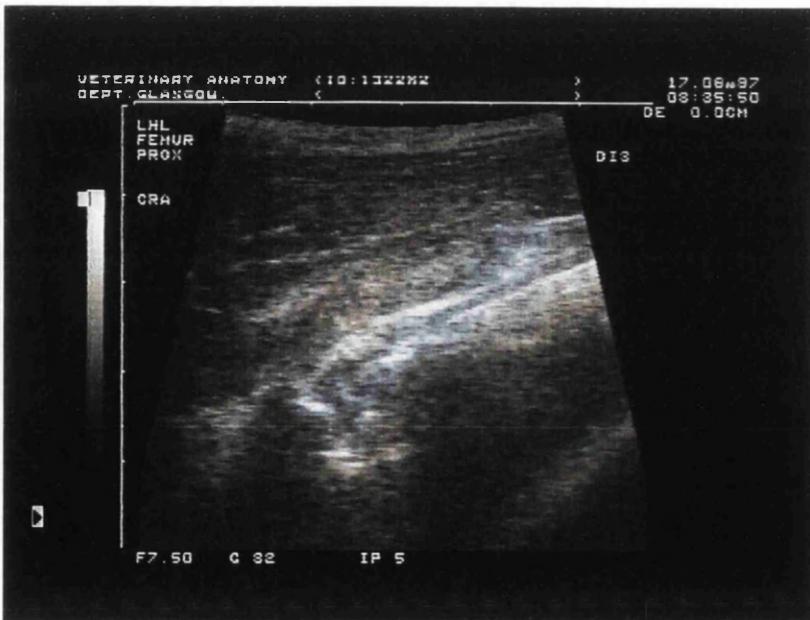
Figure 6.16.3 A big fracture gap is revealed on a longitudinal scan from the cranial aspect. It appears as discontinuity of the bone. The hyperechoic area at the fracture site and above the femur is suggestive of soft tissue reaction.

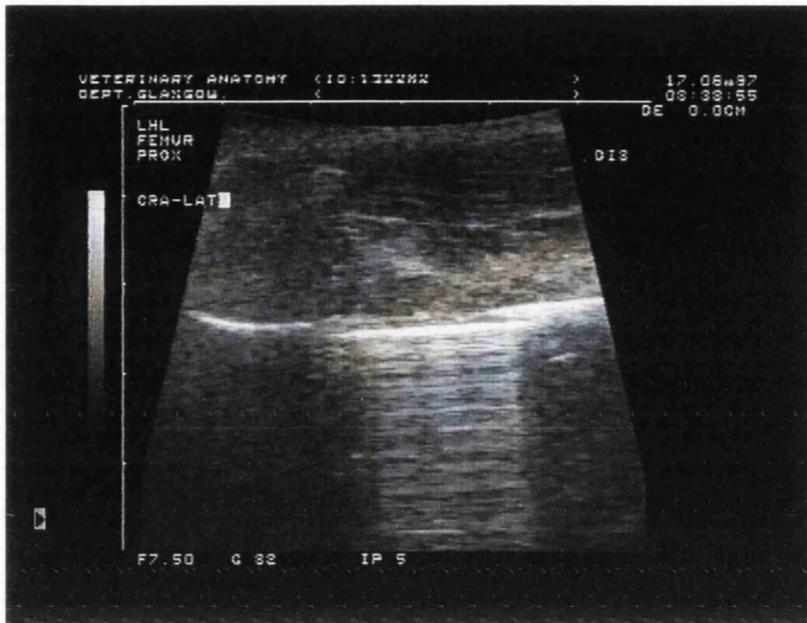
Figure 6.16.4 The large fracture gap connected by the hyperechoic straight lines with reverberation artefact is imaged on cranio-lateral scan. The hyperechoic straight lines with reverberation artefact is actually the intramedullary pin used in the fracture reduction.

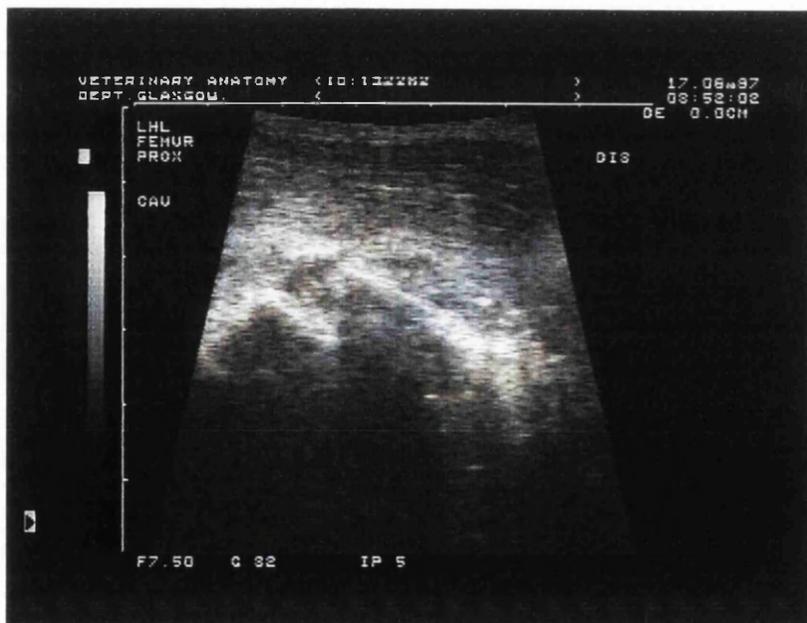
Figure 6.16.5 The loose bone fragment at the fracture site appears as hyperechoic material with acoustic shadowing artefact protruding into the muscle on longitudinal scan 24 hours after fracture repair. Note also the surrounding area appears homogenously hyperechoic suggestive of soft tissue reaction.

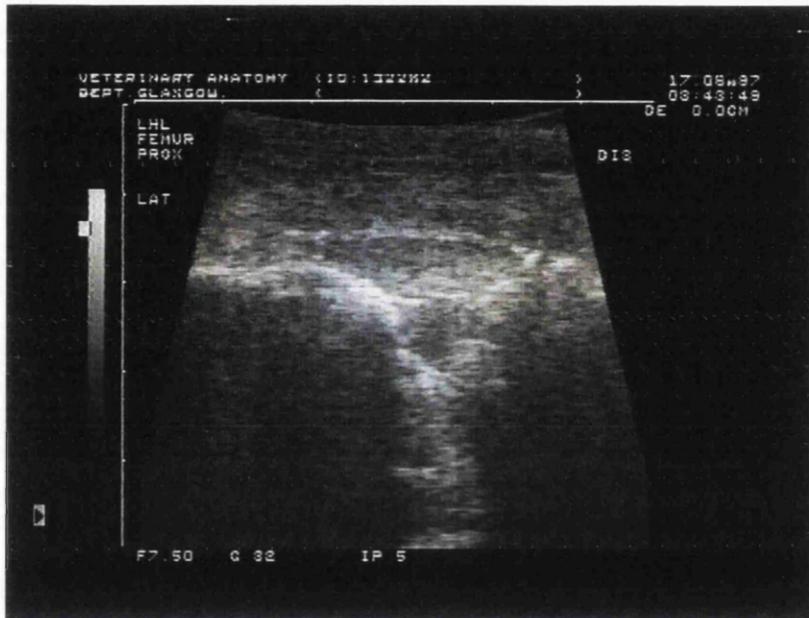
Figure 6.16.6 Longitudinal scan of the femur from the lateral aspect on day two after fracture repair shows the large fracture gap. The hyperechoic area on the bone surface at the fracture site is suggestive of periosteal tissue reaction, and the hyperechoic appearance of the area surrounding the fracture site suggests soft tissue reaction. No callus formation is seen at this stage.

surface at the fracture site suggested periosteal tissue reaction, and the hyperechoic appearance of the area surrounding the fracture site suggested a soft tissue reaction (figure 6.16.6). No callus formation was detected at this stage.

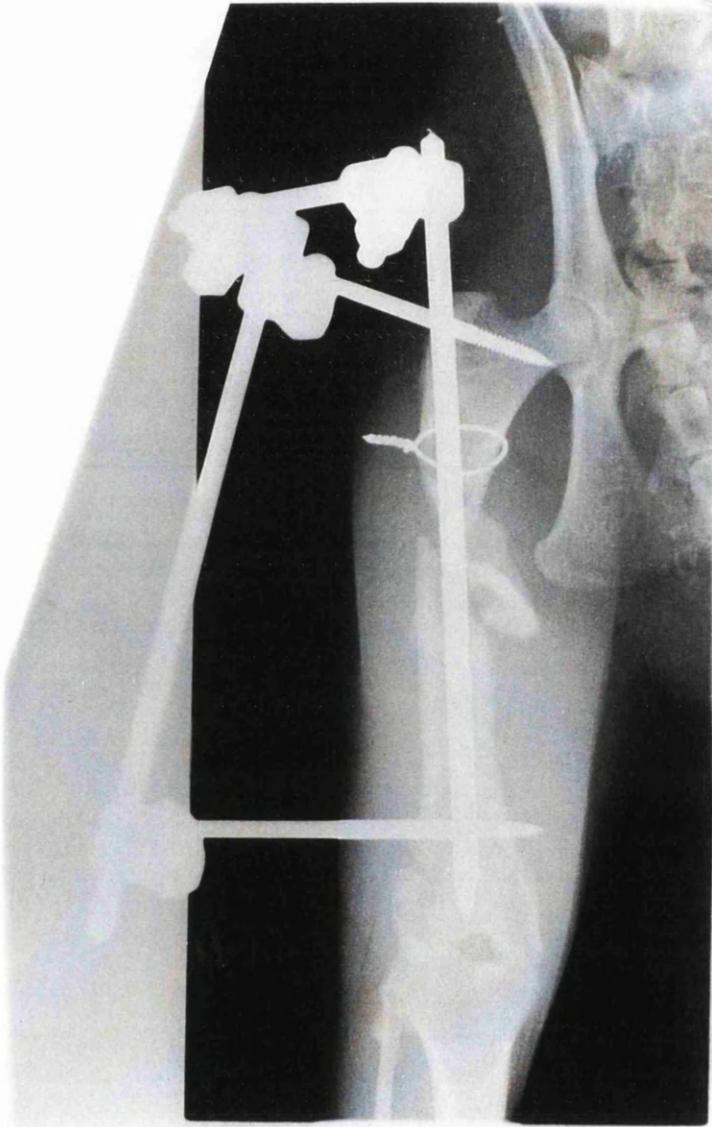
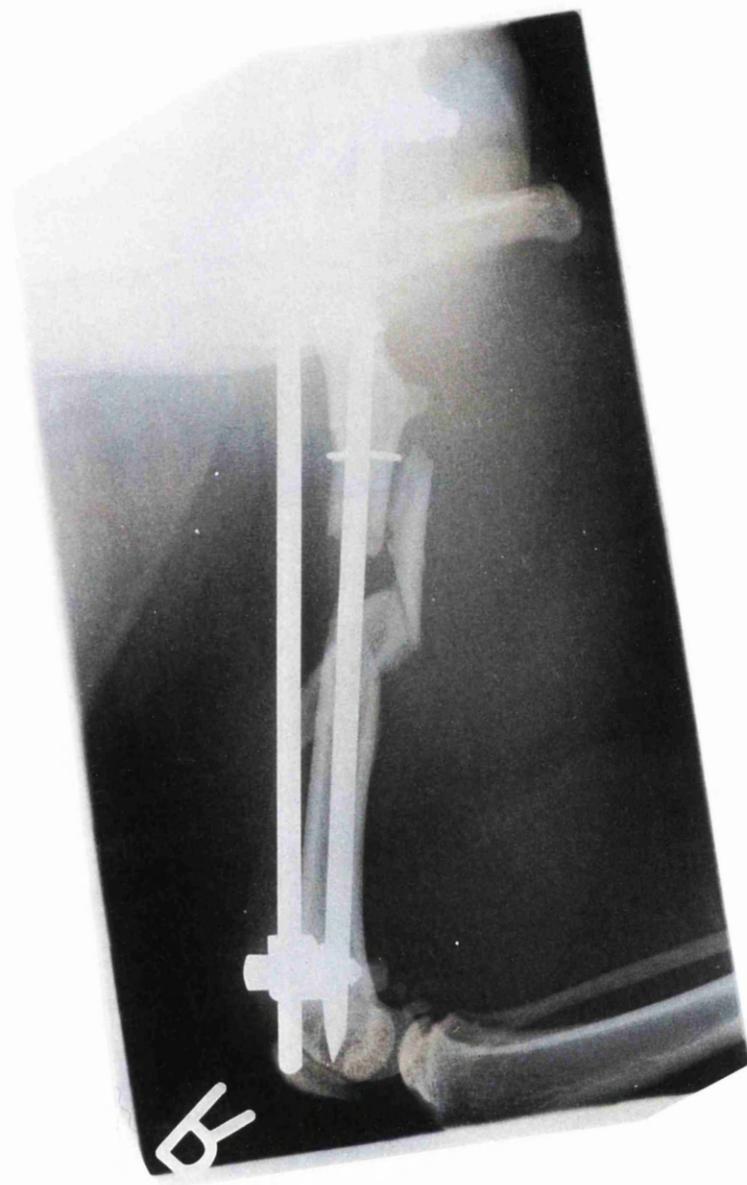
Figure 6.16.7 Radiographs taken at day 31 after fracture repair show a good alignment of the fracture fragments, with less defined fracture edges. **a**, cranial view, **b**, lateral view. There is some implant reaction around the distal pin which is seen as a subtle periosteal reaction and lucency. The soft tissue swelling is resolved. A fissure line running vertically within the proximal fragment is still visible on the lateral view.

Radiographs taken at day 31 after fracture repair showed a good alignment of the fracture fragments, with less definition of the fracture edges (figure 6.16.7). Some implant reaction around the distal pin was seen as a subtle periosteal reaction and lucency. The soft tissue swelling had resolved. A fissure line running vertically within the proximal fragment was still visible on a lateral view.

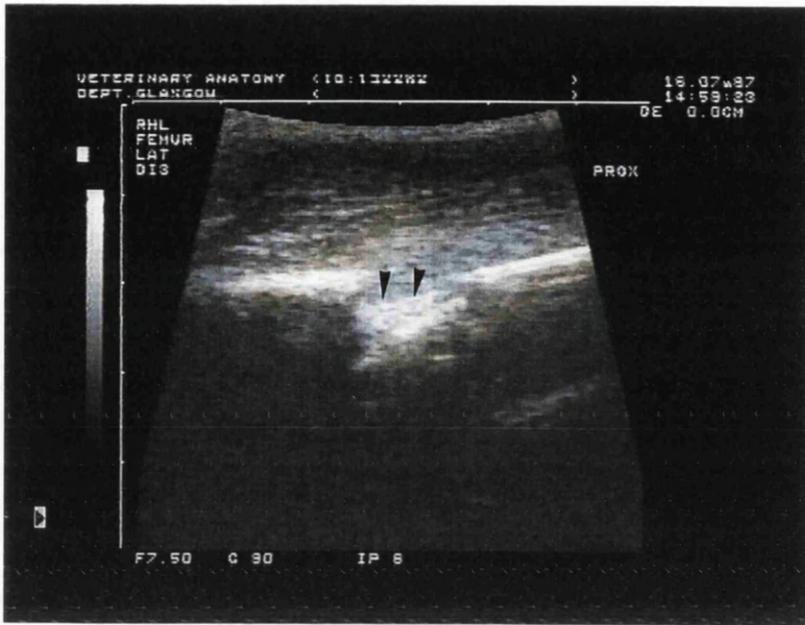
Figure 6.16.8 Longitudinal scan of the femur on day 31 after fracture repair shows the fracture site with an oblique bone fragment within the fracture gap. Note also that there is a small hyperechoic area on the bone fragment (arrow heads) which is suggestive of soft callus formation.

Ultrasonographic examination demonstrated the fracture site with an oblique bone fragment within the fracture gap. There was a small hyperechoic area on the bone fragment which suggested soft callus formation (figure 6.16.8). The intramedullary pin used in the fracture reduction was imaged connecting the two main fragments and appeared hyperechoic with reverberation artefact (figure 6.16.9). There was no callus formation detected on the bone surface at the fracture site area on the lateral side. A transverse scan on the lateral aspect revealed the fracture site with the bone fragment and an intramedullary pin. The intramedullary pin in cross sectioned appeared as a small hyperechoic image with comet tail artefact (figure 6.16.10). The bone fragment appeared hyperechoic with acoustic shadowing. The soft callus formation was detected on the transverse scan and appeared as an hyperechoic area (figure 6.16.11). The muscle area adjacent to the femur appeared hyperechoic.

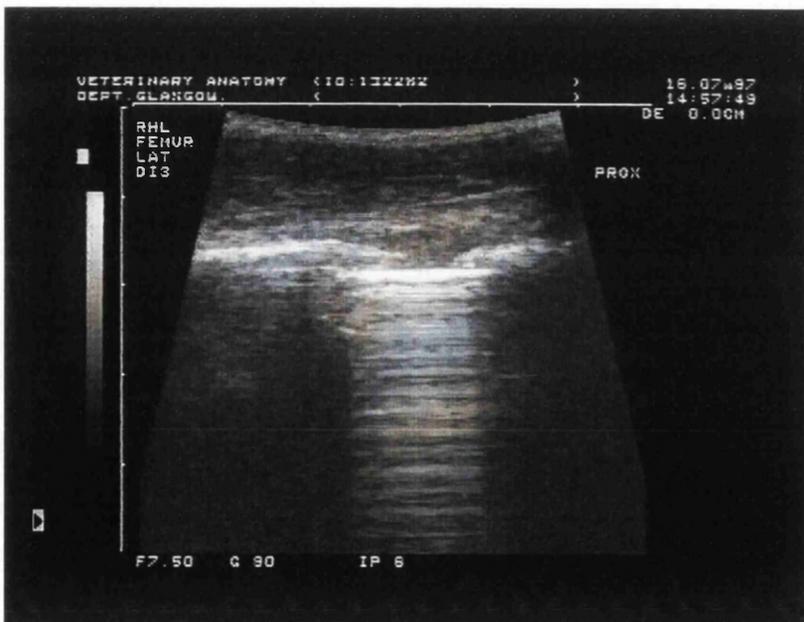
Figure 6.16.9 Longitudinal scan of the femur on day 31 after fracture repair shows the fracture gap with intramedullary pin which appears hyperechoic with typical reverberation artefact. The gap appears reduced in size but no excessive callus formation can be seen at the fracture site area and on the bone surface.

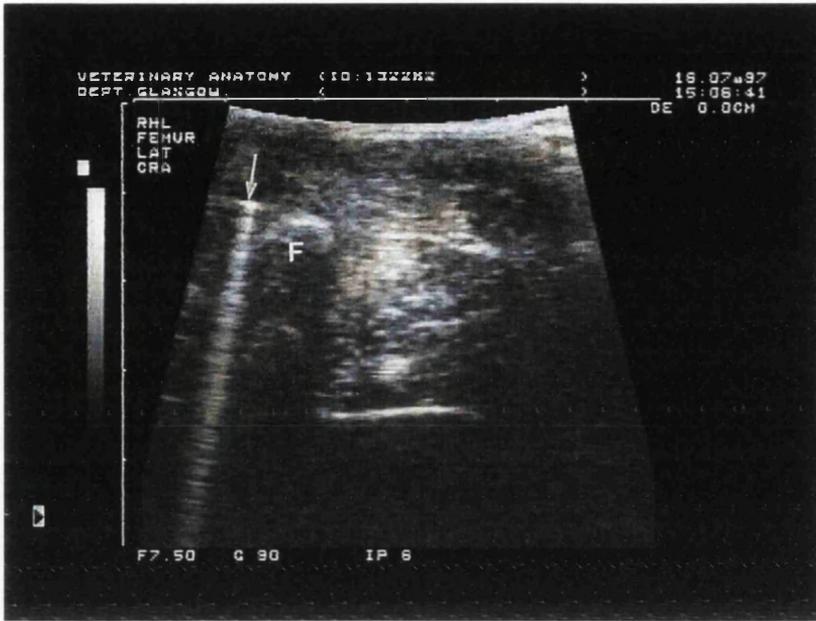
Figure 6.16.10 Transverse scan from the lateral aspect of the femur on day 31 after fracture repair shows the fracture site with the bone fragment and an intramedullary pin. The intramedullary pin scanned transversely appears as a small hyperechoic material (arrow) with comet tail artefact. F, femur.

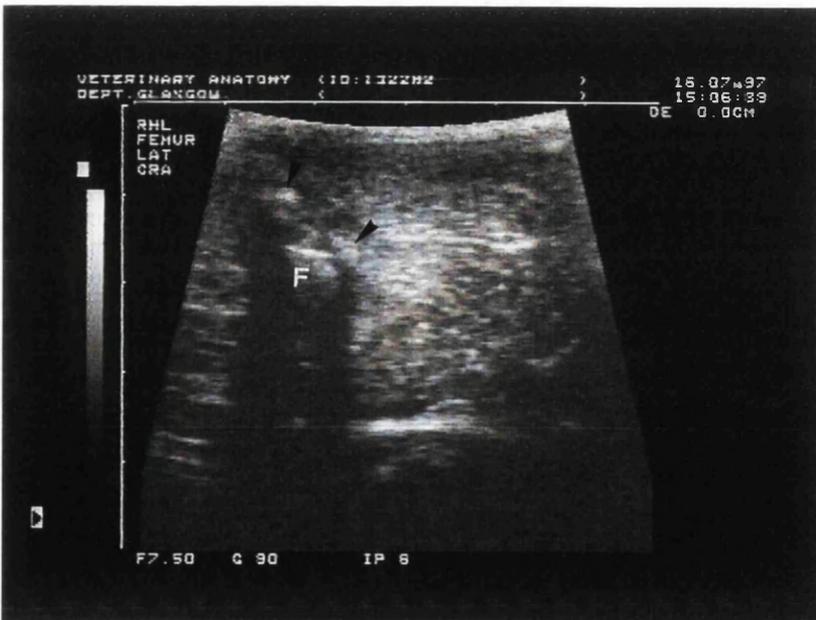
Figure 6.16.11 The soft callus formation is detected on transverse scan at the fracture site area on day 31 after fracture repair and appears as a small hyperechoic materials (arrow heads). Note also the muscle area adjacent to the femur appears hyperechoic. F, femur.

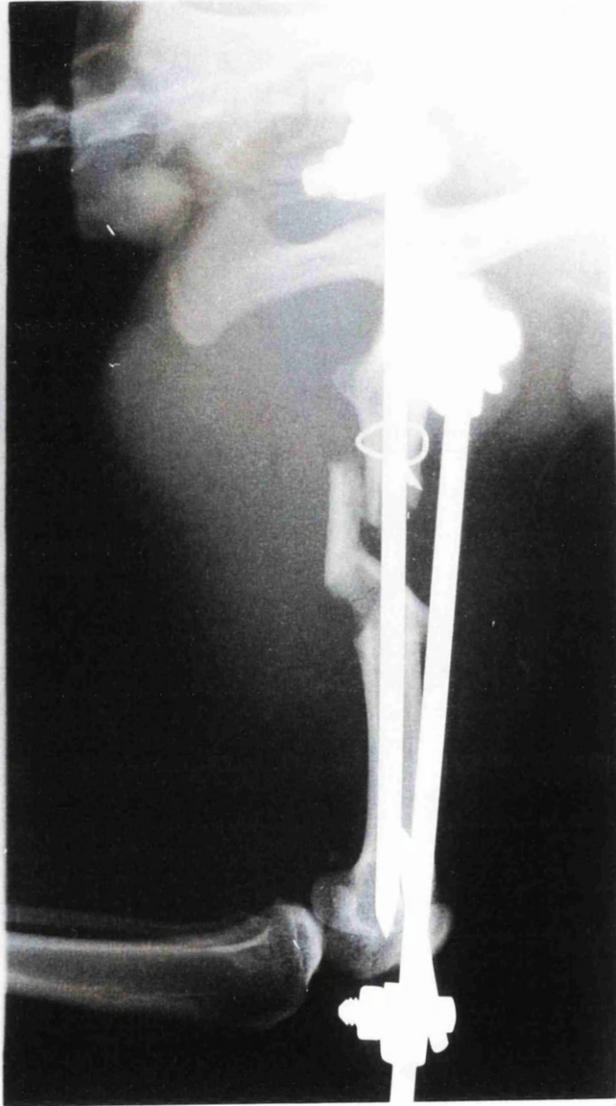
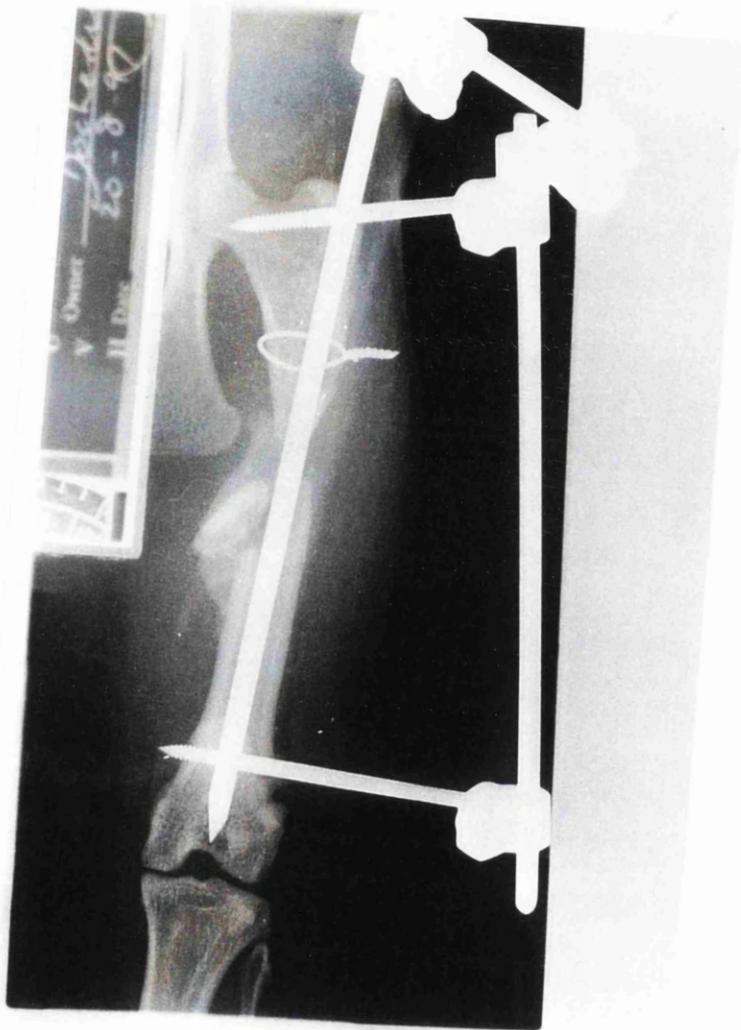
Figure 6.16.12 Radiographs taken at day 66 after fracture repair show that there is still no significant callus at the fracture site; however, the two small fragments seem less well defined than on the day 31 post operation. The density of the more distal fragment arouses suspicion of a possible sequestrum forming. A small amount of reaction is seen around the lateral end of the distal pin and minimal lucency is noted around the proximal pin at the level of the greater trochanter. Clinically, the animal could already bear weight on the fractured leg. **a**, lateral view, **b**, cranial view.

Radiographs taken at day 66 after fracture repair showed that there was still no significant callus at the fracture site; however, the two small fragments seem less well defined than on the day 31 post-operation. The density of the more distal fragment aroused suspicion of a possible sequestrum forming although the position of the fragment relative to the beam may be responsible. A small amount of reaction was seen around the lateral end of the distal pin and minimal lucency was noted around the proximal pin at the level of greater trochanter (figure 6.16.12). Clinically, the animal was already bearing weight on the fractured leg.

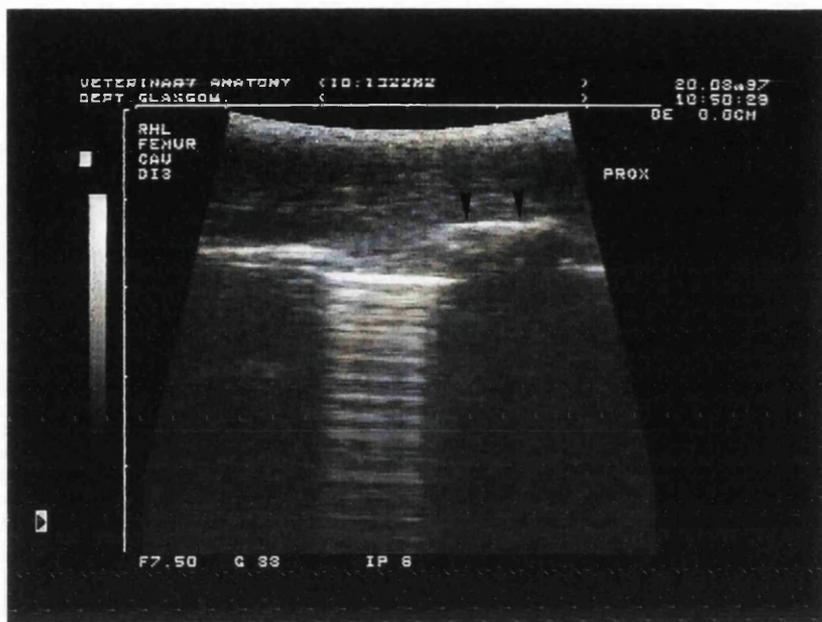
Figure 6.16.13 Longitudinal scan of the femur on day 66 after fracture repair demonstrates the fracture gap with an intramedullary pin and a bone fragment caudal to the femur (arrow heads). The intramedullary pin appears hyperechoic with reverberation artefact. There is no excessive callus formation at the fracture site.

Ultrasonographic examination demonstrated the fracture site with an intramedullary pin and a bone fragment caudal to the femur (figure 6.16.13). The bone fragment caudal to the femur at the fracture site area had started to coalesce with the main fragment. There was no excessive callus formation at the fracture site. The muscle structure appeared normal ultrasonographically. The muscle had reduced in size as shown by the small distance between the skin surface and the femur. The fracture gap was still present but the size had reduced slightly due to callus formation. On the cranial aspect scan, the fracture gap appeared small with callus formation at the end of both fragments which was trying to bridge the gap (figure 6.16.14). On the medial side, the bone fragment and the intramedullary pin were imaged (figure 6.16.15). No excessive callus formation was detected on the medial side.

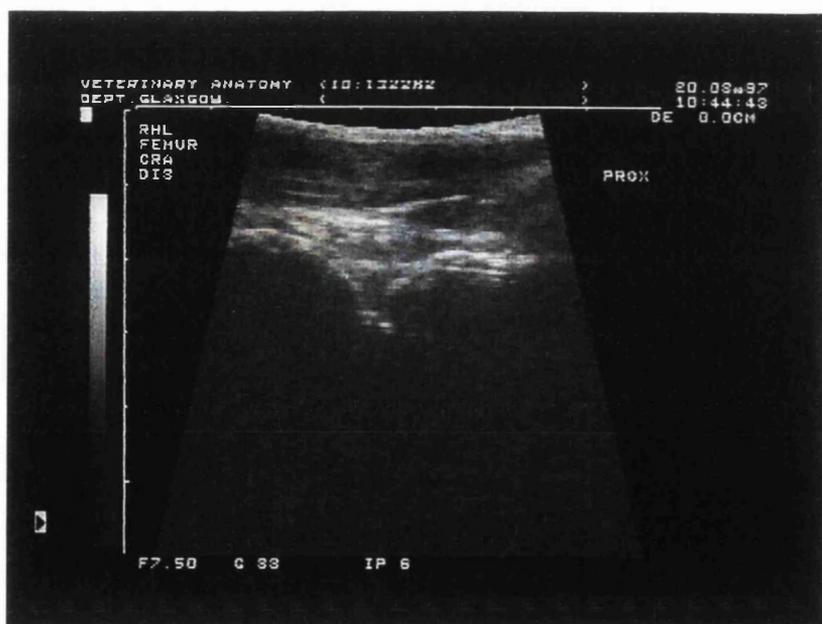
Figure 6.16.14 Longitudinal scan of the fracture site from the cranial aspect on day 66 after fracture repair shows the fracture gap which has become smaller with the callus formation at the end of both fragments. The callus formation is trying to bridge the gap.

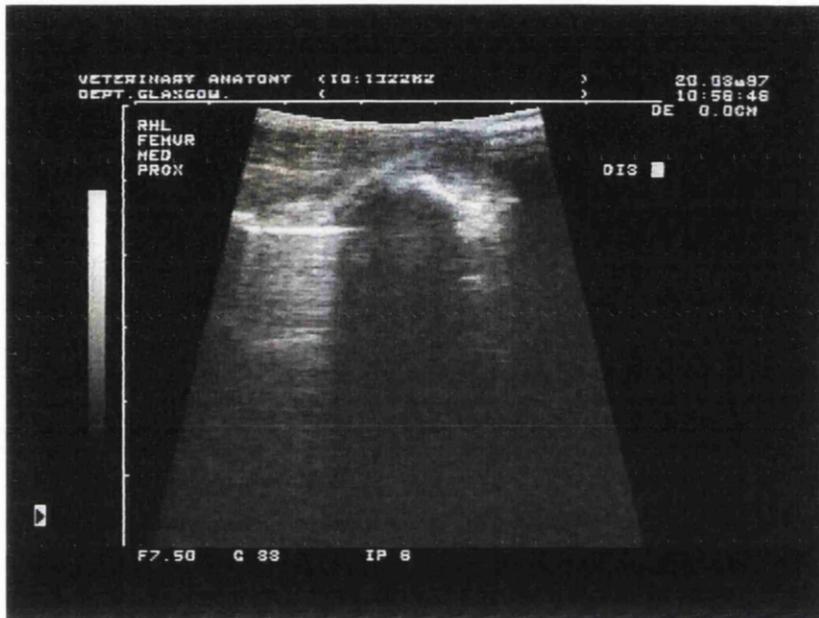
Figure 6.16.15 Longitudinal scan of the femur from the medial aspect on day 66 after fracture repair shows the fracture site area with the bone fragment and the intramedullary pin. There is no excessive callus formation detected.

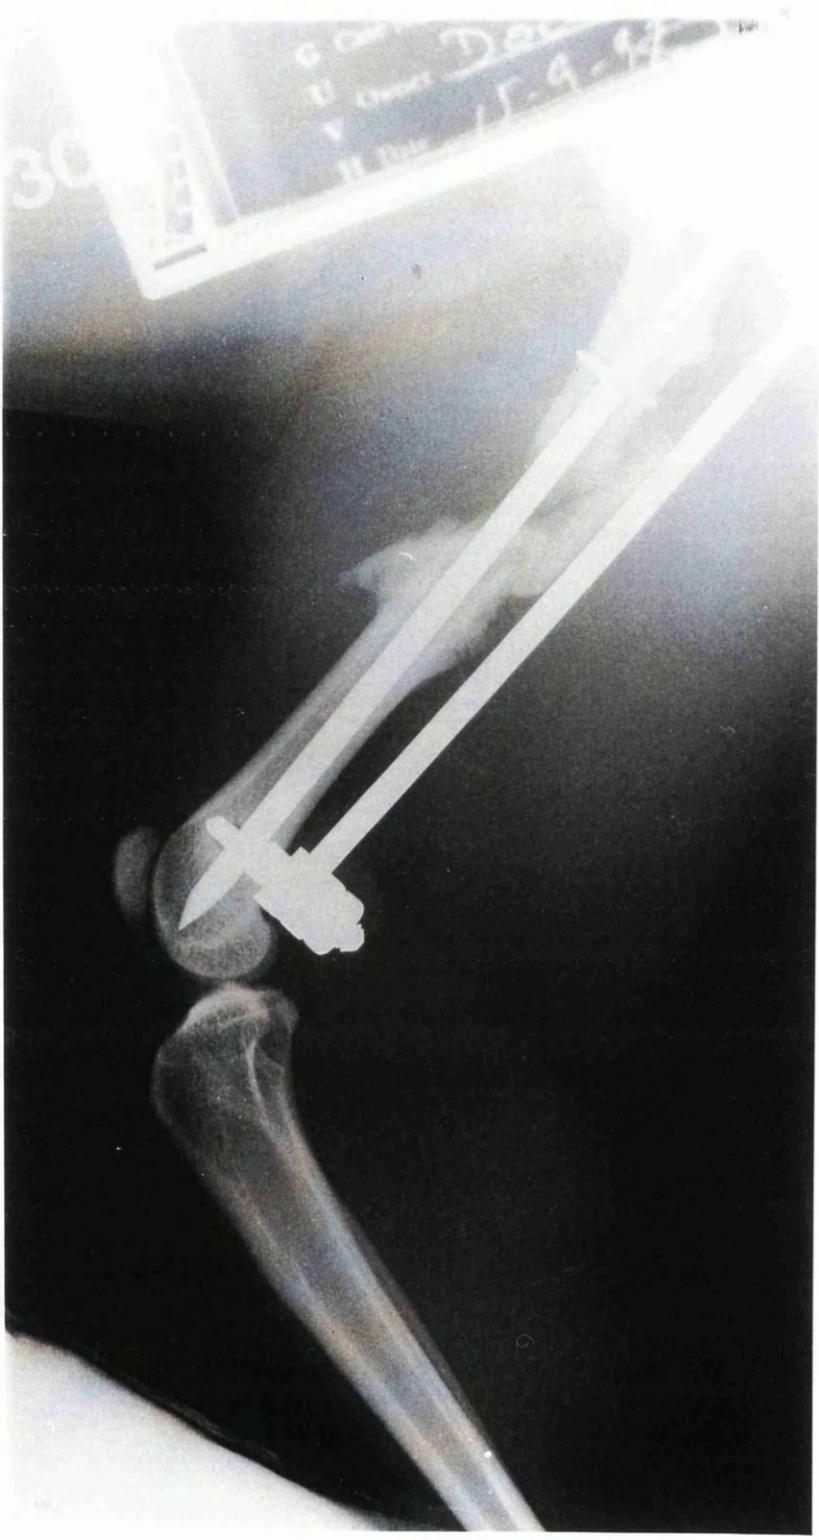
Figure 6.16.16 Radiograph taken at day 88 after fracture repair shows the implant has been modified since previous radiographs with removal of the proximal femoral fixator pin. This is because the proximal pin of the external fixator had loosened. Reaction and lucency are noted around the distal fixator pin laterally. Callus formation is bridging the fracture fragments caudally, but is limited cranioproximally.

Radiographs taken at day 88 after fracture repair showed the implant had been modified after previous radiographs with removal of the proximal femoral fixator pin. This was because the proximal pin of the external fixator had loosened. Reaction and lucency were noted around the distal fixator pin. Callus was bridging the fracture fragments caudally, but was limited cranioproximally (figure 6.16.16).

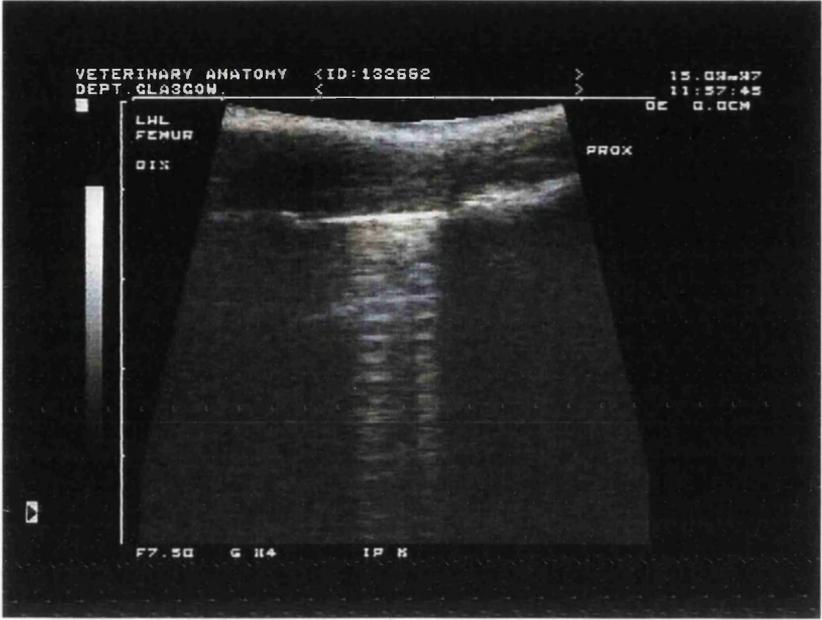
Figure 6.16.17 Longitudinal scan of the femur at the fracture site area on lateral scan at day 88 after fracture repair still shows the fracture gap with the intramedullary pin connecting the two fragments.

Ultrasonographic examination on day 88 after fracture repair still demonstrated the fracture gap with the intramedullary pin connecting the two fragments on a lateral scan (figure 6.16.17). The fracture gap appeared smaller than on the day 66 examination scans made previously and showed the presence of callus formation on a cranial aspect scan (figure 6.16.18). The fragments were not fully united on the cranial side. Transverse scan at the fracture site on the lateral aspect showed the femur with minimal callus formation and the intramedullary pin (figure 6.16.19). The intramedullary pin appeared as a small hyperechoic area with comet tail artefact. The muscle structure appeared to have a normal hypoechoic texture. On the caudal aspect the fracture gap appeared smaller than on the day 66 examination and was connected by the intramedullary pin (figure 6.16.20).

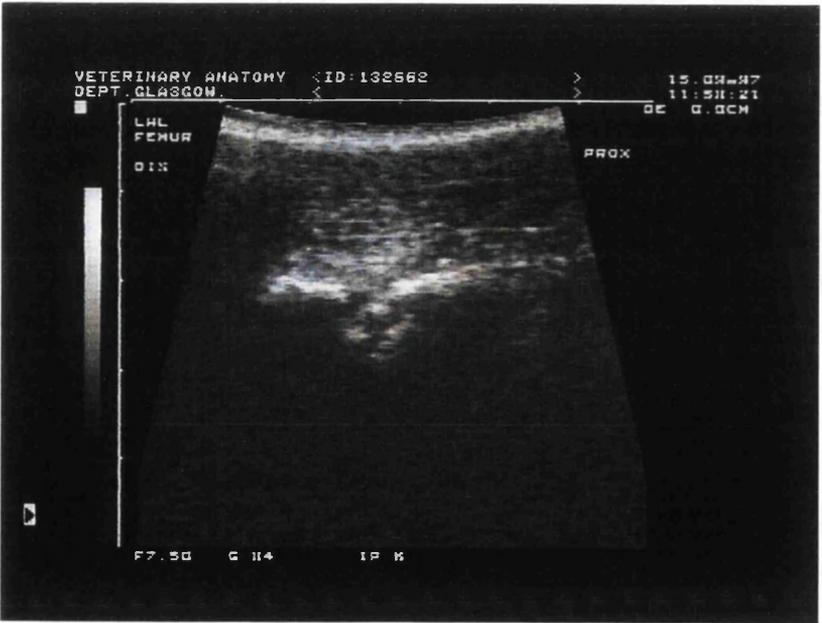
Figure 6.16.18 Longitudinal scan of the femur on cranial aspect on day 88 after fracture repair shows the fracture gap which is decreasing with the presence of callus formation within it.

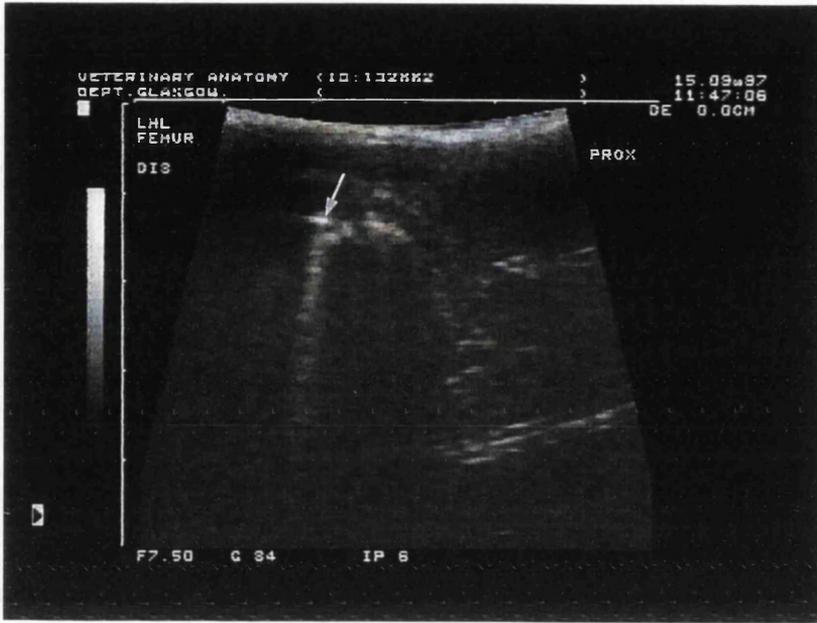
Figure 6.16.19 Transverse scan at the fracture site from the lateral aspect on day 88 after fracture repair shows the femur with minimal callus formation and the intramedullary pin (arrow). The intramedullary pin appears as a small hyperechoic mark with comet tail artefact. The muscle structure appears normal with an hypoechoic texture.

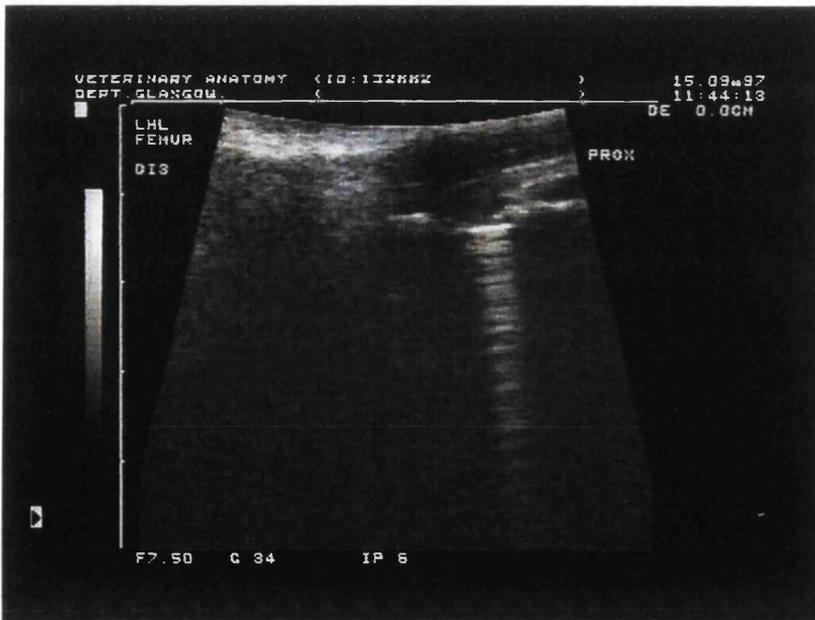
Figure 6.16.20 Longitudinal scan of the fracture site area from the caudal aspect on day 88 after fracture repair shows the fracture gap which appears smaller than in the previous scans. The intramedullary pin can still be seen.

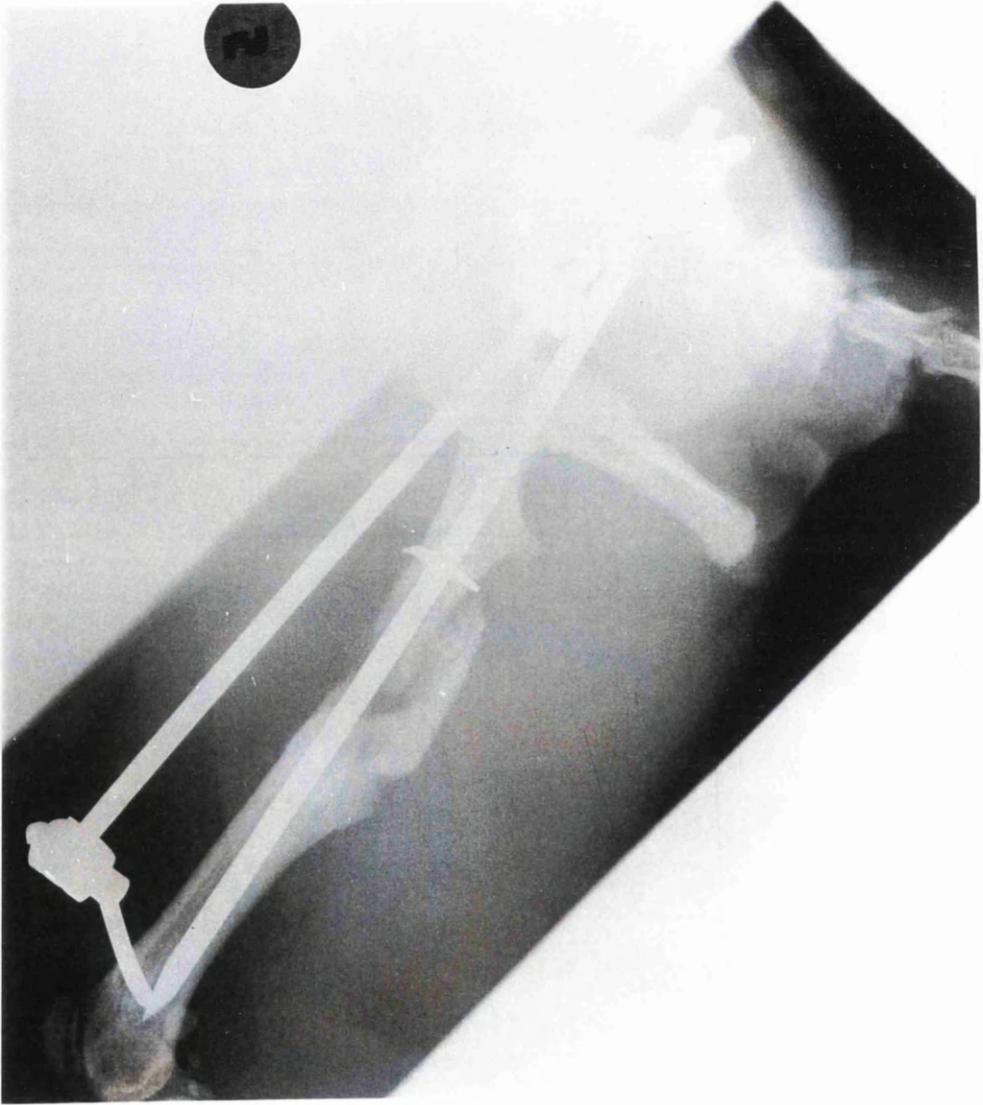
a

Figure 6.16.21 Radiographs taken at day 125 after fracture repair show there is non union and no significant callus formation at the fracture site. There is osteolucency around the pin. The external fixator has been removed at this time as the cat can use the leg and is bearing weight although there is no significant callus formation seen radiographically. It was believed that probably some weak callus had formed. **a**, lateral view, **b**, cranial view.

Figure 6.16.22 Longitudinal scan of the femur on day 125 after fracture repair demonstrates the fracture site which is being bridged by the callus on the lateral side. The small fracture gap can still be seen. This indicates that the callus formation is bridging the fracture site slowly. There is no excessive callus formation detected.

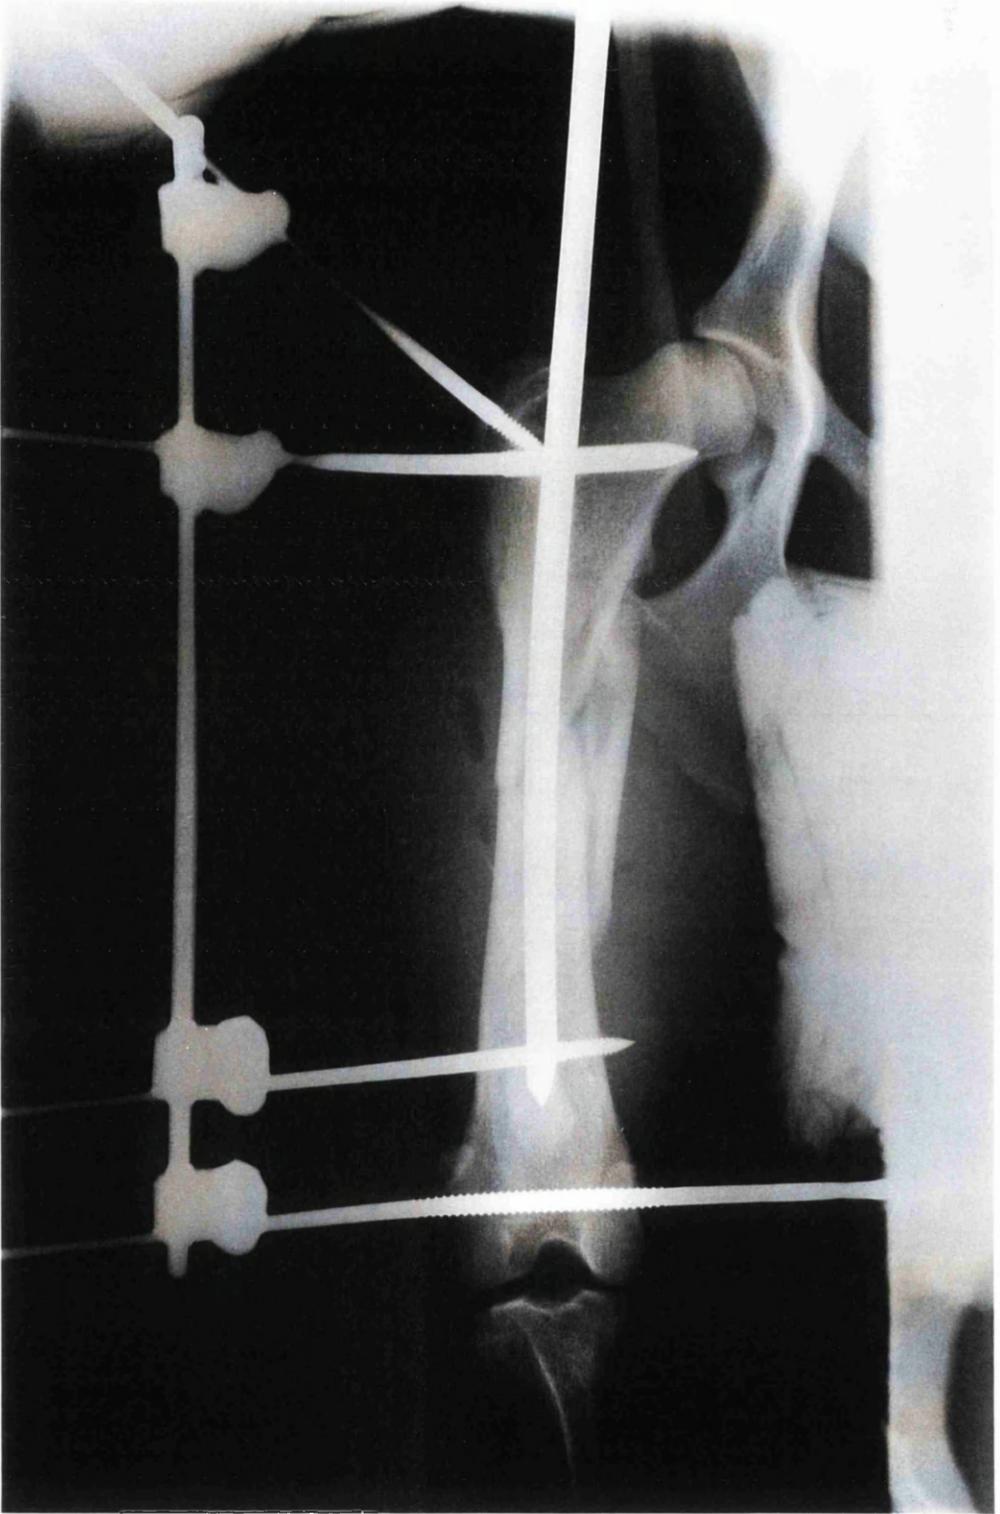
Figure 6.17.1 Radiograph obtained immediately after fracture repair. The fracture is reduced with an intramedullary pin tied in to a modified type two four pins external skeletal fixator. The repair process has resulted in good alignment of the fracture site. One fragment can be seen in situ adjacent to the main bone segments.

A two year old male Border Collie, weight 25 kg, was referred to the Glasgow University Veterinary Hospital having been found to be lame. The animal had no owner and the accident was believed to be due to jumping over a fence or wall. Radiographic examination revealed that a severely comminuted fracture of the femoral mid shaft of the left hind limb had been sustained. Fracture repair was carried out on the following day after admission and the fracture was stabilised with an intramedullary pin tied in to a modified type two four pins external skeletal fixator. Radiographs taken immediately after the fracture repair showed that the repair process had resulted in good alignment of the fracture site (figure 6.17.1). At least two fragments remained in situ adjacent to the main bone segments.

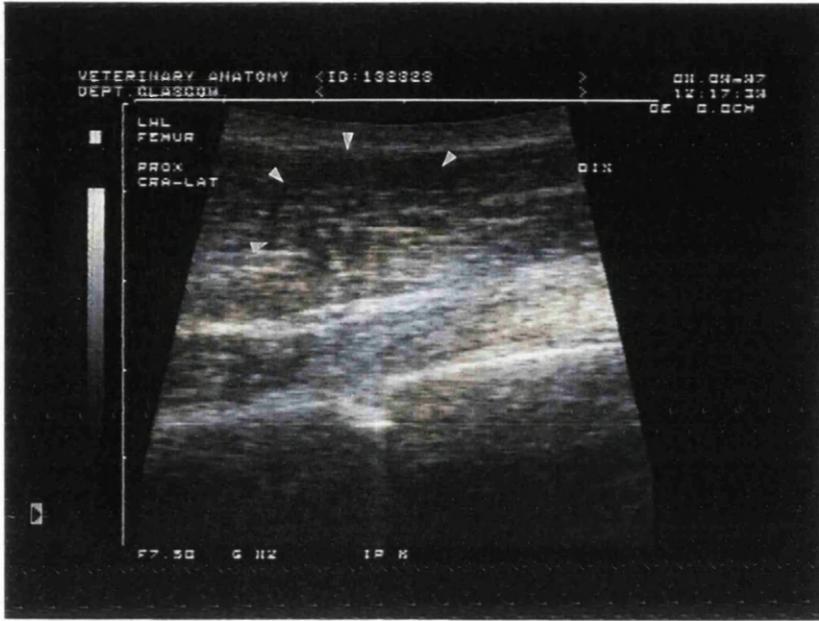
Figure 6.17.2 Longitudinal scan of the femur from the cranio-lateral aspect on day three after fracture repair demonstrates the fracture site with the presence of a small fracture gap. The fracture site appears hyperechoic with no callus formation present. Note also the area of muscle damage (arrow heads) lying above the fracture site which appears as a disorganised hypoechoic structure.

Ultrasonographic examination demonstrated the fracture site with the presence of a small fracture gap on the cranio-lateral aspect (figure 6.17.2). The fracture site appeared hyperechoic with no indication of soft callus formation being present. The muscle superficial to the fracture site appeared as a disorganised hypoechoic structure suggestive of an area of muscle damage. The fracture site scanned from the caudo-lateral aspect appeared as a defect on the bone surface but no significant gap was present (figure 6.17.3). The femur appeared smooth with no indication of soft callus formation on it, but the hyperechoic area at the fracture site was suggestive of early formation of the soft callus. A transverse scan from the cranio-lateral aspect revealed a small bone fragment caudal to the femur (figure 6.17.4). There were soft tissue and periosteal tissue reactions around the bone fragment beside the femur which appeared hyperechoic. The hyperechoic appearance of the area adjacent to the femur
