**AN ULTRASONOGRAPHIC STUDY OF MUSCULOSKELETAL
INJURIES AND MAMMARY GLAND TUMOUR IN SMALL
ANIMALS**

A thesis submitted to the Faculty of Veterinary Medicine,
University of Glasgow.

For the Degree of Doctor of Philosophy

Division of Veterinary Anatomy,
Department of Veterinary Preclinical Studies,
School of Veterinary Medicine,
University of Glasgow,
March, 1999

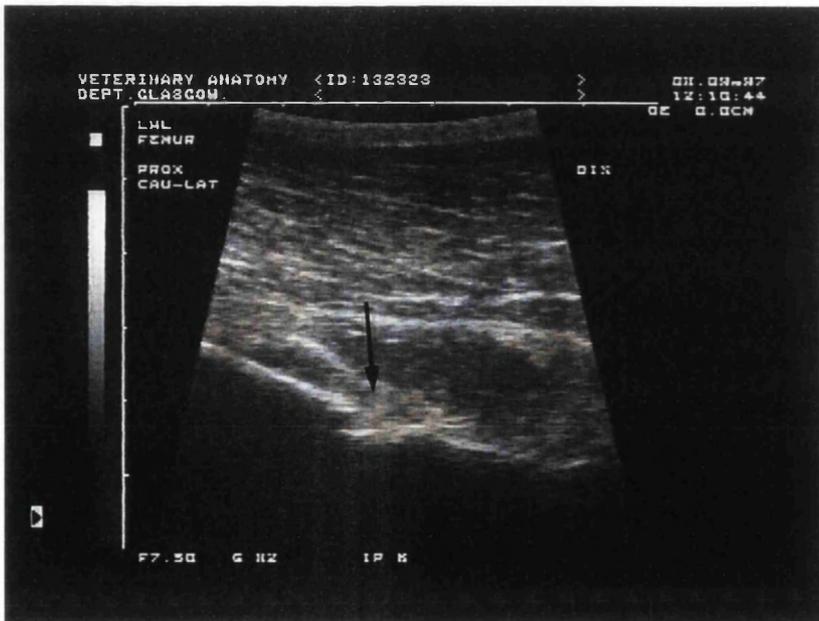
Figure 6.17.3 Longitudinal scan of the femur from the caudo-lateral aspect on day three after fracture repair shows the fracture site (arrow) which appears as a defect on the bone surface but no significant gap is present. Note also that the femur appears smooth with no indication of soft callus formation on it, but the hyperechoic area at the fracture site is suggestive of early formation of soft callus.

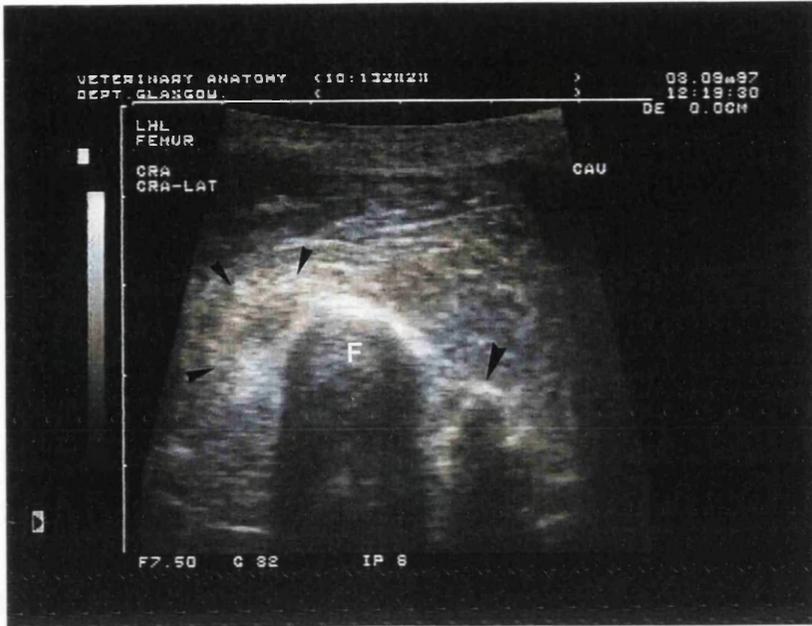
Figure 6.17.4 Transverse scan from the cranio-lateral aspect of the femur on day three after fracture repair demonstrates the femur and a small bone fragment (large arrow head) placed caudally near to the femur. There is soft tissue and periosteal tissue reactions around the bone fragment which appears hyperechoic. The area with an hyperechoic appearance adjacent to the femur cranially (small arrow heads) is suggestive of soft tissue reaction. Note also that the area of muscle damage appears as a disorganised hypoechoic structure superficial to the soft tissue reaction. F, femur.

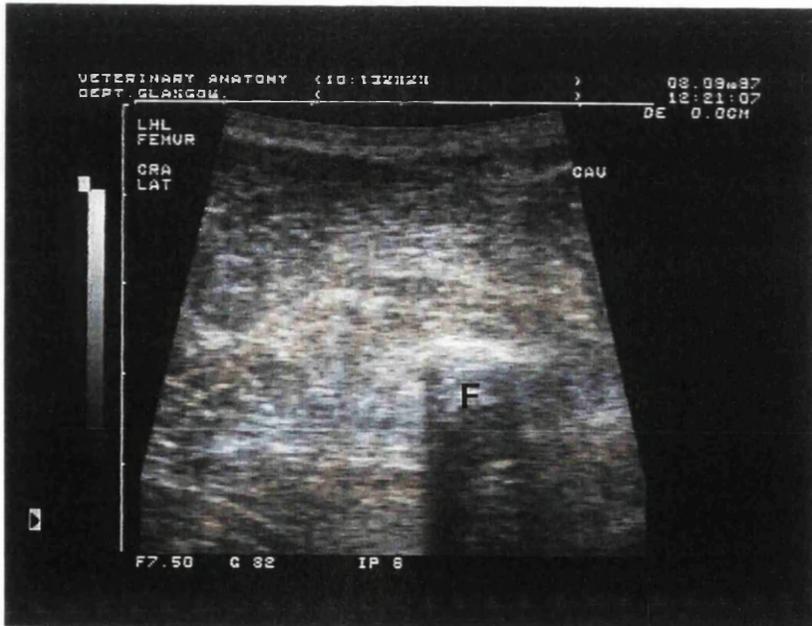
Figure 6.17.5 Transverse scan from the lateral aspect at the fracture site area on day three after fracture repair shows an abnormal femur with an hyperechoic appearance. Note there is no callus formation present. F, femur.

cranially was suggestive of an area of soft tissue reaction. The area of muscle damage appeared as a disorganised hypoechoic structure. The fracture site imaged on a transverse scan from the lateral aspect appeared as an abnormal femur with an hyperechoic appearance (figure 6.17.5). No callus formation was detected.

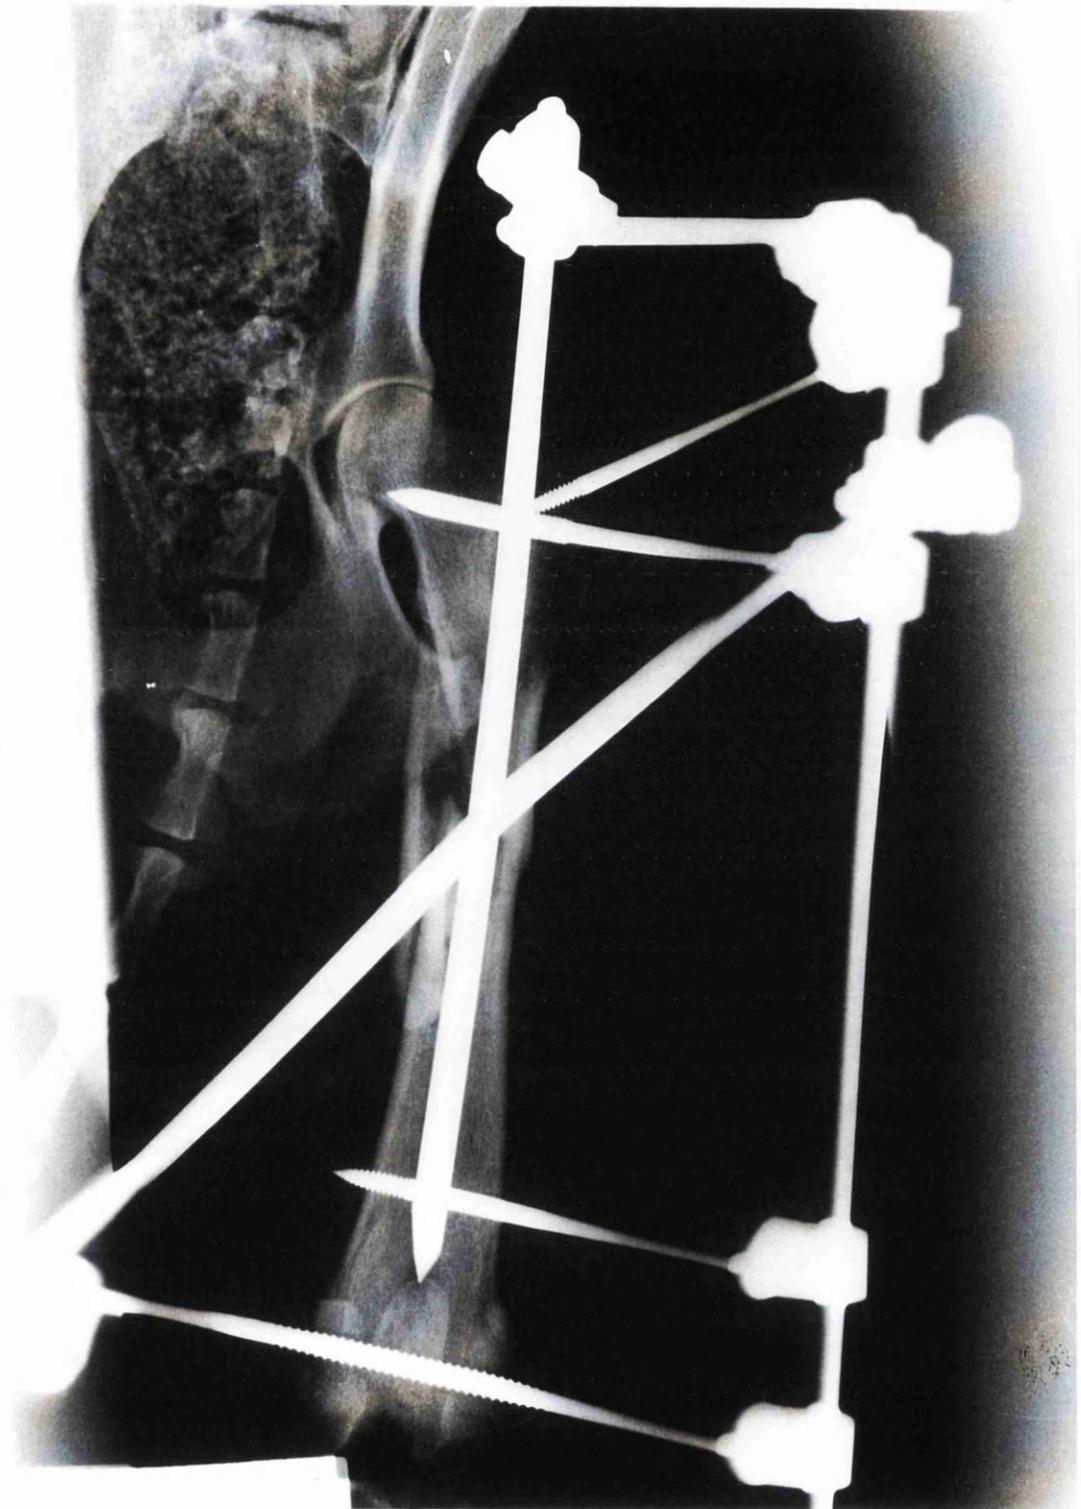
Figure 6.17.6 Radiograph taken at day 54 after fracture repair shows there is no bony callus formation, and there is insufficient reduction and alignment.

Radiograph taken at day 54 after fracture repair showed there was no bony callus formation, and there was insufficient reduction and alignment (figure 6.17.6).

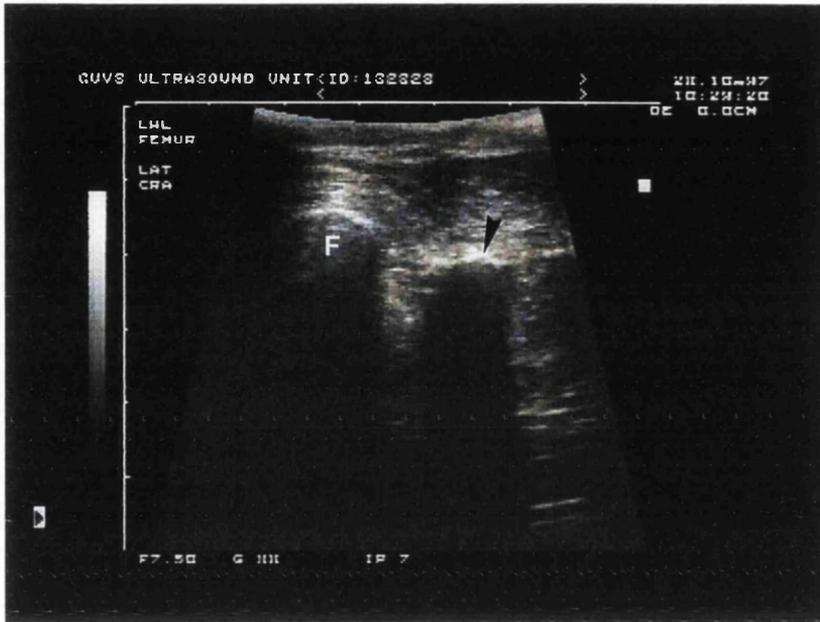
Figure 6.17.7a

Figure 6.17.7 Transverse scans at the mid femoral shaft from the lateral aspect on day 54 after fracture repair demonstrate **a**, that the distal portion of the bone fragment on the caudal side (arrow head) is separated by a space, and **b**, that the fragment appears to coalesce with the femur toward the proximal end. Note also there is no excessive callus formation present at the fracture site. The overlying muscles have a normal ultrasonographic appearance. **F**, femur.

Ultrasonographic examination at the mid shaft of the femur on a transverse scan from the lateral aspect demonstrated the distal end of the bone fragment which was separated from the femur by a small space (figure 6.17.7a), and the fragment appeared to have coalesced with the femur toward the proximal end of the fragment (figure 6.17.7b). There was no excessive callus formation detected at the fracture site. The muscle structure appeared to have normal ultrasonographic characteristics. Similarly, on the medial aspect, a transverse scan of the mid femoral shaft showed that the distal end of the fragment was separate from the femoral shaft (figure 6.17.8a), and had coalesced with the femur toward the proximal end of the fragment (figure 6.17.8b). The intramedullary pin at the fracture site imaged from the medial aspect appeared hyperechoic with reverberation artefact, connecting the two bone fragments (figure 6.17.9). The distal fragment appeared elevated from the proximal fragment on the medial aspect scan. The femur appeared smooth and no callus

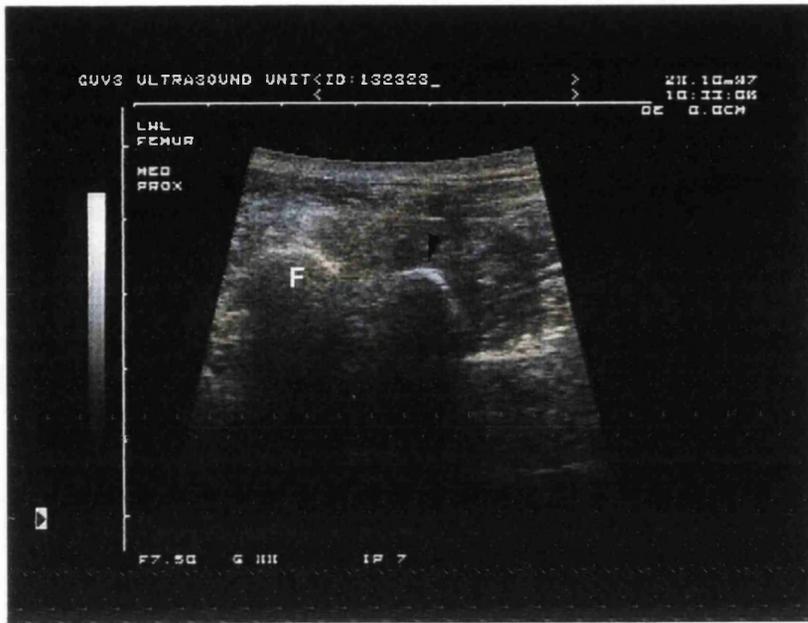
Figure 6.17.8a

Figure 6.17.8 Transverse scans of the mid femoral shaft from medial aspect on day 54 after fracture repair show the same bone fragment (arrow head) as in figure 18.7. The distal end of the fragment appears separate from the femoral shaft (a), and the proximal end appears to coalesce with the femur (b). F, femur.

Figure 6.17.8	Transverse scans of the mid femoral shaft from the medial aspect on day 54 after fracture repair show the same bone fragment as in figure 18.7 (case 17).	424
Figure 6.17.9	Longitudinal scan of the femur at the fracture site area from the medial aspect on day 54 after fracture repair shows the intramedullary pin which connects the two bone fragments (case 17).	425

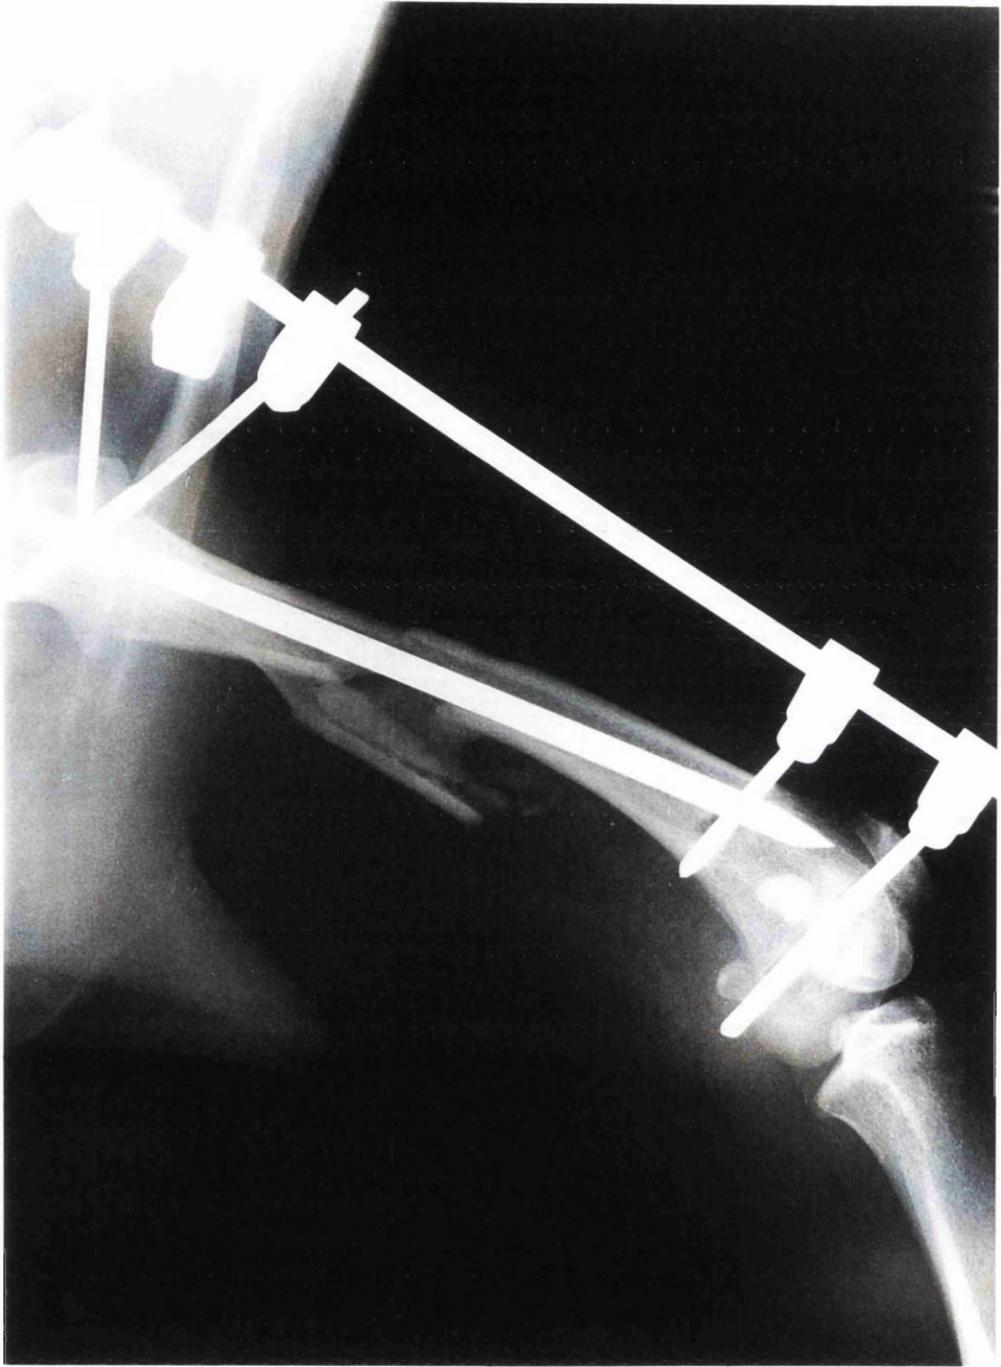
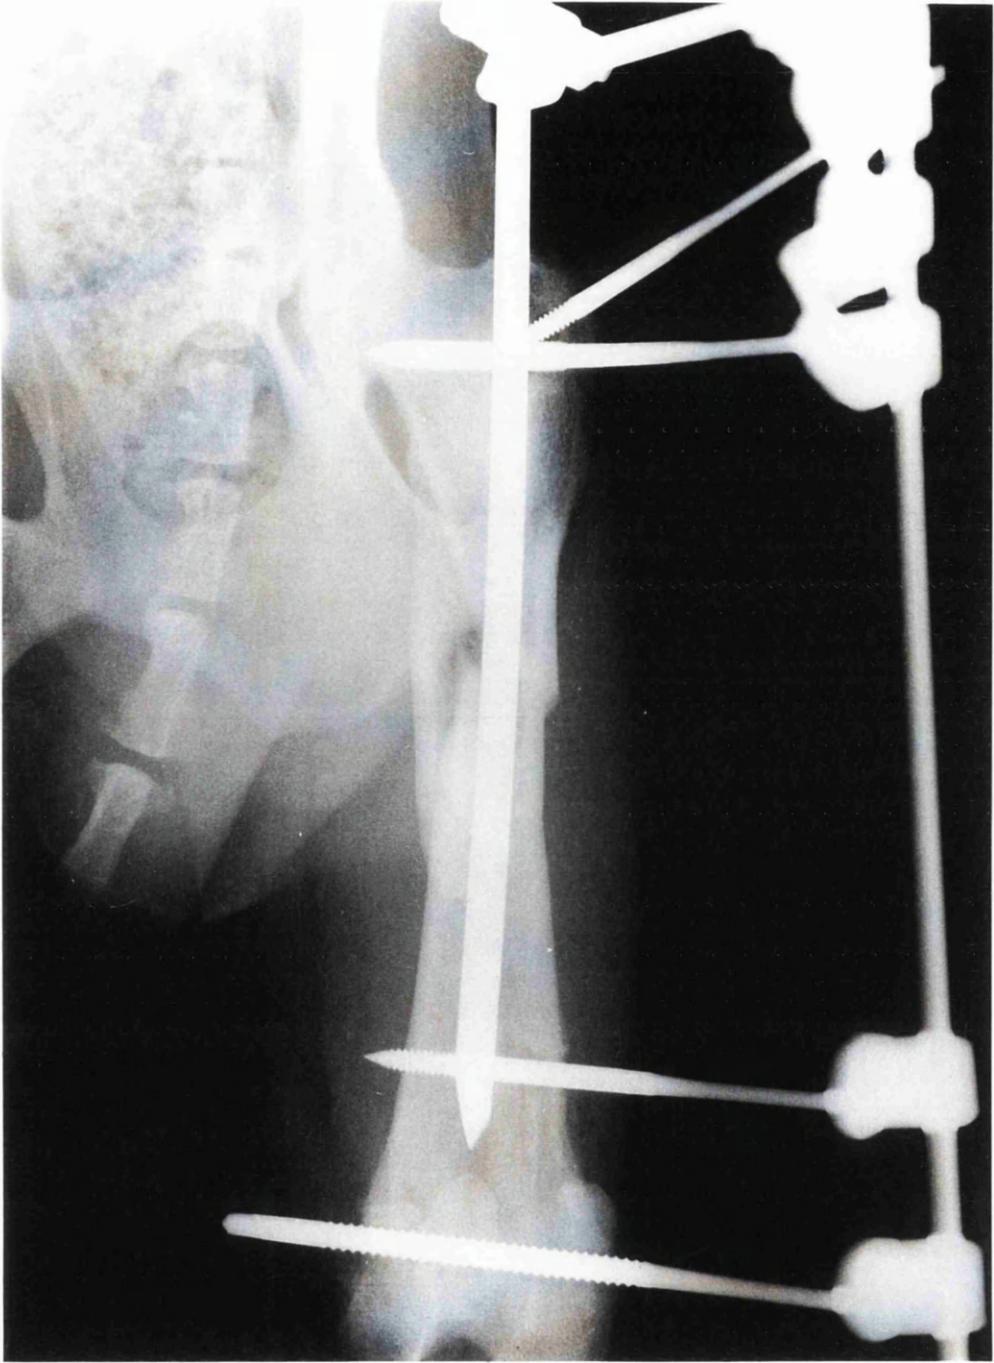
Figure 6.17.11 Radiographs taken at day 75 after fracture repair show that there is no improvement in the fracture healing process as compared to the previous radiographs. **a**, caudolateral view, **b**, cranial view. The distal pin has been removed at this time as it had become loose.

Radiographs taken at day 75 after fracture repair showed that there was no improvement in the fracture healing process as compared to the previous radiographs (figure 6.17.11). The distal pin was removed at this time as it had become loose.

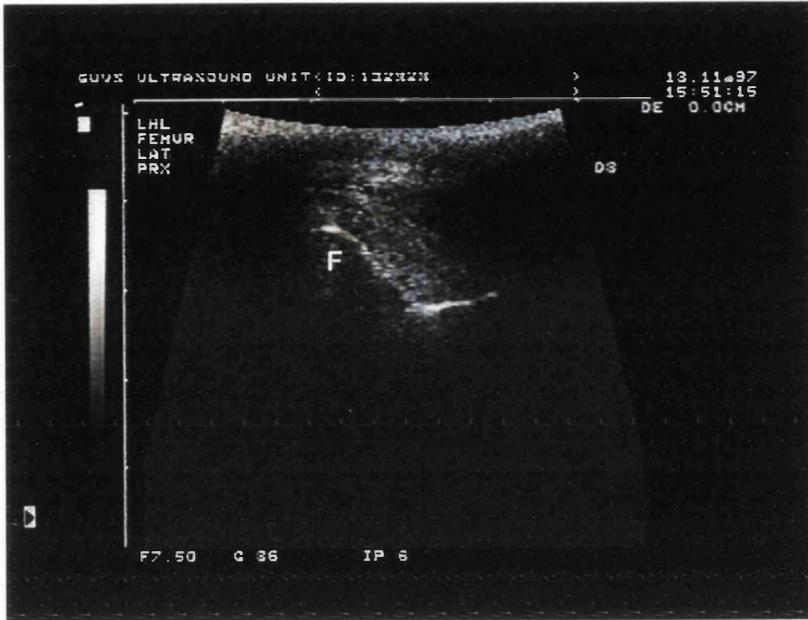
Figure 6.17.12a

Figure 6.17.12 Transverse scans of the fracture site area from the lateral aspect on day 75 after fracture repair show the smooth bone surface with no excessive callus formation. **a**, the femur and the proximal portion of the bone fragment caudal to the femur appears smooth suggestive of a remodelling process. **b**, the distal end still appears as nonunion with the femur, but soft callus formation can be seen attached to the femur and appears hyperechoic. This indicates that the healing process is in progress.

Ultrasonographic examination of the fracture site area found that there was no excessive callus formation. The femoral surface appeared hyperechoic and smooth. The femur and the proximal portion of the bone fragment on the caudal side that had coalesced with the femoral shaft appeared smooth suggestive of a remodelling process (figure 6.17.12a). However, the distal end still appeared as nonunion with the femoral shaft (figure 6.17.12b), but soft callus formation which appeared hyperechoic attached to the femoral shaft on the caudal side could be seen within the space between them. This suggested that the healing process was in progress. The muscle structure appeared as having normal ultrasonographic characteristics. The distal pin of the external fixator had been removed after the radiographic examination. Thus, on the ultrasonographic scan one hole was found on the femur representing the former site of the pin. The hole appeared hyperechoic with soft tissue and periosteal tissue reactions around it (figure 6.17.13). The anechoic area with some echogenic material within lying above the hole is suggestive of blood or fluid accumulation. A

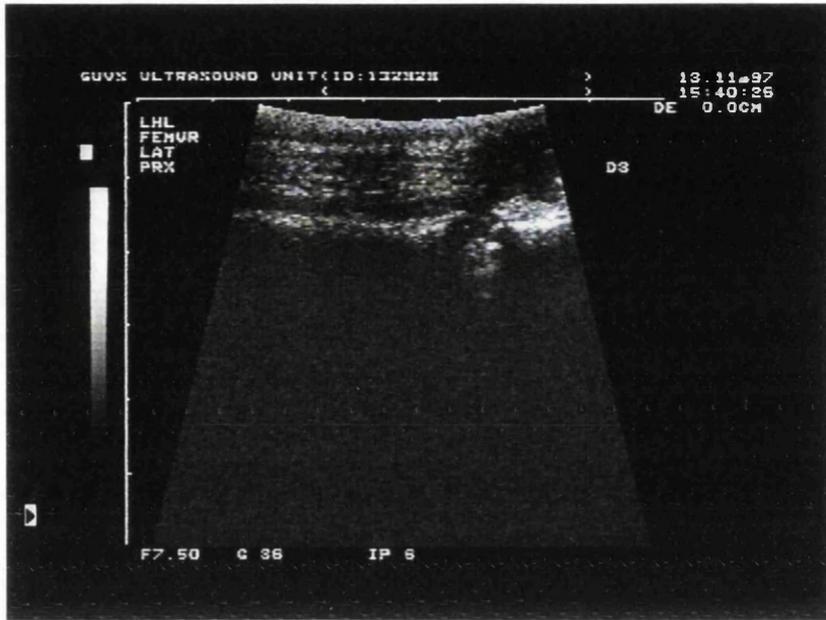
Figure 6.17.13 Longitudinal scan of the distal femur after the distal pin of the external fixator has been removed demonstrates the hole in the femur. There are soft and periosteal tissues reactions around the hole. Note that the anechoic area with some echogenic material within above the hole is suggestive of blood or fluid accumulation.

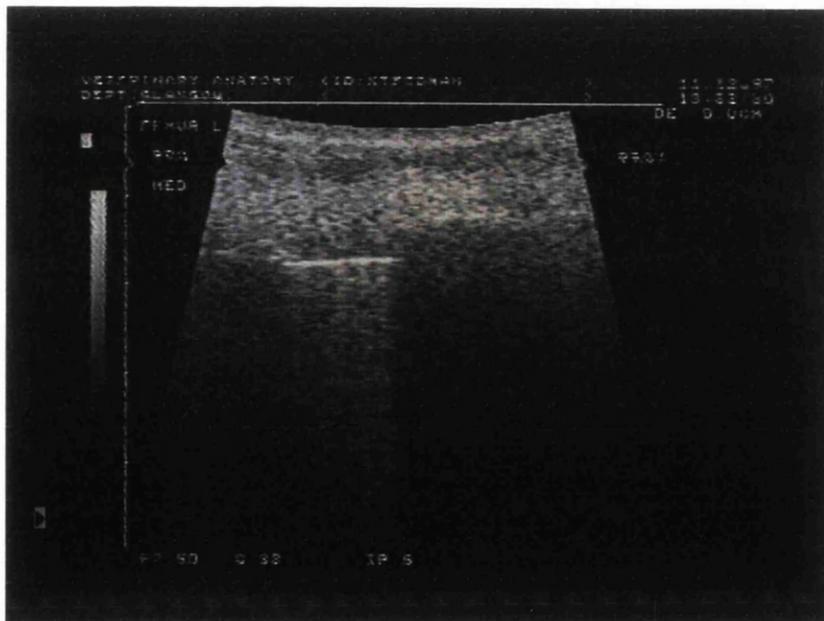
Figure 6.17.14 Longitudinal scan of the femur from the medial aspect at the fracture site area on day 75 after fracture repair shows the intramedullary pin which can still be seen appearing hyperechoic with reverberation artefact.

transverse scan on the medial aspect of the femur showed the bone fragment on the caudal side as imaged on the day 54 after fracture repair. The intramedullary pin could still be seen, appearing hyperechoic with reverberation artefact on a longitudinal scan from the medial aspect (figure 6.17.14).

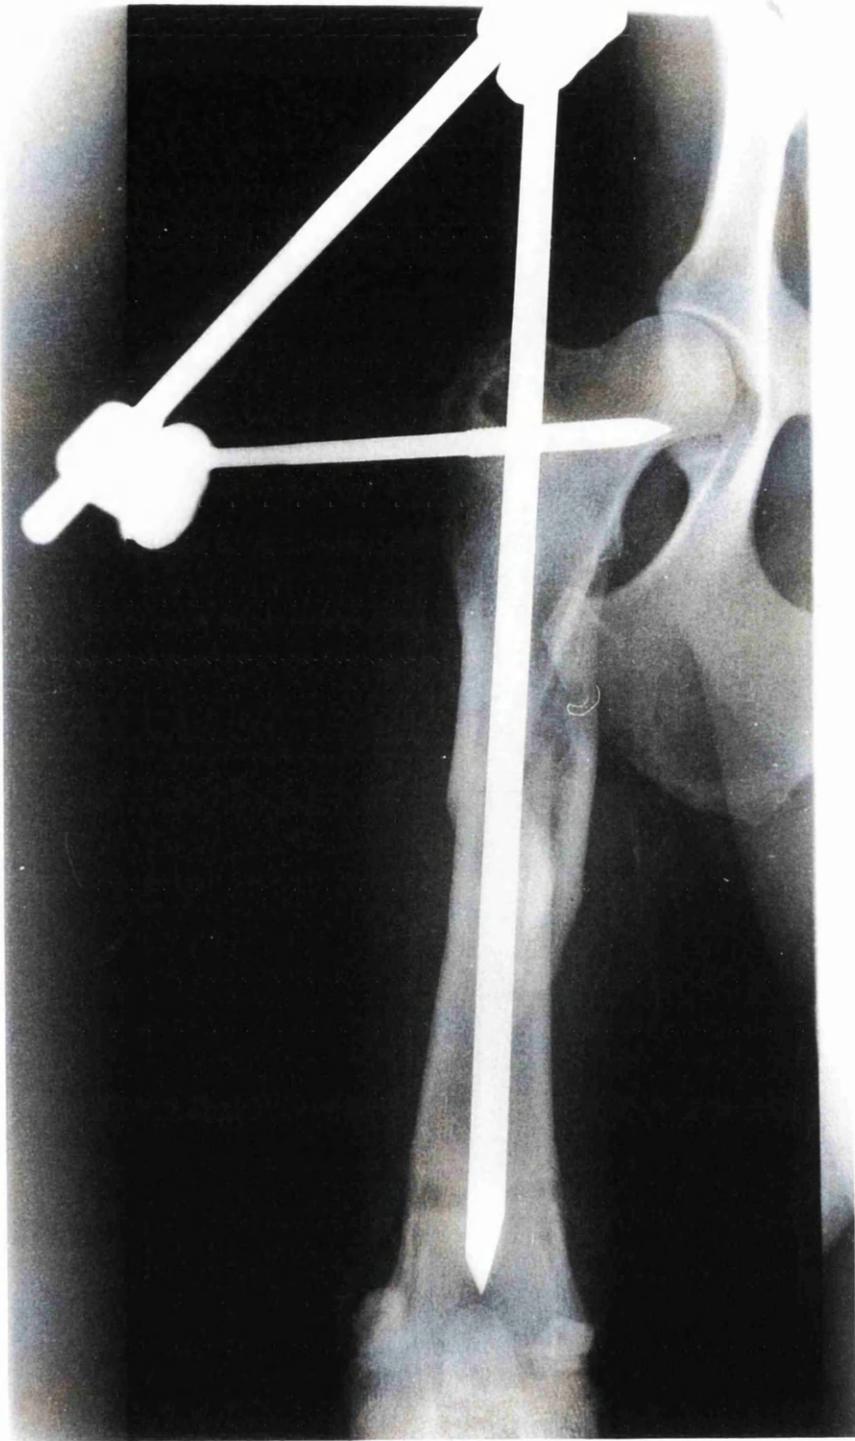
b

Figure 6.17.15 Radiographs taken at day 98 after fracture repair show that there is evidence of bony callus formation as compared with the previous radiographs although this is not complete. **a**, caudolateral view, **b**, cranial view. There is also osteolucency around the remaining pin and the holes of the previous distal pin are still osteolucent.

Radiographs taken at day 98 after fracture repair showed that there was evidence of bony callus formation as compared to the previous radiographs although this was not complete. There was also osteolucency around the remaining pin and the holes of the previous distal pin were still osteolucent (figure 6.17.15).

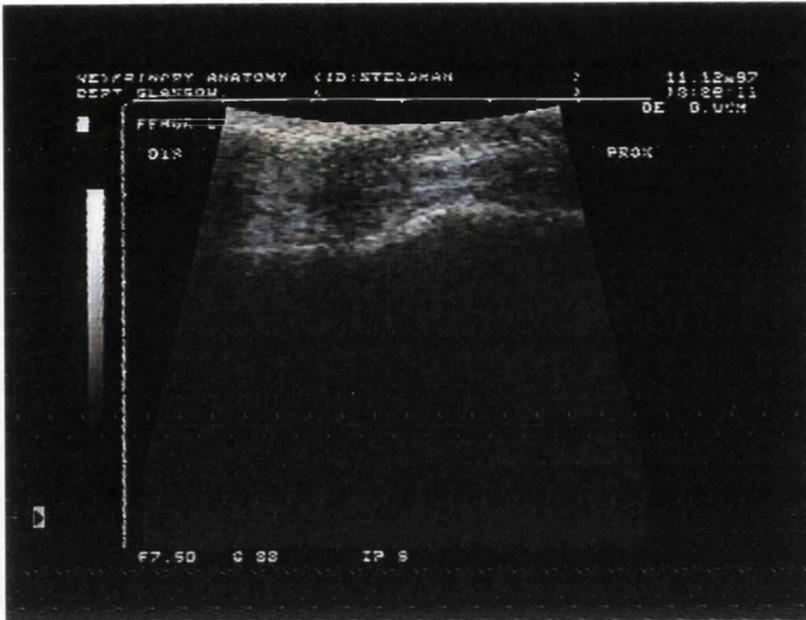
Figure 6.17.16 Longitudinal scan of the femur from the medial aspect on day 98 after fracture repair shows the bulging femoral surface with a smooth appearance suggestive of a remodelling process. The muscle structure appears to have normal hypoechoic characteristics.

Ultrasonographic examination revealed the bulging but smooth bone surface which suggested a remodelling process (figure 6.17.16). The muscle structure appeared to have normal hypoechoic characteristics. A transverse scan of the femur on the caudo-lateral aspect at the fracture site area revealed an abnormal appearance with the bone fragment lying superficial to the femur (figure 6.17.17). The femur below the bone fragment appeared to have a smooth surface showing the remodelling process. The intramedullary pin could still be seen from the medial aspect connecting the two bone fragments. The intramedullary pin appeared hyperechoic with reverberation artefact. There was bulging bone at the end of both fragments which was due to callus formation, but appeared smooth suggestive of a remodelling process (figure 6.17.18).

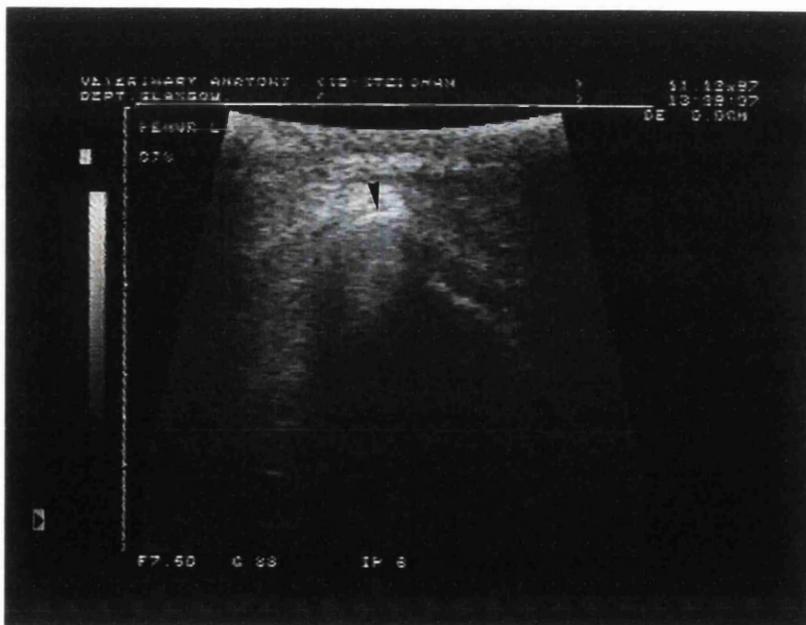
Figure 6.17.17 Transverse scan of the fracture site area from the caudo-lateral aspect on day 98 after fracture repair shows the abnormal appearance of the femur. Note the bone fragment lying superficial to the femur (arrow head) appears hyperechoic with shadowing artefact. This causes incomplete imaging of the femur below it. The femur appears to have a smooth appearance showing a remodelling process.

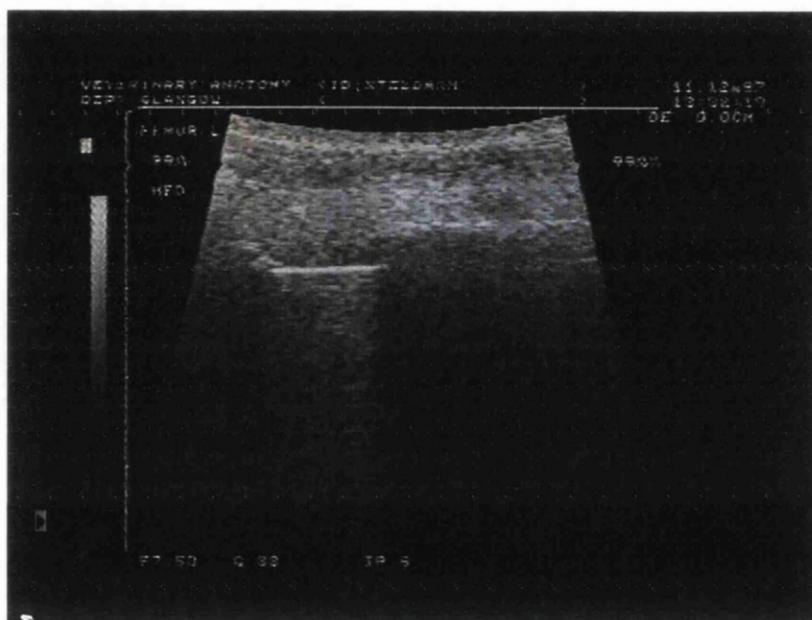
Figure 6.17.18 Longitudinal scan of the fracture site area on the medial aspect at day 98 after fracture repair shows the fracture gap with the intramedullary pin connecting the two bone fragments. The intramedullary pin appears hyperechoic with reverberation artefact. Note also there is bulging bone at the end of both fragments which is due to callus formation, but it appears smooth suggesting a remodelling process.

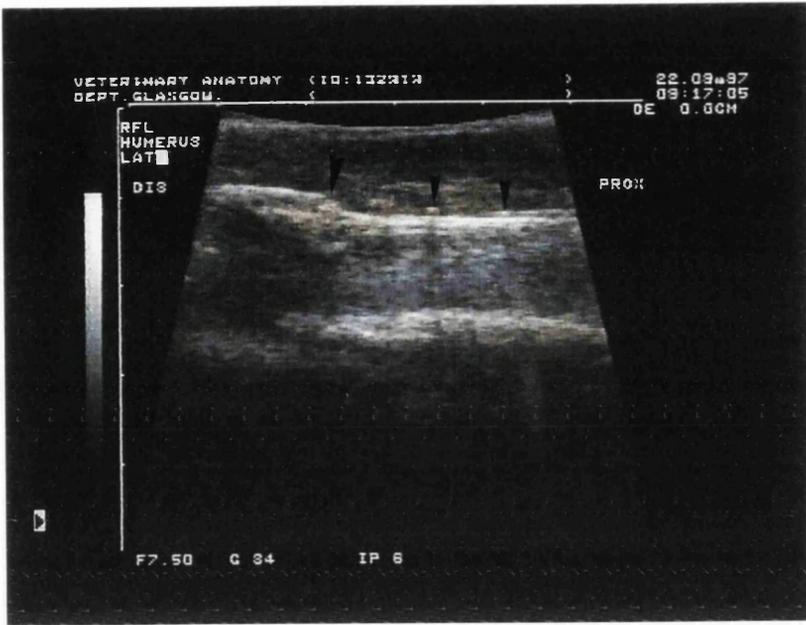
Figure 6.18.2 Longitudinal scan from the lateral aspect of the femur on day three after fracture repair demonstrates the fracture site (large arrow head) which appears well aligned with no fracture gap present. The distal fragment appears slightly elevated compared with the proximal one. Note also that the two cerclage wires (small arrow heads) near the fracture site appear as two small hyperechoic structures producing comet tail artefact.

Ultrasonographic examination demonstrated the fracture site which appeared well aligned with no fracture gap present on a lateral aspect scan (figure 6.18.2). The distal fragment appeared slightly elevated compared with the proximal one. The cerclage wires near the fracture site appeared as two small hyperechoic structures producing comet tail artefacts. By adjusting the transducer, the fracture site was imaged with a small portion of the proximal fragment being seen to over ride the distal fragment. There was no callus formation detected at the fracture site at this stage. However, the soft callus formation was detected on the bone surface at some distance from the fracture site. It developed at the area adjacent to the cerclage wires and appeared as two hyperechoic areas attached to the bone surface (figure 6.18.3). No artefact was produced by this hyperechoic material. The bone surface deep to the soft callus was still visible.

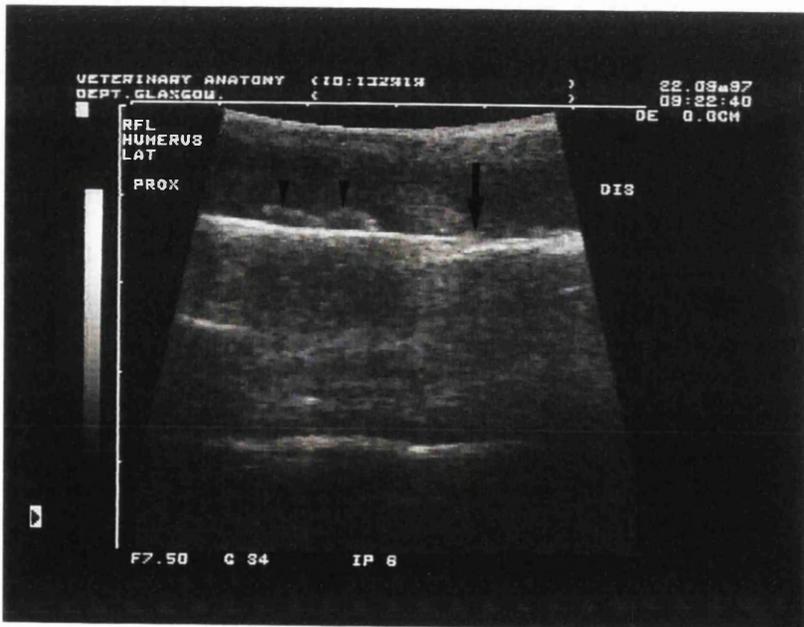
Figure 6.18.3 Longitudinal scan of the femur on day three after fracture repair shows the fracture site (arrow) which appears as a small portion of the proximal fragment slightly overriding the distal fragment. Note also the soft callus formation some distance from the fracture site (arrow heads) which appears as two hyperechoic areas but with no shadow artefact produced. The bone deep to the soft callus is still clearly visible.

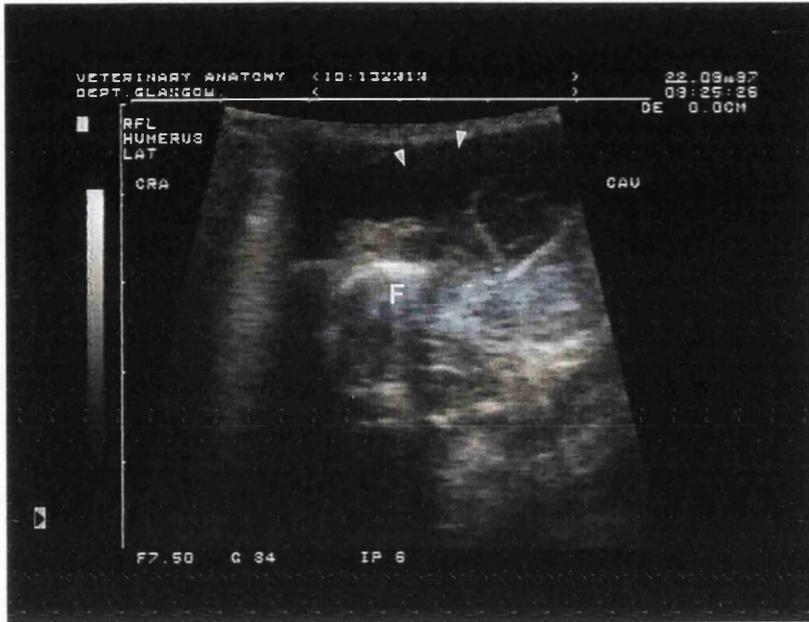
Figure 6.18.4 Transverse scan of the femur near the fracture site area on day three after fracture repair shows the femur which appears hyperechoic and the area of soft tissue reaction above the femur which appears as a disorganised hyperechoic structure. Note also that the area of muscle damage appears as a disorganised hypoechoic structure (arrow heads). F, femur.

The femoral surface appeared hyperechoic and the area of soft tissue reaction above the femur appeared as a disorganised hyperechoic structure on transverse scan (figure 6.18.4). An area of muscle damage appeared as a disorganised hypoechoic area. A further transverse scan of the fracture site revealed an abnormal femur which had lost its normal rounded shape (figure 6.18.5).

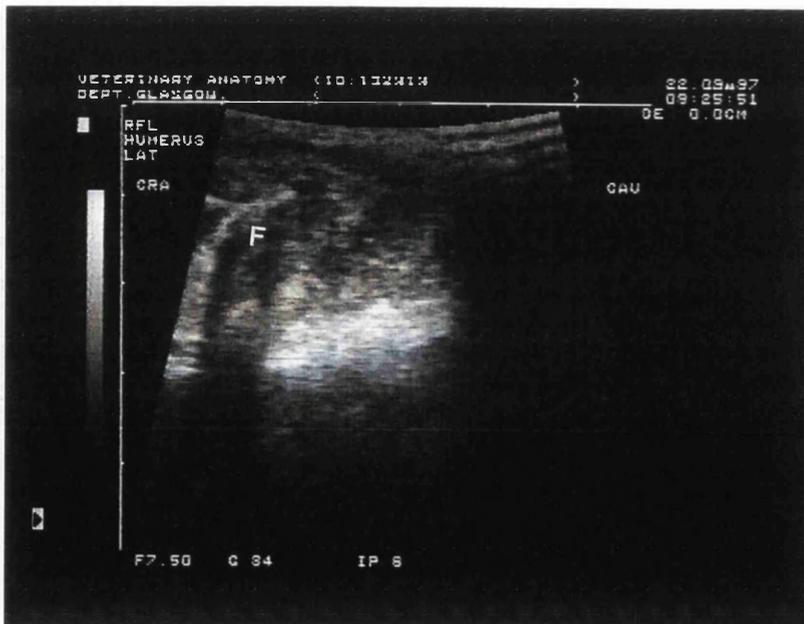
Figure 6.18.5 The fracture site on transverse scan appears as an abnormal femur which has lost its normal rounded shape. F, femur.

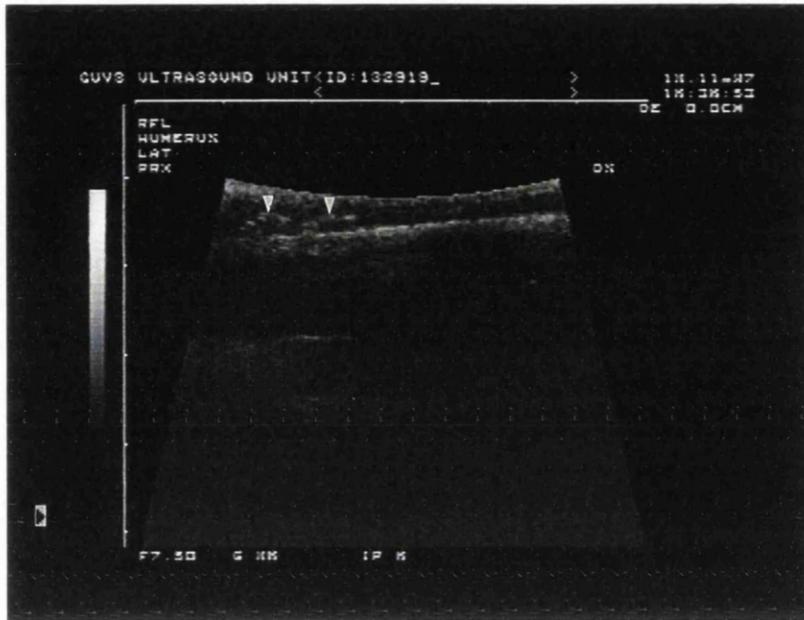
Figure 6.18.6 Longitudinal scan of the femur at the fracture site area from the lateral aspect on day 60 after fracture repair demonstrates a smooth bone surface. The fracture site is no longer detected. Note also the two hyperechoic areas suggestive of soft callus formation as seen on day three after fracture repair are still present and appear more echogenic than on the day three examination (arrow heads). The muscle has reduced in size as shown by a decrease in the distance between the skin surface and the femur which is due to muscle atrophy.

Ultrasonographic examination on the lateral aspect demonstrated the area of the fracture site which had already been bridged by the mature callus. The two cerclage wires still appeared as small hyperechoic structures and produced comet tail artefact. The muscle had reduced in size and had become smaller than imaged on the day three examination as shown by the decreased distance between the skin surface and the femur. This could have been due to muscle atrophy. The two hyperechoic areas which were seen on day three after fracture repair being suggestive of soft callus formation were still present and appeared more echogenic than on the day three examination (figure 6.18.6). The fracture site with a small gap was imaged on the medial aspect (figure 5.18.7). The intramedullary pin could be seen within the fracture gap and appeared hyperechoic with comet tail artefact. The femur when scanned transversely appeared as a round hyperechoic structure with acoustic shadowing artefact. It has returned to the normal shape.

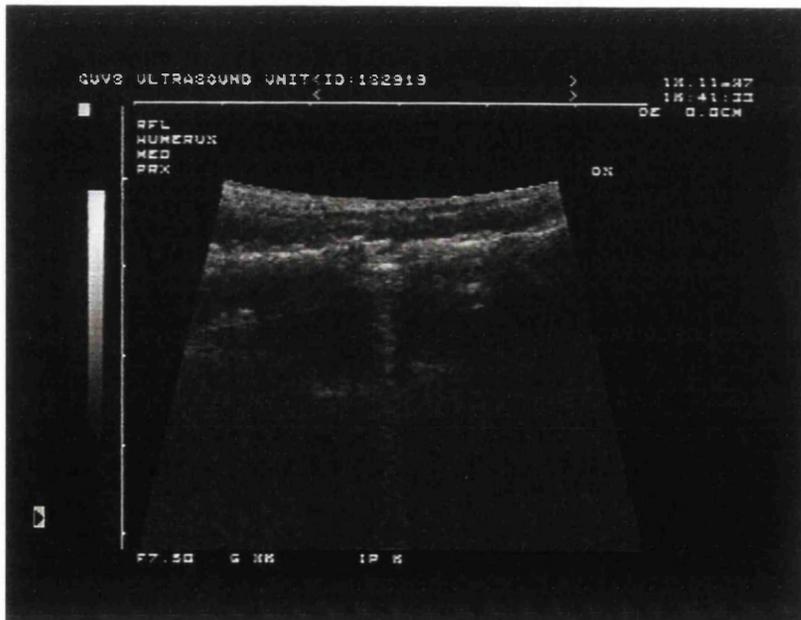
Figure 6.18.7 Longitudinal scan of the femur on the medial aspect on day 60 after fracture repair shows the fracture site with a small gap still present. Note that the intramedullary pin can be seen within the fracture gap appearing hyperechoic with comet tail artefact.

Ultrasonographically, the fracture site was not yet fully healed as the fracture site with the small gap could still be seen on the medial aspect even though the fracture site was no longer detected on the lateral side.

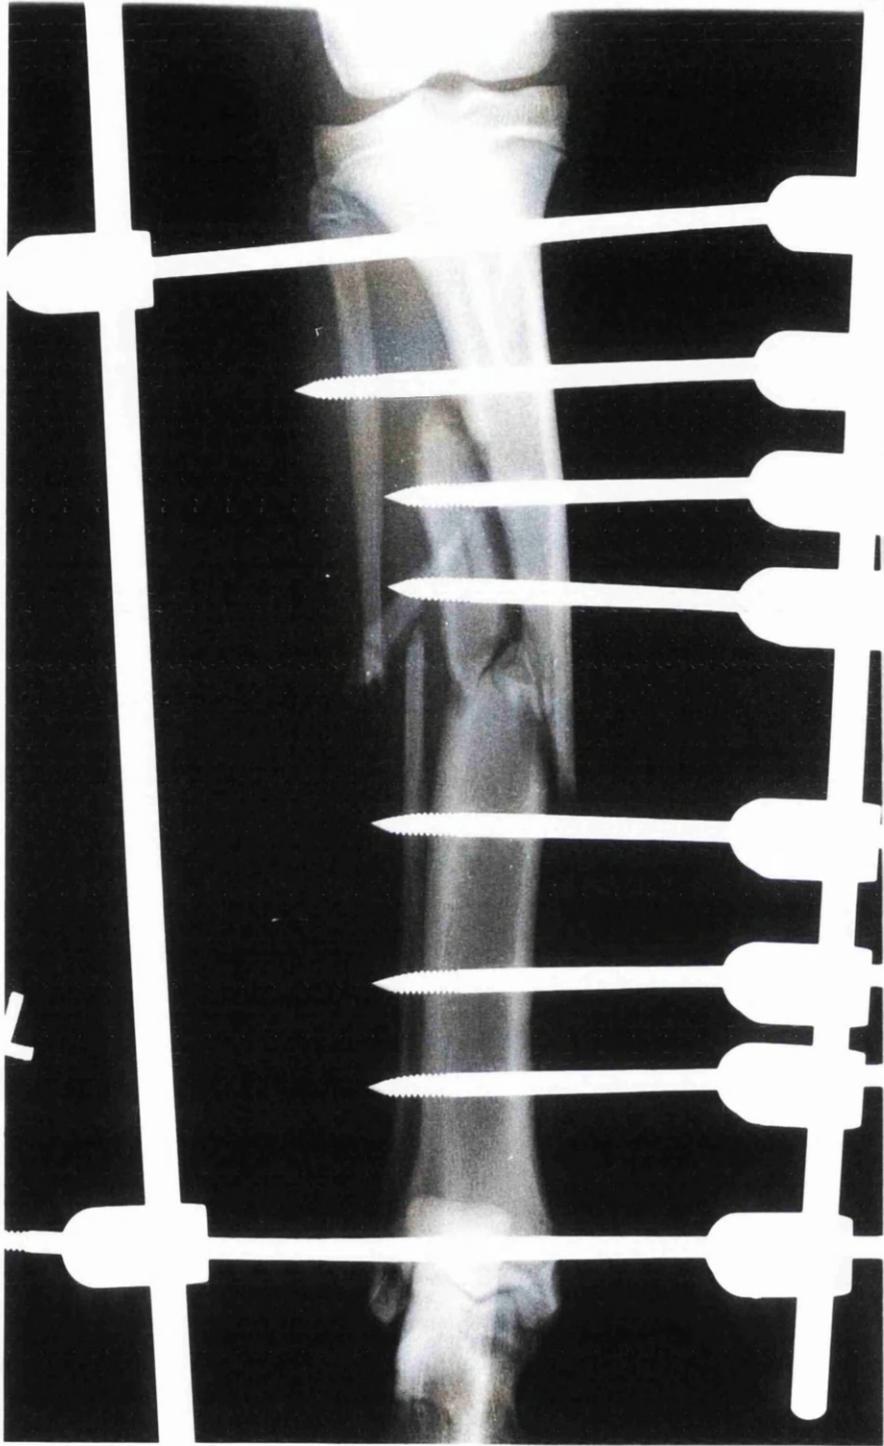
Figure 6.19.1 Radiograph taken immediately after fracture repair shows sufficient reduction and alignment, although slight valgus angulation and overriding is present. The fracture has been stabilised using type 2 external skeletal fixator with 6 half pins.

A six month old male Labrador, weight 19 kg, was referred to the orthopaedic services at Glasgow University Veterinary Hospital for assessment and treatment of a tibial fracture after having been involved in a road traffic accident. Radiographic examination revealed a proximal comminuted fracture of the left tibia with four free fragments and a latero-cranial displacement of the distal tibial shaft had been sustained with moderate overriding present. A transverse mid shaft fracture of the fibula was also present. The fracture had been stabilised using a type 2 external skeletal fixator with 6 half pins. Radiographs taken immediately after fracture repair showed sufficient reduction and alignment, although slight valgus angulation and overriding was present (figure 6.19.1).

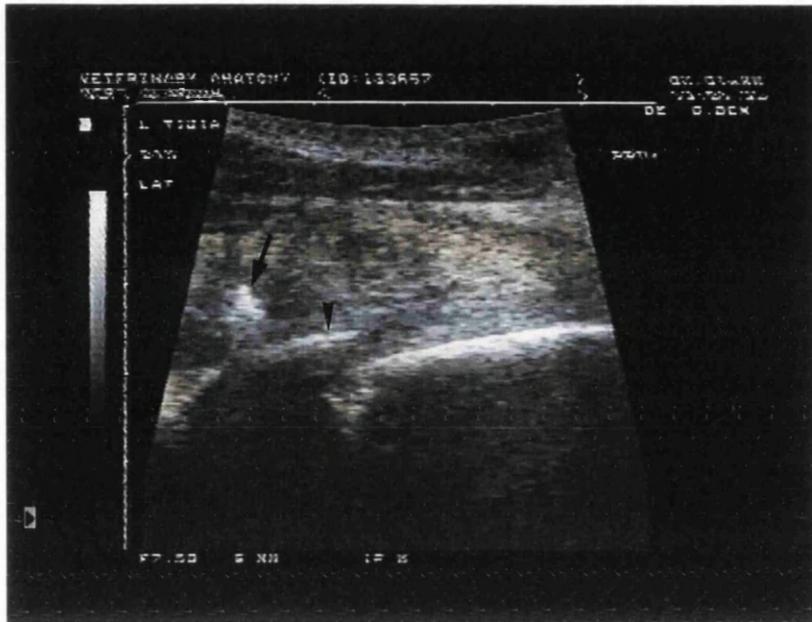
Figure 6.19.2 Longitudinal scan of the tibial shaft 24 hours after fracture repair demonstrates the fracture site with the presence of a small gap. One bone fragment (arrow head) is found at the fracture site area and appears hyperechoic. Note also the area of soft tissue reaction around the screw (arrow) appears as a disorganised hyperechoic structure.

Ultrasonographic examination at the fracture site area of the tibia on the lateral aspect demonstrated the fracture gap with a bone fragment at the fracture site (figure 6.19.2). The area of soft tissue reaction around the screw appeared as disorganised hyperechoic structure. The fracture site of the fibula was imaged from the lateral aspect and appeared as two bone segments poorly aligned (figure 6.19.3). The distal fragment of the fibula appeared elevated compared with the proximal fragment. The fracture site area imaged on a transverse scan showed a disorganised hyperechoic area around the fracture site which suggested soft tissue reaction (figure 6.19.4). The tibia and fibula had lost their normal appearance.

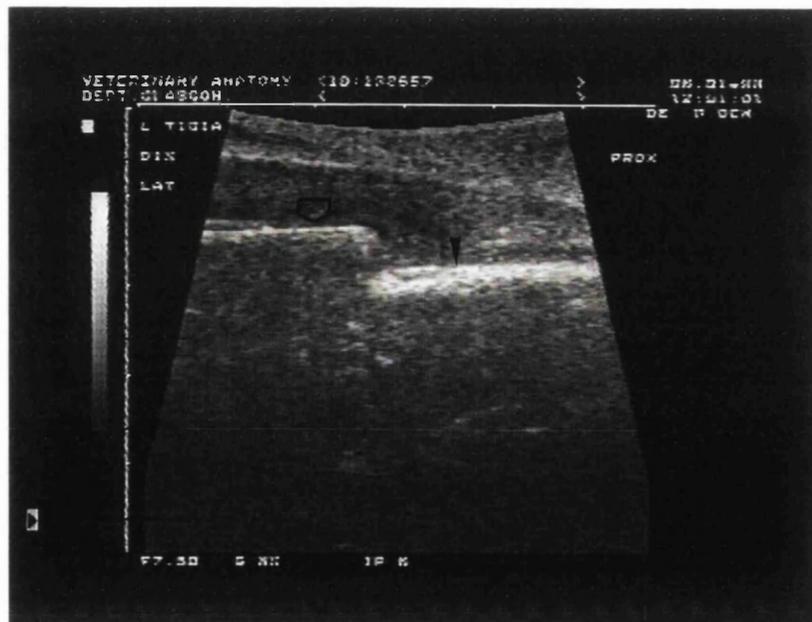
Figure 6.19.3 Longitudinal scan of the fibula 24 hours after fracture repair demonstrates the fracture site which appears with the two segments poorly aligned. The distal fragment (large blank arrow) of the fibula appears elevated compared with the proximal fragment (small arrow head).

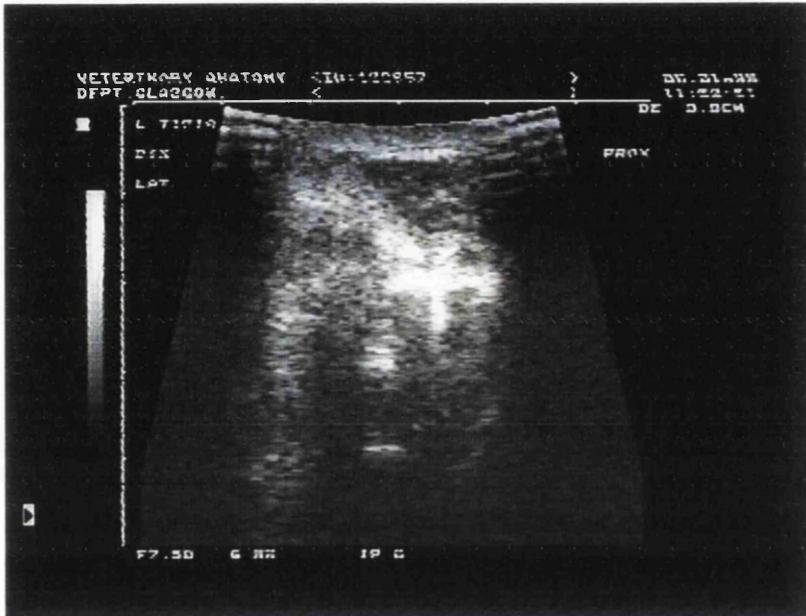
Figure 6.19.4 Transverse scan of the tibia and fibula at the fracture site area 24 hours after fracture repair shows a disorganised hyperechoic area which suggests the soft tissue reaction. The tibia and fibula have lost their normal ultrasonographic appearance.
