**AN ULTRASONOGRAPHIC STUDY OF MUSCULOSKELETAL
INJURIES AND MAMMARY GLAND TUMOUR IN SMALL
ANIMALS**

A thesis submitted to the Faculty of Veterinary Medicine,
University of Glasgow.

For the Degree of Doctor of Philosophy

Division of Veterinary Anatomy,
Department of Veterinary Preclinical Studies,
School of Veterinary Medicine,
University of Glasgow,
March, 1999

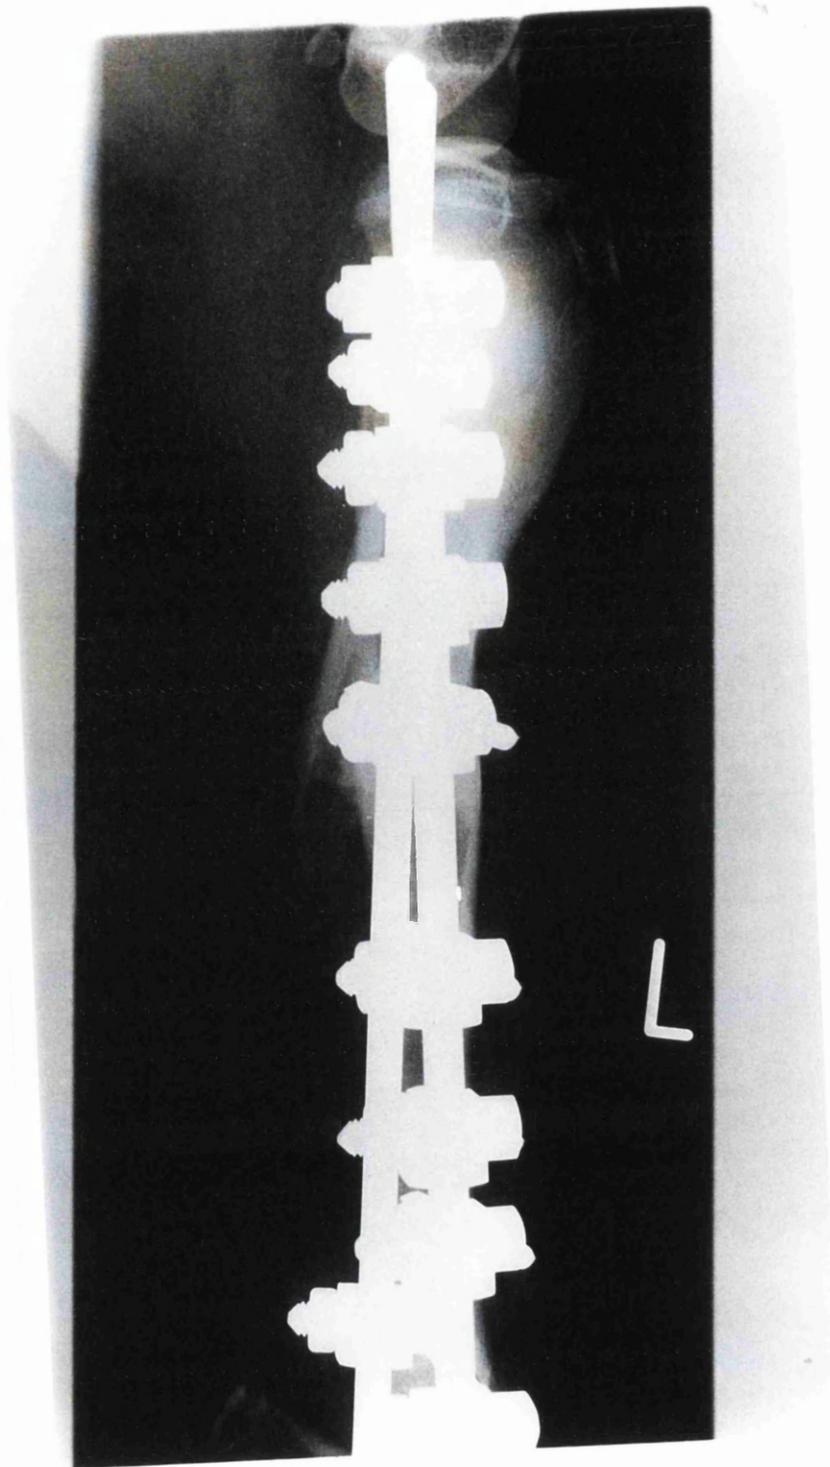
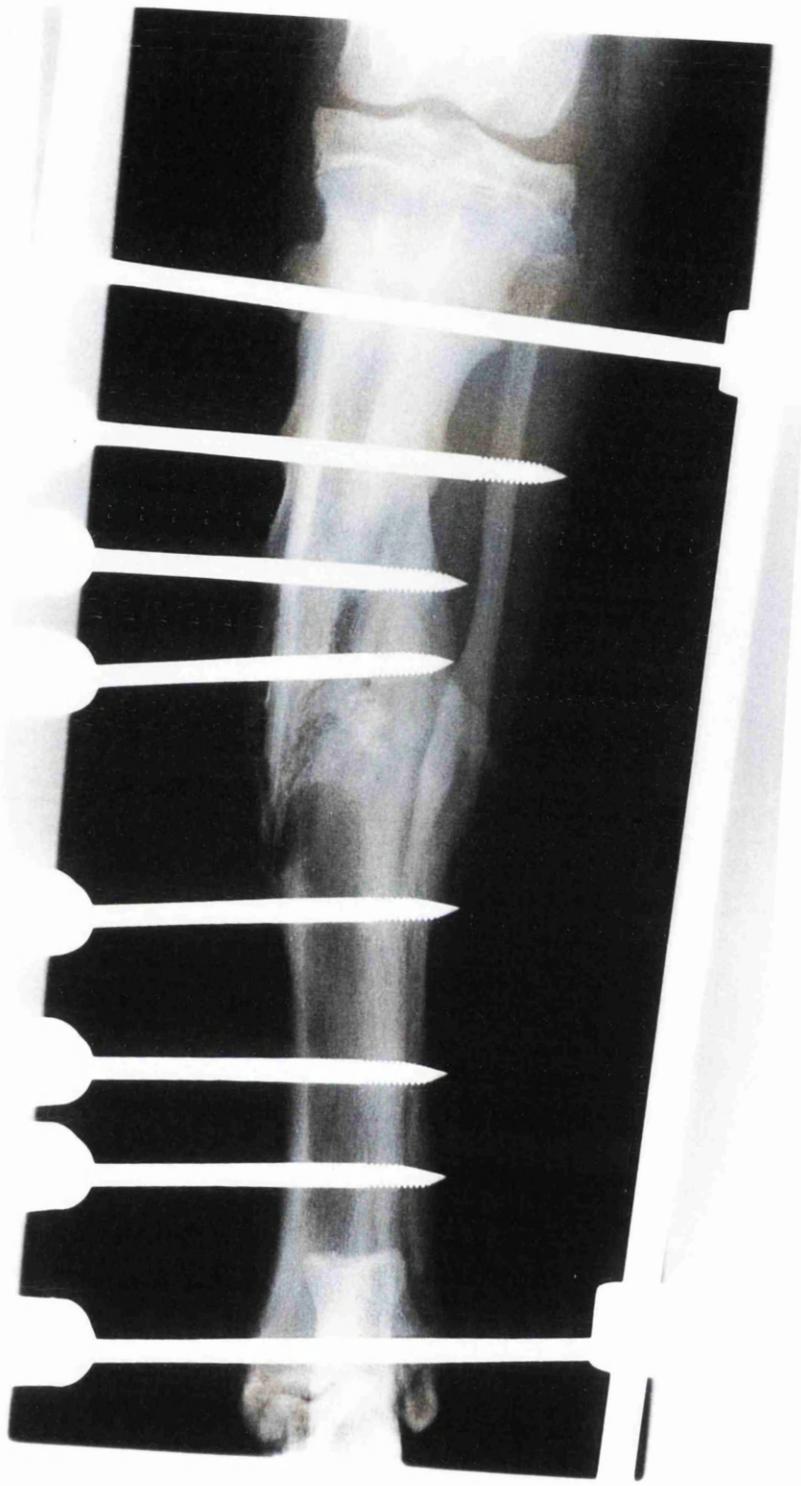
Figure 6.19.5 Radiographs taken at day 43 after fracture repair show marked callus formation but it is not complete. Note also there is moderate valgus angulation and proximal displacement of the distal fracture element. **a**, lateral view, **b**, cranial view.

Radiographs taken at day 43 after fracture repair showed marked callus formation at the fracture site but not complete. There was moderate valgus angulation and proximal displacement of the distal fracture element (figure 6.19.5). The external fixator device had been removed immediately after the radiographic examination and the animal was not expected to come again unless there was any problem.

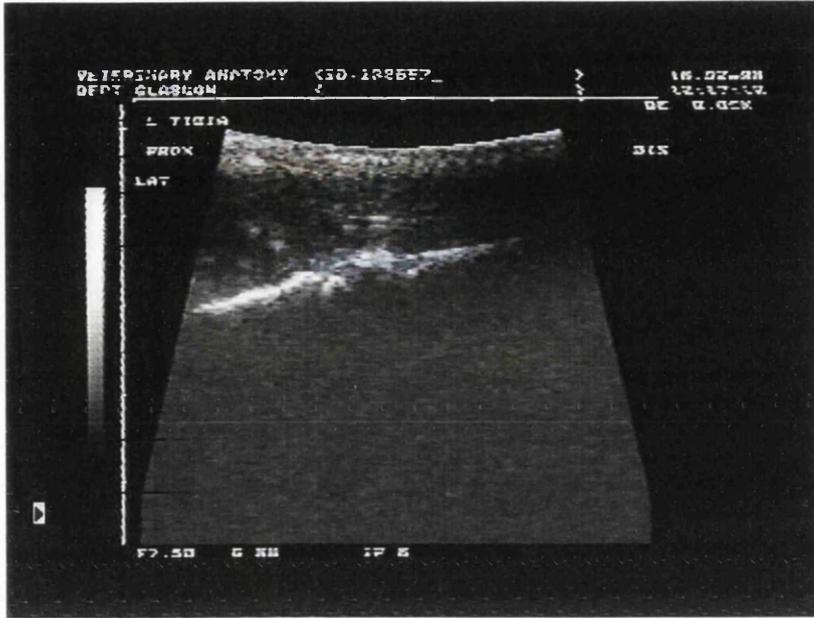
Figure 6.19.6 Longitudinal scan of the tibia at the fracture site area from the lateral aspect on day 43 after fracture repair demonstrates the presence of callus formation with a rough surface and it appears to bridge the fracture site completely.

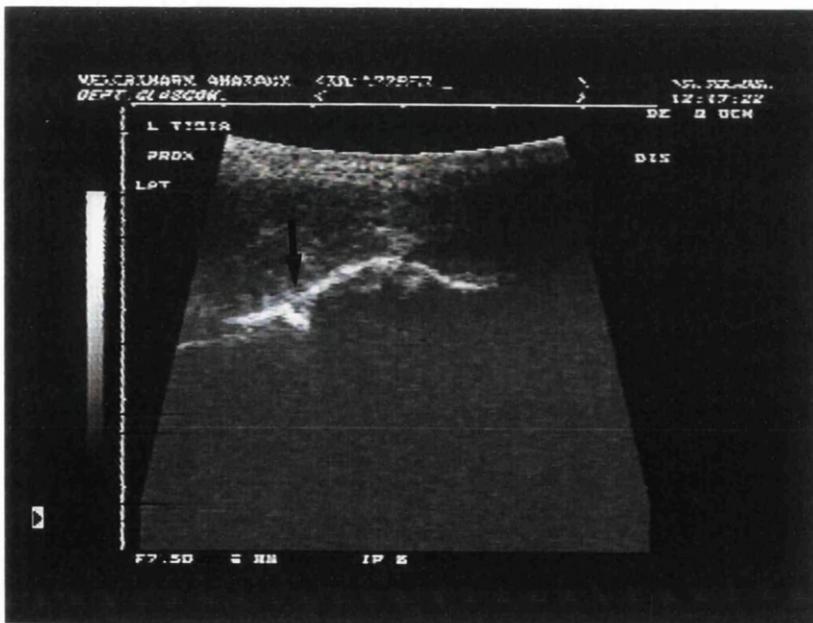
Figure 6.19.7 Longitudinal scan of the tibia from the lateral aspect on day 43 after fracture repair demonstrates a bulging bone at the fracture site area which is due to callus formation. The bulging hyperechoic surface appears smooth suggesting a remodelling process. The fracture gap however can still be detected as a shallow notch (arrow).

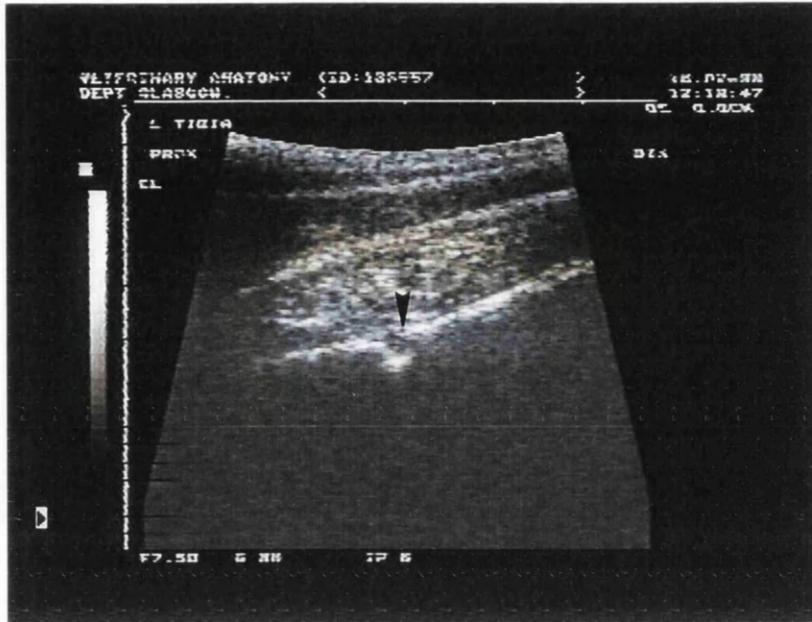
Figure 6.19.8 Longitudinal scan of the tibia from the caudo-lateral aspect on day 43 after fracture repair demonstrates the fracture site which appears as a small notch on the bone surface. Note that the muscle tissue appears to have a normal ultrasonographic appearance.

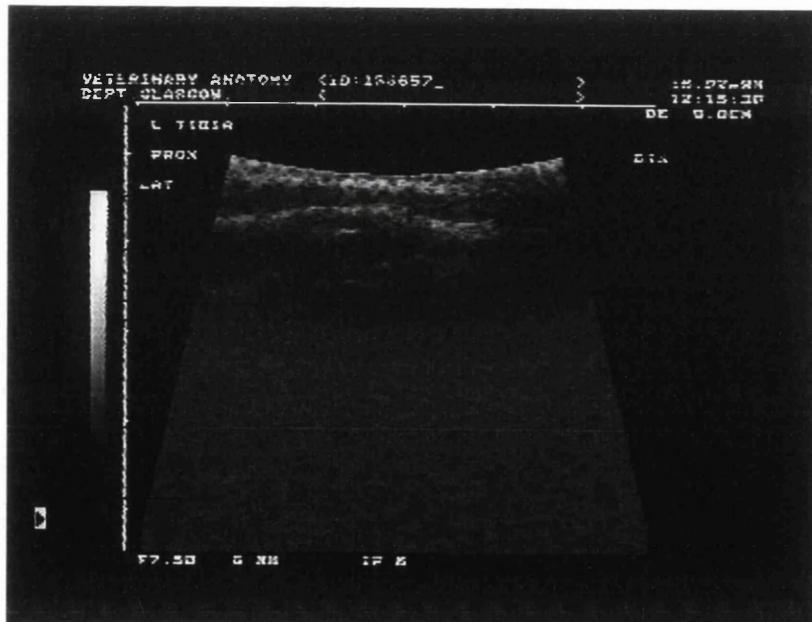
Figure 6.19.9 Longitudinal scan of the fibula from the lateral aspect on day 43 after fracture repair demonstrates the fracture site which appears to have been bridged completely by the mature callus. Note that the fibula at the fracture site area appears bulging due to callus formation but with a smooth surface appearance suggesting a remodelling process is in progress.

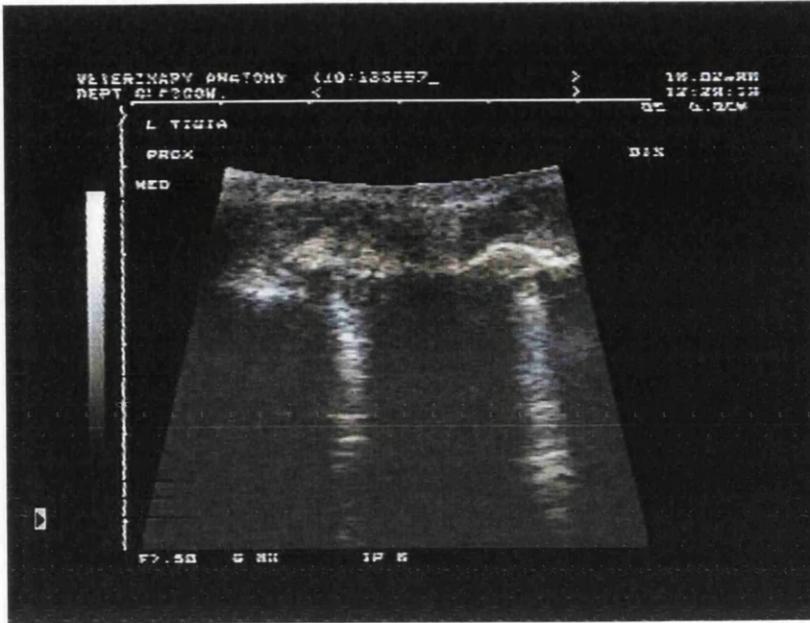
Figure 6.19.10 Longitudinal scan of the tibia from the medial aspect immediately after pin removal demonstrates a number of holes in the proximal tibia. These holes are actually the site of the external fixator pins before being removed. Note also the bulging bone surface surrounding the holes due to callus formation suggests that some movement of the pin had occurred during the fixation period. An area of soft tissue reaction is present within the holes and appears hyperechoic.

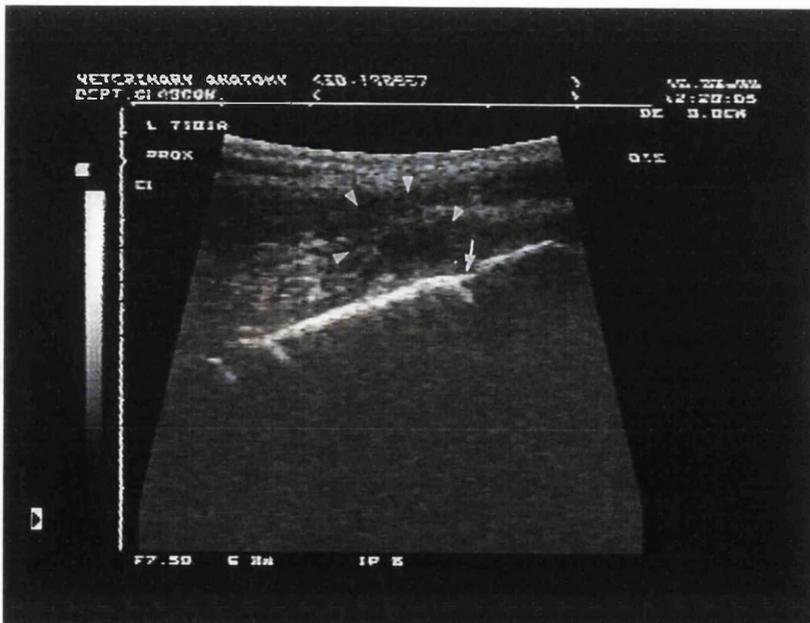
Figure 6.19.11 One hole is seen on the tibia distally on caudo-lateral scan with no significant callus formation around it (arrow). This suggests that the pin was rigidly fixed to the tibia. Note also that the area of muscle damage above the hole appears as a disorganised hypoechoic structure mixed with anechoic area (arrow heads) which represents blood. Muscle damage may have occurred during pin distraction.

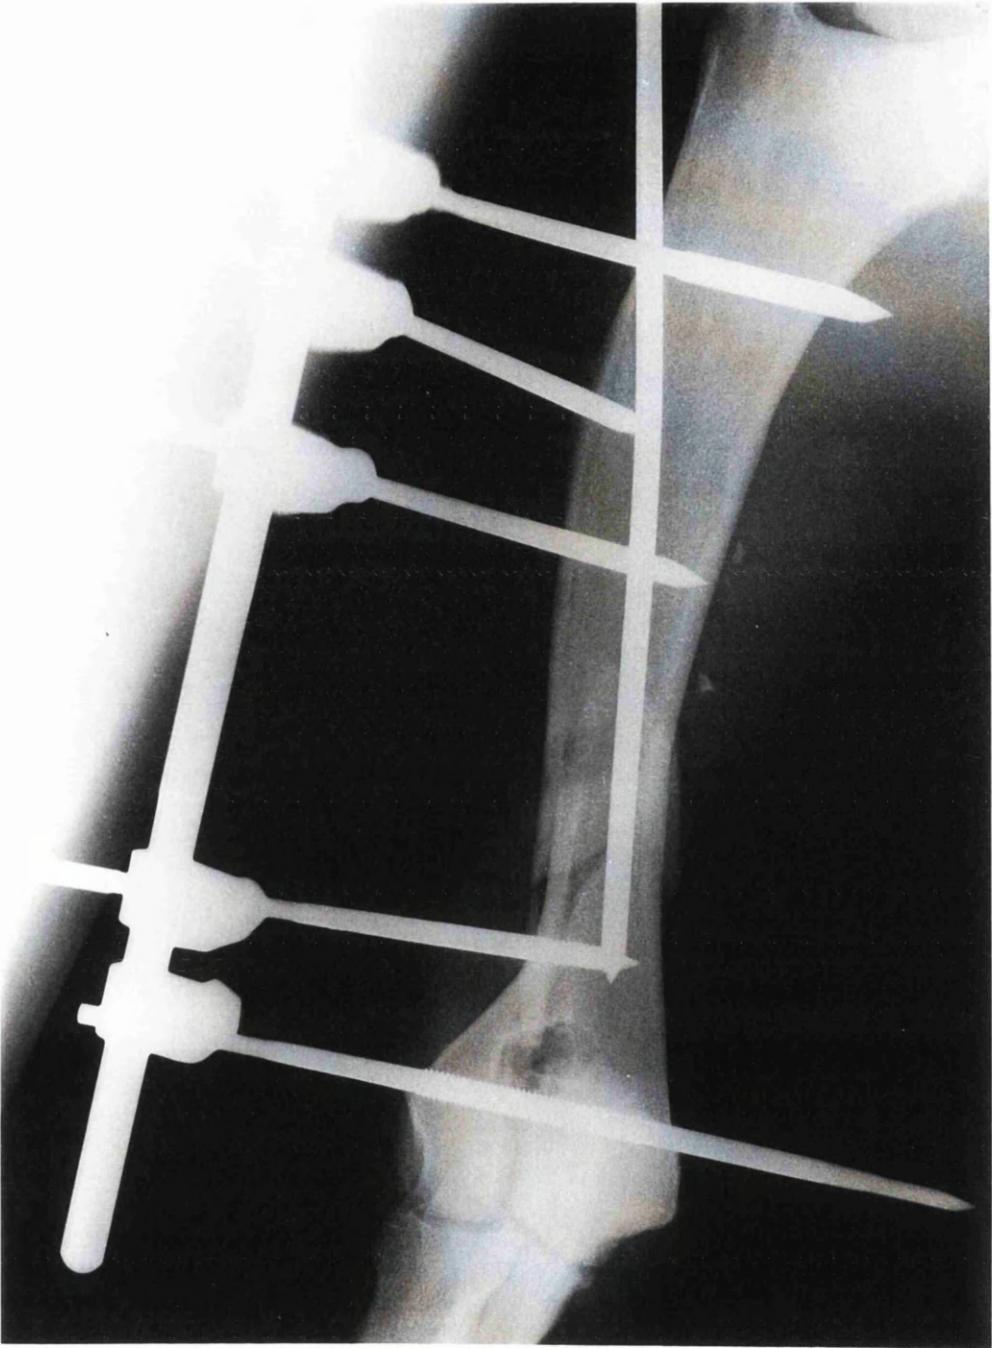
Figure 6.20.2 Radiographs taken immediately after fracture repair show that the fragments are well aligned. **a**, lateral view, **b**, cranial view. One bone fragment remains in the muscle, being caudal to the humerus at the fracture site area. The fracture line is clearly visible. There are also some small bone chips present in the muscle.

Radiographs taken immediately after fracture repair showed that the fragments were well aligned (figure 6.20.2). One bone fragment remained in the muscle, being caudal to the femur at the fracture site area. The fracture line was clearly visible. The small bone chips were also present.

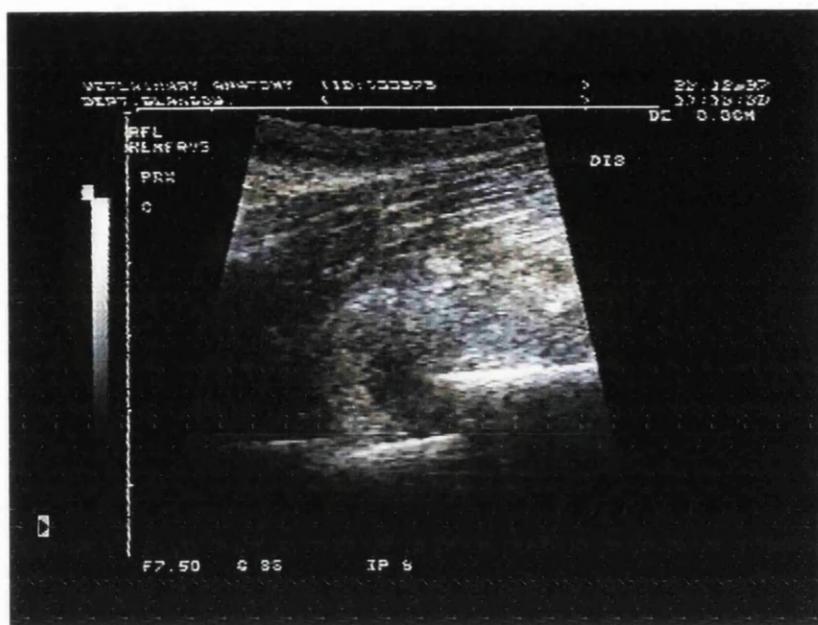
Figure 6.20.3a

Figure 6.20.3 Longitudinal scans of the humerus on day five after fracture repair demonstrate the fracture site with the segments poorly aligned. **a**, caudal aspect, **b**, cranial aspect. The distal segment appears higher than the proximal segment in **a**, and conversely, the proximal segment appears higher than the distal segment in **b**. The area of muscle damage at the end of the proximal fragment appears as a disorganised hypoechoic area. The hypoechoic area in the muscle is suggestive of blood or fluid within the muscle. No callus formation is detected at this stage.

Ultrasonographic examination demonstrated the fracture site with the fragments appearing poorly aligned. The distal fragment appeared higher than the proximal fragment on the caudal aspect (figure 6.20.3a), and conversely, the

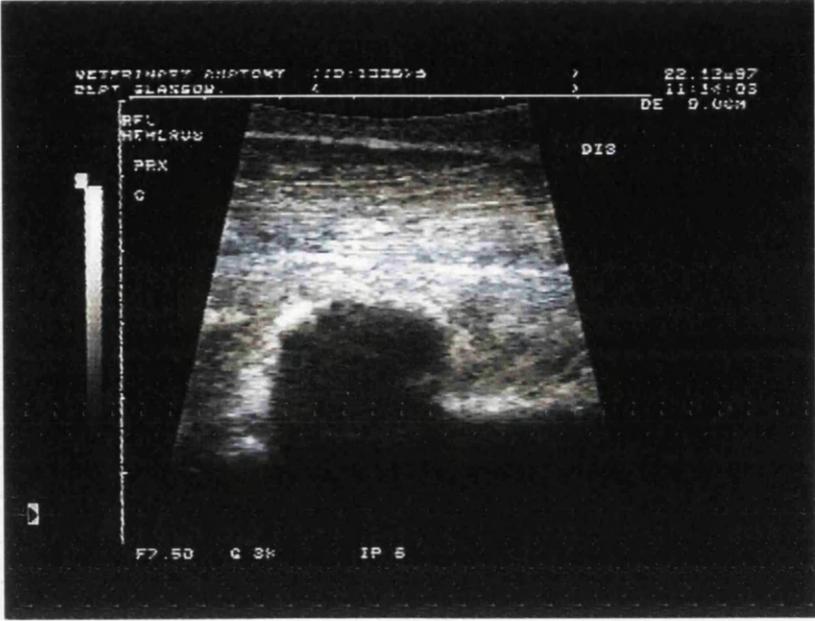
Figure 6.20.4a

Figure 6.20.4 Ultrasonographic examination of the humerus from the caudal aspect on day five after fracture repair **a**, longitudinal scan, **b**, transverse scan, shows a bone fragment caudal to the humerus which appears hyperechoic with acoustic shadowing artefact. Note that the femoral surface under the bone fragment is not imaged due to the shadow artefact. **H**, humerus.

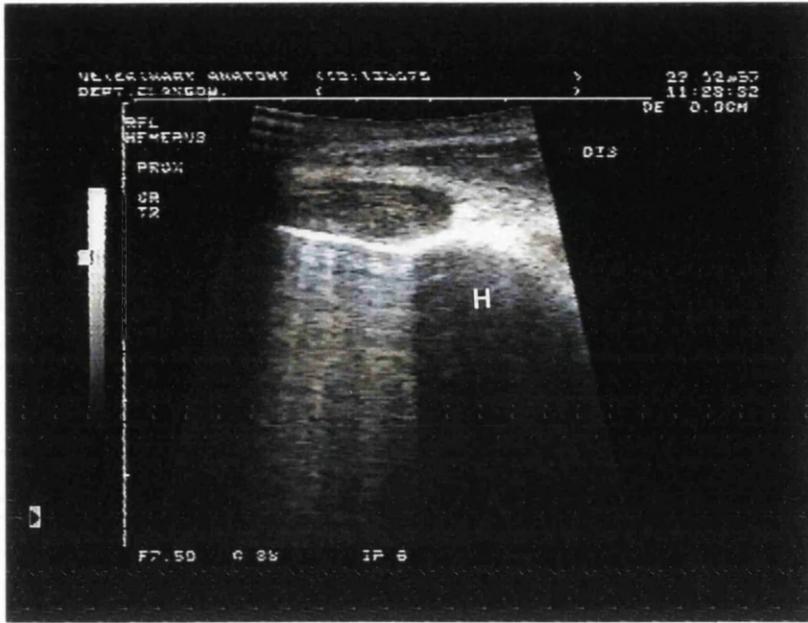
Figure 6.20.5 Transverse scan of the humerus on the cranial aspect demonstrates the external fixator pin which appears as a straight hyperechoic line and is producing reverberation artefact. H, humerus.

proximal fragment appeared higher than the distal fragment on the cranial aspect (figure 6.20.3b). The area of muscle damage at the end of the proximal fragment appeared as a disorganised hypoechoic area. The hypoechoic area in the muscle suggested the present of blood or fluid within the muscle. No callus formation was detected. One large fragment caudal to the femur was detected both on longitudinal and transverse scans and appeared hyperechoic with acoustic shadowing artefact (figure 6.20.4a and 6.20.4b). The external fixator pin appeared as a straight hyperechoic line with reverberation artefact (figure 6.20.5).

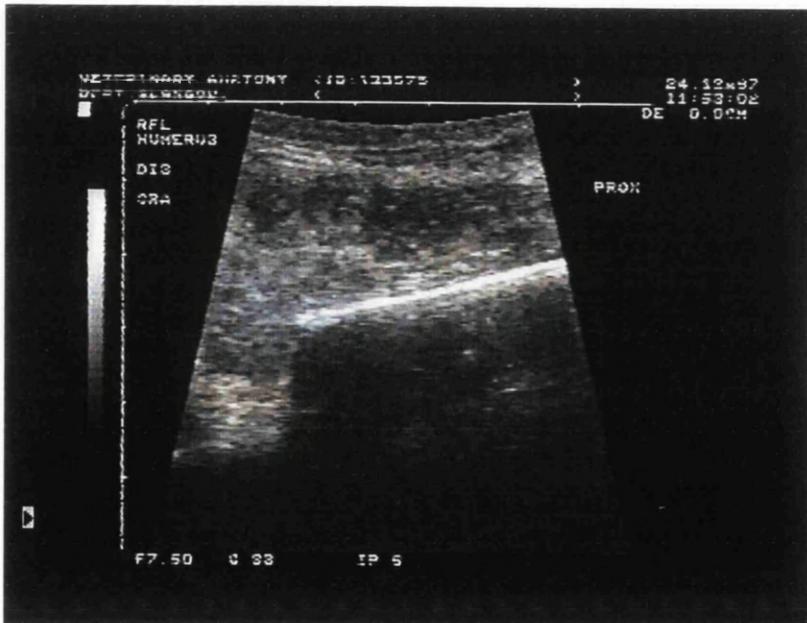
Figure 6.20.6 Longitudinal scan of the humerus from the cranial aspect on day seven after fracture repair only demonstrates the proximal fragment. The distal segment is not seen because the segments are not well aligned. Note that the area of muscle damage still appears hypoechoic but with more organised structure.

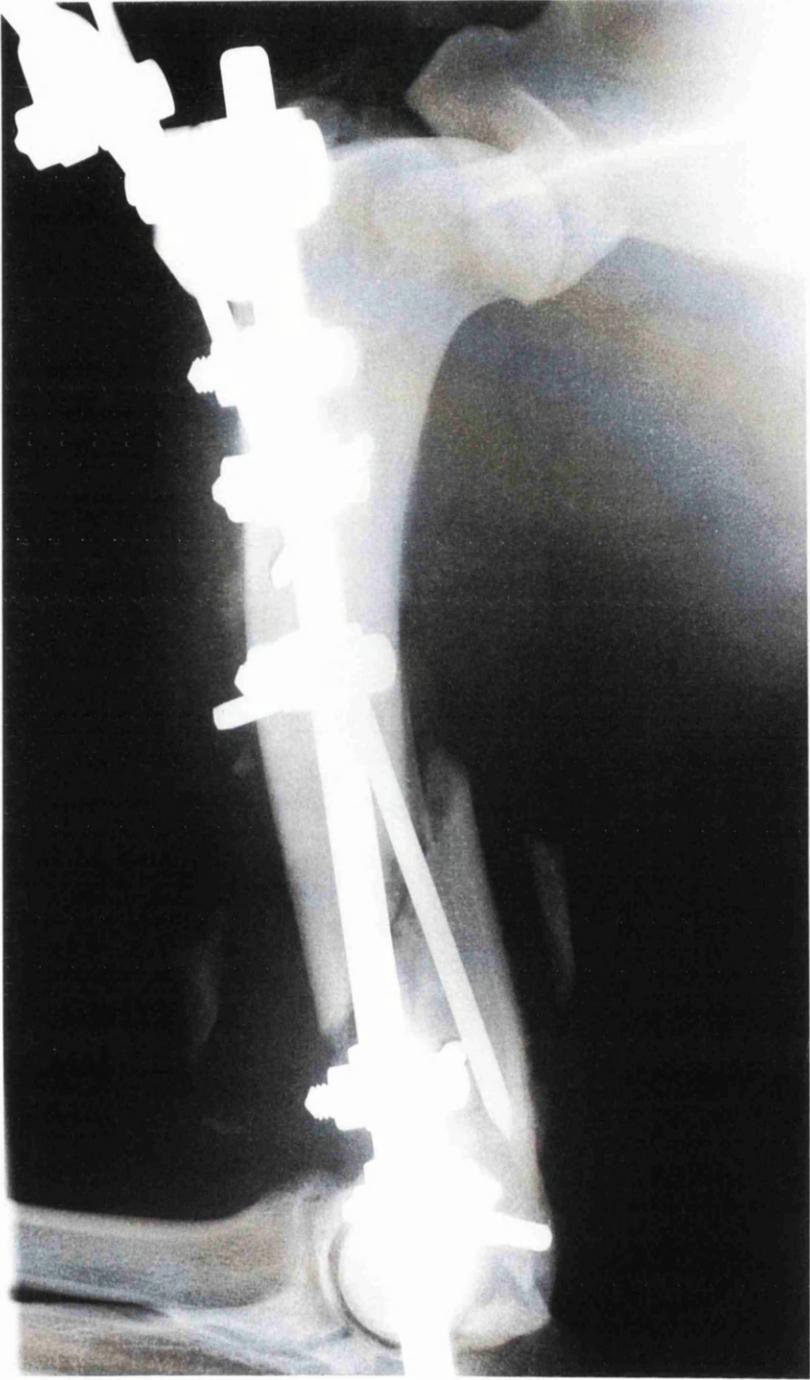
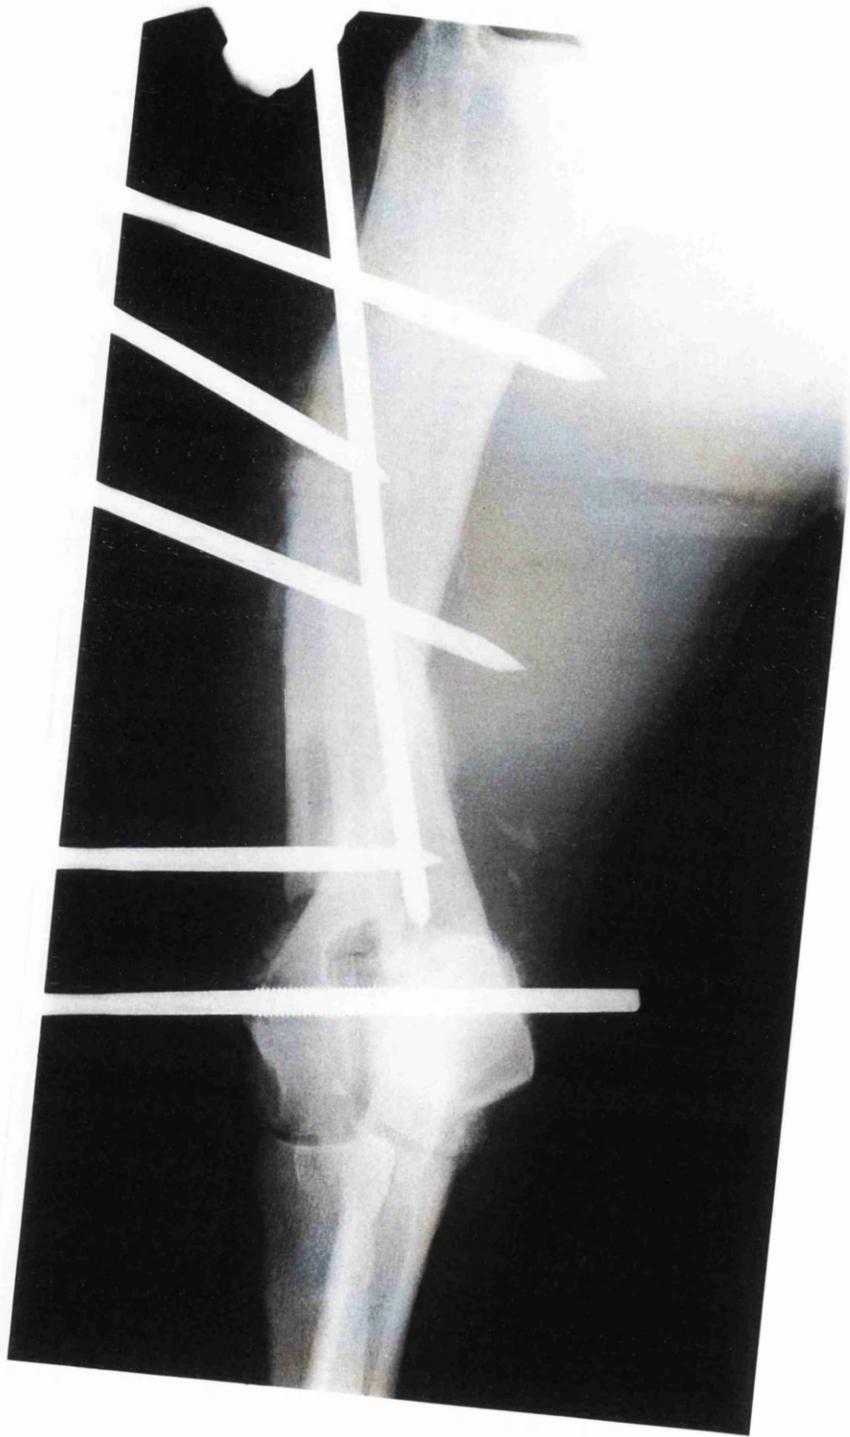
Figure 6.20.7 Radiographs taken at day 19 after fracture repair show a marked lucency around pin 2, 3 and 5, bad alignment of the fragments with caudal overriding of distal shaft fragment. Osteolysis is found around pin 2, 3 and 5, but no callus formation. **a**, lateral view, **b**, cranial view.

Radiographs taken at 19 day after fracture repair showed a marked lucency around pin 2, 3 and 5, and bad alignment of the fragments with caudal overriding of the distal shaft fragment. Osteolysis was found around pin 2, 3 and 5, but there was no callus formation (figure 6.20.7).

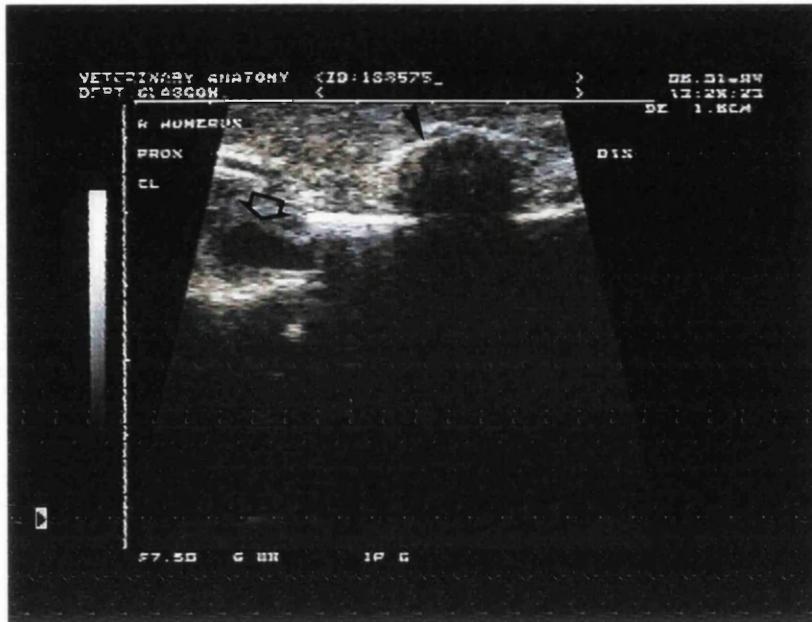
Figure 6.20.8 Longitudinal scan of the humerus from the caudal aspect on day 19 after fracture repair demonstrates a large cystic structure with well defined margin (blank arrow) at the fracture site above the proximal end segment and at the end of distal segment. The bone fragment caudal to the humerus (arrow head) remains undisplaced but appears smaller than on the previous scans. There is still no callus formation detected.

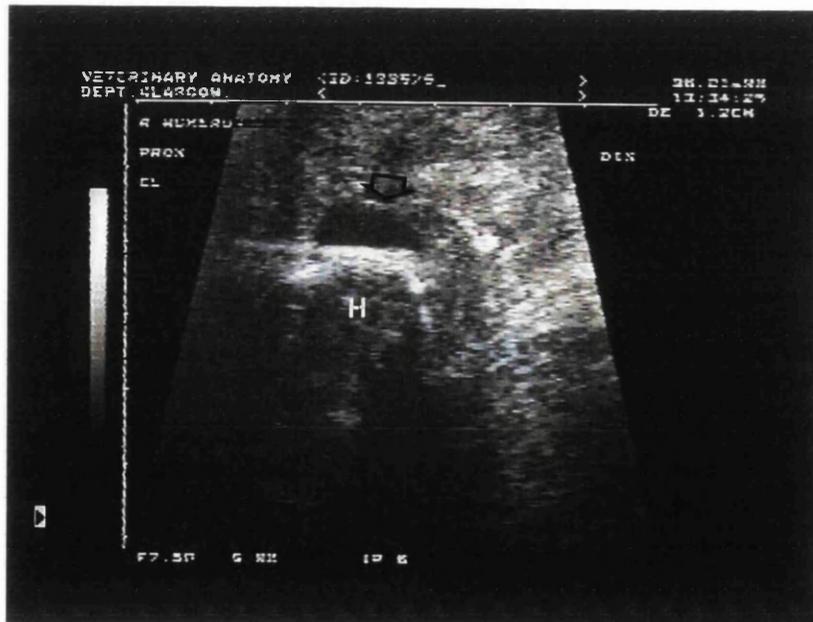
Figure 6.20.9 Transverse scan of the humerus from caudal aspect demonstrates the cystic structure on the proximal segment with a well defined margin (blank arrow). H, humerus.

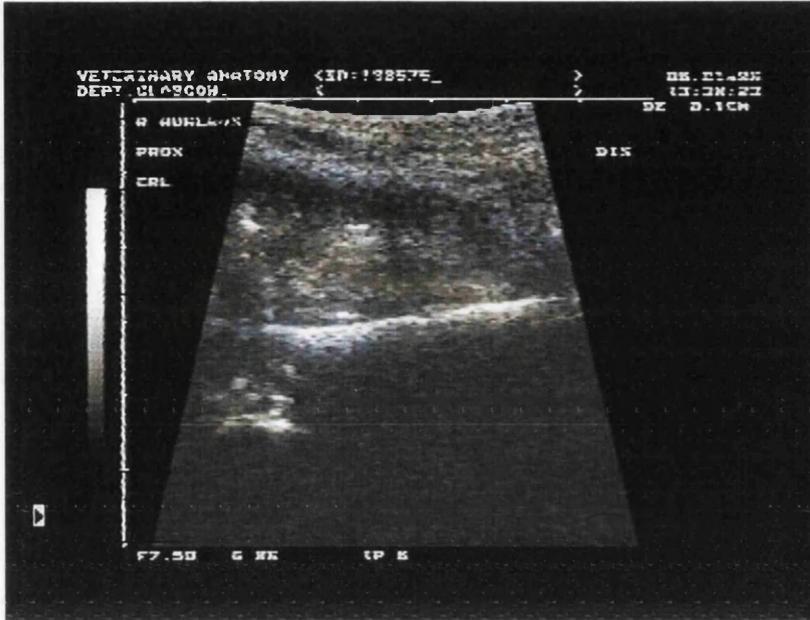
Figure 6.20.10 Longitudinal scan of the humerus from the cranial aspect on day 19 after fracture repair shows the fracture site but does not reveal the cystic structure. Note the soft callus formation at the end of the proximal fragment as shown by the hyperechoic mottled appearance.

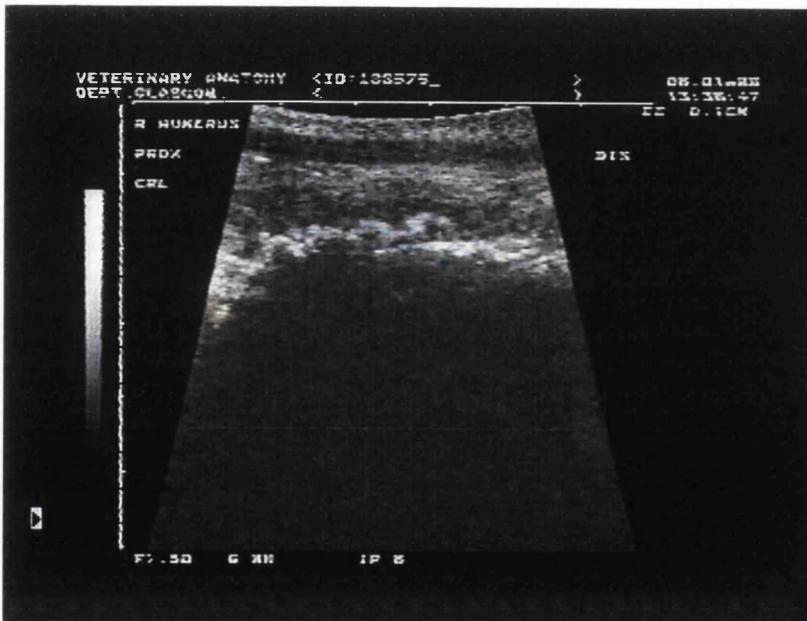
Figure 6.20.11 Longitudinal scan of the humerus from the cranial aspect on day 19 after fracture repair demonstrates callus formation on the proximal segment at some distance away from the fracture site and appears as an hyperechoic rough bone surface.

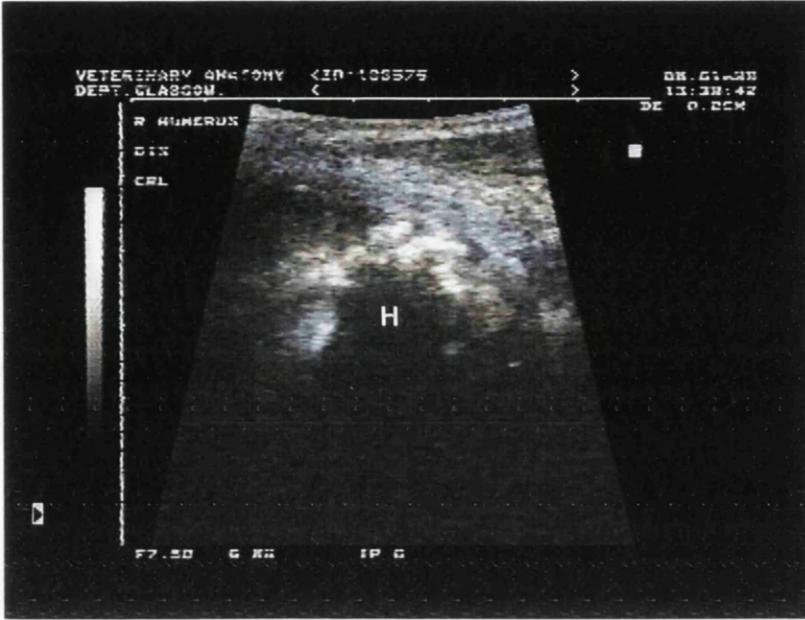
Figure 6.20.12 Transverse scan of the humerus on day 19 after fracture repair shows the abnormal appearance of the humerus with a rough surface suggestive of callus formation. H, humerus.

Ultrasonographic examination of the humerus demonstrated the fracture site but still no callus formation was detected. A large cystic structure with well defined margins was detected at the fracture site above the proximal end fragment and at the end of distal fragment on the caudal aspect scan (figure 6.20.8). The bone fragment caudal to the femur remained undisplaced but appeared smaller than on the previous scans. A transverse scan of the humerus also demonstrated the cystic structure with well defined margin above the proximal fragment (figure 6.20.9). The bone fragment superficial to the humerus appeared as on the previous scans. The muscle structure appeared as disorganised with a mixture of hypoechoic and hyperechoic structures. The cystic structure was not imaged on the cranial aspect scan. An area with an hyperechoic mottled appearance was detected at the end of the proximal fragment which was suggestive of soft callus formation (figure 6.20.10). Soft callus formation was also detected on the proximal fragment some distance away from the fracture site and appeared as an hyperechoic rough bone surface (figure 6.20.11). A transverse scan of the humerus showed the abnormal appearance of the humerus with a rough surface suggestive of callus formation (figure 6.20.12).

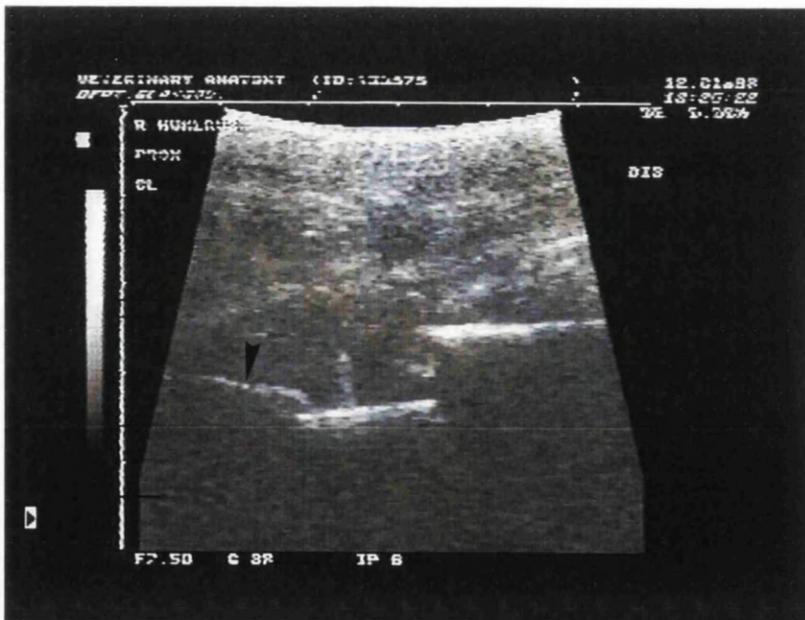
Figure 6.20.13 Ultrasonographic examination of the fracture site on day 25 after fracture repair shows there is no longer a cystic structure present. There is still no well defined callus formation to be seen at the fracture site. Callus formation could be seen on the proximal segment at some distance away from the fracture site appearing as a rough bone surface (arrow head).

Ultrasonographic examination of the fracture site showed there was no longer a cystic structure present, but that a well defined callus formation could still not be seen at the fracture site (figure 6.20.13). Callus formation was detected on the proximal fragment at some distance away from the fracture site and appeared as a rough femoral surface. A transverse scan on the proximal fragment showed the humerus with callus formation which appeared as an hyperechoic rough

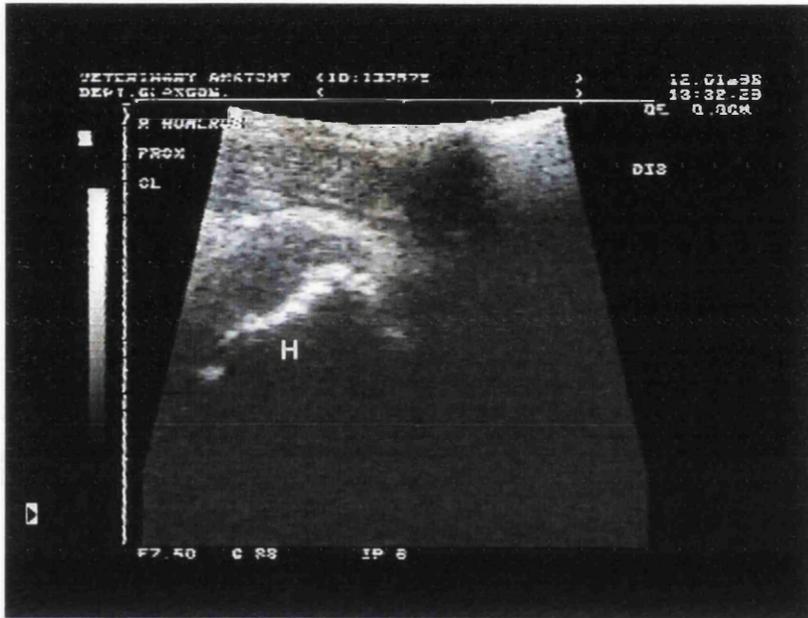
Figure 6.20.14 Transverse scan of the proximal fragment on day 25 after fracture repair shows the humerus with callus formation and appears as a hyperechoic rough bone surface. **H**, humerus.

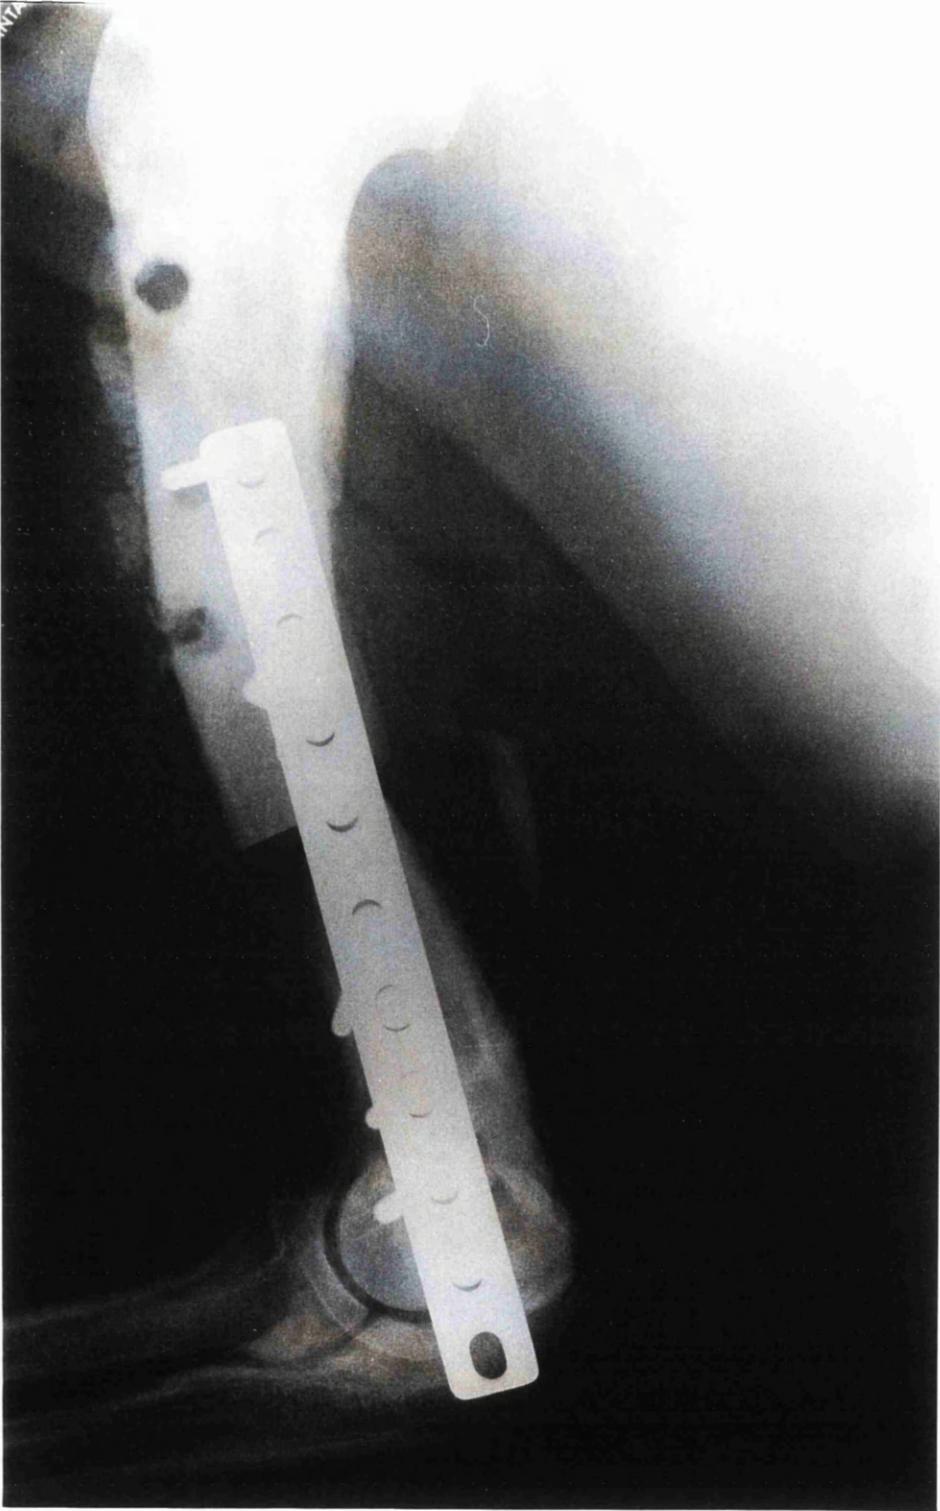
Figure 6.20.15 Radiographs taken at day 32 after fracture repair shows the fracture has been realigned by a Dynamic Compression Plate (DCP). An osteotomy has been performed at the end of the proximal fragment to stimulate new callus formation. A DCP is fixed on the medial side of the humerus with five cortex screws on each side of the plate. The realignment process has resulted in satisfactory reduction and alignment.. There is abundant periosteal pallisade like callus formation around the humeral shaft. One bone fragment remains, being caudal to the femur at fracture site area.

Radiographs taken at day 33 after fracture repair showed that there was non alignment of the humeral fracture, overriding and no bridging callus formation. The external fixator had failed, so bone plating was performed instead. A Dynamic Compression Plate (DCP) was fixed with five cortex screws on each side resulting in satisfactory reduction and alignment. An osteotomy was performed at the end of the proximal fragment to stimulate new callus formation. The plate was placed on the medial side of the femur. There was abundant periosteal pallisade like callus formation around the humeral shaft. The realignment process resulted in a good alignment but there was a large gap on the caudal side. One bone fragment remained, being cranial to the femur at the fracture site area (figure 6.20.15).

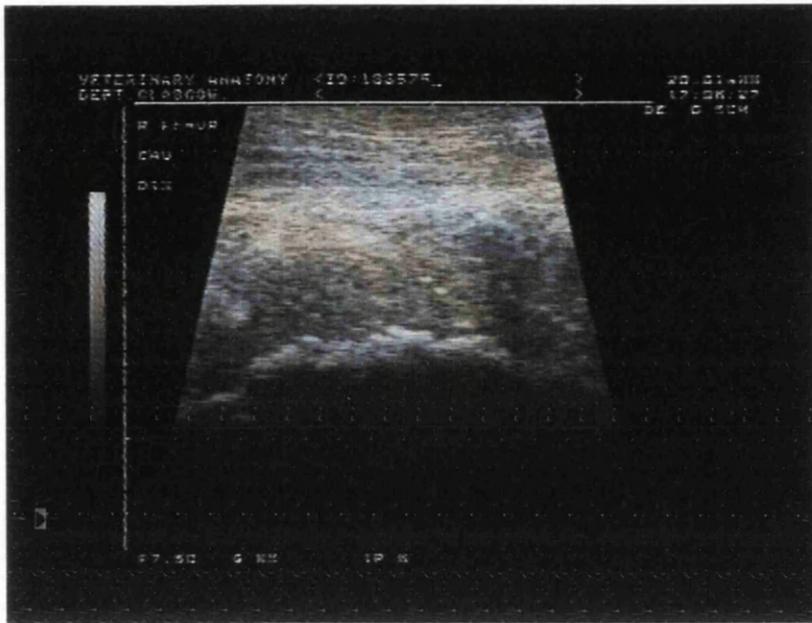
Figure 6.20.16 Longitudinal scan of the humerus from the caudal aspect on day 33 after fracture repair (24 hours after fracture realignment) demonstrates callus formation on the proximal segment some distance from the fracture site. The callus formation appears hyperechoic causing a rough bone surface appearance.

Ultrasonographic examination demonstrated the callus formation on the humerus some distance from the fracture site. The callus formation appeared hyperechoic and caused a rough bone surface appearance (figure 6.20.16). The fracture site was shown as a discontinuity of the bone on the lateral scan. The screws used in fracture reduction appeared hyperechoic with comet tail artefacts. The screw threads were shown and gave a typical characteristic appearance for the screws imaged ultrasonographically (figure 6.20.17). The area of muscle damage appeared as an hypoechoic region. A number of holes were found on the humerus which appeared hyperechoic with the presence of

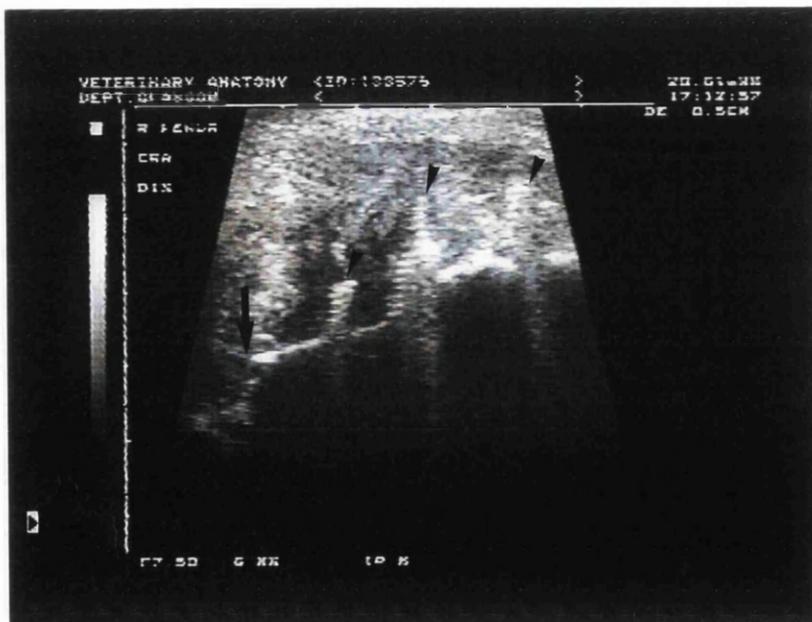
Figure 6.20.17 Longitudinal scan of the humerus from the lateral aspect 24 hours after fracture realignment demonstrates the fracture site (arrow) which appears as discontinuity of the bone. The screws used in fracture reduction appear hyperechoic and produce comet tail artefacts. The screw threads can be seen and give a typical characteristic appearance for screws imaged ultrasonographically (arrow heads). The area of muscle damage above the bone appears as a disorganised hypoechoic area.

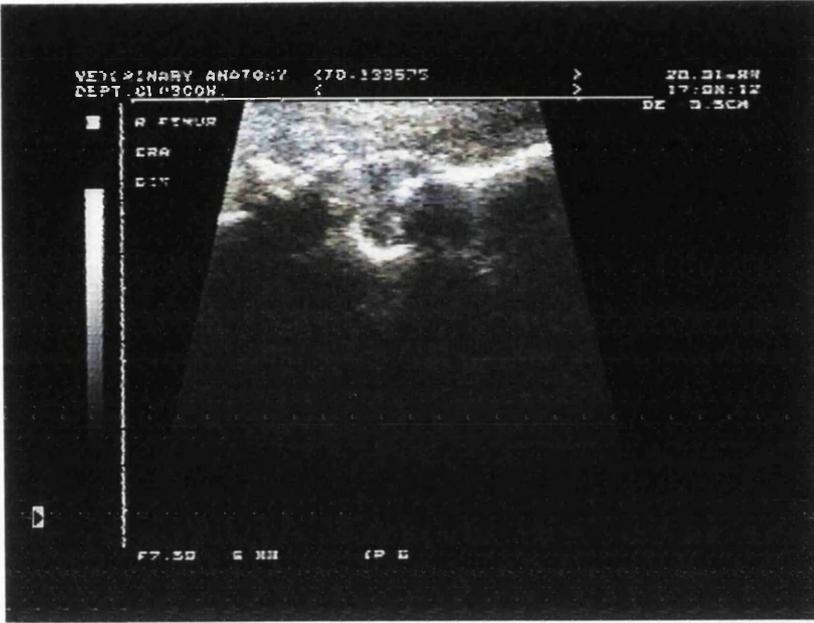
Figure 6.20.18 Longitudinal scan of the distal humerus from the cranial aspect 24 hours after realignment demonstrates a hole which appears hyperechoic with the presence of soft callus formation around it. Each hole is actually the previous site of an external fixator pin used before the recent realignment process.

soft callus formation around them (figure 6.20.18). These holes were actually the site of external fixator pins placed before the recent realignment process. The fracture site with the presence of an hyperechoic area which was suggestive of soft tissue reaction was seen on the cranial aspect scan (figure 6.20.19). The bone fragment cranial to the femur appeared hyperechoic with acoustic shadowing artefact (figure 6.20.20). A transverse scan at the fracture site area showed an abnormal femur which appeared large with a rough surface (figure 6.20.21).

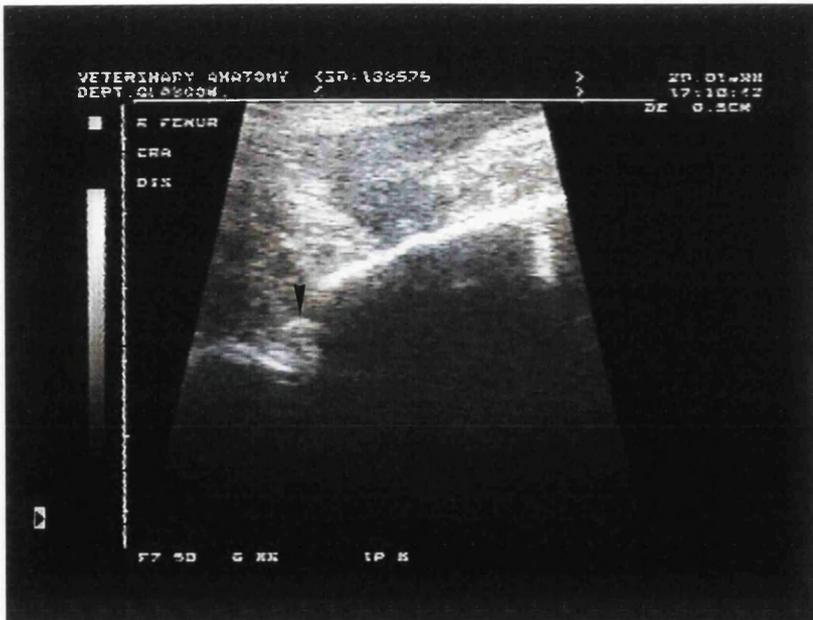
Figure 6.20.19 Longitudinal scan of the humerus 24 hours after fracture realignment demonstrates the fracture site with the presence of hyperechoic material suggestive of soft tissue reaction (arrow head).

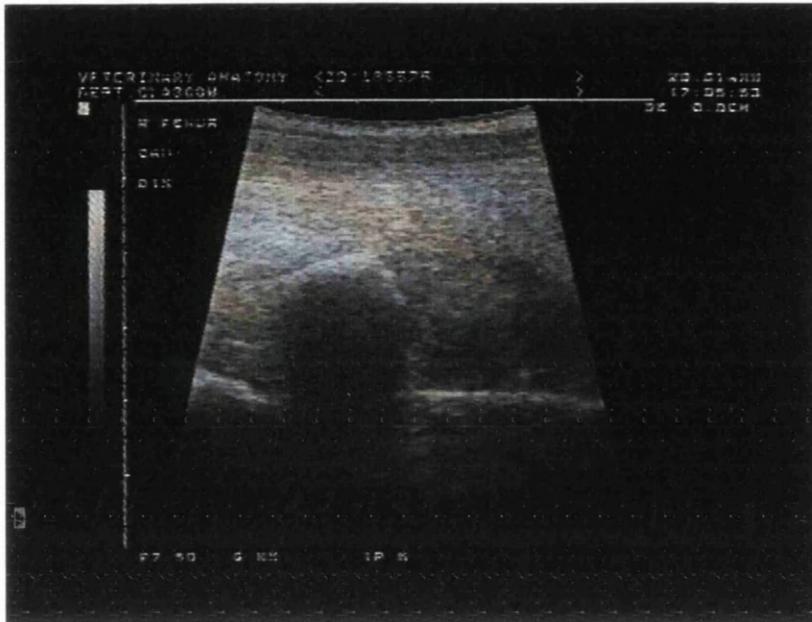
Figure 6.20.20 The bone fragment cranial to the humerus imaged from caudal aspect 24 hours after fracture realignment appears hyperechoic with acoustic shadowing artefact.
