**AN ULTRASONOGRAPHIC STUDY OF MUSCULOSKELETAL
INJURIES AND MAMMARY GLAND TUMOUR IN SMALL
ANIMALS**

A thesis submitted to the Faculty of Veterinary Medicine,
University of Glasgow.

For the Degree of Doctor of Philosophy

Division of Veterinary Anatomy,
Department of Veterinary Preclinical Studies,
School of Veterinary Medicine,
University of Glasgow,
March, 1999

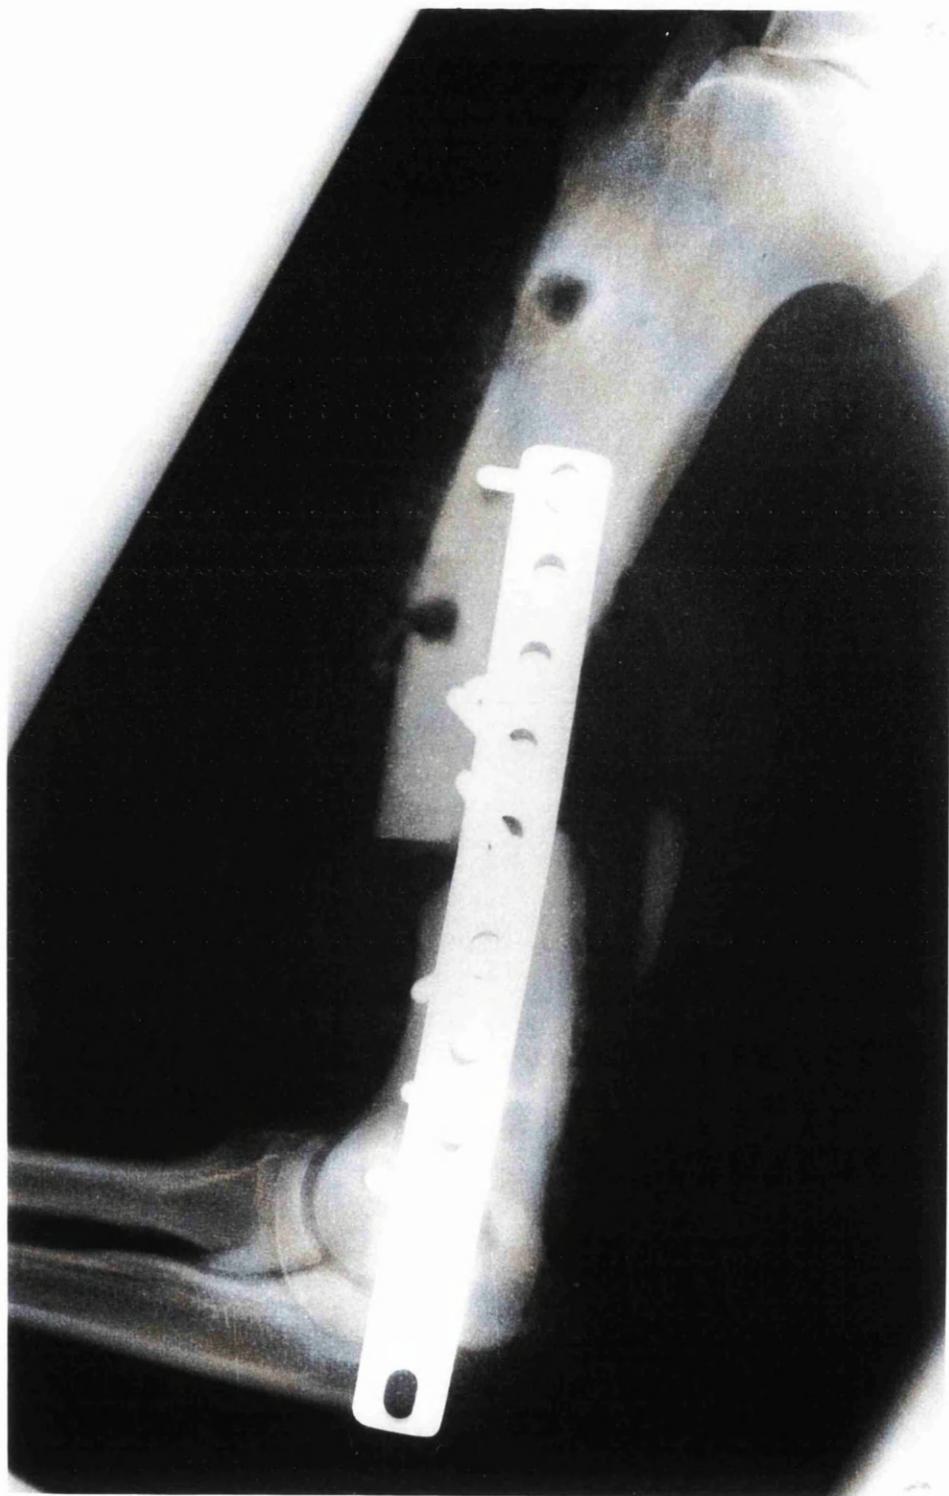
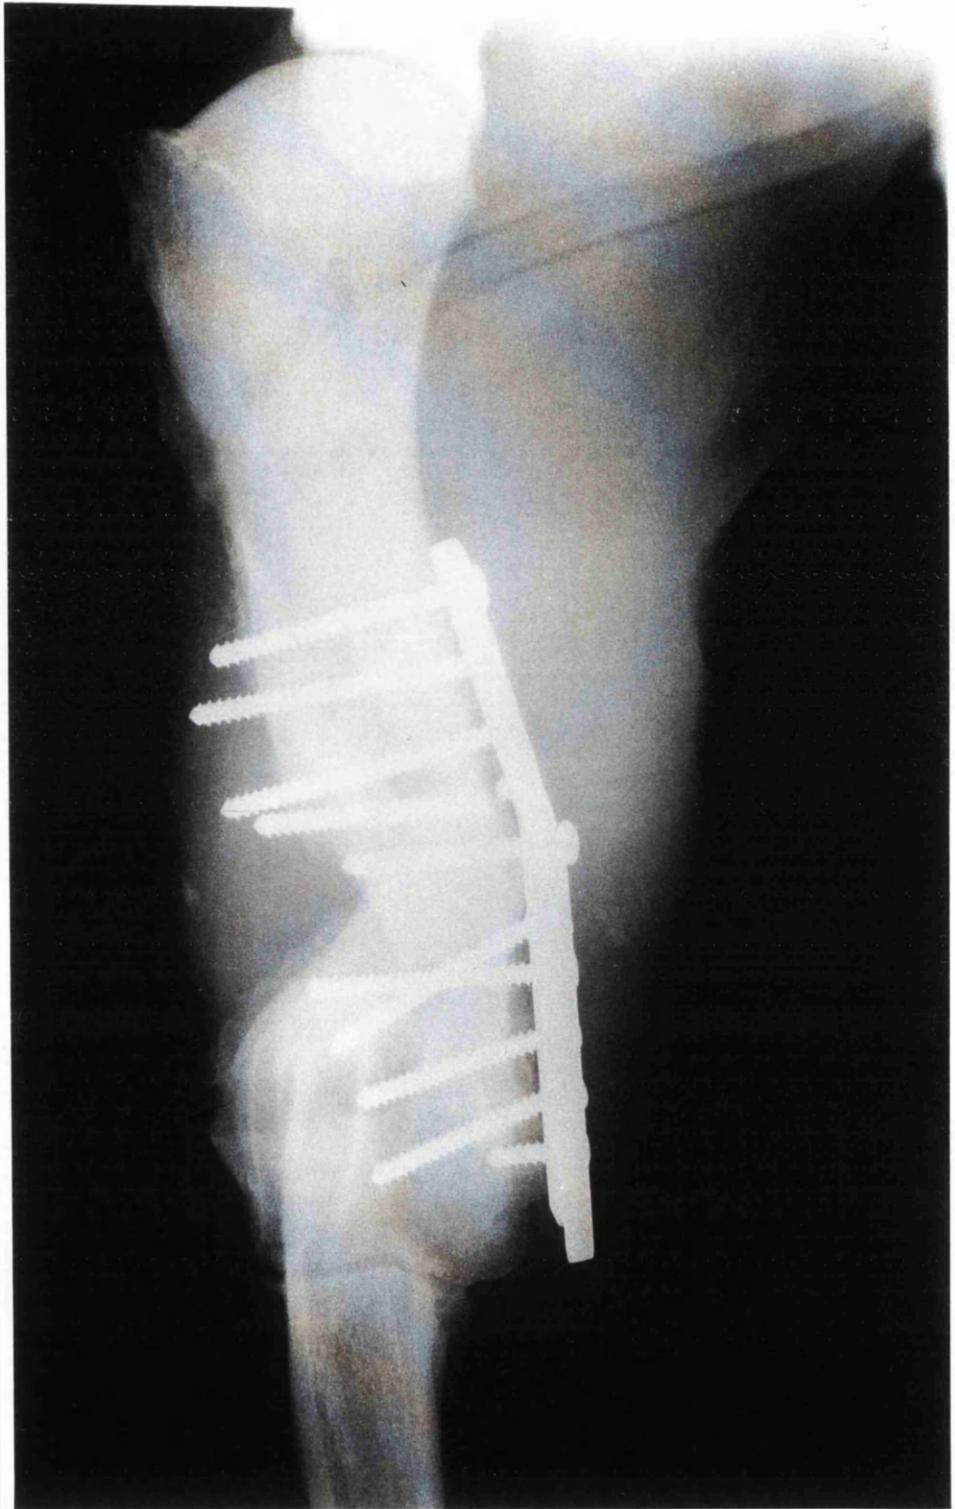
Figure 6.20.22 Radiograph taken at day 54 after fracture repair (day 22 after realignment) shows the major tubercle is laterally displaced relative to the acromion. The fracture site has been refixed by a larger plate, and one screw is broken as can be seen in cranial view (**b**). There is a caudal displacement of the distal humerus. No bridging bony callus is seen. **a**, lateral view, **b**, cranial view.

Radiographs taken at day 54 after fracture repair showed the major tubercle was laterally displaced relative to the acromion. The fracture site had been refixed by a larger plate, but one screw was broken. There was a caudal displacement of the distal humerus. No bridging bony callus was seen (figure 6.20.22).

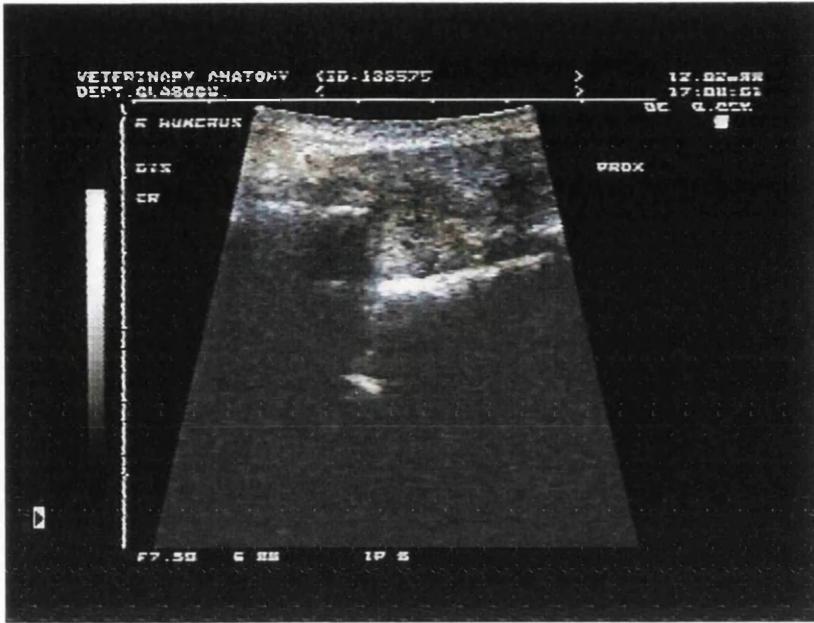
Figure 6.20.23a

Figure 6.20.23 Longitudinal scans of the humerus on day 54 after fracture repair show the fracture site and demonstrate that the two bone segments are poorly aligned. **a**, cranial aspect, **b**, caudal aspect. The proximal segment appears higher than the distal one in **b**. Callus formation can be seen on the bone surface. The area of disorganised hypoechoic appearance in the muscle is suggestive of muscle damage.

Ultrasonographic examination on day 54 after fracture repair showed the fracture site and demonstrated that the two bone fragments were poorly aligned (figure 6.20.23a). On the caudal aspect, only the proximal fragment was clearly imaged which appeared higher than the distal fragment (figure 6.20.23b). The callus formation could be detected by the rough bone surface. The muscle structure still appeared as a disorganised hypoechoic region suggesting an area of muscle damage. The holes on the bone appeared smaller than in the previous scan with callus formation bridging over the hole (figure 6.20.24). The fracture site imaged on the lateral aspect appeared as a groove and the bone fragments were completely bridged by the callus (figure 6.20.25). The bone surface

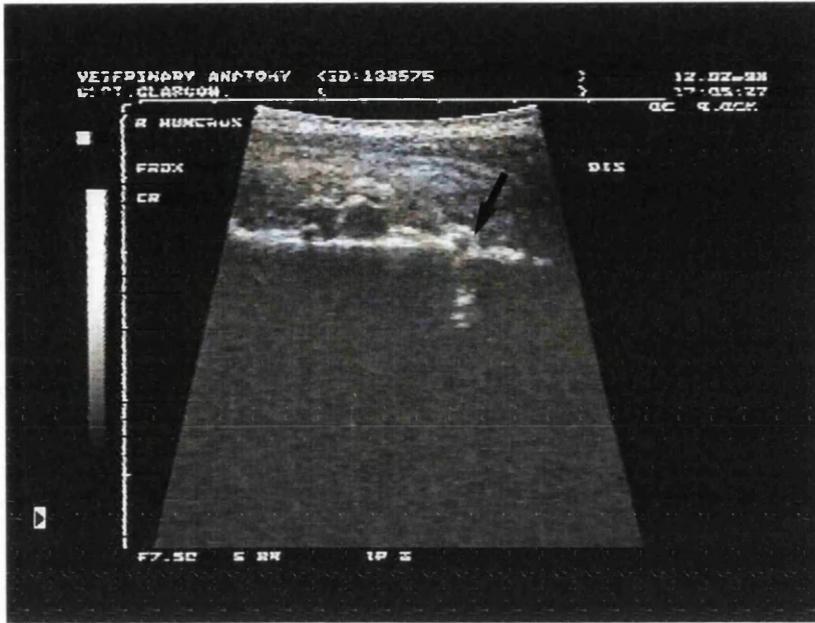
Figure 6.20.24 Longitudinal scan of the distal humerus on day 21 after fracture realignment demonstrates the hole which appears smaller than in the previous scan. The callus formation is seen bridging over the hole.

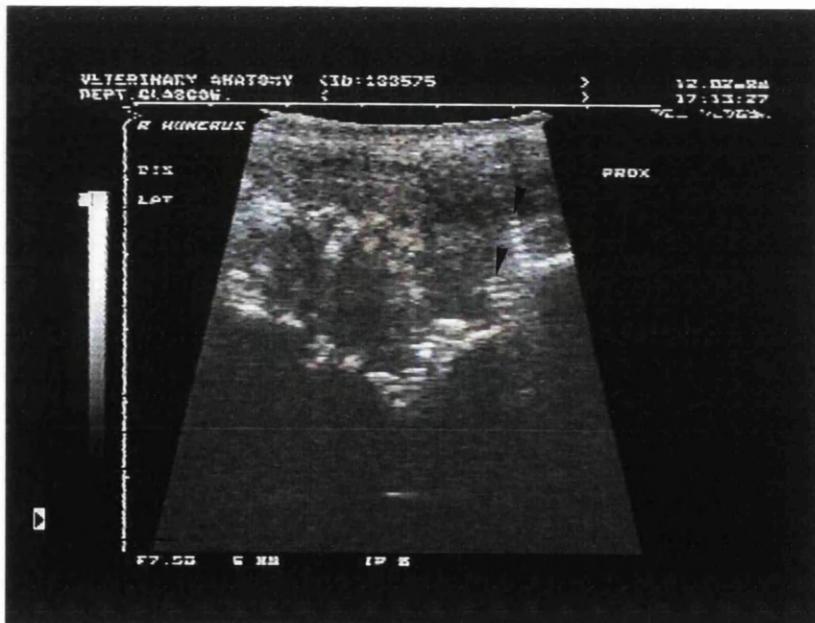
Figure 6.20.25 The fracture site imaged on lateral aspect on day 21 after fracture realignment appears as a groove and the fragments are completely bridged by the callus. The bone surface appears rough due to callus formation. The area of muscle damage can still be seen as disorganised with a mixture of hyperechoic and hypoechoic structures above the fracture site area. A number of screws (arrow heads) are also imaged at the fracture site area appearing hyperechoic.

appeared rough due to callus formation. The area of muscle damage could still be seen as disorganised and a mixture of hyperechoic and hypoechoic structures above the fracture site area. Several screws were also imaged at the fracture site area which appeared hyperechoic. Ultrasonographically, the healing of the fracture site was progressing satisfactorily.

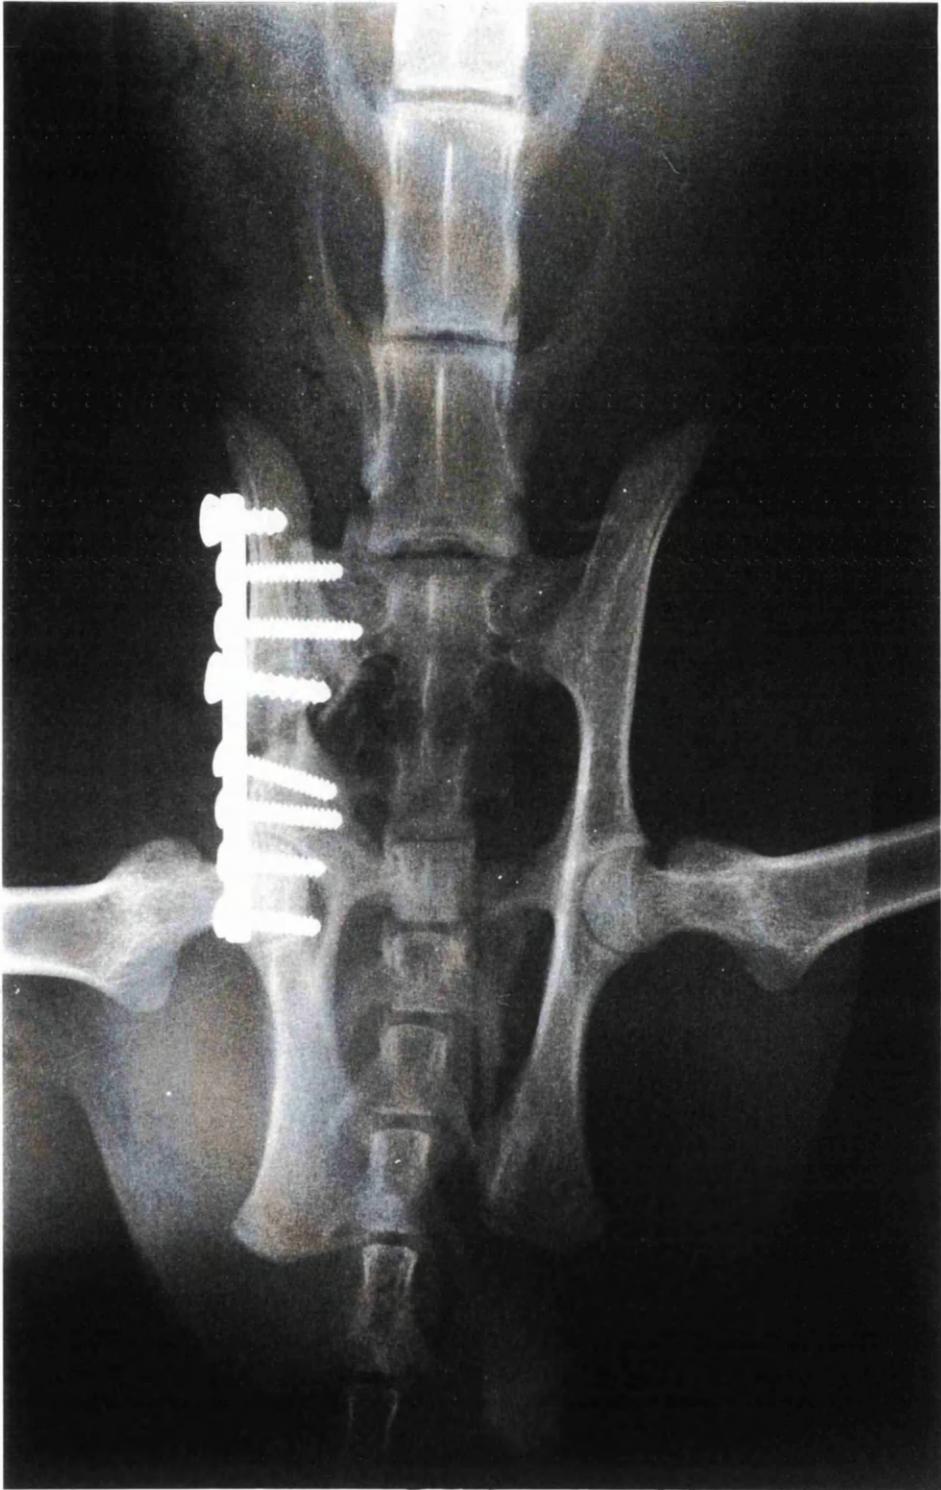
Figure 6.21.1 Radiographs obtained immediately after fracture repair show that the fracture has been stabilised with an eight hole 2.0 mm DCP contoured over the acetabulum and with placement of six screws of two different diameters. The repair process is resulting in a satisfying reduction and alignment with correct positioning of the screws. **a**, lateral view, **b**, dorsal view.

A one year old male neutered domestic short hair cat was presented to the emergency service at Glasgow University Veterinary Hospital for stabilisation of injuries following a road traffic accident. Radiographic examination of the pelvis showed a displaced right ilial shaft fracture had been sustained. A sacroiliac luxation was also present on the left side. After temporary stabilisation over the weekend surgery was performed to stabilise the pelvic fracture. An eight hole 2.0 mm Dynamic Compression Plate (DCP) was contoured over the acetabulum with placement of six screws of two different diameters to repair the ilial fracture. Whilst the cat coped well with conservative management of the pelvic fractures the displaced nature of the caudal fragment on the right warranted surgery to prevent problems in the future with constipation. Radiographs taken immediately after the fracture repair showed satisfactory reduction and alignment and correct positioning of screws (figure 6.21.1).

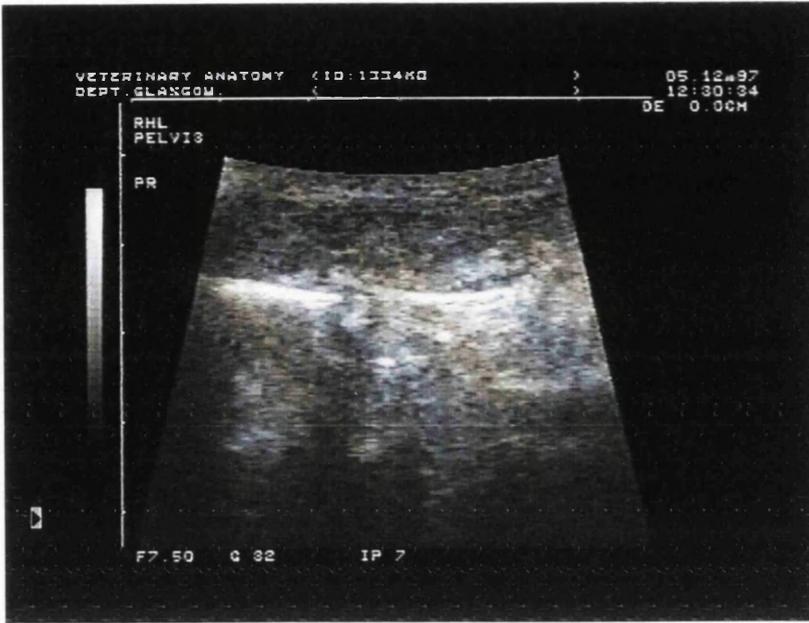
Figure 6.21.2 Longitudinal scan of the ilial shaft on day three after fracture repair demonstrates the fracture site with the presence of disorganised hyperechoic structure around the fracture site suggestive of soft tissue reaction. There is some periosteal reaction present which appears hyperechoic on the bone surface. Note also the area of muscle damage which appears as disorganised hypoechoic material over the fracture site and is mixed with the area of soft tissue reaction.

Ultrasonographic examination of the ilial fracture demonstrated the presence of disorganised hyperechoic material around the fracture site which was suggestive of soft tissue reaction (figure 6.21.2). There was some periosteal reaction present which appeared hyperechoic on the bone surface. The area of muscle damage appeared as disorganised hypoechoic material over the fracture site and was mixed with the area of soft tissue reaction. The bone plate attached to the ilial shaft appeared hyperechoic with reverberation artefact (figure 6.21.3).

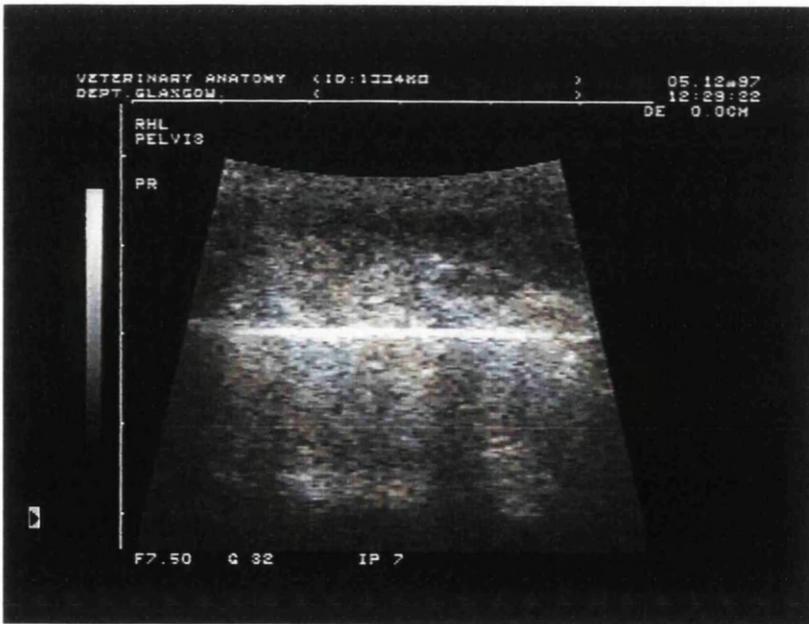
Figure 6.21.3 Longitudinal scan of the ilial shaft on day three after fracture repair demonstrates the straight hyperechoic lines with reverberation artefact which represent the bone plate that is attached to the ilial shaft.

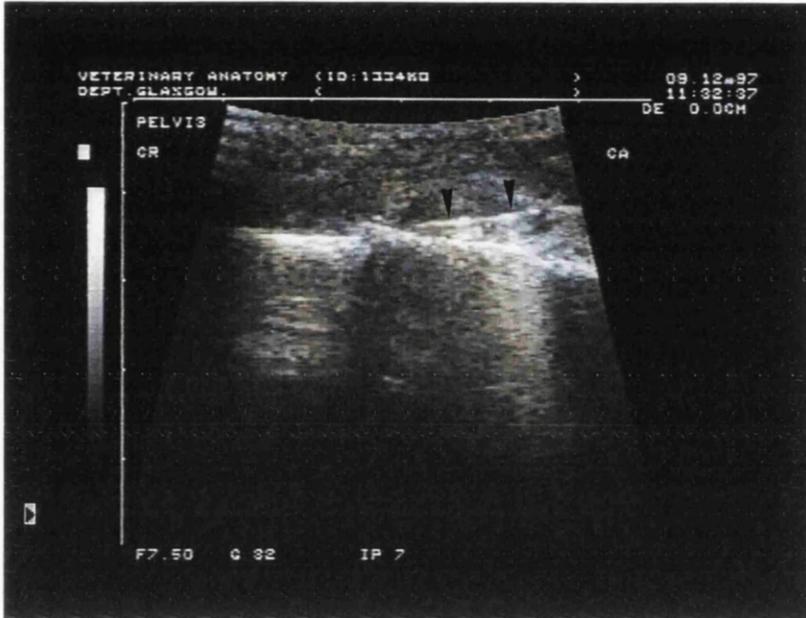
Figure 6.21.4 Longitudinal scan of the ilial shaft on day seven after fracture repair demonstrates the fracture site with a slight angulation of the ilial shaft. The bone plate can be seen over the cranial fragment (arrow heads). There is no callus formation detected.

Ultrasonographic examination demonstrated the fracture site which appeared as a slight angulation of the ilium at the fracture site (figure 6.21.4). There was no callus formation detected. The bone plate appeared hyperechoic with reverberation artefact. The periosteal reaction was detected as on the day three examination. The cat failed to return for reassessment and following ultrasonographic examinations were not done.

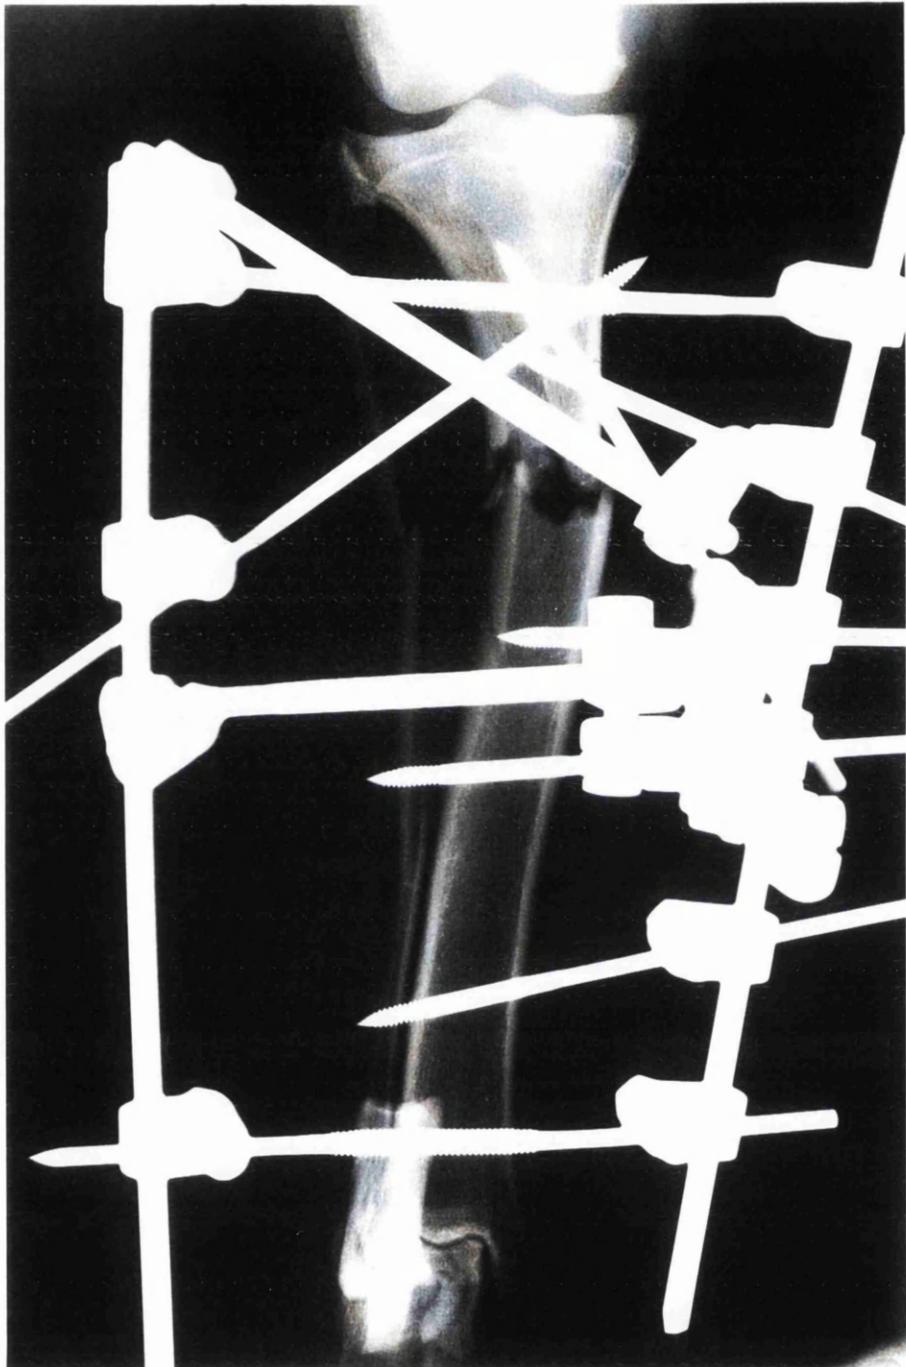
Figure 6.22.1 Radiograph obtained immediately after fracture repair shows the fracture has been repaired and stabilised with modified type II / type III external skeletal fixator. The repair process is resulting in satisfy reduction but with slight angulation.

A one year old male Labrador Retriever, weight 33 kg, was presented to the Glasgow University Veterinary Hospital for assessment of the fracture healing of a tibial fracture. The animal had been involved in a road traffic accident and had sustained a transverse fracture at the proximal third of the tibia and fibula of the right hind limb.. The fracture had been repaired and stabilised with modified type II / type III external skeletal fixator (figure 6.22.1).

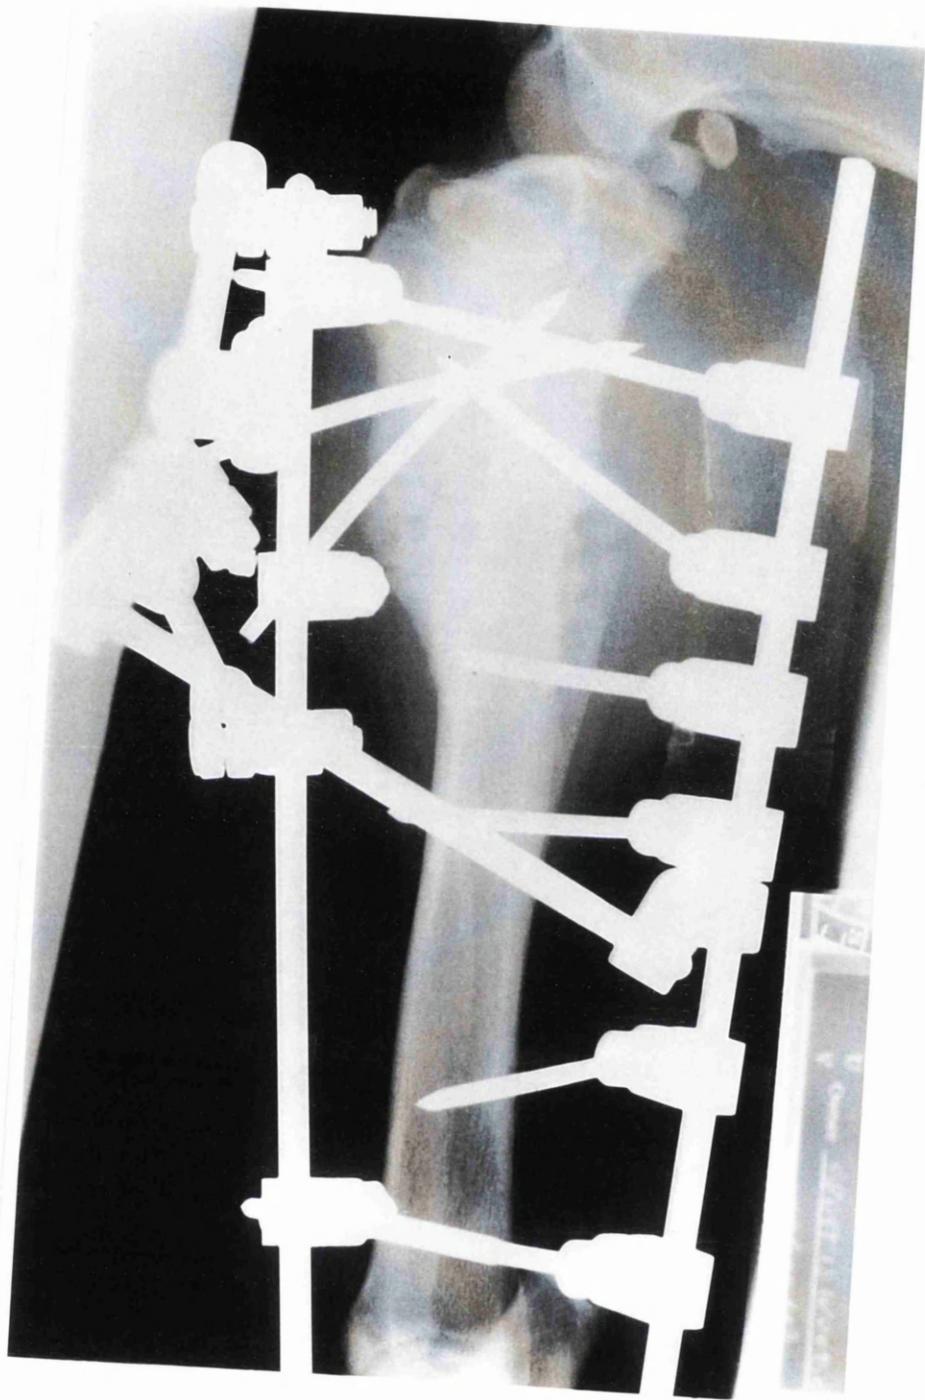
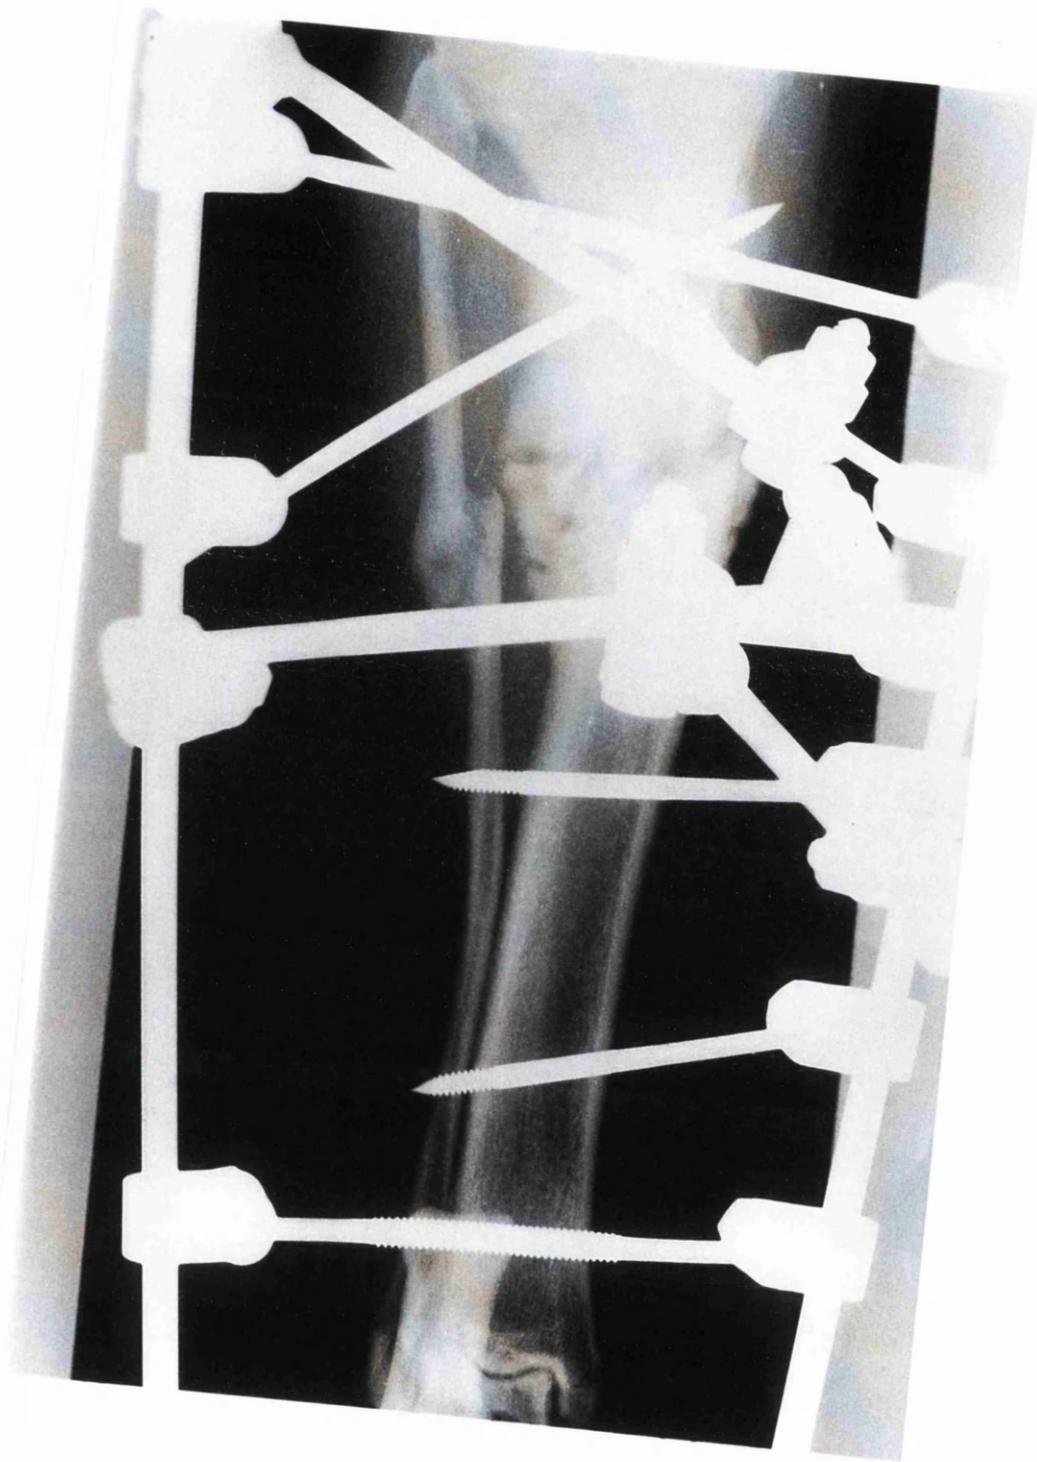
Figure 6.22.2 Radiographs obtained on day 28 after fracture repair show the healing progress is very good. **a**, lateral view, **b**, cranial view. There is one small fragment of bone that looks denser than the rest suggestive of sequestrum in **b**. The external skeletal fixator (ESF) has been scaled down to a modified type one frame.

Clinical and radiographic assessment at day 28 after fracture repair showed the healing progress was very good (figure 6.22.2). On the cranio-caudal view there was one small fragment of bone that looked denser than the rest suggestive of sequestrum. The external skeletal fixator (ESF) had been scaled down to a modified type one frame at this time. The remainder of the frame was proposed to be removed in two to three weeks time.

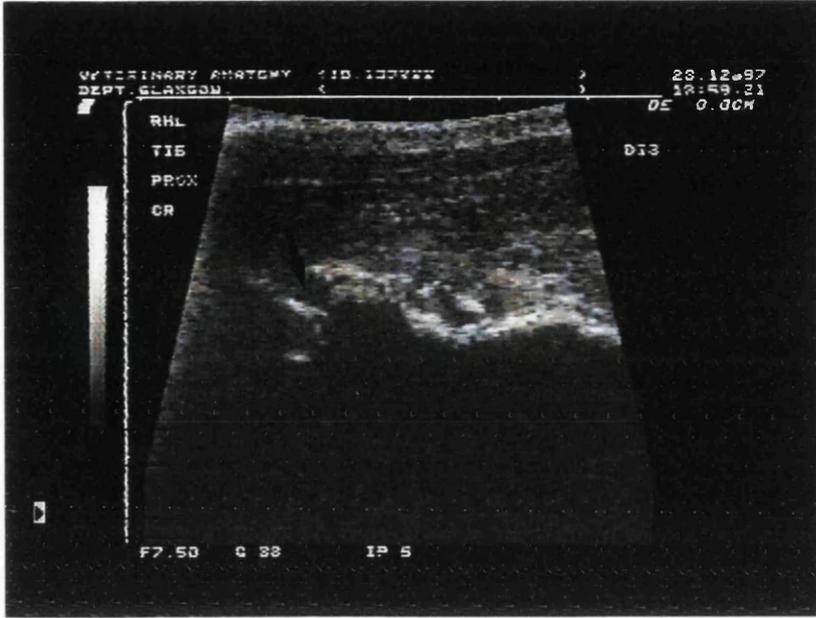
Figure 6.22.3 Ultrasonographic examination on day 28 after fracture repair demonstrates the fracture site (arrow) area with the presence of callus formation and appears as a rough and uneven bone surface. The fracture site is being bridged by the callus. The muscle tissue appears to have a normal ultrasonographic appearance.

Ultrasonographic examination of the fracture site area demonstrated the presence of callus formation bridging the fracture site (figure 6.22.3). The callus formation appeared hyperechoic with a rough and uneven bone surface. The muscle structure appeared to have normal ultrasonographic characteristics. The normal part of the tibia appeared hyperechoic with a smooth bone surface. The fracture site detected on the lateral aspect scan appeared as a small shallow gap on the bulging and rough bone surface which was due to callus formation (figure 6.22.4). The fracture site of the fibula was also detected and had been bridged completely by the callus but the fragments were poorly aligned (figure 6.22.5) The fracture site appeared hyperechoic with a rough border.

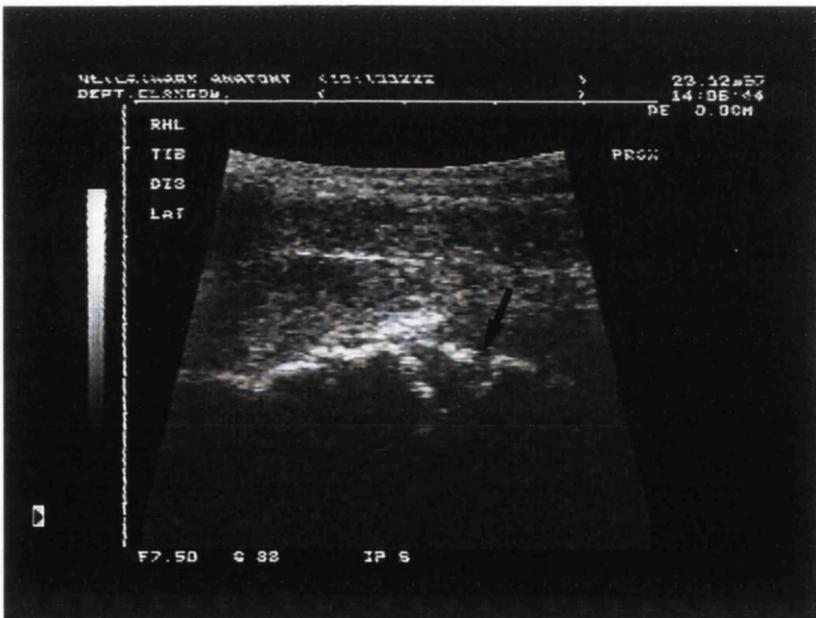
Figure 6.22.4 Longitudinal scan of the tibia from lateral aspect on day 28 after fracture repair shows the fracture site (arrow) which appears as a small shallow gap on the bulging and rough bone surface.

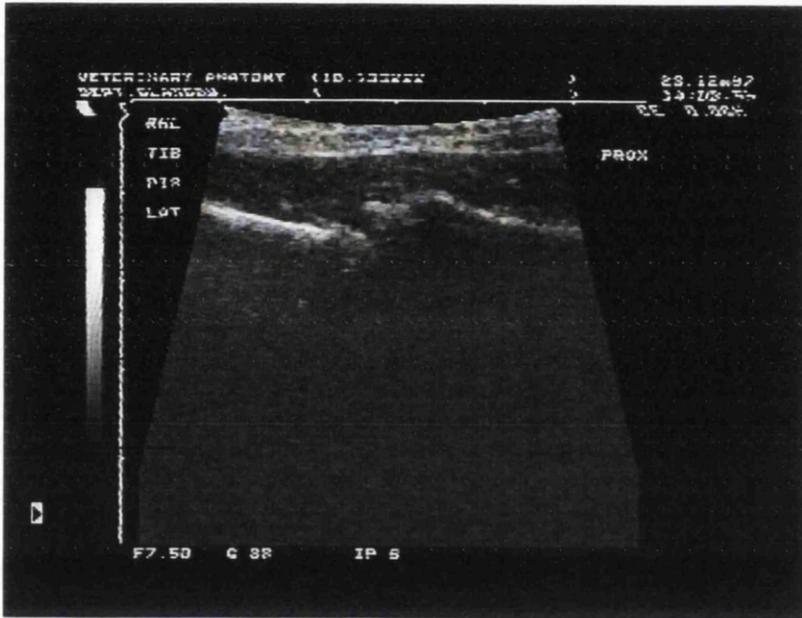
Figure 6.22.5 Longitudinal scan of the fibula on day 28 after fracture repair shows the fracture site which appears as a bulging bone surface. The fracture site has been bridged completely by the callus but the fragments are poorly align.

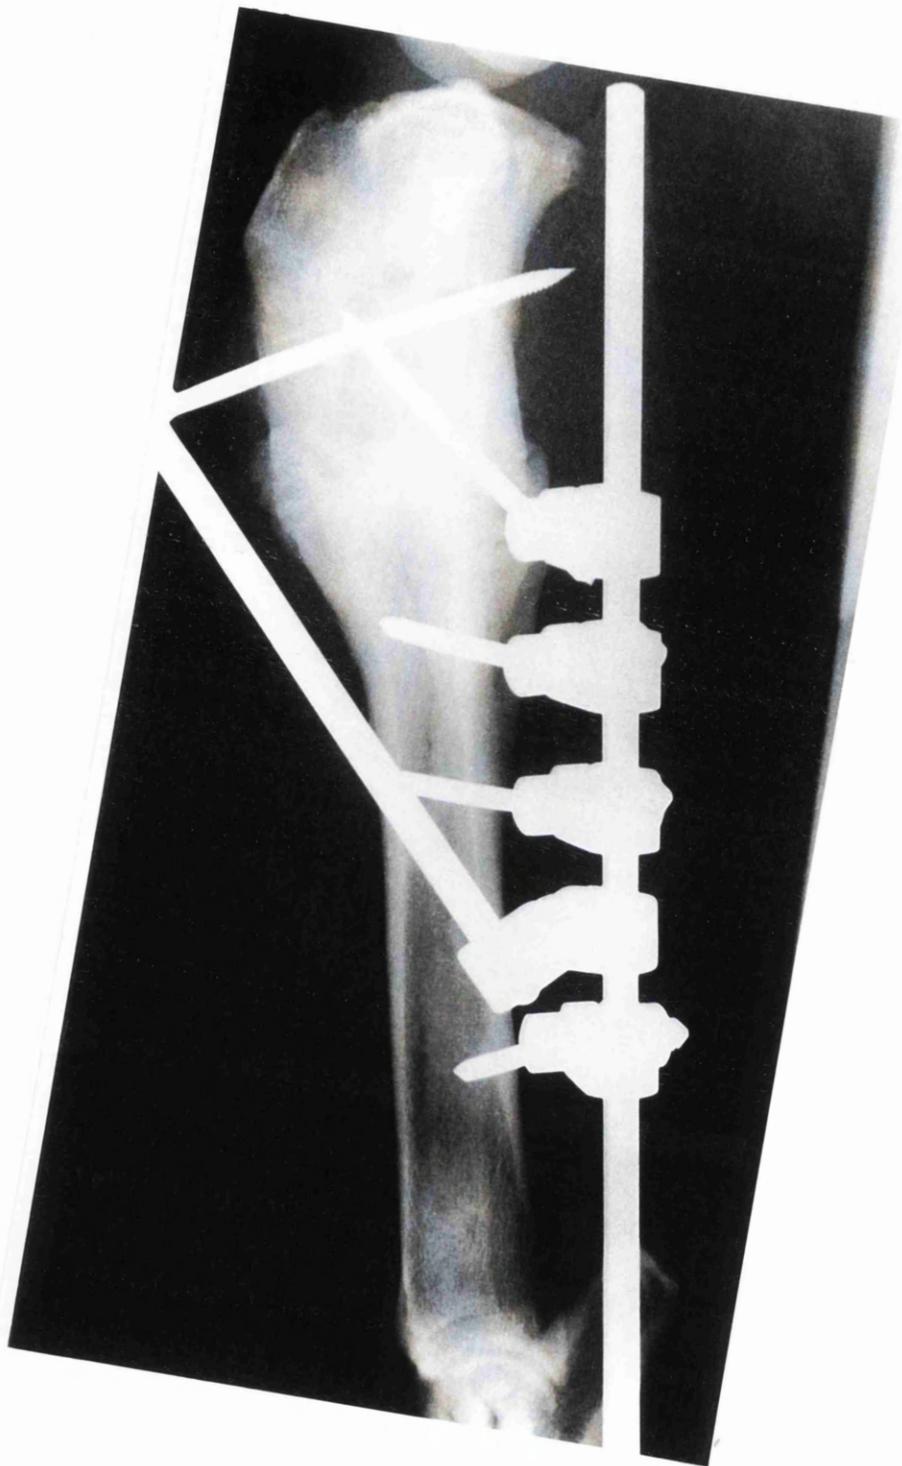
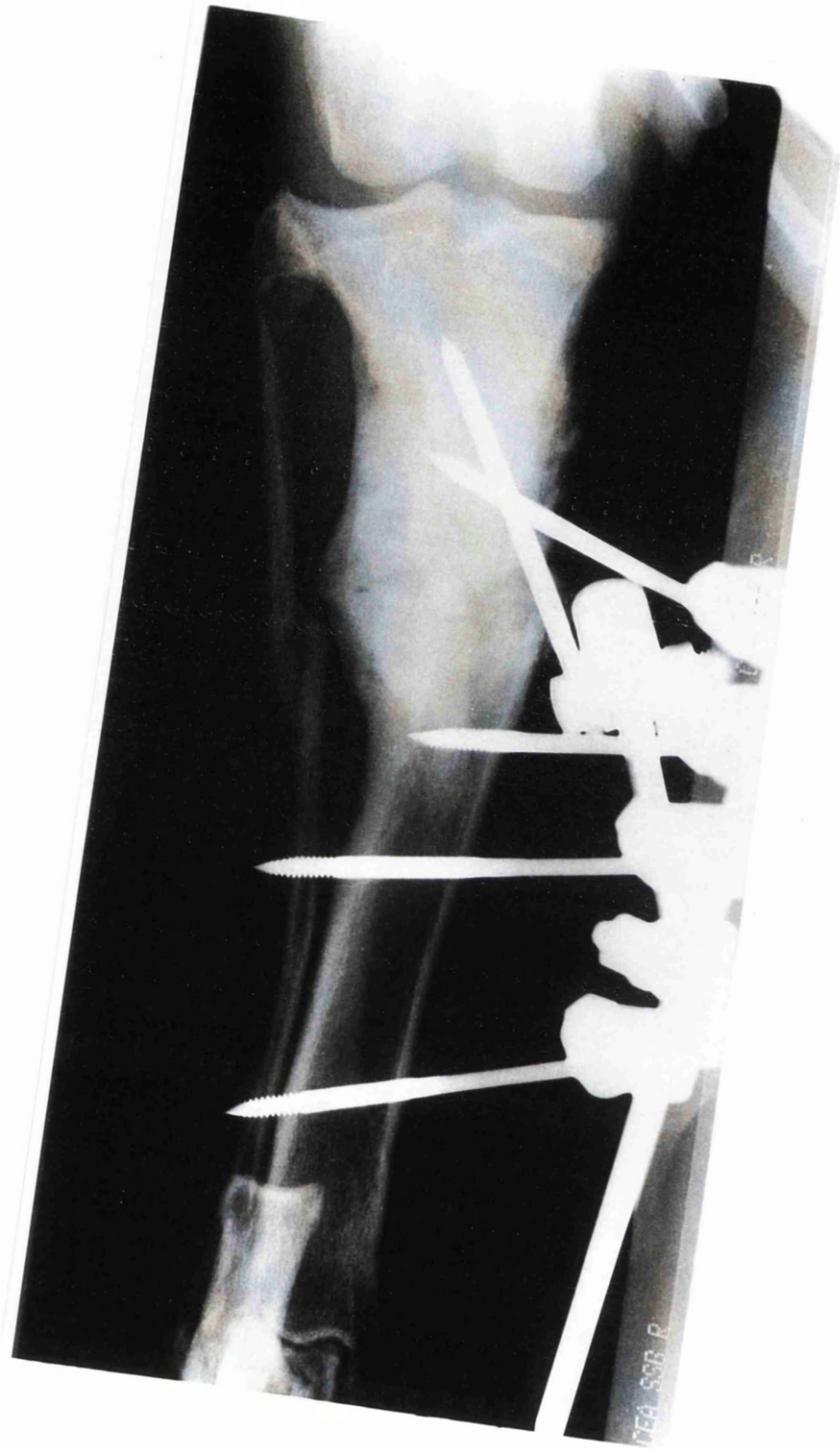
Figure 6.22.6 Radiographs taken at day 50 after fracture repair show satisfying bony callus formation, good reduction but suboptimal alignment. There is slight valgus angulation. The remaining part of the external fixator apparatus has now been removed. **a**, lateral view, **b**, cranial view.

Radiographs taken at day 50 after fracture repair showed satisfactory bony callus formation, good reduction but suboptimal alignment (figure 6.22.6). There was slight valgus angulation. The remaining part of the external fixator apparatus was removed at this stage.

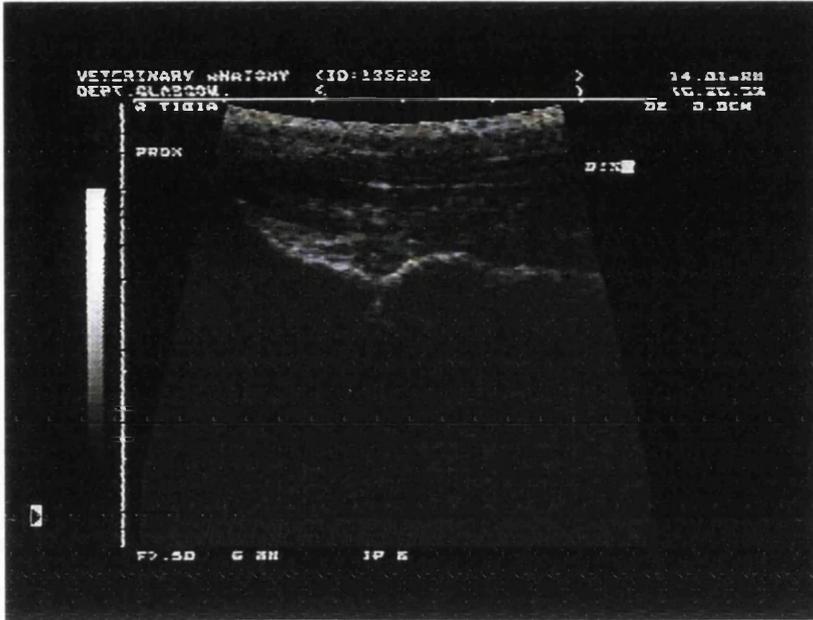
Figure 6.22.7 Longitudinal scan of the tibia on day 50 after fracture repair shows the fracture site area which appears as an uneven but less rough surface. This is suggestive of a remodelling process.

Ultrasonographic examination demonstrated the fracture site area which appeared uneven but with a reduction in the rough surface suggestive of a remodelling process (figure 6.22.7). A hole where the external fixator pin had been previously placed was detected and appeared hyperechoic. There was soft tissue reaction around the hole which appeared as disorganised and hyperechoic (figure 6.22.8). There was also blood accumulation above the hole which appeared anechoic. The fracture site of the fibula appeared as less bulging and the surface had become smooth suggestive of remodelling process (6.22.9). A transverse scan on the lateral aspect at the fracture site area demonstrated the enlarged fibula with a rough surface (figure 6.22.10). Half of the tibia was not visible due to shadowing artefact from the fibula. Ultrasonographically, the fracture site was healing satisfactorily, but was not yet complete.

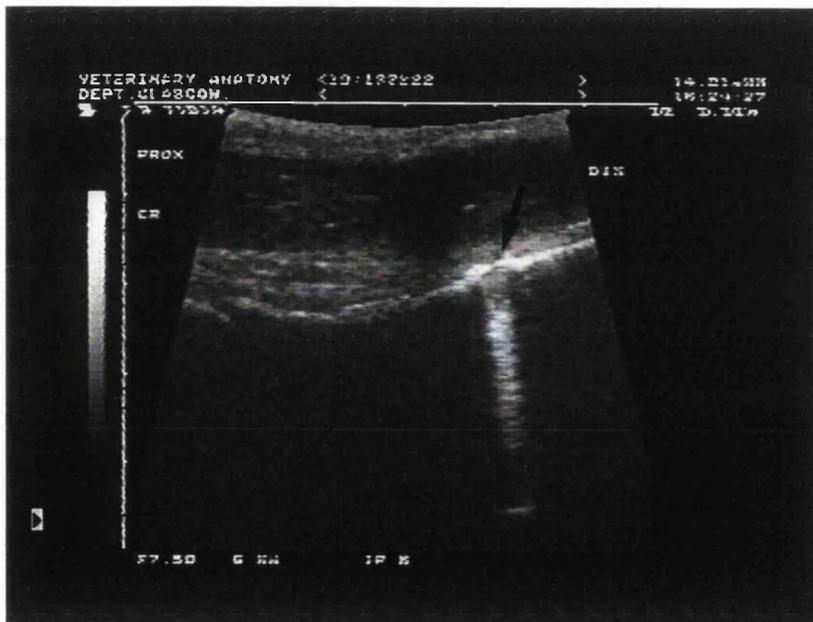
Figure 6.22.8 One hole where the pin was placed before being removed is detected on the tibia distally on longitudinal scan and appears hyperechoic (arrow). There is soft tissue reaction present around the hole which appears disorganised and hyperechoic with blood accumulation above the hole which appears anechoic.

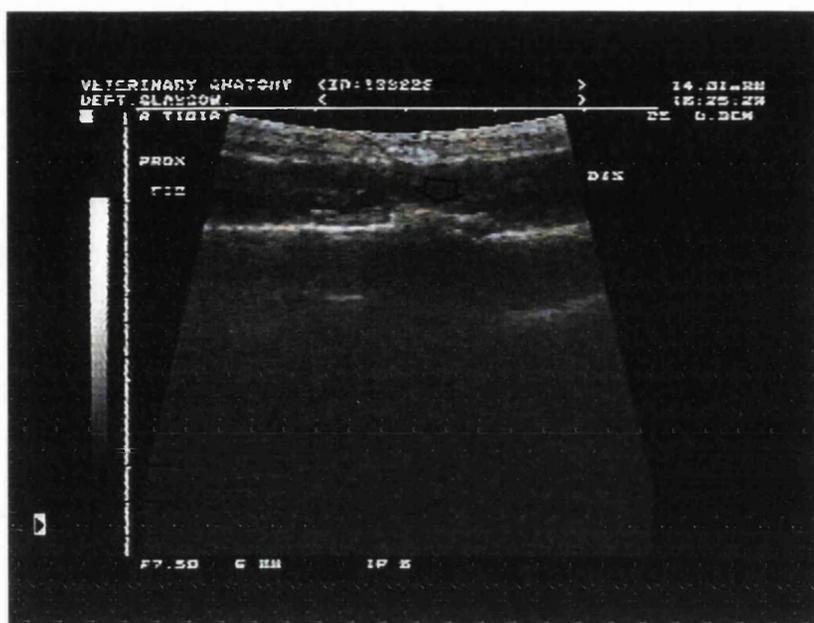
Figure 6.22.9 The fracture site of the fibula bone (blank arrow) imaged on day 50 after fracture repair appears less bulging and the surface has become smooth suggestive of a remodelling process.

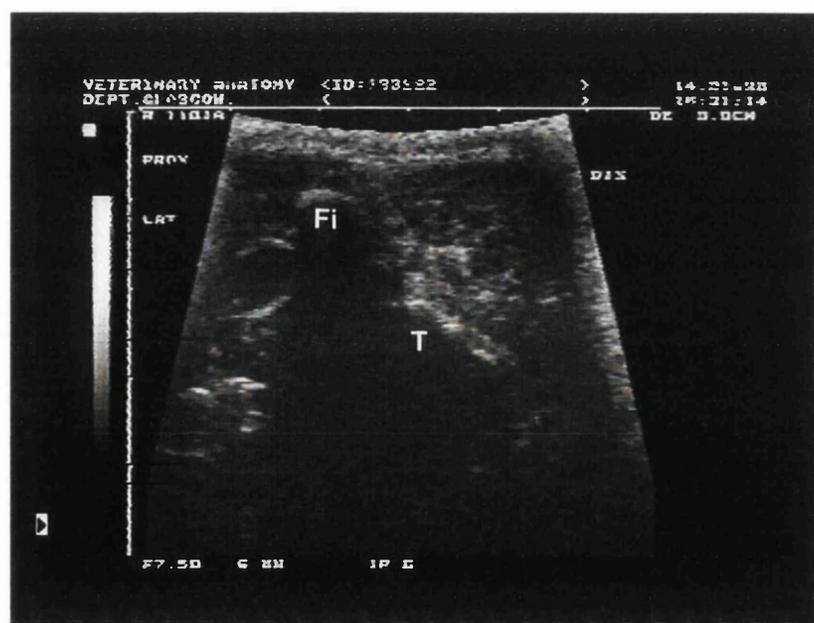
Figure 6.22.10 Transverse scan on lateral aspect at the fracture site area on day 50 after fracture repair demonstrates the enlarged, abnormal fibula above the tibia. Half of the tibia is not seen due to shadowing artefact from the fibula. T, tibia. Fi, fibula.

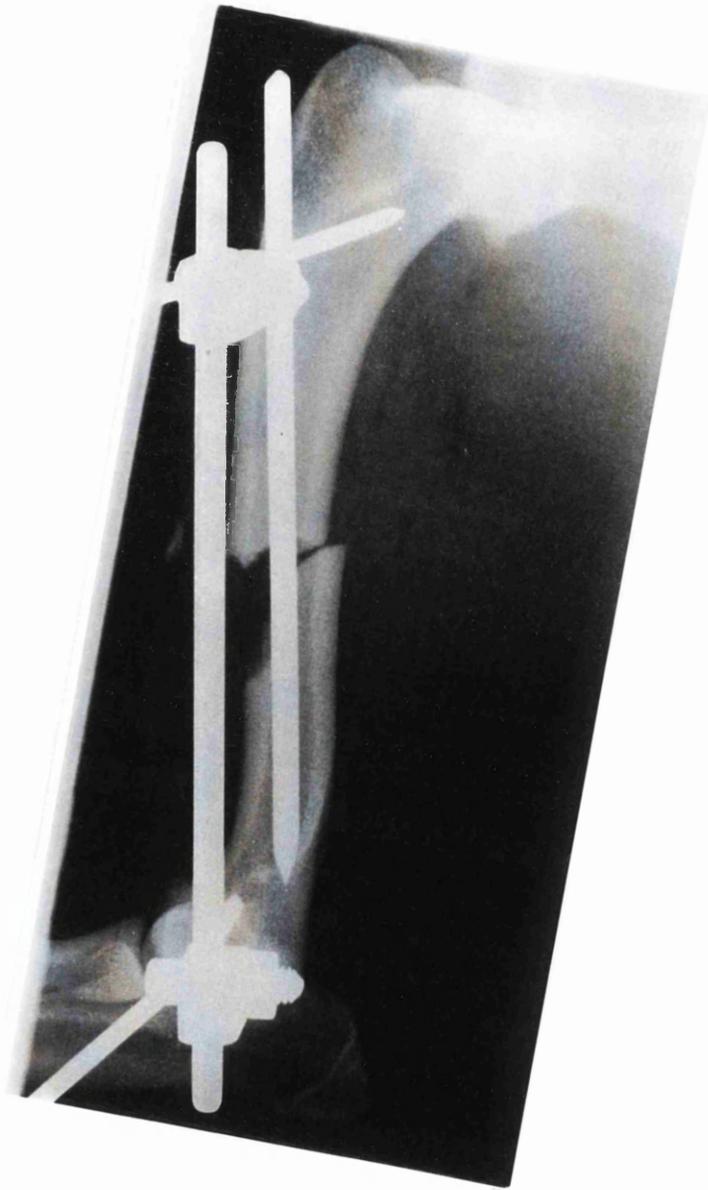
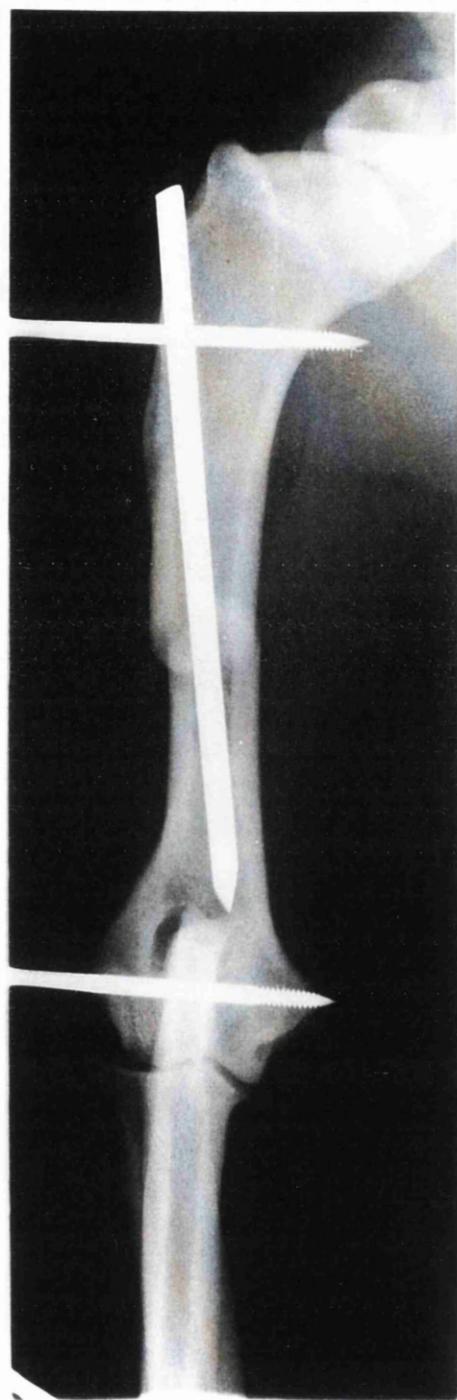
Figure 6.23.2 Radiographs obtained immediately after fracture repair show the fracture reduced via a limited exposure and stabilised with an intramedullary pin and a simple type one external skeletal fixator. The fracture repair process is resulting in satisfactory reduction, and alignment. A small bone fragment is remaining, lying cranial to the humerus. The intramedullary pin does not lie sufficiently distally. **a**, lateral view, **b**, cranial view.

A ten year old male Lakeland Terrier, weight 7.34 kg, was presented to the Glasgow University Veterinary Hospital following trauma of unknown origin three days previously. The animal was hospitalised for the first few days to correct the pre-renal azotemia. The animal was experiencing some abdominal pain which may have been due to bruising of the body wall. Radiographic examination of the humerus revealed that an oblique fracture of the left humerus had been sustained (figure 6.23.1). The fracture was reduced via a limited exposure and stabilised with an intramedullary pin and a simple type one external skeletal fixator. Radiographs obtained immediately after the fracture repair showed the fracture process resulted in satisfactory reduction and alignment (figure 6.23.2). The intramedullary pin had not been placed sufficiently distally.
