**AN ULTRASONOGRAPHIC STUDY OF MUSCULOSKELETAL
INJURIES AND MAMMARY GLAND TUMOUR IN SMALL
ANIMALS**

A thesis submitted to the Faculty of Veterinary Medicine,
University of Glasgow.

For the Degree of Doctor of Philosophy

Division of Veterinary Anatomy,
Department of Veterinary Preclinical Studies,
School of Veterinary Medicine,
University of Glasgow,
March, 1999

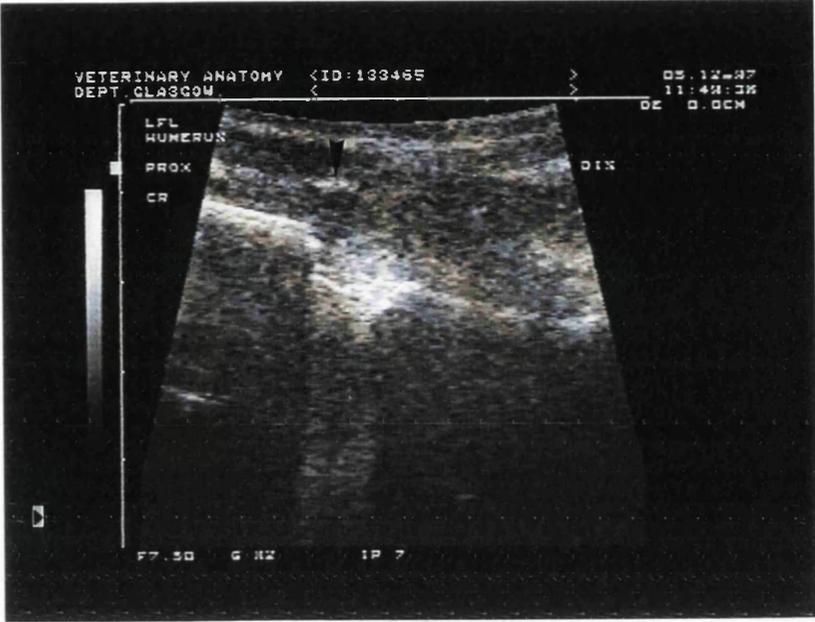
Figure 6.23.3 Longitudinal scan of the humerus from the cranial aspect on day three after fracture repair demonstrates the fracture site with the presence of a fracture gap. There is a well defined border of the bone fragment and no evidence of callus formation is detected. The hyperechoic appearance at the fracture site suggests soft tissue reaction and periosteal tissue reaction. Note also the small fragment above the humerus (arrow head) which appears hyperechoic.

Ultrasonographic examination on day three post-operation demonstrated the fracture site with the presence of a fracture gap (figure 6.23.3). There was a well defined border of the bone fragment and no evidence of callus formation was detected. However, there was an hyperechoic appearance at the fracture site suggestive of soft tissue reaction and periosteal tissue reaction. One small bone fragment lying superficial to the humerus was detected on cranial aspect scan and appeared hyperechoic. The fracture site imaged from caudal aspect scan appeared hyperechoic with a small gap present (figure 6.23.4). The bone ends appeared well aligned on the caudal scan but there was also no evidence of callus formation caudally. The fracture site on a transverse scan appeared with an abnormal shape of the humerus as compared to the normal part (figure 6.23.5a and 6.23.5b). The small bone fragment cranial to the humerus appeared hyperechoic with acoustic shadowing artefact. There was no area of muscle damage detected in this case. This was because no incision has been made on the muscle in the reduction procedure. The animal failed to return for

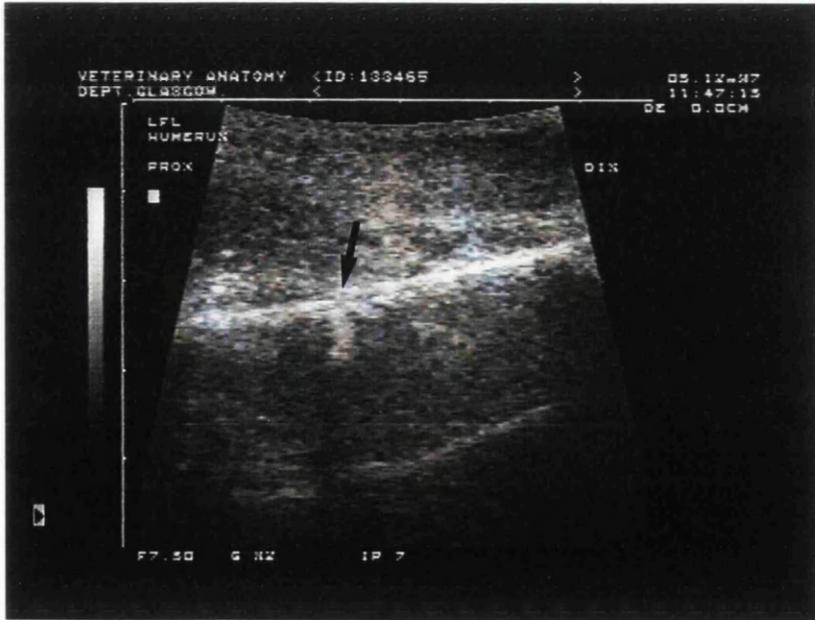
Figure 6.23.4 Longitudinal scan of the humerus from caudal aspect on day three after fracture repair demonstrates the fracture site which appears hyperechoic with a small gap (arrow). Note that the bone fragments appear well aligned and there is no evidence of callus formation.

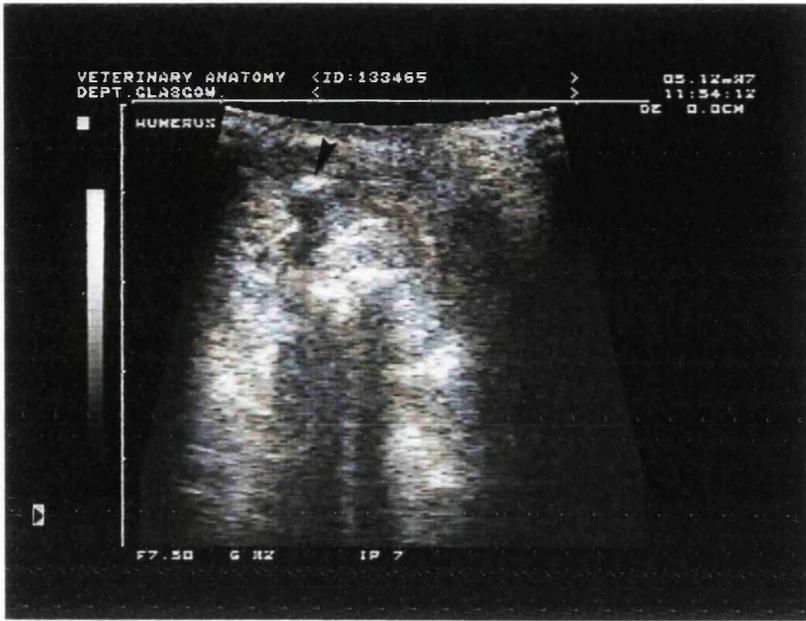
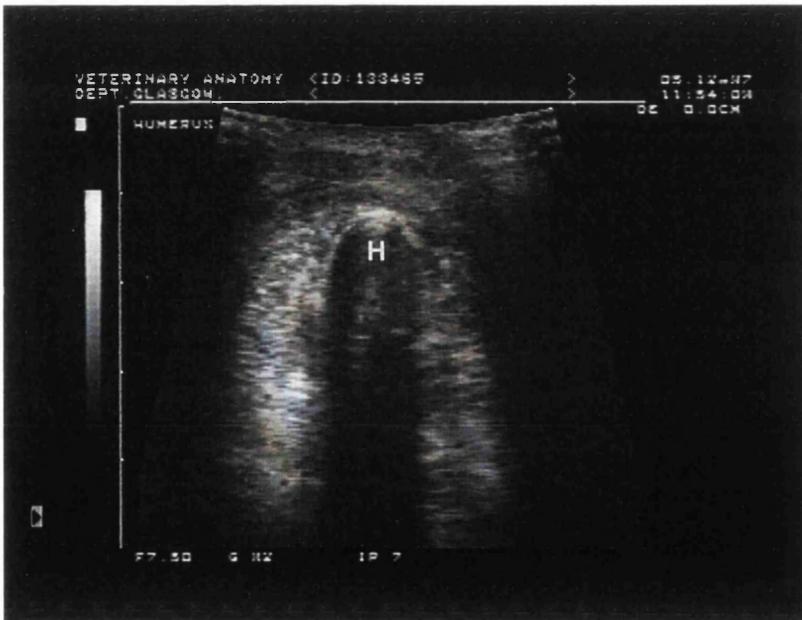
Figure 6.23.5a

Figure 6.23.5 Transverse scans of the humerus at the fracture site area from cranial aspect on day three after fracture repair show the abnormal appearance of the humerus (**a**) as compared to the normal part (**b**). Note also that the small bone fragment lying cranial to the humerus (arrow head) appears hyperechoic with acoustic shadowing artefact (**a**). **H**, humerus.
